**FINAL REPORT (Project BDV25-977-69)**

**Identification of the Mechanisms that Produce Hydrogen Embrittlement on  
Post-Tensioning Members and the Effects of Galvanic Coupling on Bridge  
Tendons**

**Final Report to Florida Department of Transportation**

April 2022

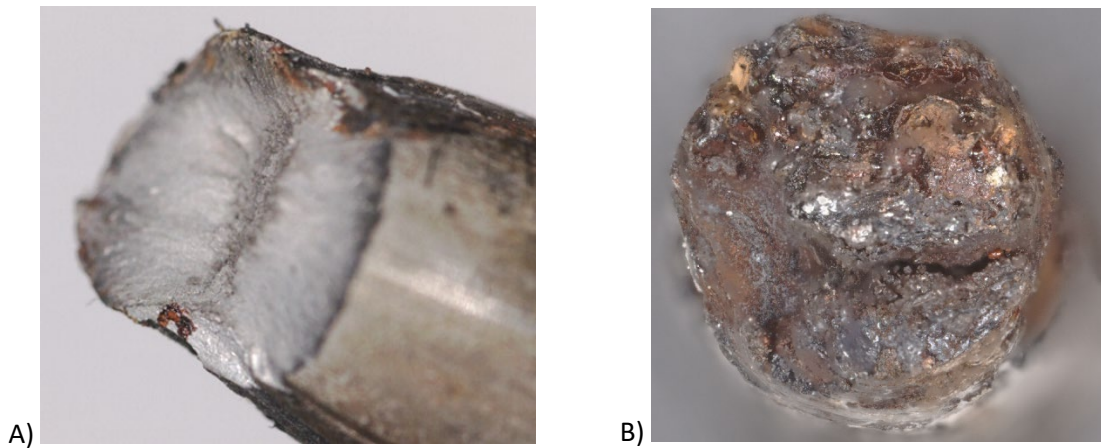
Figure 3-3. Example of (A) ductile failure with partial cup/cone fracture pattern; (B) brittle failure.

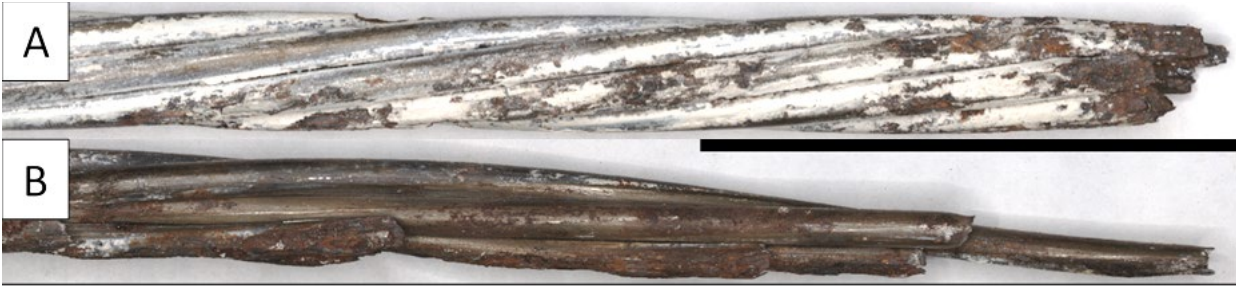
Ideally, as the tensioned high-strength steel strands are stressed beyond their yield strength, the individual wires will start to neck. The necking process occurs gradually at first and once the cross-section of the strand becomes reduced, the rate of necking will increase. The delayed behavior of ductile necking fracture allows for the tensile stresses to be redistributed from the necking wire to other neighboring wires in the same strand. In contrast, when the tensioned high-strength steel strands undergo brittle fracture behavior, the individual wires will fracture abruptly, often leading to neighboring wires to fracture near each other. Figure 3-4 shows an example of wires failing in different locations along a single strand. 51% (52/102) of the fractured wires showed no visual signs of necking and resembled a brittle failure mode. Only 10.8% (11/102) of wires showed good cup/cone ductile behavior. In general, the wires that showed ductile behavior had clear necking at the fracture and mild to no corrosion near the fracture. 54.5% (6/11) of the ductile wires that showed good cup/cone behavior were king wires.

Figure 3-4. Example of (A) a strand with brittle fractures on all wires and (B) a strand with a combination of ductile and brittle fractured wires.

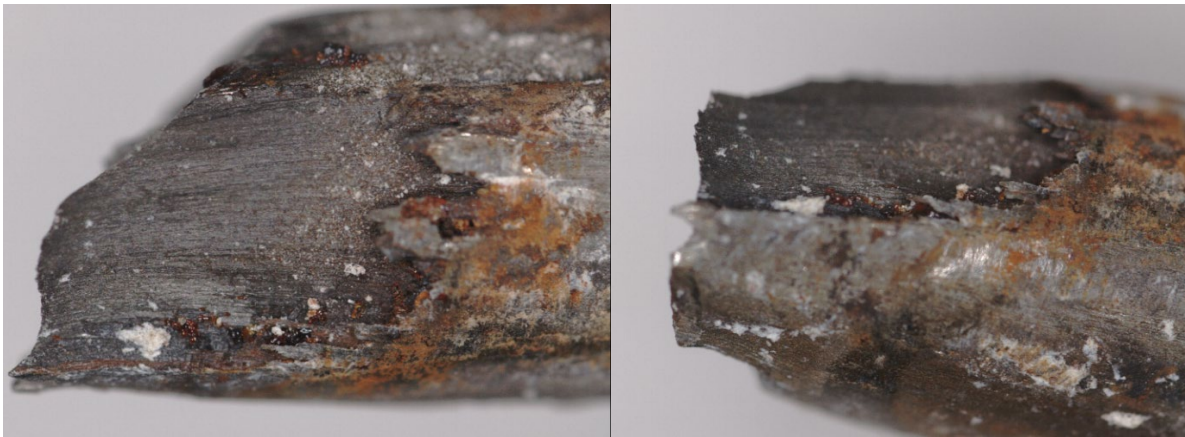
Additionally, it was noted that on  $\frac{3}{4}$  of the strands, a fracture surface that was oriented at a slight angle to the longitudinal axis of the wires was present. An example of this is shown in Figure 3-5. The smooth surface resembles a shear cracking plane normally observed at a 45-degree angle to the orientation of maximum tensile stress. The winding of the wires around the king strand could have resulted in shear cracks at a slightly different angle but confirmation of this is required. Shear cracking generally occurs due to excessive shear stress applied to a slip plane during yielding of the steel.

Figure 3-5. Example of a single wire with shear cracking at the fracture end.

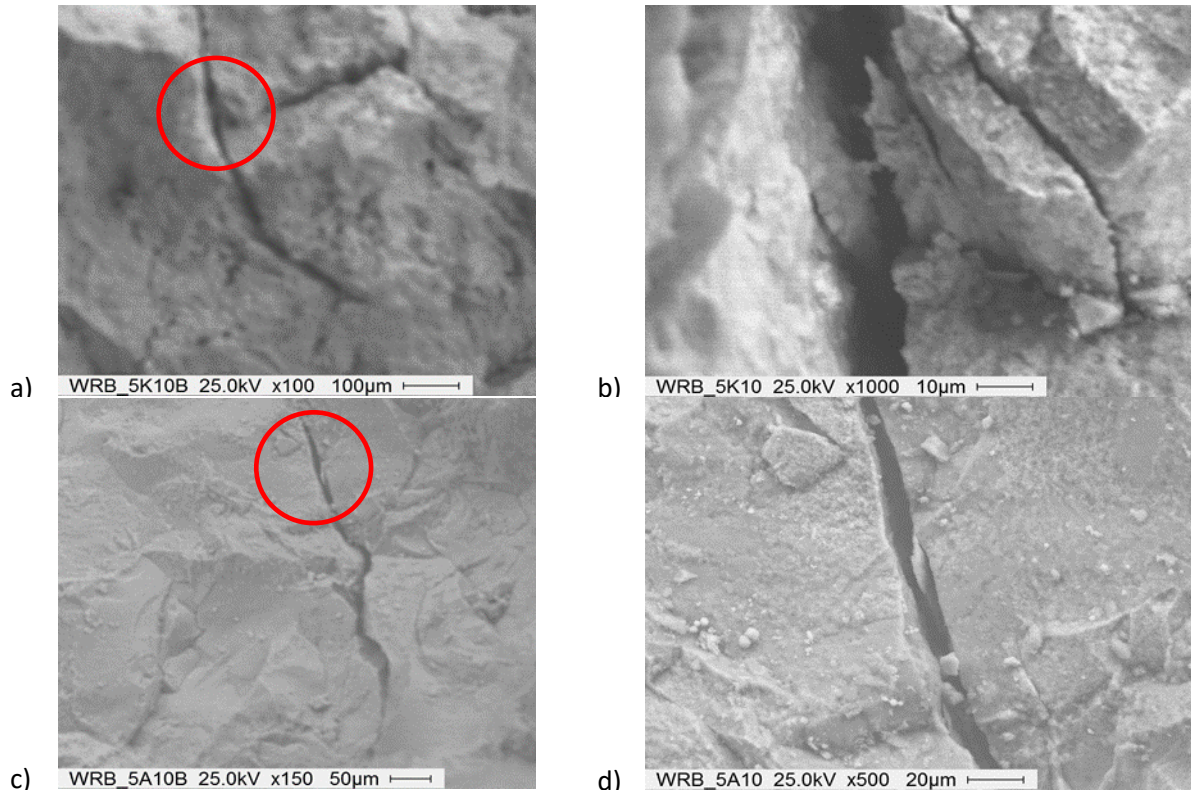
Another visible feature associated with some of the brittle failures was the presence of cracks at the fracture surface progressing longitudinally into the fracture plane and along the length of the wire. An example may be observed in the micrograph presented in Figure 3-6. These microcracks were viewed on the fracture surface of the wires however, other microcracks were also found on the side of some wires. According to [44], as the hydrogen content within the wires increases, the extent of longitudinal splitting increases and the fracture surface becomes more tortuous. Therefore, the microcracks observed are a good indication of hydrogen embrittlement.

Figure 3-6. SEM images of a microcrack on a brittle wire. Images (B) and (D) are taken at higher magnifications at the circled areas of the cracks seen on images (A) and (C), respectively.

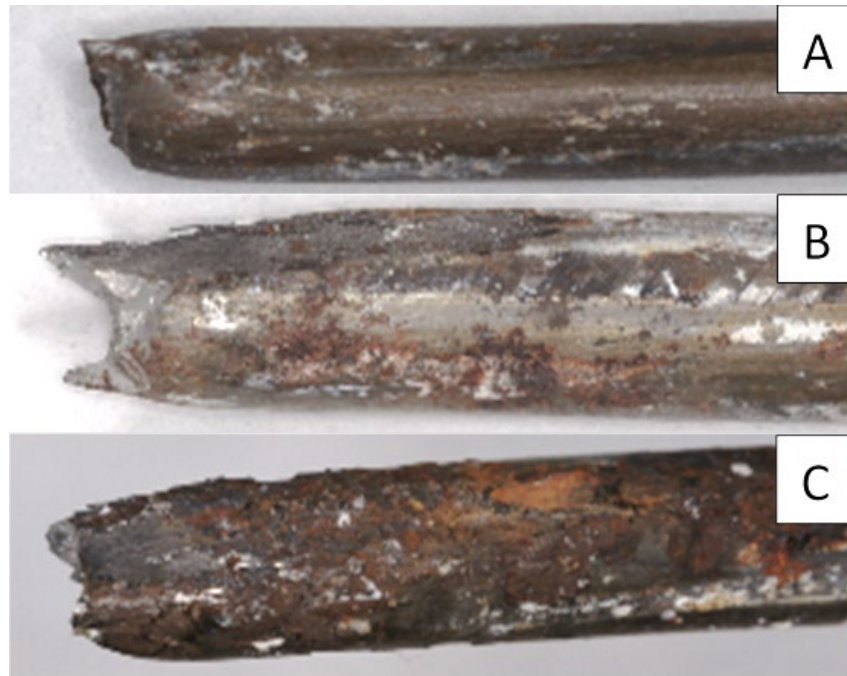
While the fracture patterns clearly show indications of embrittlement, they do not necessarily reveal their cause. Embrittlement can occur under excessive cathodic polarization or it can be induced by corrosion. Based on the results provided in Table 1, 97.1% (99/102) of wires examined showed some signs of corrosion, whether it be mild or moderate, leaving only 2.9% (3/102) of wires showing no signs of corrosion. An example of each degree of corrosion can be seen in Figure 3-7. In general, most of the wires observed experienced mild uniform surface (Figure 7b) corrosion near the fractured end of the strand. In some cases, moderate corrosion was observed in more localized areas in the form of significant metal loss. Only a few of the wires did not have visible signs of corrosion near the fractured end.

Figure 3-7. Example of (A) strands that have no corrosion, (B) mild corrosion, and (C) moderate corrosion.

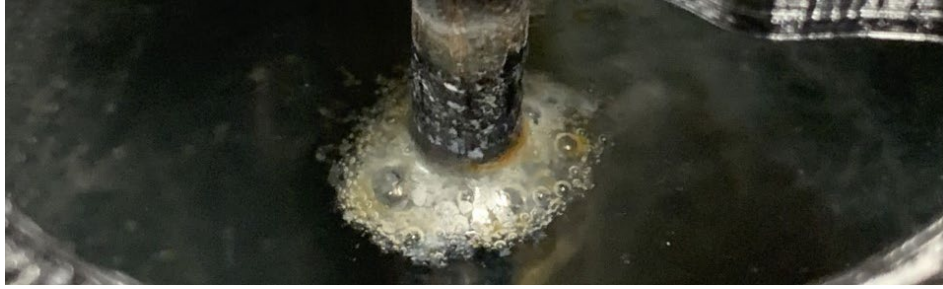
Based on Figure 4-6 to Figure 4-8, the elevated current densities of the voided tendons filled with mild and aggressive water show that the hydrogen evolution reaction was likely occurring throughout the duration of those experiments. Further evidence of the hydrogen evolution reaction can be seen in Figure 4-9. This figure shows a photo of one of the solution-filled mock tendons at the end of the experiment where small bubbles were visible at the steel solution interface likely resulting from their formation due to hydrogen evolution at the steel strand surface.

Figure 4-9. A photo of a galvanized steel duct filled with an aggressive water solution after one week of exposure showing hydrogen bubbles forming on the surface of the steel.

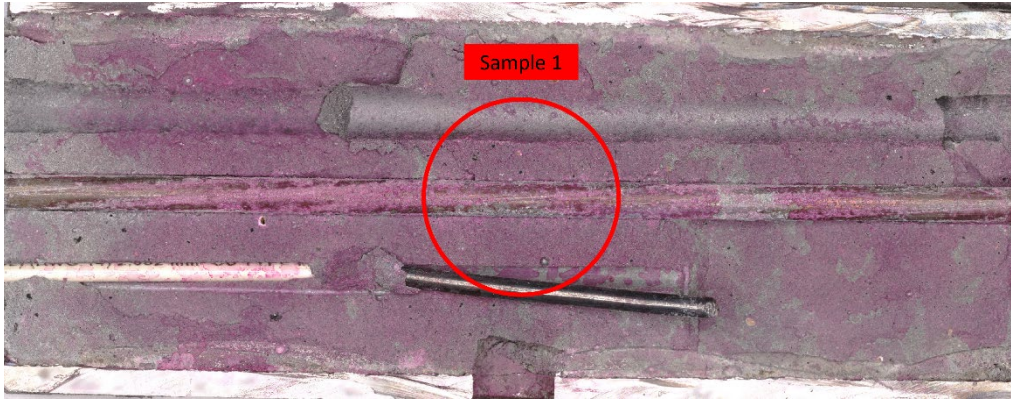
Tendon 1 was cast with the manufacturer's recommended water-to-cement ratio of 0.28 referred to as the good grout condition. During the autopsy, the grout was characterized as having a uniform porosity and uniform alkalinity. Figure 5-2 shows the section view of the grout in Tendon 1. The steel wire showed no signs of corrosion or visual signs of embrittlement. Figure 5-3 shows the inside view of the galvanized duct from Tendon 1. The inner wall of the galvanized duct was uniform in color and showed no signs of zinc corrosion or pitting.

Figure 5-2. Section view of Tendon 1 cast with good grout ( $w/c = 0.28$ ).

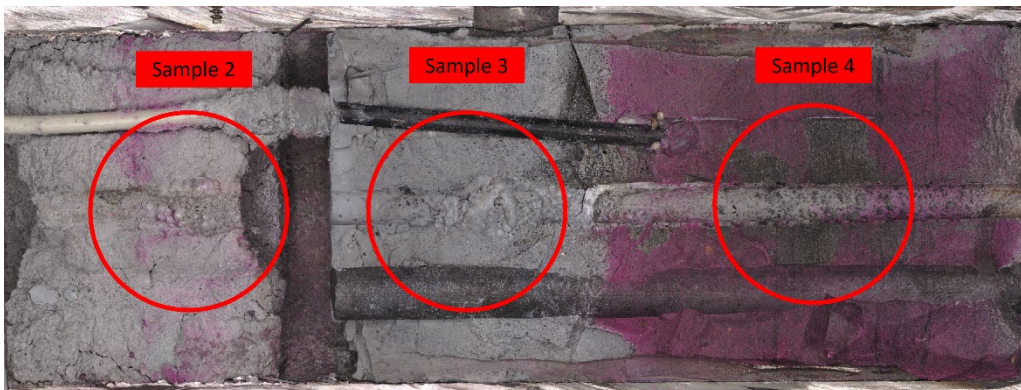
Tendon 5 was cast with a 0.5 water-to-cement ratio which is almost double the recommended amount. This grout condition is referred to as the very soft condition. During the autopsy, the grout was characterized as having two distinct porosities and three distinct alkalinity zones. Importantly, a full void was identified in the upper 1/3 portion of the specimen observed as the left portion in Figure 5-4.

Figure 5-4. Section view of Tendon 5 with very soft grout ( $w/c = 0.5$ ).

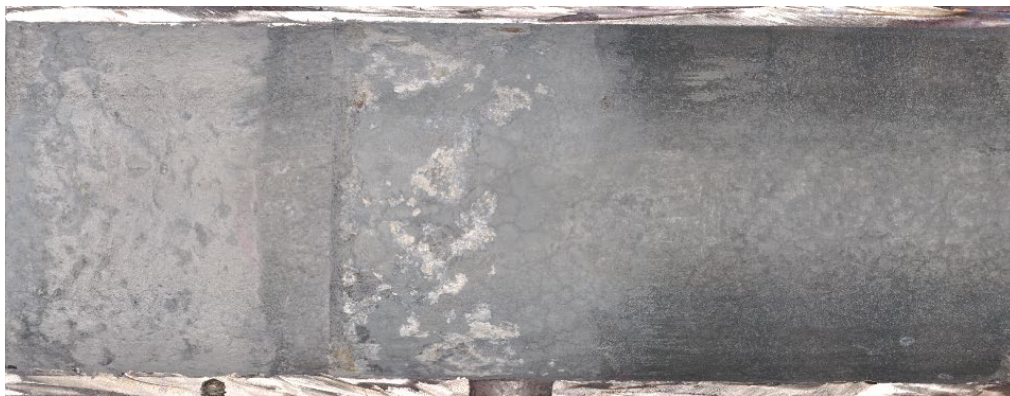
Figure 5-5 shows the inside view of the galvanized duct from Tendon 5. Three distinct zones were observed along the inner surface of the galvanized duct. On the right side of Figure 5-5 (bottom of tendon), the duct wall appeared darker in color corresponding with the size of the high alkaline grout band. The center zone of the duct was lighter in color and white zinc corrosion products can be seen along with minimal amounts of orange iron oxide. The left side of Figure 5-5 (top of tendon) shows a lighter color similar to the center zone but without the zinc and iron oxide products. From this it is clear that the low alkalinity region of the grout resulted in corrosion of the galvanized duct. The maximum corrosion penetration was measured using a 3D profilometer and was  $\sim 76 \mu\text{m}$  which corresponds to an approximate corrosion rate of  $100 \mu\text{m}/\text{yr}$ . If it is assumed that such a high corrosion rate persists over time, corrosion through the thickness of the duct would occur in  $\sim 40\text{-}50$  years. Further analysis of the grout in this region should provide more understanding of the potential cause of the corrosion.

Figure 5-5. Inside view of the galvanized duct from Tendon 5 with very soft grout ( $w/c = 0.5$ ).

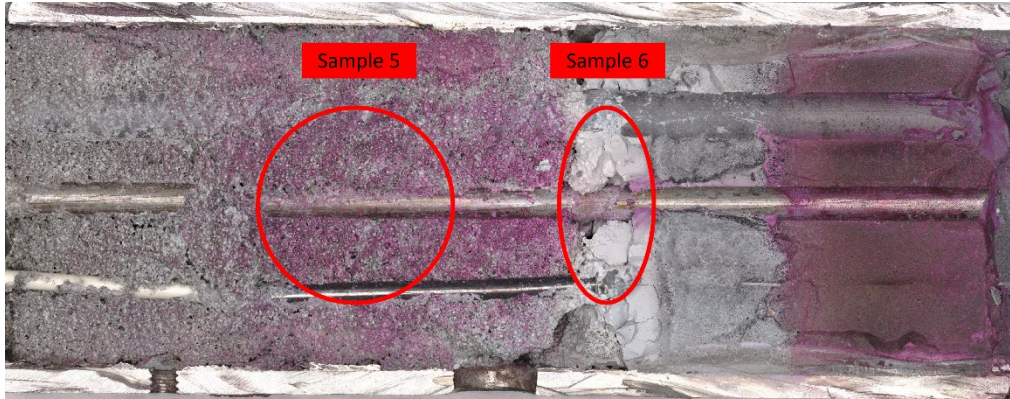
Tendon 7 was cast with an intermediate water to cement ratio of 0.38 referred to as the semisoft grout condition. During the autopsy, the grout was characterized as having three distinct porosities and three distinct alkalinity zones. Importantly, a partial void was identified in the center of the grout. Figure 5-6 shows the section view of the grout in Tendon 7.

Figure 5-6. Section view of Tendon 7 with semisoft grout (w/c = 0.38).

On the right side of Figure 6 (bottom of tendon), beneath the partial void, the grout was of similar porosity and density compared to the good grout in Tendon 1 and the grout at the bottom of Tendon 5. In the center of Tendon 7, the grout was a lighter gray color and was of low strength. On the left side of Figure 5-6 (top of tendon), above the partial void, the grout contained larger pores similar to the grout at the top of tendon 5 and was less dense compared to the grout at the bottom of the tendon. Similar to the grout in the top of Tendon 5, the porous grout above the partial void did not easily propagate cracks initiated from the chisel during the autopsy and instead would crumble when a minimal force was applied to it. Further, the light gray grout in the center of the tendon was even weaker and would crumble when pinching with one's fingers. The alkalinity test showed a distinct band of low alkalinity in the center region of the wire, just below the partial void similar to Tendon 5. The steel wire also showed slight orange staining in the low alkaline region of the grout due to possible corrosion. However, after bead blasting the surface of the wire, no significant corrosion pits were found. Figure 5-7 shows the inside view of the galvanized duct from Tendon 7.

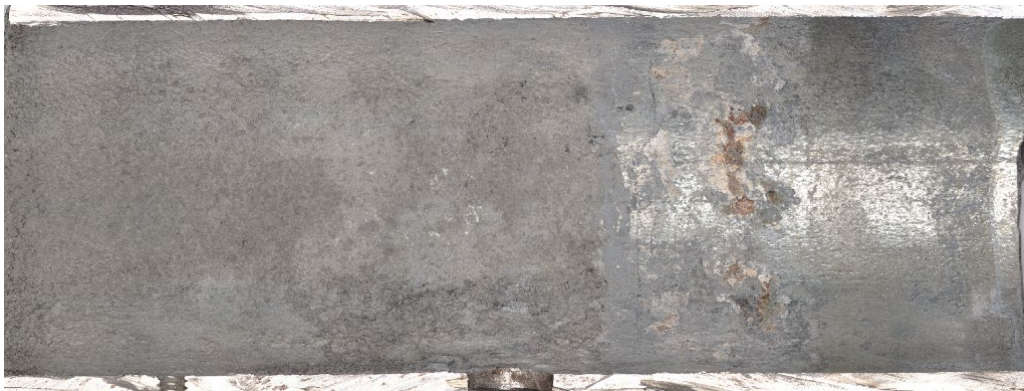
Figure 5-7. Inside view of the galvanized duct from Tendon 7 with semisoft grout (w/c = 0.38).

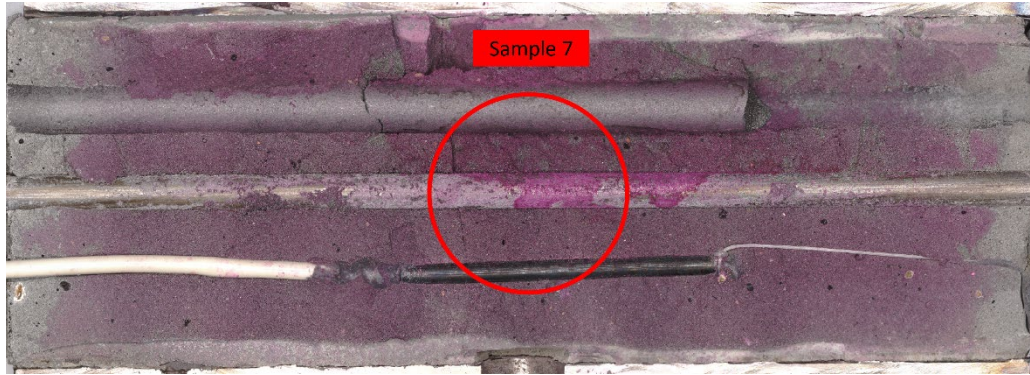
Figure 5-8: Section view of Tendon 10 made with grout mixed from a 3.5% NaCl by weight of water solution ( $w/c = 0.28$ ).

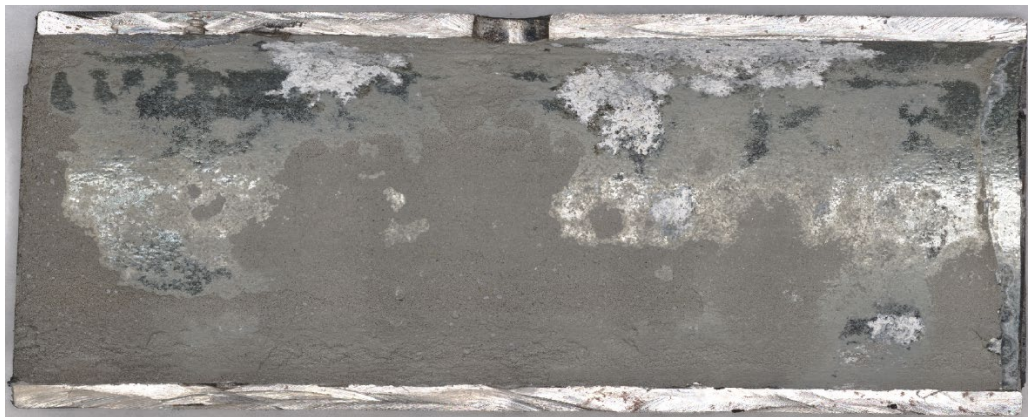
Figure 5-9: Inside view of the galvanized duct from Tendon 10 made with grout mixed from a 3.5% NaCl by weight of water solution ( $w/c = 0.28$ ).
