BDV25-977-69

Florida Department of Transportation Research

Identification of the Mechanisms that Produce Hydrogen Embrittlement on Post-Tensioning Members and the Effects of Galvanic Coupling on Bridge Tendons

June 2023

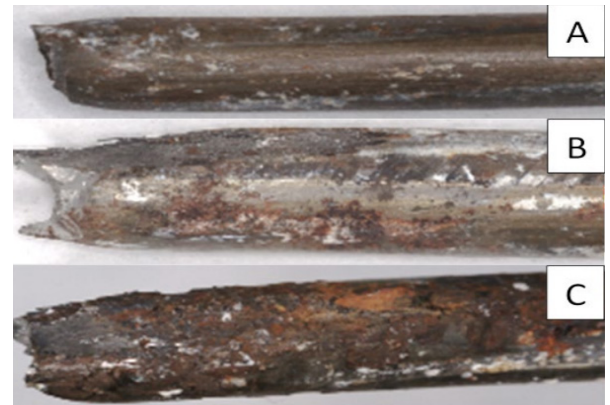
Example of (A) strands that have no corrosion; (B) mild corrosion; and (C) moderate corrosion.
