# Durability Evaluation of Florida's Fiber-Reinforced Polymer (FRP) Composite Reinforcement for Concrete Structures

**Final Report**

**March 2017**

UF Project No. 106074 & 107174  
FDOT Contract No. BDV31-977-01

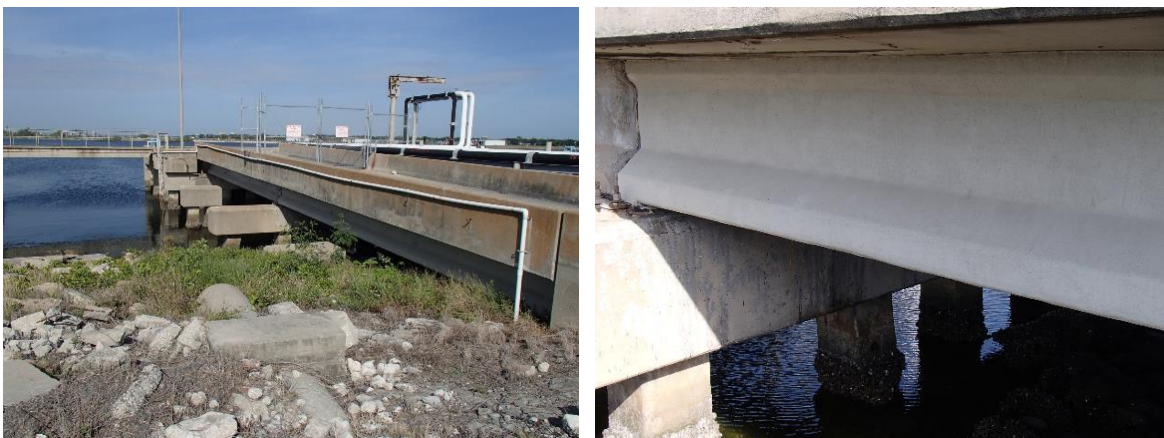
Figure 63—Site conditions at Port of Tampa Berth 21

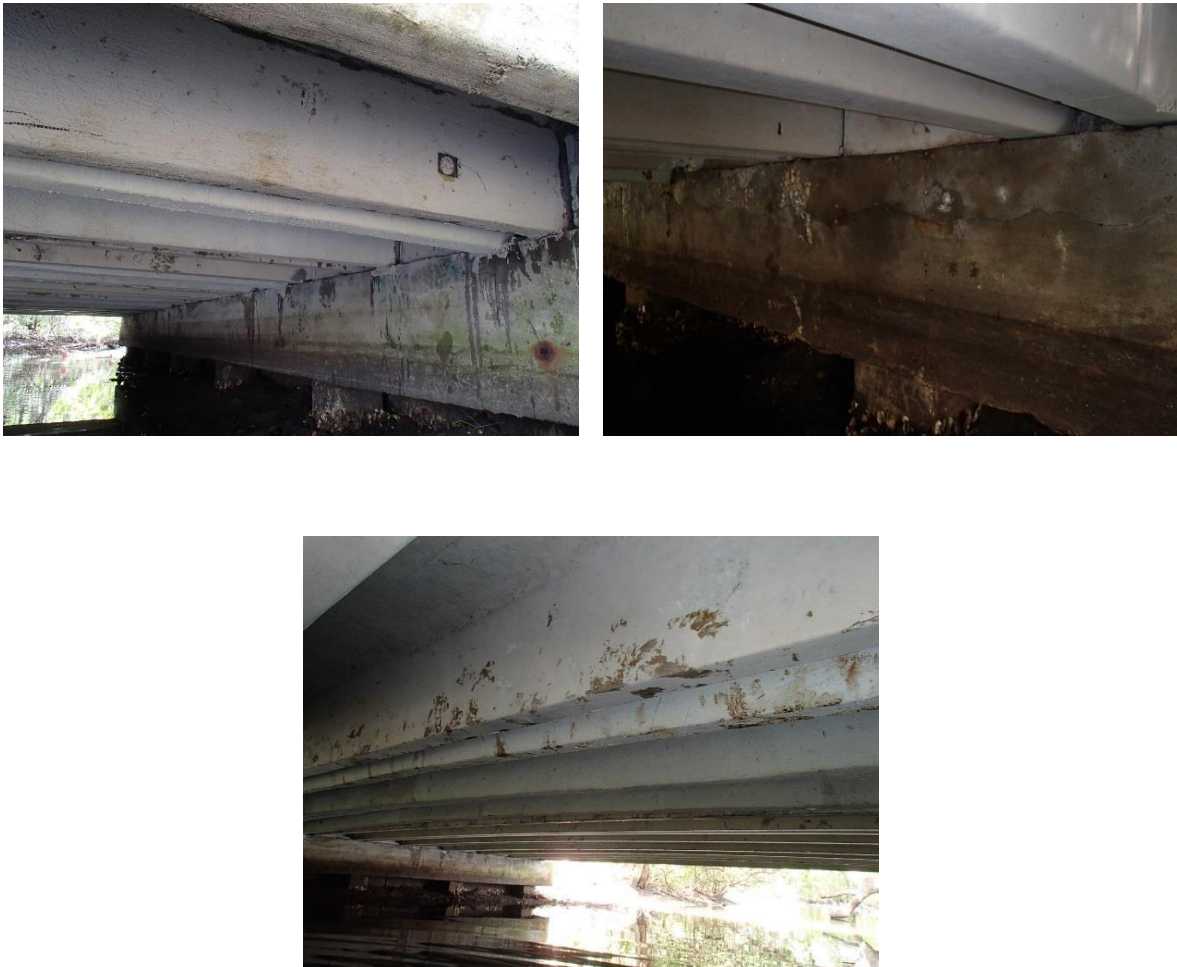
Phillips Lane bridge experienced significant corrosion damage (brackish water environment), and was repaired with CFRP wraps in 2001. No significant deterioration of the composite wrap was observed (Figure 64), with an exception of one girder where an entire side of the wrap was debonded as observed during the visual inspection (Figure 65) based on visual inspection. The debonded CFRP was located on one of the vertical faces of the concrete channel girder; close proximity of adjacent webs would have made accessing the concrete for surface preparation and CFRP installation difficult. Observation of multiple pull-off test locations (performed in the past) revealed rust staining and adhesive failure modes (Figure 66). The inspection was performed in 2015.

Figure 64—Girders with external FRP on Phillips Lane Bridge

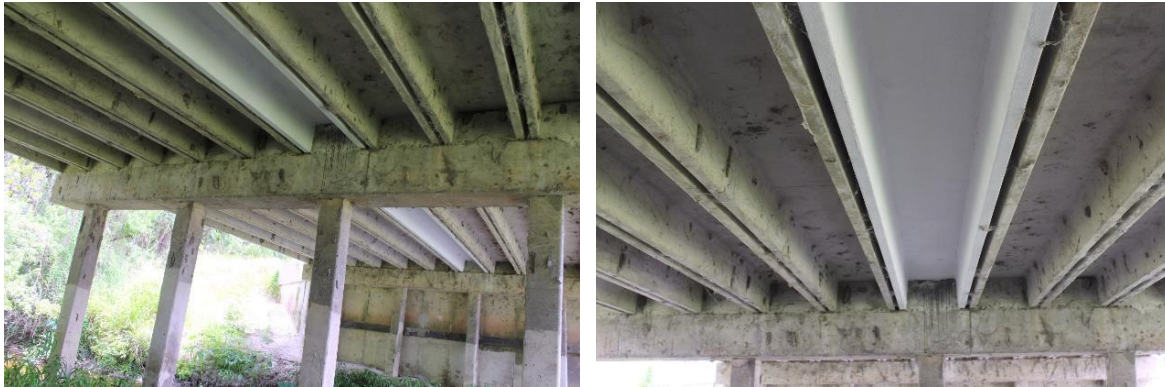
Figure 71—Repaired superstructure on Durant Road Bridge

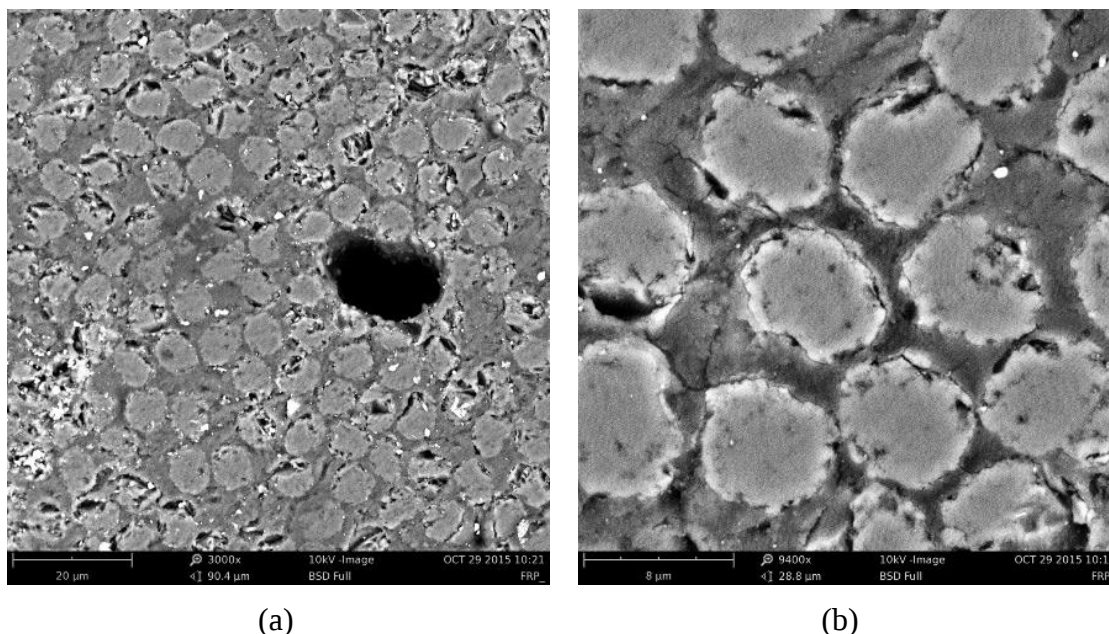
Collected images showed defects within the FRP composite (Figure 104). Voids within the matrix were likely a result of inadequate impregnation of dry carbon-fiber fabric in the field. At higher magnifications, microcracks located at the fiber-matrix interface were observed. These fibers could be due to manipulation of the samples during the extraction, or due to the environmental degradation. Larger microcracks were also present in the epoxy-concrete interfacial region, as shown in Figure 105. Sustained loading, combined with fatigue and environmental impacts could have been the cause of these microcracks. While further research is necessary to understand the source of cracking near the interface, these observed microcracks might result in early onset of debonding once they reach their critical length.

Figure 104—SEM images of defects present within the CFRP composite including (a) voids and (b) epoxy microcracking

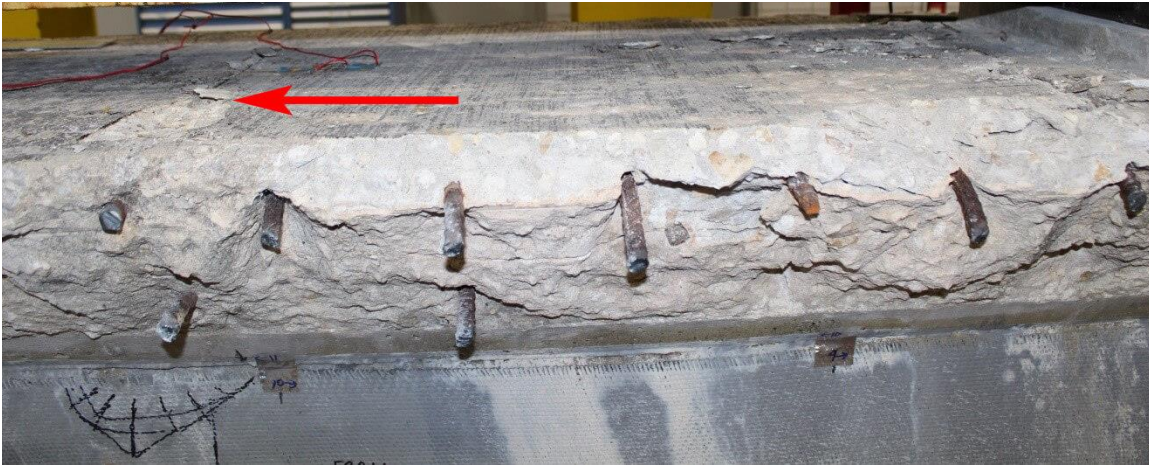
Figure 112—Failure of concrete in compression indicated by red arrow

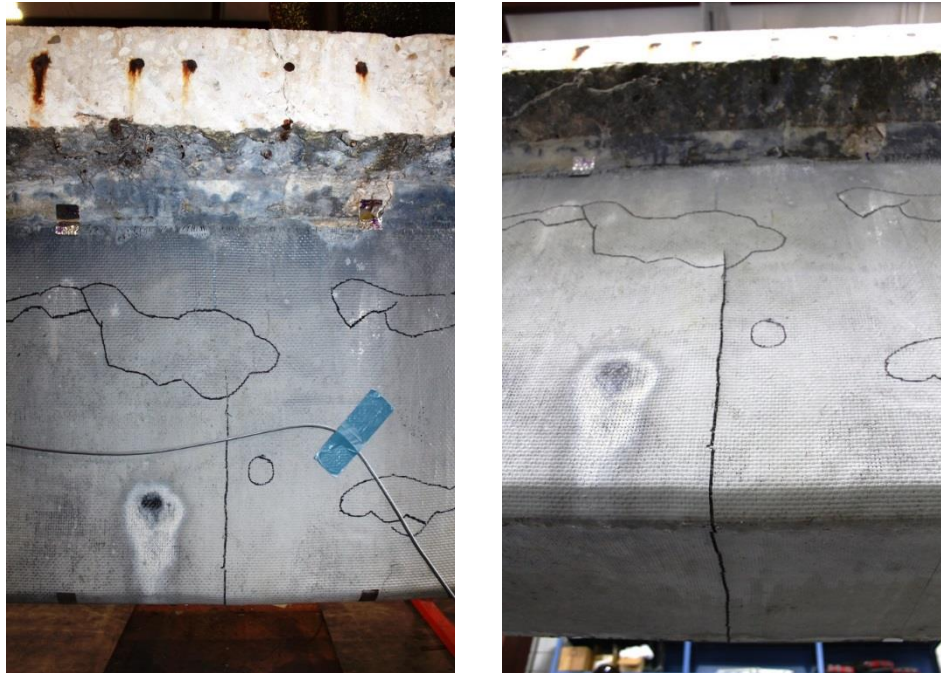
Figure 113—Rupture of CFRP near midspan

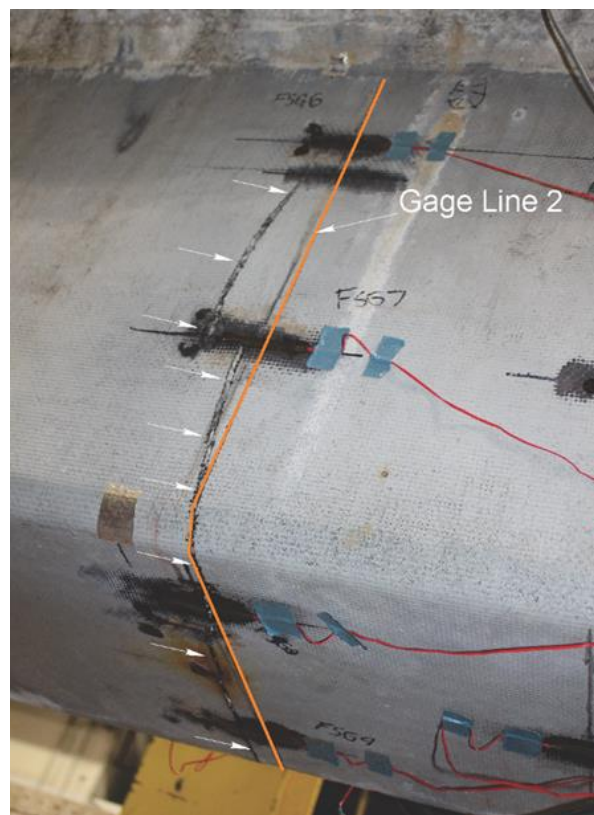
Figure 117—CFRP rupture relative to Gage Line 2 on Girder #1

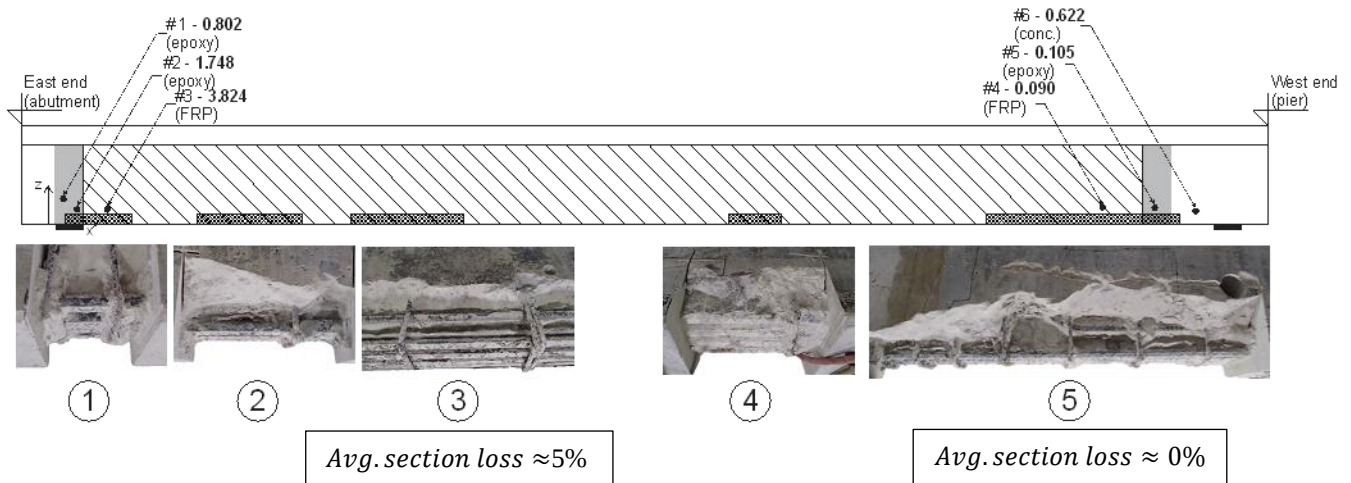
Figure 125—State of reinforcement and chloride contents (pcy) at specified locations along the north face of Girders #1 and #2

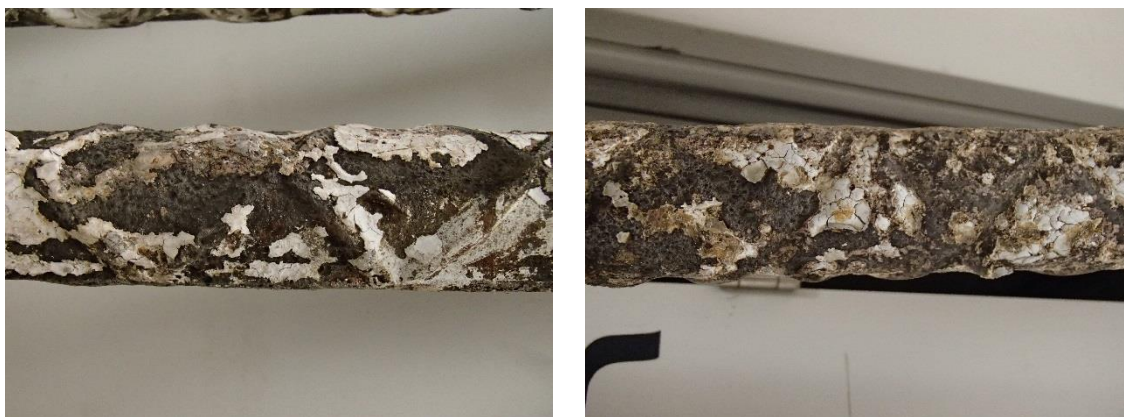
Figure 126—Close-up images of corroded reinforcement

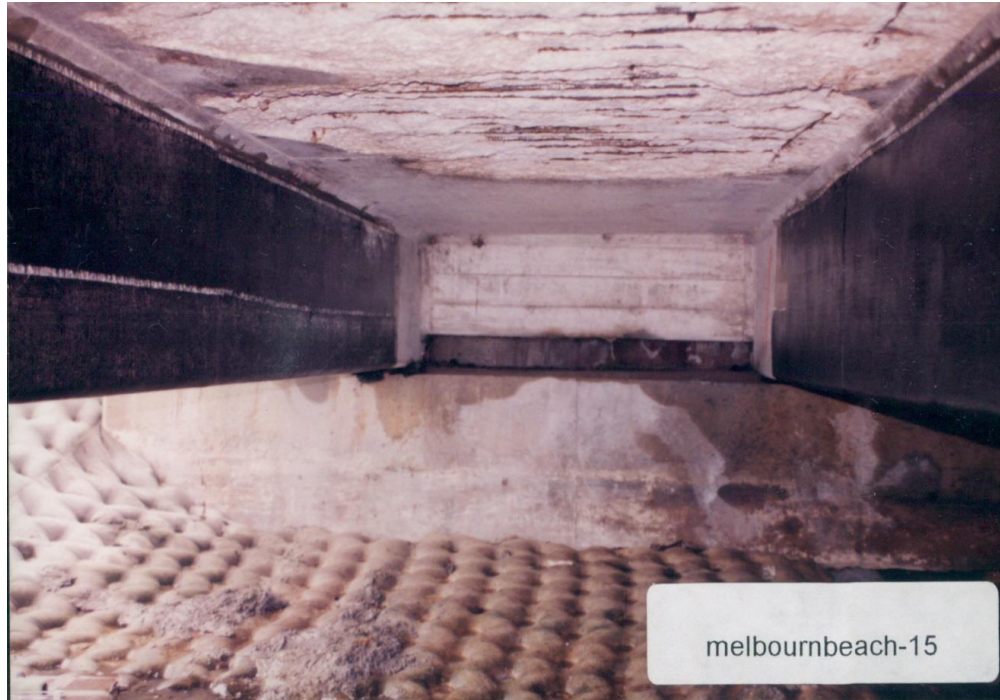
Figure 130—Example of wetting caused by wind and wave action

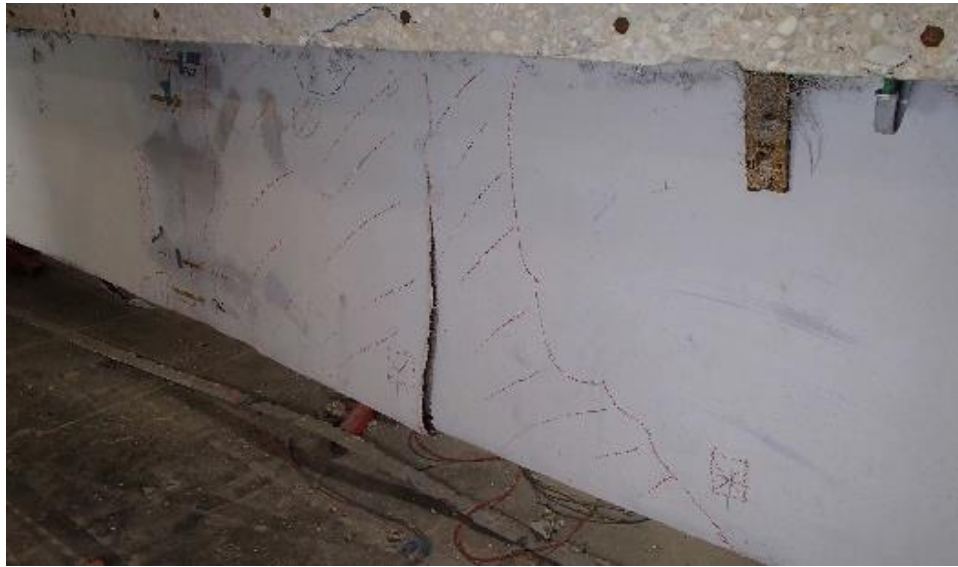
Figure 174—GFRP rupture (Girder 3-4)

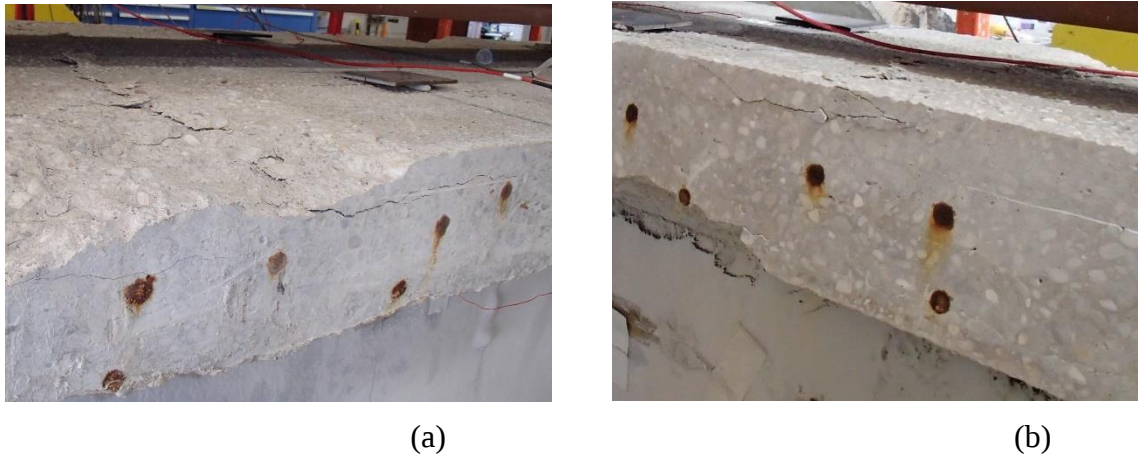
Figure 196—Crushing of concrete in compression (Girder 4-3): (a) west elevation (b) east elevation

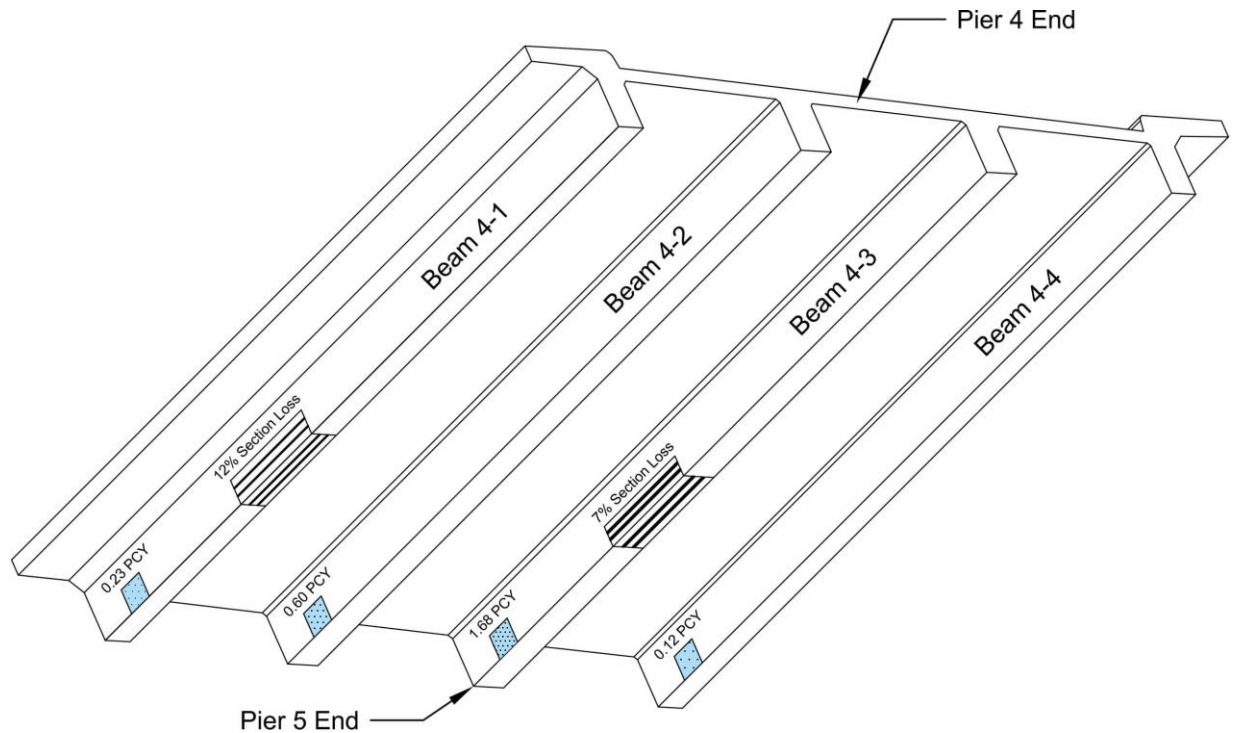
Figure 222—Chloride ion contamination levels and section loss in steel reinforcement in Span 4

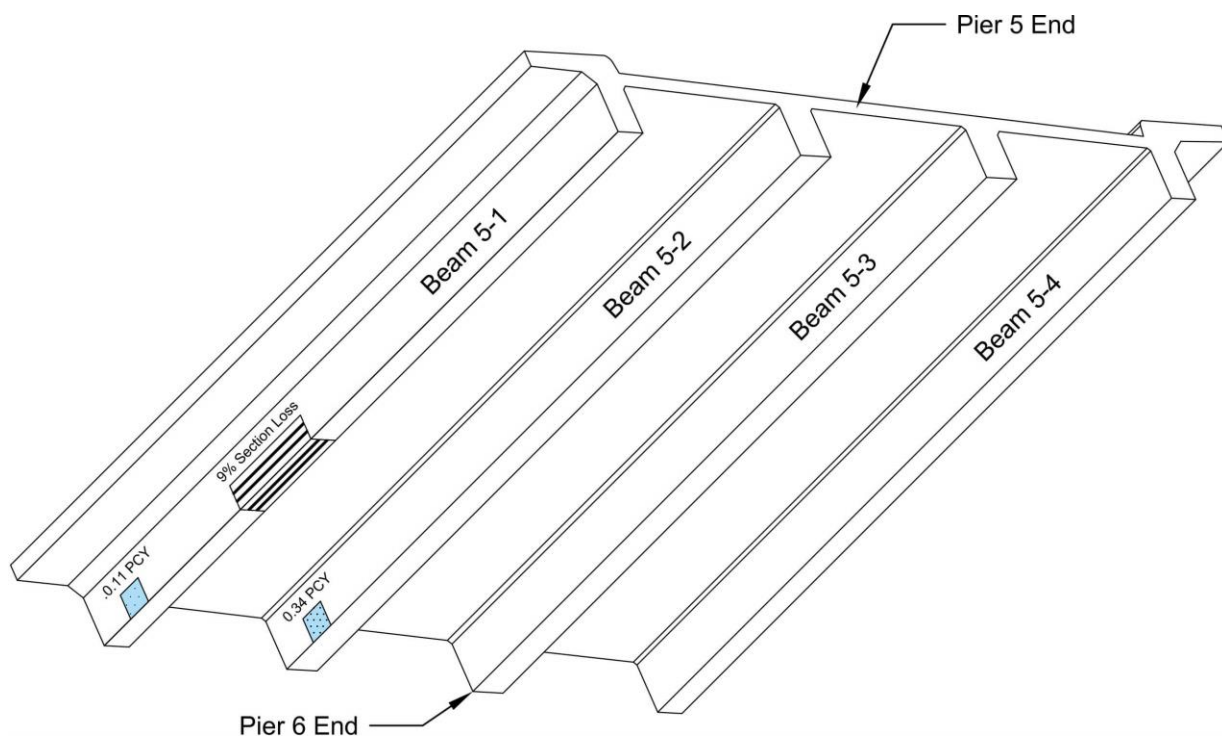
Figure 224—Chloride ion contamination levels and section loss in steel reinforcement in Span 5

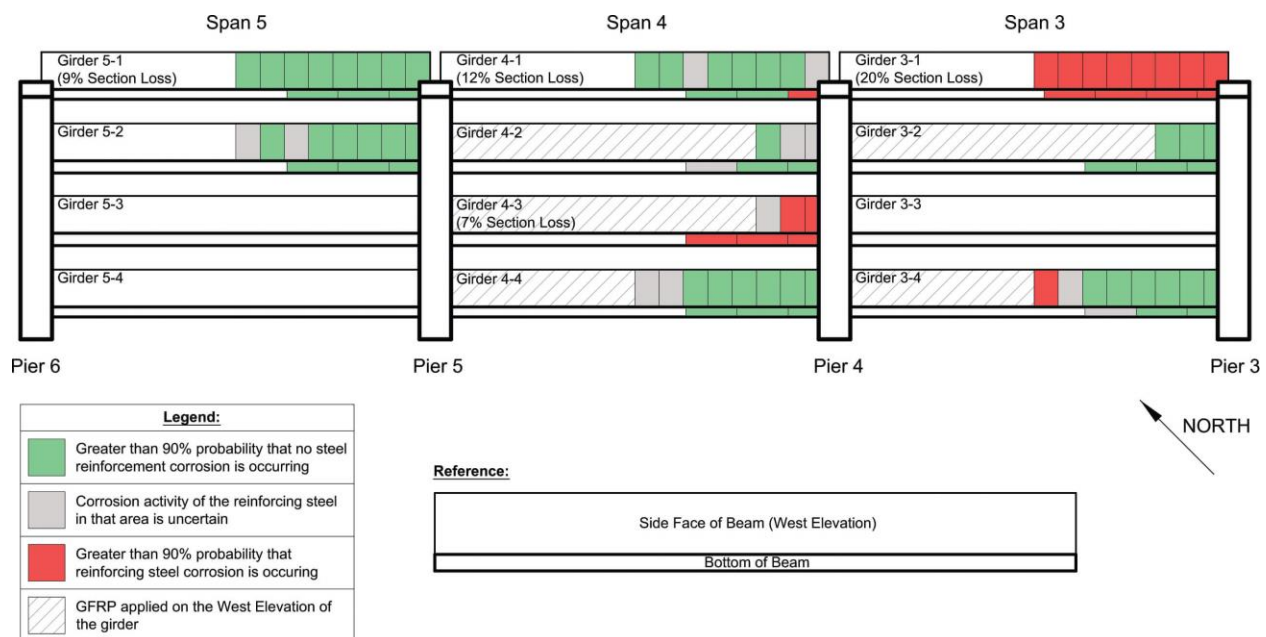
Figure 225—Corrosion potential mapping on girders in spans 3, 4, and 5

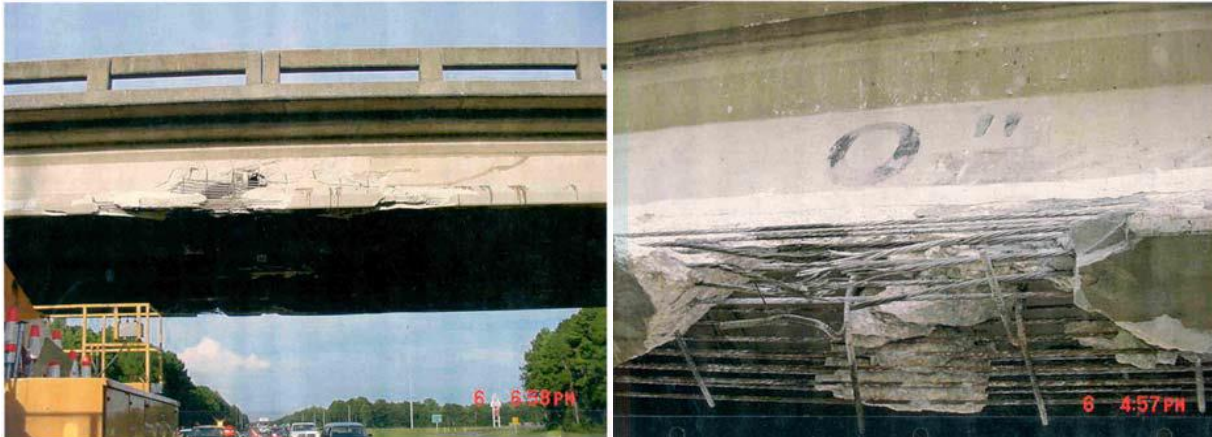
Figure 227—Girder damage from vehicle impact in July of 2001

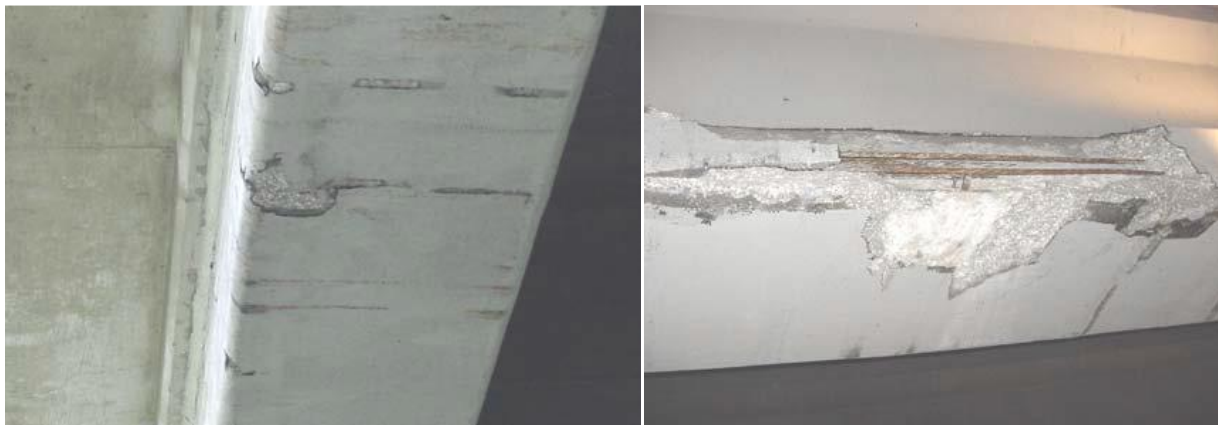
Figure 229—Condition of girder before and after vehicle impact in June of 2003

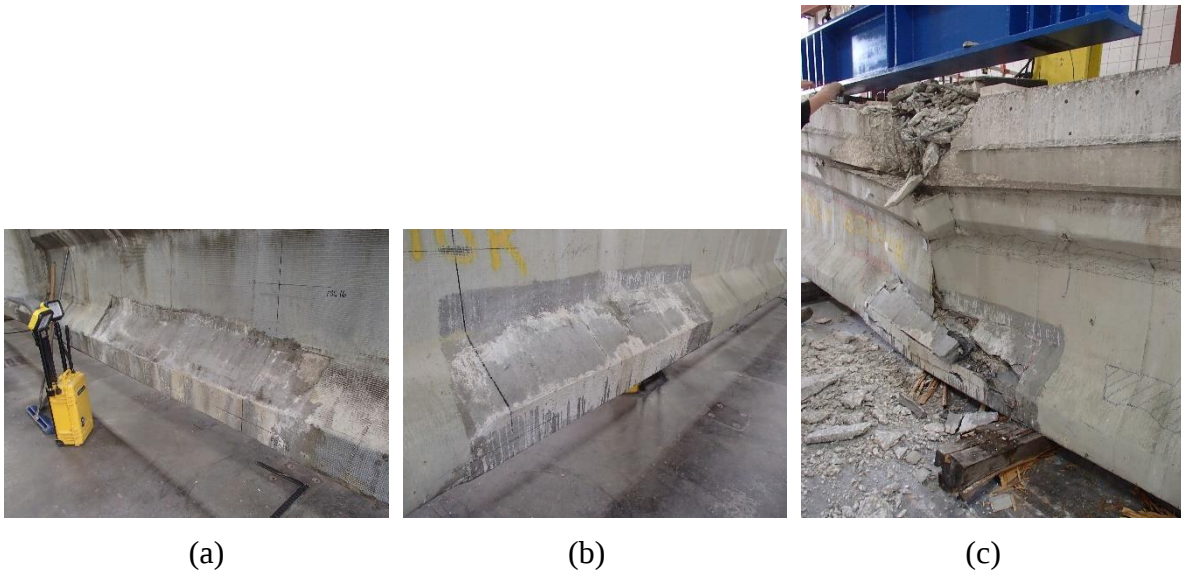
Figure 249—Repaired region of Girder 2: (a) west face initially before testing (b) east face initially before testing (c) east face after failure
