Final Report

July 2018

Use of Small Unmanned Aerial Vehicles (sUAV) for Structural Inspection

Florida Department of Transportation (FDOT)
Office of Maintenance
Richard I. Kerr, P.E. – Project Manager

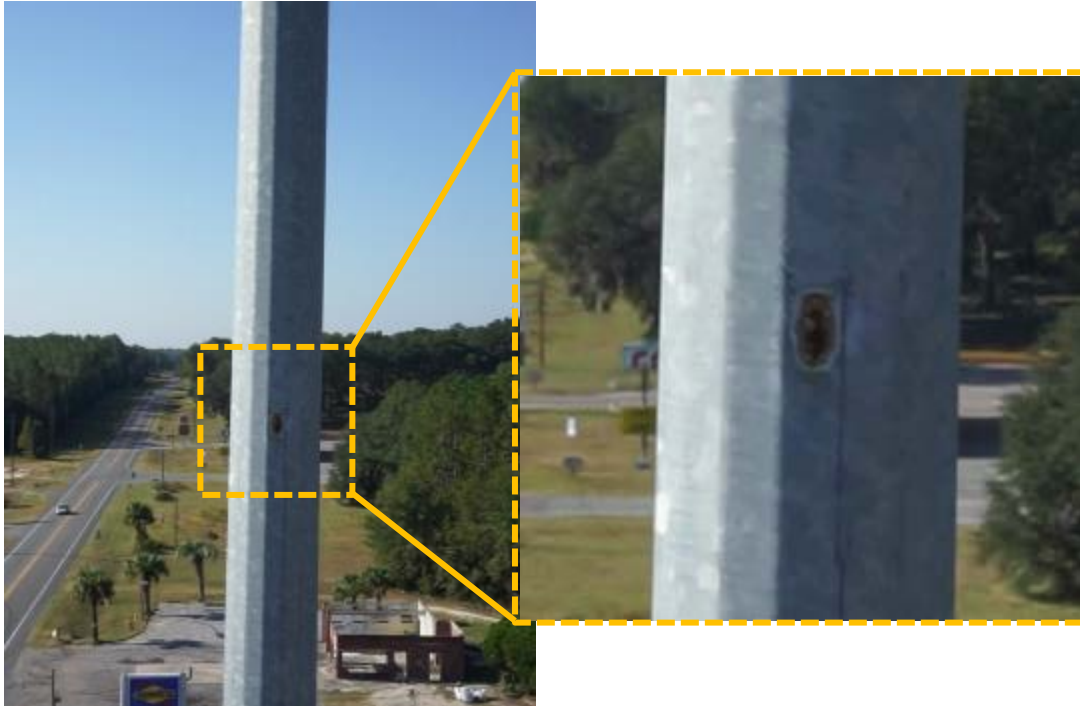
This HMLP was the third pole to be inspected. The HMLP that was originally selected was changed to avoid nearby power lines. During this inspection, corrosion, which had been detected in previous inspections, was found above the first slip joint on the northeast face of the pole. An image of the corrosion, pulled from a frame of the video, is shown in Figure 3-5.

Figure 3-5. Corrosion above first slip joint on northeast face of 32P054

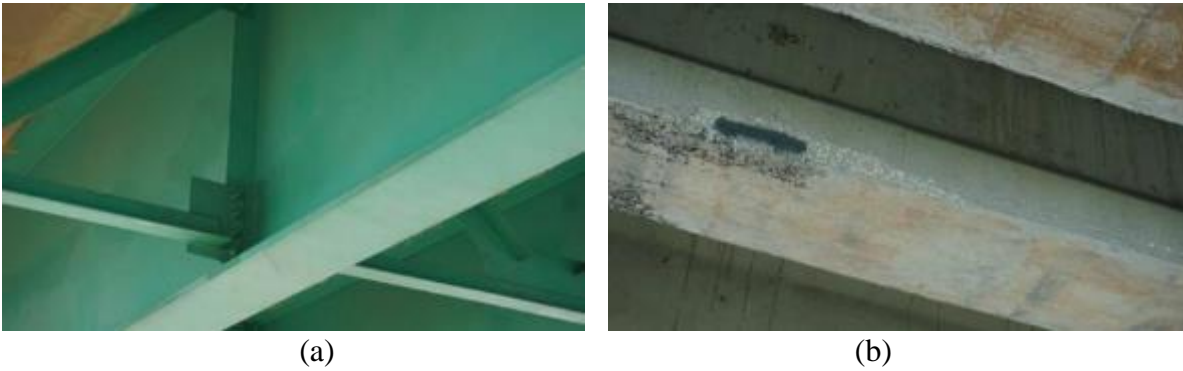
Figure 4-4. Sample images from inspection at 720044 and 720690: (a) connection of lateral bracing between beams in Span 9, 720690, and (b) spall on Beam 6-6, 720044

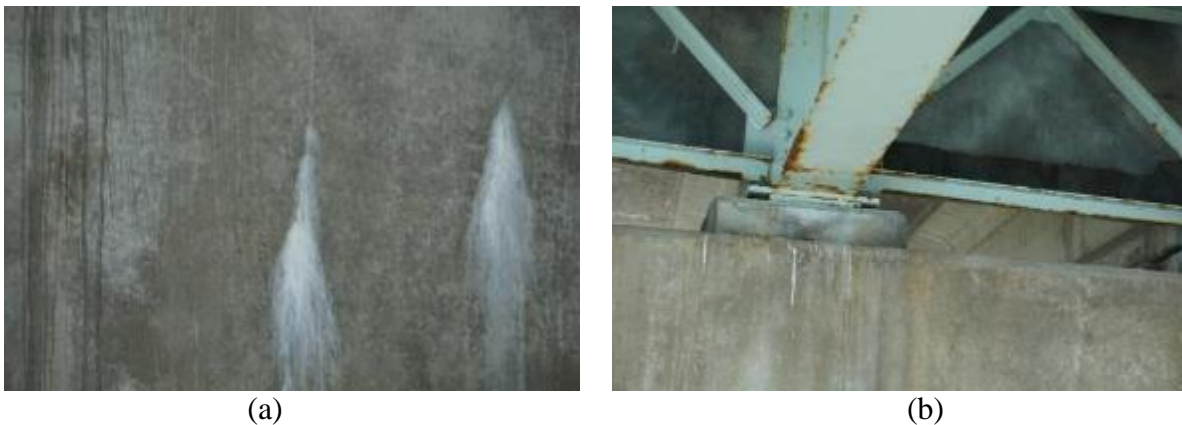
Figure 4-6. Sample images from inspection at 790148: (a) cracking with efflorescence in Pier Cap 4B, 790148, and (b) interior bearings in Span 7 over Pier 7

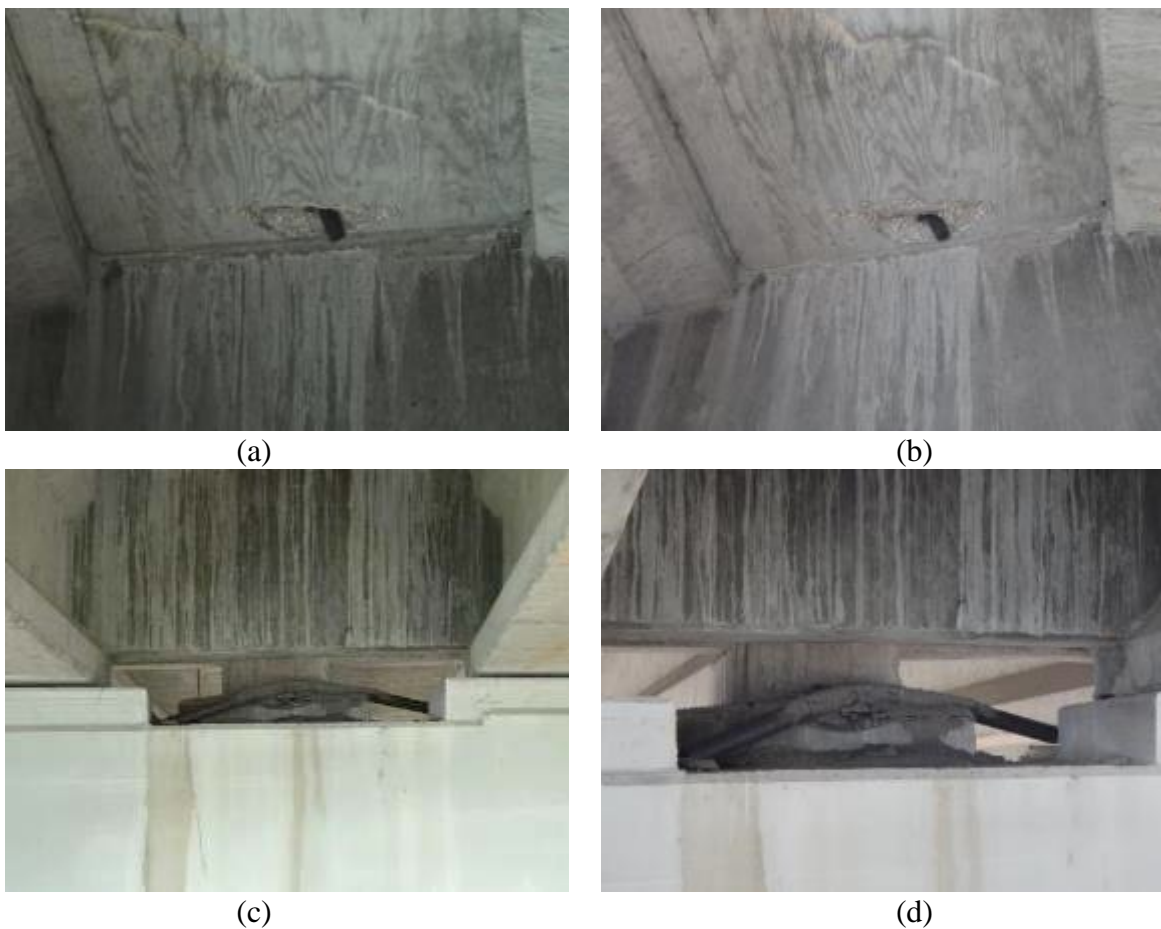
After inspecting Span 4, the crew relocated to Span 6 and conducted a special inspection of two specific deficiencies: debris in Bay 7 on Pier Cap 6 and missing anchor bolts on the outside of Beam 6-1. The sUAV was not programmed to transition from OFM flight underneath the bridge to GPSM flight outside the bridge. As a result, the sUAV was not flown outside the bridge, so the missing anchor bolts were not seen. Finally, the inspection crew moved to Span 9 to take an image of a large spall in the deck underside of Bay 9 over Pier Cap 9. Because the sUAV was in the outermost bay of the bridge, the optical flow camera only had a partial view of the bridge, which resulted in a smaller estimate of displacement than the sUAV was experiencing. Because of this, along with wind gusts, the sUAV had difficulty stabilizing and took three attempts to take an image of the deficiency. This spall and the debris on Pier Cap 6 were photographed both by the inspection crew in the UBIV and by the sUAV. Figure 4-10 shows a comparison of these images. As can be seen, the quality is comparable.

Figure 4-10. Comparison of images taken from sUAV (a and c) and images taken from UBIV (b and d). (a - b) spall in deck underside of Bay 9 over Pier Cap 9; (c - d) debris in Bay 7 on Pier Cap 6

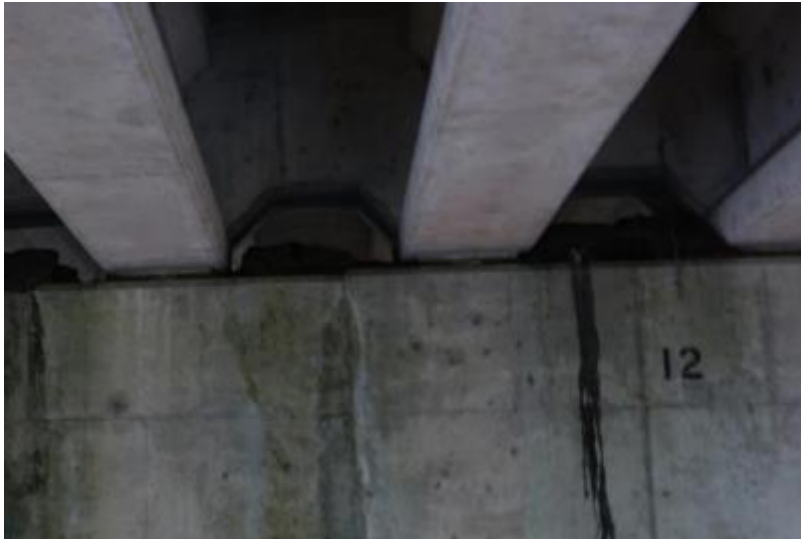
Figure 4-13. View of debris build-up on Bent Cap 12 of 300031

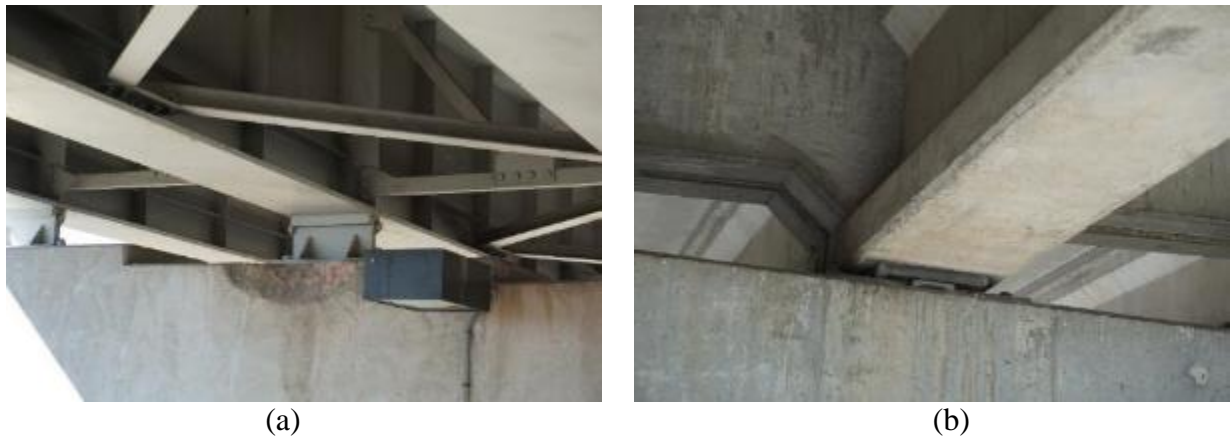
Figure 4-22. Sample images from 720114: (a) spall in Pier Cap 32 under Beam 32-7, and (b) bearing under a typical prestressed concrete girder.

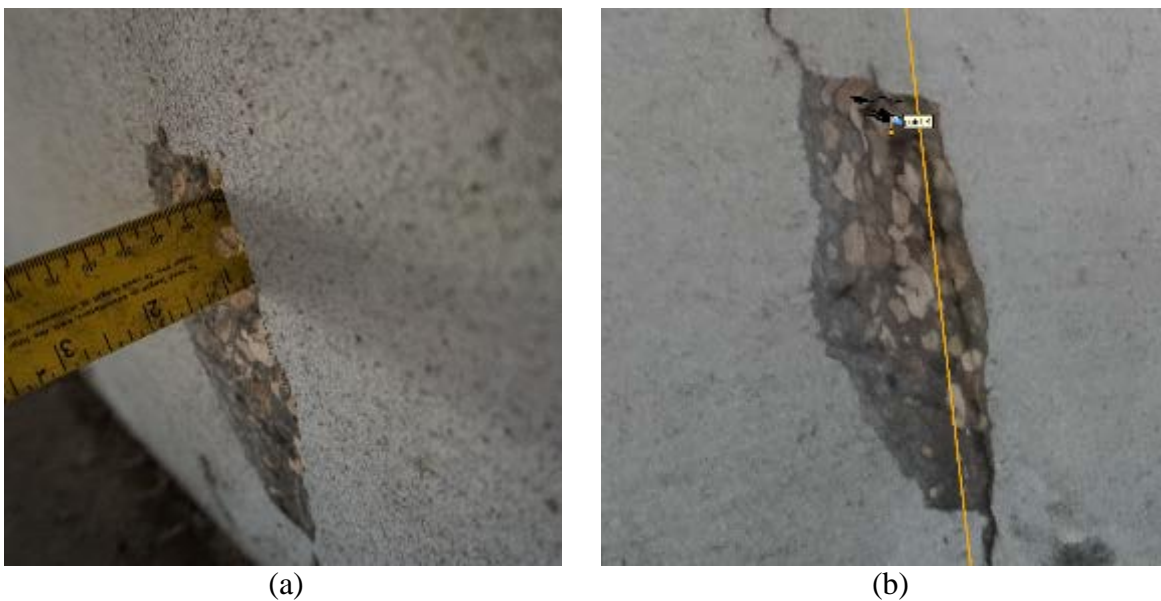
Figure 5-17. Spall on 260102: (a) Image of spall with ruler for scale, and (b) reconstructed spall with image laid over model

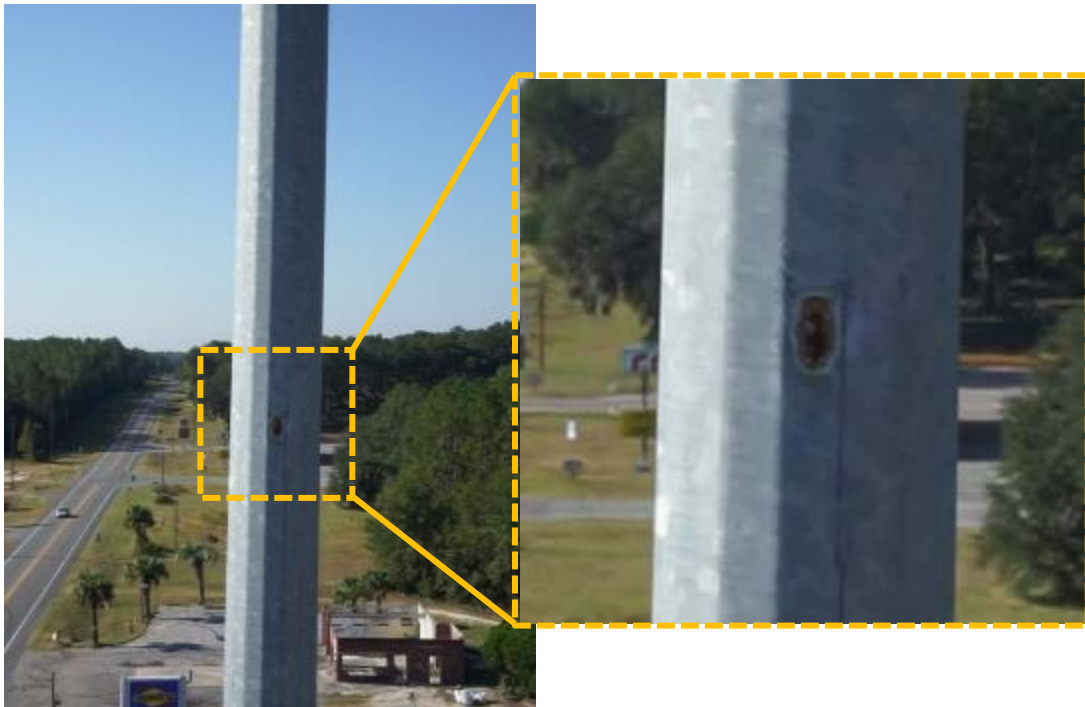
Figure A2-18. 32P054 - View of Corrosion above Second Slip Joint from Northeast

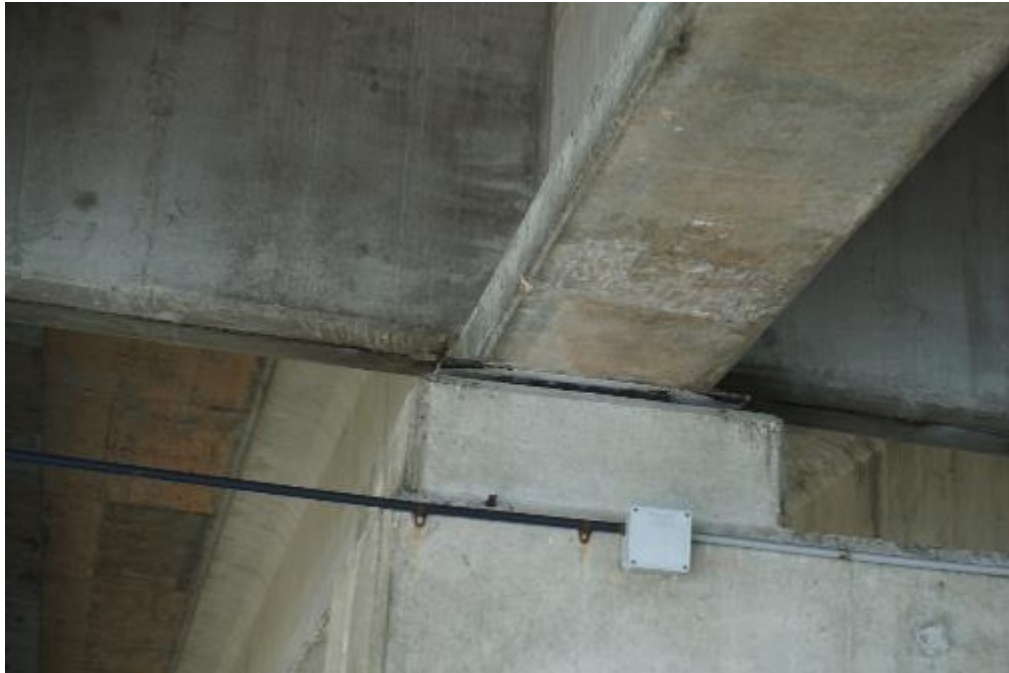
Figure A2-57. 790148 – Typical view of conduit with broken straps

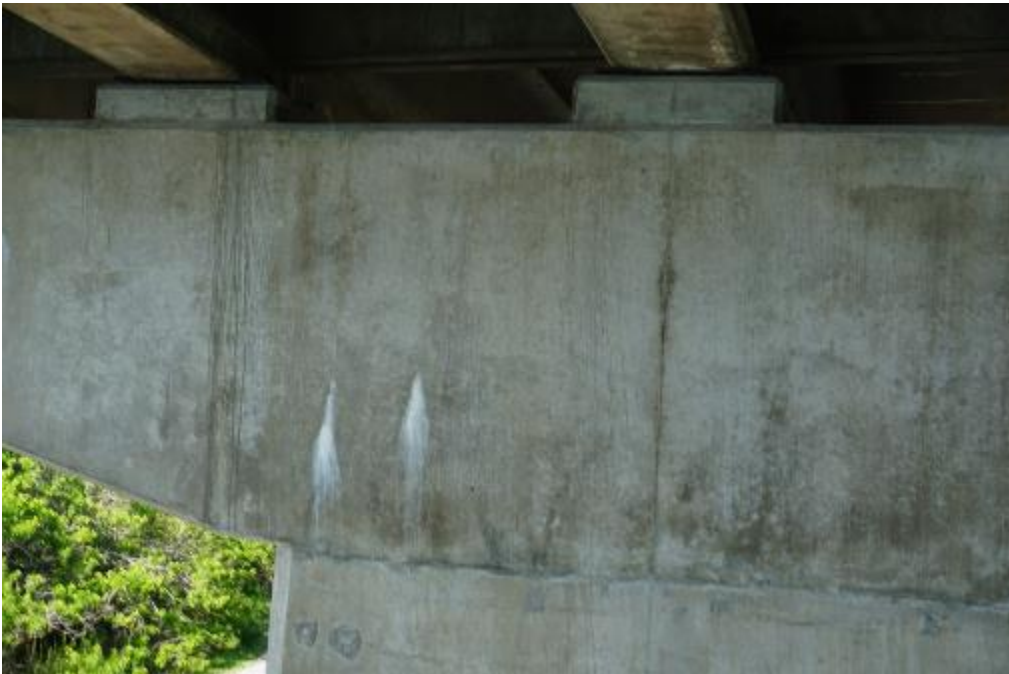
Figure A2-60. 790148 –View of cracking with efflorescence in pier cap

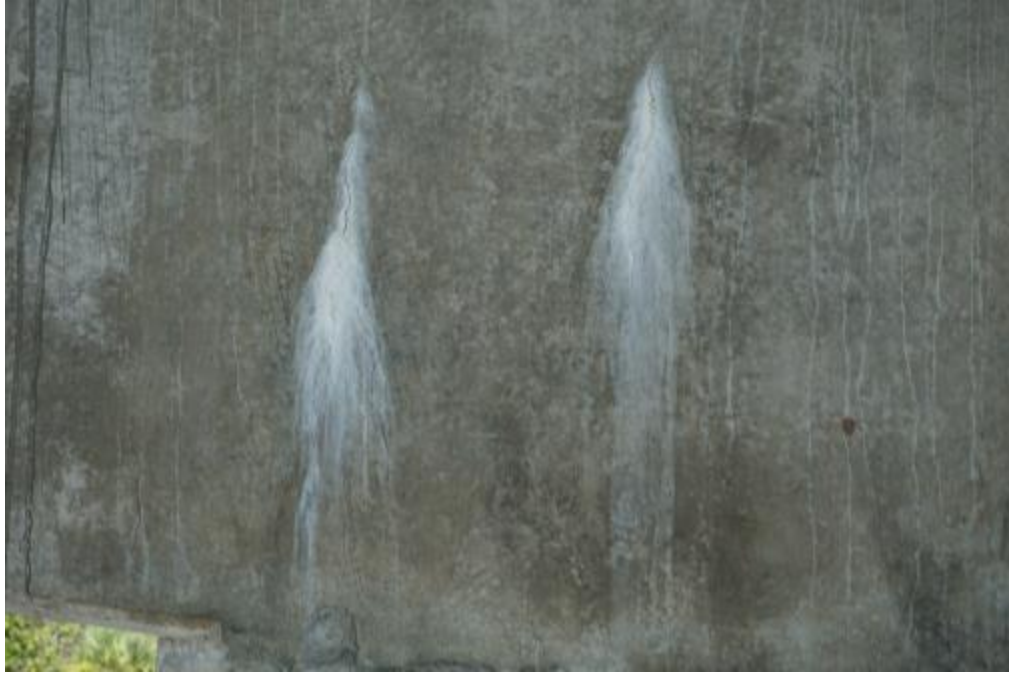
Figure A2-61. 790148 – Close up view of cracking with efflorescence in pier cap

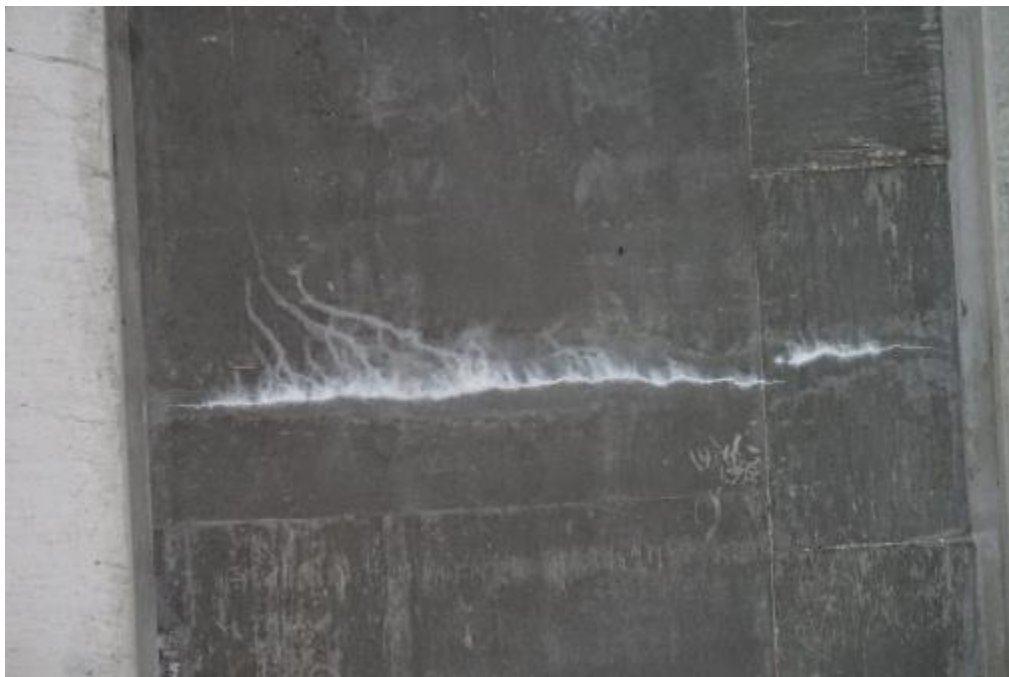
Figure A2-62. 790148 – Typical view of cracking with efflorescence in deck underside

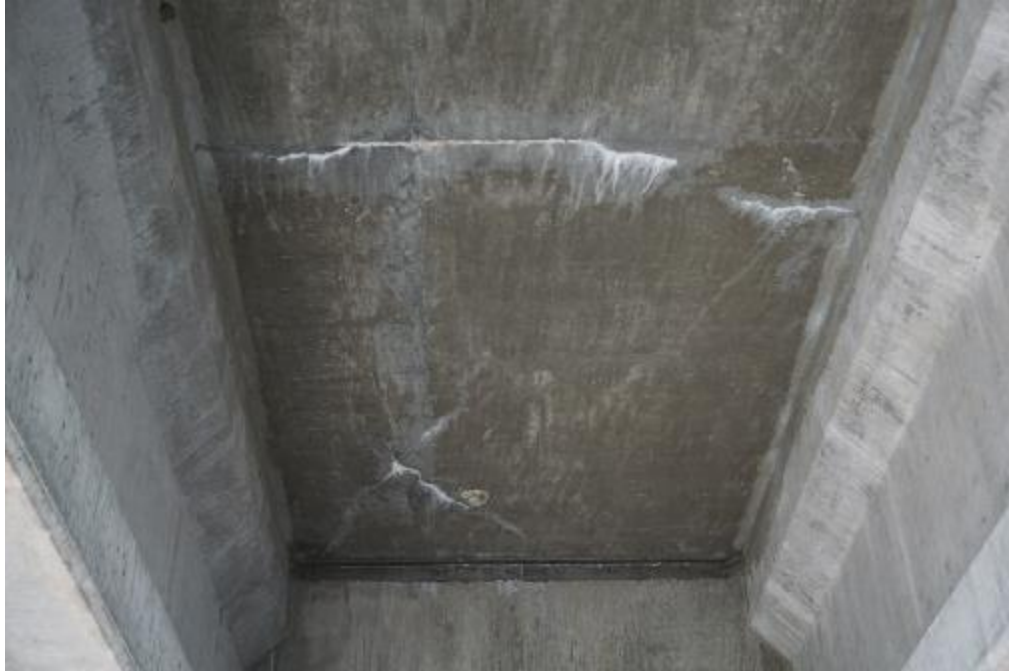
Figure A2-68. 790152 – Typical view of cracking with efflorescence in deck underside

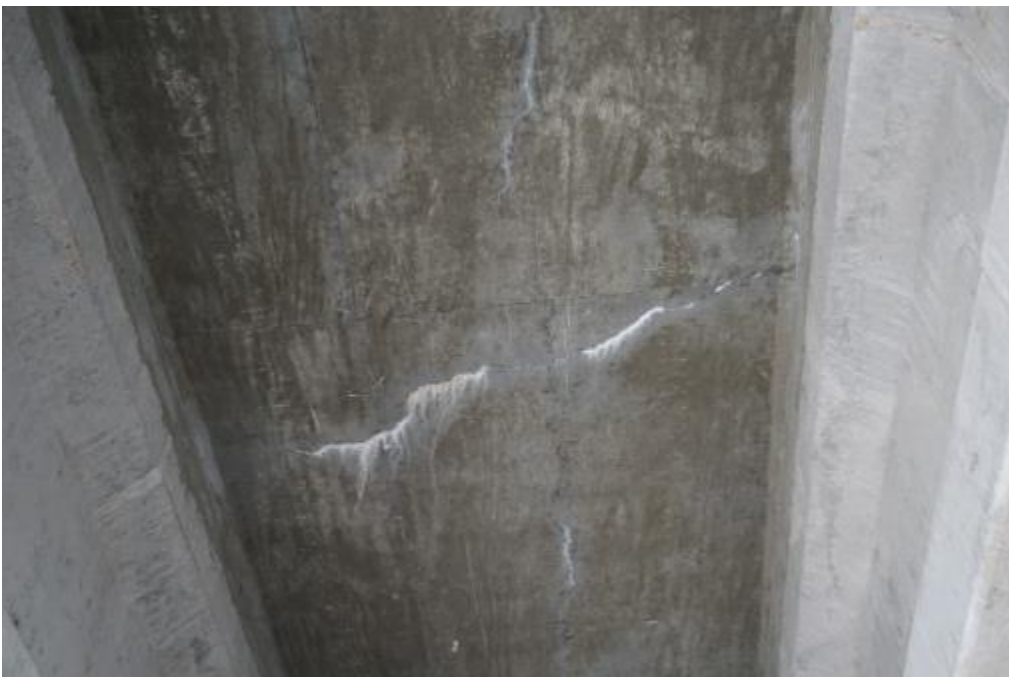
Figure A2-69. 790152 – Typical view of cracking with efflorescence in deck underside

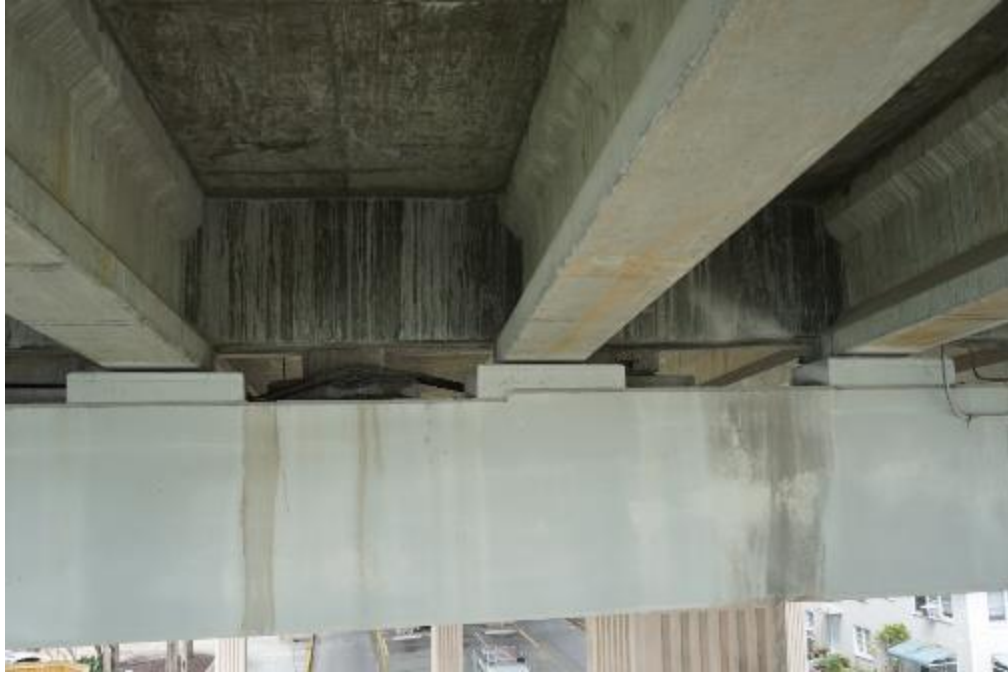
Figure A2-70. 790152 – View of debris on pier cap

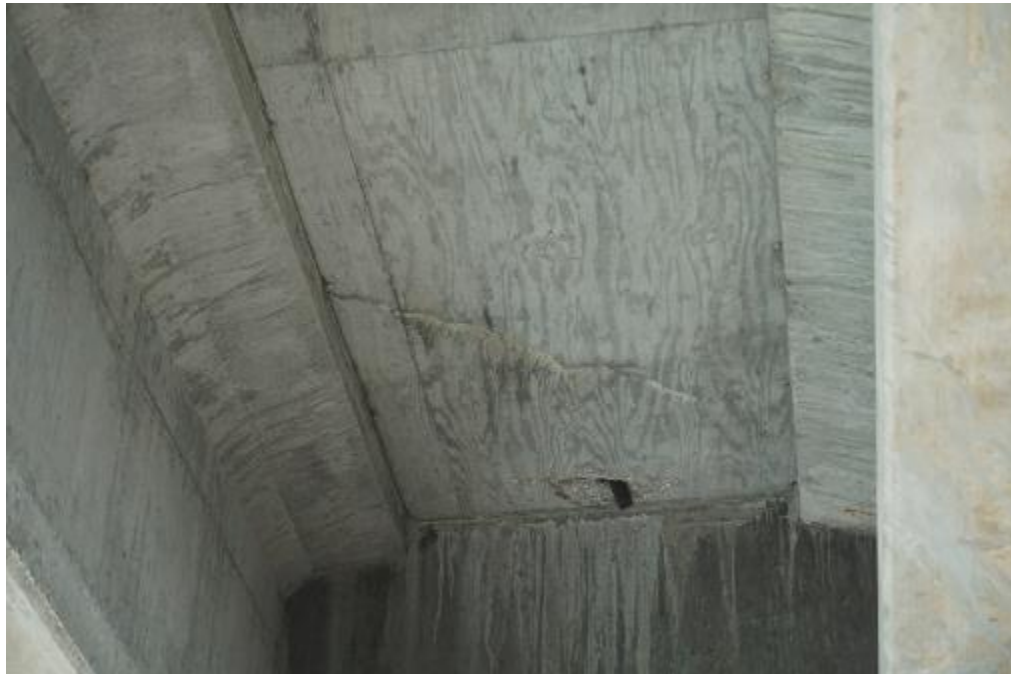
Figure A2-73. 790152 – View of spall in deck underside

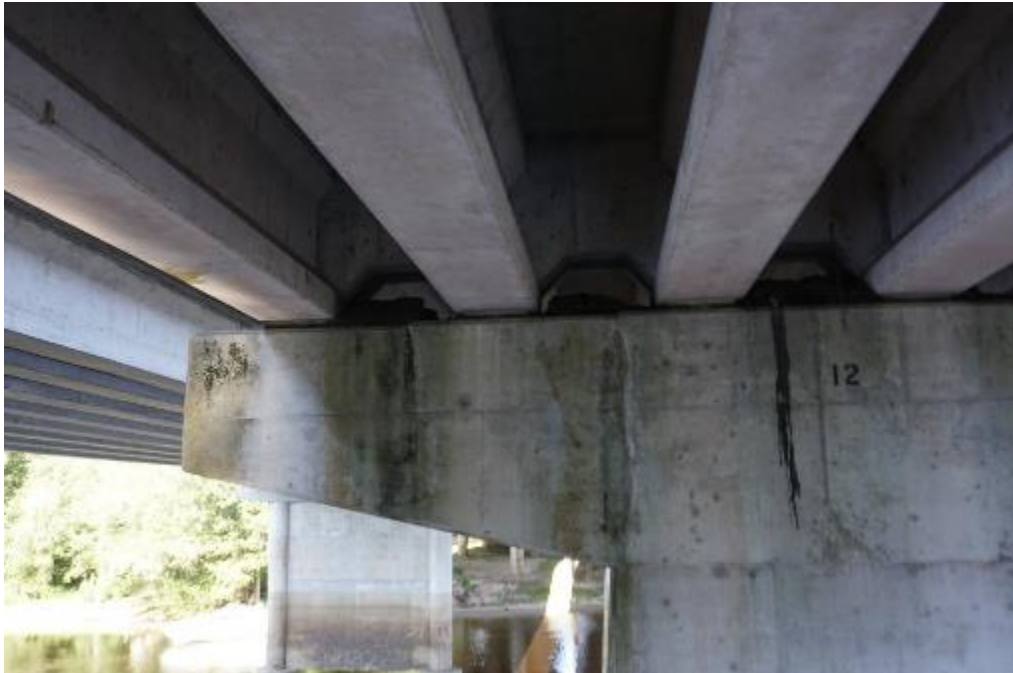
Figure A2-74. 300031 – Typical view of debris on top of pier cap

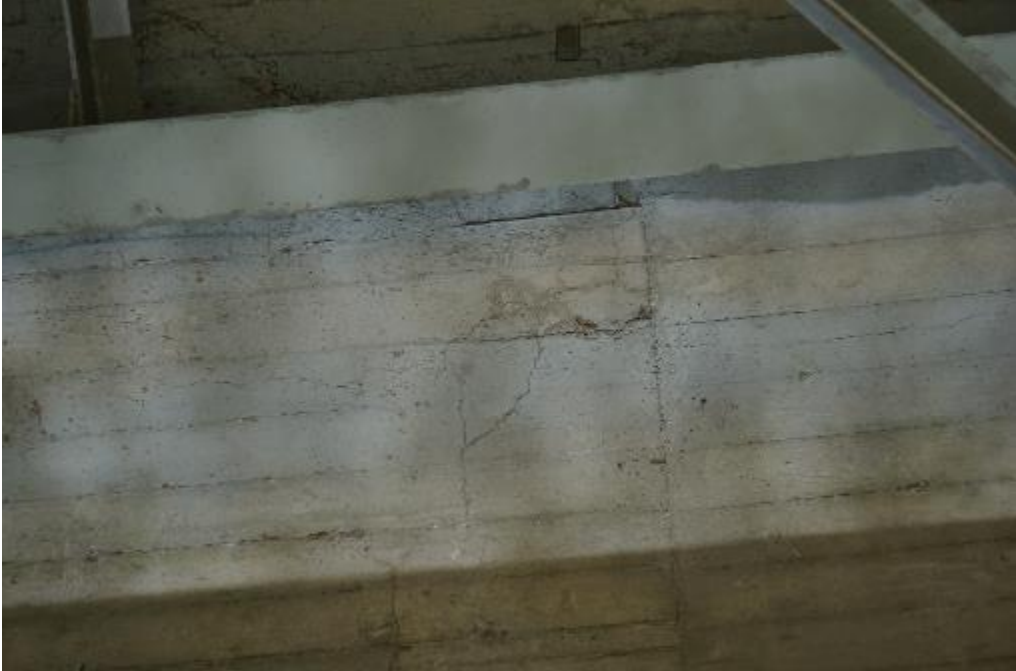
Figure A2-82. 320061 – Typical view of cracking in deck underside

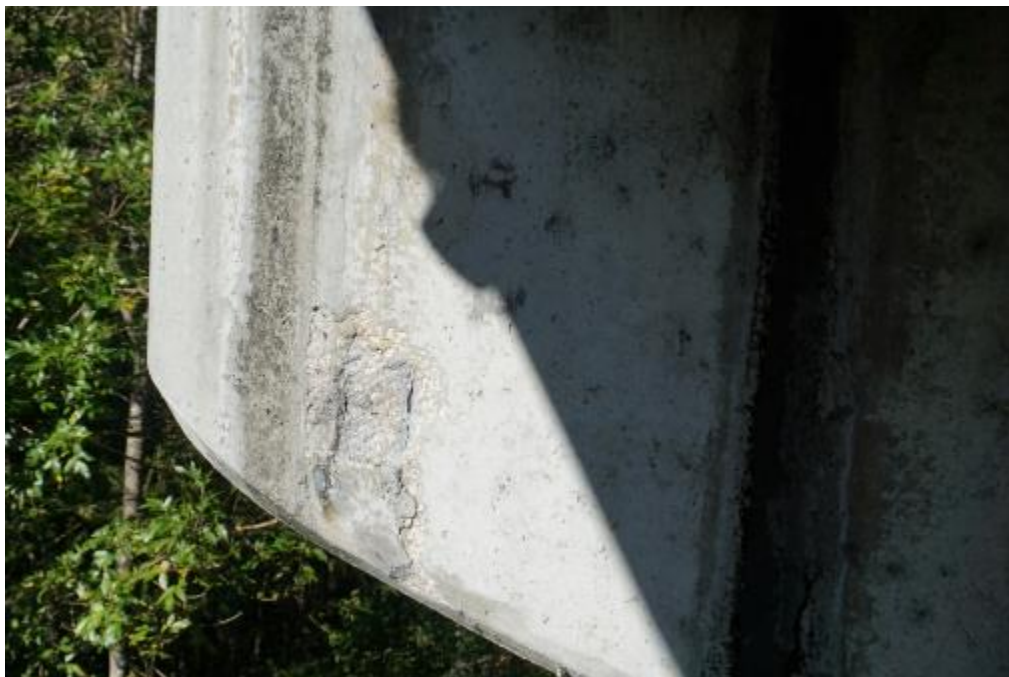
Figure A2-89. 360055 – View of spall in pier cap

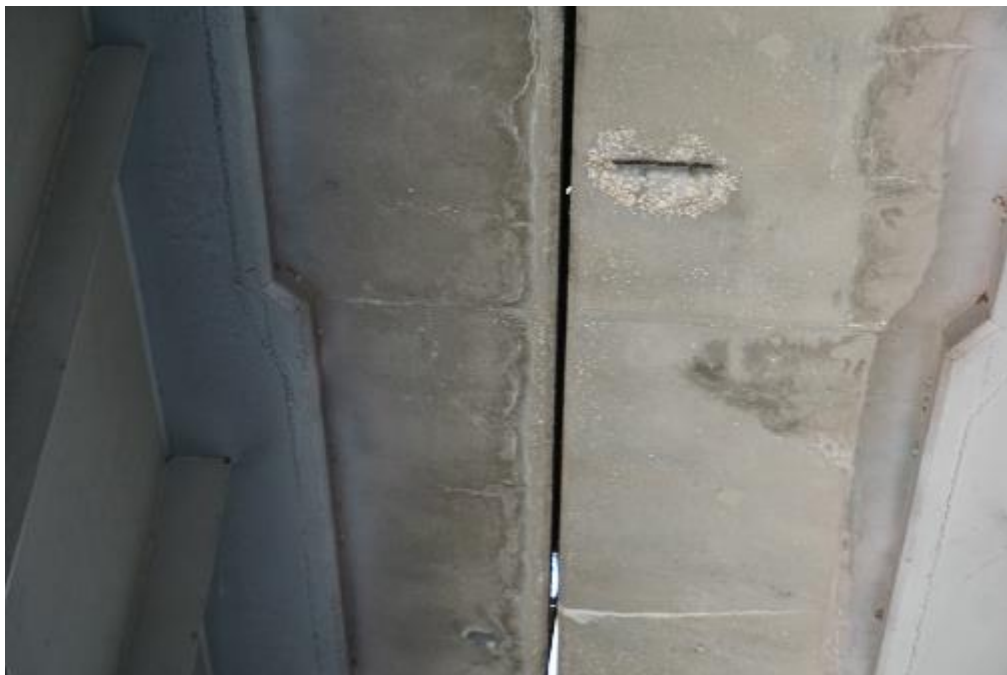
Figure A2-100. 720114 – Typical view of spall in deck underside

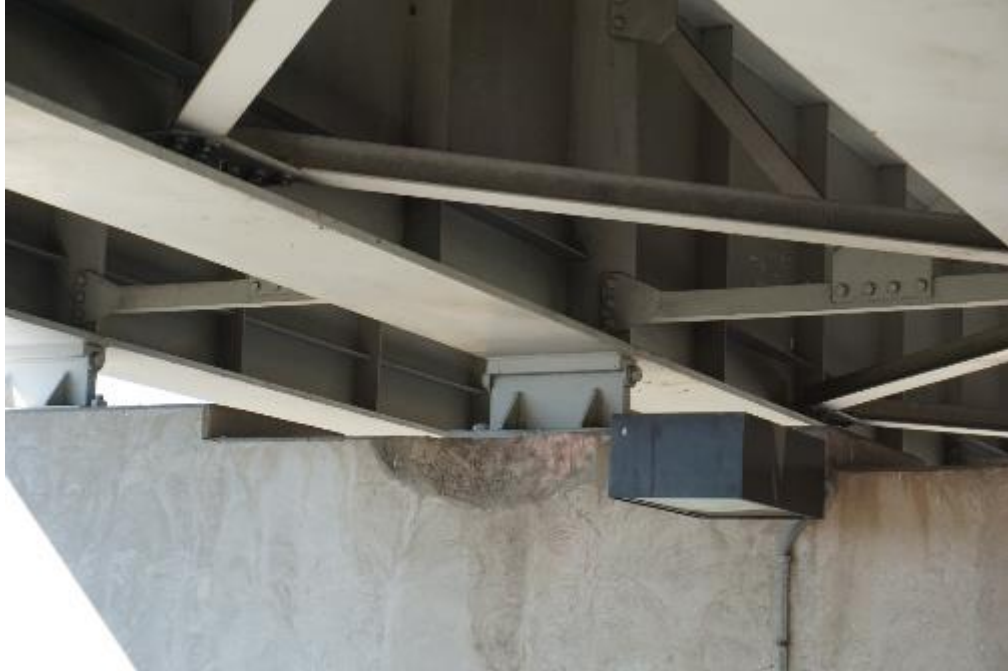
Figure A2-101. 720114 – Typical view of spall in pier cap underneath steel beam
