Evaluation of Roadway Worms/Distortions

Final Report

Prepared by:
Applied Research Associates, Inc.
430 W 5th Street, Suite #700
Panama City, Florida 32401
850-914-3188 / 850-914-3189 Fax

Contract No. BE491

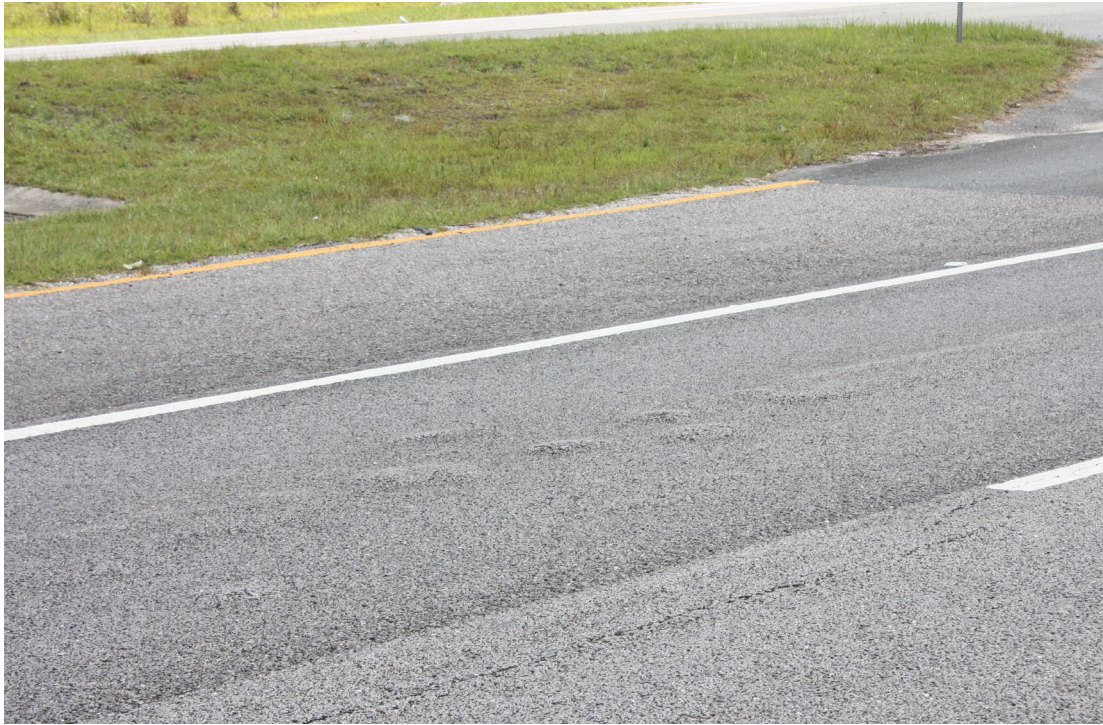
Figure 3-4. SR 79 Worm Distress

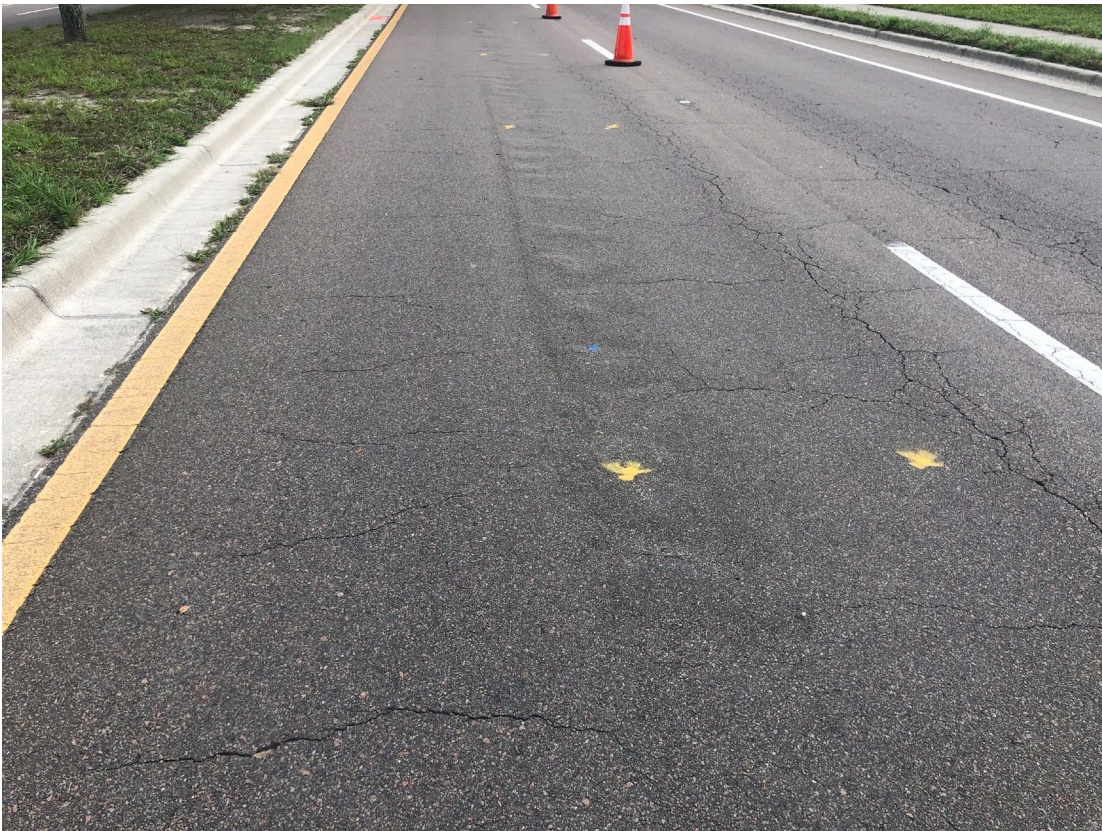
Worms are present in un-trafficked areas of the lane but primarily between the wheel paths. A greater density of the worm distress is present where the longitudinal crack component of block cracking occurs (Figure 3-6). The research team originally assumed the presence of cracking would provide relief for the mechanism causing worms; however, this does not appear to be the case. Worms occur on the site despite there being a substantial amount of age-related cracking on the pavement surface. The roadway consists of 12-ft lanes and a divided median. Curb and gutter are present throughout. A cross-slope drains water from the inside lanes to the outside lanes. The cross-slope ranges from 1.3% to 2.3% in the worm section and 0.8% to 2.9% in the control section. No standing water or drainage issues were observed.

Figure 3-6. SR 26 Worm Distress

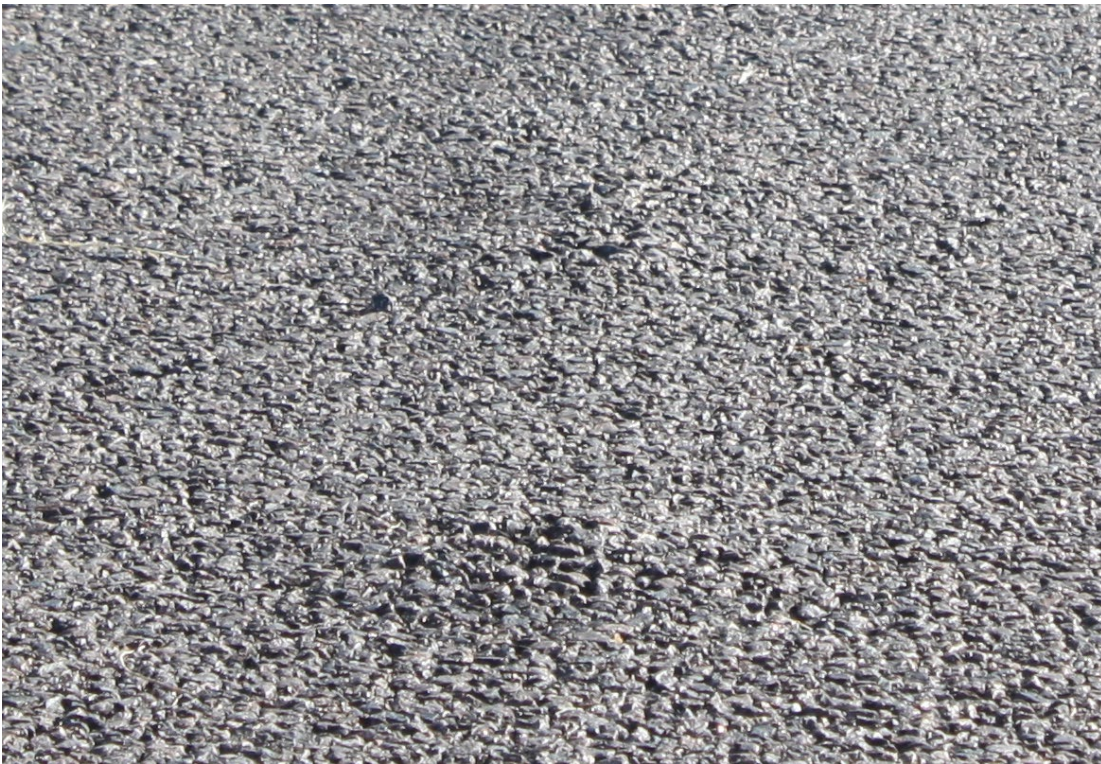
The worm distresses occur both as round and roughly rectangular in shape (Figure 3-10). The roadway surface is an OGFC. The worm distresses ranged in height from approximately 0.25 to 0.5 in. The control section is at a higher elevation on a vertical curve. The severity of worm distress increases in areas of lower elevation. The roadway consists of two 12-ft lanes. The centerline is crowned. Cross slopes range from 1.1% to 3.1% in the worm section and 1.2% to 2.6% in the control section. No standing water or drainage issues were observed.

Figure 3-10. US 17 Worm Distress

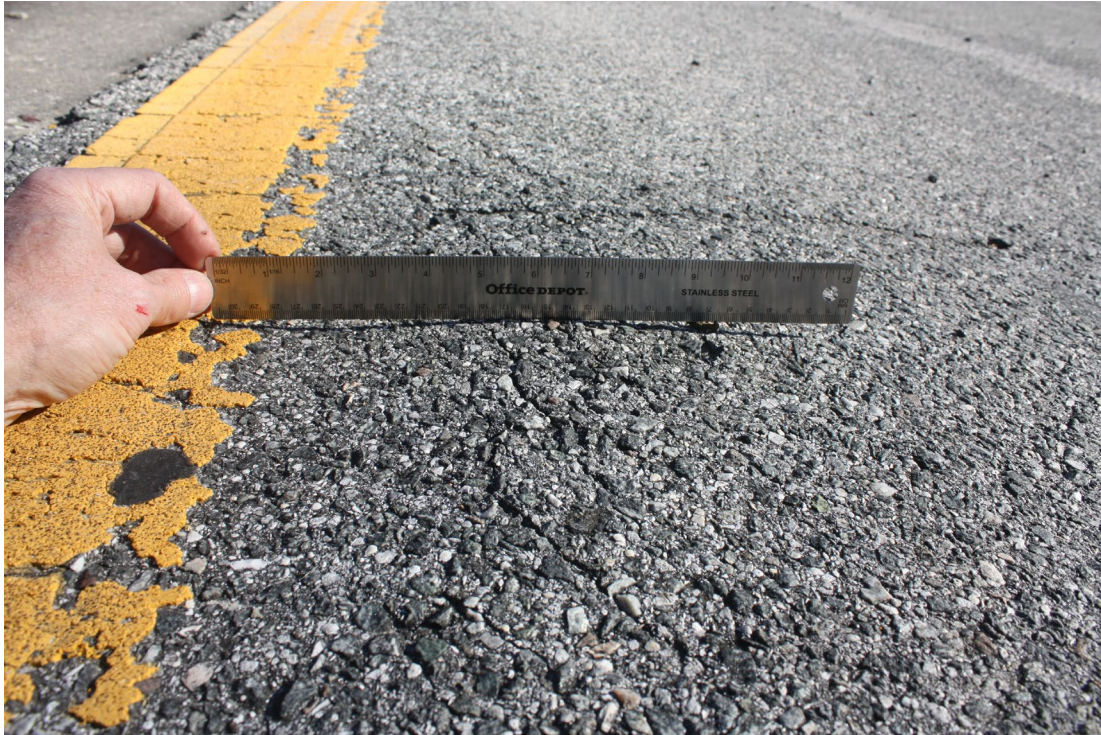
This roadway features two different dense-graded asphalt (DGA) surface mixes. Both lanes exhibit worm distresses, indicating worm distress may not necessarily be being associated with factors related to the top AC lift. Worm distresses are not considerably severe (< 0.25 in tall) and occur infrequently. No worm distresses were observed over 390 ft of the 581-ft test section. Figure 3-12 presents a close-up of a worm distortion on the left edge of the worm section. The roadway consists of 12-ft travel lanes, with a 5-ft gore area separating the mainline from a 6-ft parking lane. Curb and gutter are present throughout. A cross-slope drains water from the inside lanes to the outside lanes. The cross-slope ranges from 1.6% to 2.7% in the worm section and 1.9% to 2.8% in the control section. No standing water or drainage issues were observed.

Figure 3-12. SR 20 Worm Distress

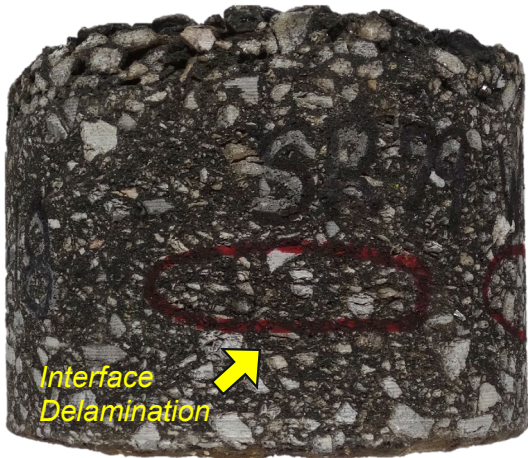
All cores collected from SR 79 were intact. Typical field cores are presented in Figure 4-47 through Figure 4-50. Delamination between the bottom two structural asphalt layers was observed more frequently in worm section cores. Some segregation of aggregate was evident on the bottom AC lift. AC layer thicknesses were consistent between the worm and control sections. The overall AC layer thickness and individual lift thicknesses are presented in Figure 4-51.

Figure 4-47. SR 79 MP 0.427 Worm Section Core – Structural AC Layer Delamination

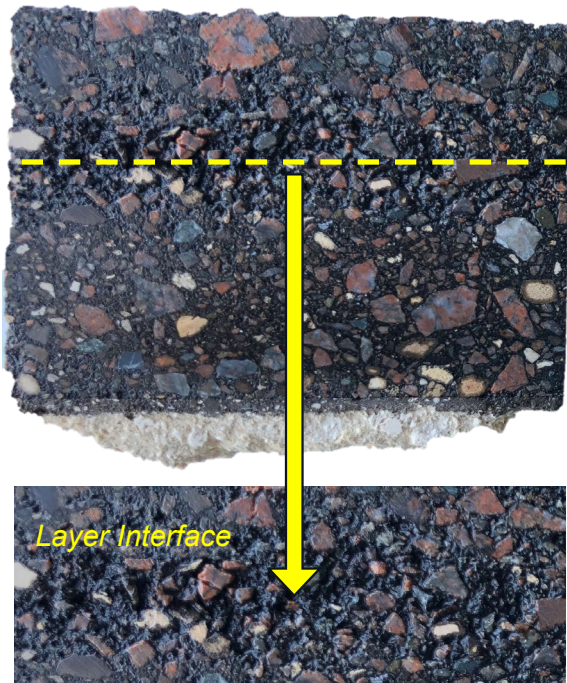
All cores collected from SR 26 were intact. Typical field cores are presented in Figure 4-52 through Figure 4-55. Voids in the pavement structure were noted in both the top two DGA layers for control and worm section cores. The greatest concentration of voids was at the interface of these two layers in the worm section, especially at the bottom of the surface course. The stripped aggregate at this subject interface, shown in Figure 4-52, could be indicative of water traveling along the interface. SR 26 AC layer thicknesses are presented in Figure 4-56. Surface mix lift thicknesses were within 0.1-in agreement on average. The bottom lift AC was 0.6-in thicker in the worm section.

Figure 4-52. SR 26 MP 8.837 Worm Core Cross-Section – Stripping/Voids at Layer Interface

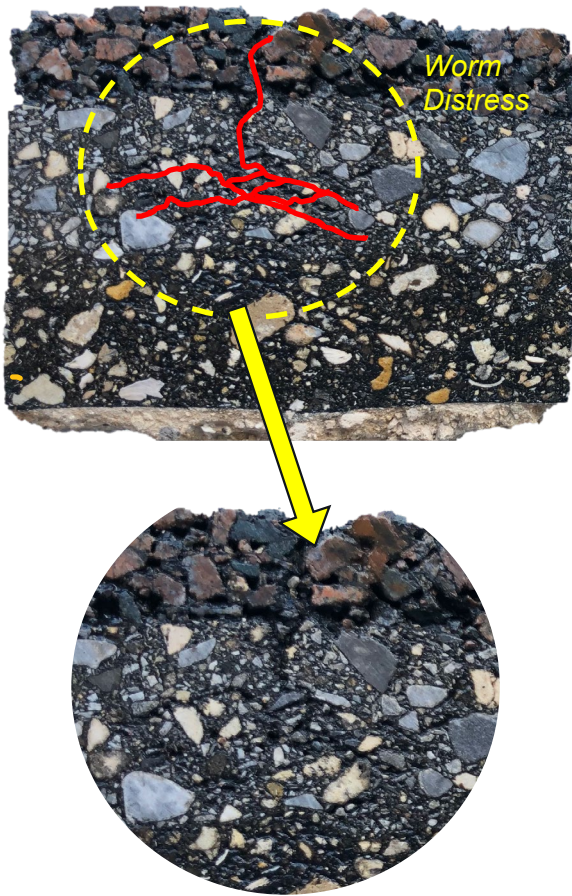
All cores collected from US 17 were intact. Typical field cores are presented in Figure 4-62 through Figure 4-65. Voids, segregation, and cracking were observed in the top DGA layer of worm section cores. Discoloration and pitting were also observed in both control and worm section layers. These defects are mostly concentrated in the top DGA layer. Figure 4-62 presents the cross section of a worm distress that was cored and sectioned, showing a crescent shaped fracture pattern consistent with the profile of a worm distress. The AC layer interfaces appear to be undamaged/not delaminated. US 17 AC layer thicknesses are presented in Figure 4-66. The composite asphalt structure is 1-in thicker than the control asphalt, on average.

Figure 4-62. US 17 MP 17.762 Worm Distress Cross-Section Showing Crack Pattern in Upper Structural AC Layer

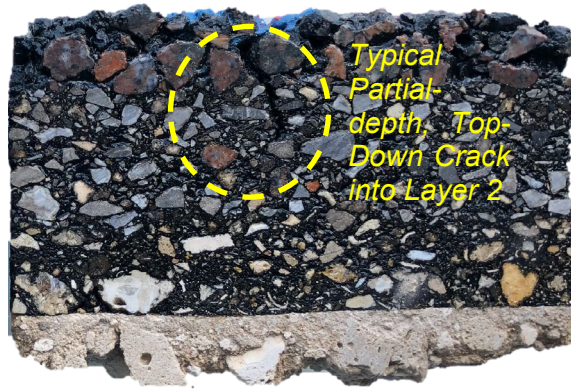
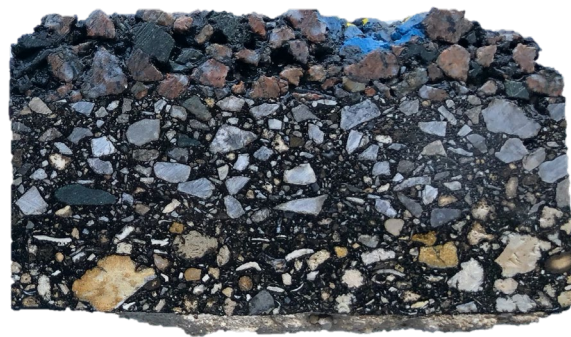
Figure 4-63. US 17 Typical Control AC Cross-Sections at (a) 17 MP 17.740 with Partial Depth Crack and (b) MP 17.406

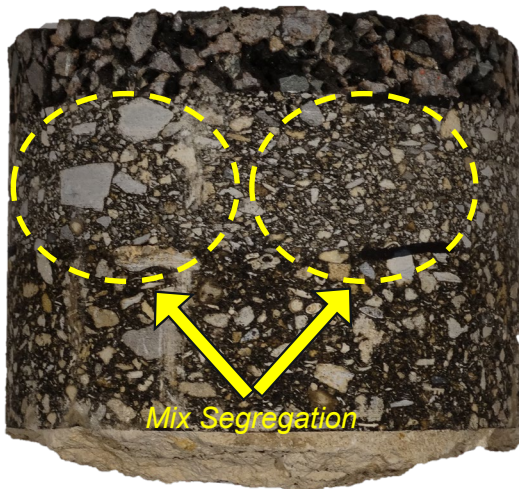
Figure 4-64. US 17 Worm Core at MP 17.795 – Layer 2 Segregation

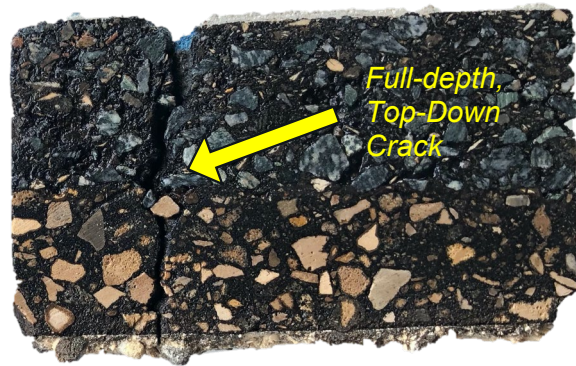
Figure 4-68. SR 20 MP 2.973 Control Section Paving Lane Joint Cross-Section Showing Top-Down Crack

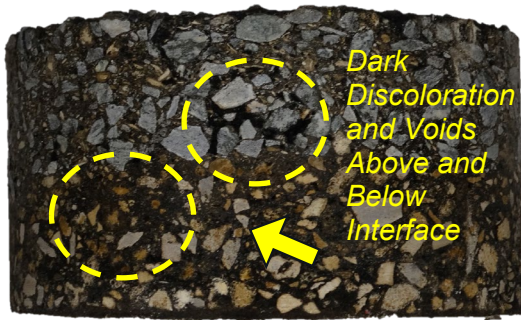
Figure 4-69. SR 20 Worm Section Paving Lane Core with Large Air Voids at MP 2.442

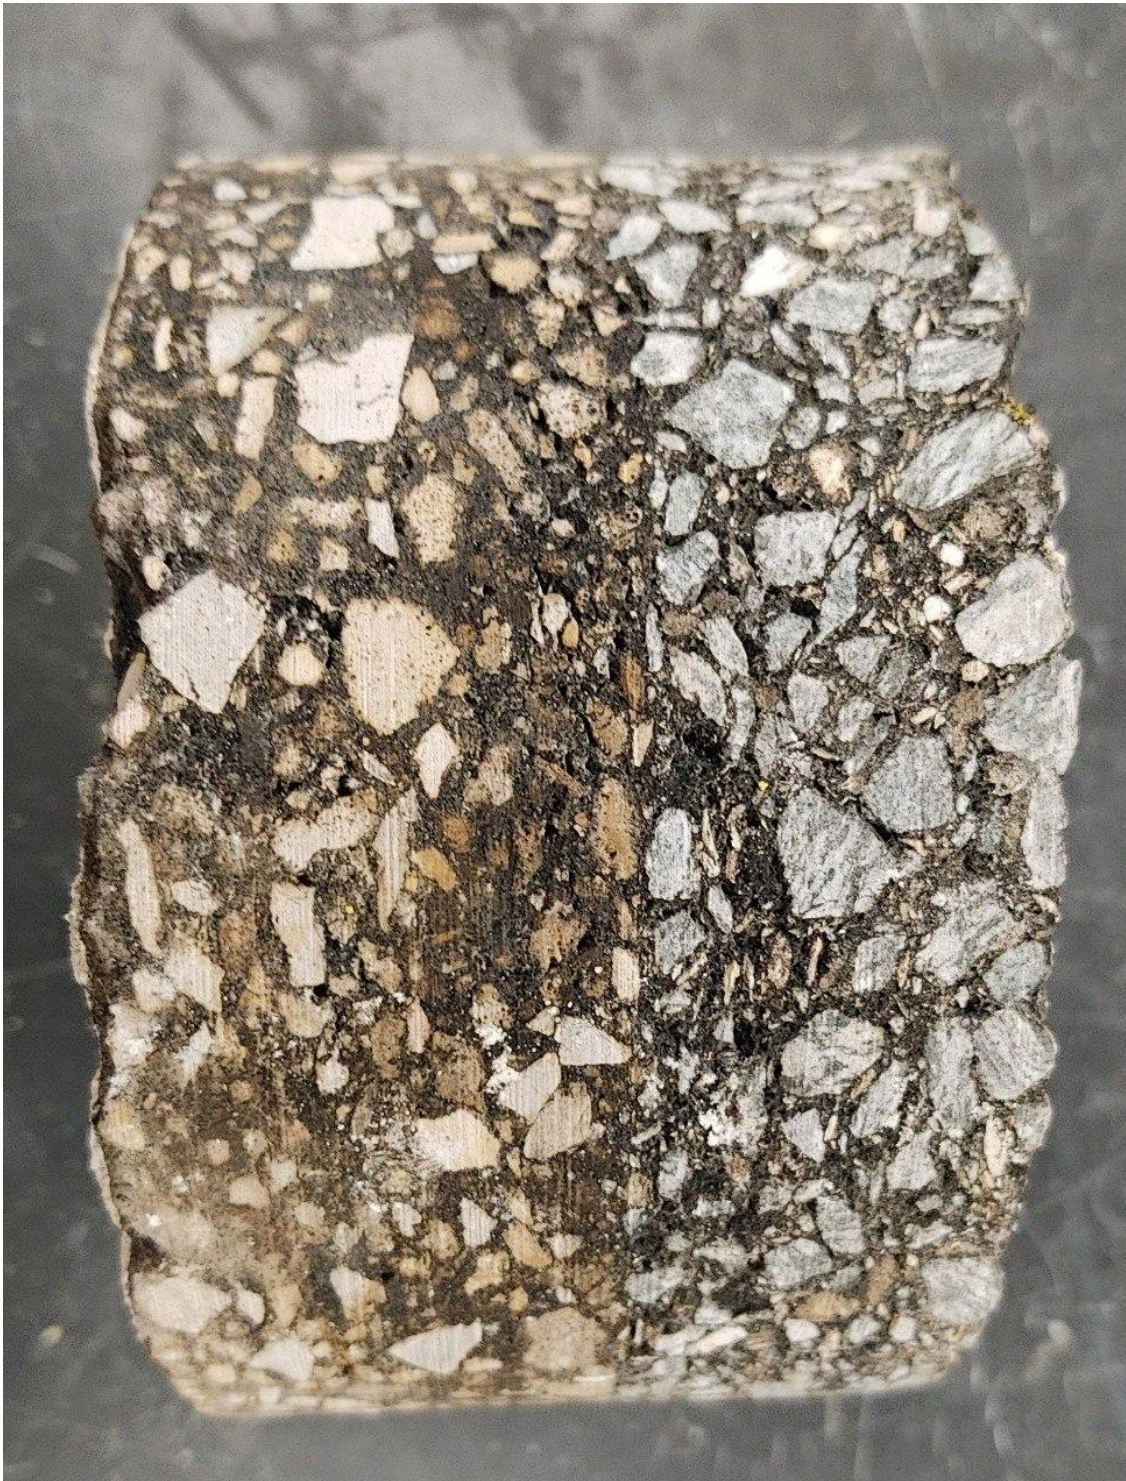
possibly indicating a loss of durability, stiffness, and strength of the AC at the subject interface. Of the 58 tests performed, 14 failures were observed in the top AC layer, 8 failures were observed in the bottom layer, 30 cores sheared at the interface, and 5 cores exhibited fractures in both the upper and lower AC layers. No core samples from US 17 fractured along the interface. Both AC layers at the interface were considerably deteriorated; however, the lower layer exhibited the most severe pitting and voids. A close-up of these distresses along the interface are shown on a typical worm section core in Figure 4-89.

Figure 4-89. Close-up of Air Voids at US 17 Worm Core Layer Interface

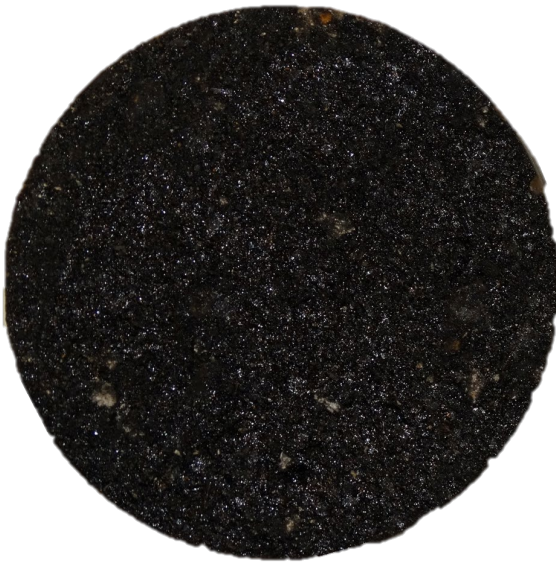
Control Section MP 0.391

- Control Section: No evidence of tack coat; voids in the surface texture may be a product of the movement of water in the interface.
 - Worm Section: No evidence of tack material; significant pitting and voids could be a product of the movement of water in the interface.

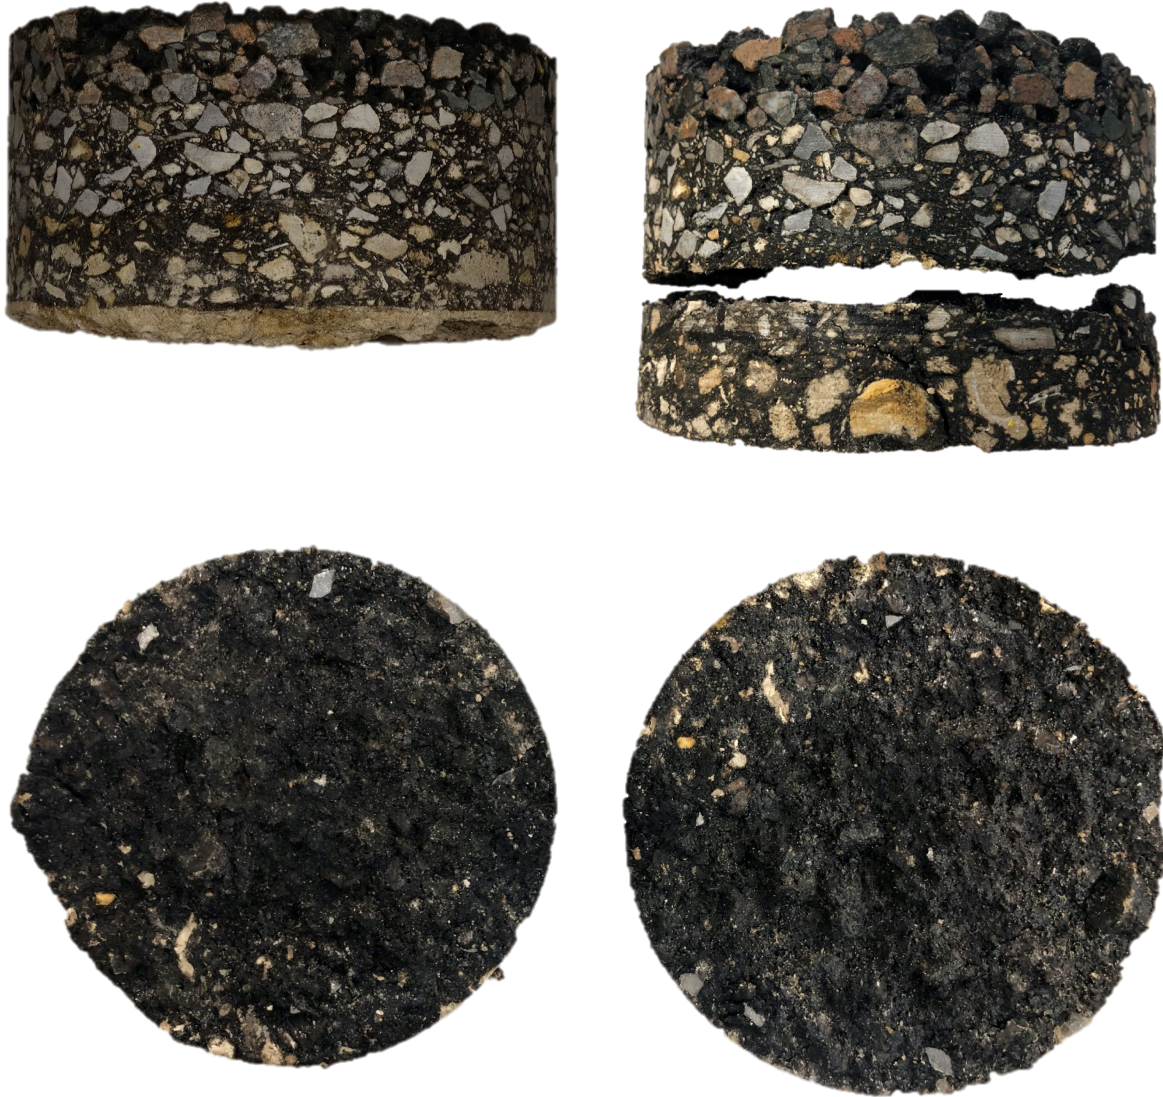
Figure 4-93. US 17 Control Section MP 17.403 Bond Test Failure Outside of Interface

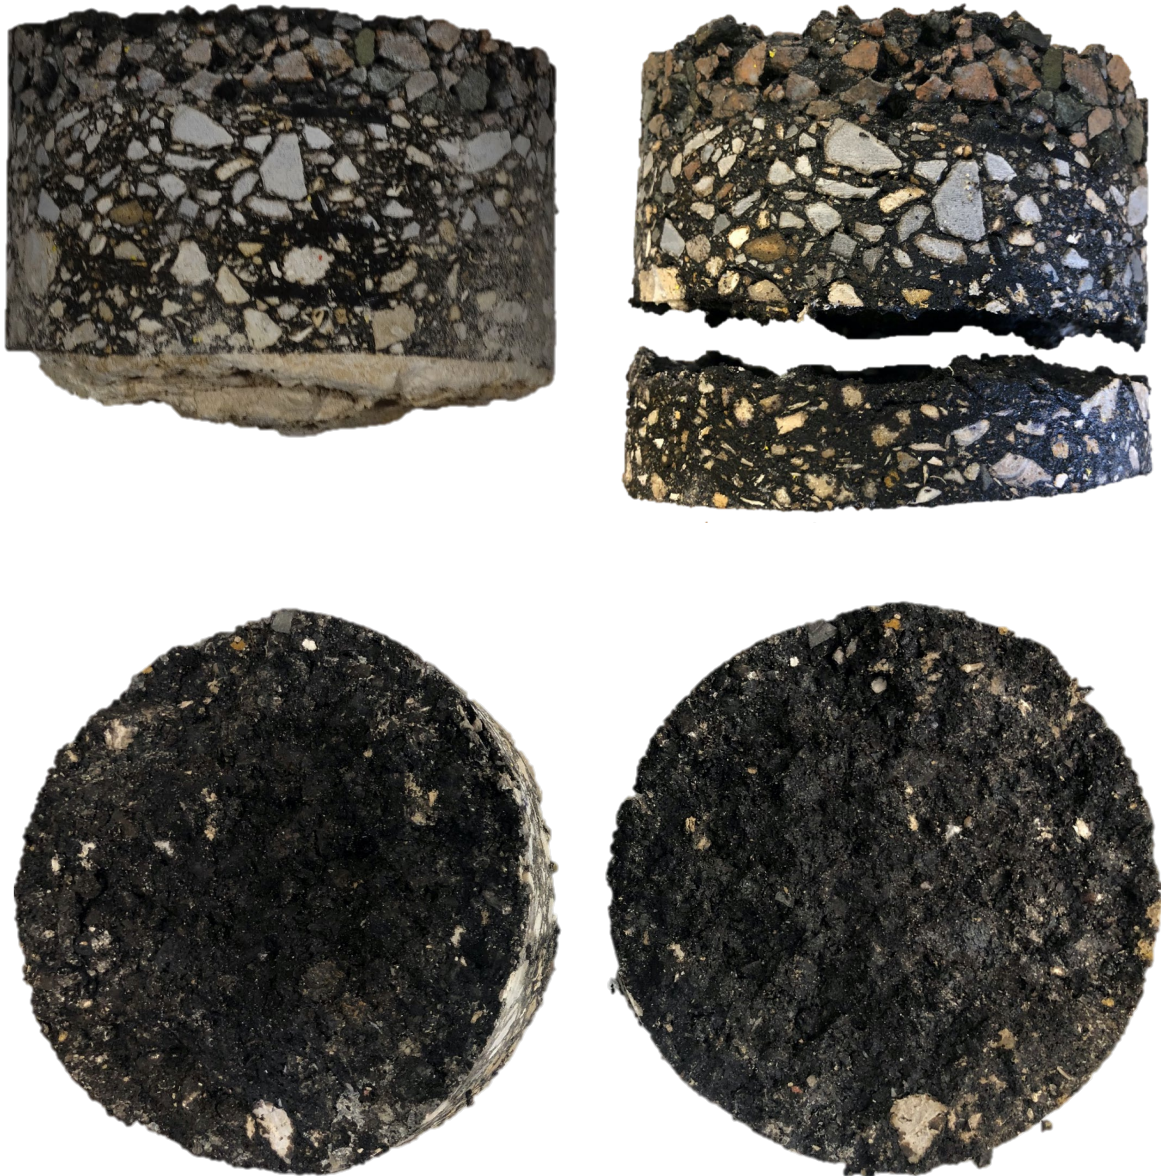
Figure 4-94. US 17 Control Section MP 17.401 Bond Test Failure Outside of Interface

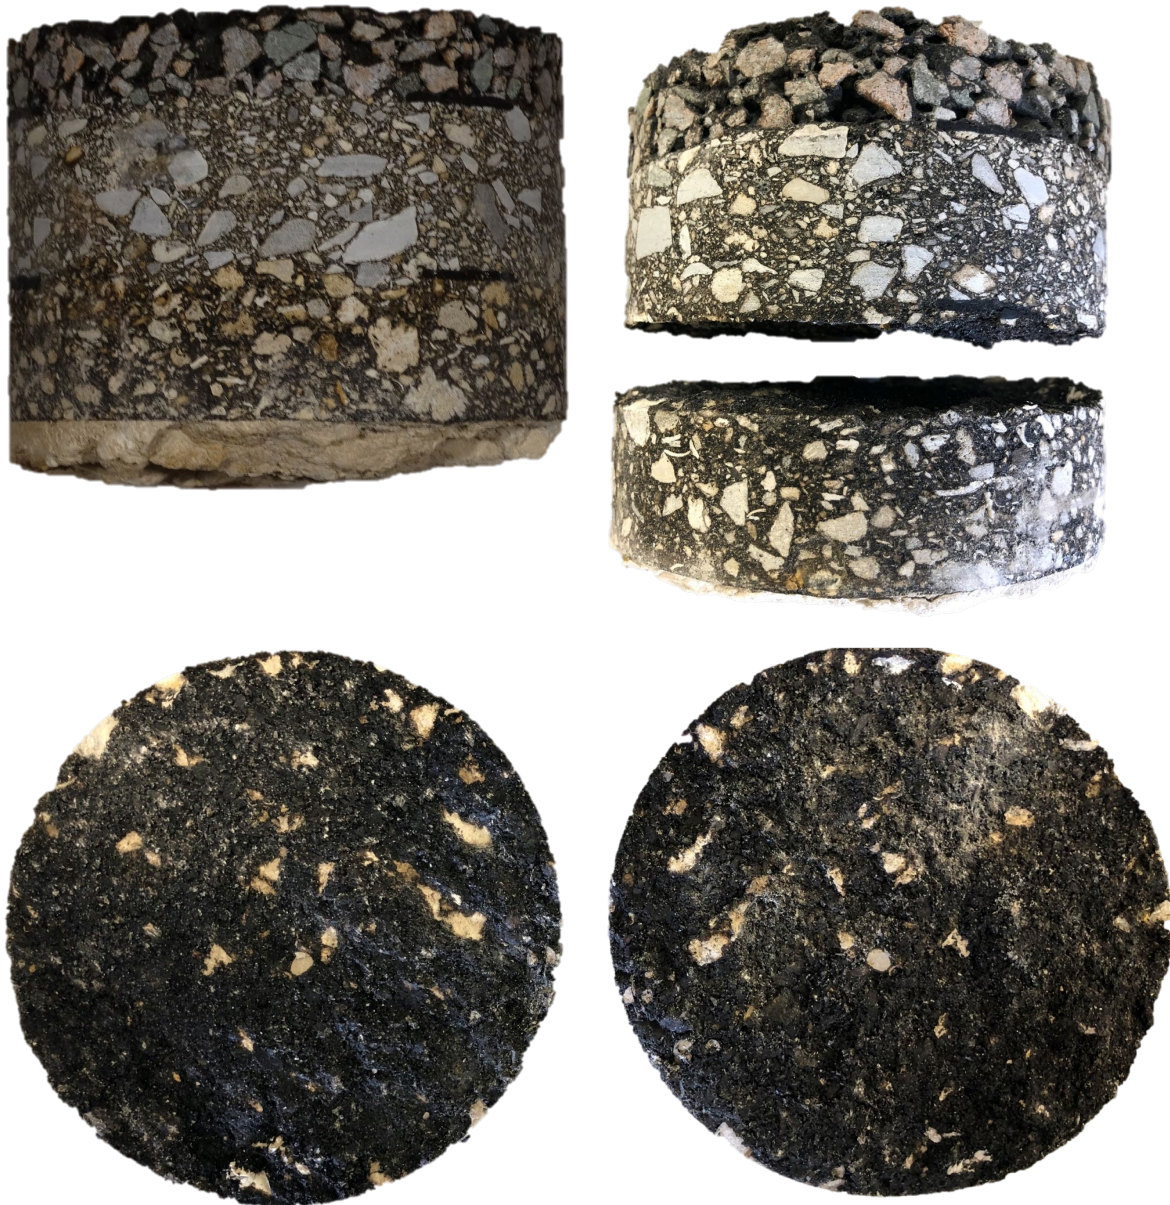
Figure 4-95. US 17 Worm Section MP 31.130 Bond Test Failure Outside of Interface

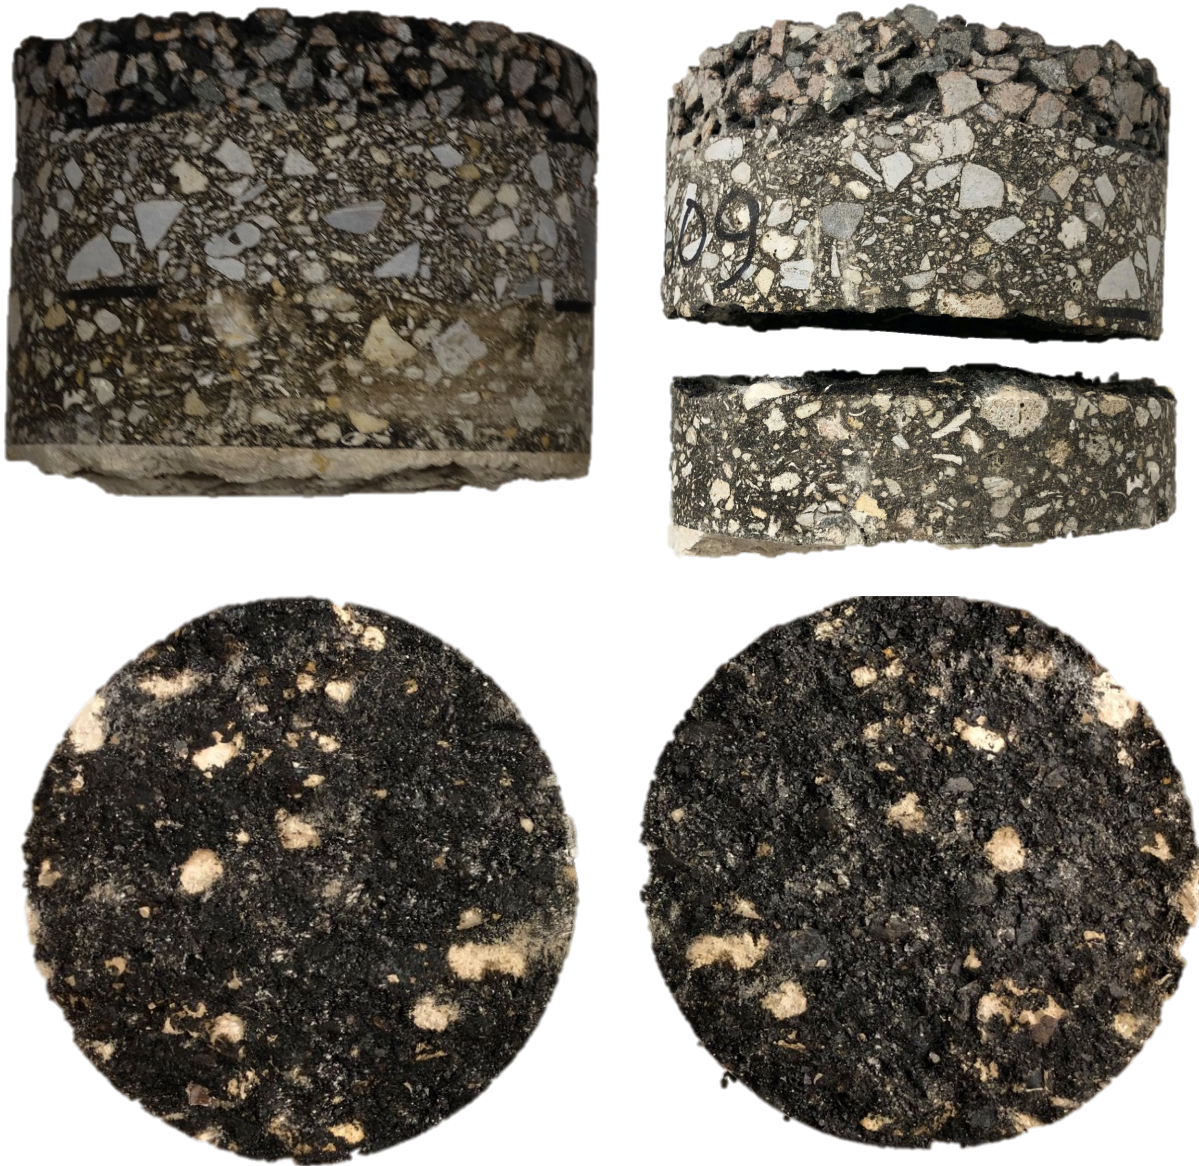
Figure 4-96. US 17 Worm Section MP 31.146 Bond Test Failure Outside of Interface
