Evaluation of FDOT Corrosion Prevention and Control Programs

DOT-RFP-19-9059-GH

FINAL REPORT

Wiss, Janney, Elstner Associates, Inc.

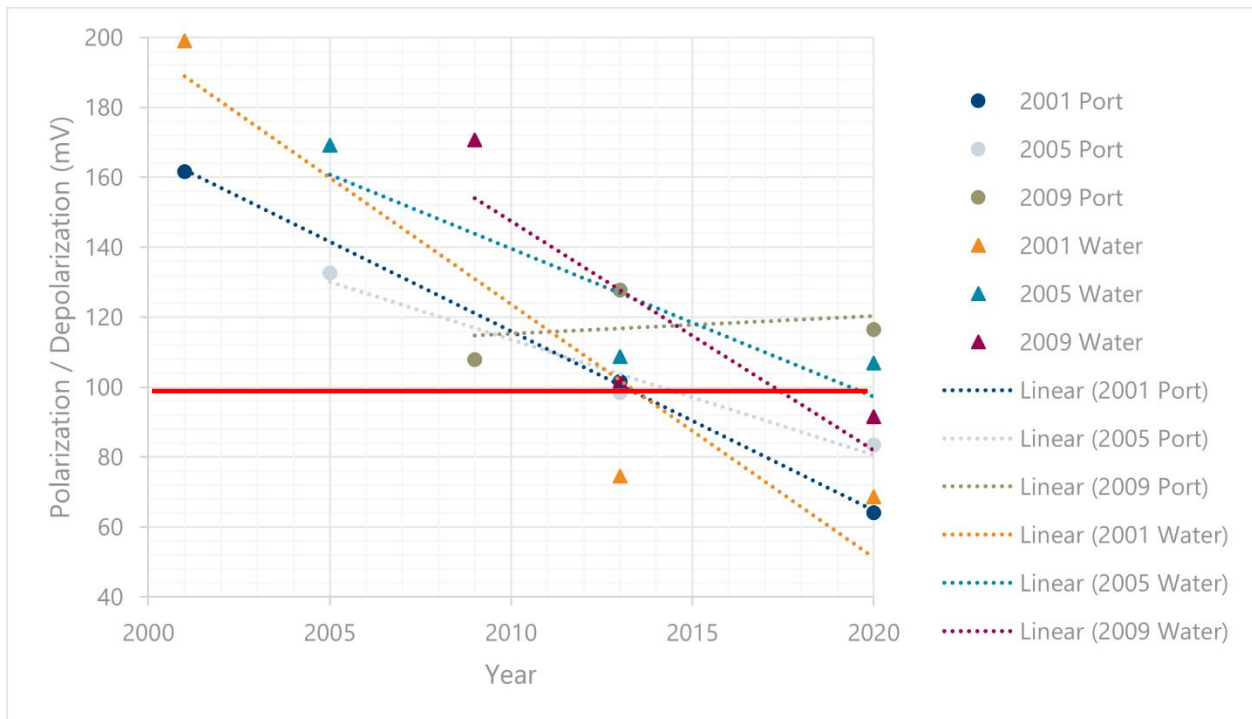
Polarization/Depolarization – A review of polarization/depolarization showed similar trends in decline as a result of the age of the CP pile jacket, which is displayed in Figure 11. Although the data trends were slightly less linear, the decline in depolarization measurements in 2020 ranged from 37 to 65 percent less than polarization measured at initial commissioning, with the exception of the 2020 measurement of the 2009 installation within the port. A likely explanation for this observation is that five of the ten pile jackets evaluated out of the 2009 installation lot decayed for 70 days due to access, over one month longer than the remainder of evaluated pile jackets. A portion of the polarization decay can occur within the first 24 to 48 hours. However, it is rarely enough time to achieve full depolarization of the steel owing primarily to slow migration of oxygen to the steel surface, especially in partially saturated concrete cover. Full depolarization may take months for the structure to finish decaying, particularly above the waterline, as illustrated in this data.

Figure 11. Overview of polarization/depolarization decay as a function of time. The red line indicates the minimum 100 mV polarization/depolarization recommended threshold for adequate CP.

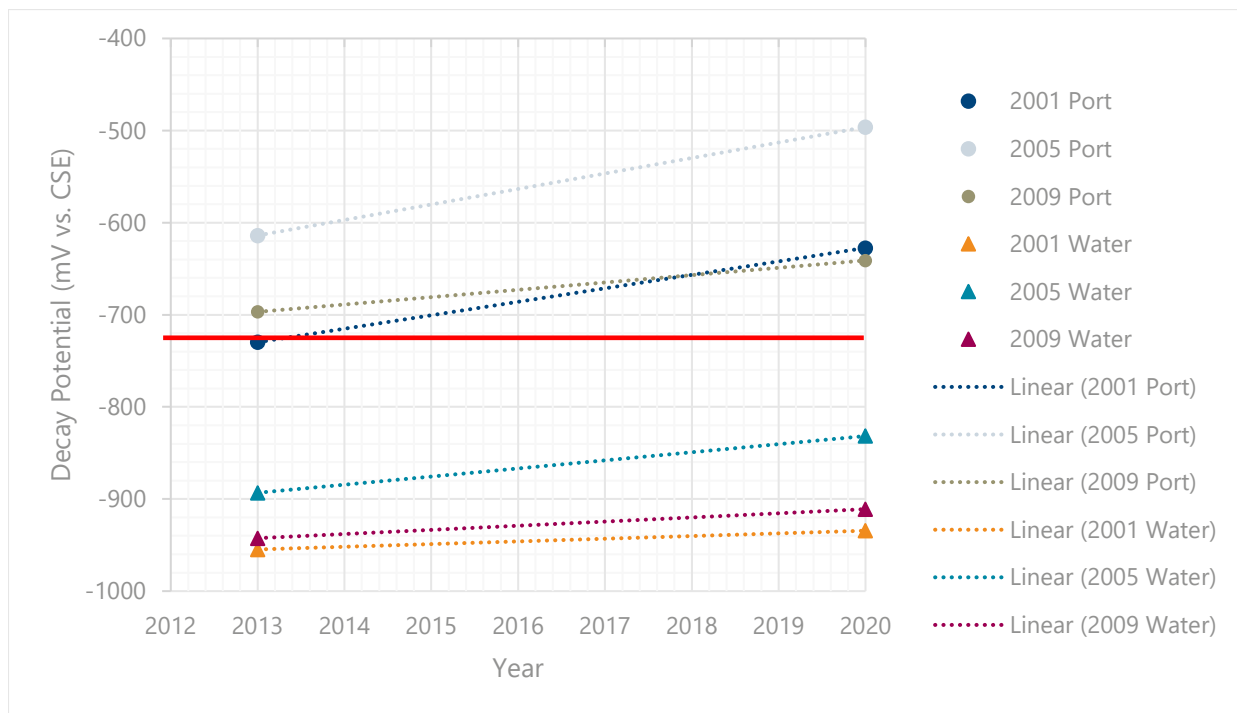
Figure 12. Overview of decay potential as a function of time. The red line indicates the maximum -720 mV vs. CSE decay potential recommended threshold for adequate CP.

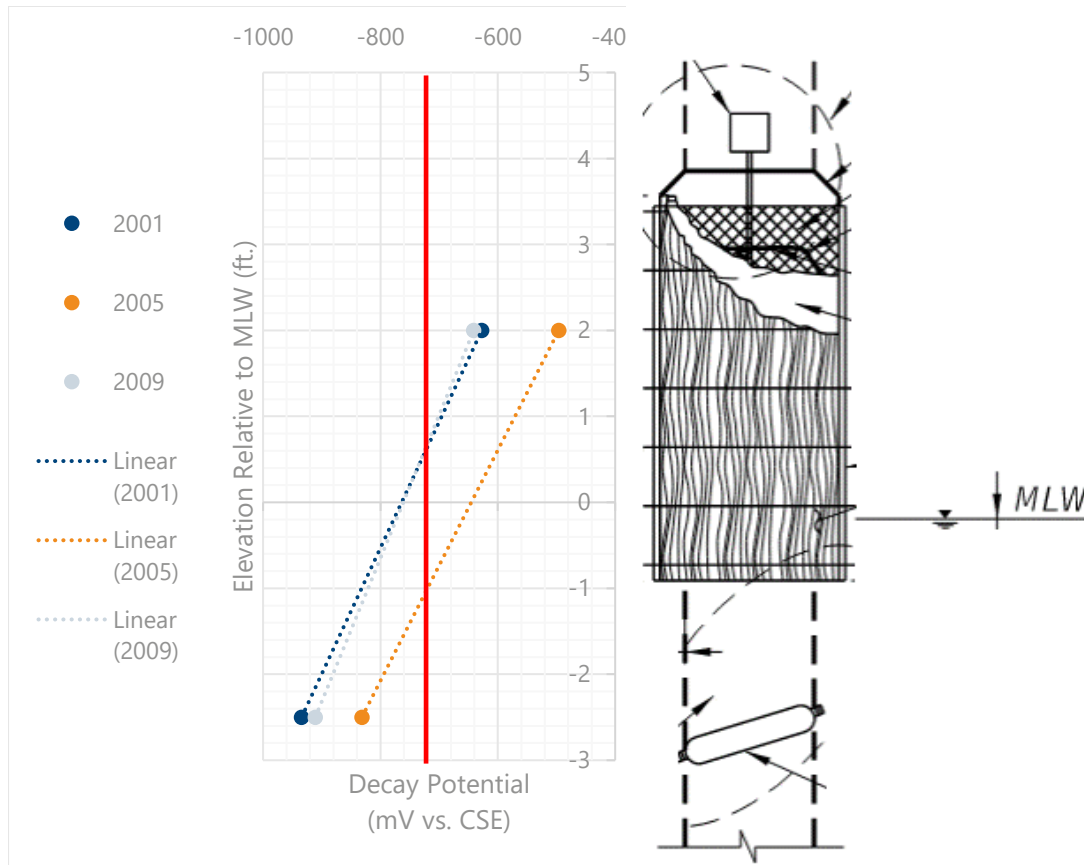
side with a relative CP pile jacket elevation in Figure 13, with the port measurement shown at 2'-0" above MHW (0'-6" above MLW) and the water measurement 3'-0" below the waterline. In this figure, the elevation of water measurements may vary, and decay potentials are shown as linear; however, these assumptions may not be entirely accurate. Regardless of these potential variations, it is clear that the average decay potentials are likely more positive than the -720 mV vs. CSE threshold within a maximum of 2'-0" above the waterline, although exact elevations will vary by CP pile jacket and environmental conditions. Additionally, although data was not obtained at higher elevations on the CP pile jackets, it can be assumed that decay potentials will be more positive as elevation increases.

Figure 13. Relative side-by-side comparison of average decay potentials as a function of CP pile jacket elevation. The red line indicates the maximum -720 mV vs. CSE decay potential recommended threshold for adequate CP.

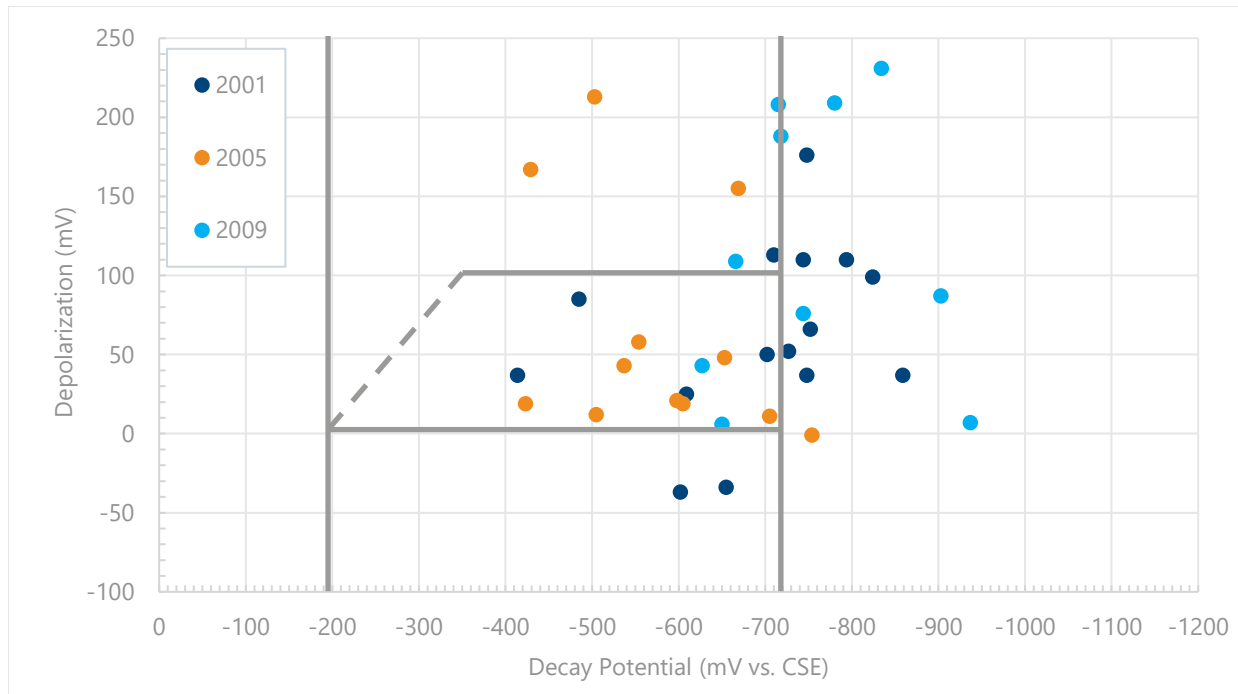
To illustrate electrical performance against criteria established by industry standards, Figure 20 and Figure 21 plot depolarization versus decay potentials for the 2021 measurements obtained within the monitoring port and water for the three different generations of CP pile jackets, respectively. As expected, significant scatter is observed in the data, making a correlation difficult between these electrical measurements and differentiating the performance of the jacket generations on an individual CP pile jacket basis. However, one clear trend that is further illustrated is the significantly more negative decay potentials within the water than in the port, while depolarization values remain similar. The submerged portions of the piles would be expected to have more highly negative potentials because the oxygen availability is limited and thus affects the electro-chemical behavior of the bar. Additionally, the presence of the submerged bulk anode and low resistivity of seawater interacting with the grout creates a lower resistance and more favorable path for the ionic current to flow through, compared to the grout above the waterline, particularly at the higher elevations.

Figure 20. Plot showing depolarization versus decay potentials measured in the monitoring port for the three generations of installations

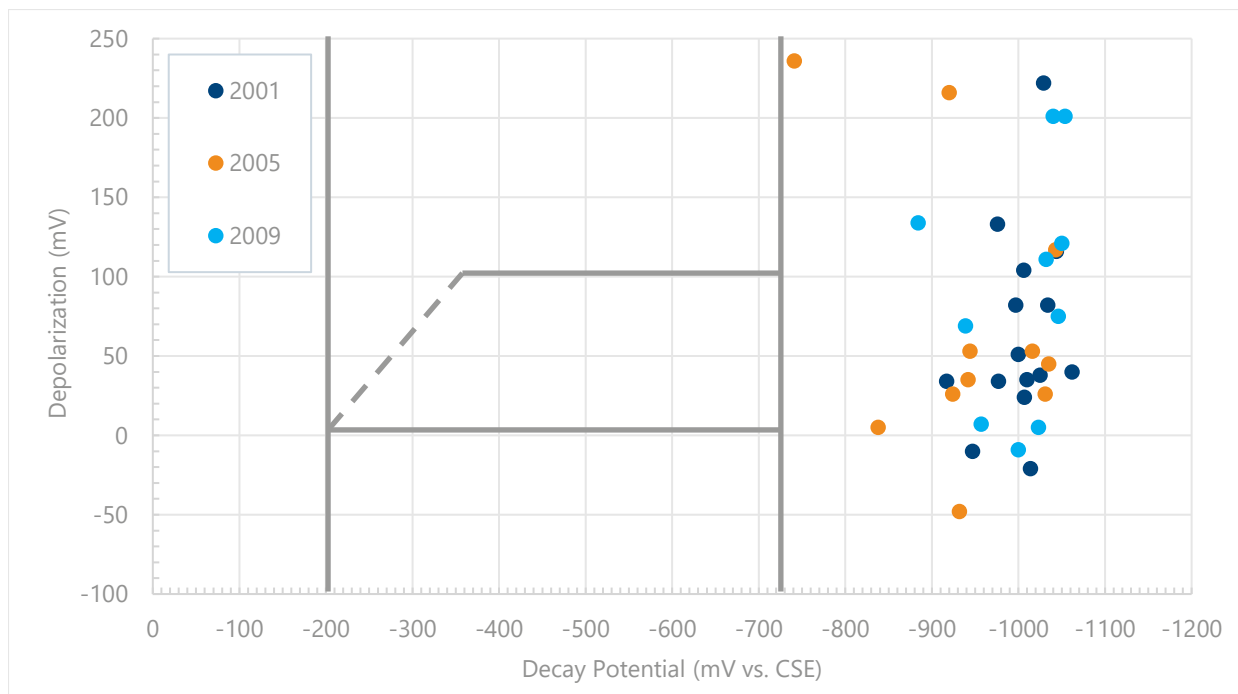
Figure 21. Plot showing depolarization versus decay potentials measured in the water for the three generations of installations

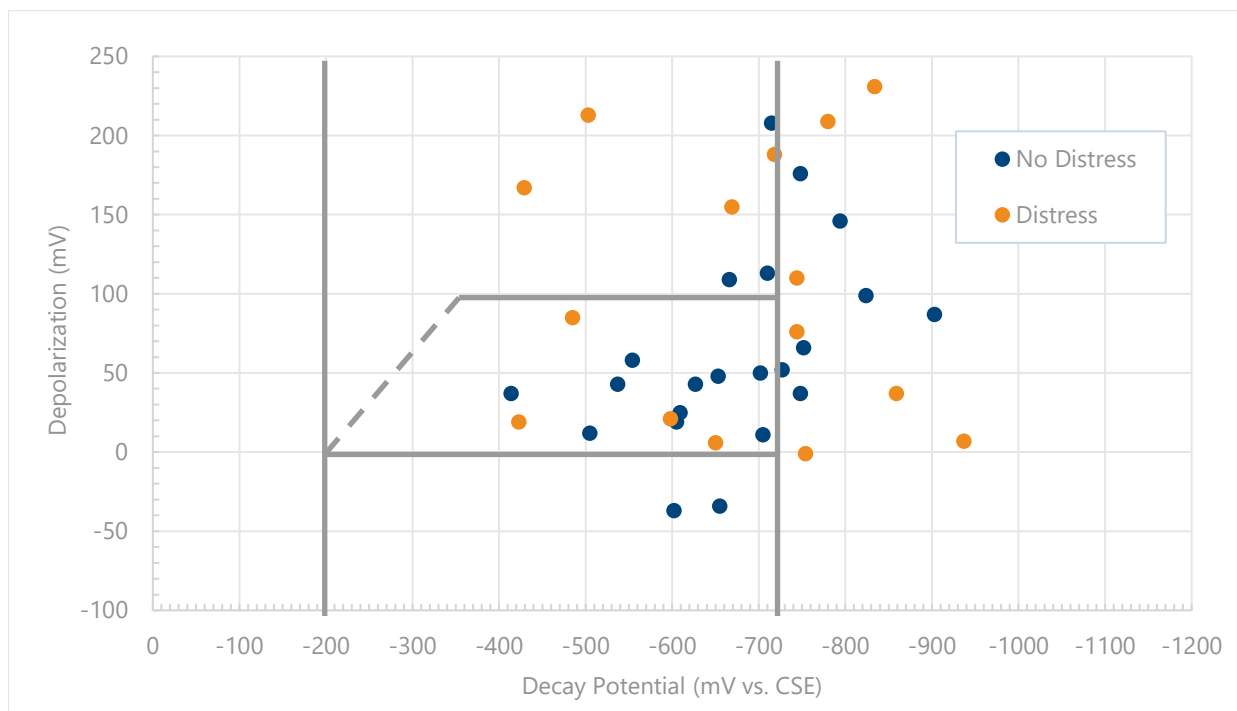
jacket, specifically distress deemed a result of ongoing corrosion of the embedded steel, which is provided in Figure 22. Similar to the data sorted by CP pile jacket installation previously presented, no clear correlation is present between electrical data within the monitoring port and distress observed above the top of the jacket. While previously displayed trends illustrate lesser CP from the CP pile jacket at higher elevations of the pile, the depolarization values and decay potential values measured from within the port do not reflect the actual protection provided at the top or just above the jacket. To illustrate the lack of correlation between CP pile jacket electrical data and visible distress above, 11 of the 21 pile jackets falling within the “100% protected” categories within the jacket exhibited distress above the jacket, while the two pile jackets within the “Unprotected” category did not exhibit distress above the jacket.

Figure 22. Plot showing depolarization versus decay potentials measured in the monitoring port for piles with and without distress.

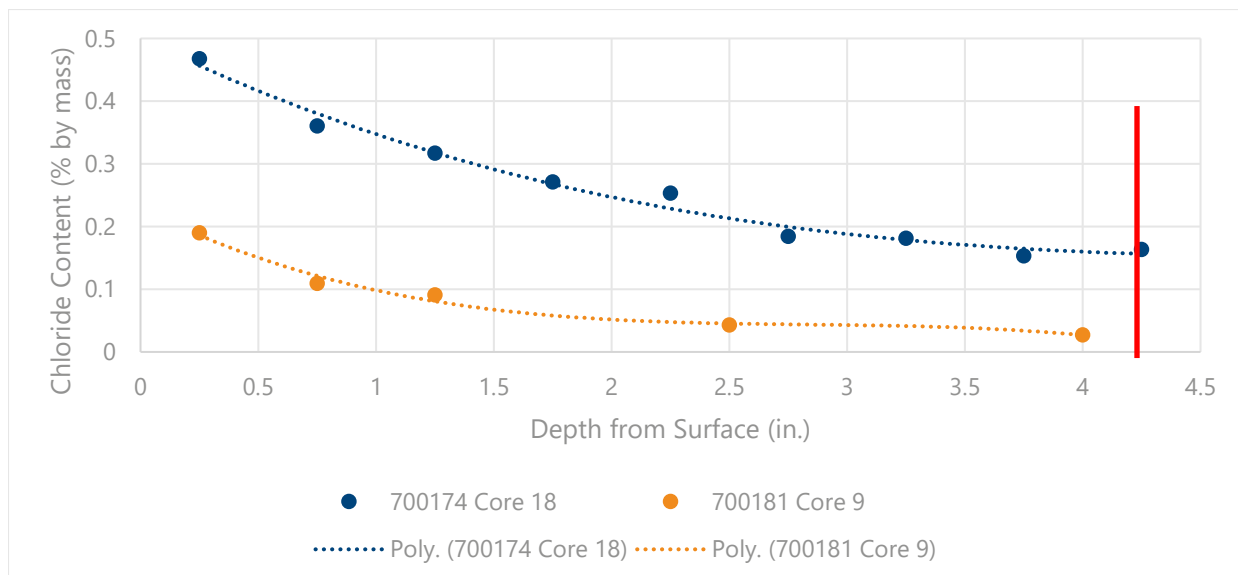
Figure 33. Chloride profiles for crash wall core samples. Cores shown are Core 18 (Bridge No. 700174, 2011) and Core 9 (Bridge No. 700181, 2021). The red line indicates an approximate depth of the reinforcing steel (4.25 in.)

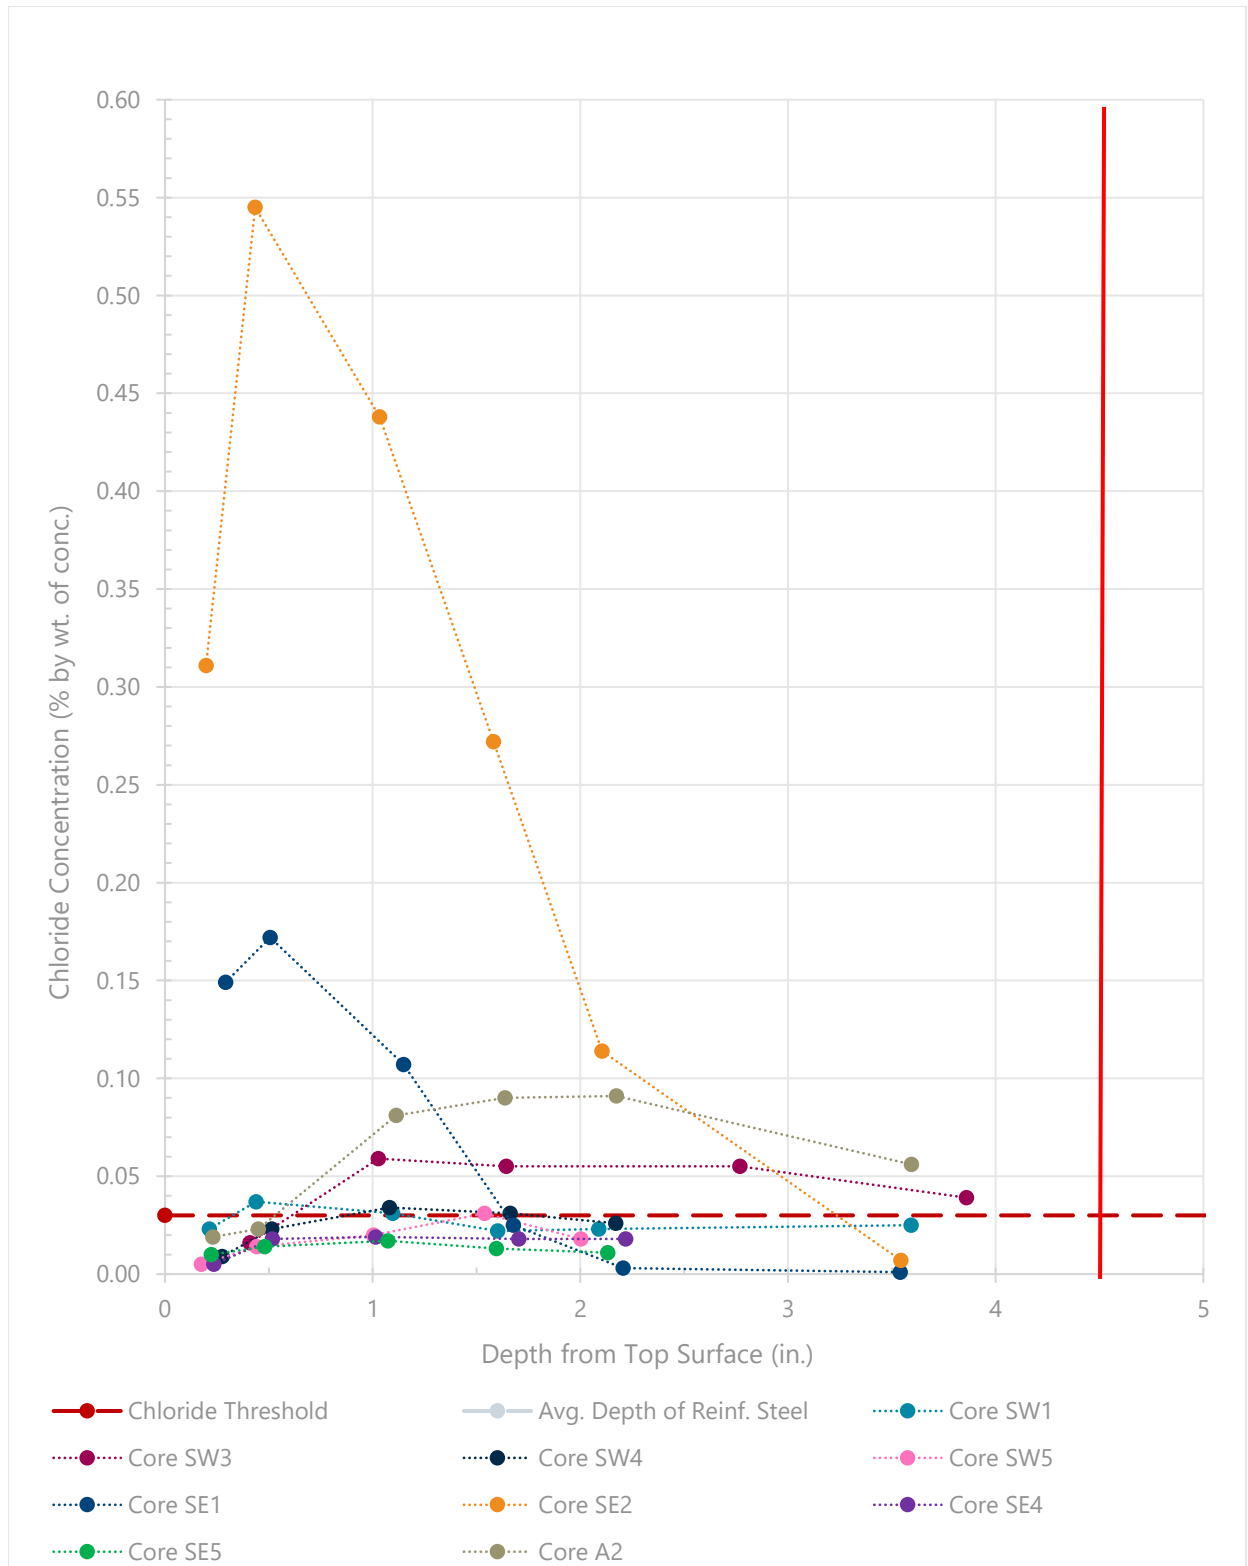
Figure 41. Chloride profiles for the core samples. Cores shown are SE1, SE2, SE4, and SE5 (Bridge No. 860467), SW1, SW3, SW4, and SW5 (Bridge No. 860466), and A2 (Bridge No. 860319). The red line indicates an approximate depth of the reinforcing steel (4.50 in.)

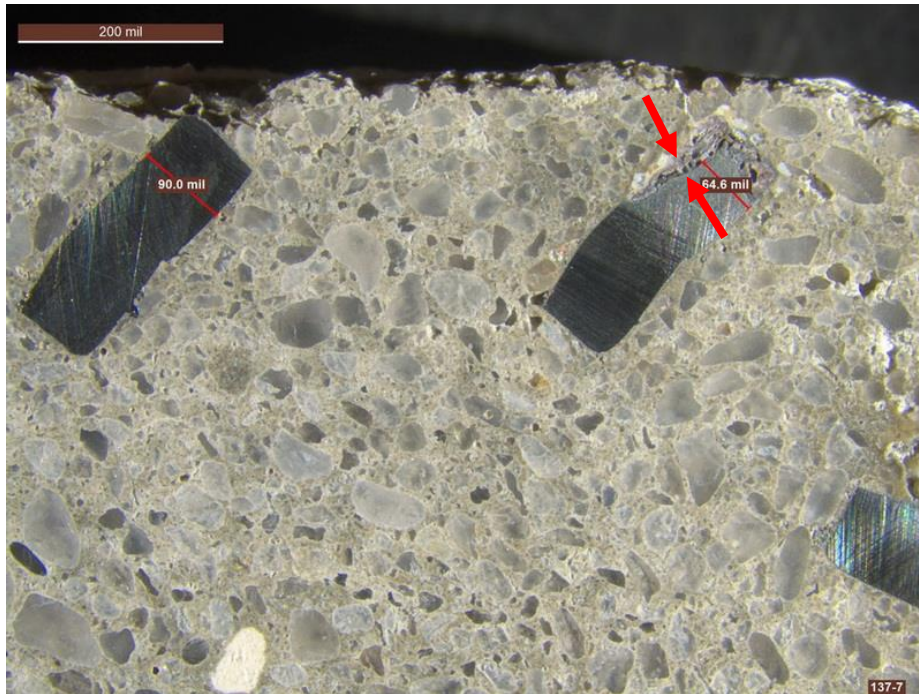
Figure 58. Sample 137-7. Close-up view of zinc mesh shows its condition and thickness measurements. The mesh showed localized corrosion and minor section loss near the corner. Mesh was free of significant corrosion or section loss elsewhere. Arrows indicate corroded portion.

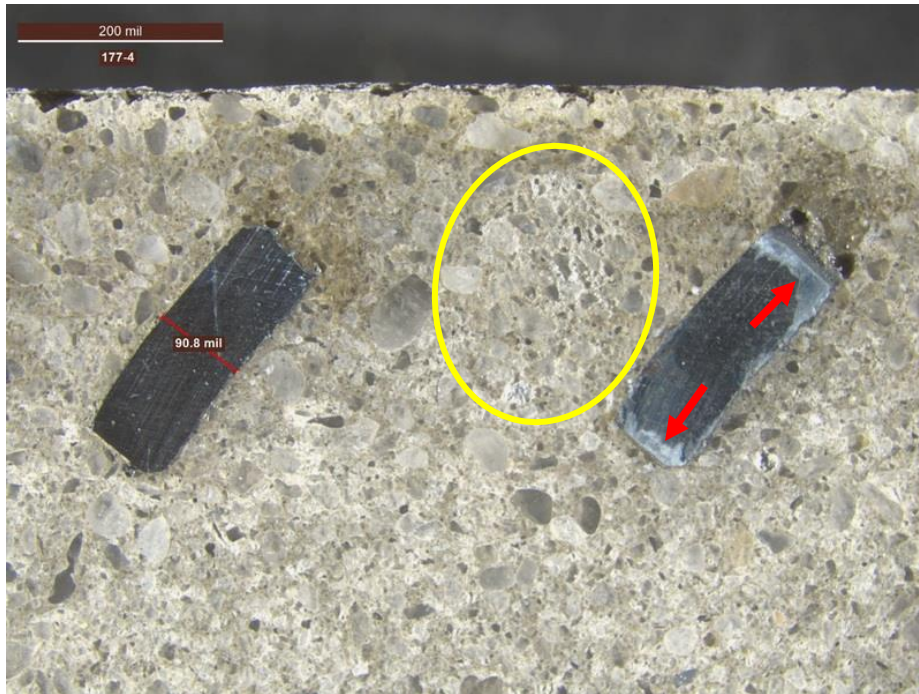
Figure 59. Sample 177-4. Close-up view of zinc mesh shows its condition and thickness measurements. Very localized corrosion and minor section loss were observed. Red arrows indicate locally corroded zinc. White efflorescence was also observed on the lapped section (yellow circle).

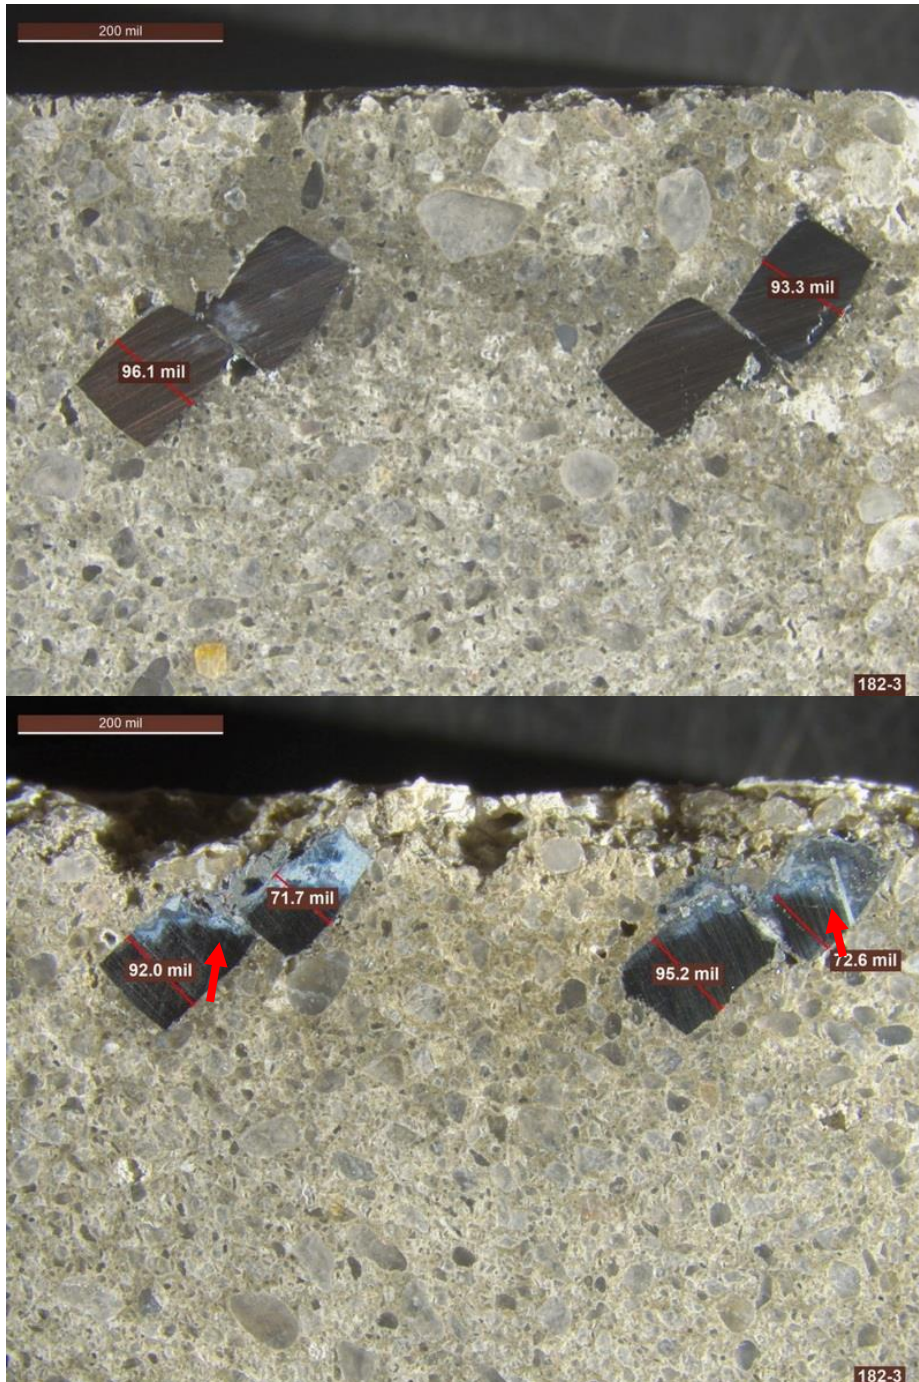
Figure 60. Sample 182-3. Close-up views of zinc mesh show its condition and thickness measurements. Localized corrosion and section loss were observed. Red arrows indicate corroded or partially corroded zinc.

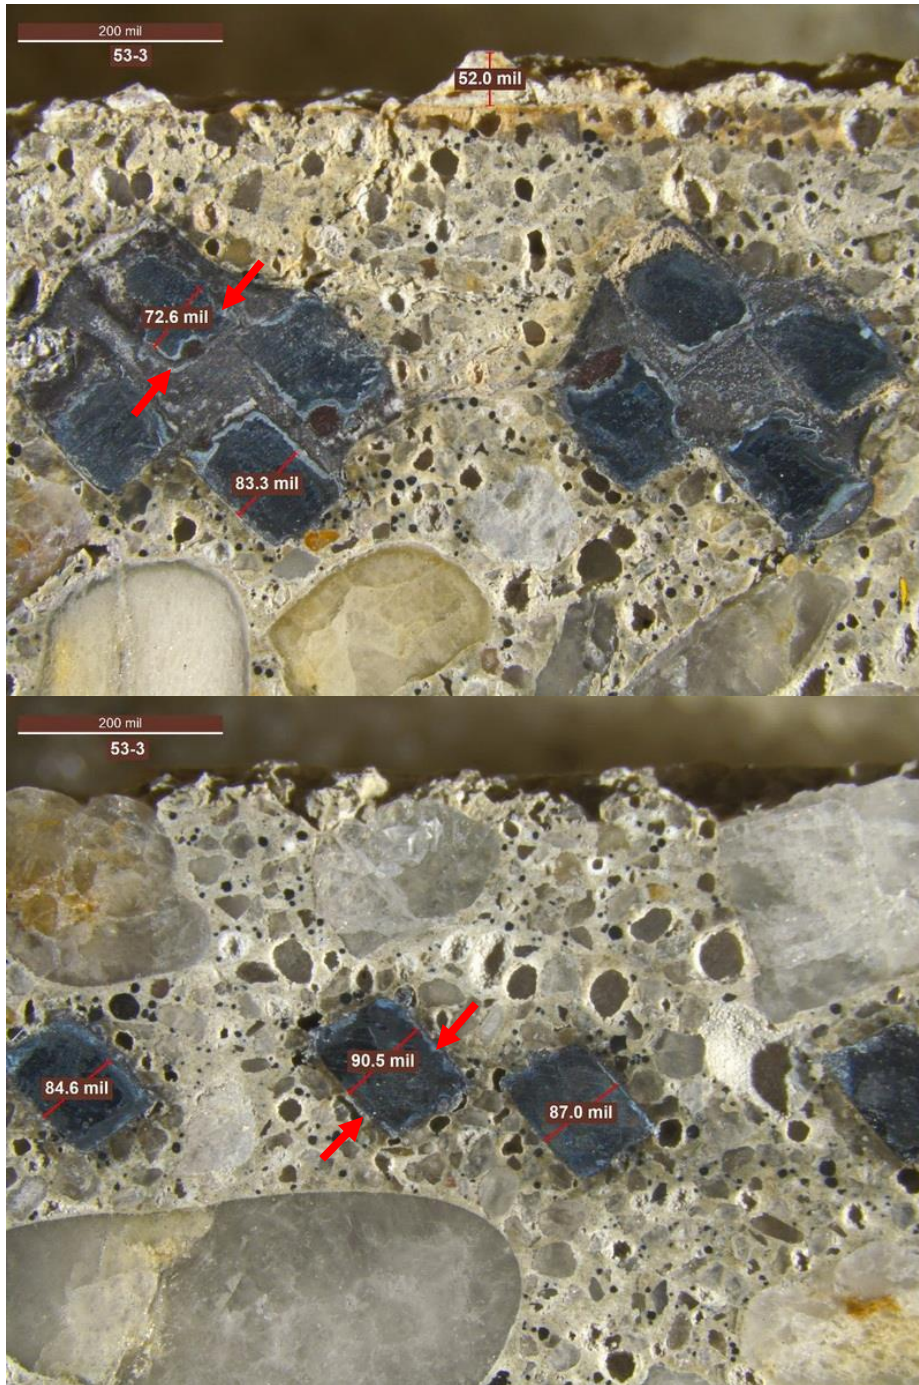
Figure 62. Sample 53-3. Close-up views of zinc mesh show its condition and thickness measurements. A mesh joint appeared to be present at a corner of the concrete sample (top photo). Corrosion and minor section loss were observed.

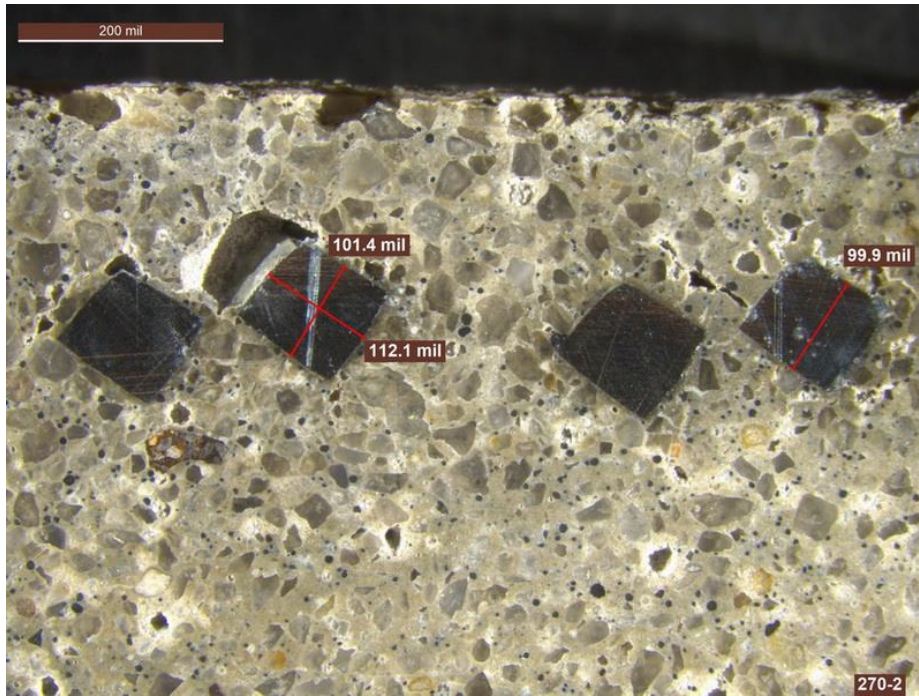
Figure 63. Sample 270-2. Close-up view of zinc mesh shows its condition and thickness measurements. Generally free of significant corrosion or section loss.

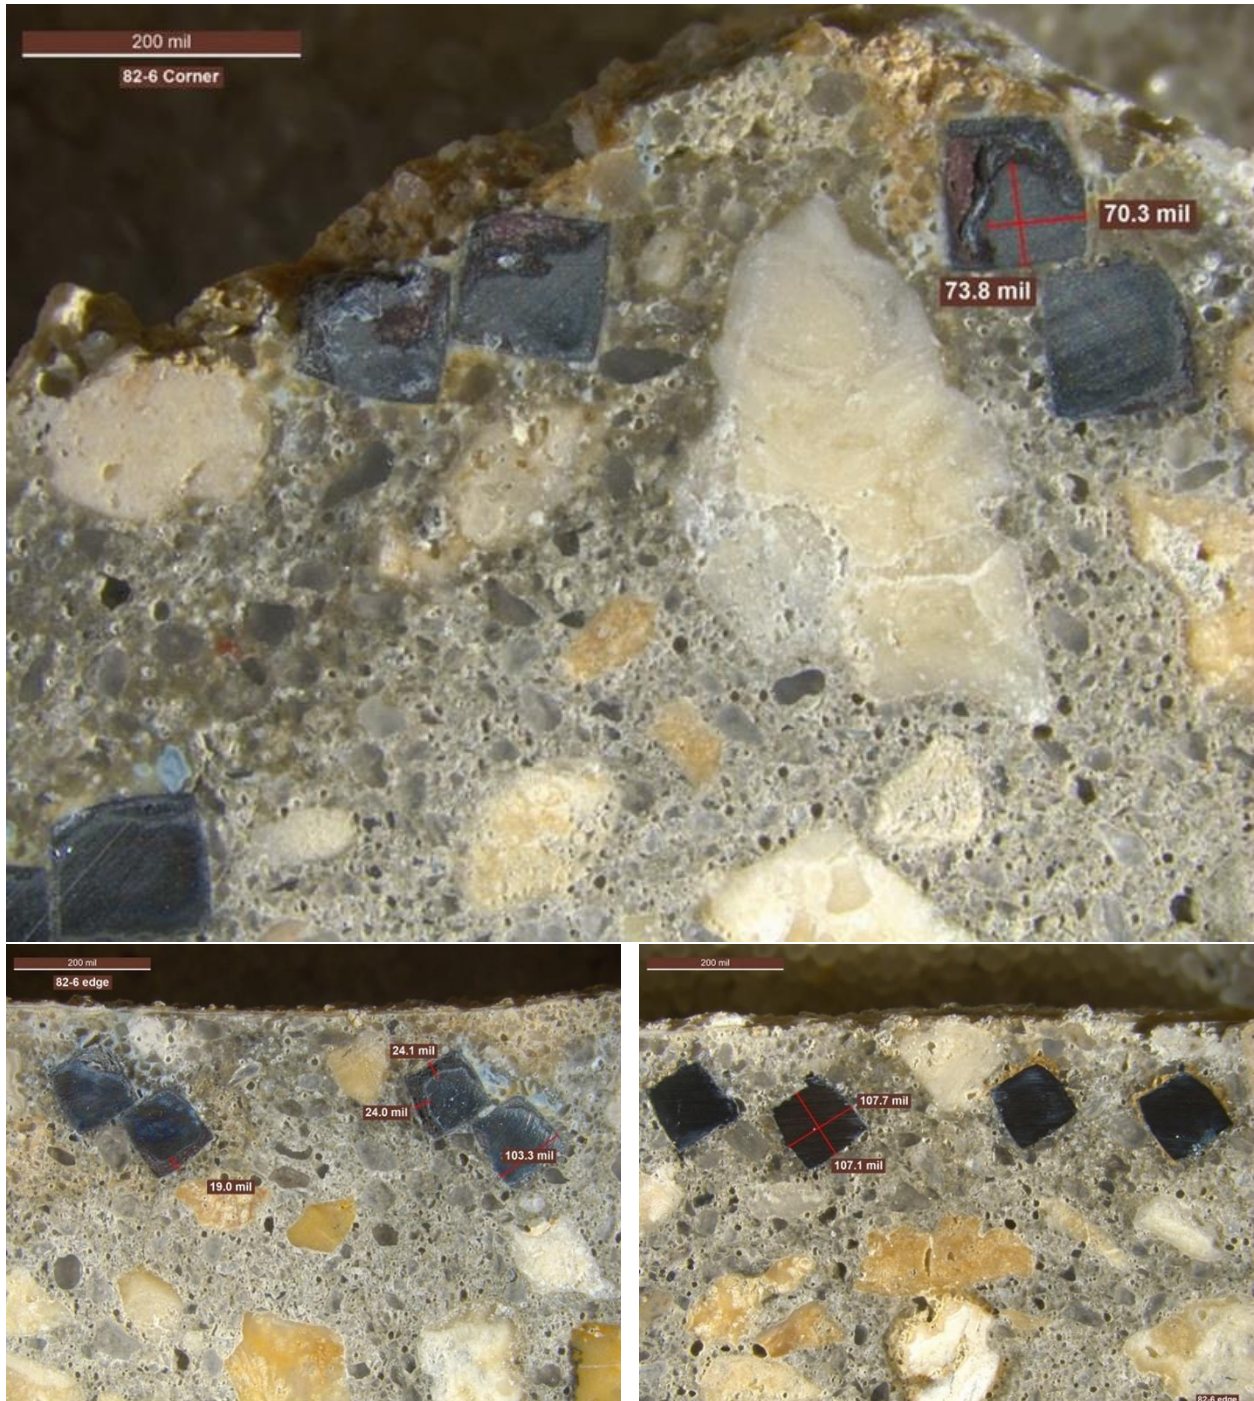
Figure 64. Sample 82-6. Close-up views of zinc mesh show its condition and thickness measurements. Corrosion and minor section loss were observed at the corner (top photo); less corrosion and section loss along the two edges (bottom photos).

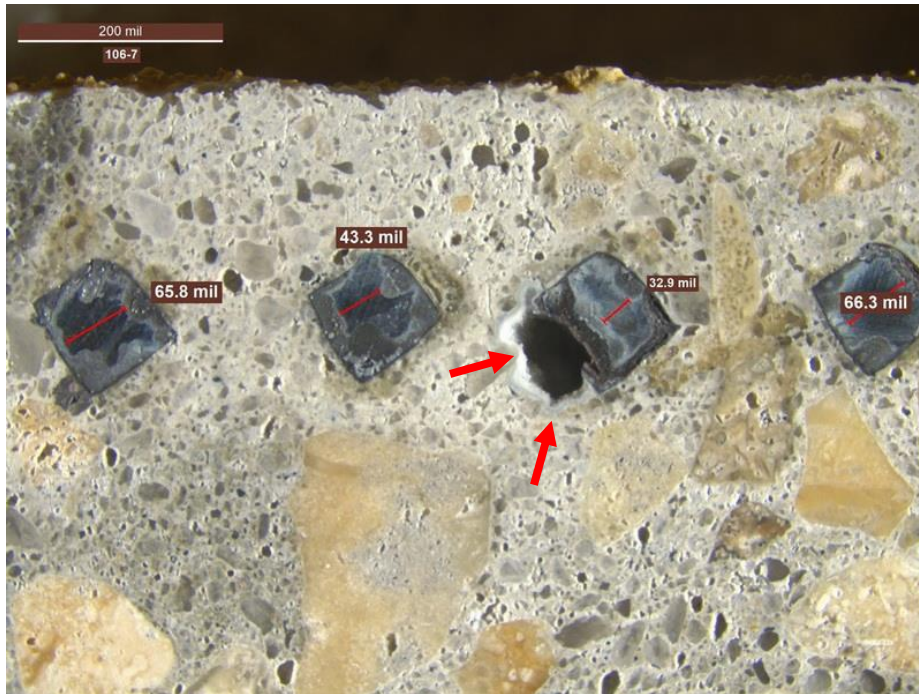
Figure 65. Sample 106-7. Close-up view of zinc mesh shows its condition and thickness measurements. Widespread corrosion and significant section loss were observed. Red arrows indicate white deposits suspected to be zinc corrosion product.

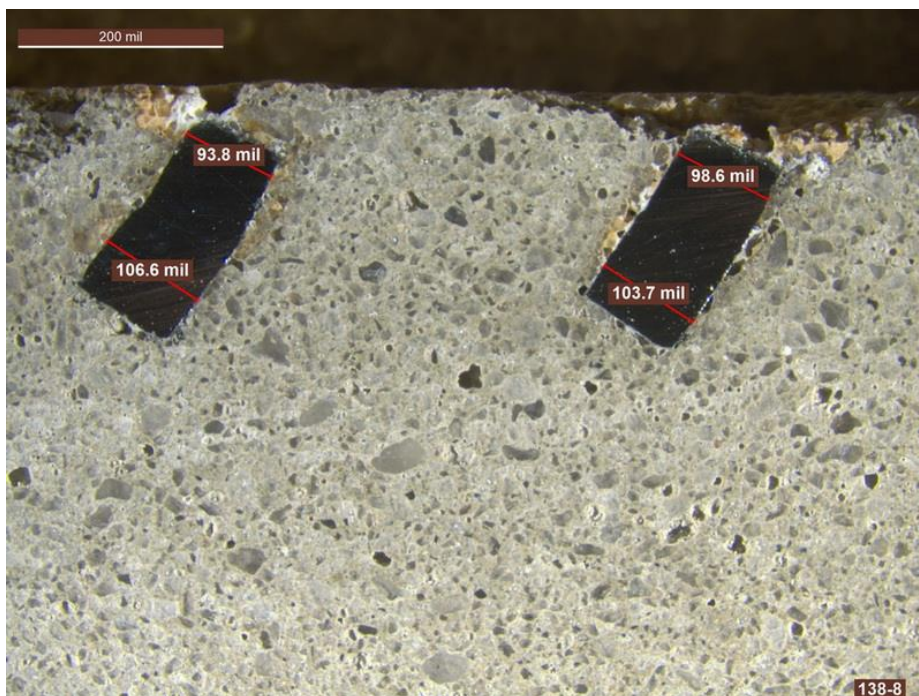
Figure 66. Sample 138-8. Close-up view of zinc mesh shows its condition and thickness measurements. Corrosion and minor section loss were observed.

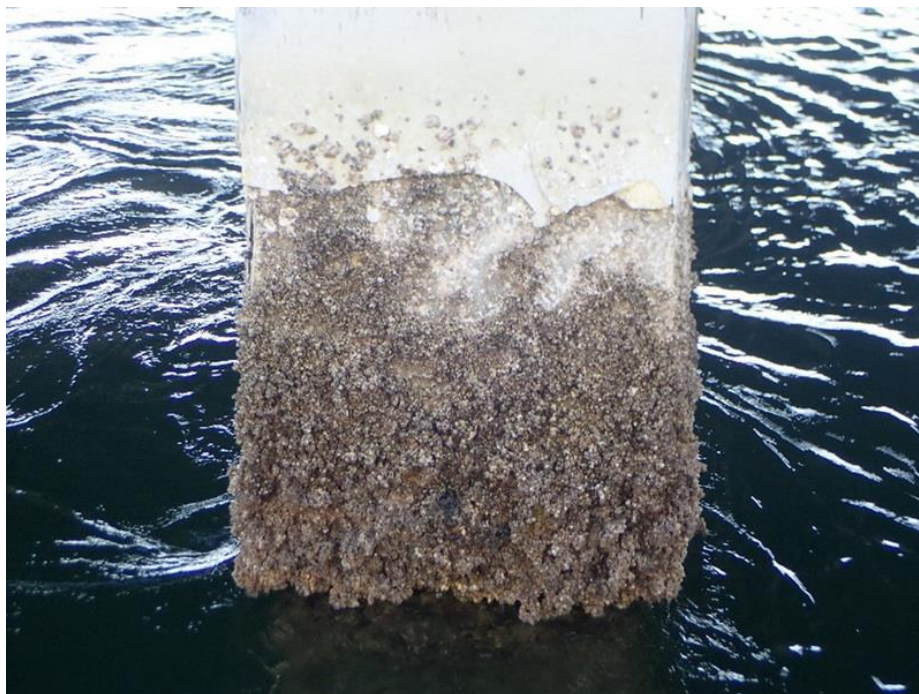
Figure 70. Missing portion of pile jacket (Pile 12-1)

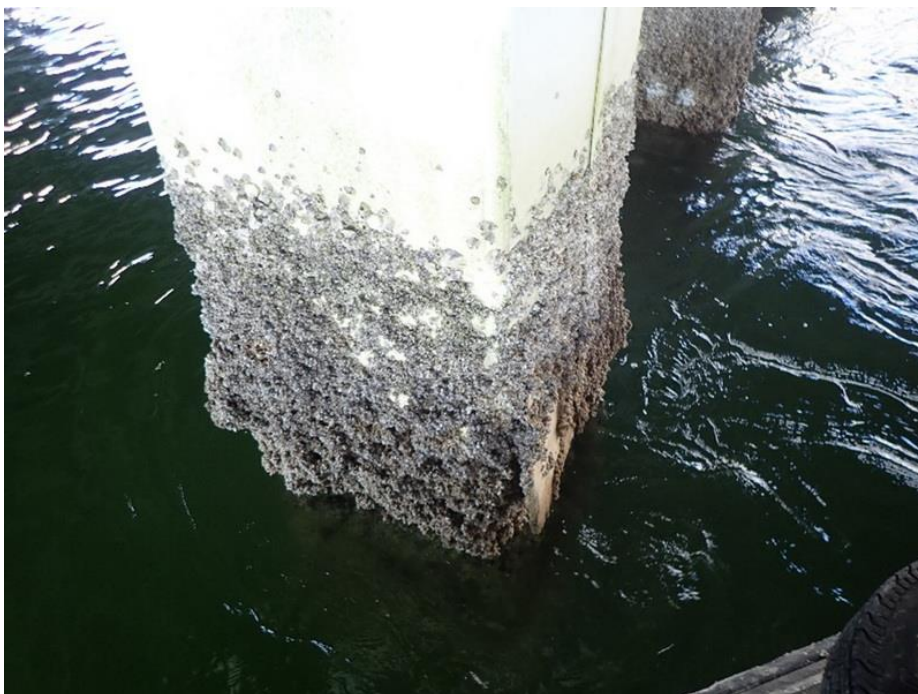
Figure 72. Split pile jacket near waterline (Pile 14-4)

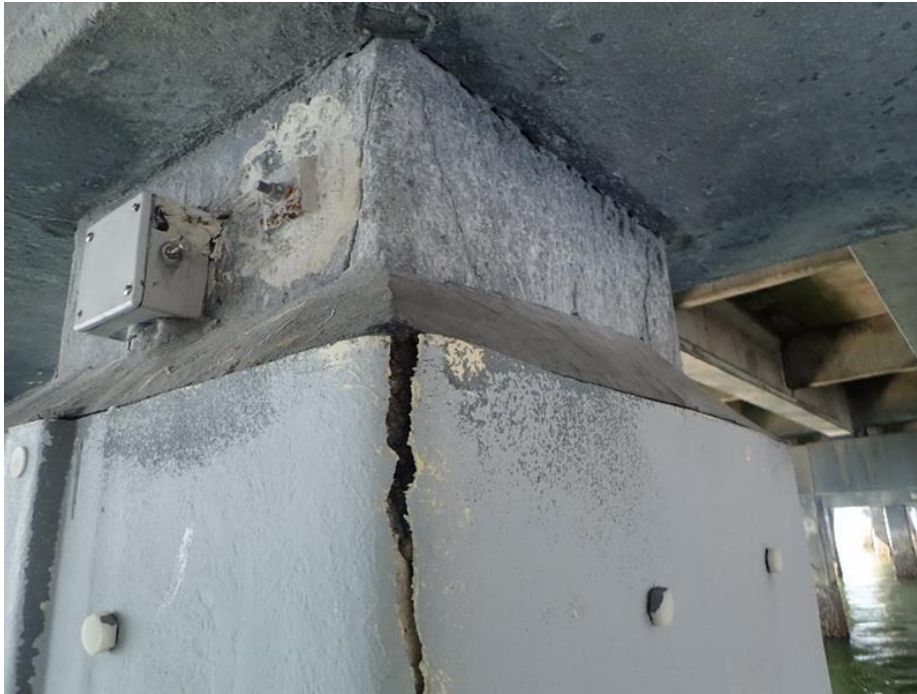
Figure 73. Split pile jacket and multiple vertical cracks on pile (Pile 44-5)

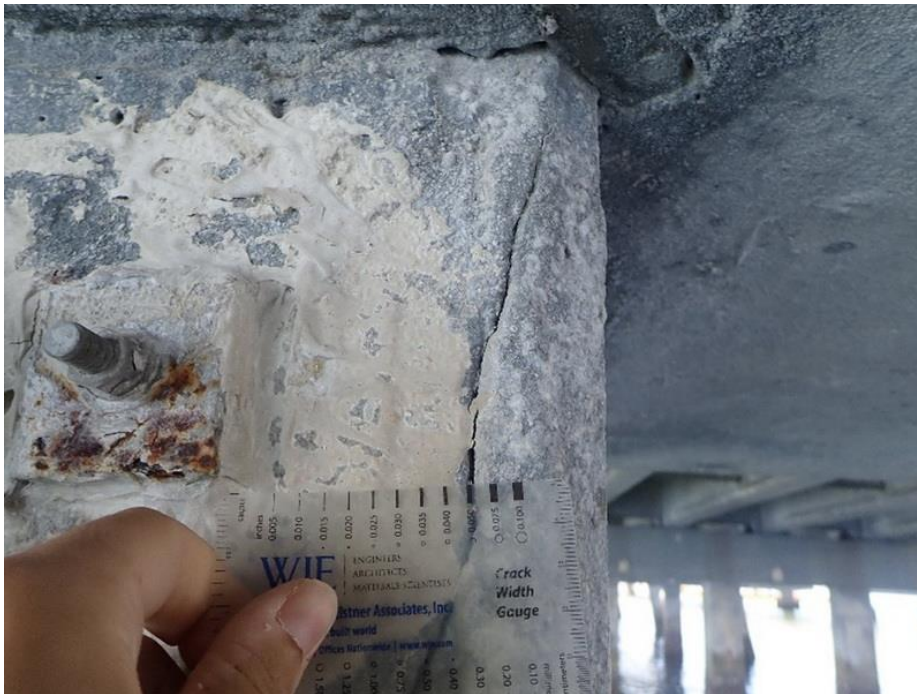
Figure 74. Cracking measured up to approximately 50 mil wide (Pile 44-5)

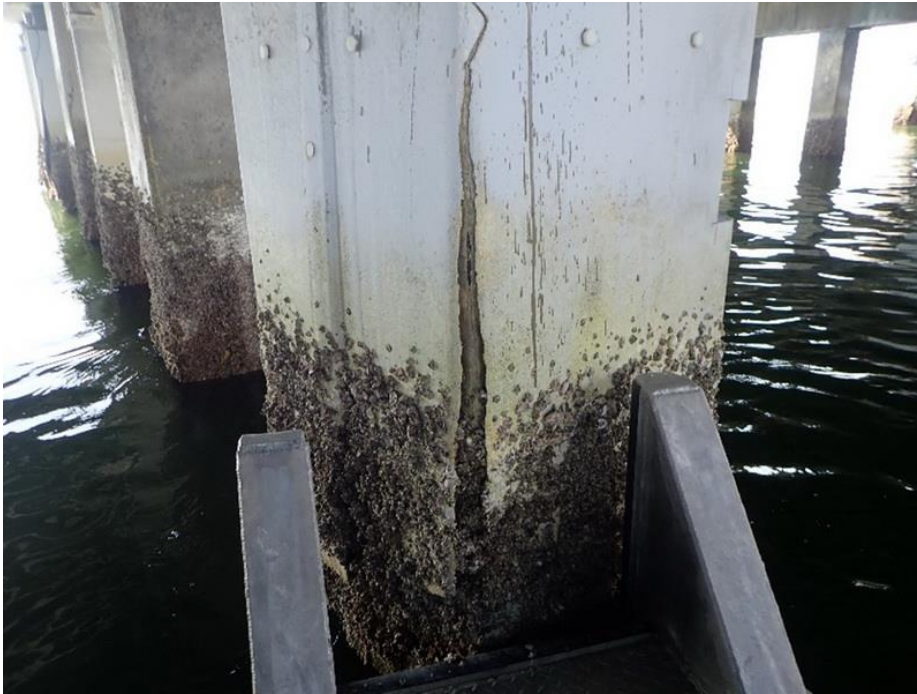
Figure 75. Vertical splitting of jacket (Pile 53-3)

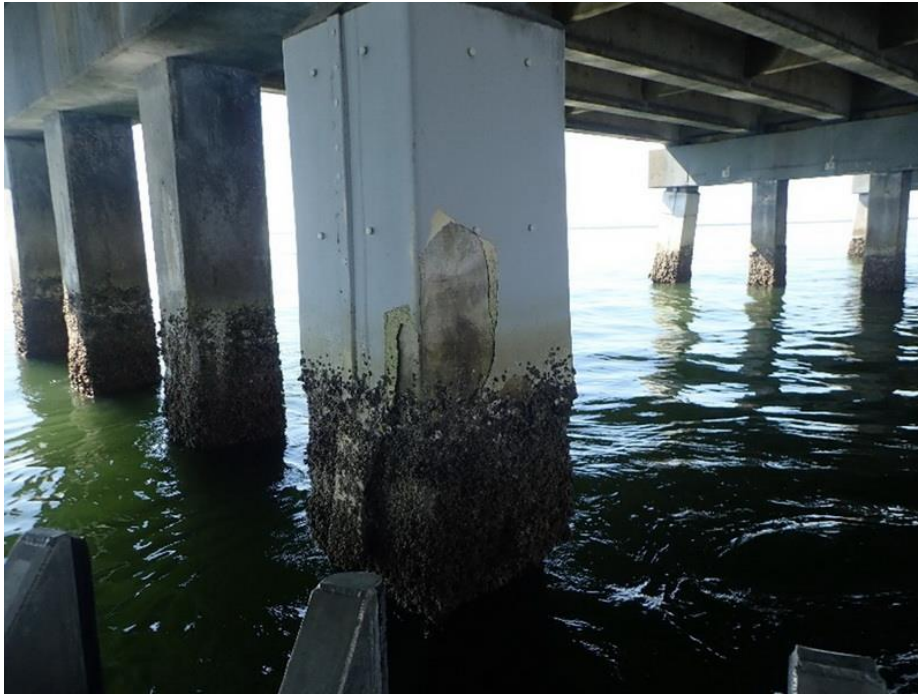
Figure 77. Jacket splitting and missing around lower perimeter of pile (Pile 73-5)

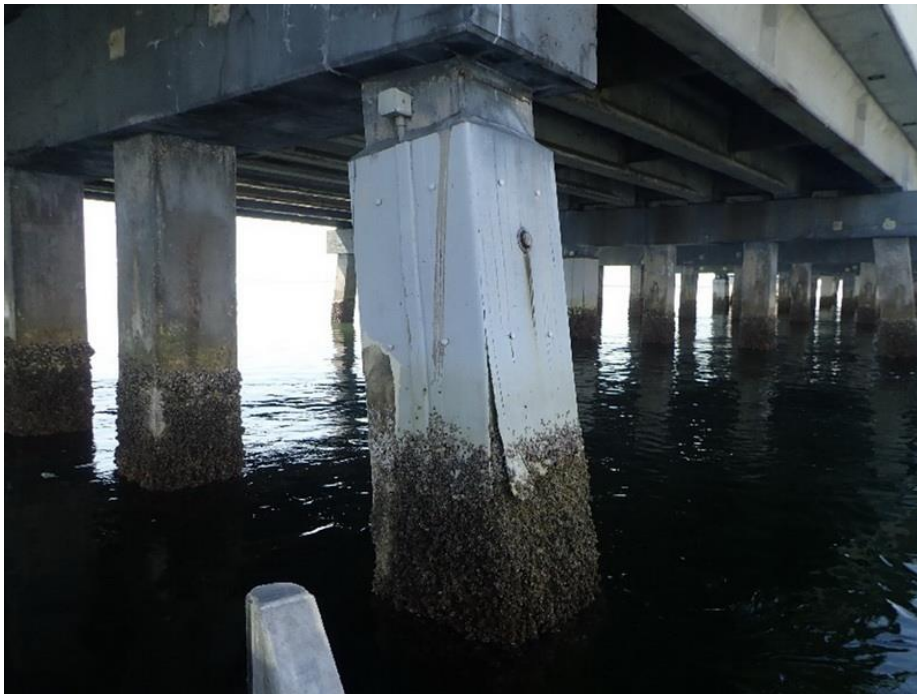
Figure 82. Significant distress of jacket (Pile 120-1)

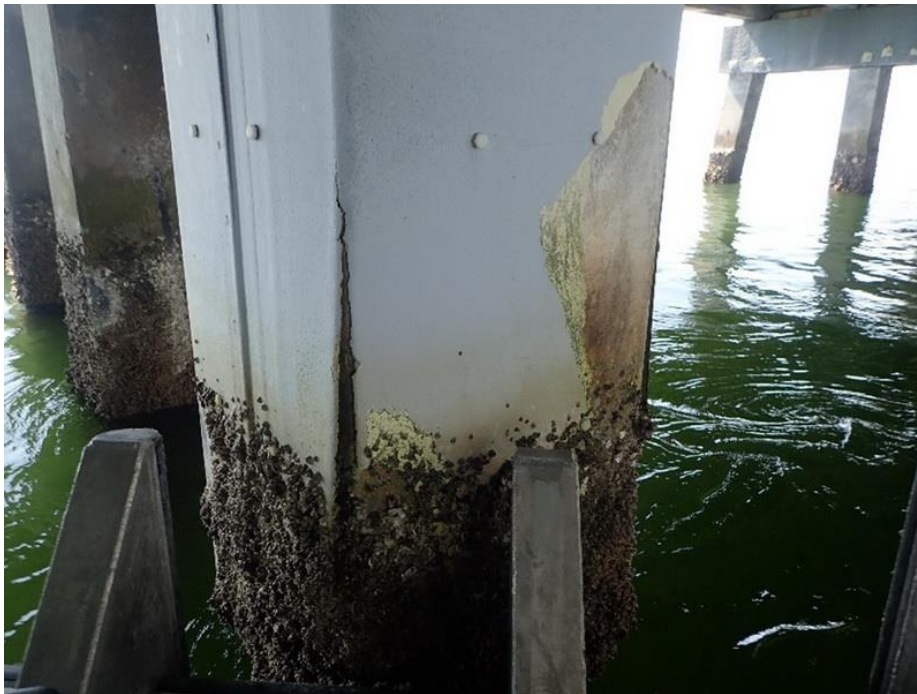
Figure 86. Significant distress of jacket (Pile 133-5)
