Evaluation of FDOT Corrosion Prevention and Control Programs

DOT-RFP-19-9059-GH

FINAL REPORT

Wiss, Janney, Elstner Associates, Inc.

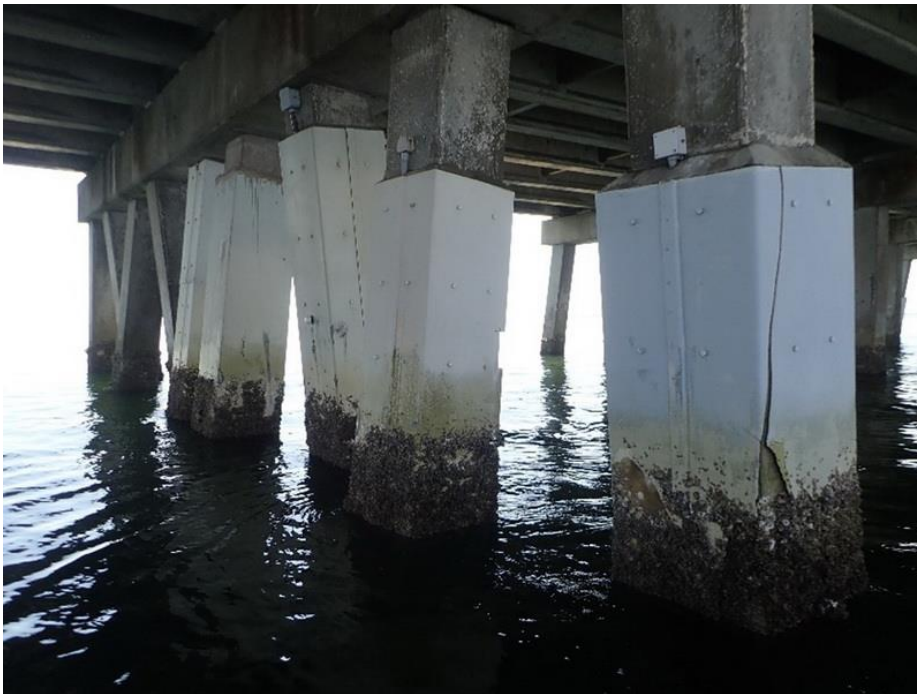
Figure 90. Vertical cracking of jacket (Pile 182-3)

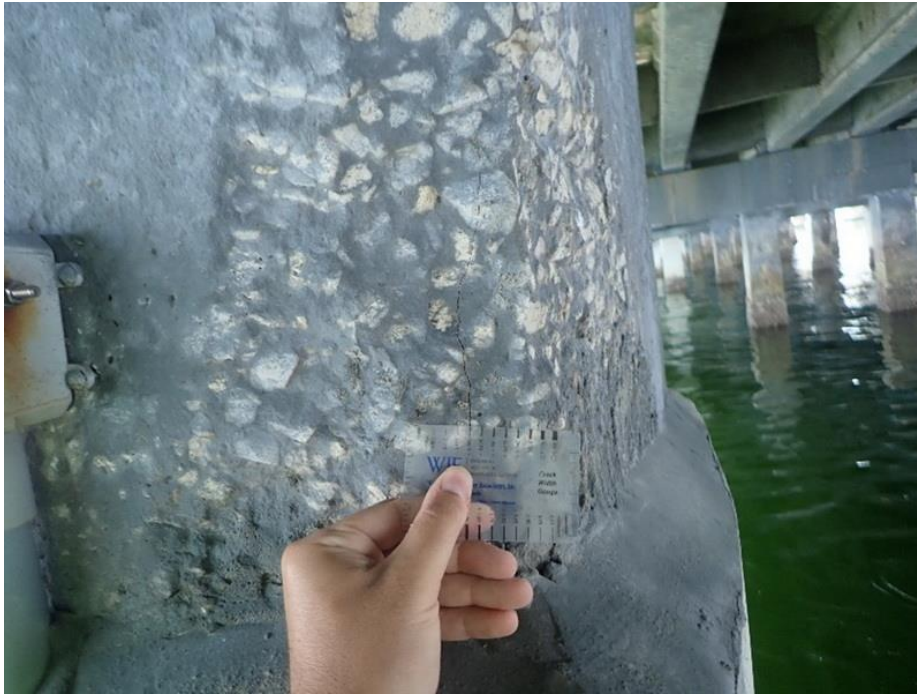
Figure 91. Cracking measured up to approximately 20 mil wide and spalling of pile (Pile 190-6)

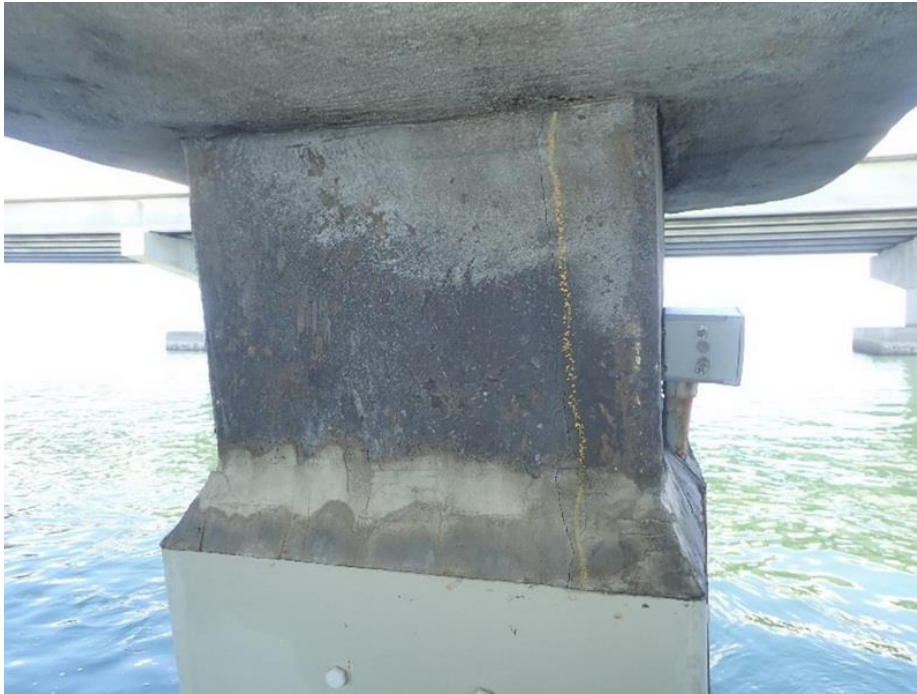
Figure 93. Repair and cracking measured up to approximately 30 mil wide (Pile 198-1)

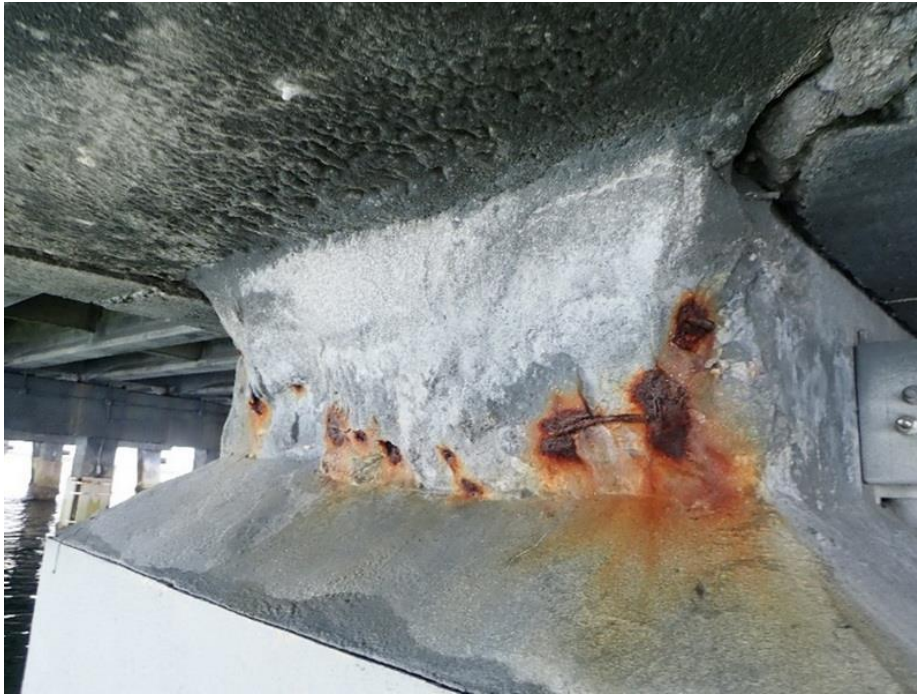
Figure 95. Repairs with corroded anchors on pile (Pile 214-6)

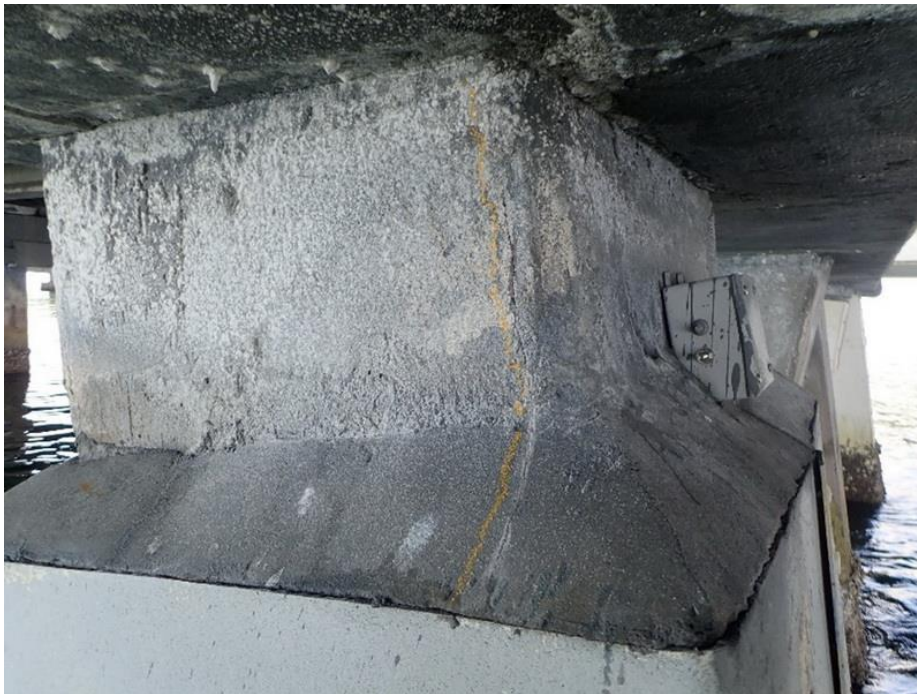
Figure 96. Vertical cracking of the pile (Pile 236-7)

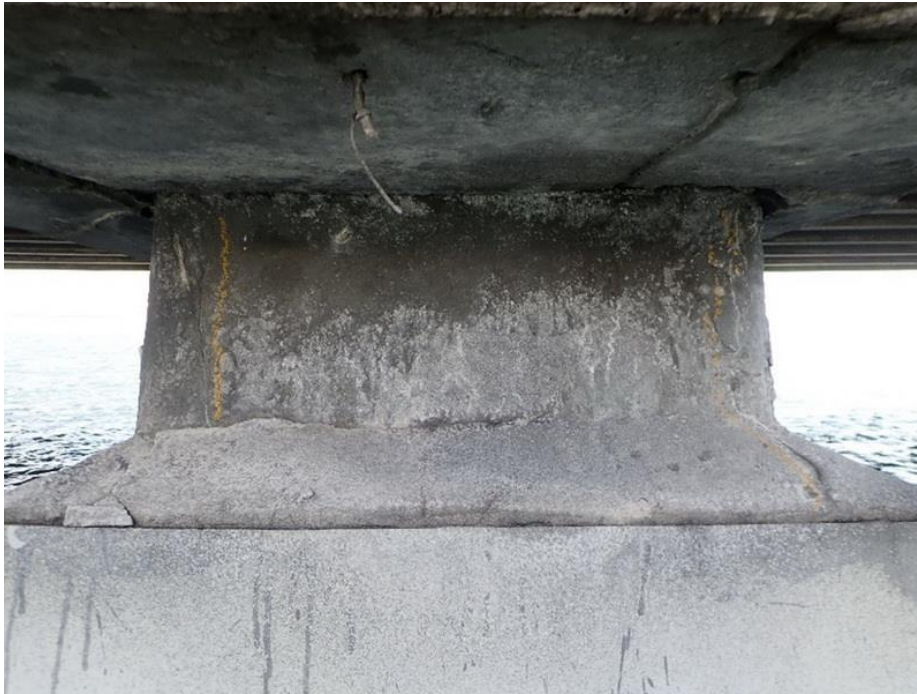
Figure 97. Two vertical cracks of the pile measured up to approximately 5 mil wide (Pile 263-1)

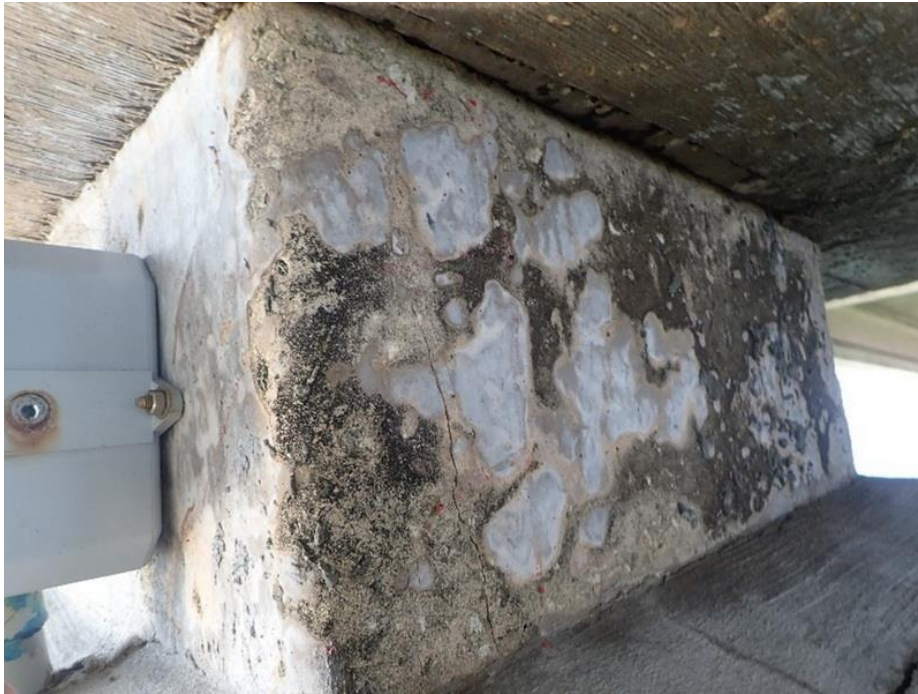
Figure 105. Cracking measured up to approximately 25 mil wide (Pile 82-6)

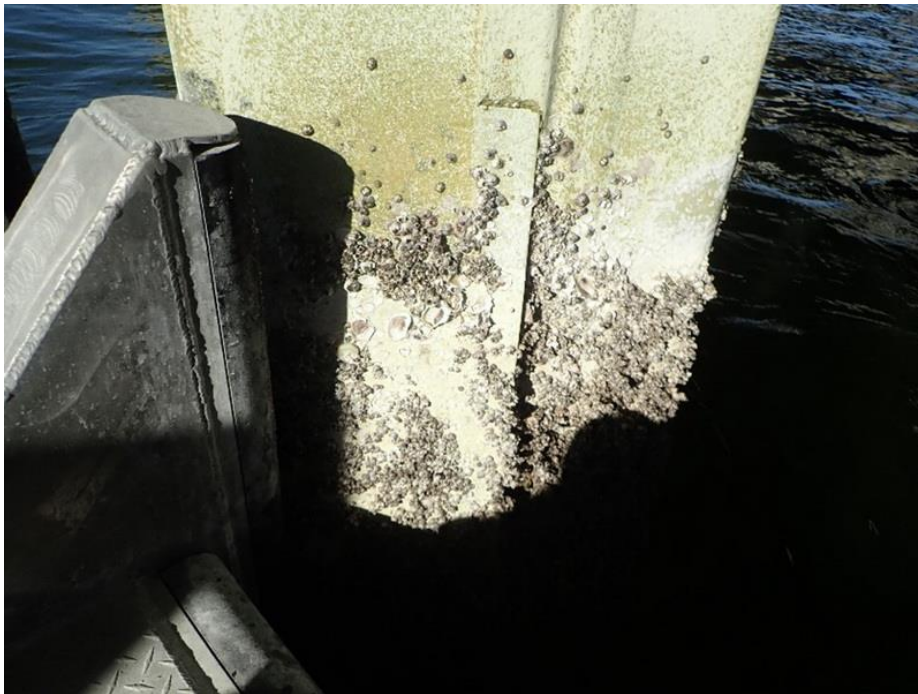
Figure 106. Jacket opening at the bottom (Pile 85-4)

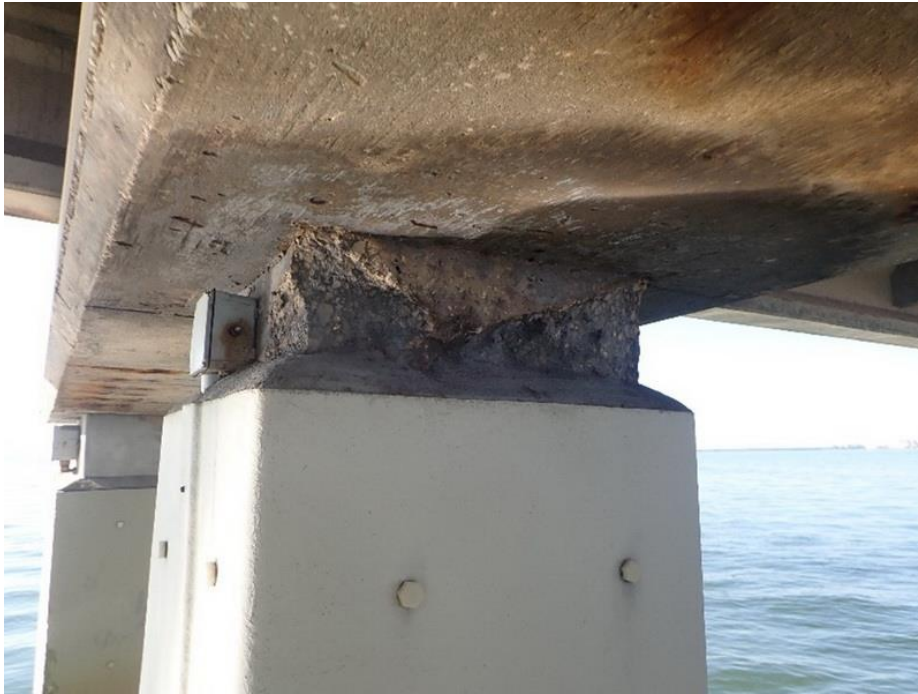
Figure 107. Spalling of pile (Pile 85-4)

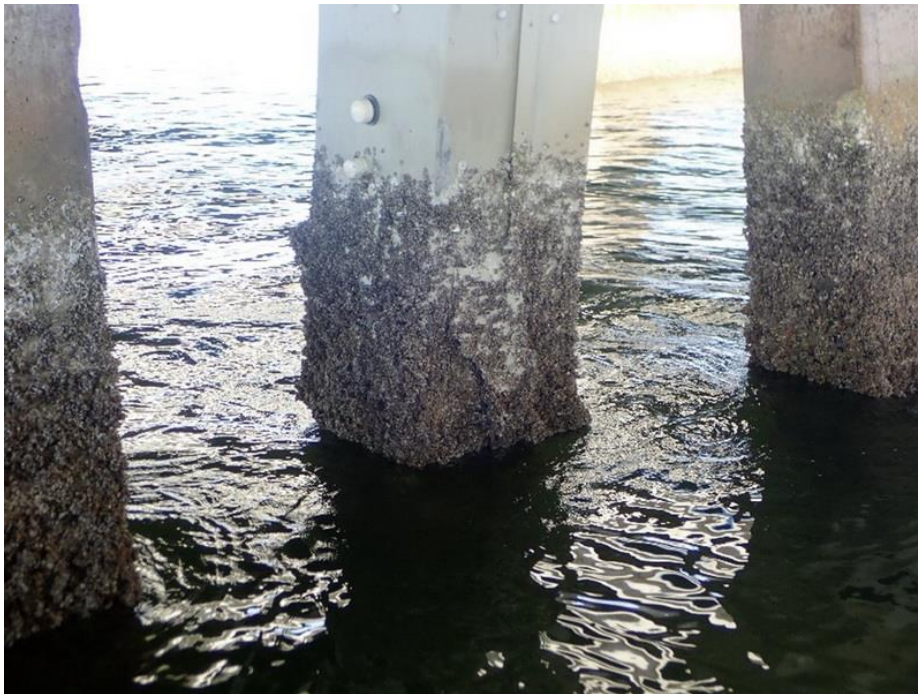
Figure 108. Jacket broken at the bottom Pile 94-3)

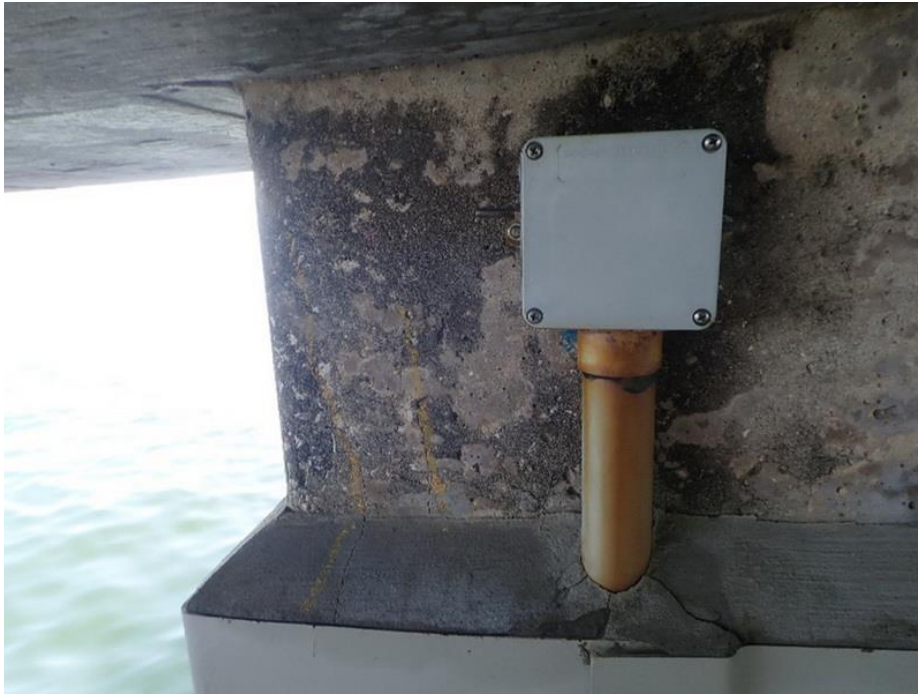
Figure 113. Cracking on pile (Pile 144-4)

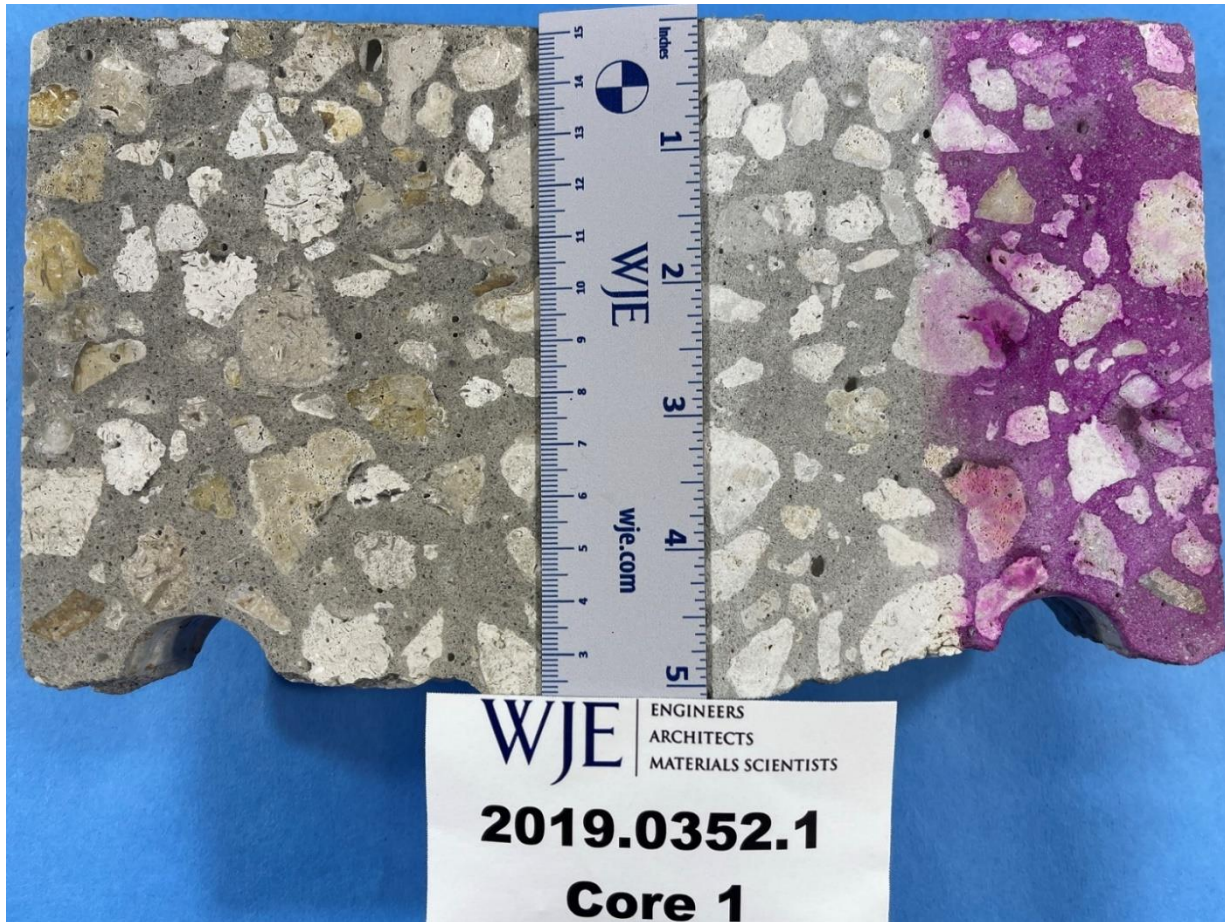
Figure 118. Core 1. Lapped cross section and matching saw-cut section stained with phenolphthalein solution to determine the depth of carbonation, which was less than 0.1 inch. Distribution of paste and aggregate appeared to be uniform and the concrete was well consolidated.

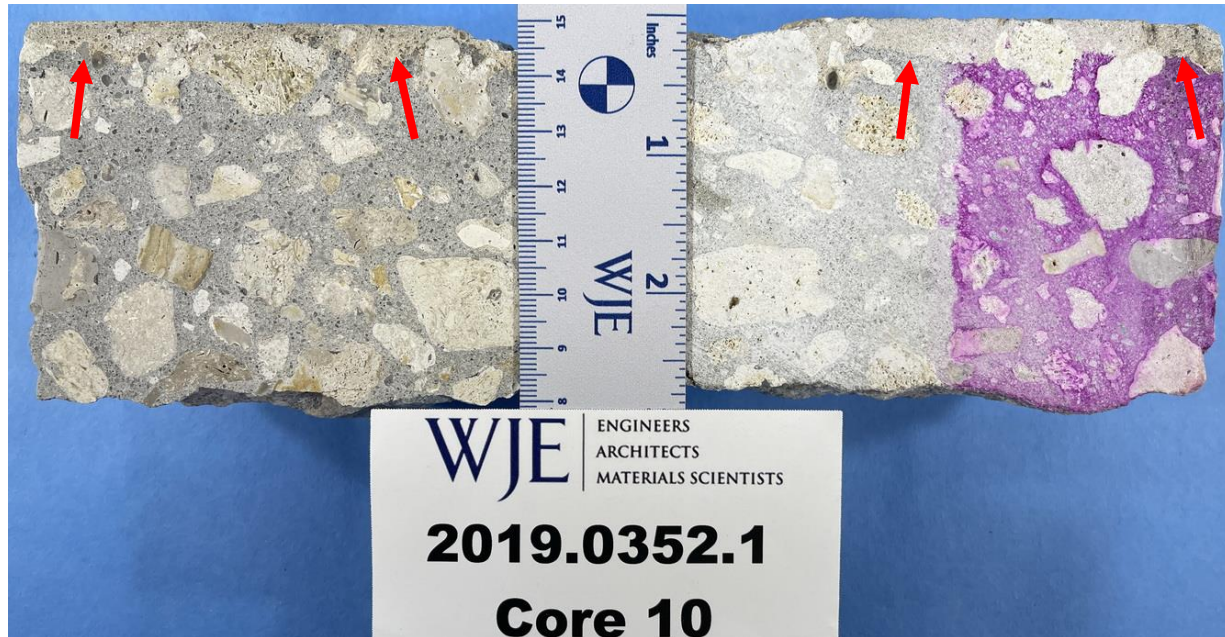
Figure 119. Core 10. Lapped cross section and matching saw-cut section stained with phenolphthalein solution to determine the depth of carbonation, which was approximately 0.3 inch as indicated by red arrows. Distribution of paste and aggregate appeared to be uniform and the concrete was well consolidated.

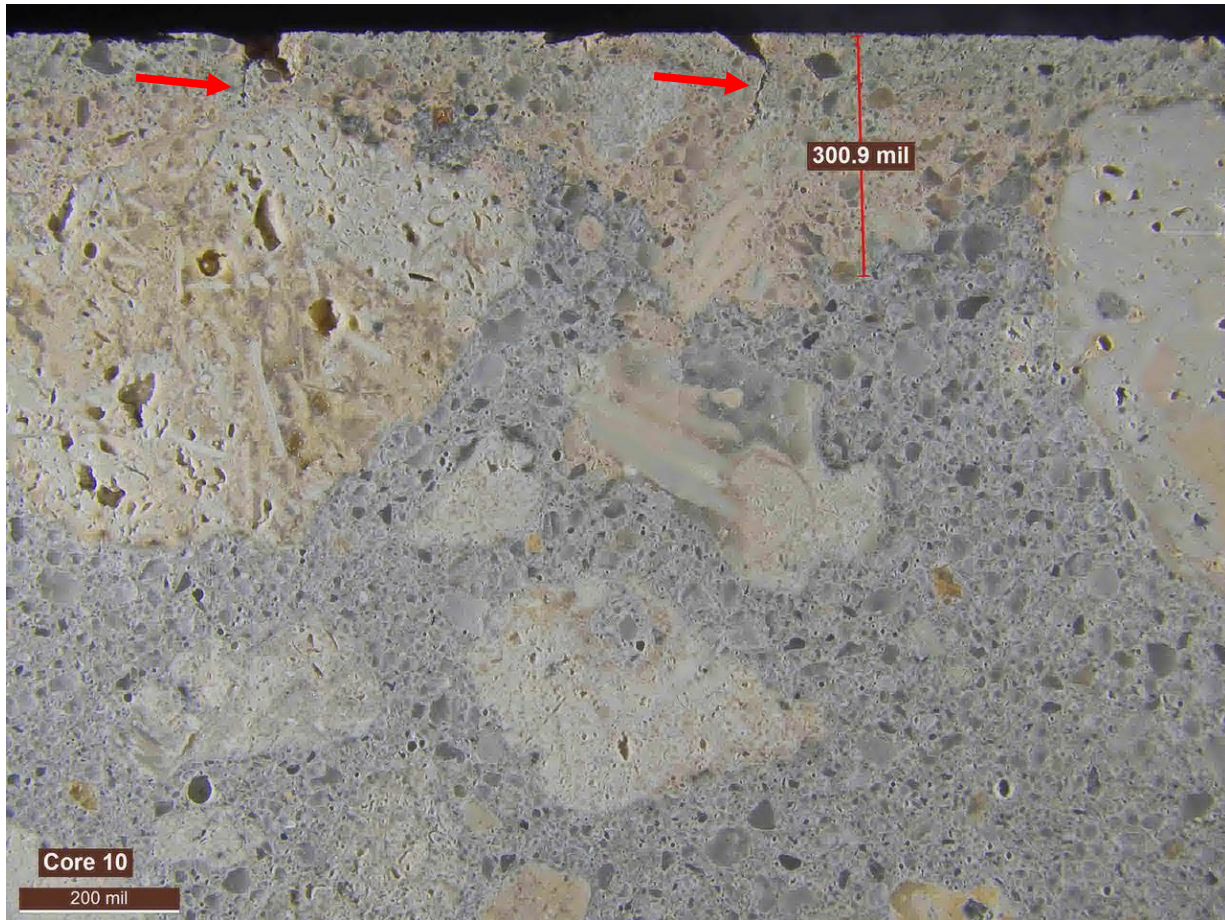
Figure 122. Core 10. Closeup view of the exterior region shows the appearance of aggregate, paste, air voids, and a discolored, carbonated top layer measuring approximately 300 mils (0.3 inch). Arrows indicate short vertical cracks/microcracks.

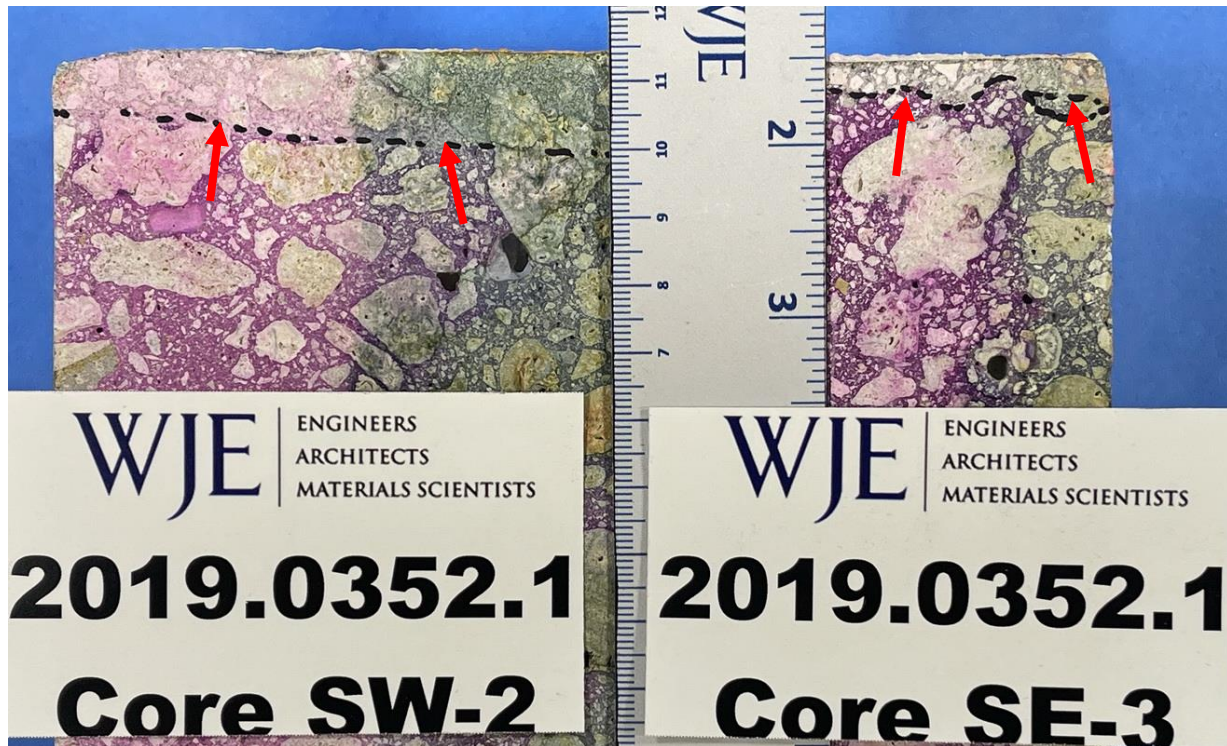
Figure 130. Saw-cut cross sections stained with phenolphthalein solution (left portion in each core) and a rainbow solution to determine the depth of carbonation. Carbonation was 0.4 to 0.5 inch in Core SW-2 and 0.2 to 0.3 inch in Core SE-3, as indicated by the color variation (red arrows).
