*Final Report: Submitted to*  
**State of Florida**  
**Department of Transportation**

*Submitted by the*  
**Texas A&M Transportation Institute**

**Green Bike Lane Evaluation for Florida Pavements**

**Final Report**

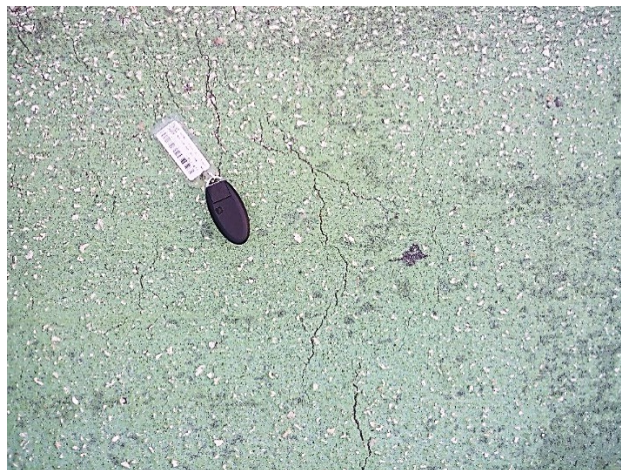
The research observed three MMA sections in Orange County (i.e., sites 27, 57, and 58). The sections were about four years old. However, the sections are worn out and need immediate maintenance (Figure 3-3). This particular MMA product seems to have insufficient durability and wears away under traffic too soon, even though other MMA markings tend to be strong and durable.

**Figure 3-3. Worn-Out MMA.**

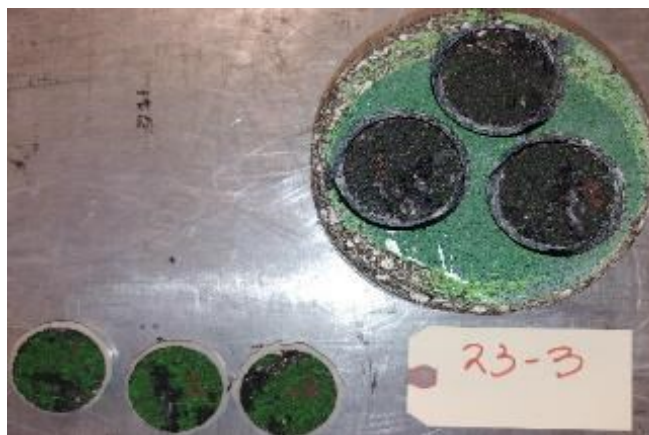
- a) **Clean Delamination:** The specimen fails at the GCPM/substrate interface (Figure 3-10). The substrate and treatment are stronger than the bond.

**Figure 3-10. Clean Delamination under Pull-Off Test.**

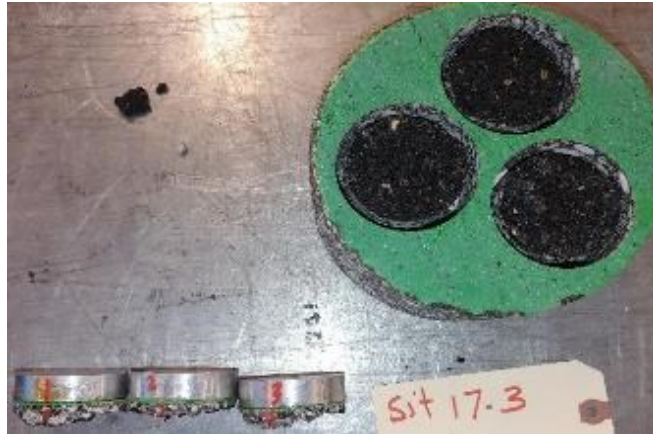
- b) **Substrate Failure:** Figure 3-11 shows the substrate failing near the bond interface. Possibly due to an inadequate substrate (i.e., low-density substrate), the GCPM surface peeled off with aggregates attached underneath.

**Figure 3-11. Substrate Failure near the Interface under Pull-Off Test.**

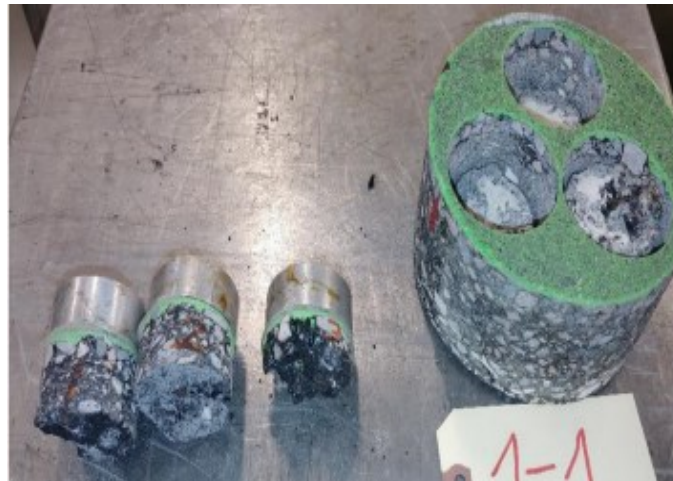
- c) Figure 3-12 also shows substrate failure, but this time the breakage occurred deep into the asphalt mixture. The GCPM to substrate bond is stronger than the mixture.

**Figure 3-12. Substrate/HMA Failure under Pull-Off Test.**

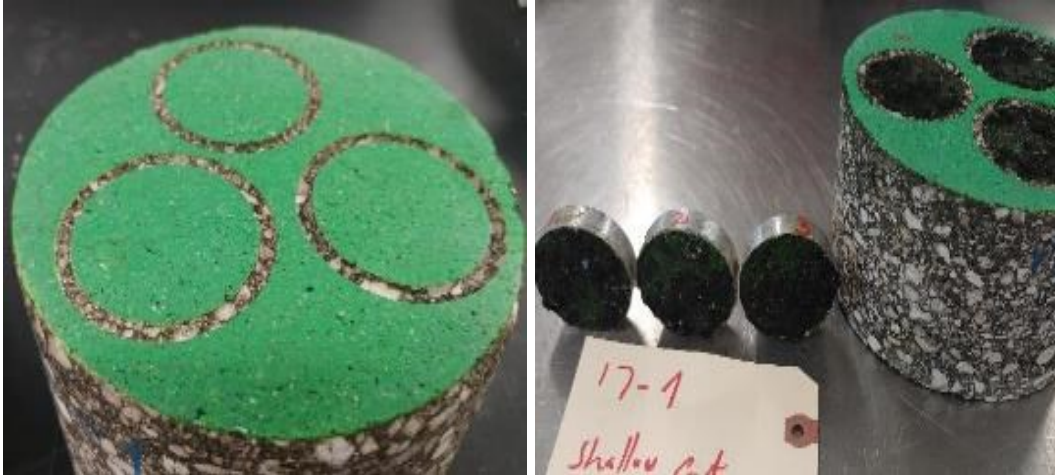
- d) **Forced Surface Debond:** Cutting the GCPM surface just enough to expose the substrate (about  $\frac{1}{8}$  inches) can encourage failure at the interface. As Figure 3-13 shows, the shallow cut still does not guarantee bond failure, since the substrate near the test could still be weaker than the bond. The team demonstrated the forced debond on two epoxy-treated cores (sites 7 and 17) (Figure B-18 and Figure B-19), and both produced a bond strength above 150psi. Similar results were observed for the other two specimens that broke at surface level (Appendix B).

**Figure 3-13. Forced Surface Debond.**

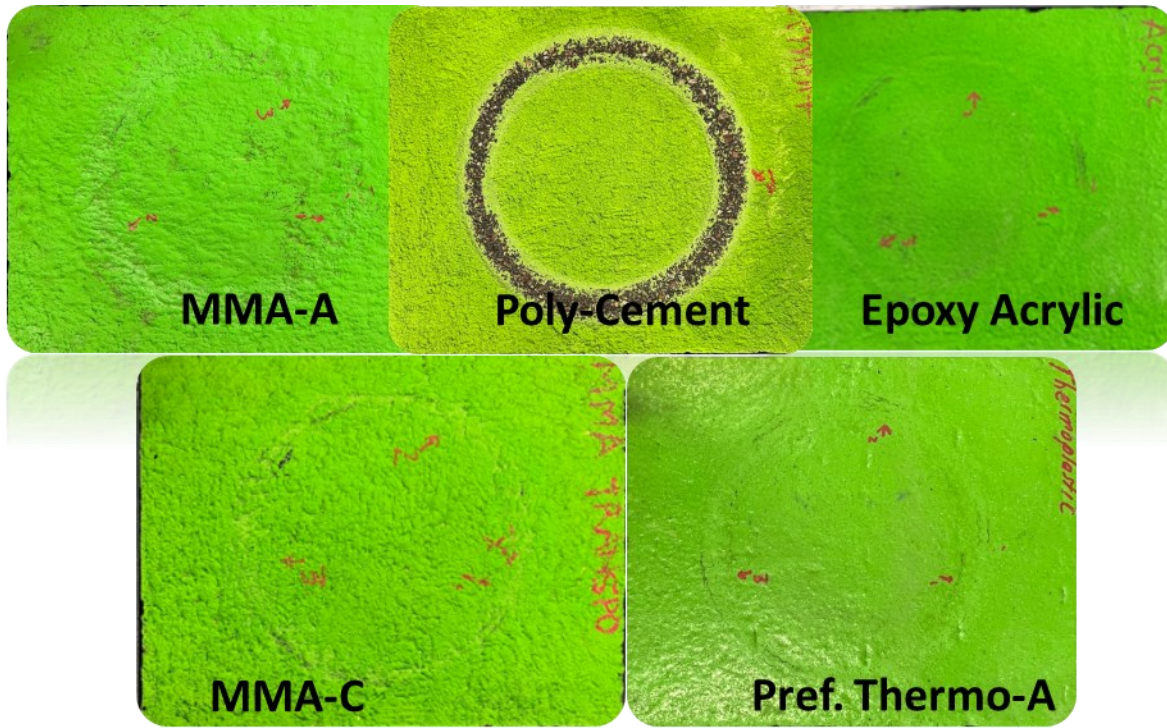
All the GCPM materials, except the polymer cement, withstood 150,000 cycles with minimal wear (Figure 4-3). The polymer cement sample, however, was polished down to the substrates after just 5,000 cycles, and there was no reason to continue testing the specimen. The polymer cement was cured seven days before testing, which should be sufficient since the treatment can be open to traffic after the day of installation. It may be an indication that the material is not suitable for heavy turning and stop-and-go urban traffic.

**Figure 4-3. All GCPM Polished at 150,00 Cycles Except Polymer Cement at 5,000 Cycles.**

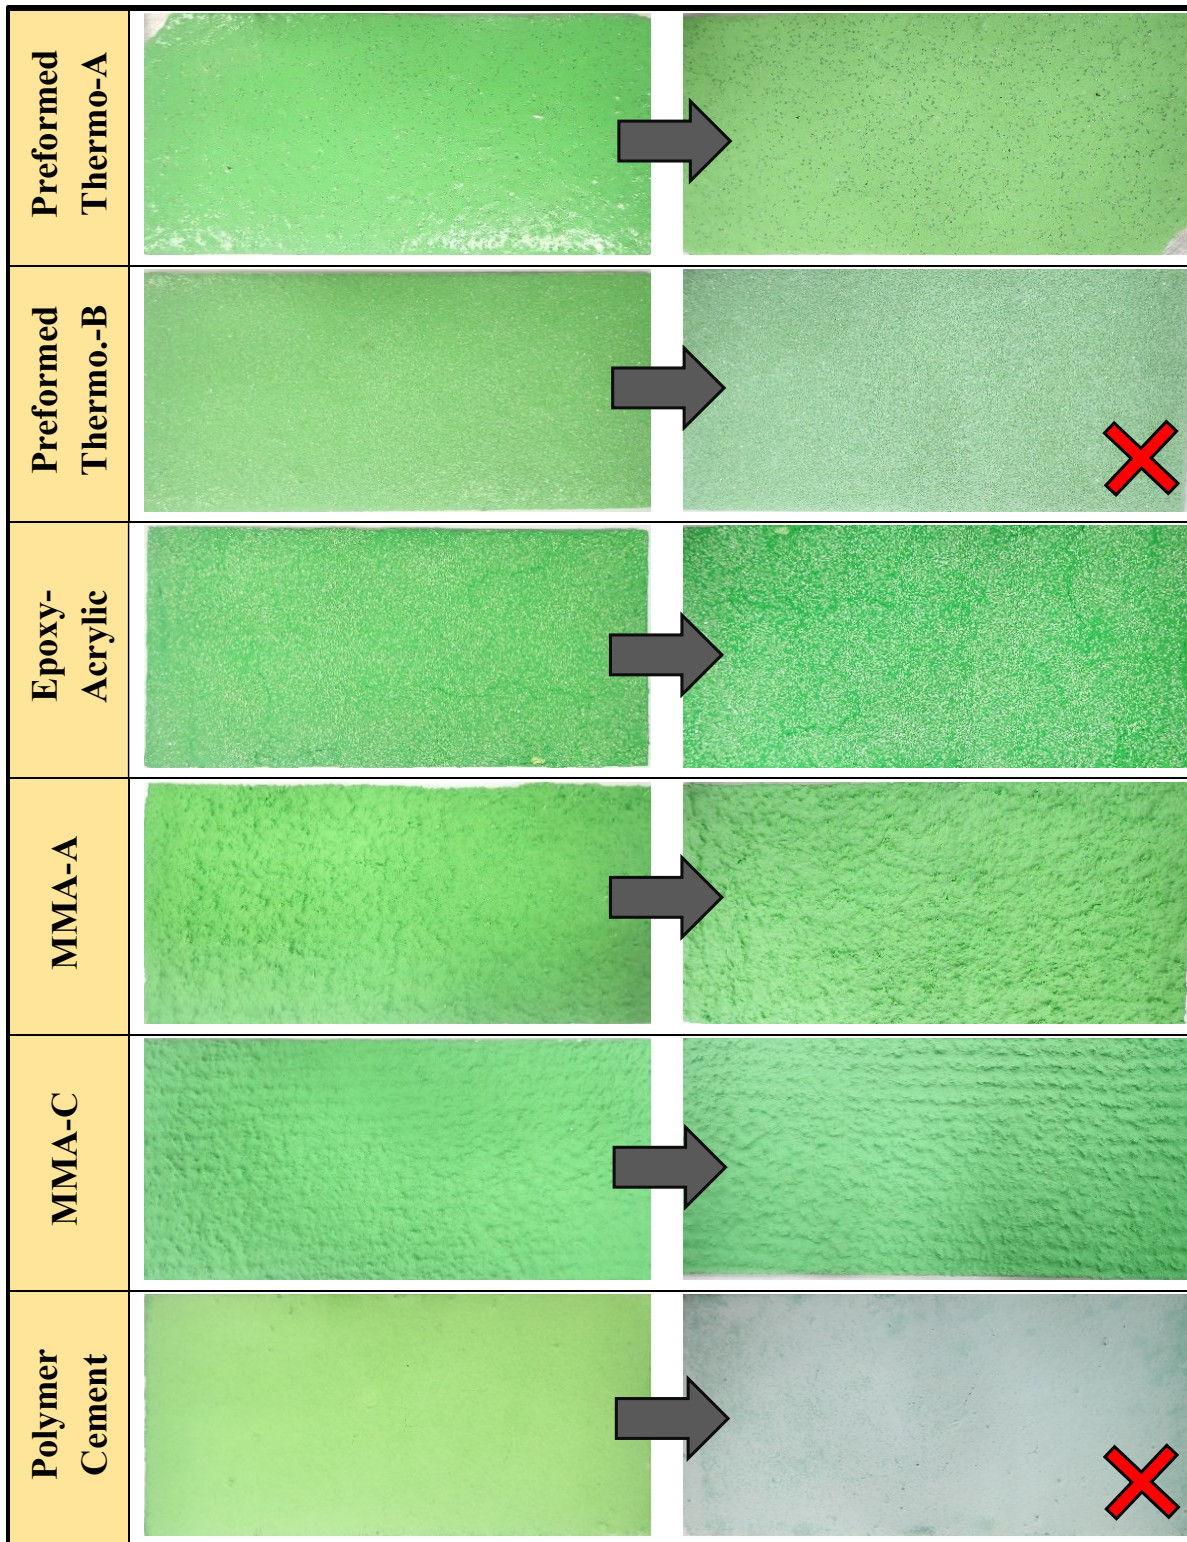
The GCPM specimens before and after 1,000 exposure hours are shown in Figure 4-8. The red “X” indicates samples that do not comply with the color requirements after weathering. The average chromaticity (x, y) coordinates and luminance (Y) are shown in Table 4-9 and Table 4-10, respectively. In addition, the research team plotted the chromaticity (x, y) coordinates against the standard FHWA color box to observe if the material’s color excessively faded (Figure 4-9). The materials are deemed to fade color if the coordinates fall off the box. For example, close observation of the data shows that the cementitious material (P-CM) fell off the color box below 98 hrs of exposure. Similarly, a thermoplastic material (C-TP) fell off the color box below 250 hrs of exposure.

**Figure 4-8. GCPM Specimens before and after 1,000 Hours of Weatherometer Exposure.**

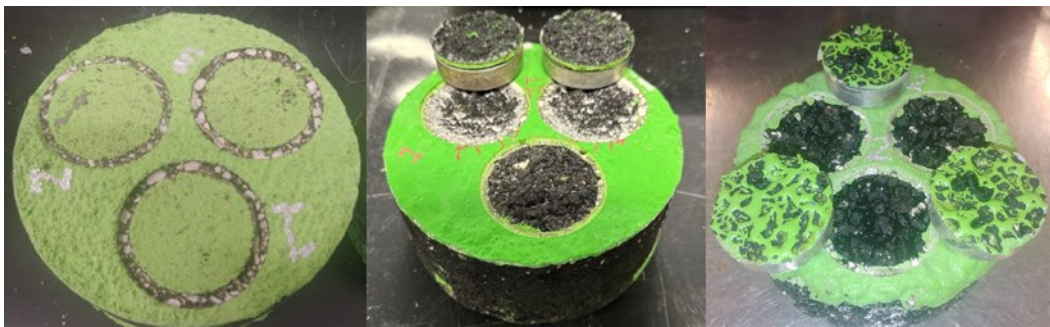
Every sample except the polymer cement failed near the bond interface and had pieces of substrate aggregate attached (Figure 4-12). The preformed thermoplastic on OGFC peeled off with few aggregates because it has less surface area to hold. The polymer cement, however, failed within the GCPM. Table 4-11, Figure 4-13, and Figure 4-14 show the average pull-off strength values for different GCPMs on different substrates. The values indicate that the OGFC is the weakest substrate, as was observed in the field study. The highest substrate strength was observed on high-density DGFC. On average, the epoxy modified acrylic GCPM offered the highest bond strength.

**Figure 4-12. Pull-Off Test Mode of Failure.**

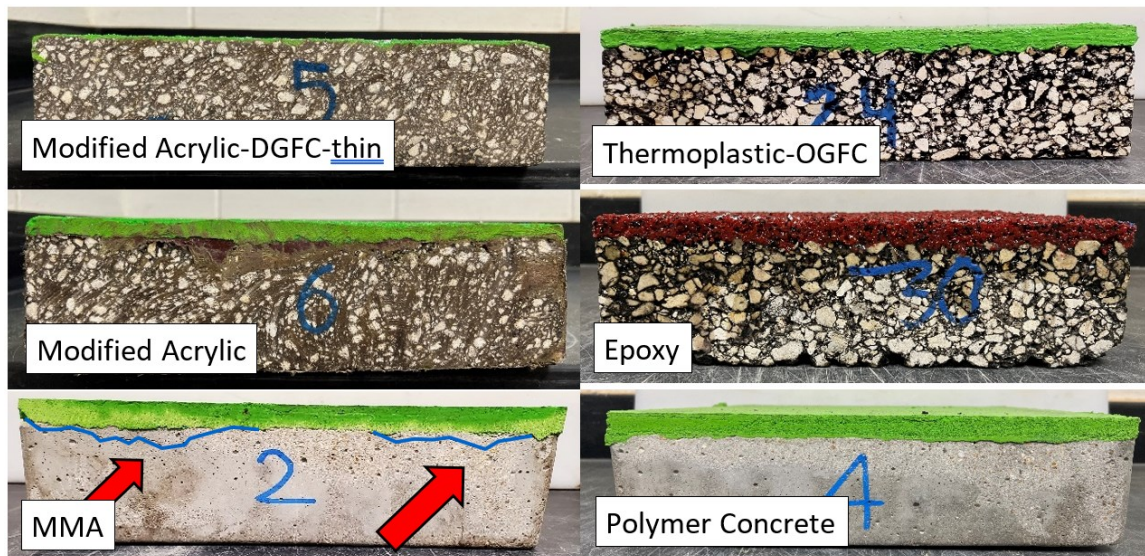
Figure 4-18 shows examples of the slabs after freeze and thaw conditioning. The full cracking results are in Table 4-13. The research team observed that one concrete slab treated with 0.5-inch MMA had thermal-induced cracking. The only other signs of distress were from the sample preparation. The polymer-cement slab on concrete had shrinkage cracking on the surface. This treatment on this sample, notably, had a higher water content because of mixture segregation. The thick modified-acrylic samples also had shrinkage cracks on the surface (Figure 4-19). The cracks were induced by curing the water-based treatment quickly with a heat gun.

Figure 4-18. Samples after Freeze-Thaw.

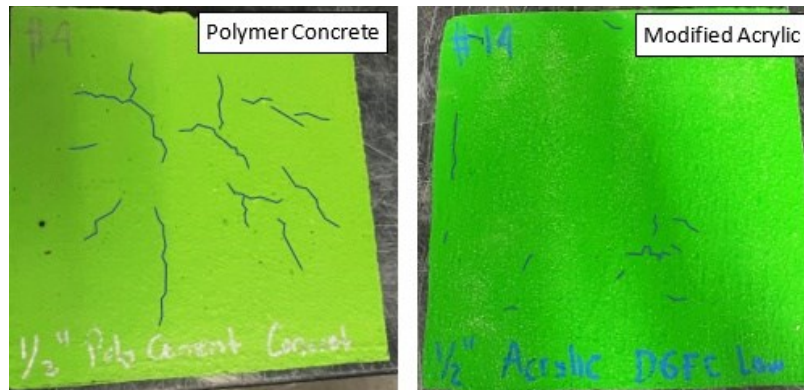
**Figure 4-19. Shrinkage Cracking after Surface Preparation (Cracks Enhanced).**

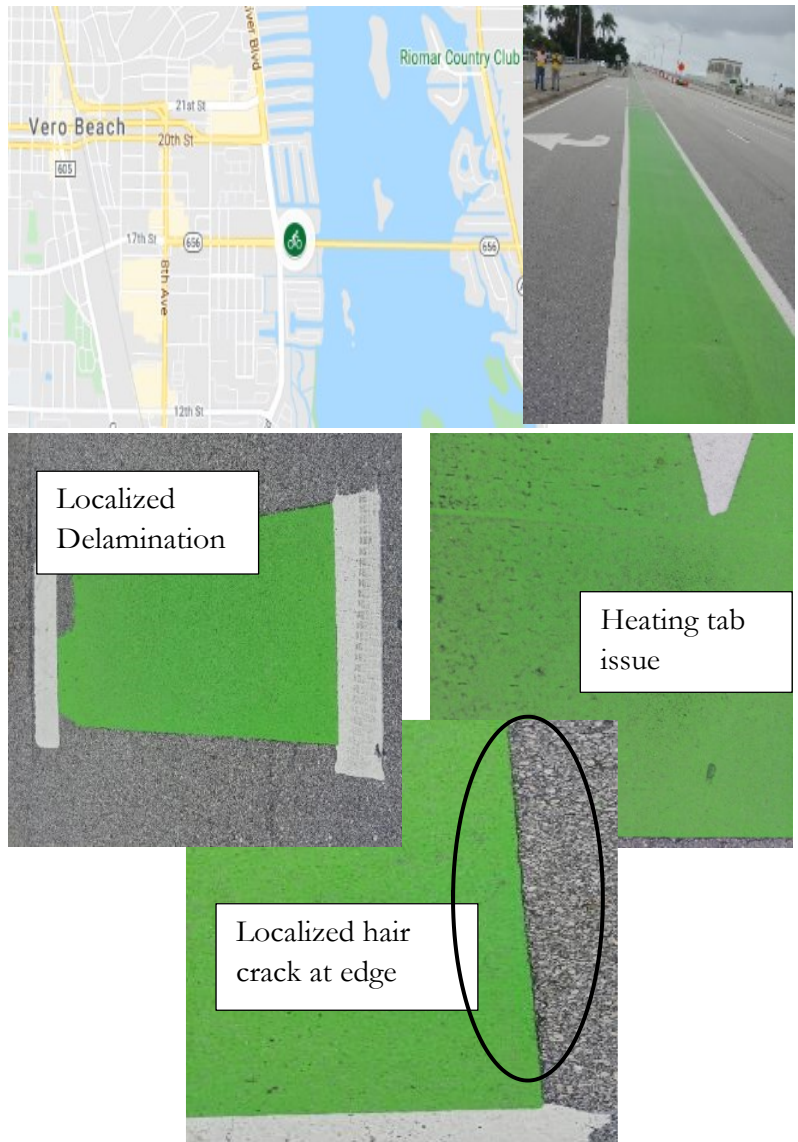
Figure A-1. Site 15-Location and Distresses.

- Construction and Materials
  - The bike lane was constructed in October 2018 on a new DGFC substrate built in the same period (Figure A-1). The bike lane is in District 4, Indian River County.
- Observation
  - Overall good condition.
  - Minor overheating issues (construction problem).
  - Hairline cracks around edges of some skips.
  - One localized delamination on one of the skips.

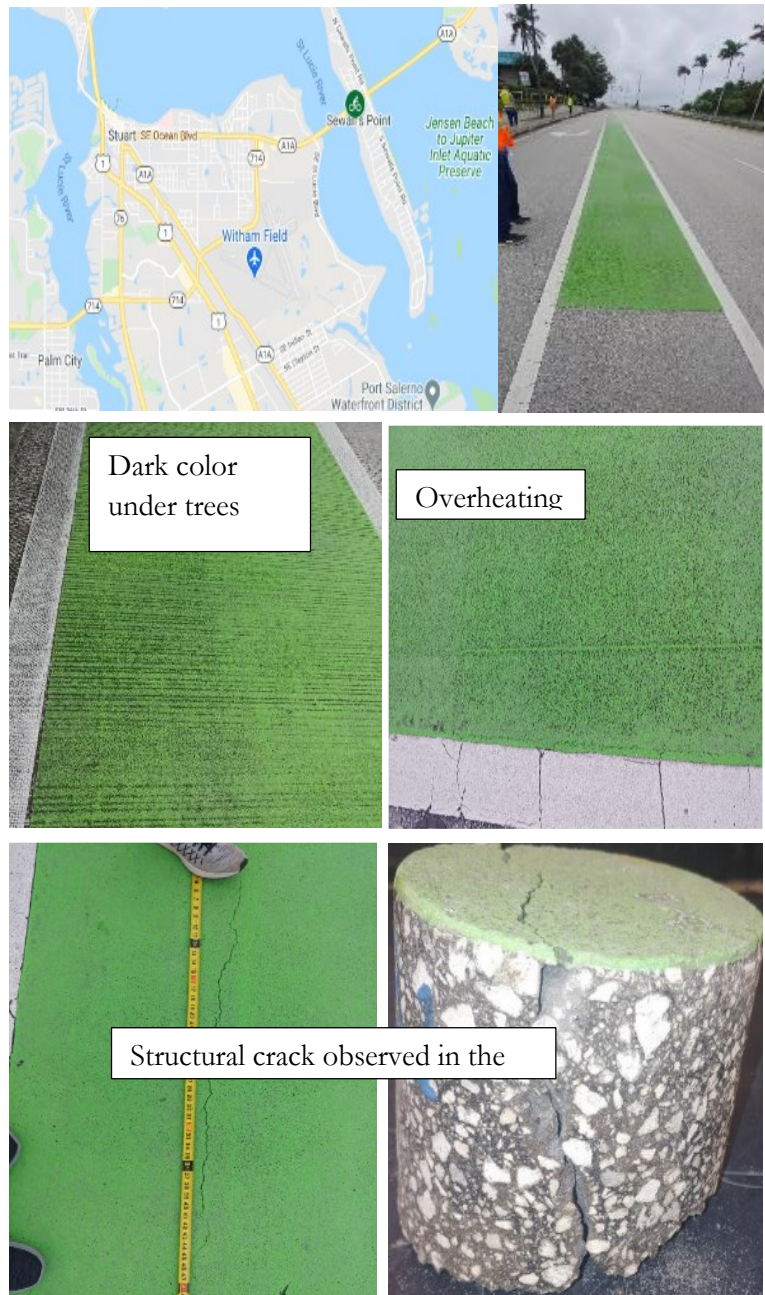
**Figure A-2. Site 8-Location and Distresses.**

- Construction and Materials
  - The bike lane was constructed in October 2018 on a concrete bridge and extended to a DGFC substrate built-in February 2013 (Figure A-2). The bike lane is in District 4, Indian Martin County.
- Observation
  - Overall good condition.
  - Minor overheating issues (construction problem).
  - Dark color under trees.
  - One localized longitudinal crack; lab investigation on cores indicates the crack is structural related and extends about 5 inches deep.

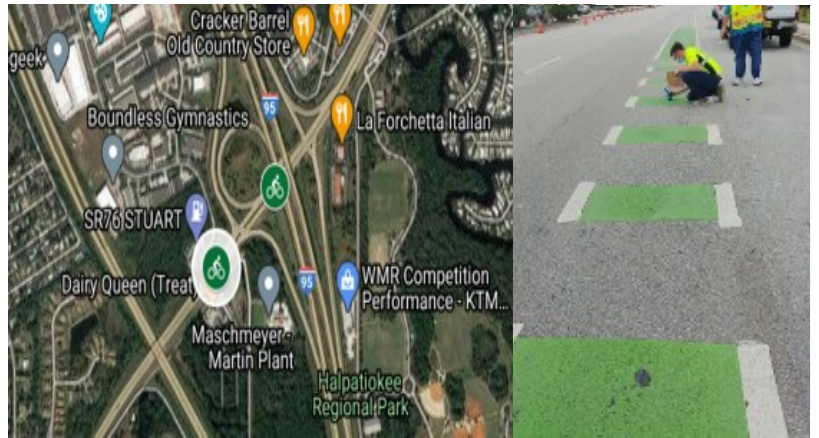
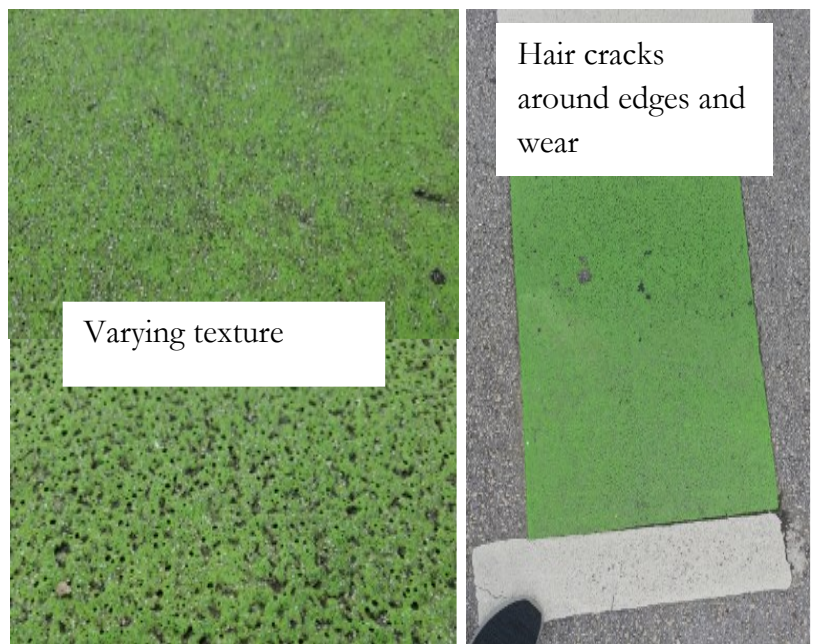
Figure A-3. Site 10 through 13-Location and Distresses.

- Observation
  - The research team observed minor overheating issues (construction problem).
  - Hair cracks around edges.
  - The varying texture from one place to another. May be due to different treatment.
  - In general, the lane is in good condition.

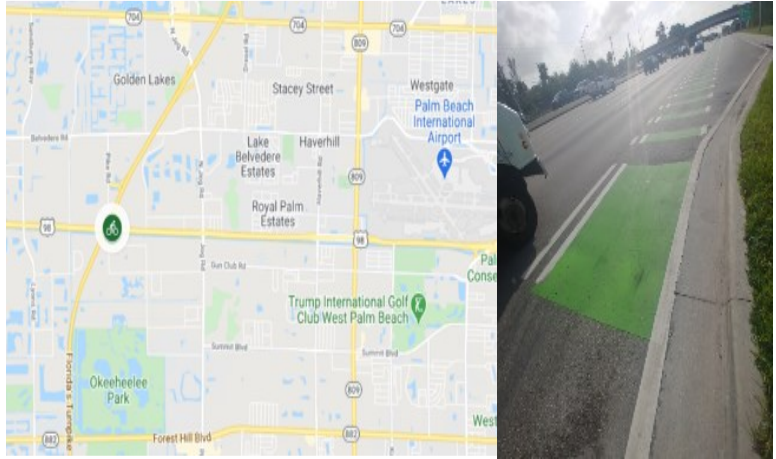
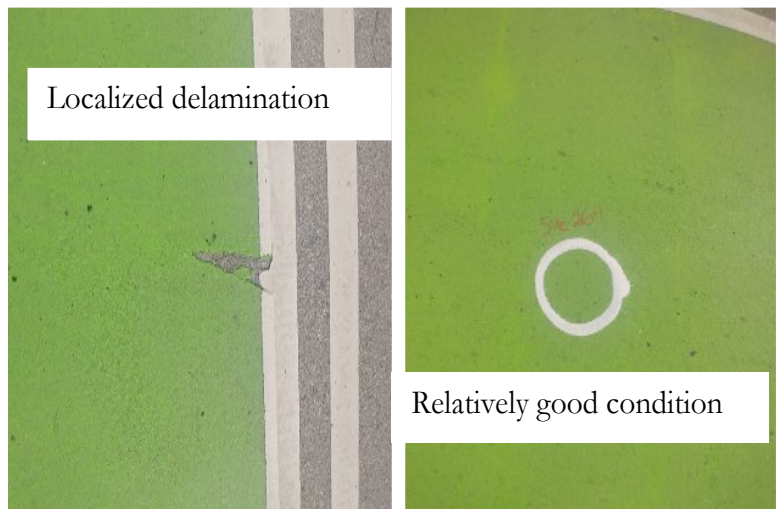
**Figure A-4. Site 26-Location and Distresses.**

- Observation
  - Overall good condition.
  - Small delamination. It looks like a dent from a sharp object.

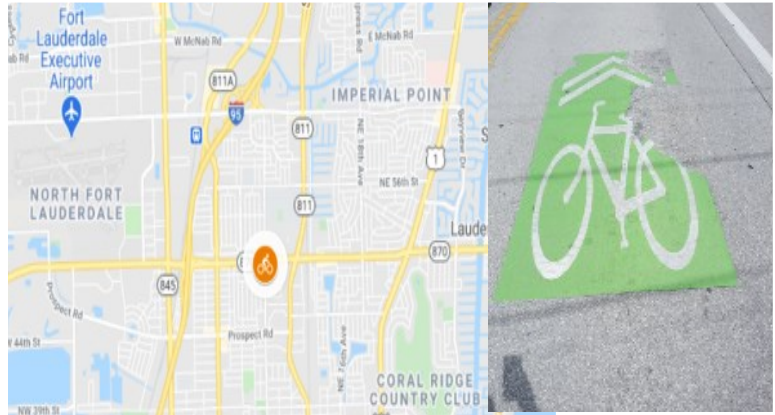
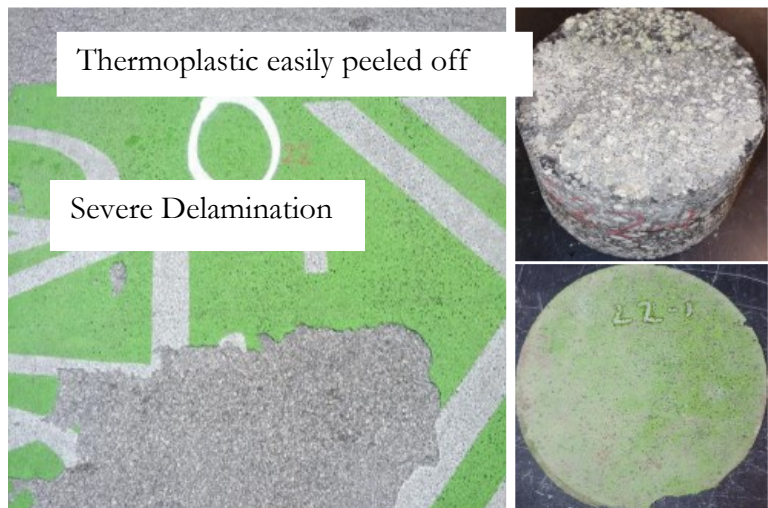
**Figure A-5. Site 22-Location and Distresses.**

- Observation
  - Overall poor condition.
  - Severe Delamination.
  - Delamination reduced the green bike lane treatment to less than 60 percent.
  - Thermoplastic could easily peel off.

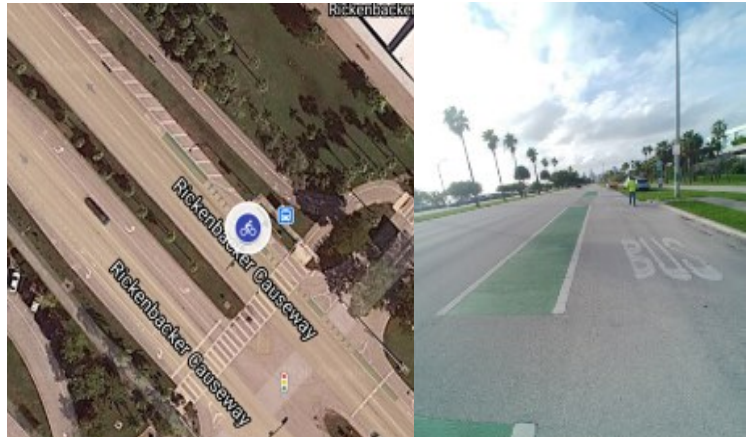
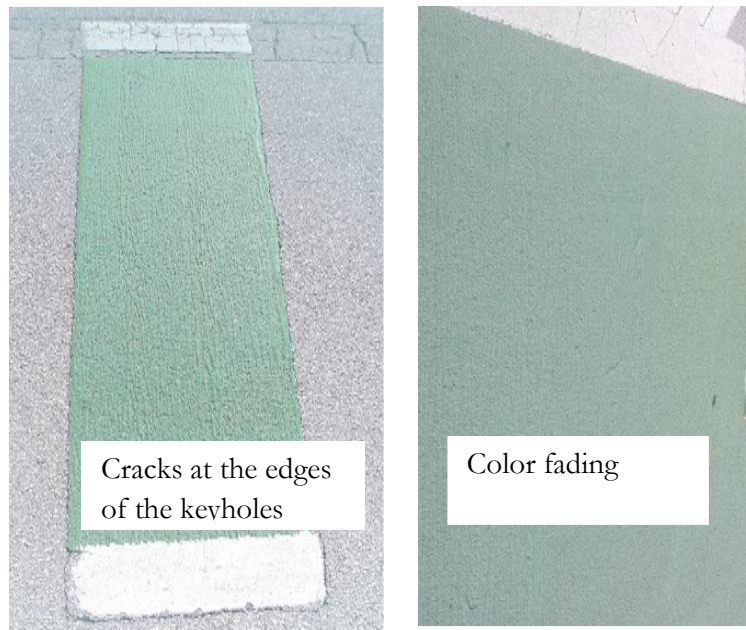
**Figure A-24. Site 30-Location and Distresses.**

- Observation (Figure A-24)
  - Rougher and relatively thicker surface treatment on the bike lane than most of the sites surveyed.
  - The bike lane is in the city center with a couple of roadside parking alongside. Therefore, traffic conflicting the bike lanes is inevitable.
  - Cracks at edges of some keyholes.
  - Color fades.
  - Except for color fading, the lane is in good condition.
