Report Prepared by:  
Dr. Francisco J. Presuel–Moreno  
With  
Samantha Mavrak  
David Anguelov

## **Final Report**

Evaluation of Concrete Specimens Prepared with Corrosion Resistant  
Reinforcement after Long Term, Greater than 15 years, Outdoor and  
Laboratory Exposures

Contract Number – FDOT (BED27-977-04)  
FAU (AWD003253)

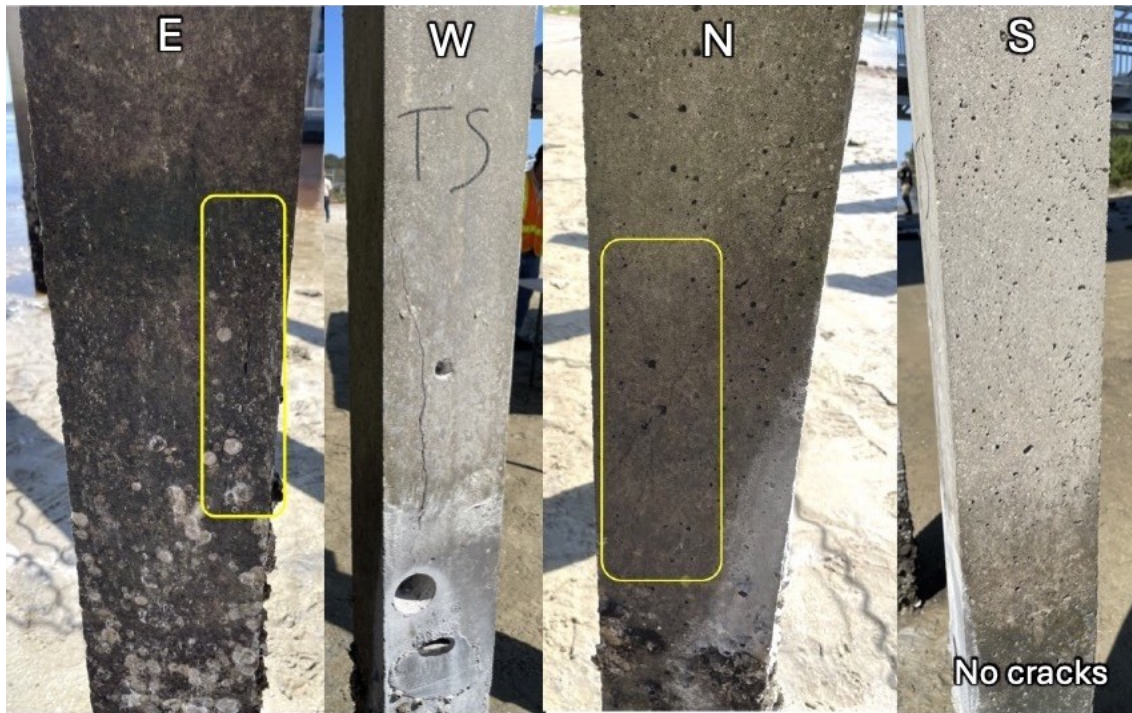
Three surfaces showed cracks for Column A with MMFX rebars, shown in Figure 5-1. In October 2024, a core was obtained that included a rebar segment on the west face. The southern face showed no cracks. Similarly, three surfaces showed cracks for Column B with MMFX rebars (Figure 5-2). The east face had no visible cracks. For MMFX Column C, three surfaces showed cracks (Figure 5-3). Like Column B, the east face had no visible cracks.

Figure 5-1. Picture showing surface conditions of east, west, north, and south faces of column MMFX-A.

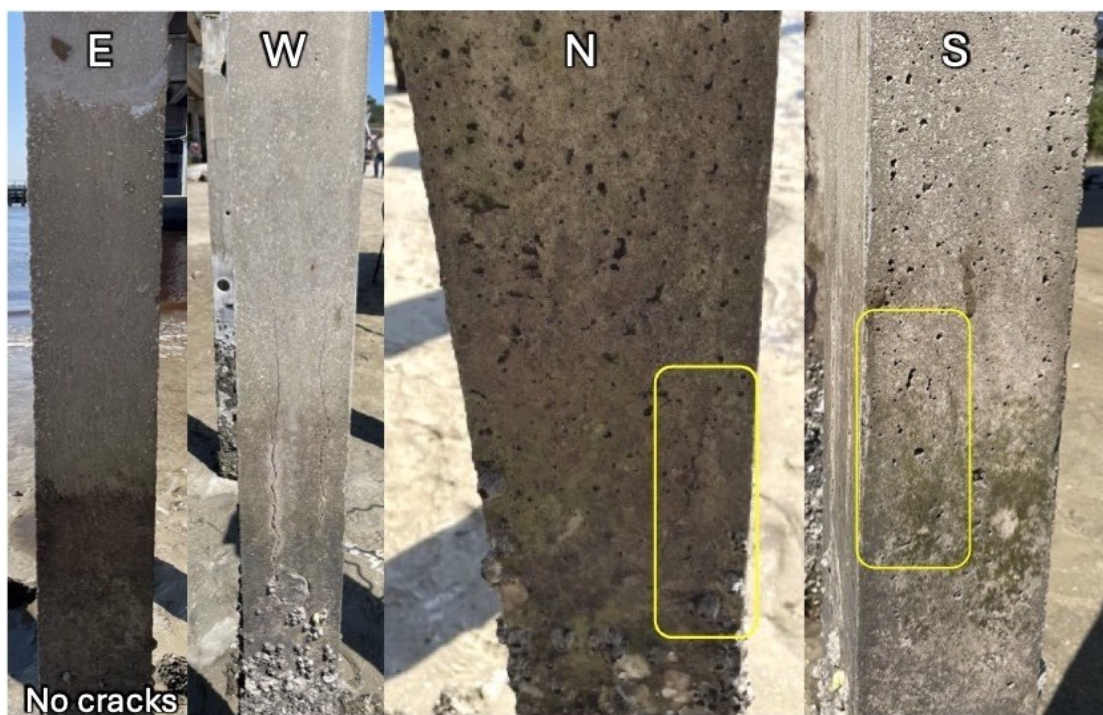
Figure 5-2. Picture showing surface conditions of east, west, north, and south faces of column MMFX-B.

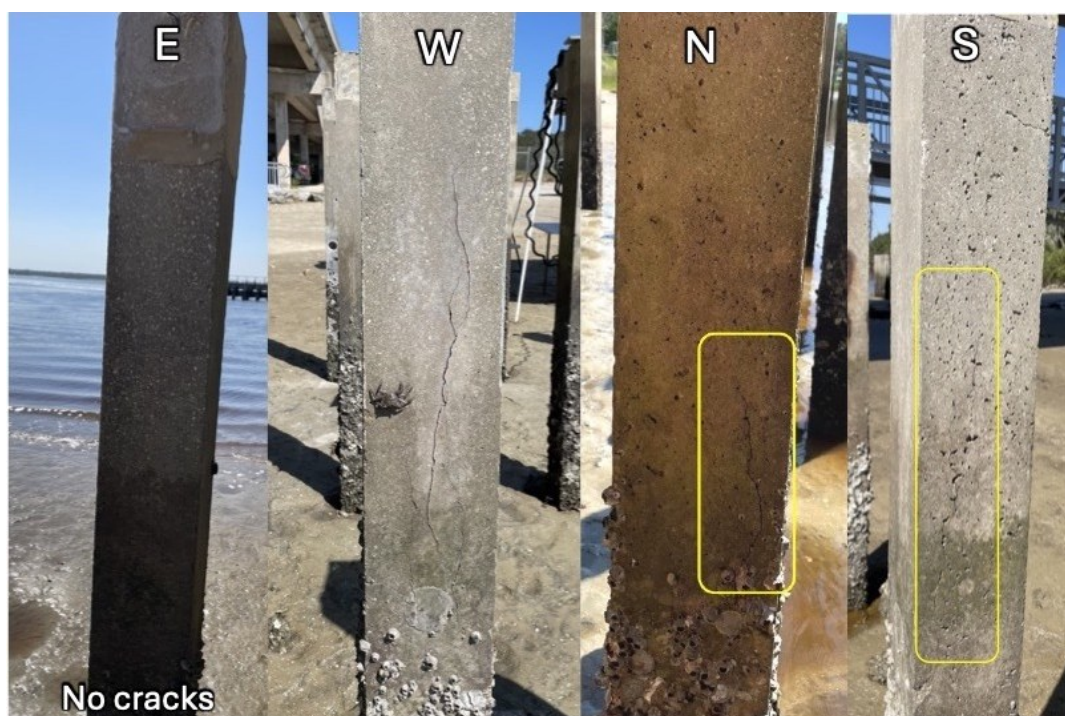
Figure 5-3. Picture showing surface conditions of east, west, north, and south faces of column MMFX-C.

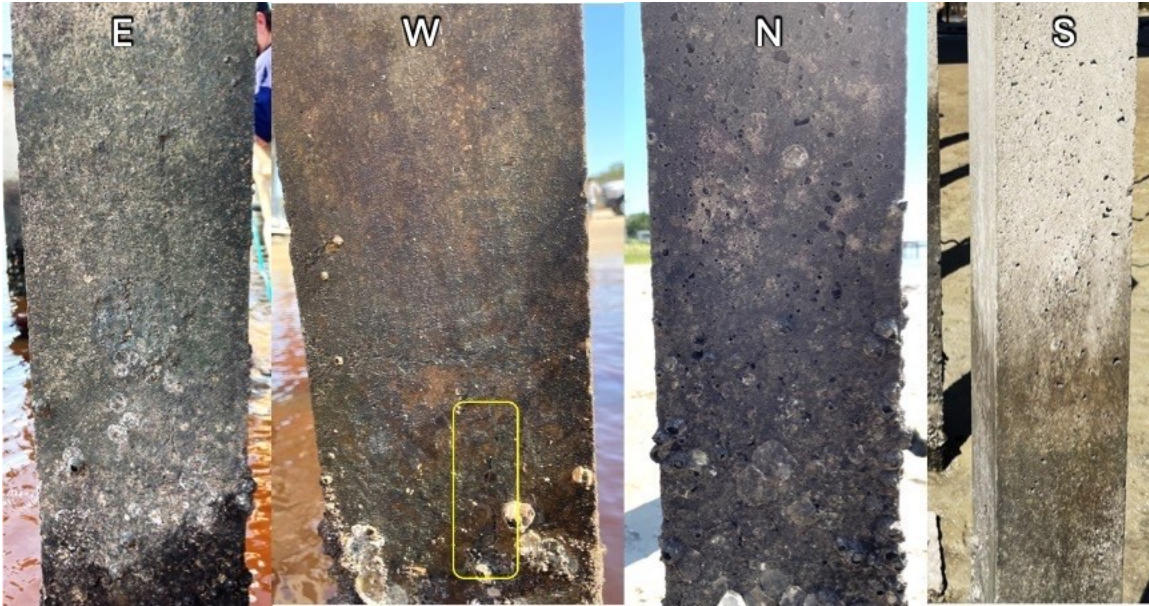
Most 3CR12 column surfaces showed cracks. All four surfaces in Column A had cracks (Figure 5-4). Cores were obtained by FDOT-SMO from Column A on a different date or after FAU had left the site. No rebars were included in the cores obtained.

Figure 5-4. Picture showing cracks on the surface of each face of column 3CR12-A.

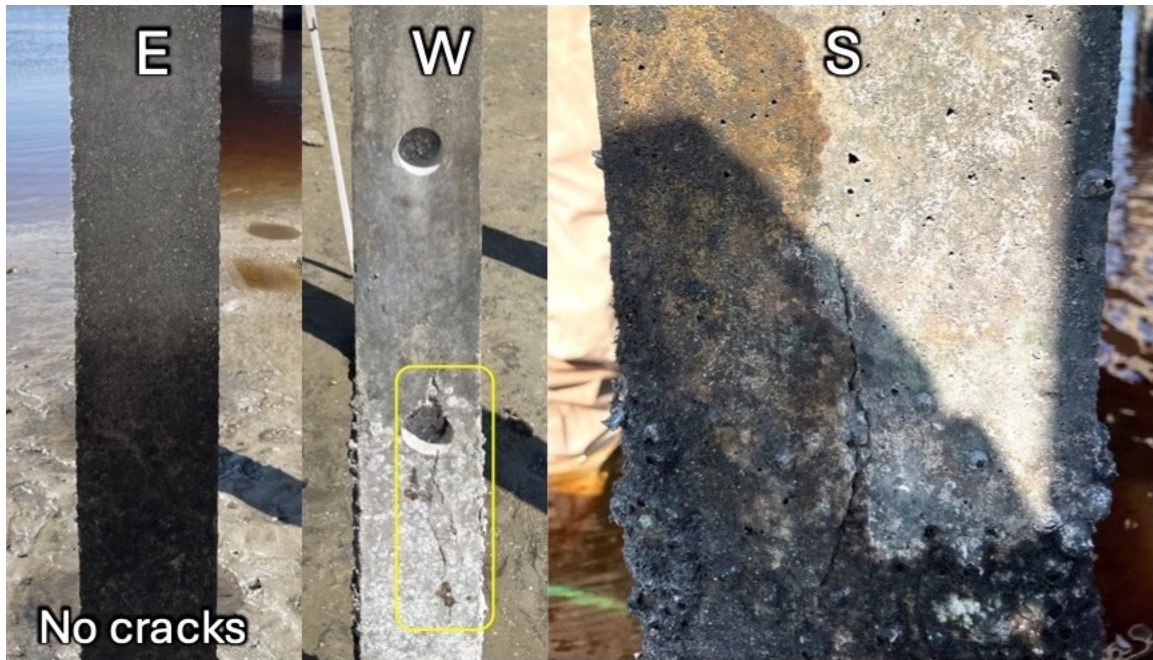
Only two column surfaces in Column B (Figure 5-5) showed signs of cracks: the west face and the south face. Two cores were obtained from Column B, but no rebar was removed. One of the cores reached the rebar. Only a small section of the rebar trace was observed in the core, and no corrosion markings were transferred to the concrete. Three surfaces in Column C showed cracks along the rebar length (Figure 5-6). Two cores were obtained from Column C: one 6" above water line and one at the water line. One of the two cores reached the rebar; no corrosion markings were transferred to the rebar trace.

Figure 5-5. Picture showing surface conditions of east, west, and south faces of column 3CR12-B. North face not pictured.

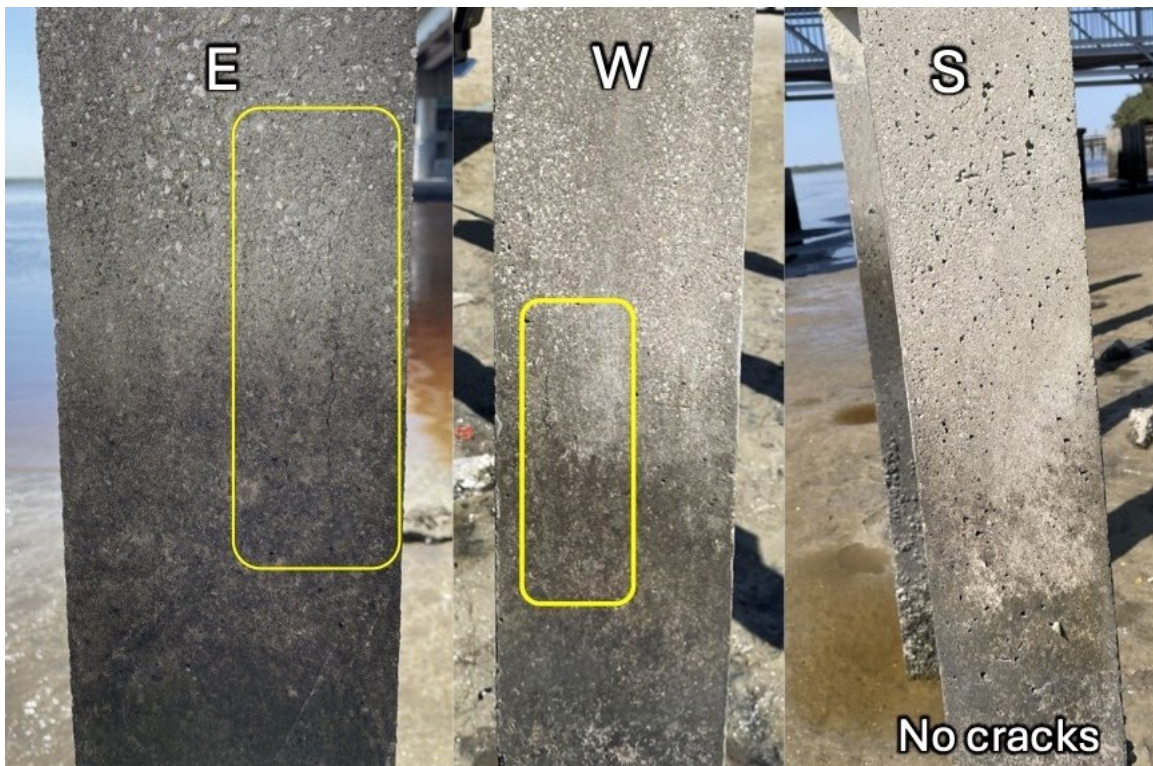
Figure 5-6. Picture showing surface conditions of east, west, and south faces of column 3CR12-C. North face not pictured.

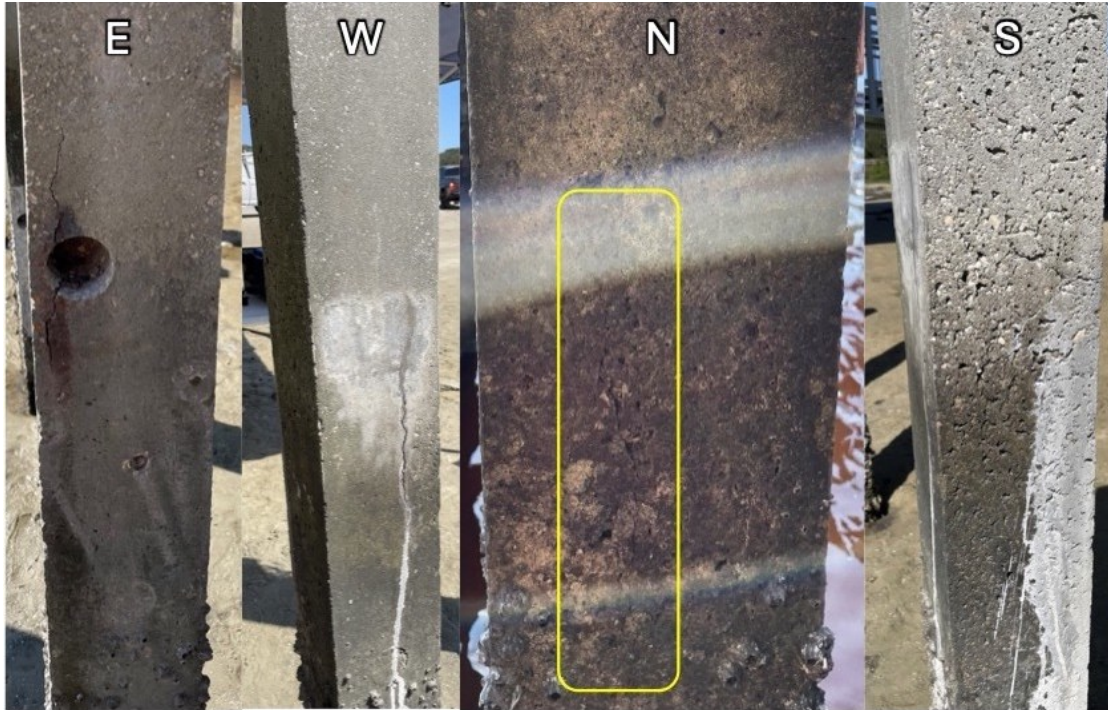
Figure 5-7. Picture showing cracks on the surface of each face of column 2101-A.

Figure 5-7 shows the surface condition for column 2101-A, three surfaces (E, W, N) showed cracks. Several surfaces on columns 2101-B and 2101-C had at least two visible cracks along the lengths of two rebars. The west and north faces of 2101-B, shown in Figure 5-8, exemplifies this. The east and west faces of 2101-C in Figure 5-9 also exhibit several cracks along rebar lengths.

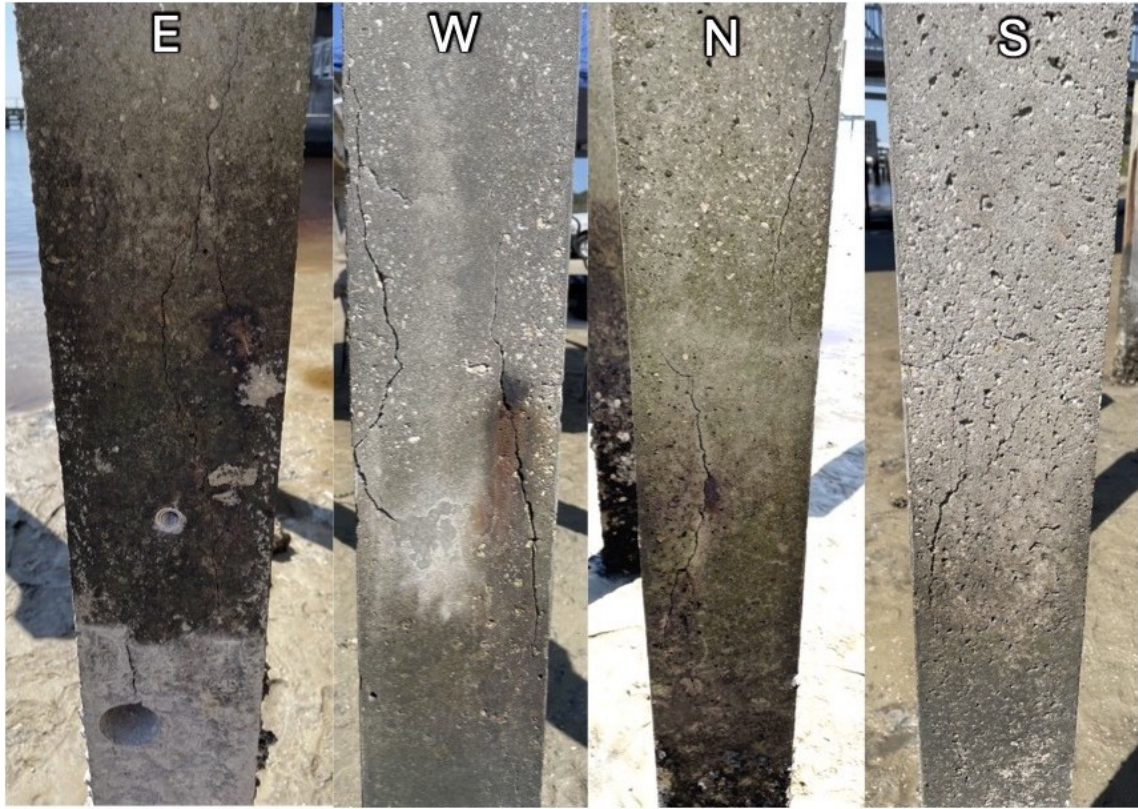
Figure 5-8. Picture showing cracks on the surface of each face of column 2101-B.

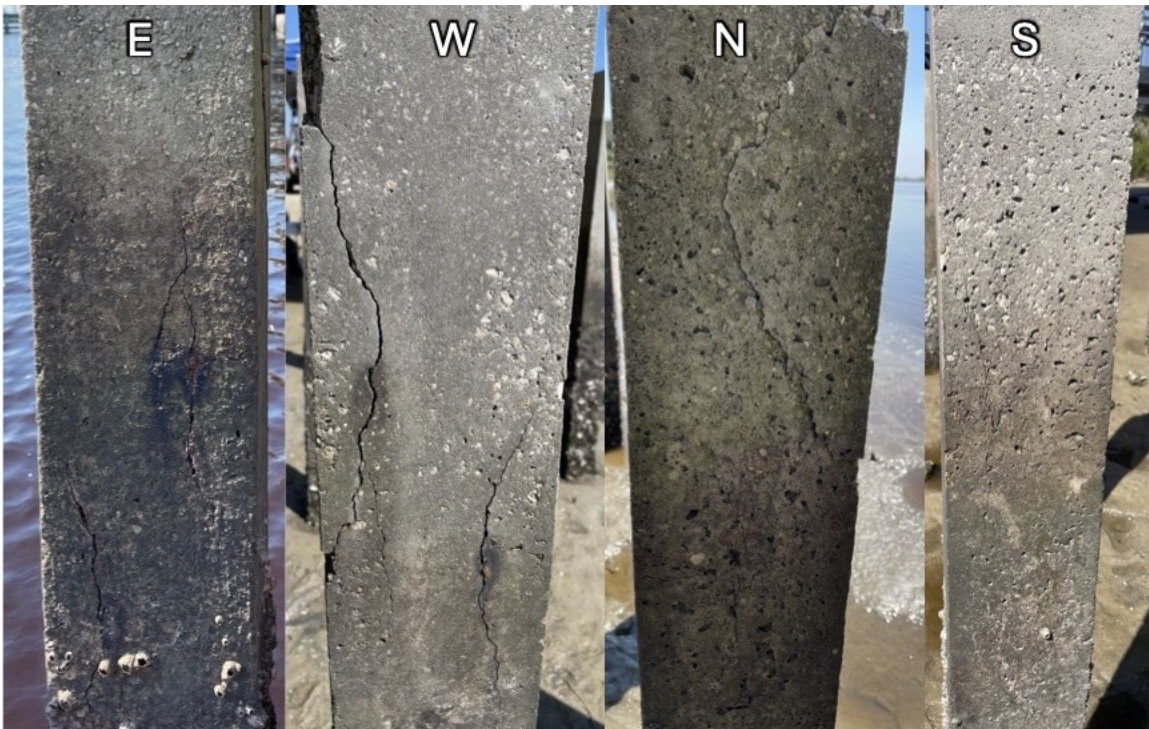
Figure 5-9. Picture showing cracks on the surface of each face of column 2101-C.

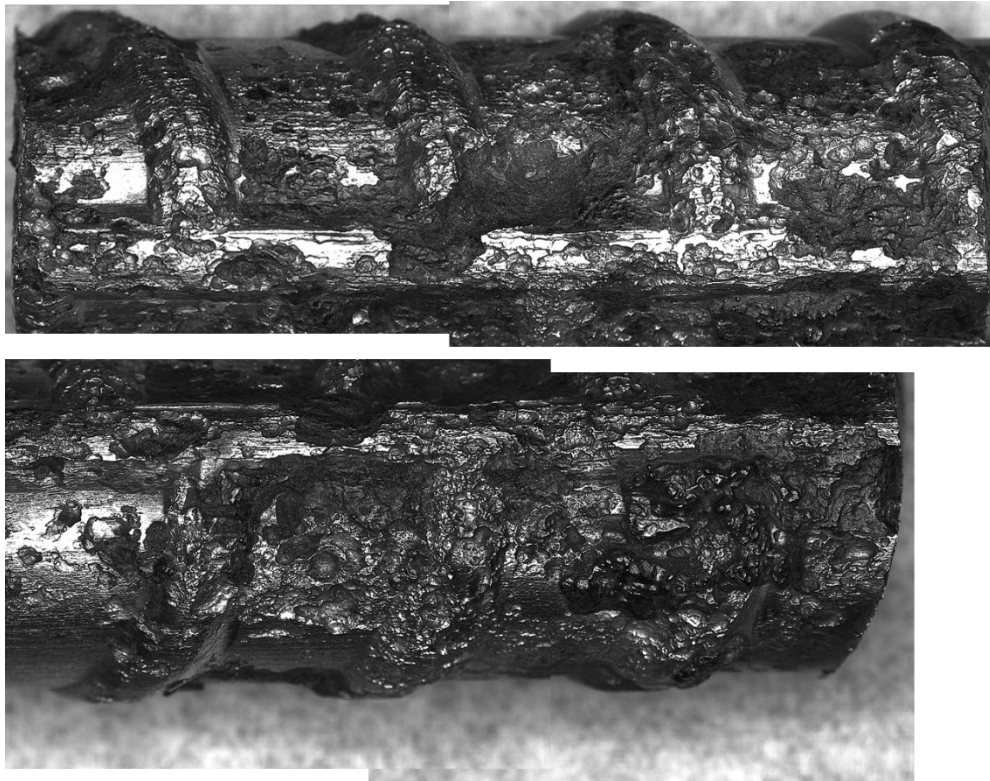
Figure 5-46. MMFX rebar section close-up of the region with most corrosion.

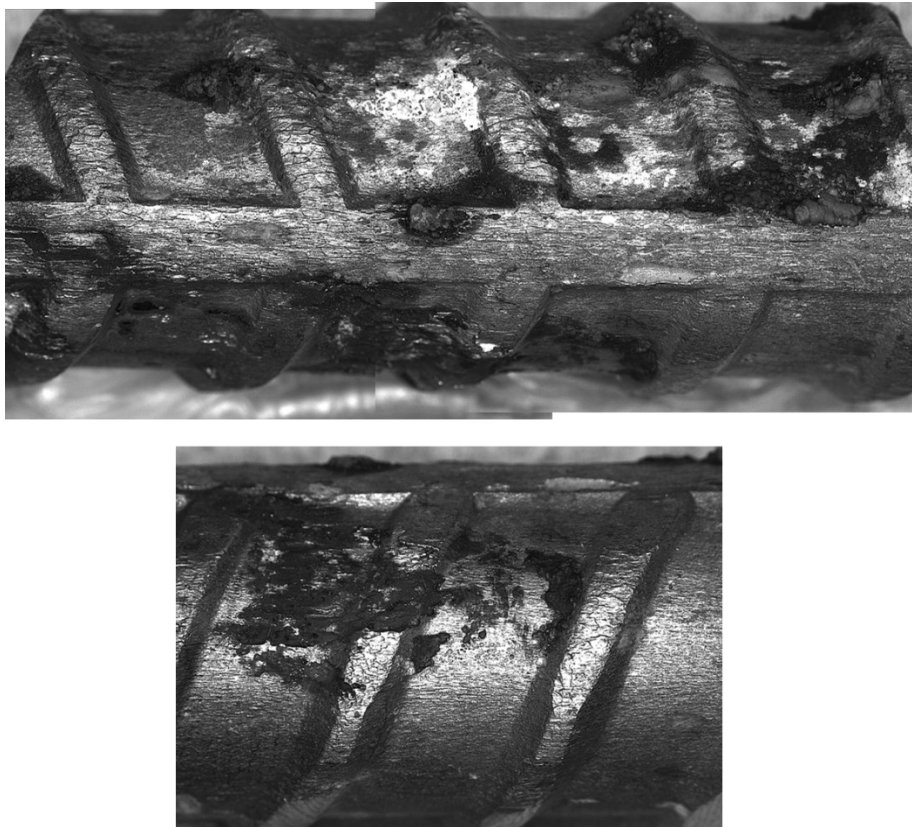
Figure 5-50. 2101 (Column B) rebar section close-up of the region with most corrosion.

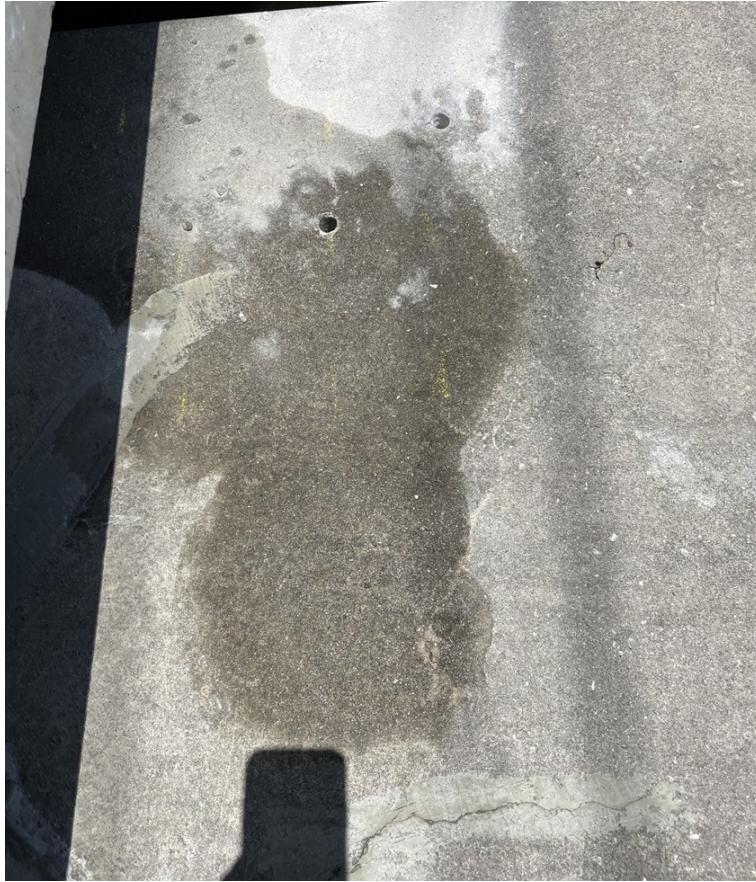
Figure 6-2. Drilled hole to access rebar at location one. A crack was visible transverse to the phone shade.

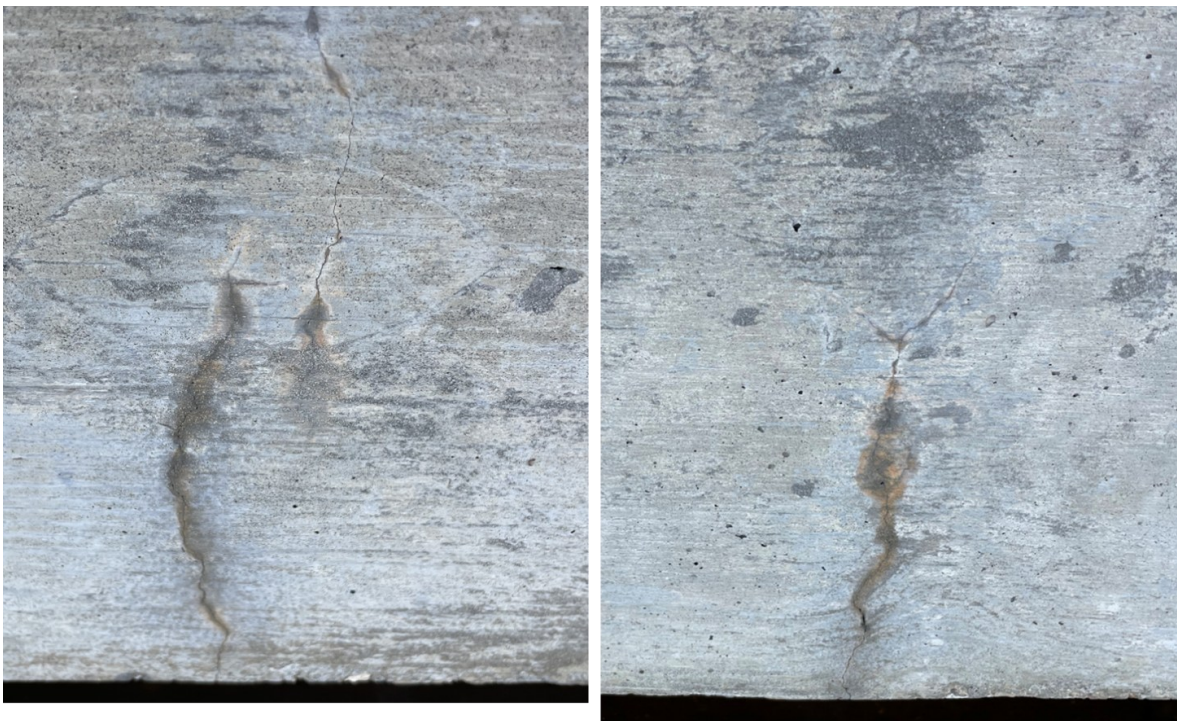
Figure 6-4. Close-up of two of the cracks (moisture allows for observation).

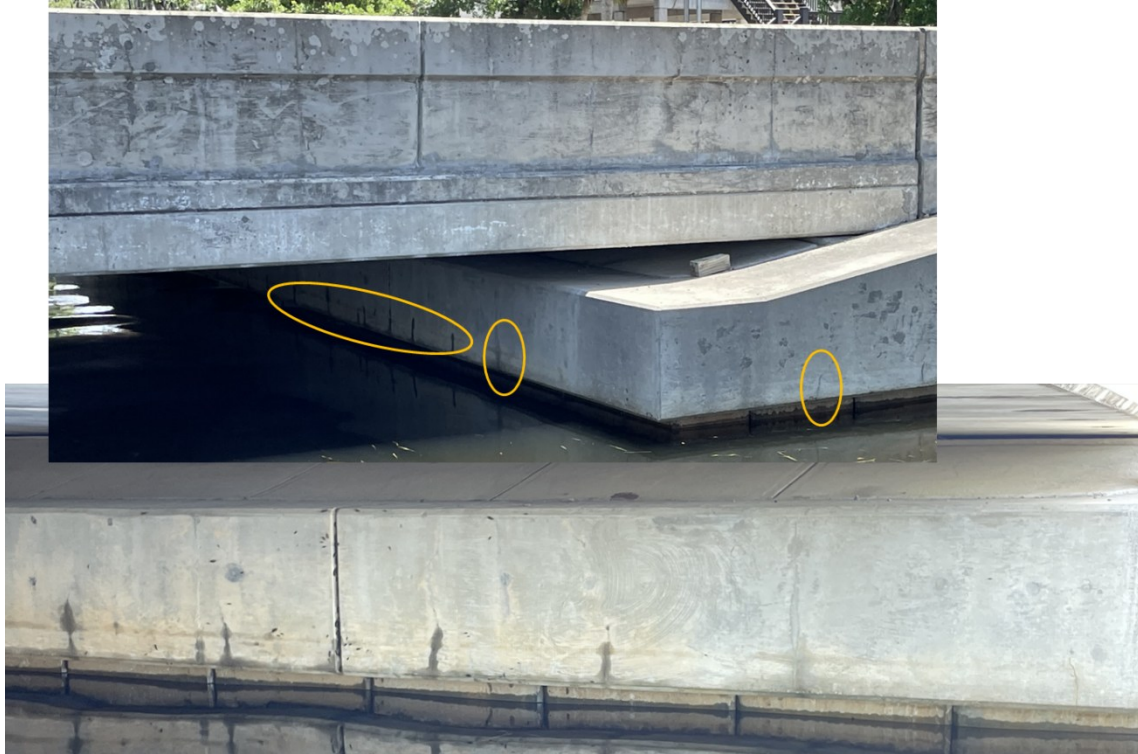
Figure 6-5. South side of the bridge under the deck, showing several cracks (moisture allows observation).

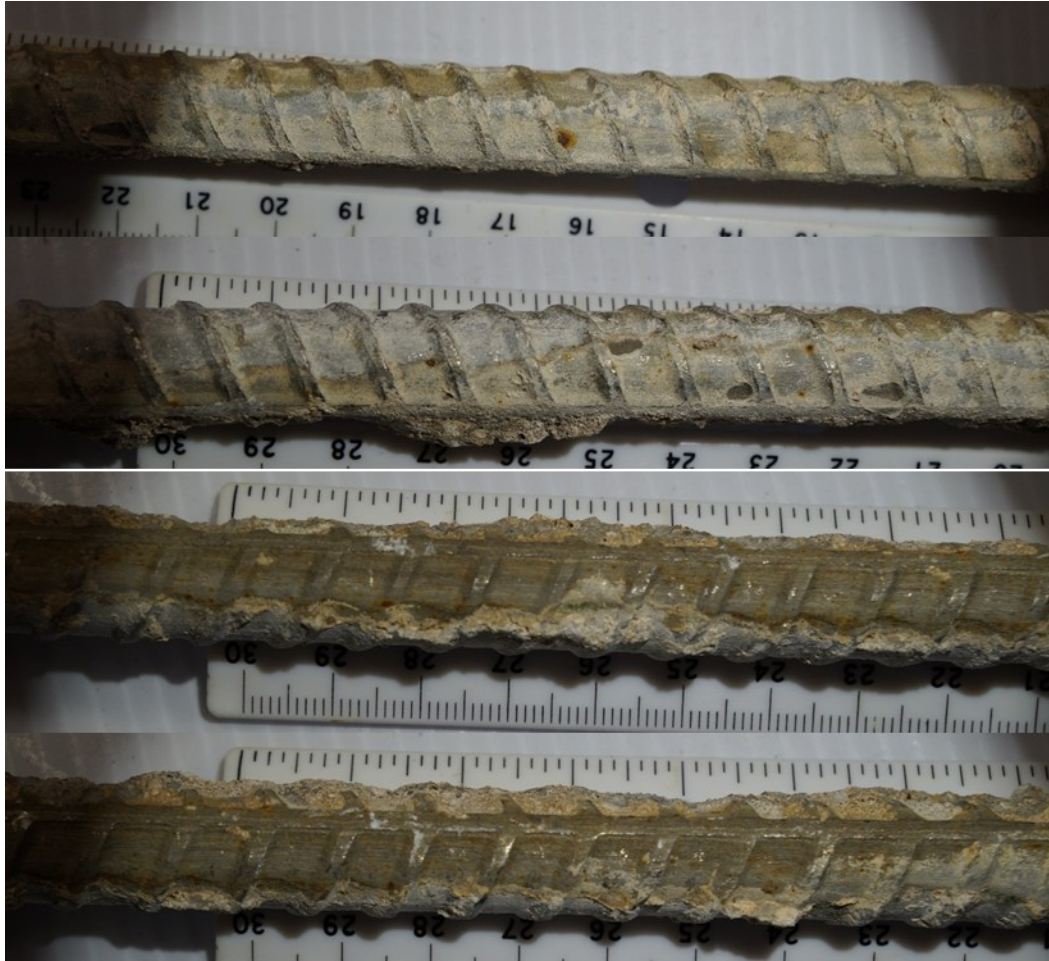
Figure 7-22. Closeups of pitting corrosion on 304SS rebars.

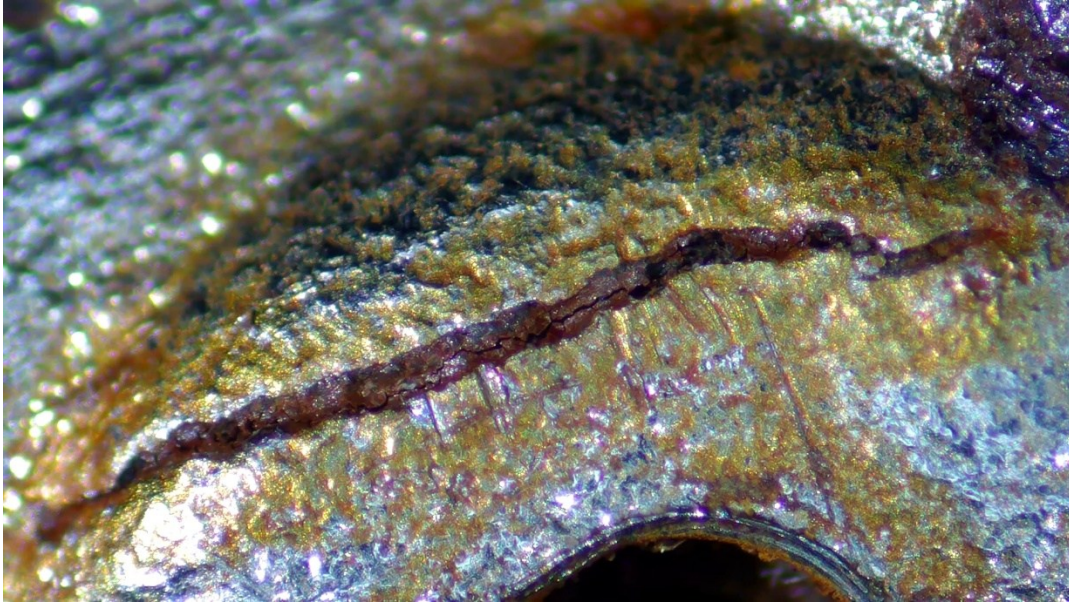
Figure 7-44. Bump with crack in hole 10 on top side of rebar B of sample BCCD-CT2-1.

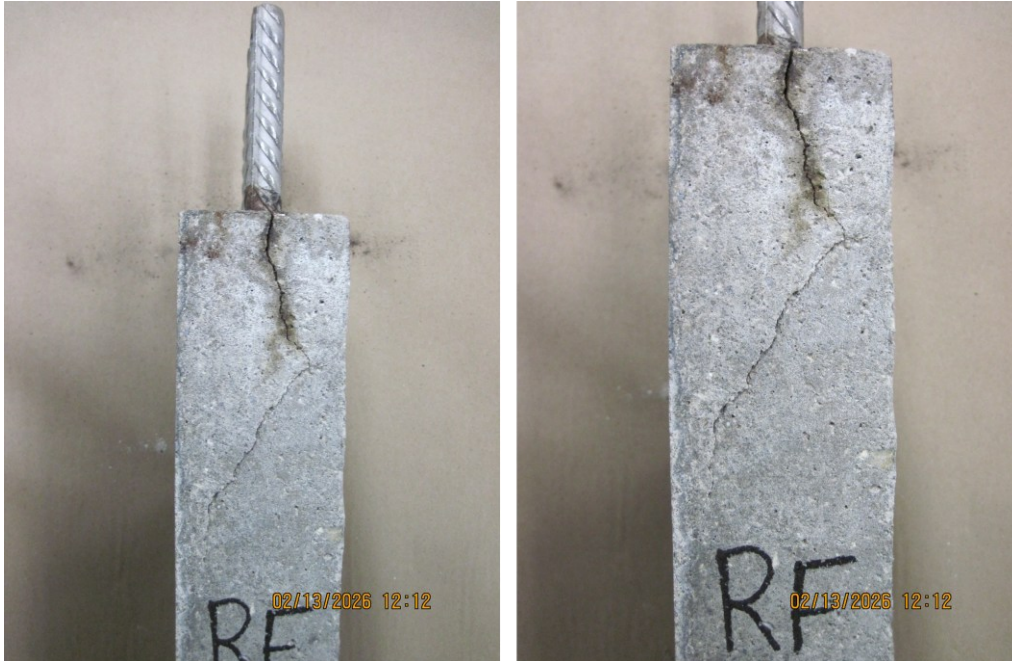
Figure 8-2. Right side crack of sample STD3-2101-B before termination.

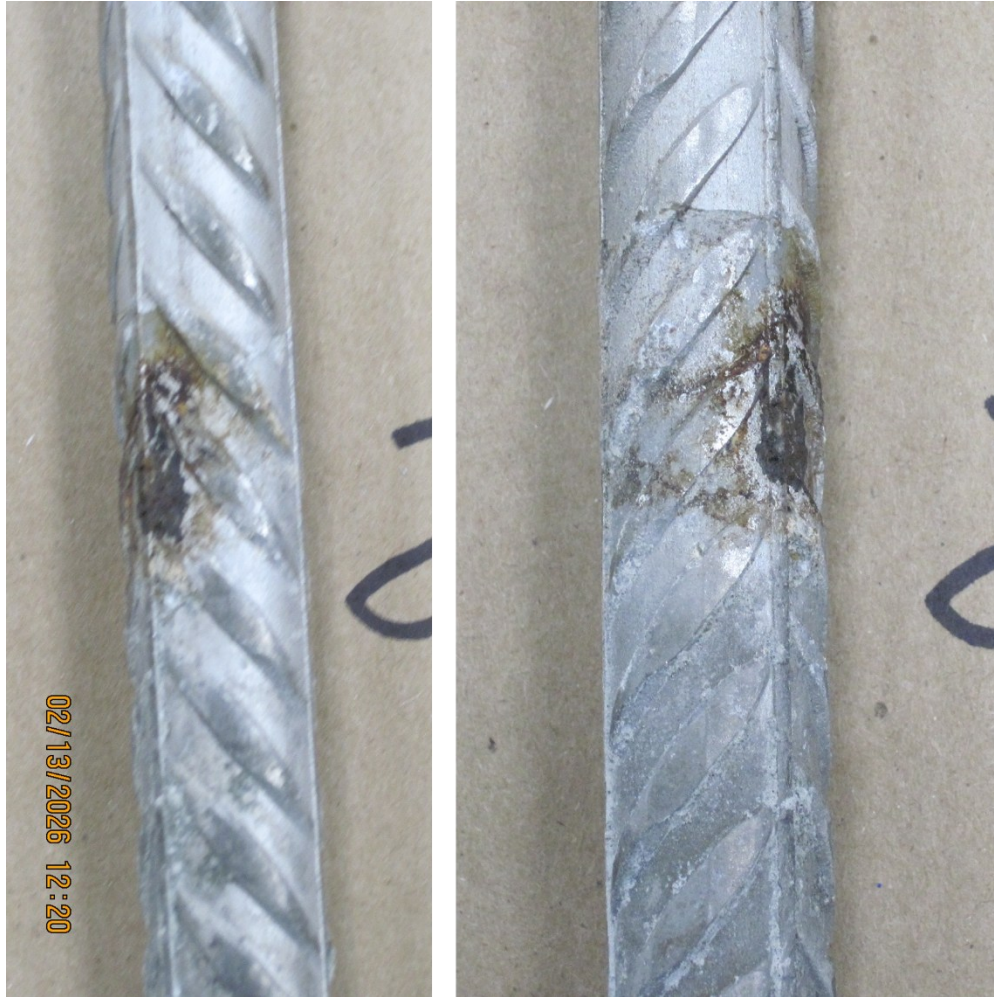
Figure 8-17. Close up of corrosion spot on rebar 2 of sample STD3-2101-B at multiple angles.

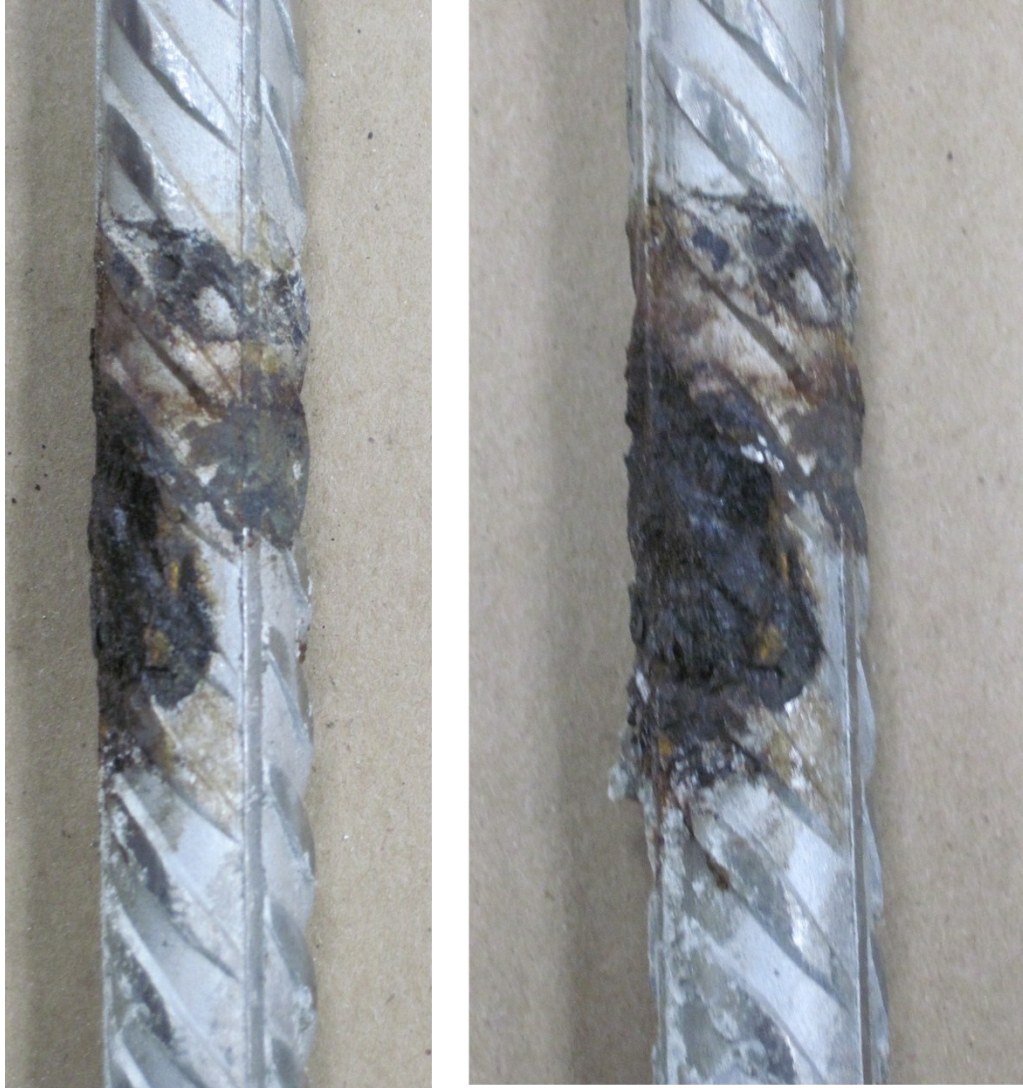
Figure 8-18. Close up of corrosion spot on rebar 3 of sample STD3-2101-B at multiple angles.

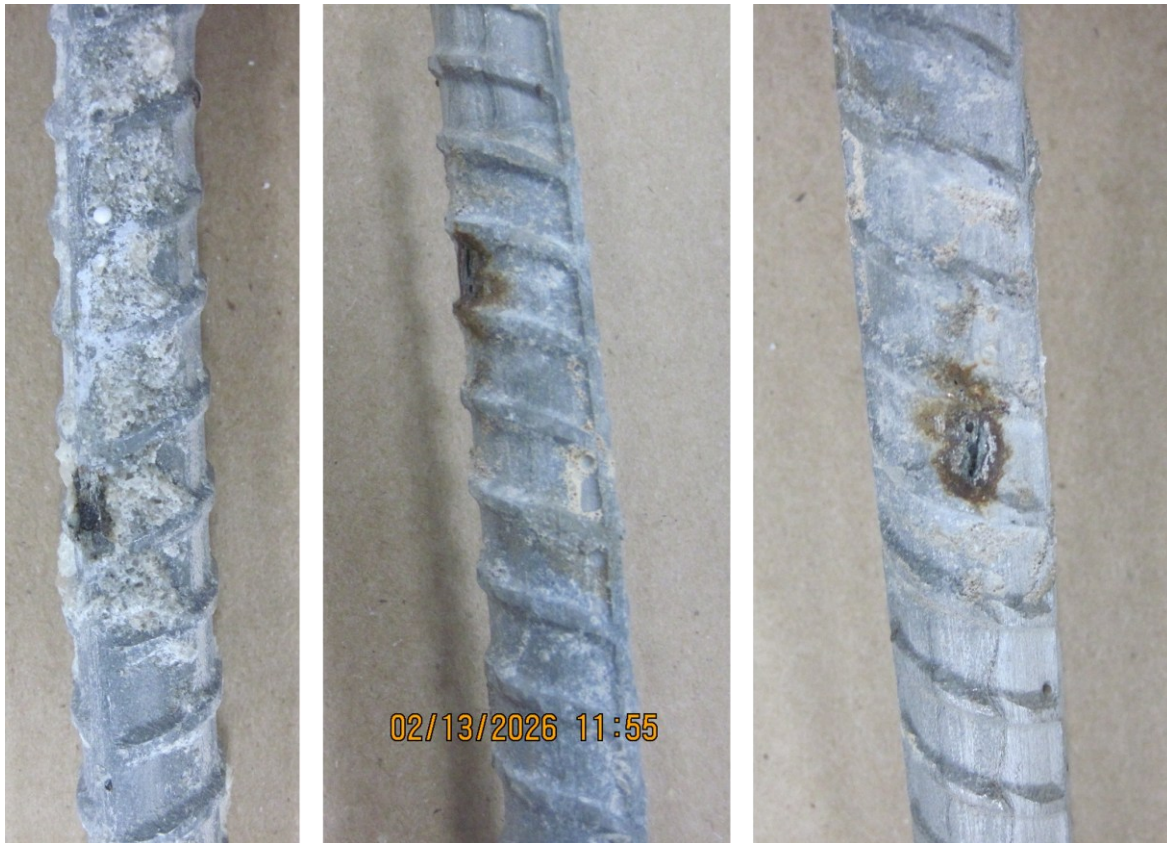
Figure 8-22. Close up corrosion spots on rebar 1 of sample BENT-STD3-304-C.

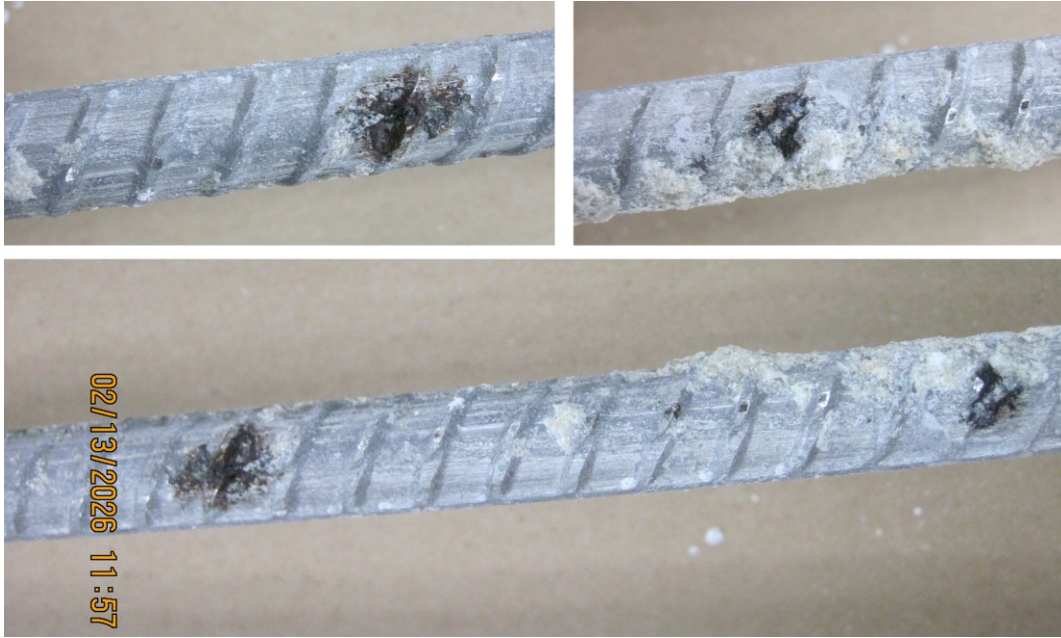
Figure 8-24. Close up corrosion spots on rebar 3 of sample BENT-STD3-304-C.

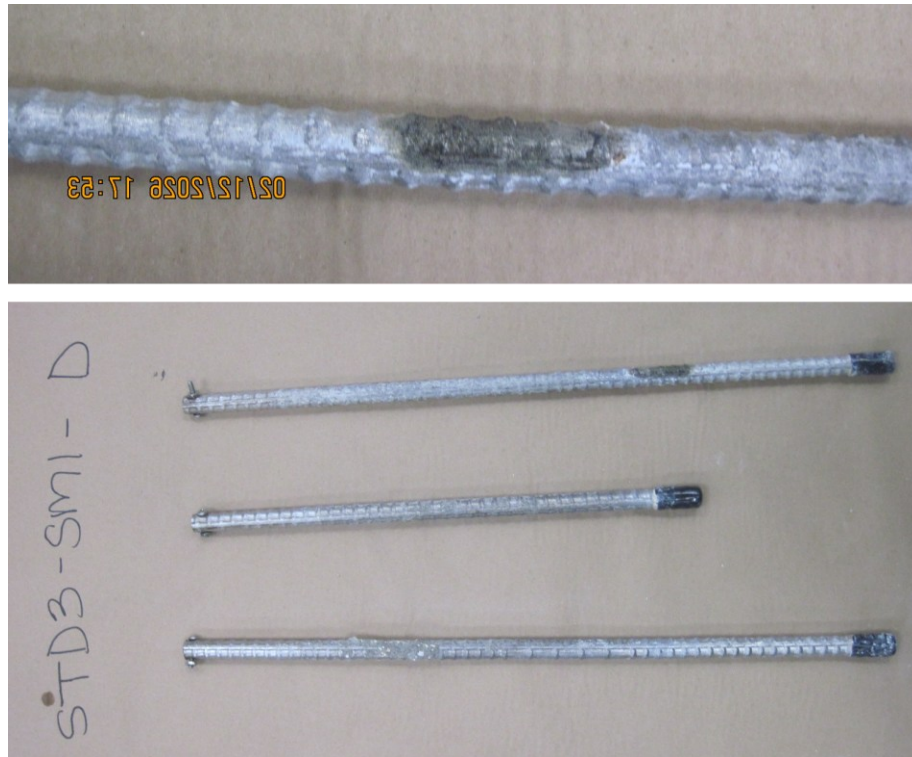
Figure 8-25. All rebars and close up image of corrosion spot on rebar 3 of sample STD3-SMI-D.

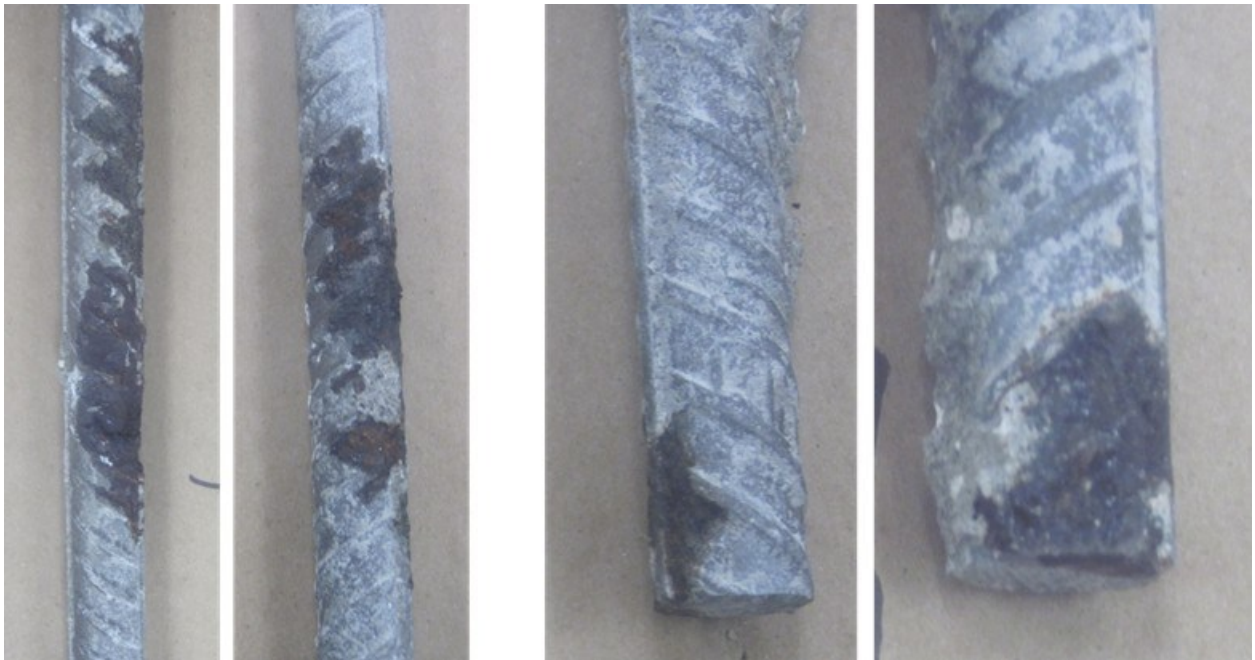
Figure 8-27. Corrosion spots on rebar 1 (right 2 images) and 2 (left) of sample STD3-3CR12-E.

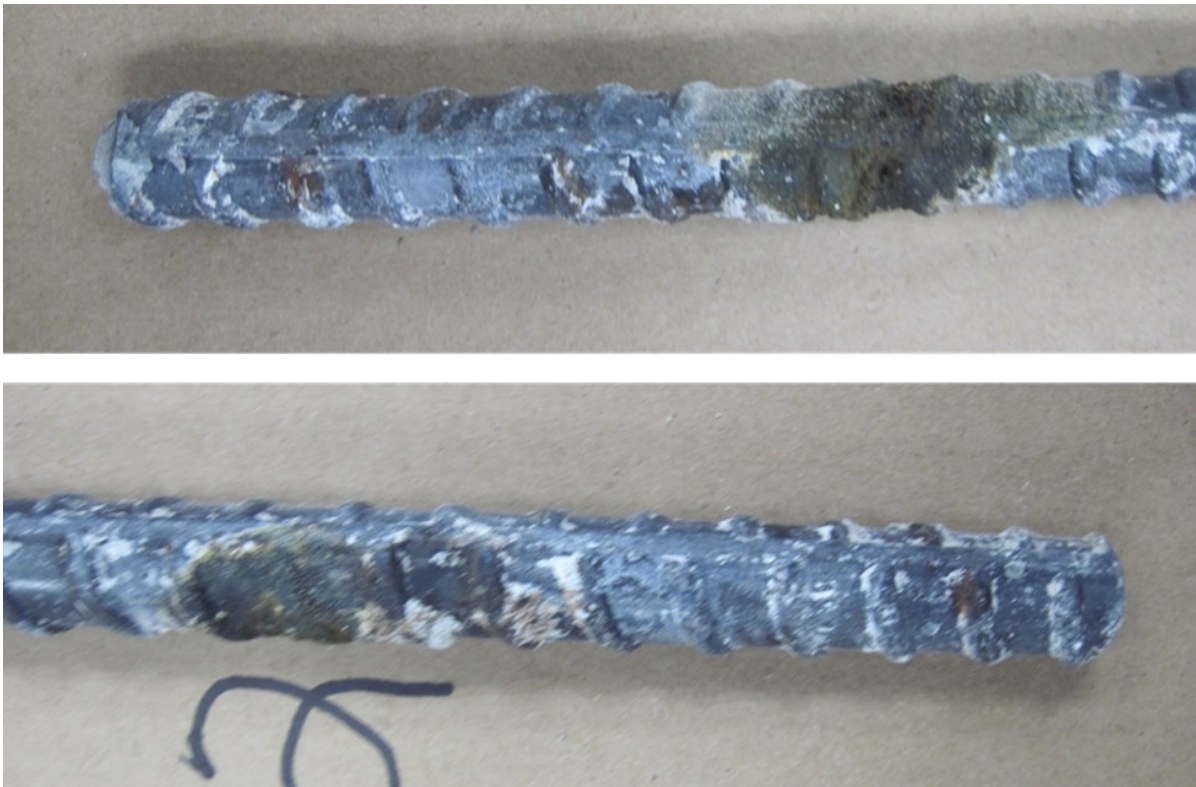
Figure 8-35. Corrosion spots on rebar 2 of sample ELEV-MMFX-A.

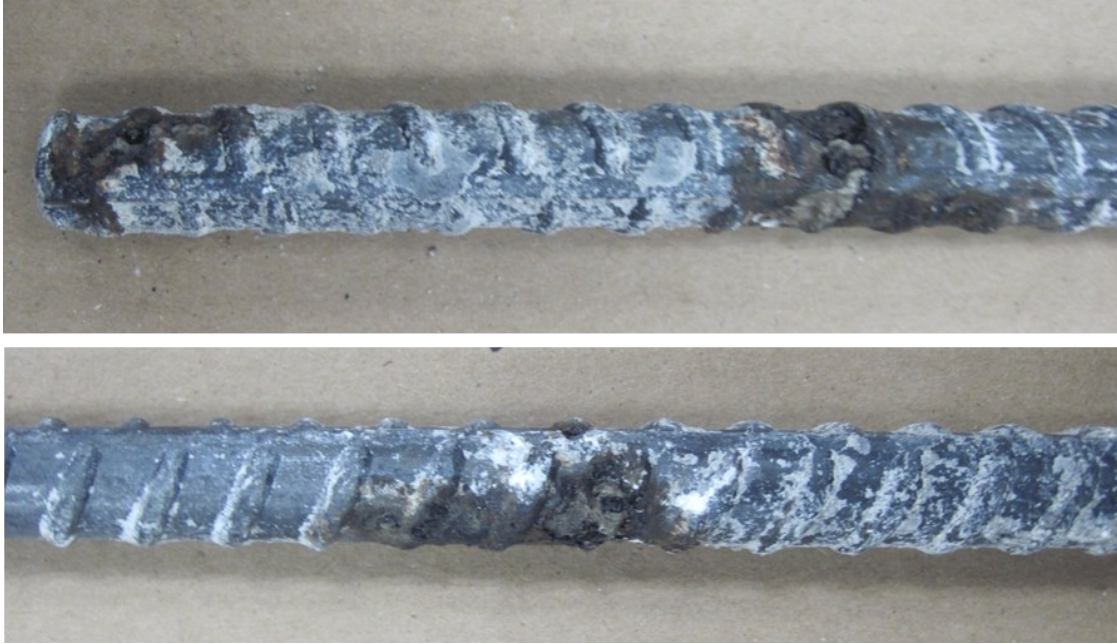
Figure 8-36. Corrosion spots on rebar 3 of sample ELEV-MMFX-A.

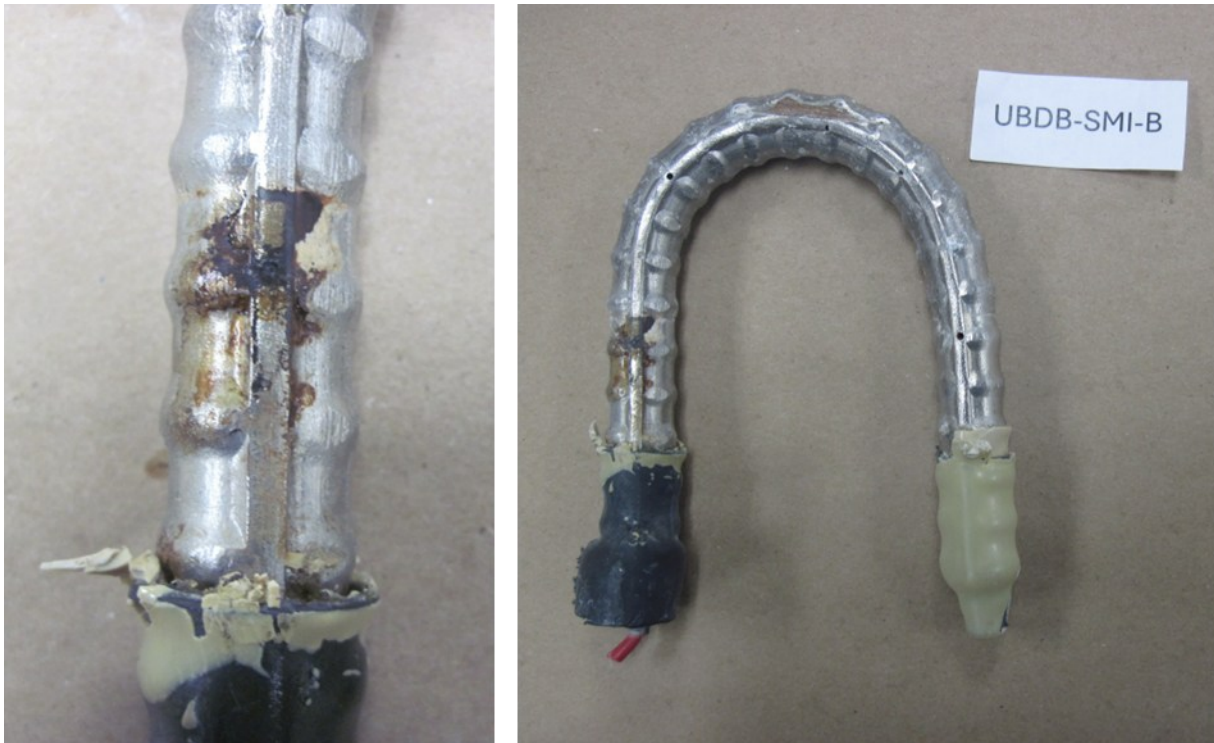
Figure 8-38. Corrosion spots on bottom side of sample UBDB-SMI-B (G109).

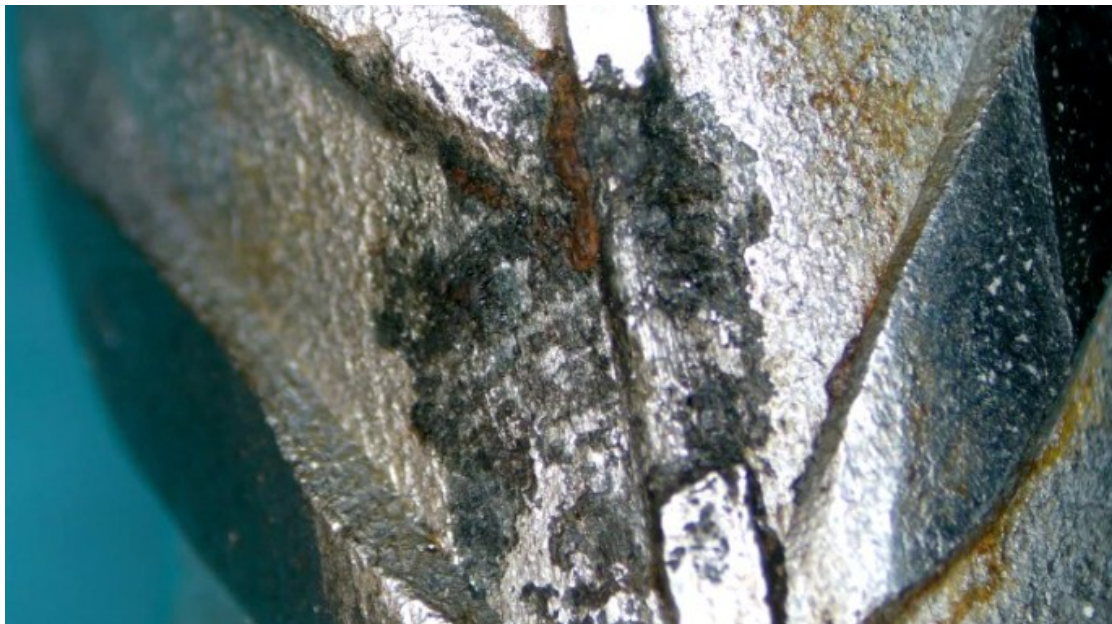
Figure 8-40. Corrosion spot observed on rebar 2 of STD3-2101-B.
