Report Prepared by:  
Dr. Francisco J. Presuel–Moreno  
With  
Samantha Mavrak  
David Anguelov

## **Final Report**

Evaluation of Concrete Specimens Prepared with Corrosion Resistant  
Reinforcement after Long Term, Greater than 15 years, Outdoor and  
Laboratory Exposures

Contract Number – FDOT (BED27-977-04)  
FAU (AWD003253)

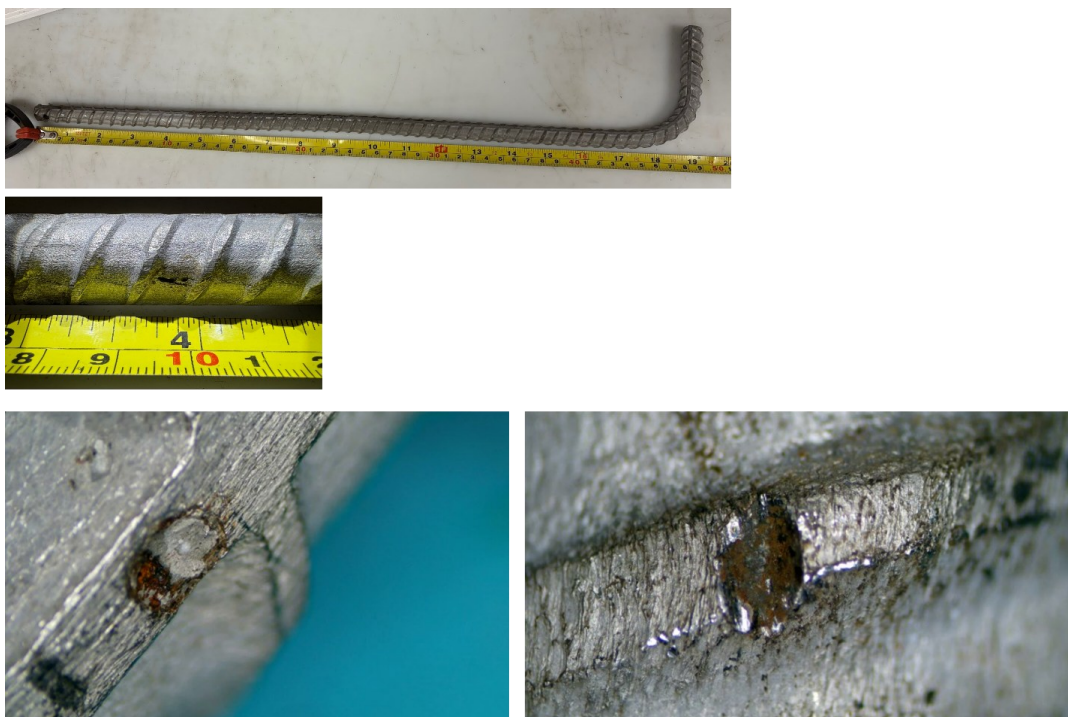
Figure 8-44. STD3-304-C (BENT) - full length of rebar 1 and corroding locations.

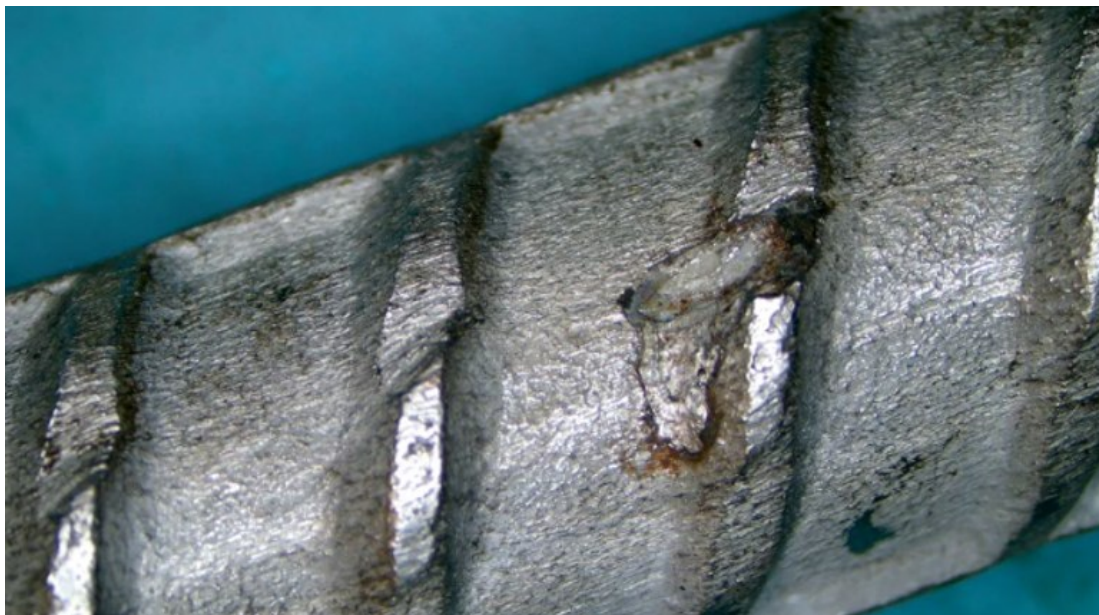
Figure 8-45. STD3-304-C (BENT) rebar 3 corroding site after cleaning.

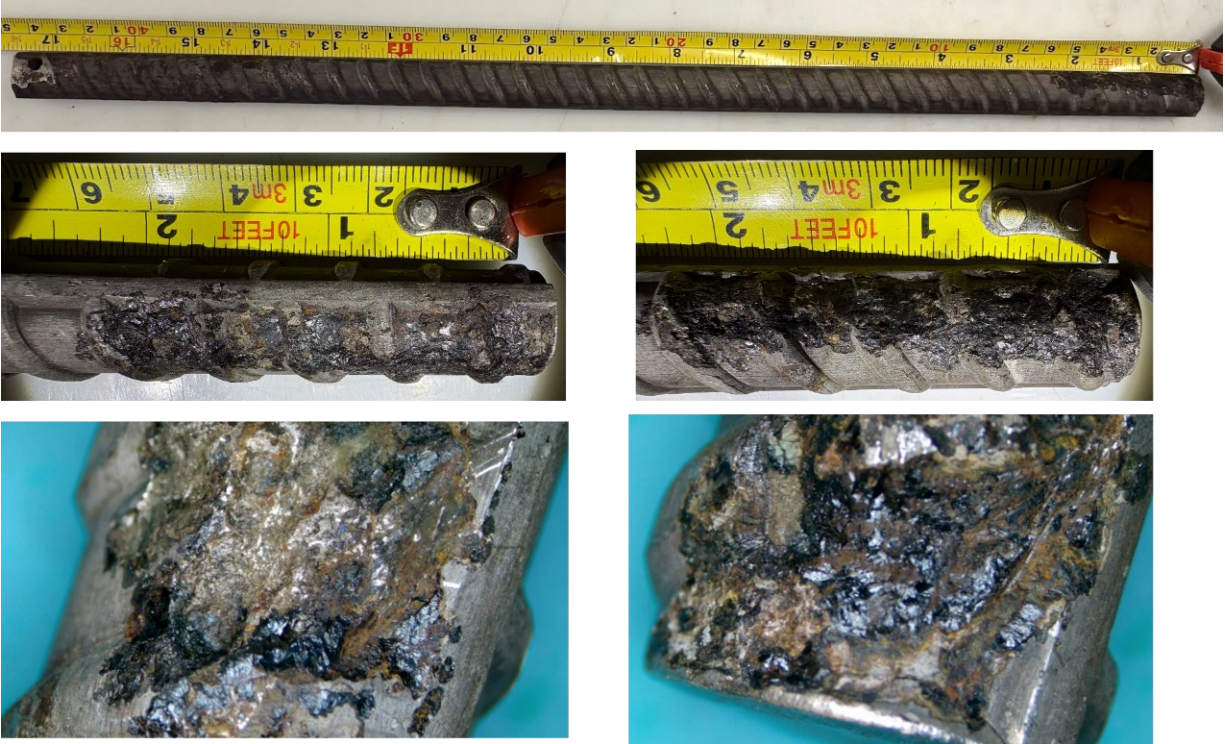
Figure 8-51. STD3-MMFX-B - full length of rebar 2 and notable areas of corrosion damage.
