# **Guardrail Height Safety Requirements Given Recent Crash History and Evolution of Vehicle Design**

FDOT Contract No: BED32-977-03

Final Report

Principal Investigator: Scott Parr, Ph.D., PE  
Graduate Student: Delaney Morgan, M.S.

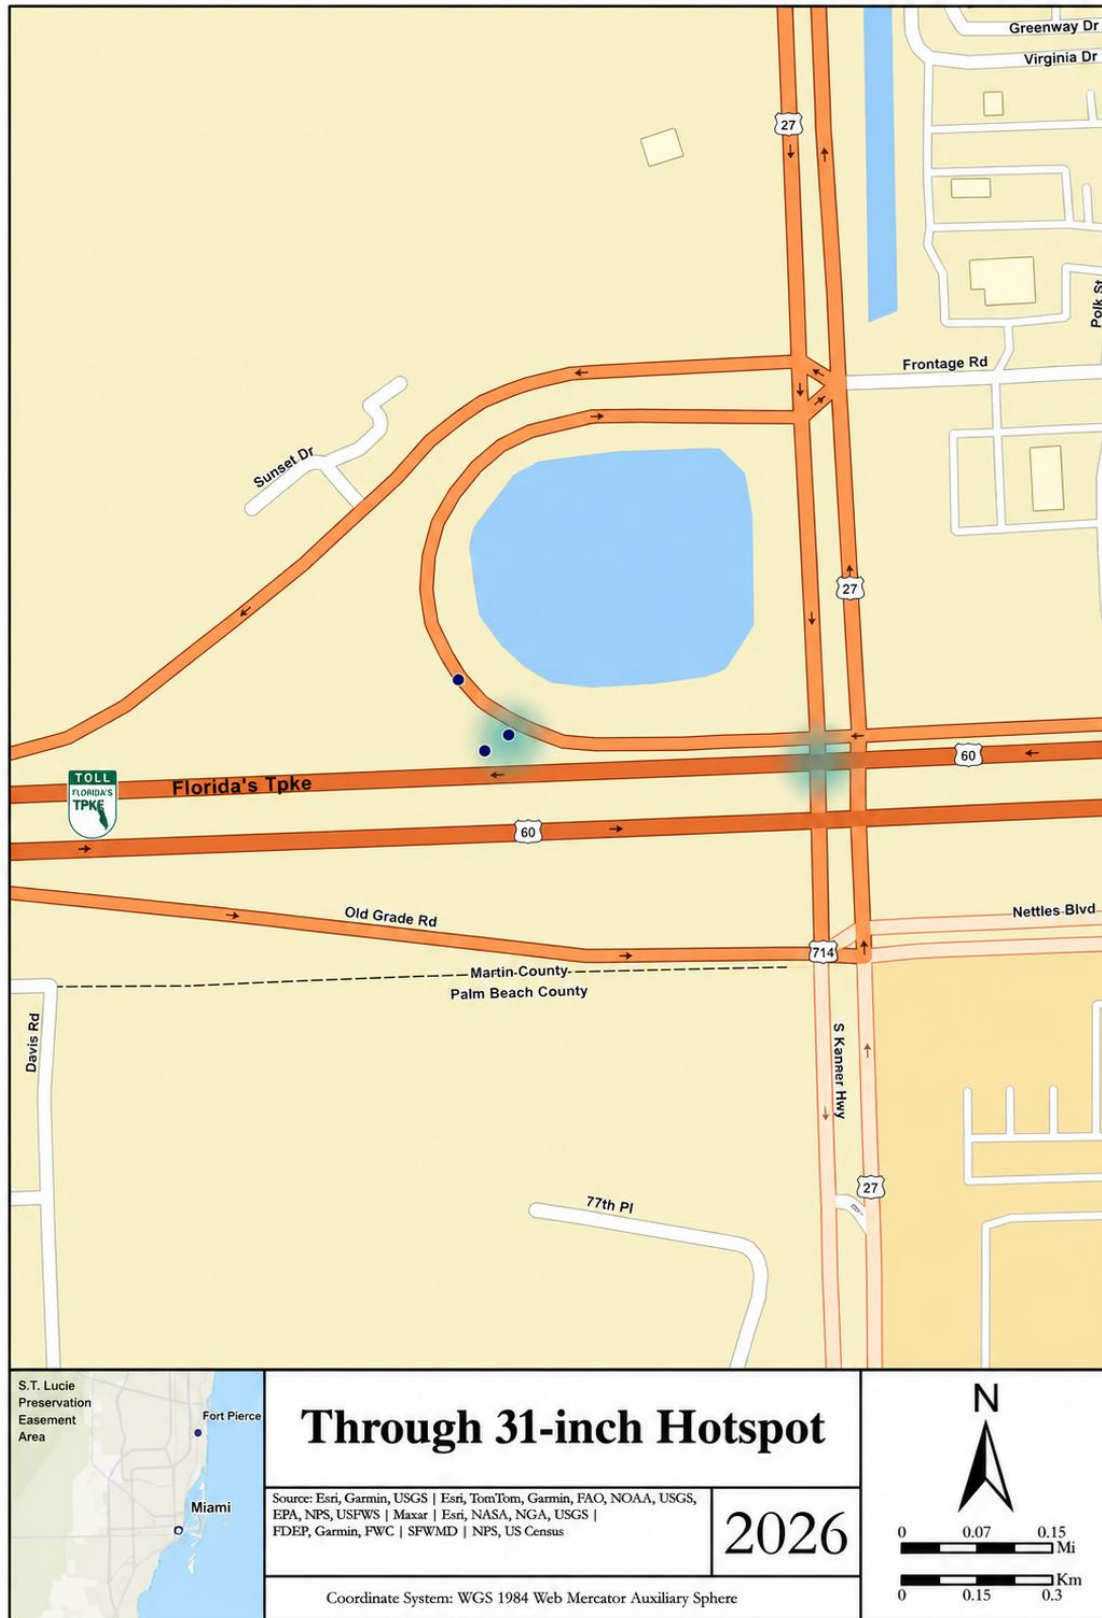
Figure 7-7: Hot-spot location 1 — Miramar, Florida

Figure 7-7 shows the mapped location of the three confirmed Through failures at the westbound exit ramp from Florida's Turnpike to NW 27th Avenue. The figure illustrates the close spatial proximity of the failure events and provides the basis for identifying this ramp as a selected hot-spot location for detailed review.

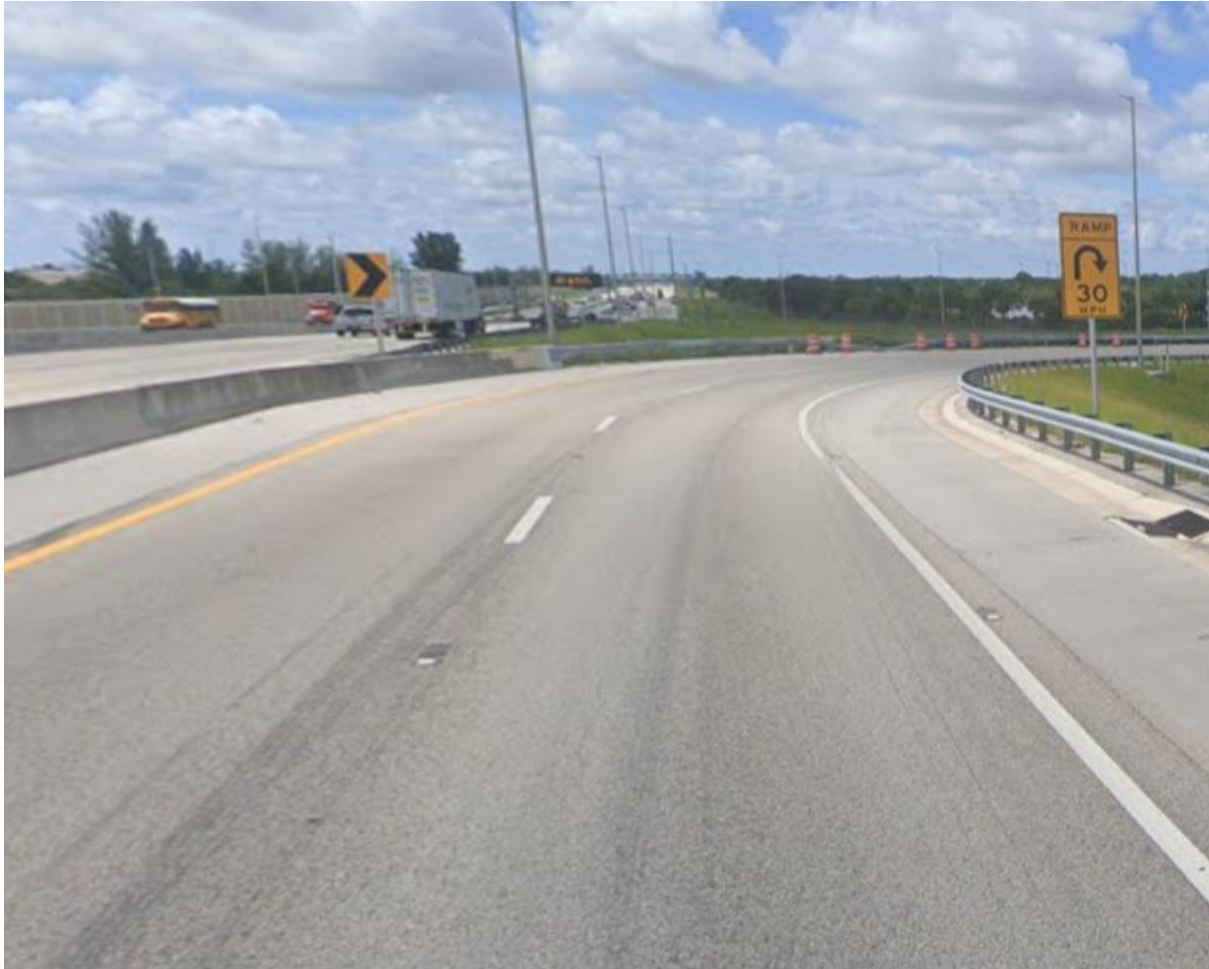
**Figure 7-8: Hot-spot location 1 site image**

The repeated occurrence of Through failures at this ramp location suggests that the site may represent an area of concern. Based on available imagery provided in Figure 7-8, the ramp includes a curved alignment, and the failure events appear to be concentrated within the ramp environment. This type of location may involve interactions between approach speed, ramp curvature, driver path, impact angle, and roadside barrier placement. Figure 7-8 provides a site-level image of the ramp area to support the preliminary review of roadway context.

Figure 7-8 shows the exit ramp from Florida's Turnpike to NW 27th Avenue. The image shows a ramp advisory speed of 30 mph and visible evidence of a recent guardrail Through failure at the time the image was captured. The apparent failure location is on the outside of the ramp curve, where vehicles departing the roadway would be expected to strike the guardrail face.

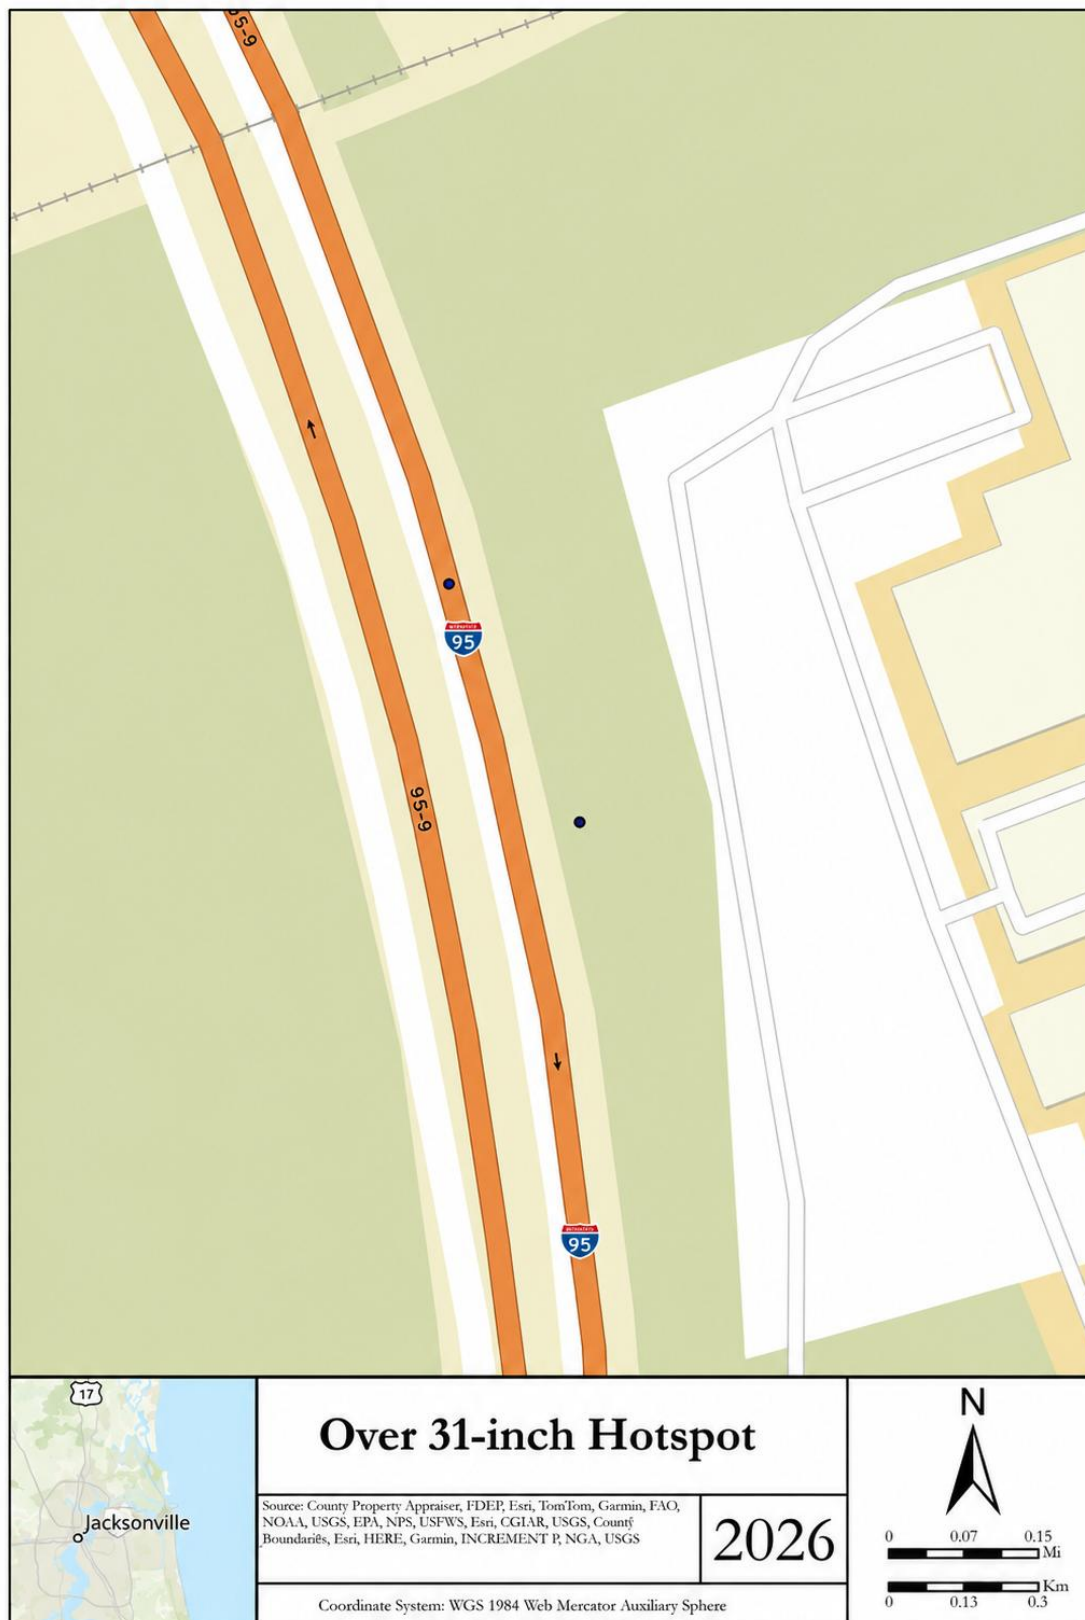
**Figure 7-9: Hot-spot location 2 — Jacksonville, Florida**

Figure 7-9 shows the mapped location of the two confirmed Over failures along northbound I-95 in Jacksonville. Both failures occurred in close proximity and were associated with the 31-inch guardrail height standard, supporting the selection of this site for detailed review.

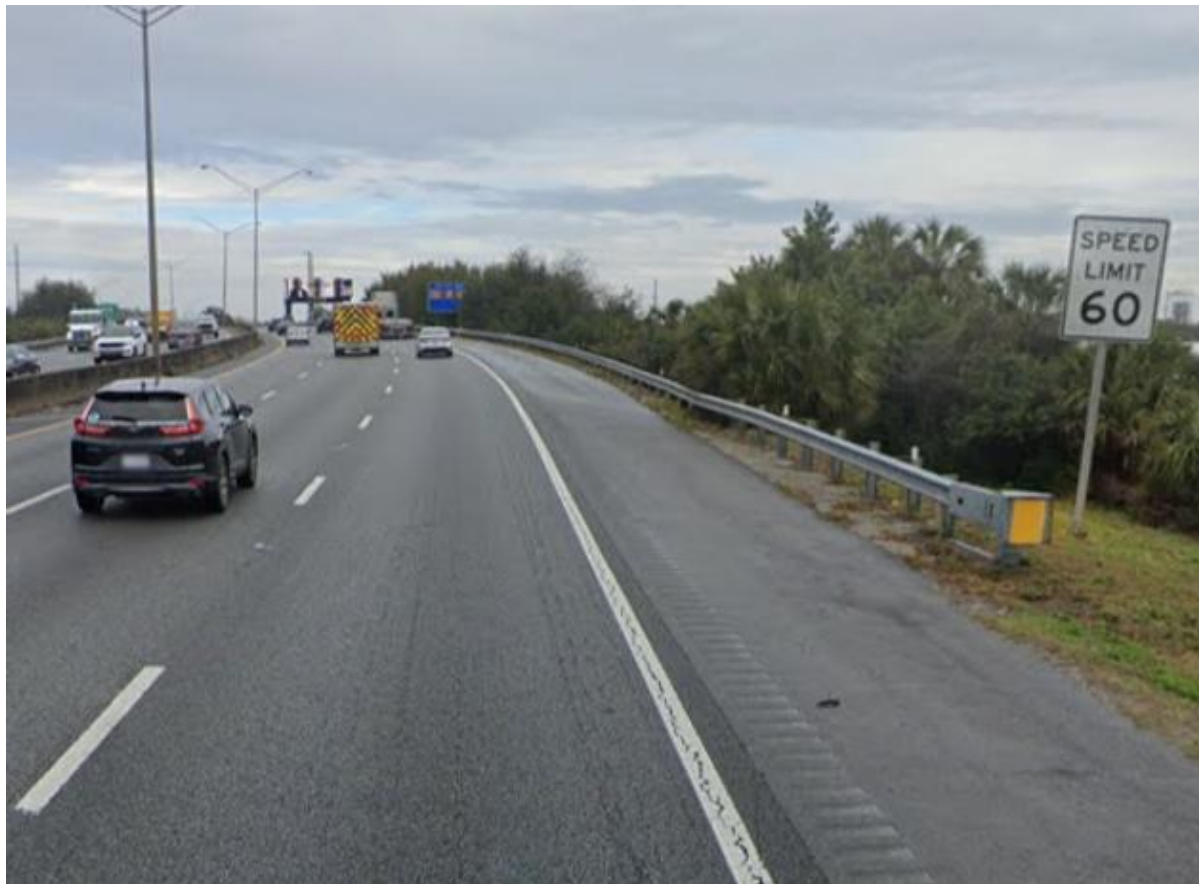
**Figure 7-10: Hot-spot location 2 site image**

The repeated occurrence of Over failures at a 31-inch guardrail location is notable because the 31-inch standard was adopted to better address the modern vehicle fleet. The roadway context includes a freeway environment where operating speeds and vehicle departure path may be important factors in understanding the observed failures. Figure 7-10 shows the northbound I-95 roadway segment associated with Hot-Spot Location 2. The roadway includes a gradual horizontal curve to the left. As shown in Figure 7-9, the documented Over failures occurred on the outside of this curve, along the right side of the roadway.

The image suggests that the three travel lanes are superelevated through the curve, while the outside shoulder appears to transition to a negative cross slope. The guardrail is located beyond this outside shoulder. This configuration may be important because vehicles departing from the positively superelevated travel lanes at high speed may continue across the negatively sloped shoulder before contacting the guardrail. Under this condition, the vehicle trajectory and the relative elevation difference between the travel lane and the guardrail base may effectively reduce the functional height of the guardrail at impact.

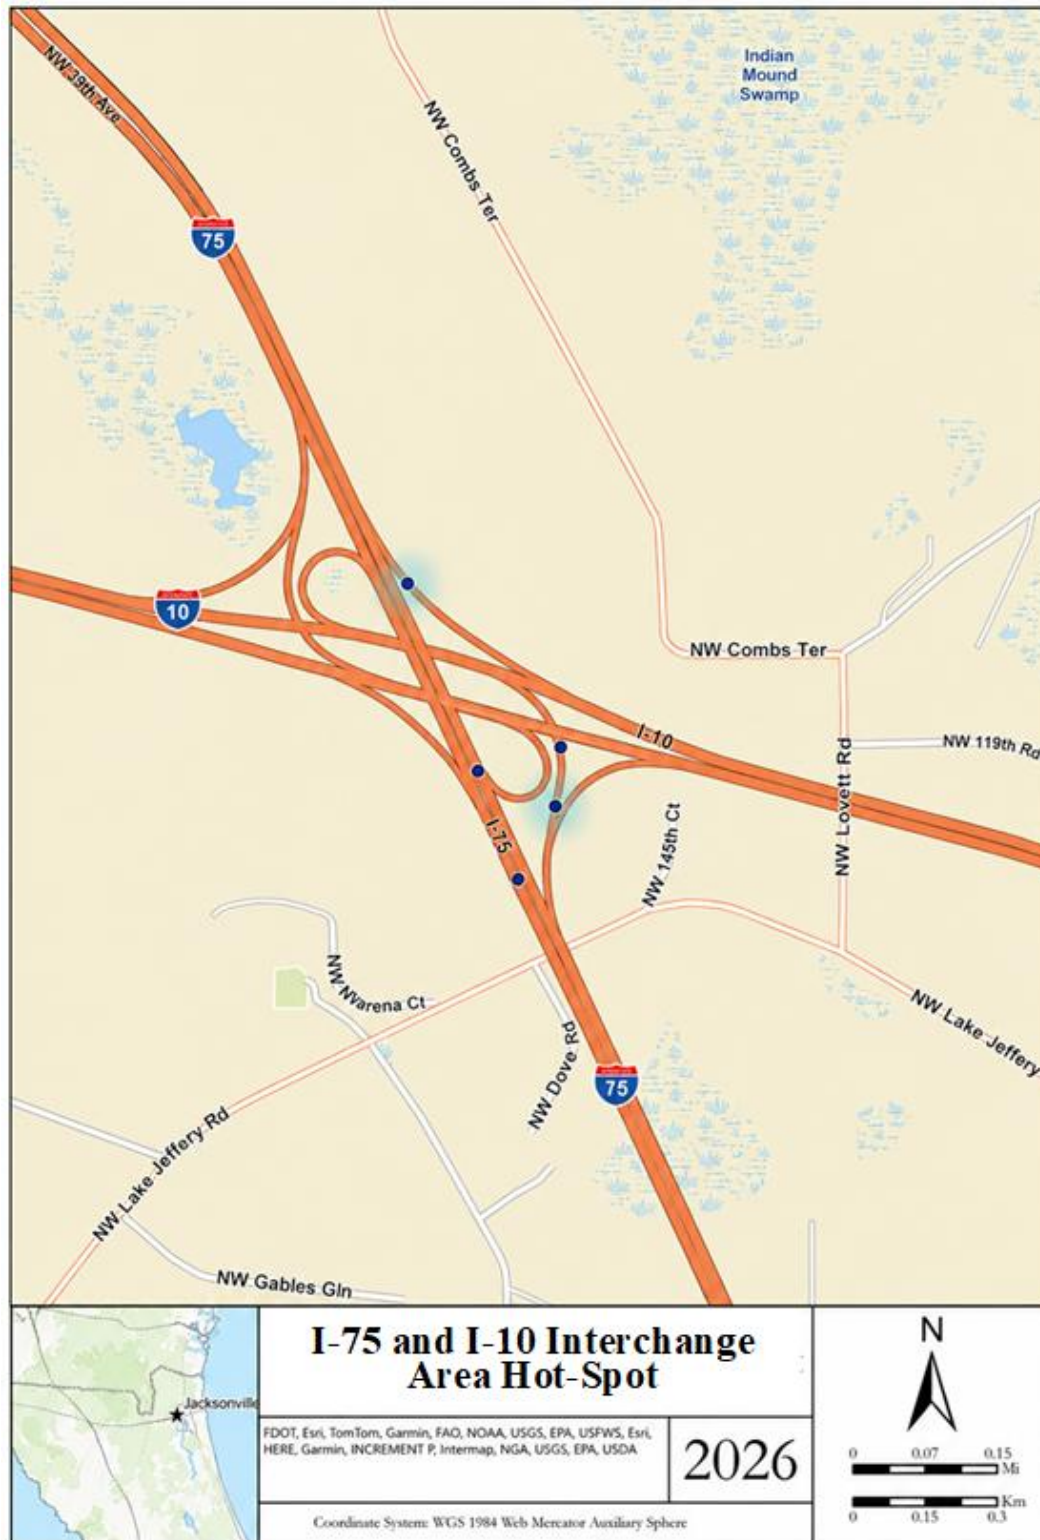
Figure 7-11: Hot-spot location 3 — Lake City, Florida

Figure 7-11 shows the mapped location of the confirmed guardrail failures within the I-75 and I-10 interchange area near Lake City. The figure illustrates that the failures are not concentrated at a single guardrail segment, but instead occur across multiple ramp movements within the interchange. This spatial pattern supports treating the location as an interchange-level area of concern rather than an isolated point location.

The interchange appears to be an older Interstate-era facility. Although the exact construction date and subsequent reconstruction history were not confirmed as part of

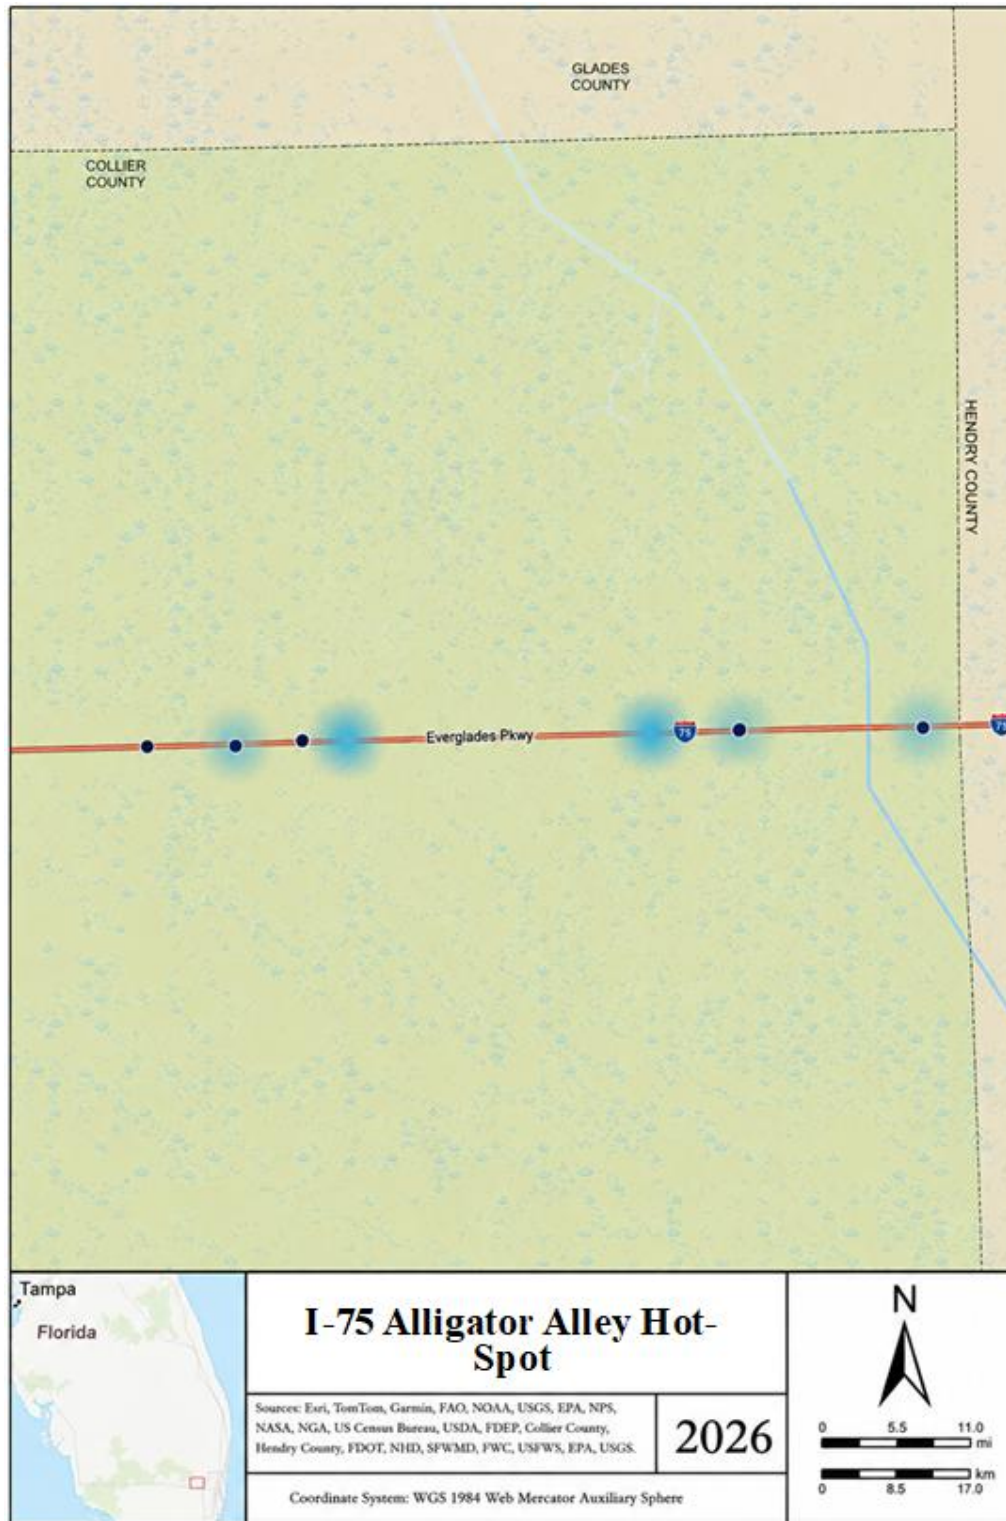
Figure 7-12: Hot-spot location 4 — I-75 Alligator Alley near the Broward-Collier County line

Figure 7-12 shows the mapped location of the confirmed guardrail failures along I-75 Alligator Alley near the Broward-Collier County line. The figure illustrates that the failures occurred within the same general rural freeway corridor, but not necessarily at a single guardrail installation. This spatial pattern supports treating the location as a

corridor-level area of concern, particularly because the segment includes multiple guardrail sections, more than one guardrail height standard, and both Over and Through failure modes.

Because the failures are distributed along a rural freeway corridor rather than at a ramp or interchange, the repeated failures may be associated with broader corridor conditions
