SUBJECT: Temporary Design Bulletins C00-5 and C01-01 (Post-Tensioning Issues)
Dated September 29, 2000 and February 7, 2001, Respectively

Florida Department of Transportation
District 3

Final Report

This report summarizes inspections, tests, analyses, and repairs of the Mid-Bay Bridge post-tensioning system.

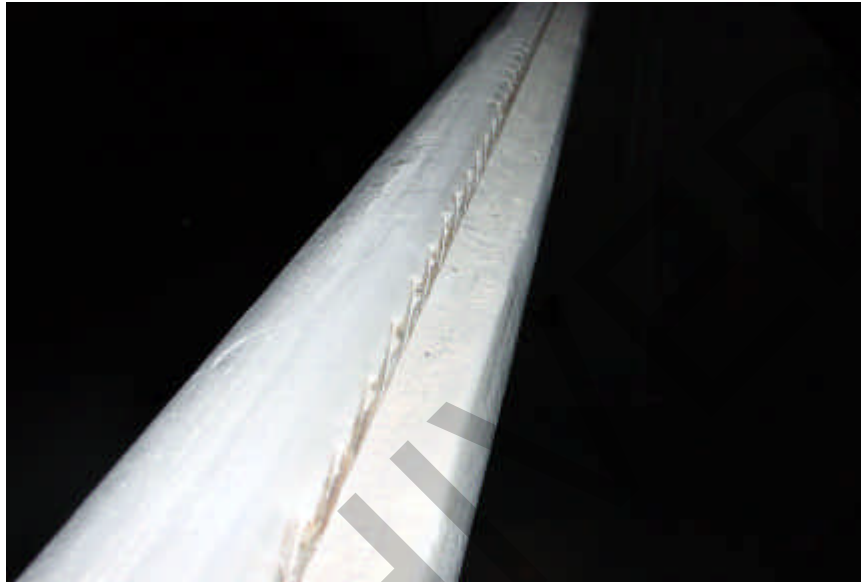
Field notes of the sounding inspections for the Mid-Bay Bridge are found in Appendix A. These results show a consistent presence of voids in the tendons, though no significant distress was found during this inspection. The voids appear to be the result of air entrapped during grouting, expansive gasses produced within the grout, and formation of bleed water trails prior to grout set. Figure 2.1 shows a large void found in Tendon 37-4.

Figure 2.1 – Bleed water trail in Tendon 37-4 found by sounding inspection.

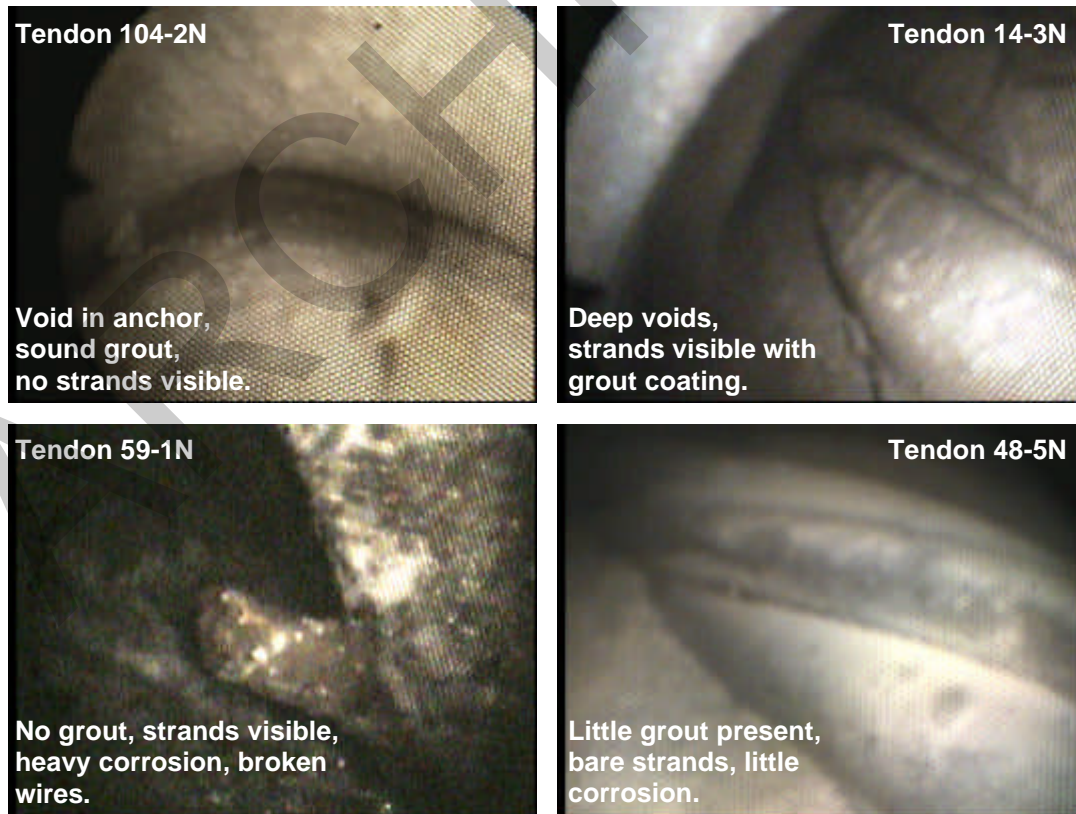
Figure 2.4 shows photographs of borescope inspections of different anchorages in the Mid-Bay Bridge. These photographs show four typical conditions found during inspections of the anchors.

Figure 2.4 – Still photographic results of Borescope Inspections.

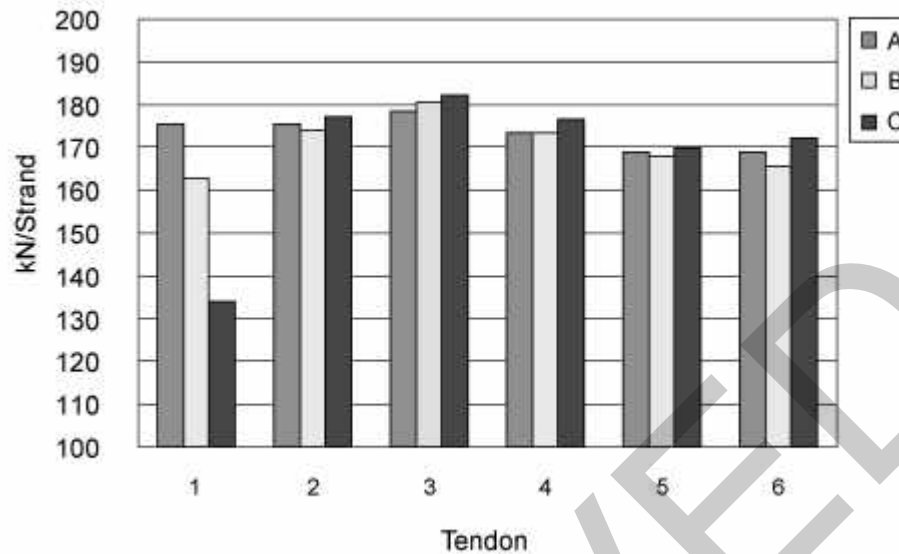
The vibration testing of Tendon 9-1 gave an indication that force had been lost in one portion of the tendon. Figure 2.7 shows the results for all tendons in Span 9. This bar chart shows a drop in the force in Tendon 9-1 between the deviation diaphragm and the expansion joint pier segment. The borescope inspection of this anchor showed heavy corrosion and wire breaks at this end of the tendon.

Figure 2.7 – Vibration results for Span 9

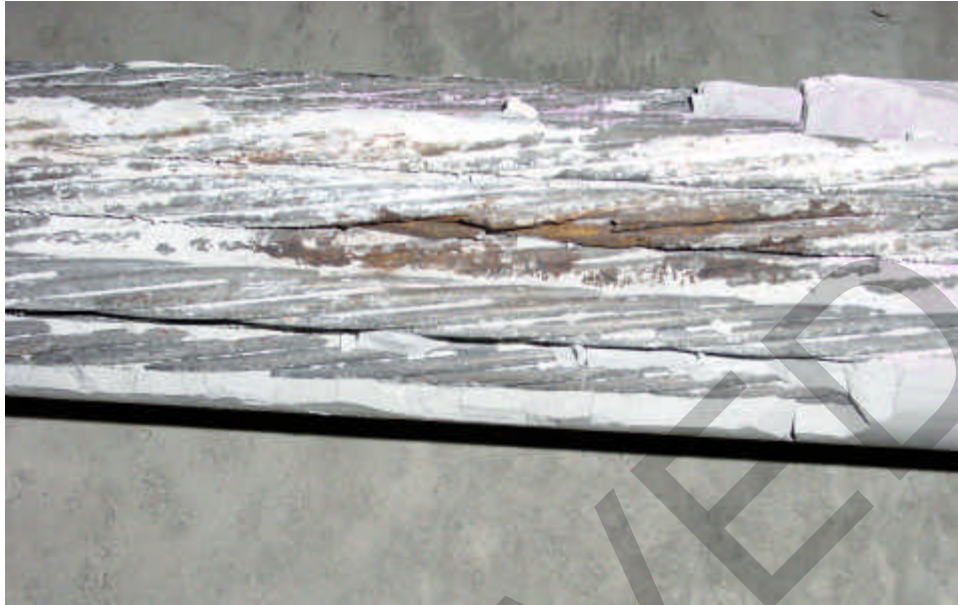
Figure 2.8 shows a stripped portion of Tendon 40-2. The grout in this portion of Tendon 40-2 was very fractured and chalky. Two wires in one of the seven-wire strands were broken. Two other wires in the same strand broke as additional grout was removed from the section. This portion of the tendon was marked for future patching and wrapping. Results of the Visual Tendon Inspections are provided in Appendix E of this Report.

Figure 2.8 – Visual Inspection of Tendon 40-2 with corrosion in the free length of tendon.

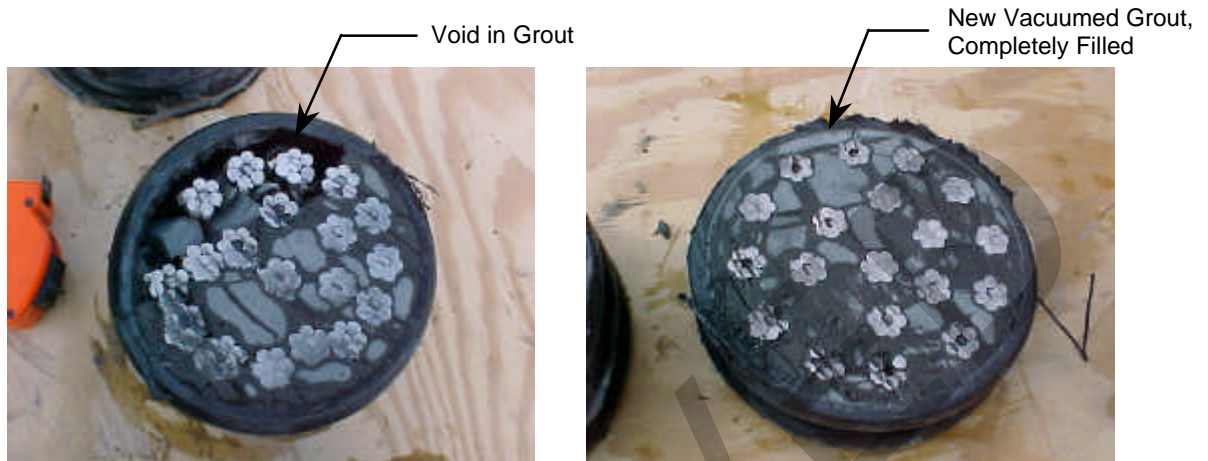
injected under a positive pressure still had large voids, as shown at the left in Figure 2.12. Voids were not present in the tendons injected by vacuum and there was a consistent flow of the grout into the voids and small annular spaces between the primary grout and duct (note the extent of the lighter colored grout at the top of Figure 2.12 on the right).

Figure 2.12 – Mock-up tests segments: pressure injection (left) and vacuum Injection (right).

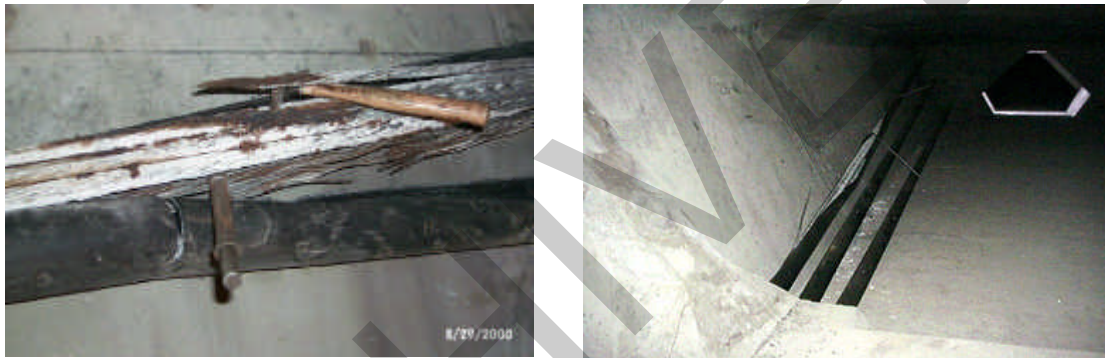
Tendon 28–6 was discovered partially failed on August 28, 2000 during a regularly scheduled FDOT annual inspection of the Mid-Bay Bridge. The inspectors found the duct at this location to be significantly cracked and bulging. Figure 3.1 shows the corrosion of Tendon 28-6 after the duct had been cut away in the free length of the tendon between a deviation diaphragm and expansion joint pier segment diaphragm. The extensive damage to the duct did not permit the evaluation of whether defects in the duct prior to strand failure may have led localized corrosion of the tendon.

Figure 3.1 – Tendon 28-6

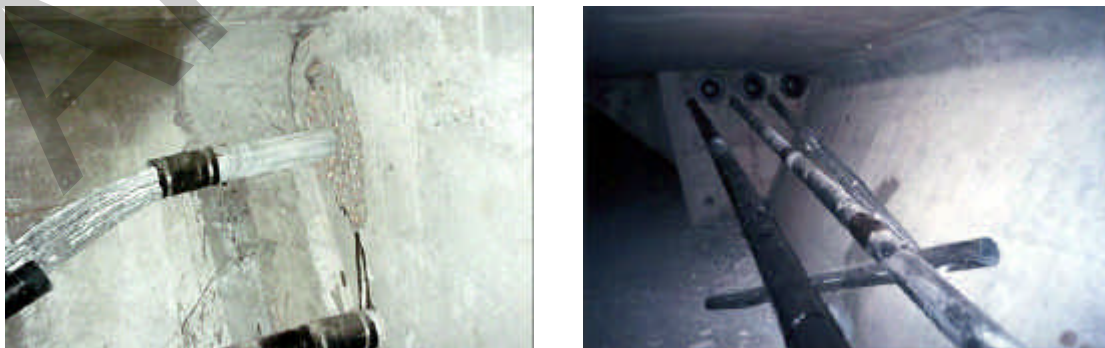
An immediate “walk-through” inspection of the Mid-Bay Bridge was conducted after finding the damage to Tendon 28-6. This inspection found that Tendon 57-1 had completely failed. This was evidenced by the complete pull out of the tendon and embedded steel duct from the expansion joint diaphragm. The failure of Tendon 57-1 is shown in Figure 3.2.

Figure 3.2 – Tendon 57-1: failure at Expansion Joint Diaphragm (left),
View towards Pier Segment Diaphragm (right)

The corrosion of the prestressing steel in the anchor of Tendon 57-1 produced a loss in cross sectional area, which led to strand failures. The force from these failed strands was then restrained through bond with the steel duct through grout that was present in the duct. Load in the steel pipe was transferred to the surrounding concrete. Forces in the remaining unbroken strands were carried back to the anchor plate. Eventually the corrosion and breaking of additional strands was sufficient to exceed any resistance provided by the remaining prestressing strands causing all the load to be transferred to the steel duct/concrete interface. Bond between the rigid duct and the diaphragm concrete then failed allowing the tendon to slip into the span.

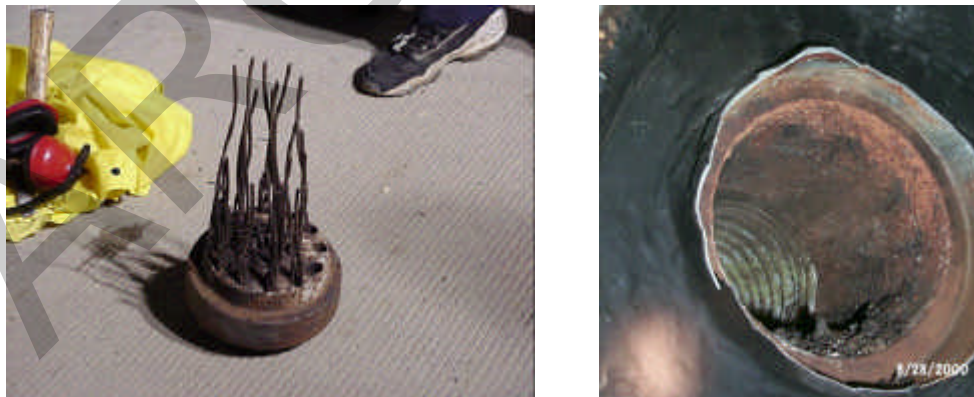
Figure 3.3 shows two other photographs related to the failure of Tendon 57-1. The photograph on the left shows the anchor plate after removal from the anchorage. The majority of the strands are still held in the anchor plate by the wedges. The extent of the corrosion and the nature of the corrosion-induced breaks are evident. The photograph on the right of Figure 3.3 shows the extent of the corrosion inside of the multi-plane anchor casting. This photograph also gives evidence that the water contributing to corrosion was sealed in place in the anchor during construction. The protective epoxy coating and black mastic seal was completely intact at the time of the discovery of the failed tendon. The light gray circumferential break, shown completely around the anchor, is the epoxy layer of the anchor protective coating.

Figure 3.3 – Anchor plate and anchor of Tendon 57-1

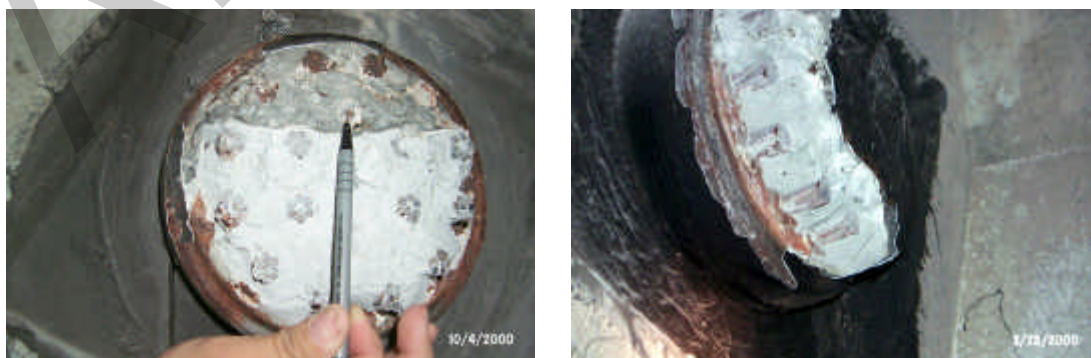
Figure 3.4 shows two examples of dark gray secondary grout in anchors of the Mid-Bay Bridge. The photograph on the left shows the dark gray grout used as a pour-back to fill the cap during construction, leaving in place a partially voided trumpet. The light colored grout in this photograph comes through the grout bleed hole into the cap during grouting. Caps with subsidence or partial fill were consistently found to be indicative of a partially filled trumpet. The photograph on the right shows the dark gray grout throughout the anchor.

Figure 3.4 – Secondary Grout in Anchor Caps
