SUBJECT: Temporary Design Bulletin DB-C01-1 and Commentary

Draft Report

This report summarizes inspections, tests, analyses, and repairs of the Mid-Bay Bridge post-tensioning system

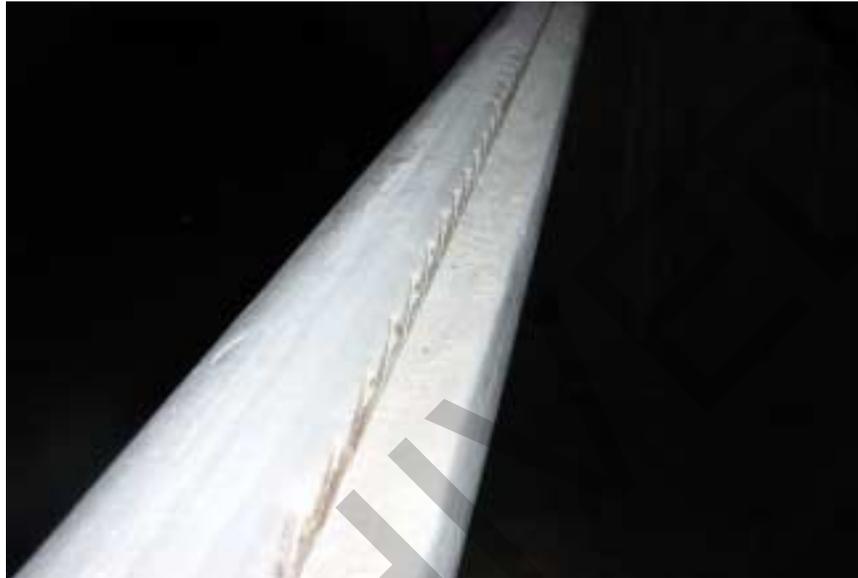
Examination of the two failed tendons, one in Span 28 and one in Span 57 revealed that the condition of the grout for these tendons was suspect. Air cavities, bleed water trails and soft, chalky grout characteristics were observed. Significant voids in grout or a highly porous grout can reduce the corrosion protective capabilities of this system. For this reason, a program of sounding the tendons for voids was initiated. In this procedure, an inspector walks the length of each tendon tapping lightly with a small tack hammer, listening for changes in the resulting sound. Locations of variations in sound that would imply a void are recorded. Locations where significant variations in sound are found are then evaluated for the need of a visual inspection. Visual inspection includes removing a portion of the polyethylene duct and visually inspecting the prestressing strands and surrounding grout.

Figure 2.1 – Bleed water trail found by sounding inspection.

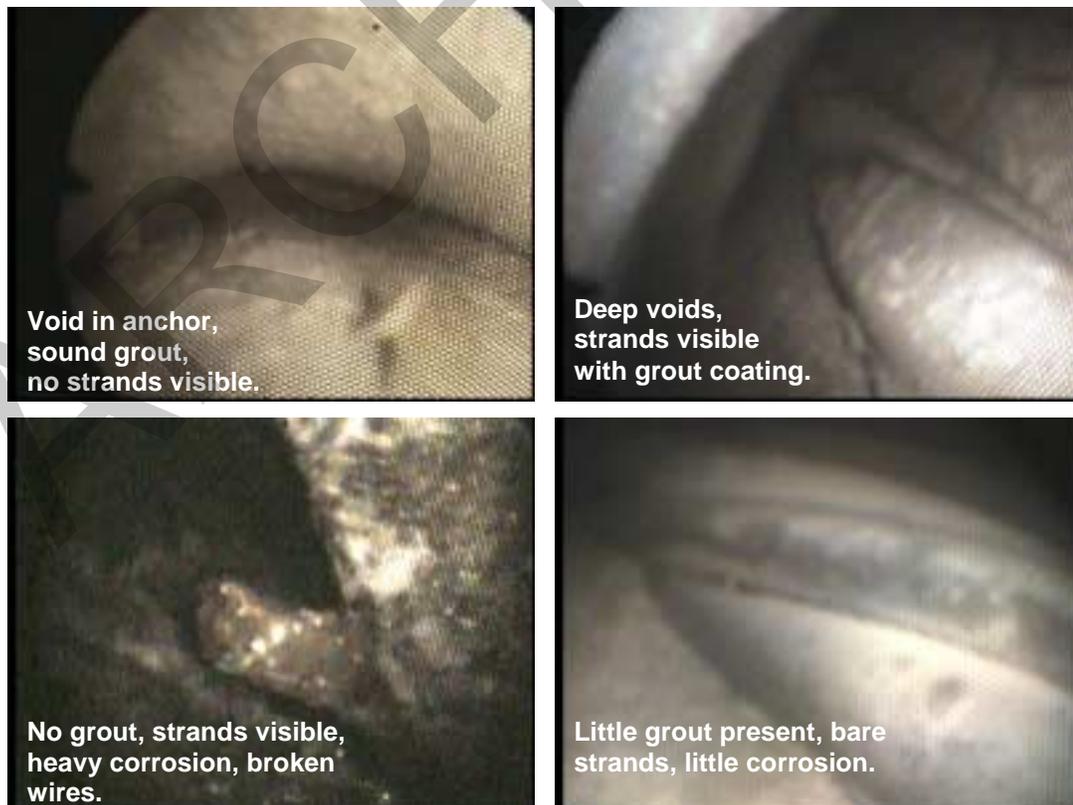
Figure 2.4 – Still photographic captures from Bore Scoping Inspections.

Figure 2.4 shows four photographic still captures of bore scope inspections of different anchorages. These photographs show four typical conditions that were found in the anchor heads of the Mid-Bay Bridge. Clockwise from the upper left, the anchor conditions are:

- Tendon 104-2, North Anchor: Small void, no strands exposed.
- Tendon 14-3, North Anchor: Large void, strands visible with thin grout coating (moon dust)
- Tendon 59-1, North Anchor: Large void, strands visible with little corrosion
- Tendon 48-5, North Anchor: No grout, heavy corrosion, broken wires

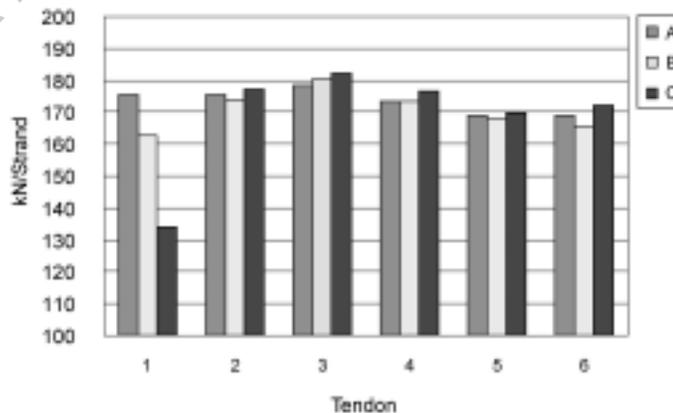
Figure 2.7 – Vibration results for Span 9

The vibration testing of Tendon 9-1 gave an indication that force had been lost in one portion of the tendon. Figure 2.7 shows the results for all tendons in Span 9. This bar chart shows a drop in the force in Tendon 9-1 between the deviation diaphragm and the expansion joint pier segment. Bore scope review of this anchor gave indications of heavy corrosion and wire breaks at this end of the tendon.

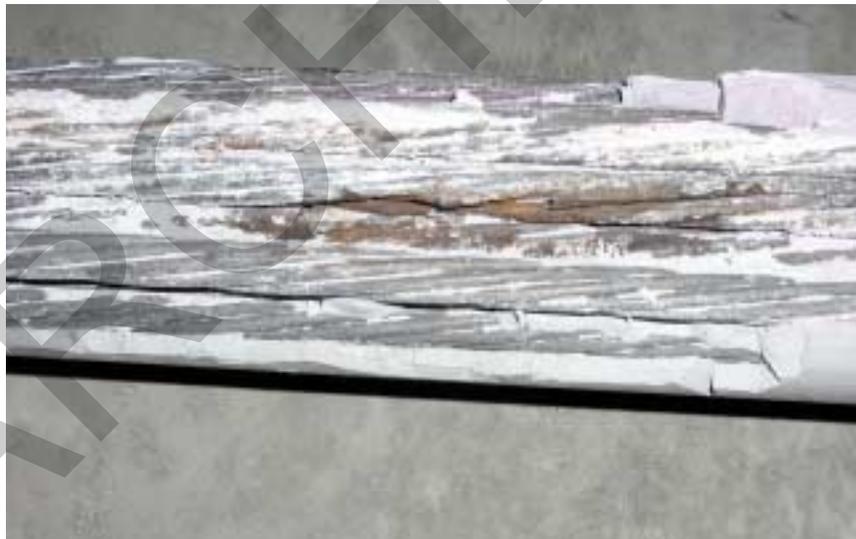
Several visual inspections were made of areas in the free length of the post-tensioning tendons of the Mid-Bay Bridge. These inspections were performed by stripping portions of the polyethylene duct in the vicinity of an area believed to be experiencing corrosion. These areas were located during the sounding inspections, mag-flux inspection or as an observation during the initial walk-through inspection of an obvious defect in a duct. Several of these locations were found to be locations where corrosion had taken place or was ongoing. Figure 2.8 shows a stripped portion of Tendon 40-2. When this area was first stripped the grout was found to be very fractured and chalky to the touch. Two wires in one of the seven-wire strands were broken. Two other wires in the same strand broke as additional grout was removed from the section. The portion of the tendon was marked for future patching and wrapping. Further implications of this type of duct defect are discussed in Chapter 3, Section 3.6 and Chapter 4, Section 4.3.

Figure 2.8 – Tendon 40-2, corrosion in the free length of tendon.

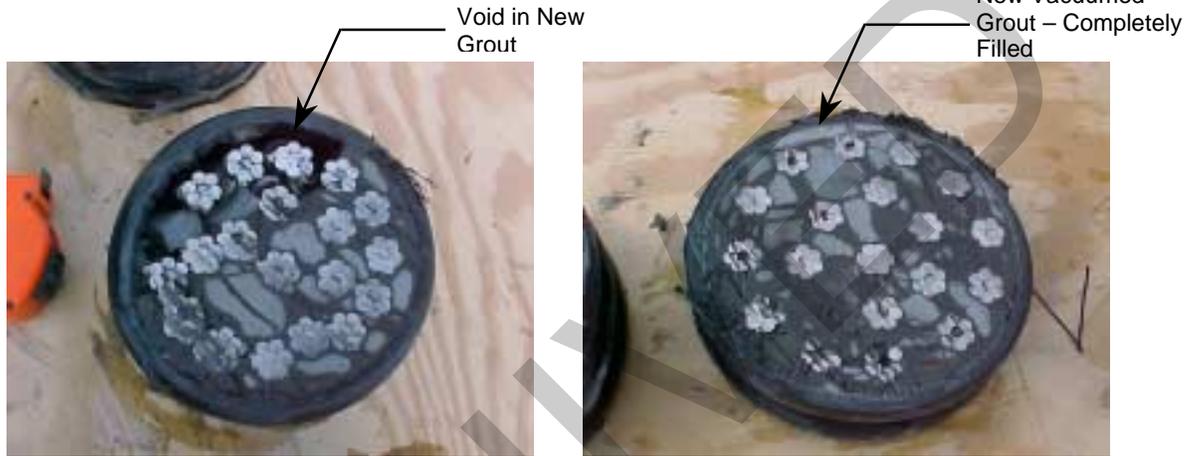
Figure 2.12 – Mock-up tests segments: pressure injection (left) and vacuum Injection (right).

Following the injection and hardening of the grout, the test specimens were cut into sections along the length of the tendon. These sections were reviewed to determine the efficiency of the two grout injection methods. Figure 2.12 shows a section of specimen injected under positive pressure on the left, and a section of a specimen injected under a vacuum on the right. The results of the tests indicated that the vacuum injection method better filled the voids in the mock-up samples. The specimens injected under a positive pressure were found to have voids, as shown at the left in Figure 2.12, or to have clearly defined interfaces between the new and old grout. Voids were not present in the tendons injected under a vacuum and there was a consistent flow of the grout into the voids and around the annular spaces inside the duct (note the extent of the lighter colored grout at the top of Figure 2.12 on the right).

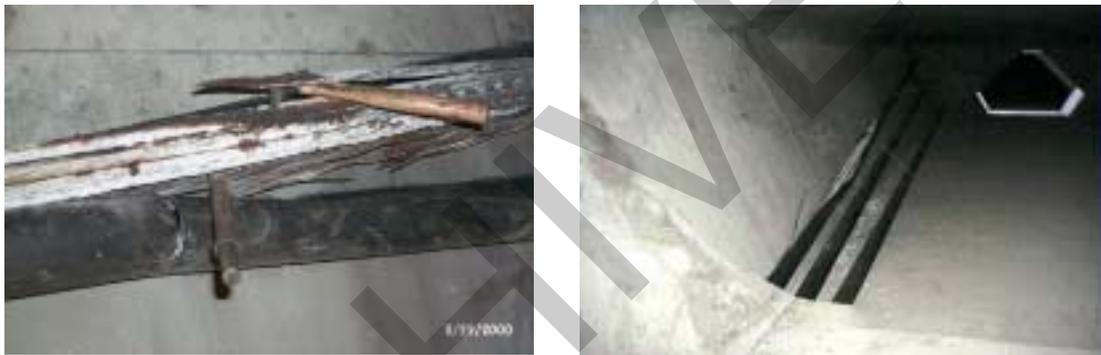
Figure 3.1 – Tendon 28-6

The first tendon, Tendon 28-6, was discovered partially failed on August 28, 2000 during a regularly scheduled FDOT annual inspection of the Mid-Bay Bridge (one of two inspections the bridge receives each year). The inspectors found the duct at this location to be significantly cracked and bulging. Figure 3.1 shows that the corrosion of Tendon 28-6 in the free length of the tendon between a deviation diaphragm and expansion joint pier segment diaphragm after the duct had been cut away. Damage to the duct after strand failure did not permit the evaluation of whether damage to the duct prior to strand failure led to the localized corrosion of the tendon.

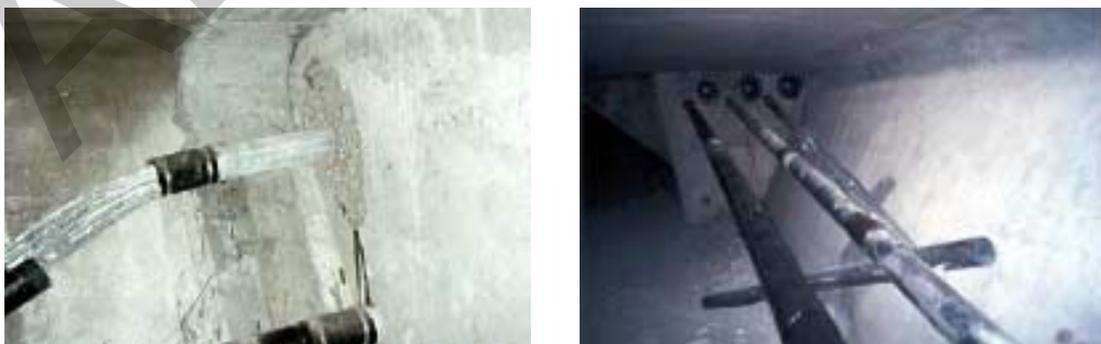
Figure 3.2 – Tendon 57-1

An immediate walk-through inspection of the Mid-Bay Bridge was conducted after finding the damage to Tendon 28-6. This inspection found that Tendon 57-1 had completely failed. This was evidenced by the complete pull out of the tendon and embedded steel duct from the expansion joint diaphragm. The failure of Tendon 57-1 is shown in Figure 3.2.

The corrosion of the prestressing steel in the anchor produced a loss in cross sectional area that caused strands to fail. The force from these failed strands was then restrained through the bond with the steel duct and the unbroken strands through the grout that was present in the duct. The load in the steel pipe was transferred to the surrounding concrete and the force in the remaining intact strands was carried back to the anchor head. The rigidity of the diaphragm concrete versus the remaining strands would force the majority of the load into the steel pipe and surrounding concrete. Eventually the corrosion and breaking of the strands was sufficient to exceed any resistance provided by the few remaining prestressing strands and all the load was transferred to the steel duct/concrete interface. This bond between the rigid duct and the diaphragm concrete then failed allowing the tendon to slip into the span.

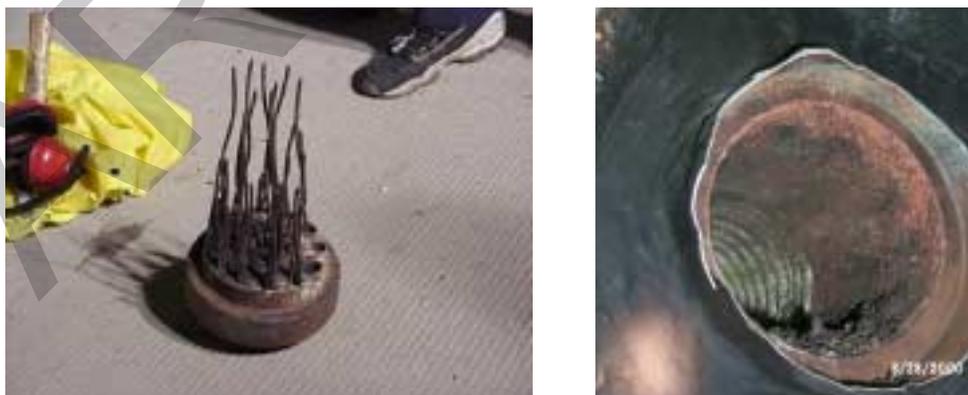
Figure 3.3 – Anchor Head and Anchor of Tendon 57-1

Figure 3.3 shows two other photographs of the failed Tendon 57-1. The photograph on the left shows the anchor head after removal from the anchorage. The majority of the strands are still held in the anchor head by the wedges. The extent of the corrosion and the nature of the corrosion-induced breaks are evident. The photograph on the right of Figure 3.3 shows the extent of the corrosion inside of the multi-plane anchor casting. This photograph also gives evidence that the water contributing to corrosion was locked in place in the anchor during construction. The protective epoxy coating and black mastic seal was completely intact at the time of the discovery of the failed tendon. The light gray circumferential break, shown completely around the anchor, is the epoxy layer of the anchor protective coating.

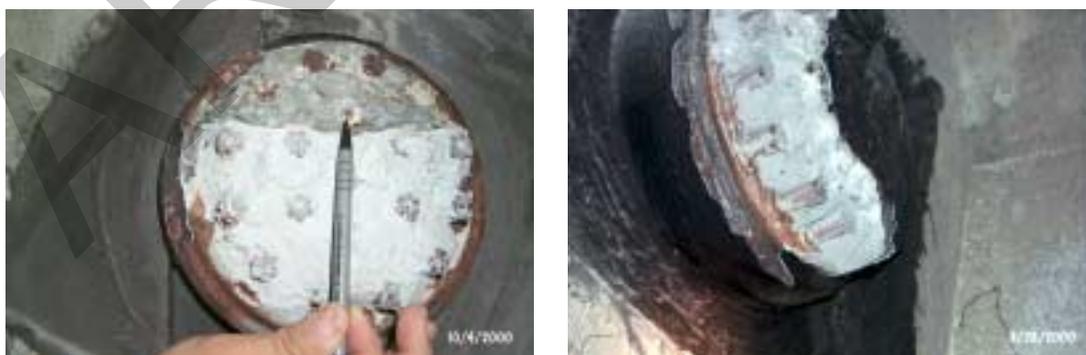
Figure 3.4 – Dark Gray Grout

Figure 3.4 shows two views of dark gray grout at anchors of the Mid-Bay Bridge. The photograph on the left shows the dark gray grout used as a pour-back to fill the cap during construction, leaving a partially voided trumpet. The light colored grout in this photograph comes through the grout bleed hole into the cap during grouting. Caps with subsidence or partial fill were consistently found to be indicative of a partially filled trumpet. The photograph on the right shows the dark gray grout throughout the anchor.

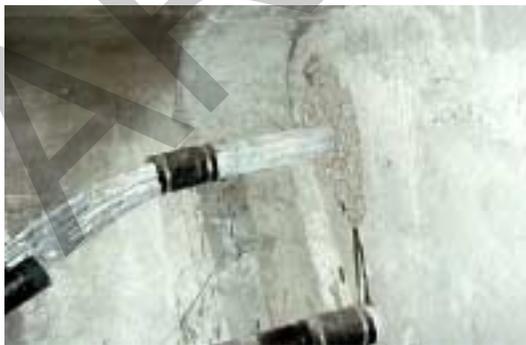
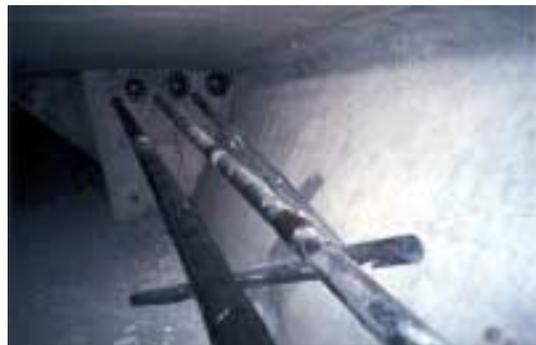
4.2.2 Span 57 - Tendon 1

Like Tendon 28-6, this tendon was one of the post-tensioning tendons that had failed and was discovered during the annual inspection. A description of this tendon is found in Section 1 of Chapter 3. The tendon had already been replaced when the bore scope inspections were started.
