Inspection and Monitoring of Fabrication and Construction for the West Halls River Road Bridge Replacement

Contract Number BDV30-706-01

TASK 1 Deliverable: End of Construction Report
(Part A – Fabrication and Construction)

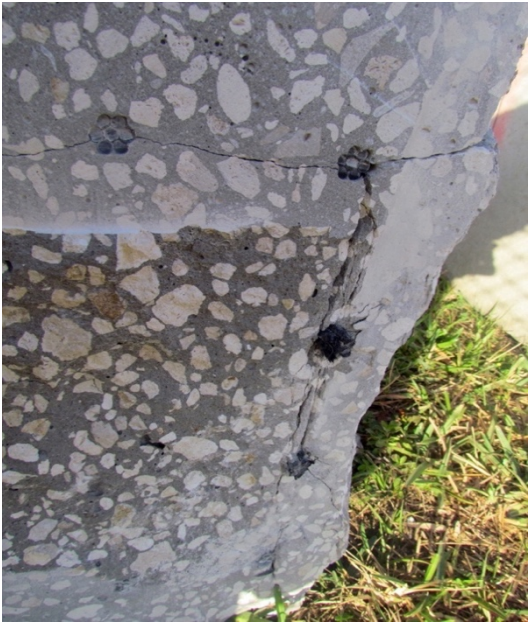
Extensive cracking between the CFCC strands was observed on the cutoff faces of piles R1 (bent 5 pile 1), R13 (bent 5 pile 2), and R2 (bent 4 pile 2). On pile R13, cracks were present between the strands on two sides of the pile end and tearing of the CFCC strand was visible, as shown in **Figure 7**. A longitudinal crack, approximately 2 ft in length, extended from the cutoff end. The majority of the CFCC strands on the cutoff face of pile R13 were recessed, as shown in **Figure 8**. Pile R1 had cracking between the CFCC strands on one side of the pile end, and all strands were recessed (**Figure 9**). The pile also had a longitudinal crack approximately 1.5 ft from the cutoff

Figure 7: Cracking on Pile R13 cutoff

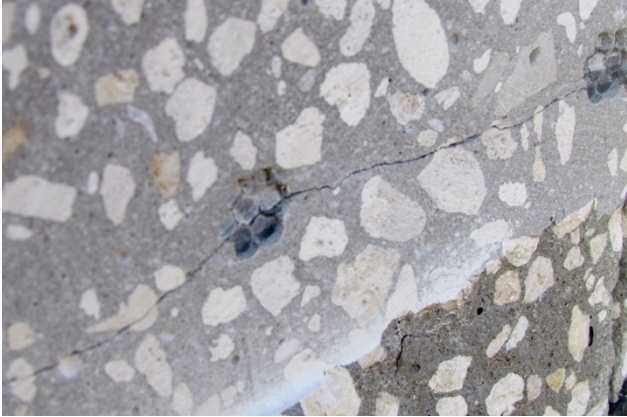
Figure 8: Pile R13 cutoff recessing of strands

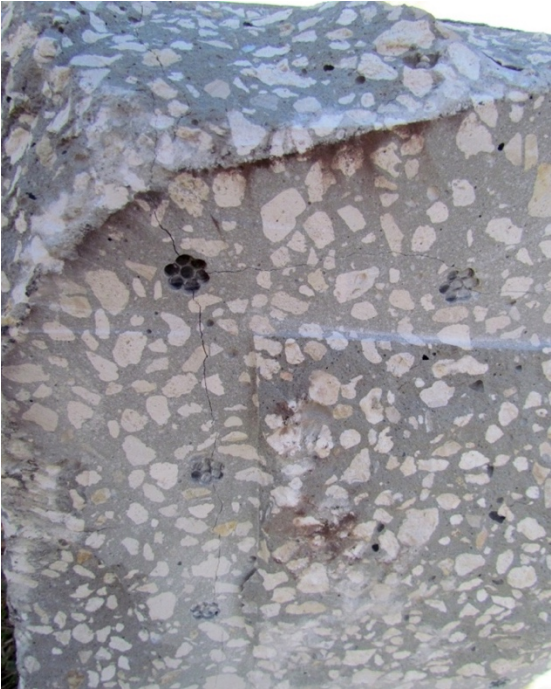
Figure 9: Pile R1 cutoff cracking between strands

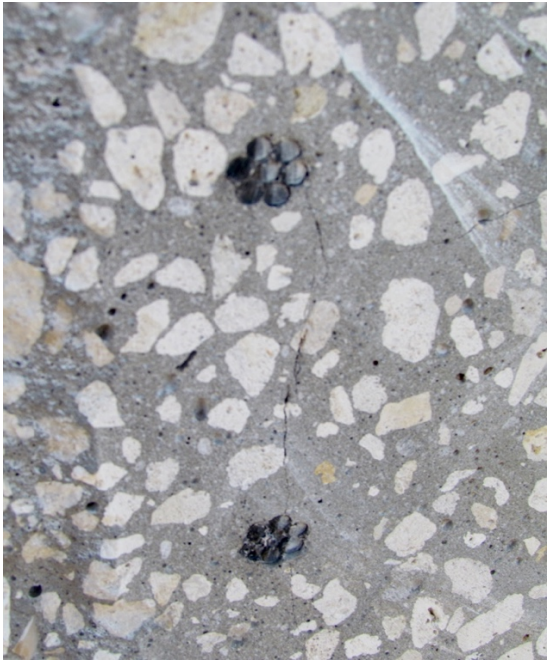
end. Pile R2 had slight cracking between CFCC strands on one side of the pile end, as shown in **Figure 10**.

Figure 10: Pile R2 cutoff cracking between strands

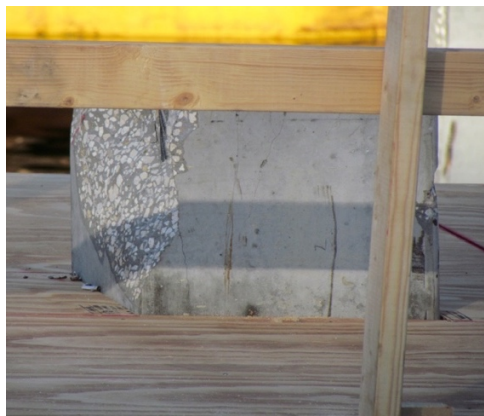
During the cutoff of piles 1, 2, and 3 at bent 5, the pile heads were damaged; spalling of pile 2 at bent 5 is shown in **Figure 11**. In all three piles, the spall lengths did not extend beyond the area that will be covered by the pile cap, and therefore, Astaldi proposed to remove loose material from the pile heads and pour the pile cap as planned. Excessive cracking was noted on pile 2 at bent 5 after pile cutoff procedures occurred. A 23.25-in. crack was present on the west face of the pile and a 28.0-in. crack on the east face. The crack also extended through the CFCC strands on the top of the pile. The cracks were 0.011 in. wide at the top of the pile and decreased to 0.001 in. wide at the end of the crack.

Figure 11: Spalling of Pile 2 Bent 5

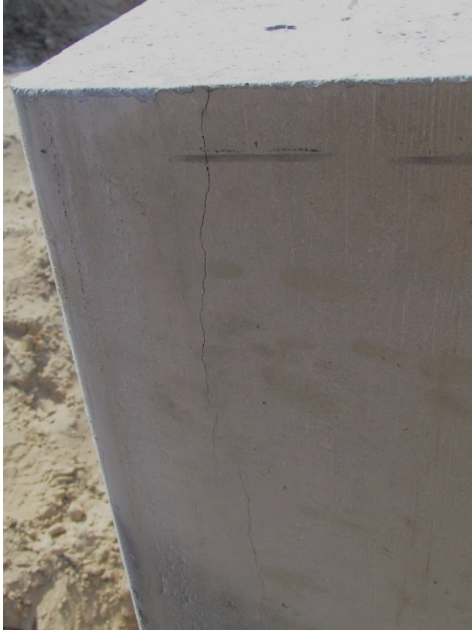
After pile cutoff on bent 6, cracking was evident on pile 1. A crack extended from the north face of the pile, through the CFCC strands, and continued down the south face of the pile. Recessing of the CFCC strands was also evident on piles 1 and 3 at bent 6. **Figures 12** and **13** show the pile cracking and the recessing of the strands on pile 1 at bent 6.

Figure 12: Cracking of Pile 1 at Bent 6

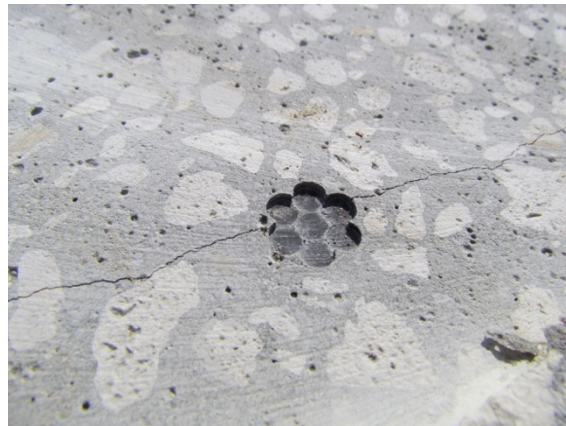
Figure 13: Recessing of CFCC strand
at Pile 1 Bent 6

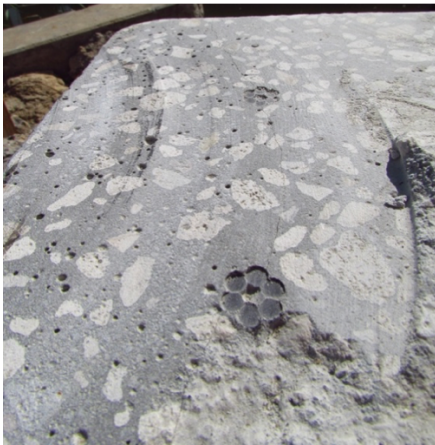
Bent 1 pile 2 exhibited cracking between the CFCC strands from the west to the east on the northern row of strands, and a few of the strands recessed slightly. The north-western edge of the pile spalled, and one of the CFCC strands tore, as shown in **Figures 16-18**. In bent 1 pile 3, one strand recessed slightly, as shown in **Figure 19**.

Figure 16: Spalling of Bent 1 Pile 2

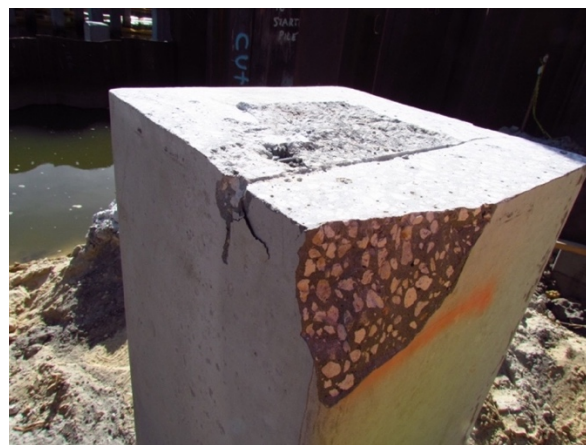
Figure 17: Cracking between CFCC (Bent 1 Pile 2)

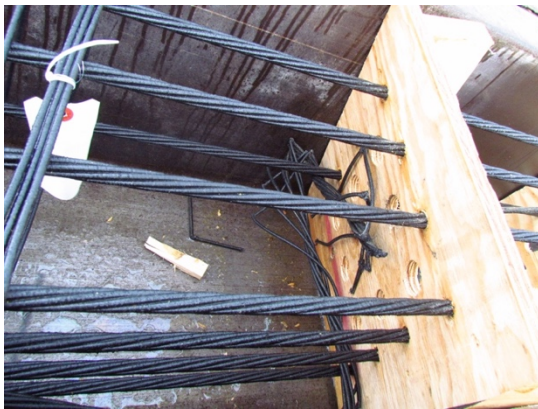
Figure 32: Broken CFCC strand

Workers removed the broken CFCC strand, cut the coupler off each end, pulled a new CFCC strand, and installed the couplers on the new strand. After stressing strand No. 11 again, the strands were left to sit overnight, to ensure strand stability.

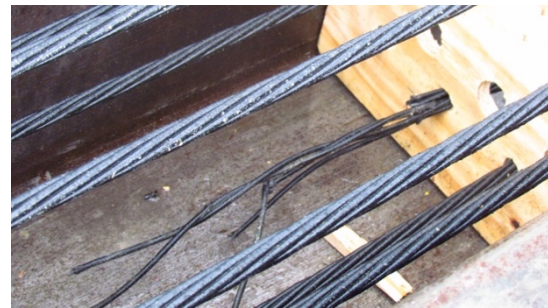
Figure 33: Broken CFCC strand

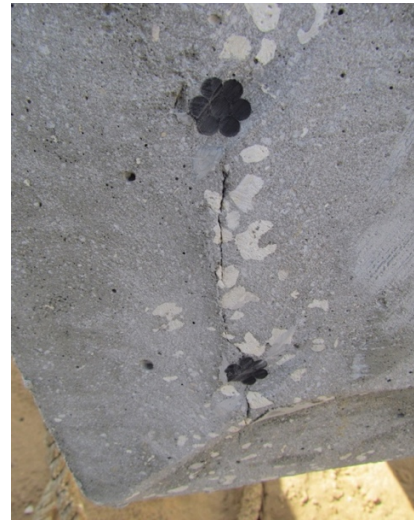
Figure 58: Cracks on piles for Bent 6

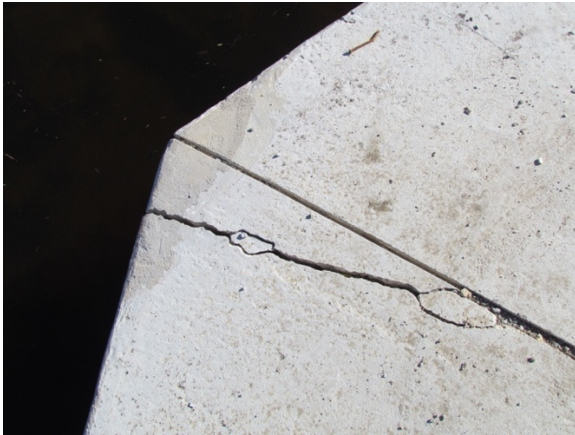
During placement of the rubble rip rap, cracks on the sheet pile wall corners expanded. Crack widths on walls 2A-3A were in excess of ½ in. and extended the entire length of the pile cap, while the cracks on walls 2B-3B were approximately ¼ in. wide and also extended the length of the pile cap. The cracks on the top and face of walls 2B-3B are shown in **Figures 84, 85, and 86**. On walls 2A-3A, A2B Engineering LLC proposed to cut away the cracked pile cap (**Figure 87**), roughen the concrete surface, apply an APL approved epoxy, and form and pour the pile caps using the original concrete mix design. The proposed repair procedure for walls 2B-3B included injecting an FDOT approved epoxy into the cracks and restoring the control joint with a ¾ in. saw cut.

Figure 84: Crack on top of seawall 2B-3B

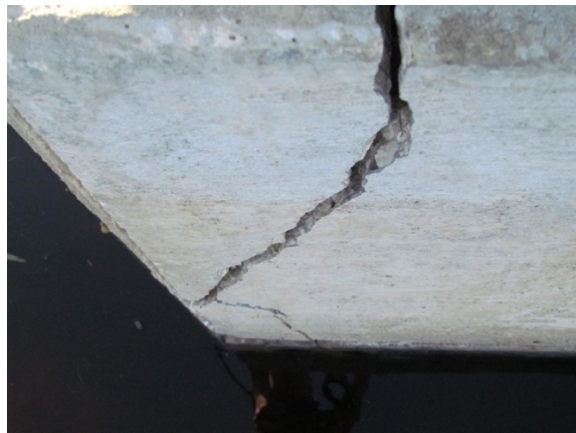
Figure 85: Crack on face of seawall 2B-3B

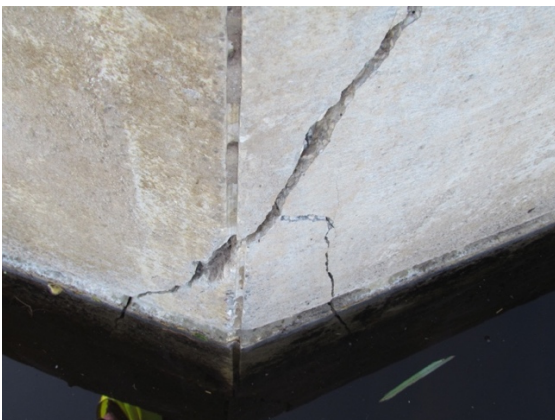
Figure 86: Cut out crack on walls 2A-3A

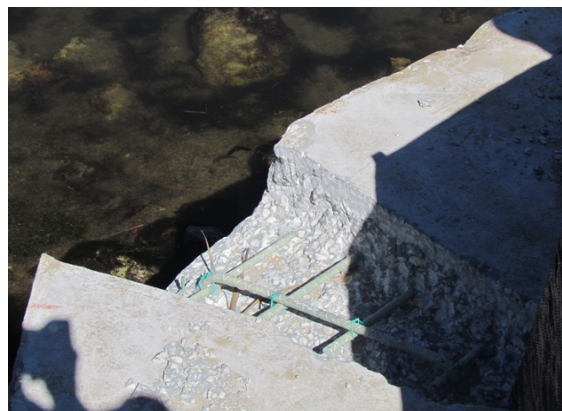
Figure 87: Crack on face of seawall 2B-3B

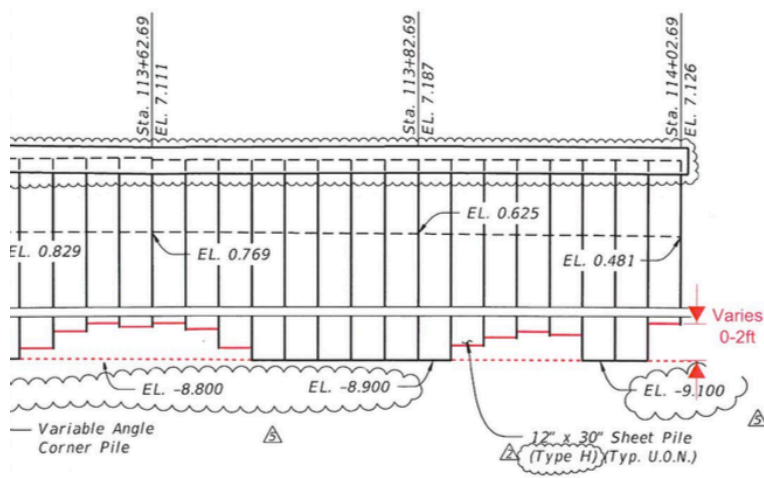
Sheet pile wall 8B is composed of twenty-one (21) sheet piles, of which twelve (12) of them did not meet minimum tip elevation, as shown in **Figure 91**. A2B Engineering LLC performed an independent analysis using Support IT to determine the sufficiency of the sheet pile walls. The analysis yielded an increased tie-back force from 1.523 kips/ft to 2.013 kips/ft. To account for the increase in tie-back force it was proposed to add additional deadmen anchors (with one stainless steel bar) every 5 ft where the sheet piles did not meet minimum tip elevation, as shown in **Figure 92**.

Figure 91: Wall 8B elevation

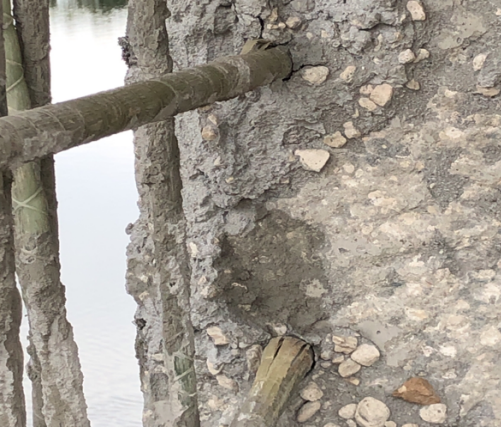
Figure 108: Damaged 8A1 GFRP bar

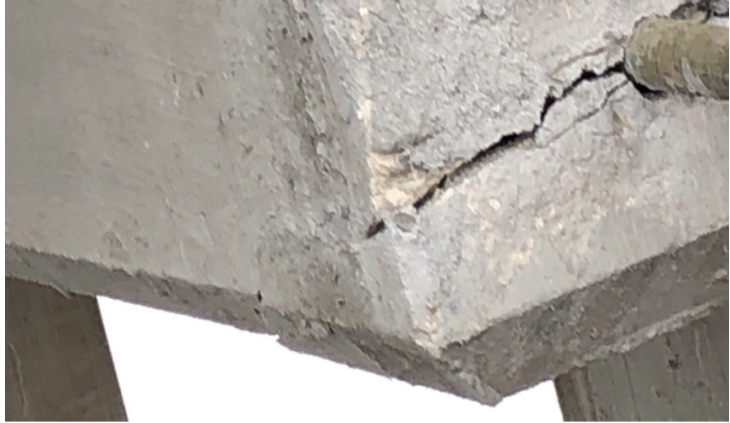
Figure 109: Crack along bottom row of GFRP bars

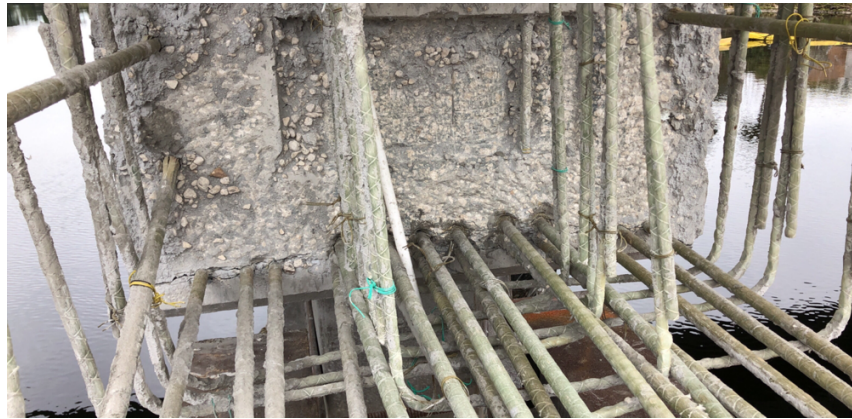
On the week of Jan 7th, 2019, the bottom form for bent four (4) pier cap collapsed resulting in a load and a half of concrete falling into Halls River. The first load of concrete was in the form for over an hour before the second load caused the failure. Damaged occurred to 8A1 GFRP bars located approximately 1 ft from the bottom of the pile cap, shown in **Figures 108-110**. Additional cracking occurred in the bottom 6 in. of the cap and spanned the entire width of the pier cap, as shown in **Figure 109**. To repair the damage to the GFRP bars, holes were drilled to install additional #8 bars 4 ft 6 in. in length next to the damaged 8A1 bars. The bars have an embedment length of 2 ft 1 in. and maintain a minimum spacing of 1 in. from the existing 8A1 bars. The #8 bars were lapped by the 8A2 bars in the construction joint. Additionally, ¼ in. stainless Tapcon screw anchors with an embedment length of 2.1 in. were installed across the repair area. The screws were installed 6 in. on center with a ½-in. concrete cover. An epoxy bonding agent was also applied to the affected area before the concrete pour.

Figure 110: Damaged Pier Cap 4

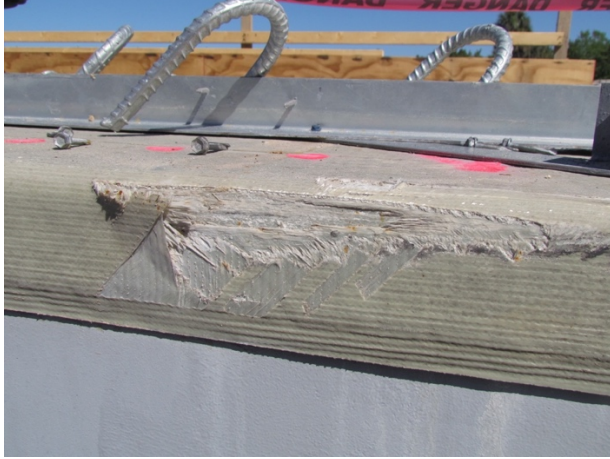
Figure 158: Damaged HCB lid
