Inspection and Monitoring of Fabrication and Construction for the West Halls River Road Bridge Replacement

Contract Number BDV30-706-01
FSU Project ID 038971

**TASK 2 Deliverable: Six-Month Report
(Part A – Visual inspection of bridge)**

Draft 1 Submitted June 14, 2020

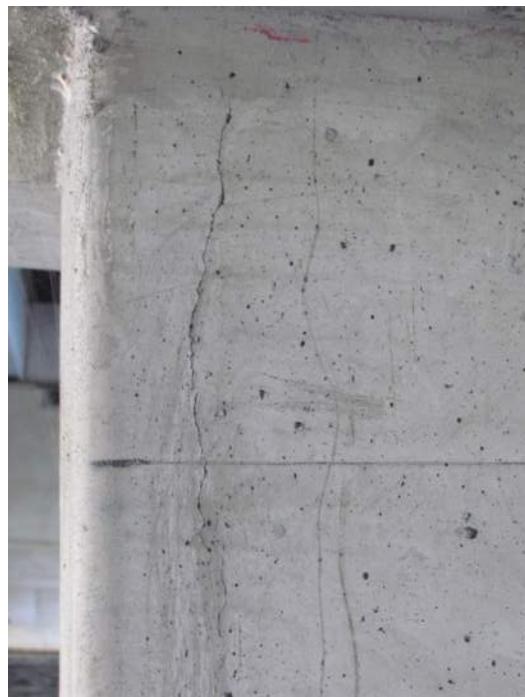
Minor cracking was observed on a few prestressed carbon fiber composite cable (CFCC) piles (**Figure 2**). Overall, the piles appeared to be in good condition with no signs of distress.

Figure 2: Crack on CFCC pile

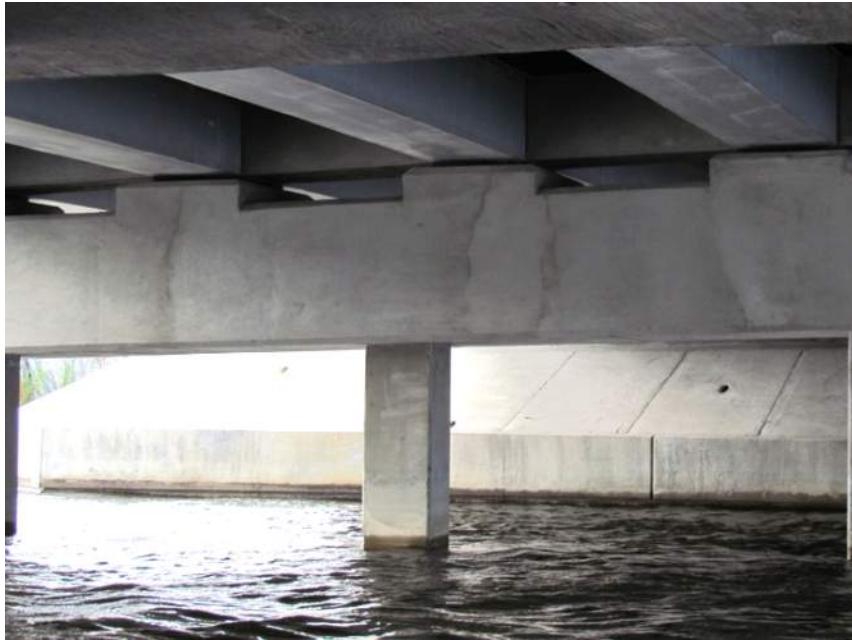
The bent caps exhibited minor cracks and staining from drainage at the beam locations (**Figure 3**).

Figure 3: Staining from water drainage

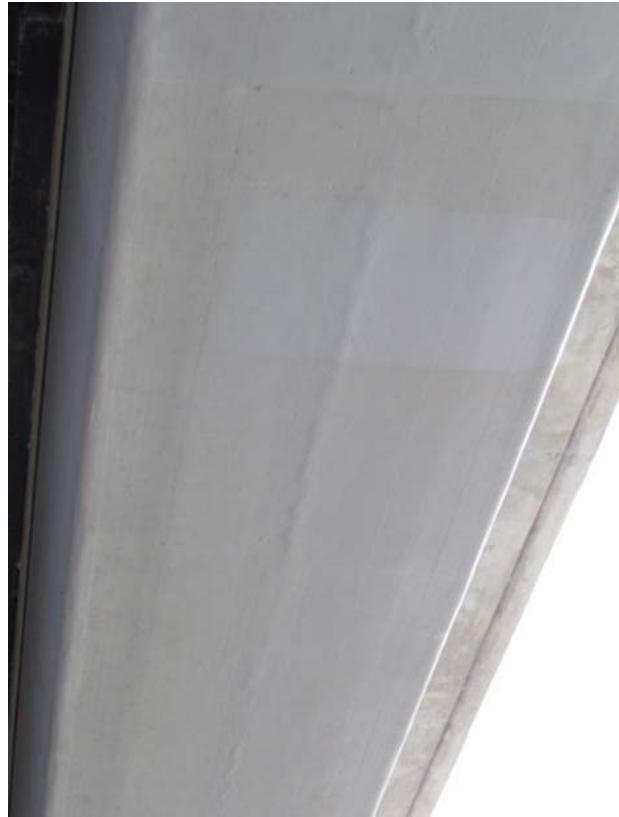
The bearing pads did not display any excessive lateral deformation. The hybrid composite beams (HCBs) exhibited no apparent damage or cracking on the fiberglass shell and no flaking of the gel coat. A handful of the beams had ripples on the bottom of the fiberglass shell ([Figure 4](#)), and most of the beams had areas where the gel coat was a different color or patched ([Figure 5](#)).

Figure 4: Ripples on underside of HCB

In both the three- and six-month inspections, there were no signs of distress visible to the naked eye. No noticeable deterioration was noticed between the two inspections. Particular areas of interest were the ripples on the bottom of the fiberglass shell ([Figure 4](#)) and the gel coat patched areas ([Figure 5](#)) that were noticed at the 3-month visit; those areas had not visibly changed at the 6-month visit.

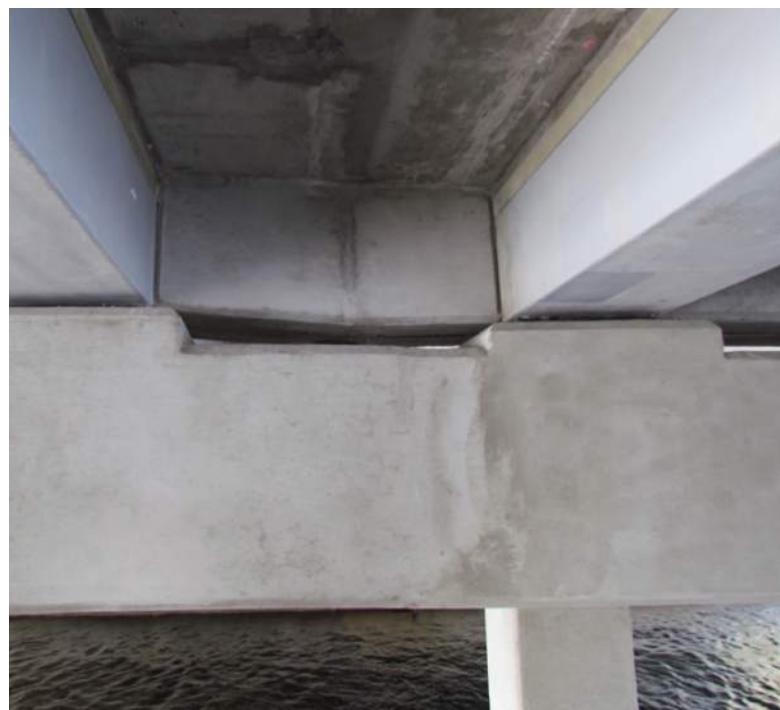
Figure 5: Gel coat patch on HCB

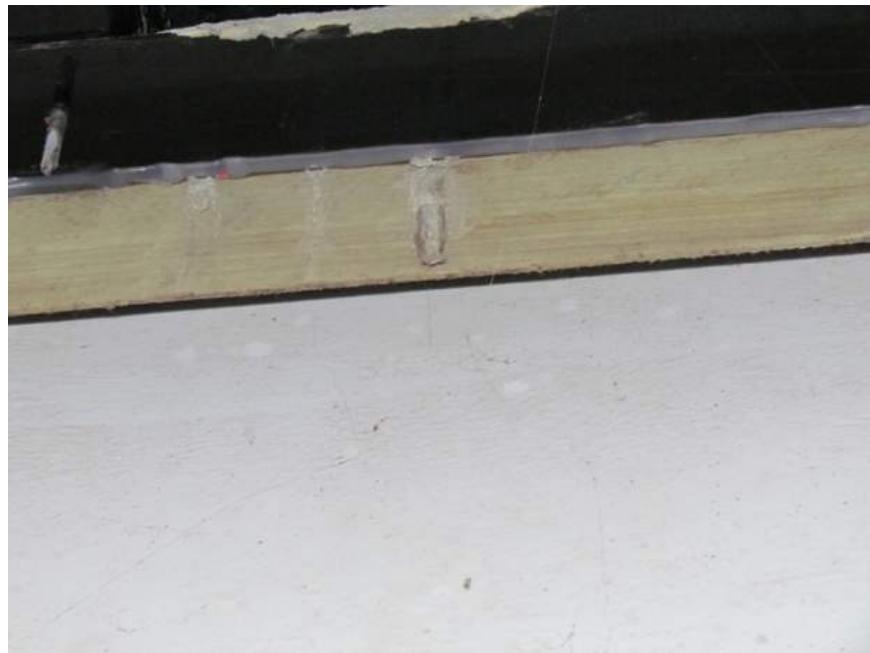
The hybrid composite beam lid did not have a gel coat applied during fabrication, and there was a noticeable gap between the lid and the vertical web of the beam ([Figure 6](#)). The lid edge appeared to be in adequate condition, though, with no deterioration or bucking. The lid of beam 5-2, which was patched during construction, does not appear to have changed ([Figure 7](#)).

Figure 6: HCB lid separation

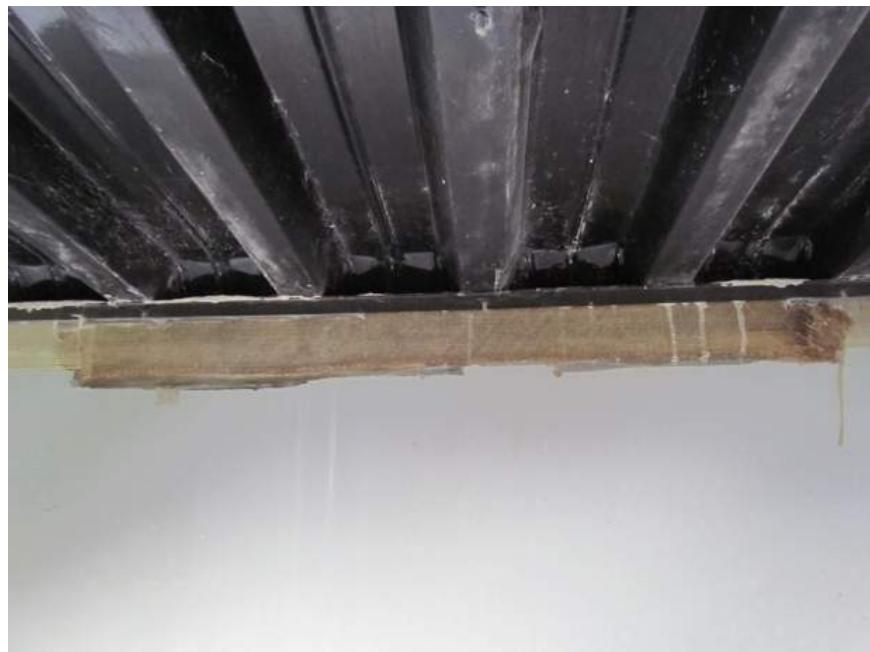
Figure 7: Beam 5-2 patch

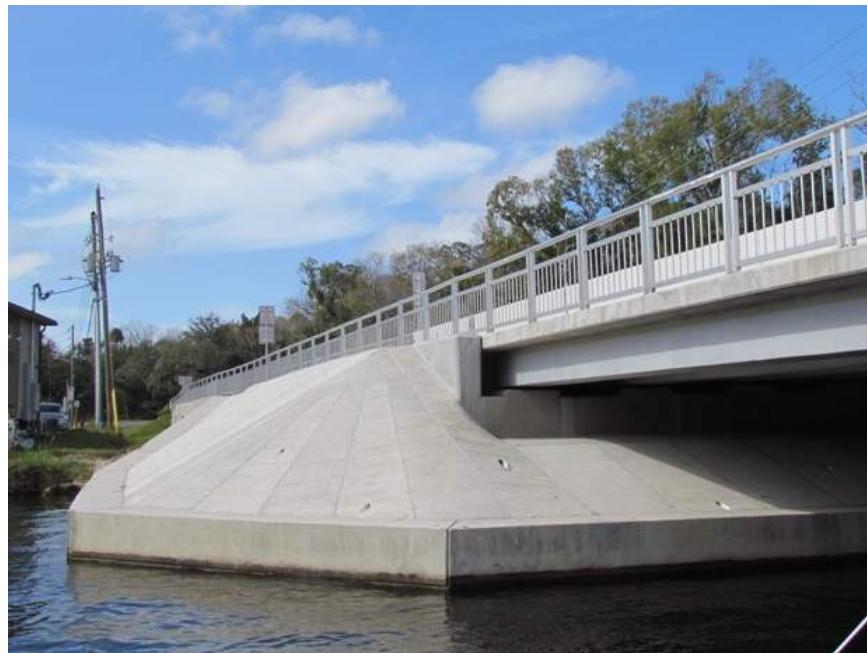
Where the underside of the slab is visible from the connection between construction phases, the slab is in good condition. The slope pavement, retaining walls, and sheet pile walls were all undamaged ([Figure 8](#)). Rough patches and low areas were noted on the roadway near the construction joint from the phases of construction ([Figure 9](#)); no large cracks were visible on the sidewalks.

Figure 8: Slope pavement and sheet pile wall

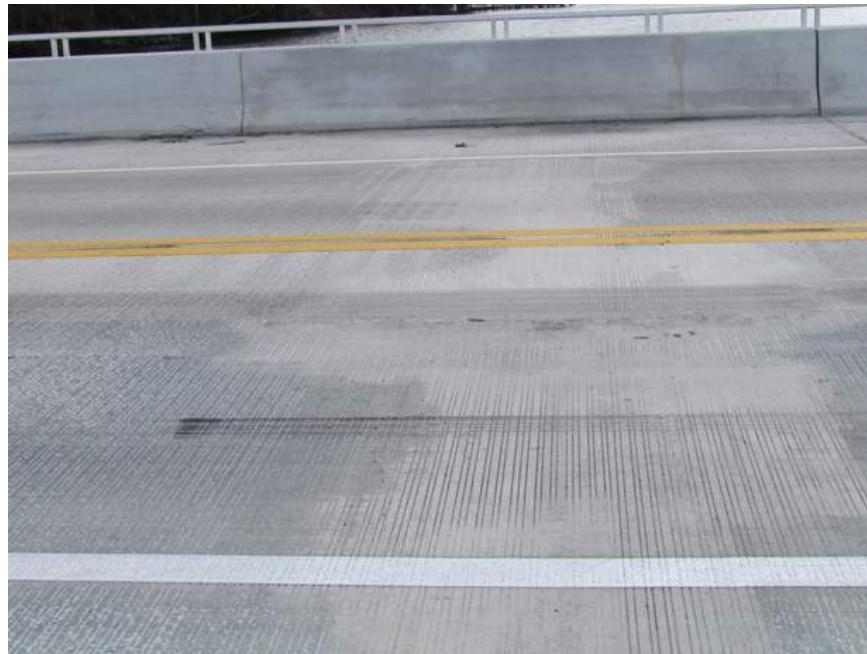
Figure 9: Rough area on roadway

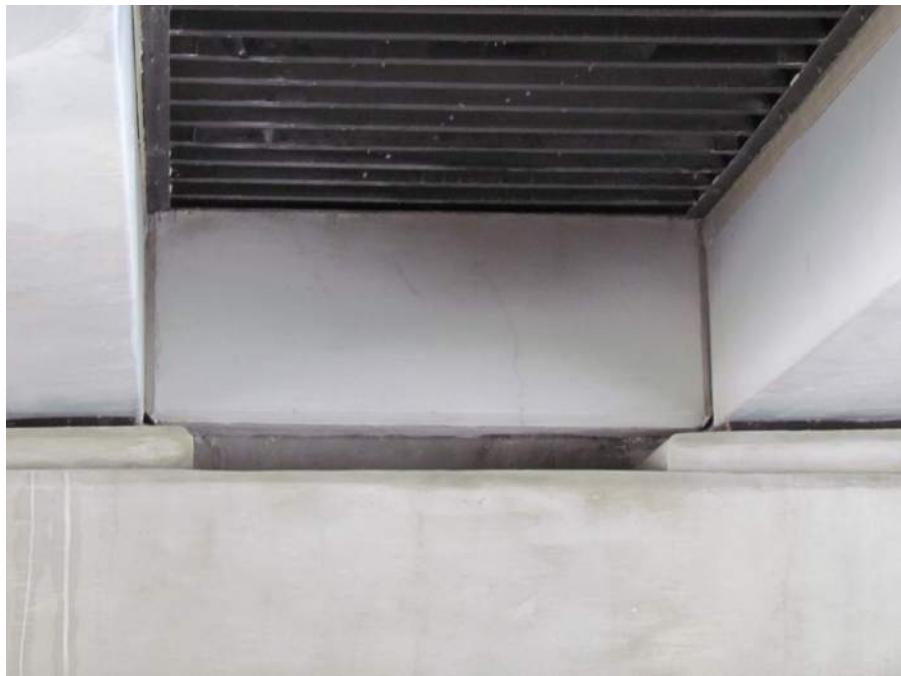
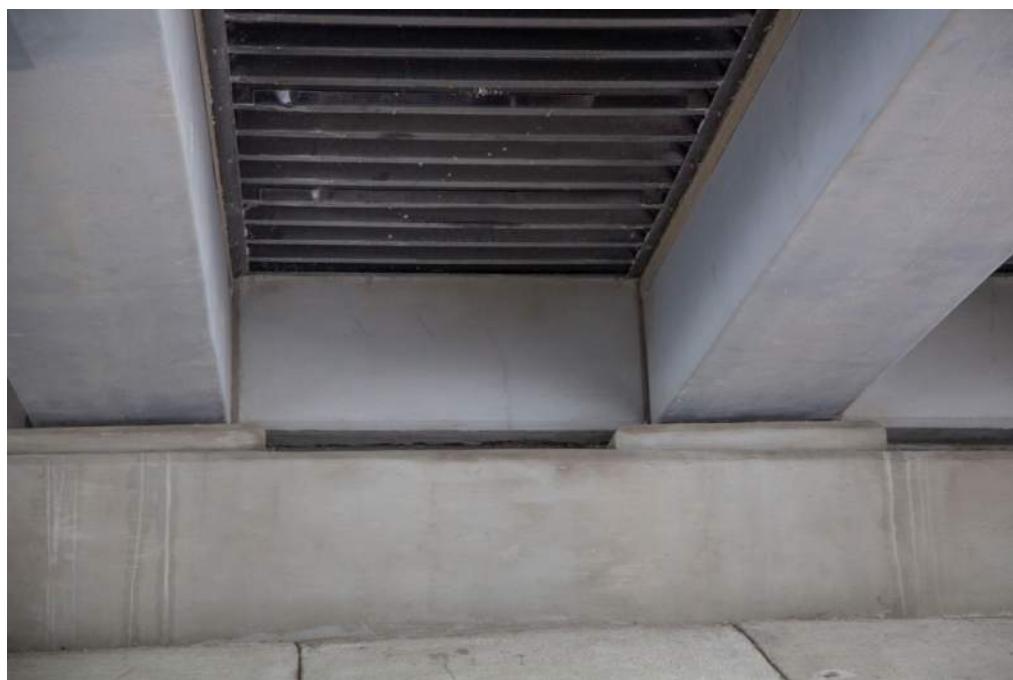
End Bent 1 diaphragm crack (Figures 32-33):

Figure 32: Diaphragm in End Bent 1 at 3 months, looking west

Figure 33: Diaphragm in End Bent 1 at 6 months, looking west

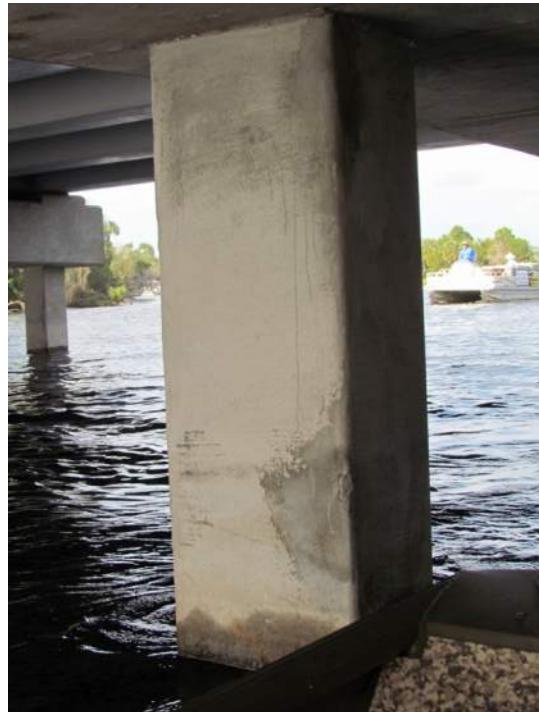
Figure 36: Bent 5 at 3 months, looking northwest; pile discoloration

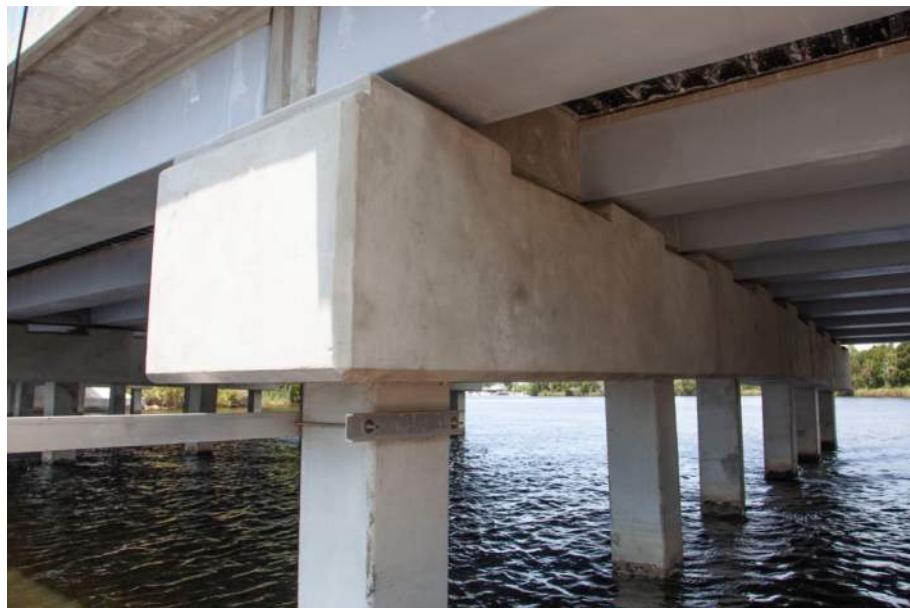
Figure 37: Bent 5 at 6 months, view from south side, looking northwest; pile discoloration (third pile from foreground)
