Inspection and Monitoring of Fabrication and Construction for the West Halls River Road Bridge Replacement

Contract Number BDV30-706-01

TASK 4 Deliverable: Two-Year Report
(Visual inspection of bridge)

Draft 1 Submitted December 27, 2021

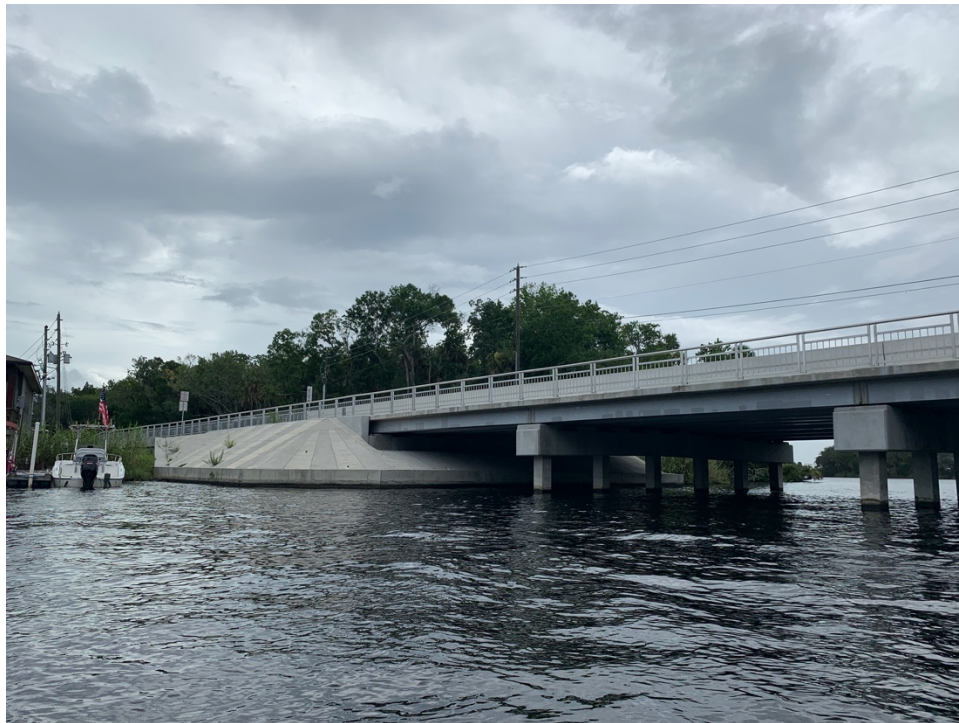
Figure 1: Halls River Bridge, Spans 1 and 2, looking northwest

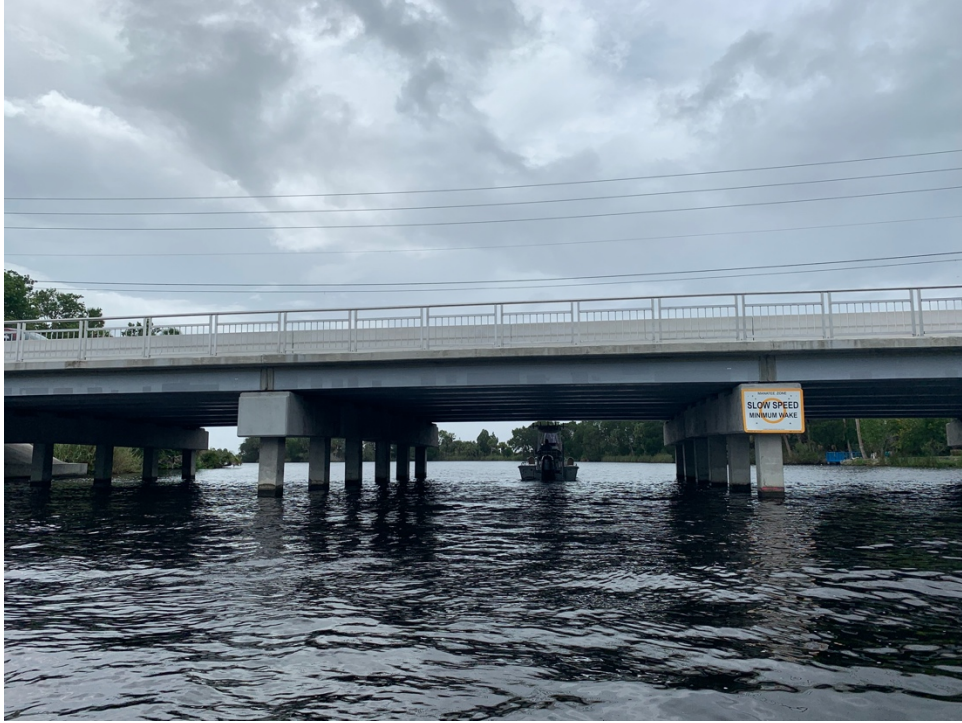
Figure 2: Span 3, looking north

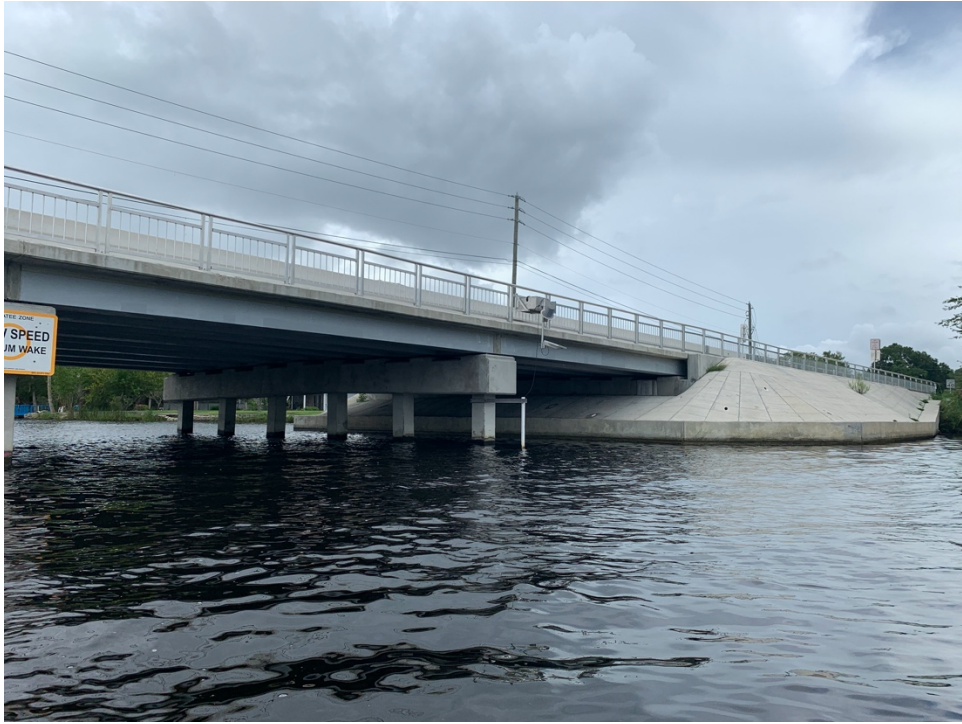
Figure 3: Spans 4 and 5, looking northeast

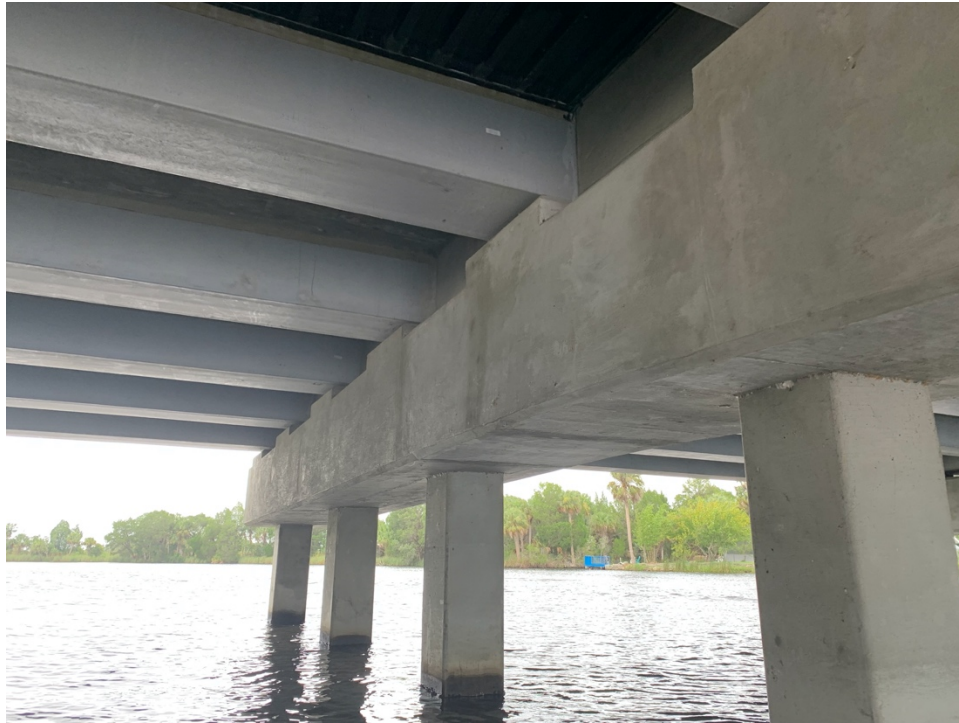
Overall, the prestressed carbon fiber composite cable (CFCC) piles appeared to be in good condition. The bent caps exhibited minor staining from drainage at the beam locations. (**Figure 4**).

Figure 4: Bent 2, looking northeast, minor staining on bent cap from water drainage

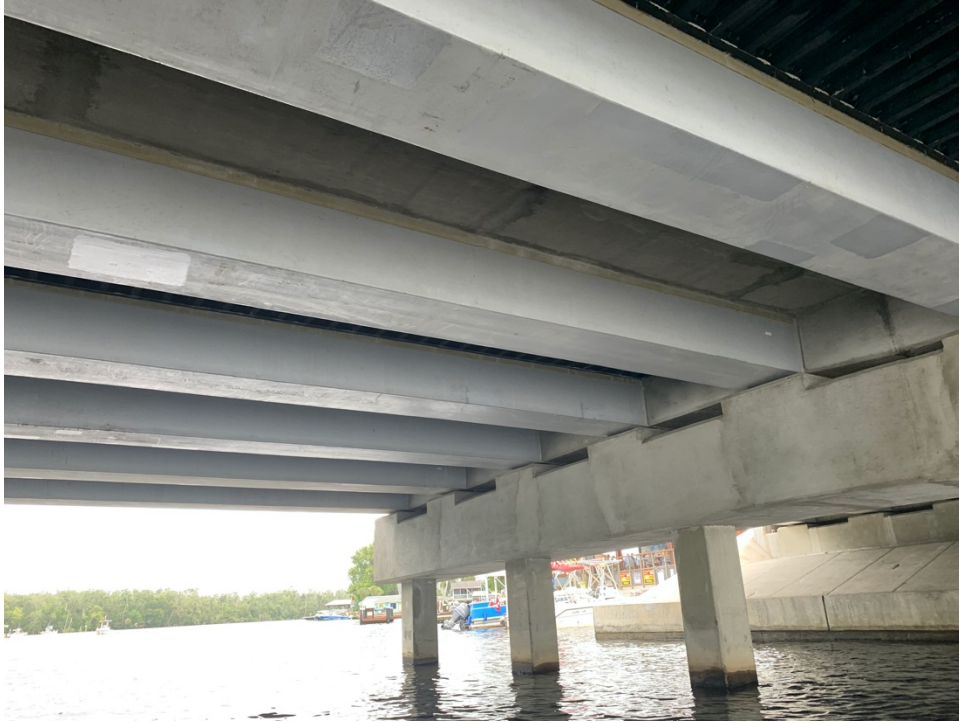
The hybrid composite beams (HCBs) exhibited no apparent damage or cracking on the fiberglass shell and no flaking of the gel coat (**Figures 5 and 6**).

Figure 5: Span 2, looking southwest at Bent 2

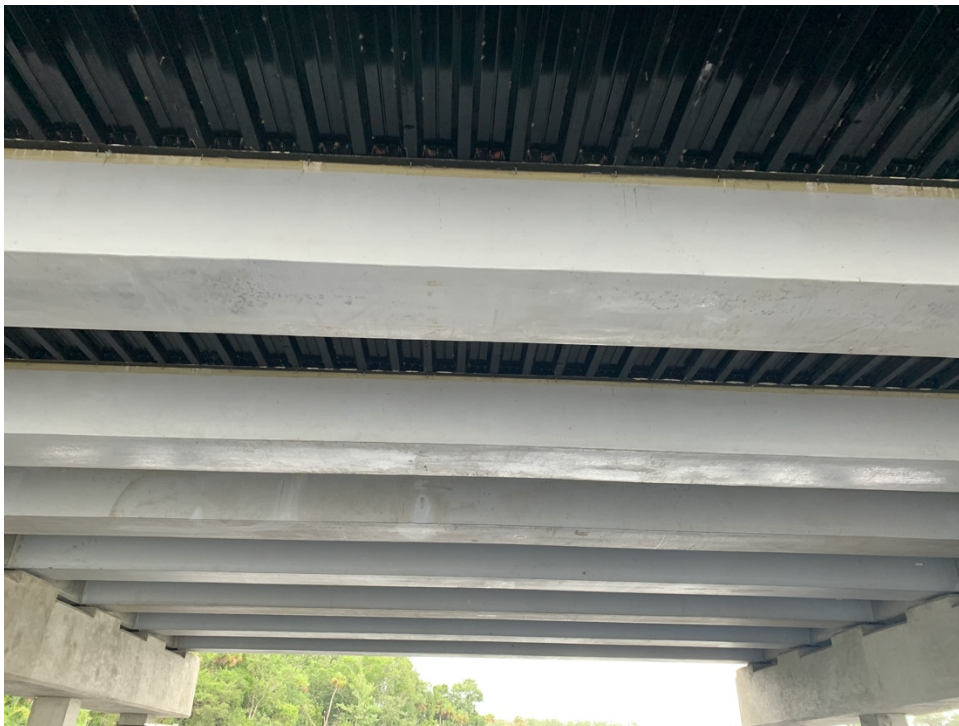
Figure 6: Span 4, gel coat patches on HCB beams

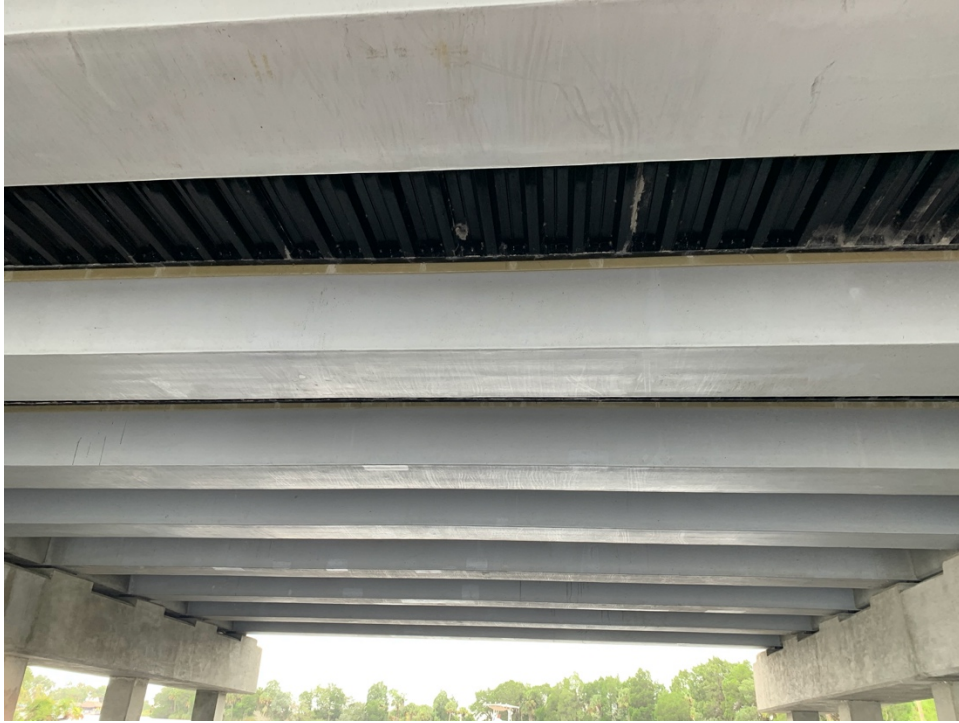
The HCB lid did not have a gel coat applied during fabrication. The noticeable gap between the lid and the vertical face of the HCBs does not appear to have changed since the first visit at 3 months after construction. The lid edge appeared to be in adequate condition, with no noticeable deterioration, bucking, or further separation from the beam (**Figure 7**).

Figure 7: Small gap between HCB lid and vertical face of HCB

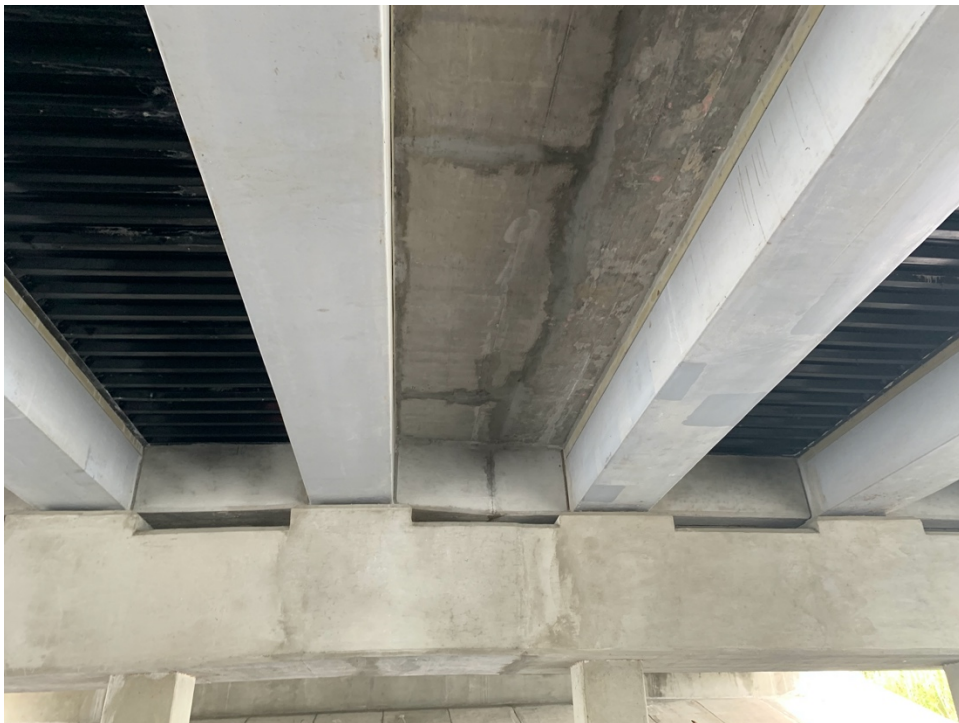
The underside of the slab is visible between two of the beams in each span, as a result of the connection between construction phases that was constructed without stay-in-place decking, and the slab appeared to be in good condition (**Figure 8**). There is some staining, but it appears to be original from construction.

Figure 8: Bottom of slab where connection between construction phases was made, at Bent 2, looking west

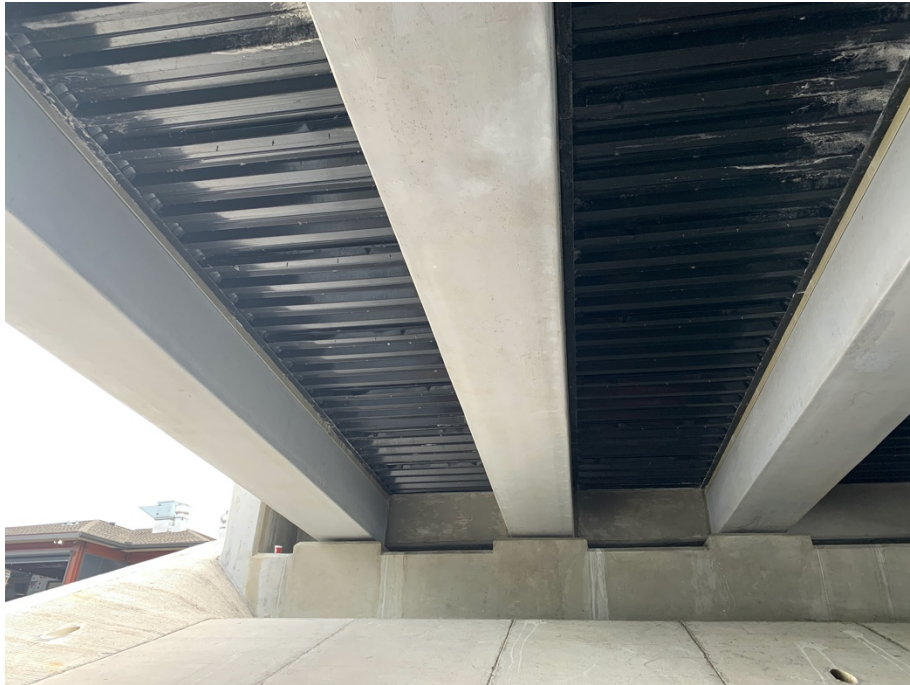
No changes in the end bents were noticed from the last inspection (**Figure 9**). The abutment walls were in good condition (**Figure 10**).

Figure 9: End Bent 1, looking west

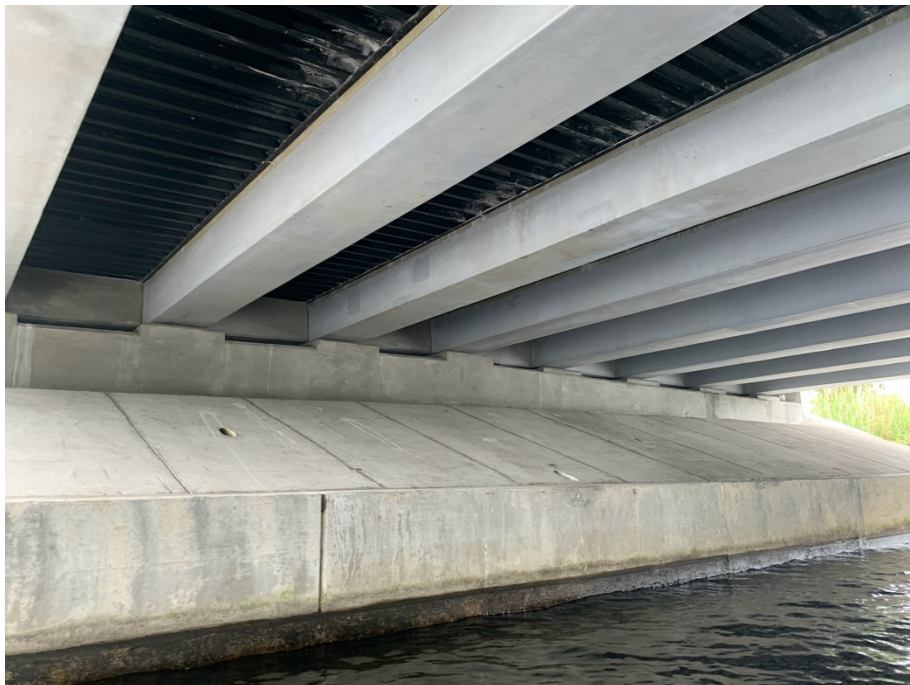
Figure 10: End Bent 1, looking northwest

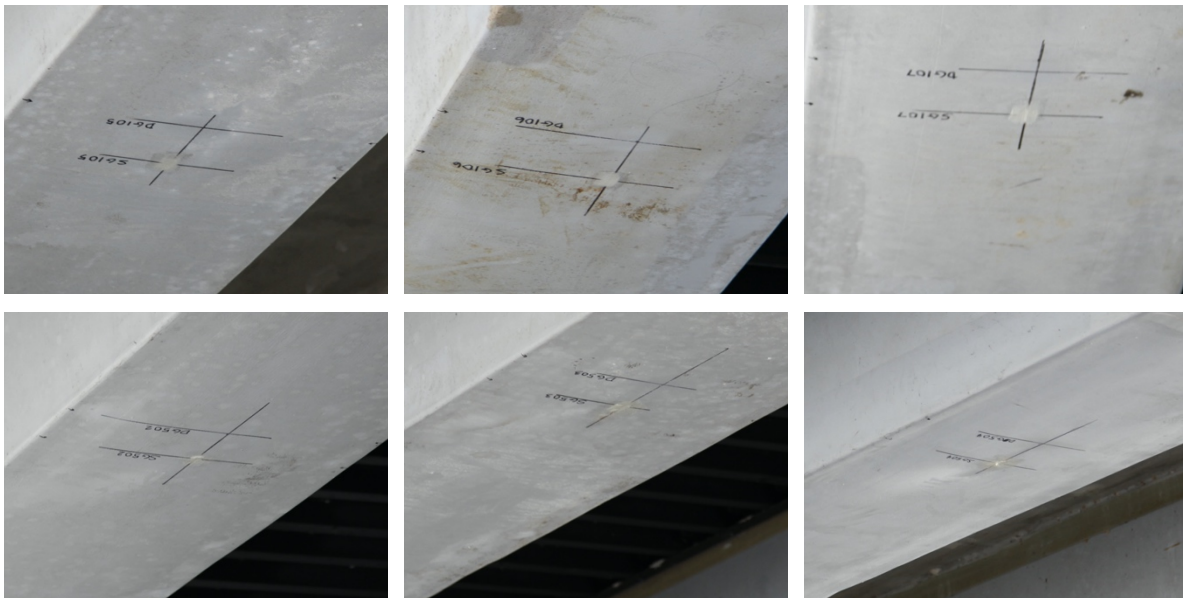
Of particular interest during this inspection were the patches on the bottom of the beams. The patches were made at the conclusion of a recent load test, performed on Spans 1 and 5 on October 6, 2021. The patches were made to repair the beams where strain gages had been adhered. **Figures 13 and 14** show photos of several of the patches. The patches appear to be holding up well, with no signs of flaking or debonding.

Figure 13: Patches on beams where strain gages were placed for load test

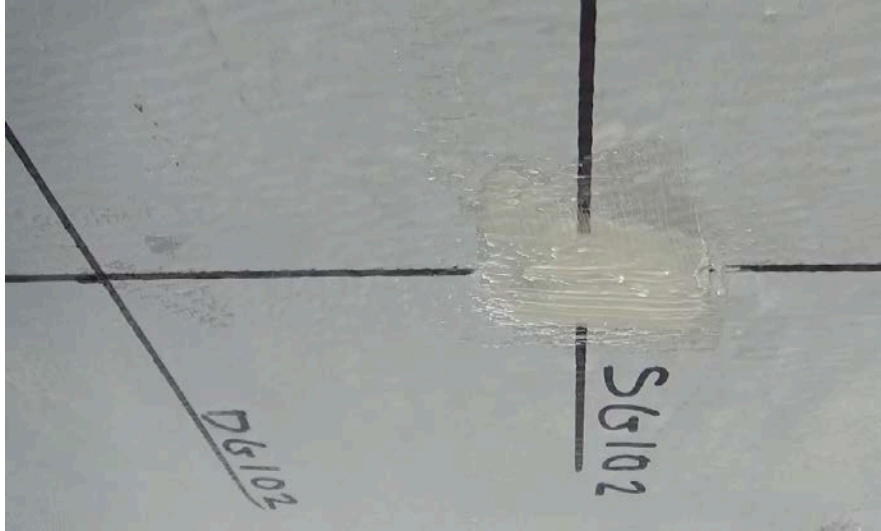
Figure 14: Patch on beam where strain gage SG102 was placed for load test

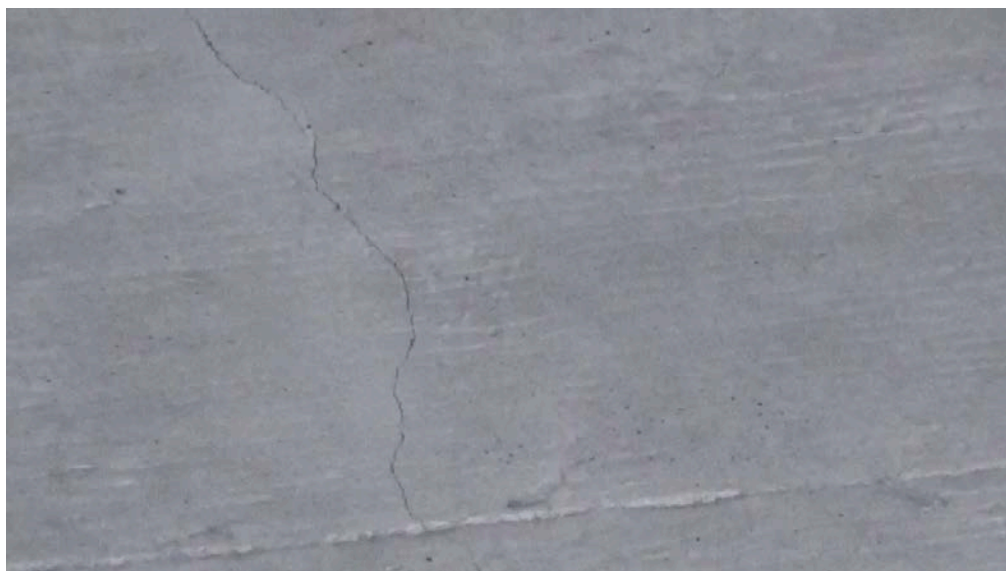
Another area of interest was the underside of the slab that was exposed from the joint between construction phases (where stay-in-place forms were not used). During the load test, the truck wheels were placed along the joint, in Spans 1 and 5, and some high strains were detected, making this an area of interest during the inspection. A crack (see **Figure 15**) was noticed in Span 1, about 2 feet east of where strain gage SG112 had been placed for the load test. The crack runs transverse to the bridge (perpendicular to the beams). For another view of the crack, see the videos with *Slab1_Slab-Construction-Joint* in the filename.

Figure 15: Bottom of slab at construction joint, Span 1, crack near SG112 (at two years)

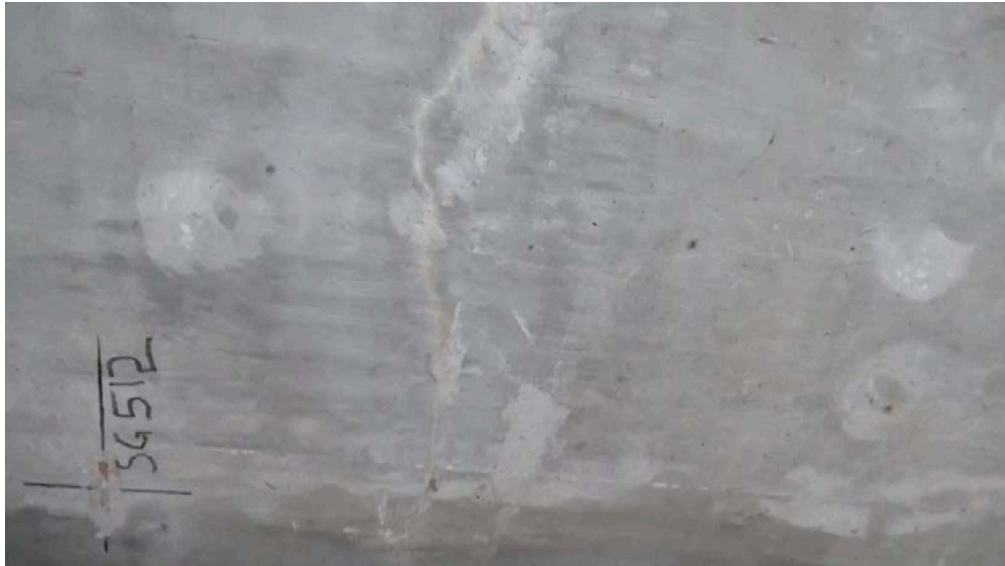
No open cracks were visible from underneath in Span 5. However, a crack (see **Figure 16**) with efflorescence was noticed about 2 feet east of where strain gage SG512 had been placed for the load test. The crack runs transverse to the bridge (perpendicular to the beams). For another view of the crack, see videos with *Slab5_Slab-Construction-Joint* in the filename.

Figure 16: Bottom of slab at construction joint, Span 5, crack near SG512 (at two years)

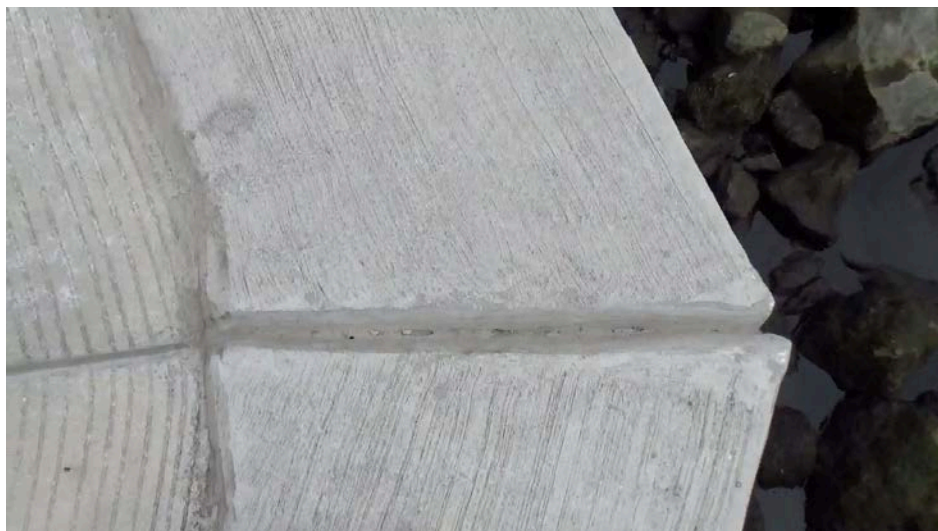
The end bent sheet pile walls were inspected from the water and by walking along the cap. No noticeable cracks were seen on top of the cap (**Figures 17 and 18**).

Figure 17: End Bent 1, top of sheet pile wall cap at corner, no cracks (at two years)

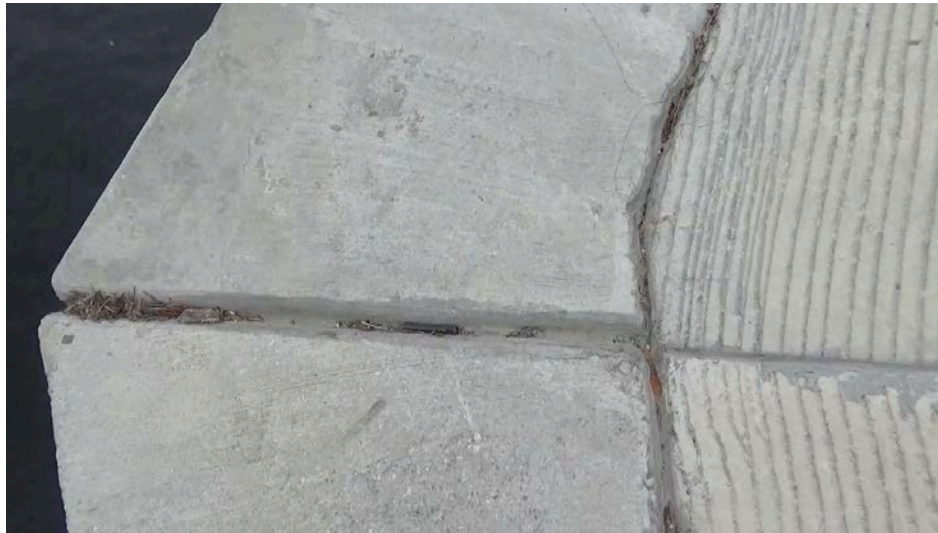
Figure 18: End Bent 6, top of sheet pile wall cap at corner, no cracks (at two years)

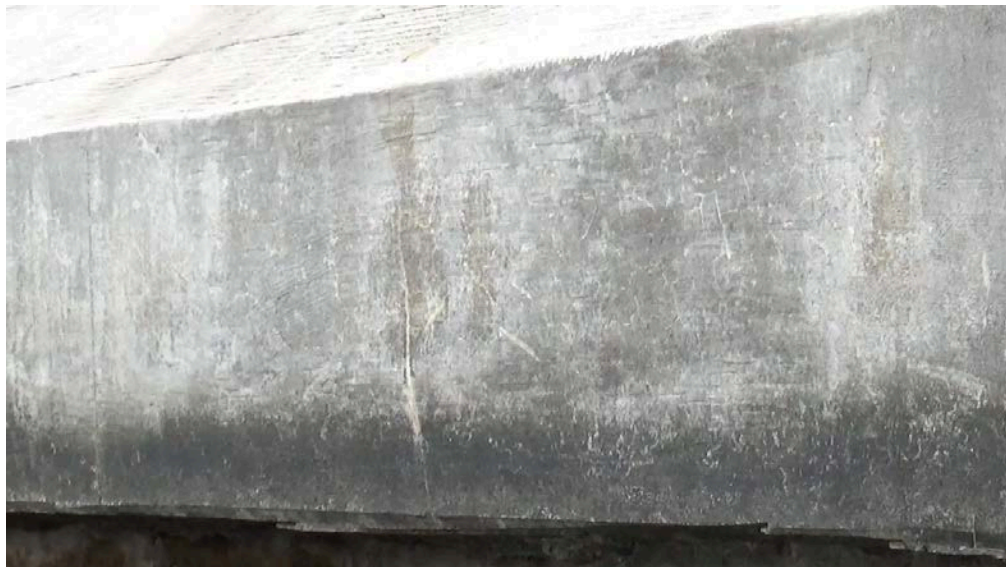
However, there were some cracks on the vertical face of the sheet pile wall caps. A large crack with efflorescence was noticed on End Bent 6 (**Figure 19**), but several other cracks were open, particularly at the corners (**Figures 20-23**). Some of the cracks were also noticed and documented during previous visits. **Figure 24** shows some missing joint filler at one of the corners.

Figure 19: End Bent 6, sheet pile wall cap, vertical crack with efflorescence

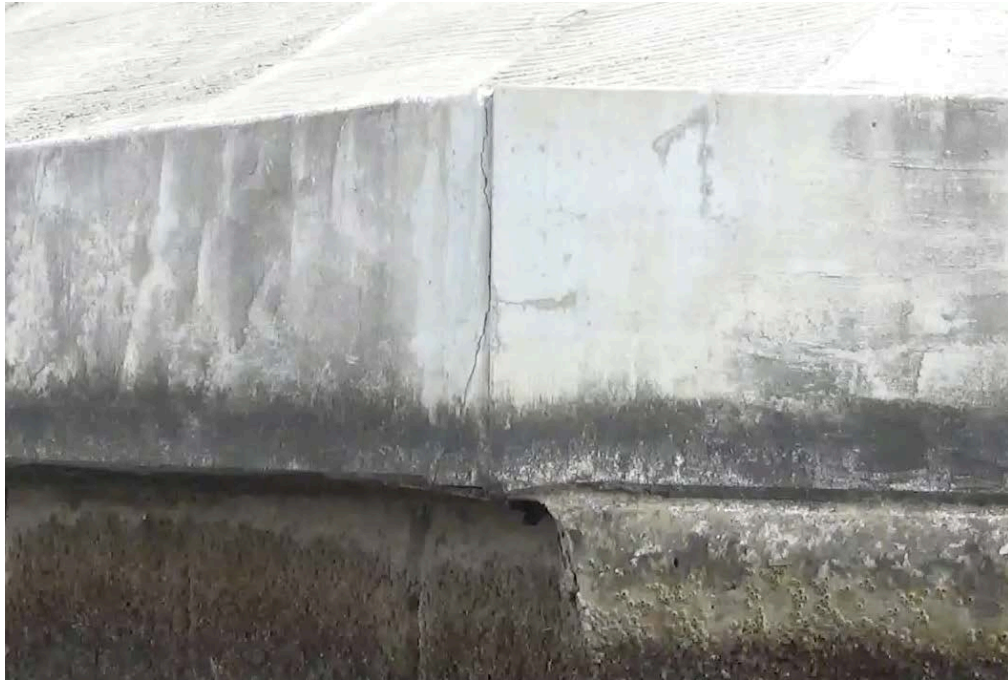
Figure 20: End Bent 6, sheet pile wall cap, vertical crack on northernmost corner

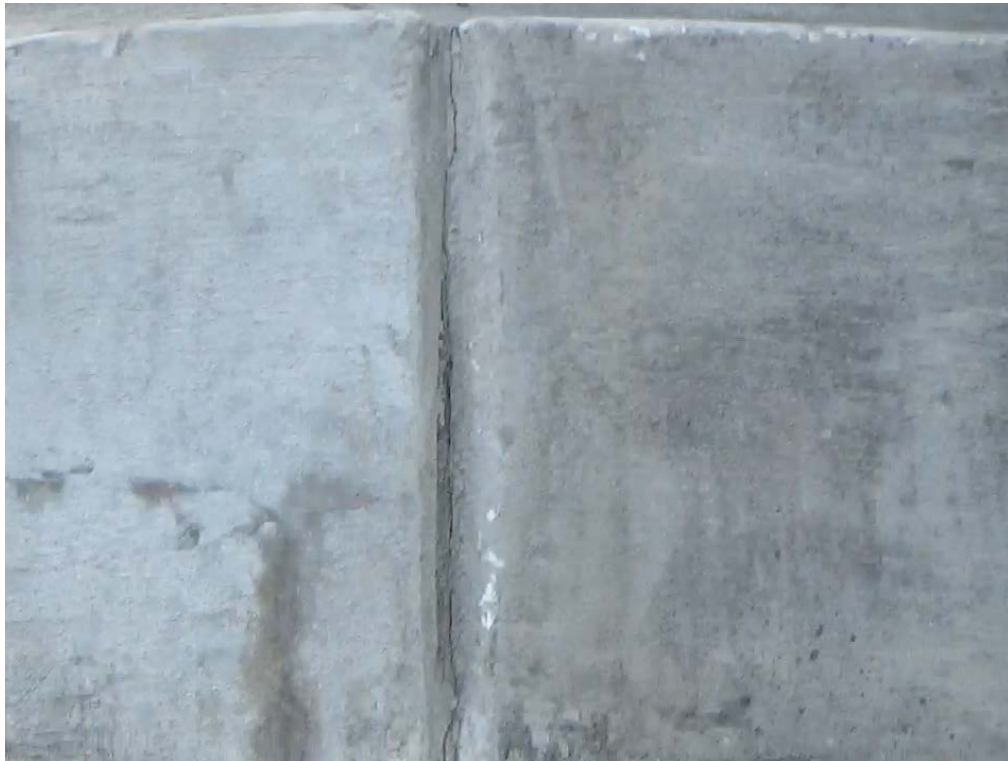
Figure 21: End Bent 6, sheet pile wall cap, vertical crack on north corner of front face

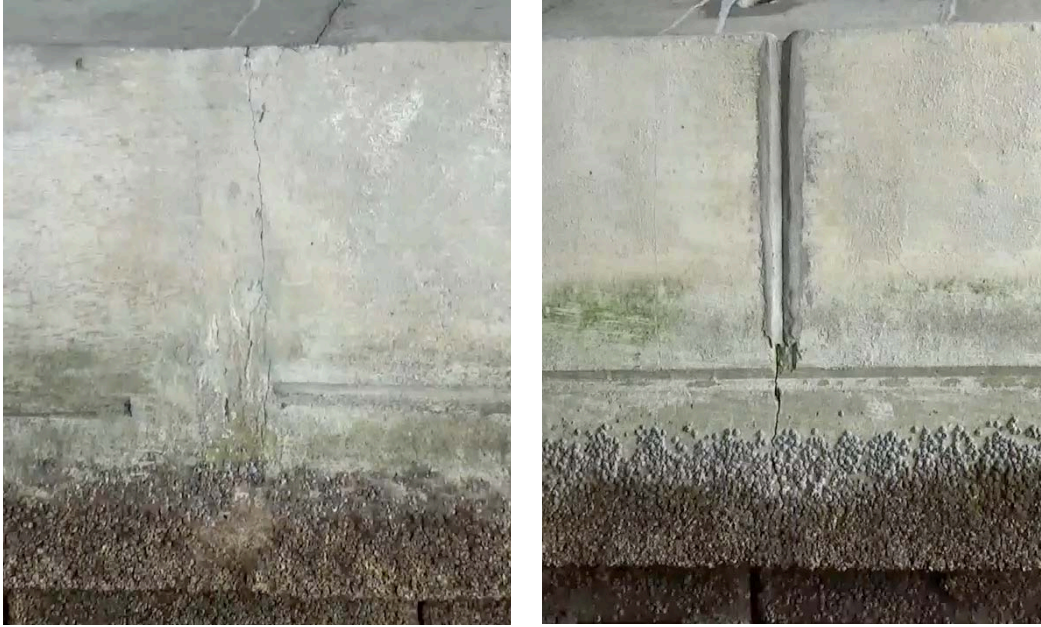
Figure 22: End Bent 6, sheet pile wall cap, vertical cracks at two locations on front face

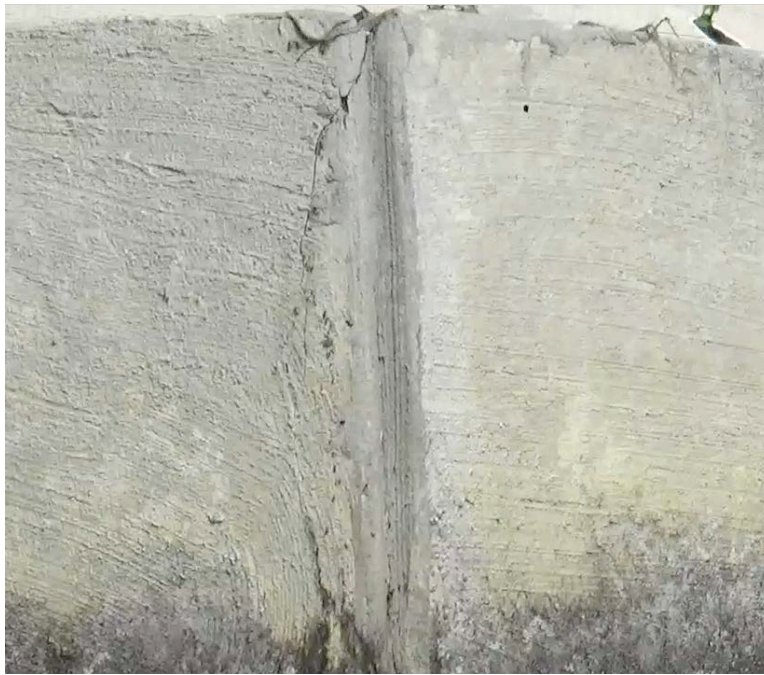
Figure 23: End Bent 6, sheet pile wall cap, vertical crack on south corner of front face

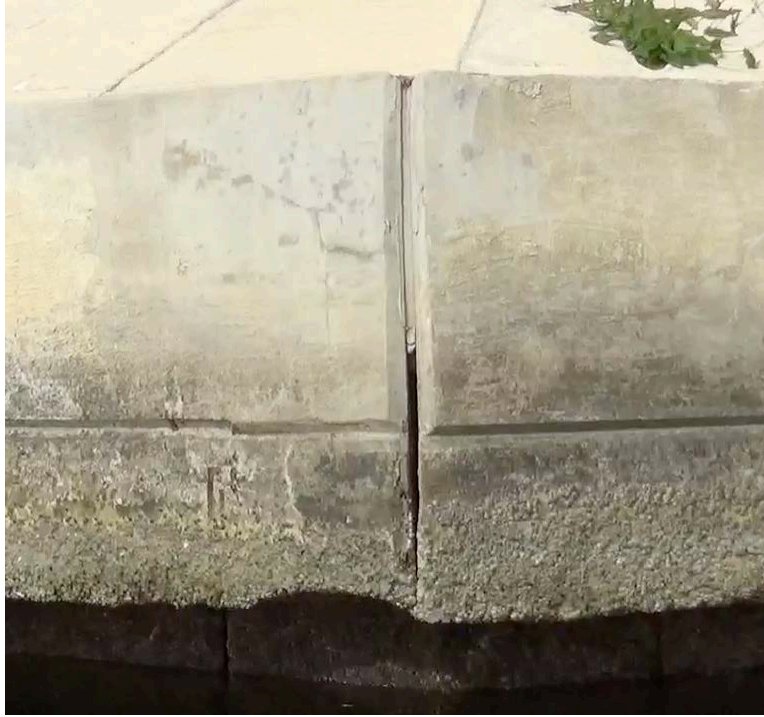
Figure 24: End Bent 6, sheet pile wall cap, joint filler missing on southernmost corner

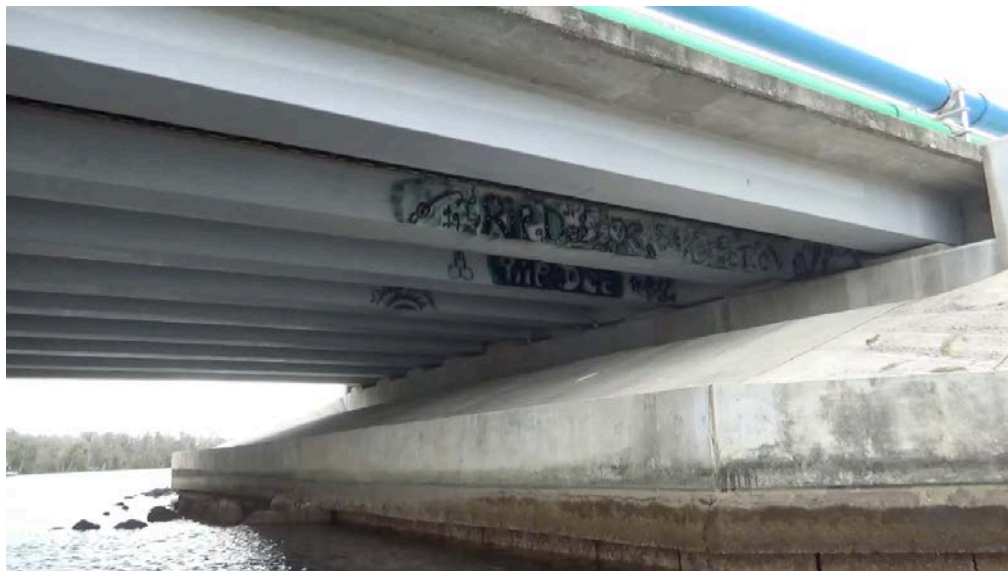
Several of the beams above End Bent 1 are covered with graffiti, as shown in **Figure 25**.

Figure 25: Graffiti on beams above Bent 1, looking southwest (at two years)

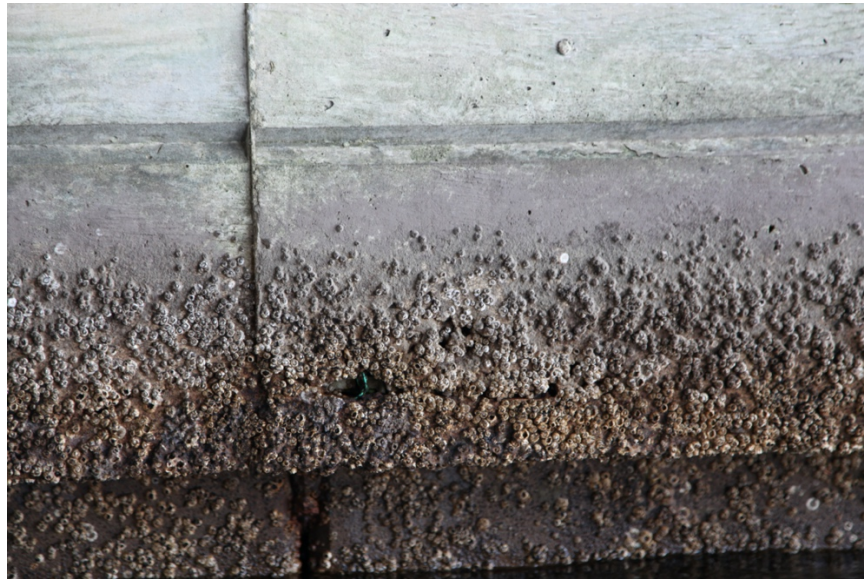
Barnacles have found residence on the sheet pile walls and caps (**Figures 26 and 27**).

Figure 26: Barnacles on end bent sheet pile wall and cap (at two years)

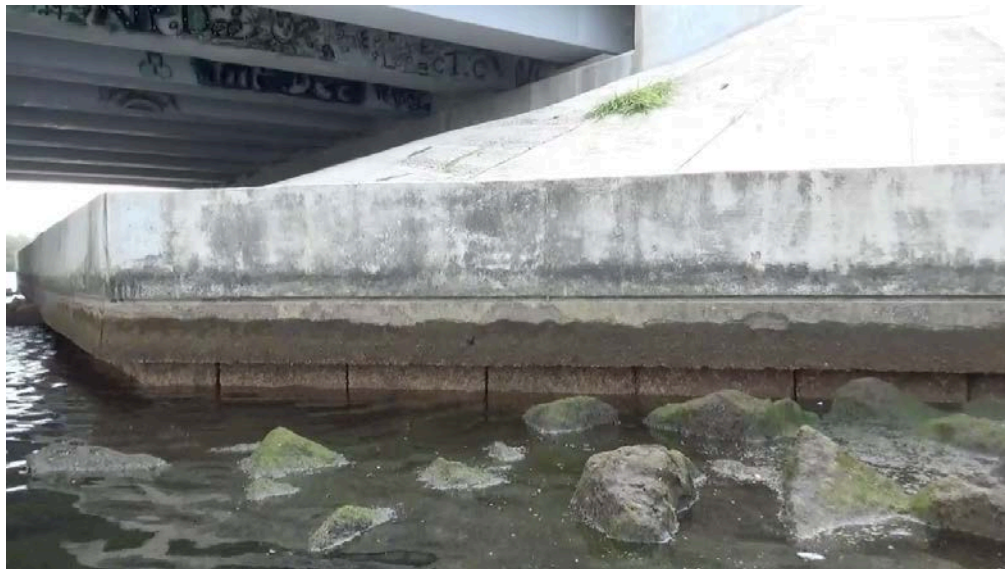
Figure 27: Barnacles on end bent sheet pile wall (at two years)

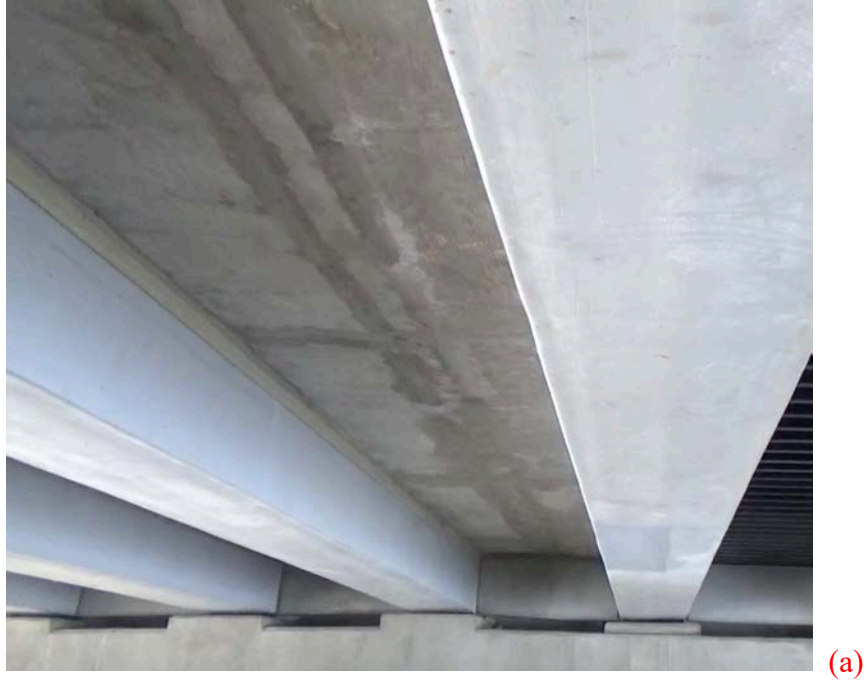
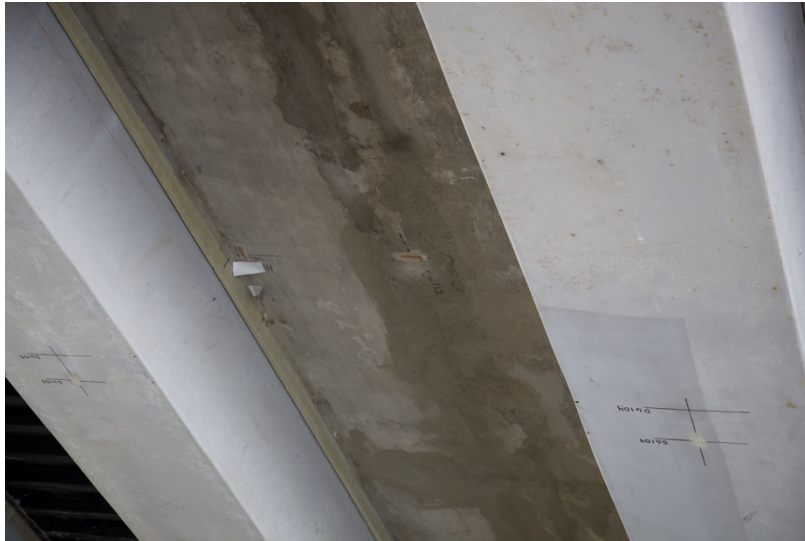
Figure 28: Slab at construction joint in Span 1, near SG112 from load test; (a) at three months, (b) at two years

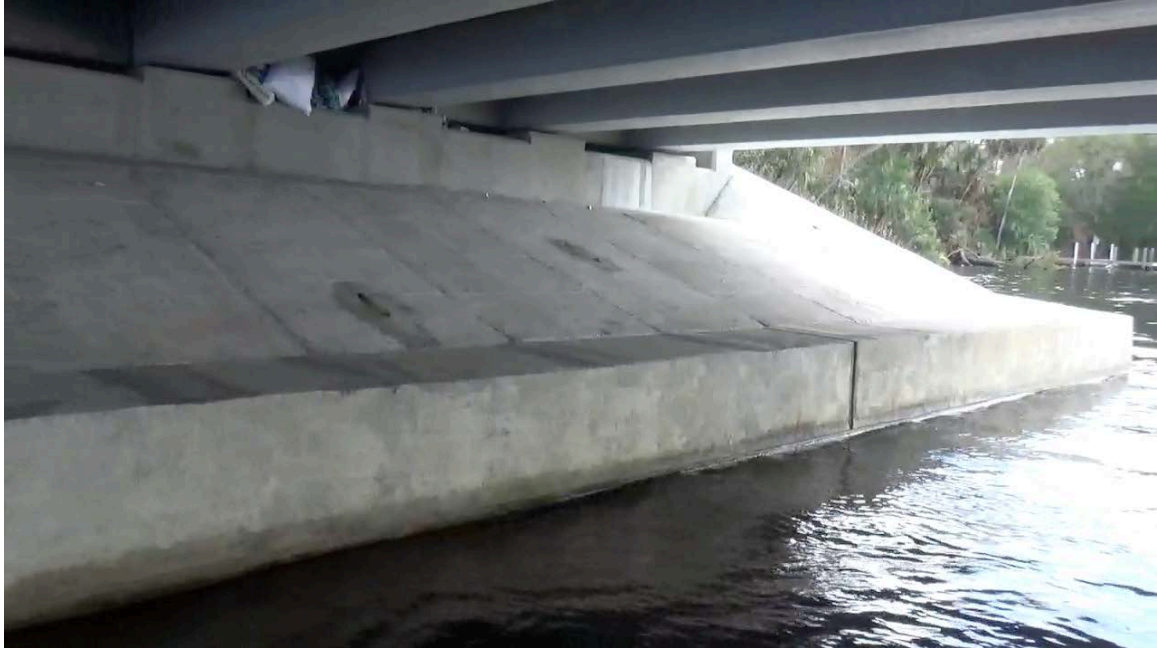
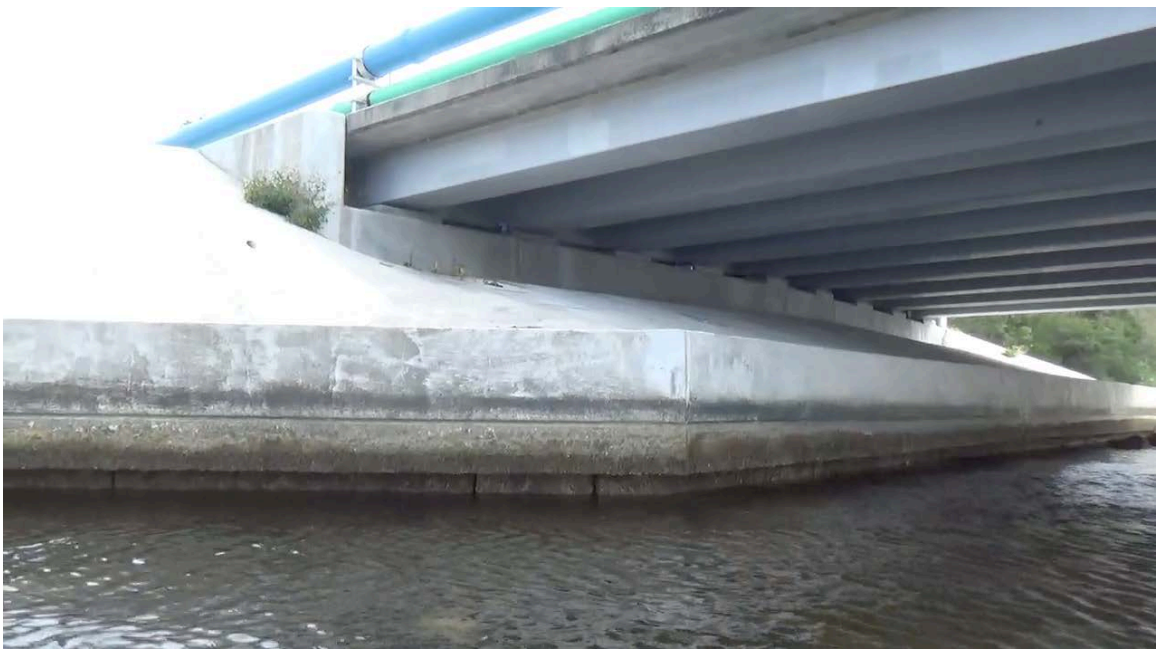
In this chapter, photos are provided to make comparisons over time, from the first inspection at three months (**Figures 28(a)-33(a)** and **35(a)-36(a)**) or nine months (**Figure 34(a)**) to the last inspection at two years after construction (**Figures 28(b)-36(b)**). The most noticeable differences over time are the growth of barnacles on the end bent sheet pile walls and caps (**Figure 29**) and the additional staining and growth on the intermediate bent piles (**Figures 30-33**).

Figure 29: End Bent 6, looking southeast; (a) at three months, (b) at two years

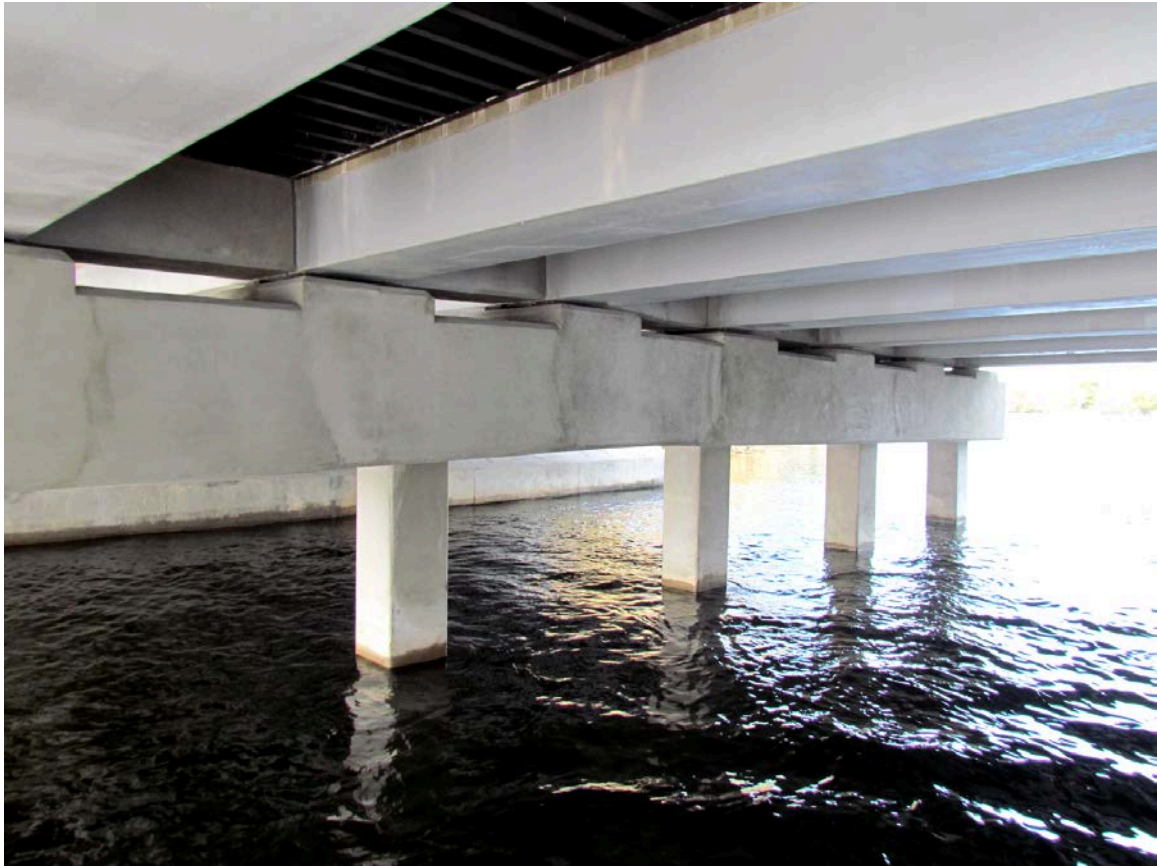
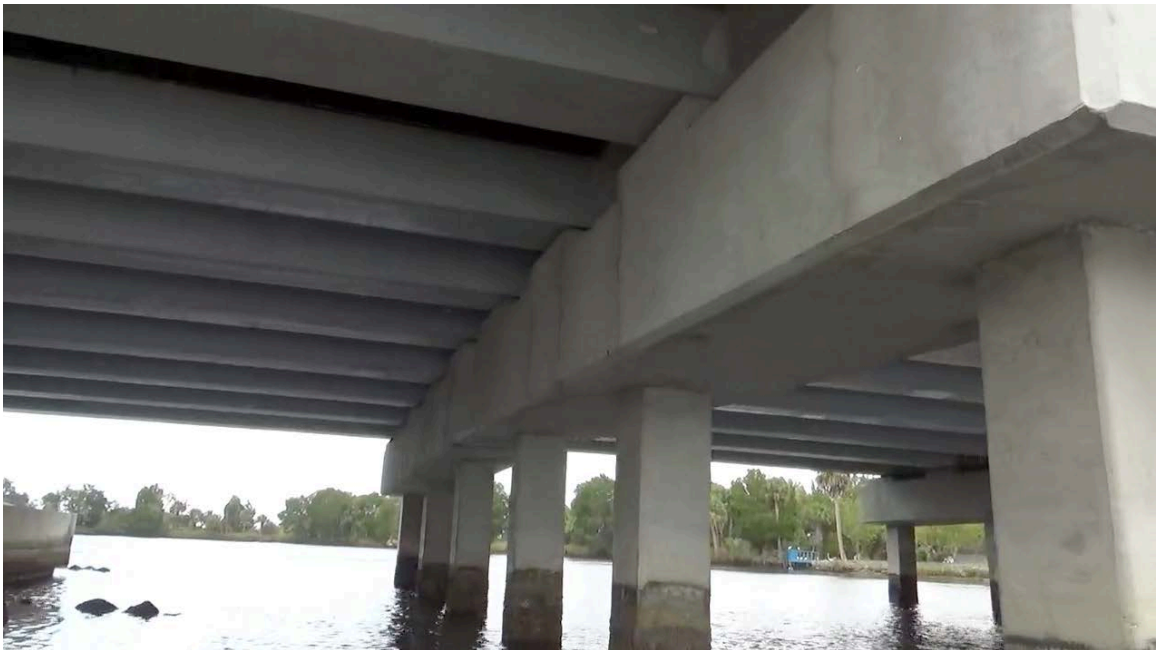
Figure 30: Bent 2; (a) looking northwest, at three months, (b) looking northeast, at two years

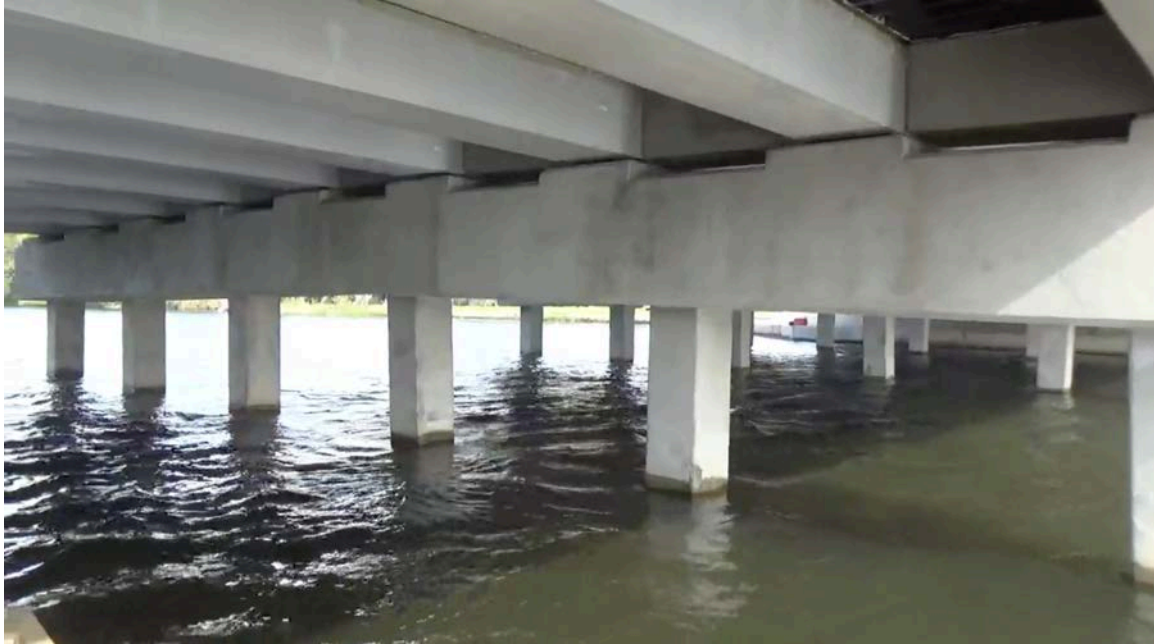
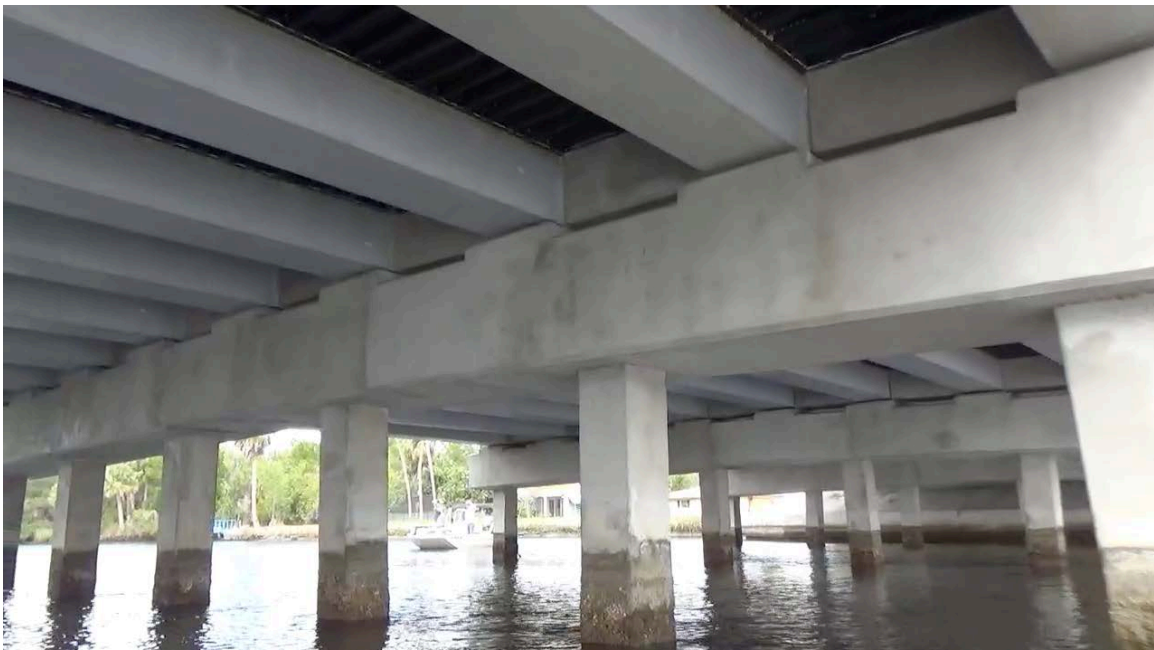
Figure 31: Span 2, looking northeast at Bent 3; (a) at three months, (b) at two years
