Inspection and Monitoring of Fabrication and Construction for the West Halls River Road Bridge Replacement

Contract Number BDV30-706-01

TASK 4 Deliverable: Two-Year Report
(Visual inspection of bridge)

Draft 1 Submitted December 27, 2021

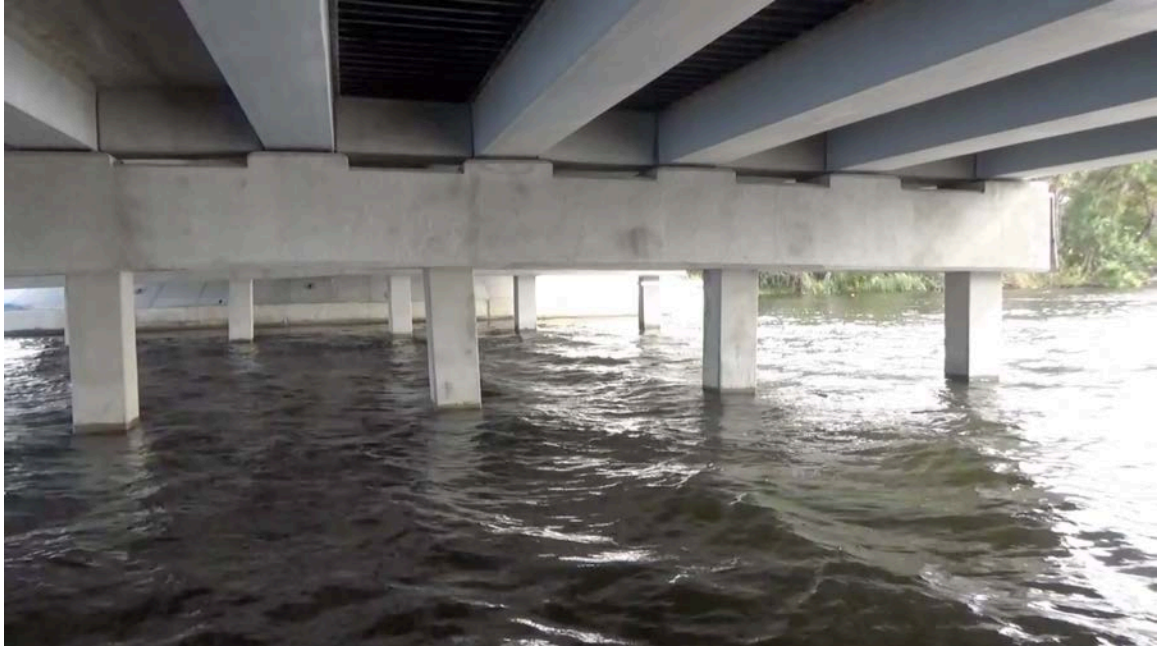
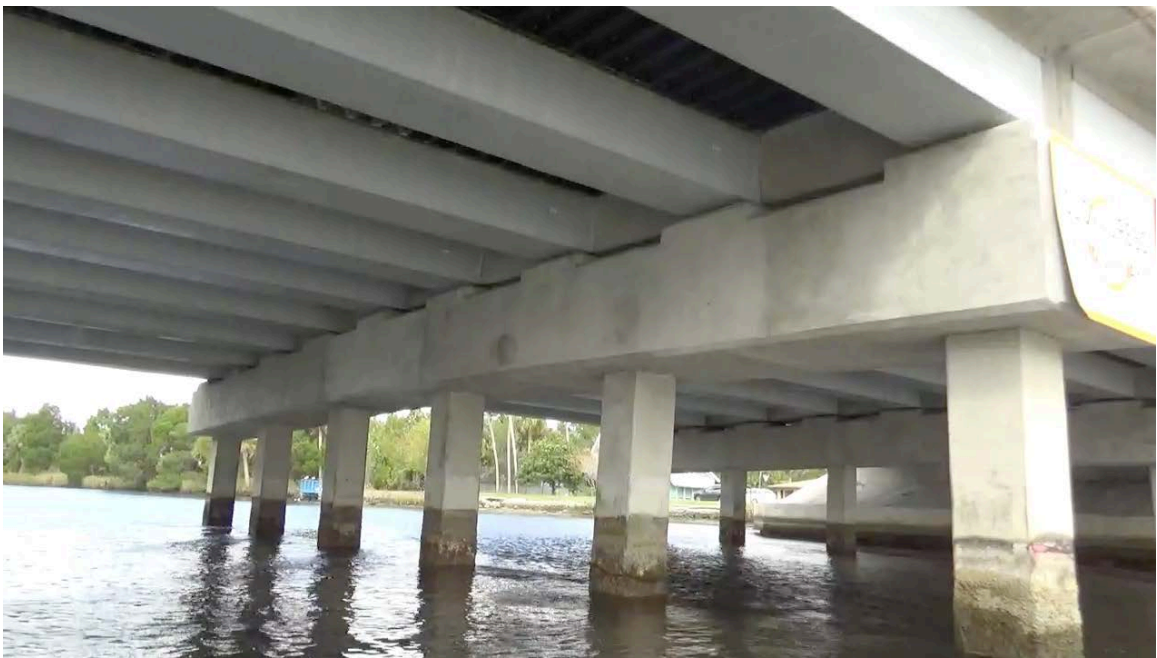
In this chapter, photos are provided to make comparisons over time, from the first inspection at three months (**Figures 28(a)-33(a)** and **35(a)-36(a)**) or nine months (**Figure 34(a)**) to the last inspection at two years after construction (**Figures 28(b)-36(b)**). The most noticeable differences over time are the growth of barnacles on the end bent sheet pile walls and caps (**Figure 29**) and the additional staining and growth on the intermediate bent piles (**Figures 30-33**).

Figure 32: Bent 4; (a) looking east, at three months, (b) looking northeast, at two years

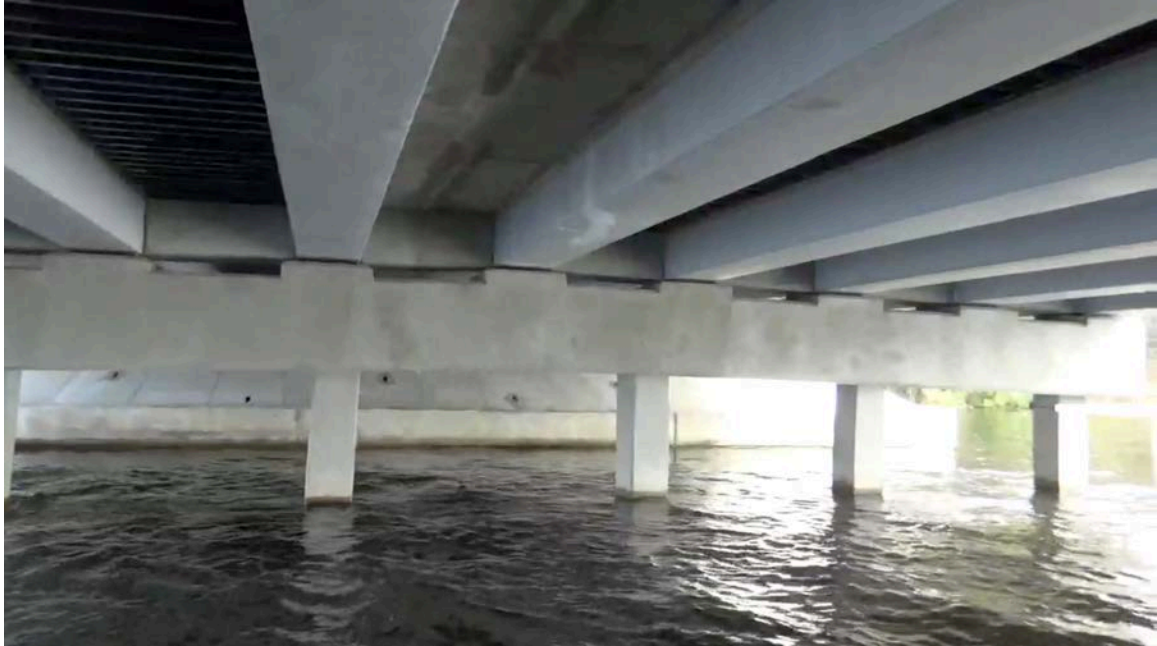
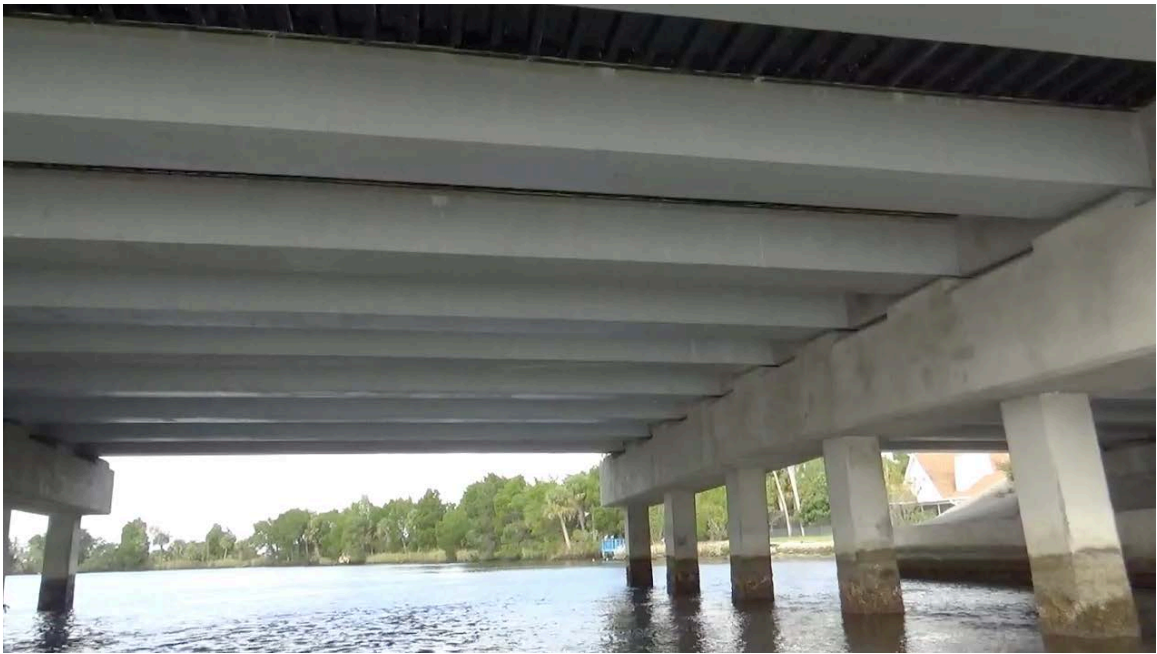
Figure 33: Bent 5; (a) looking east, at three months, (b) looking northeast, at two years

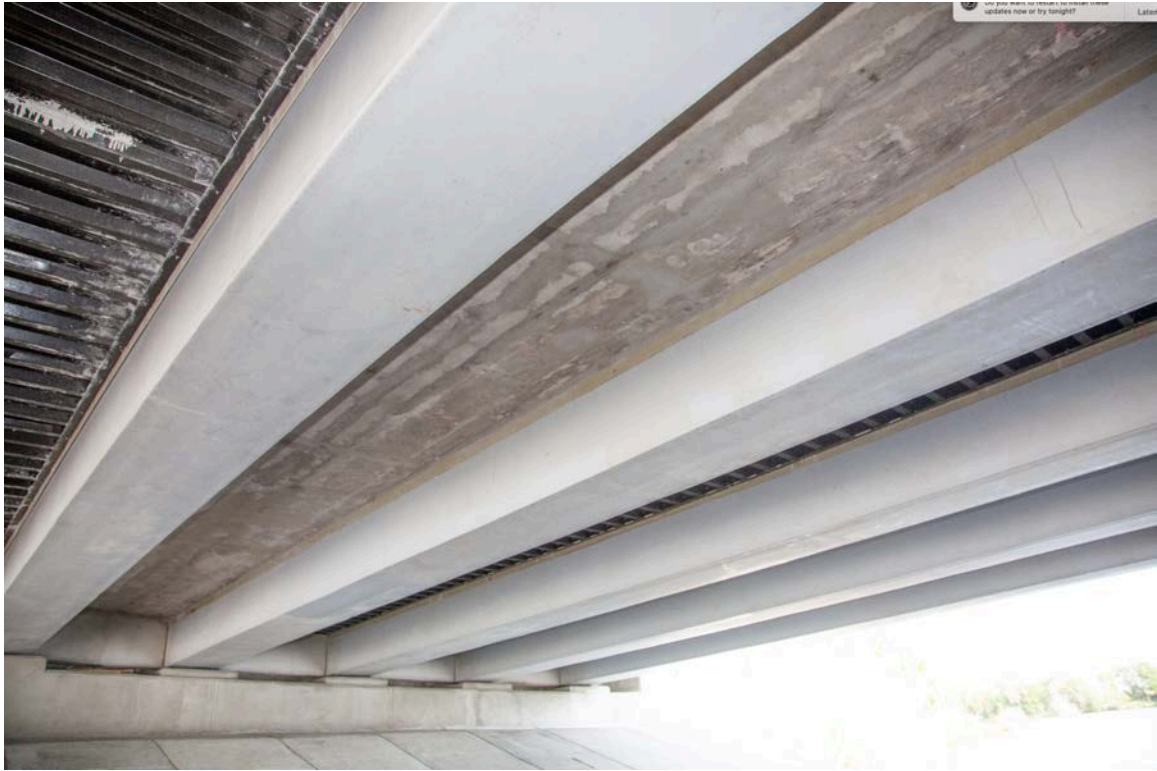
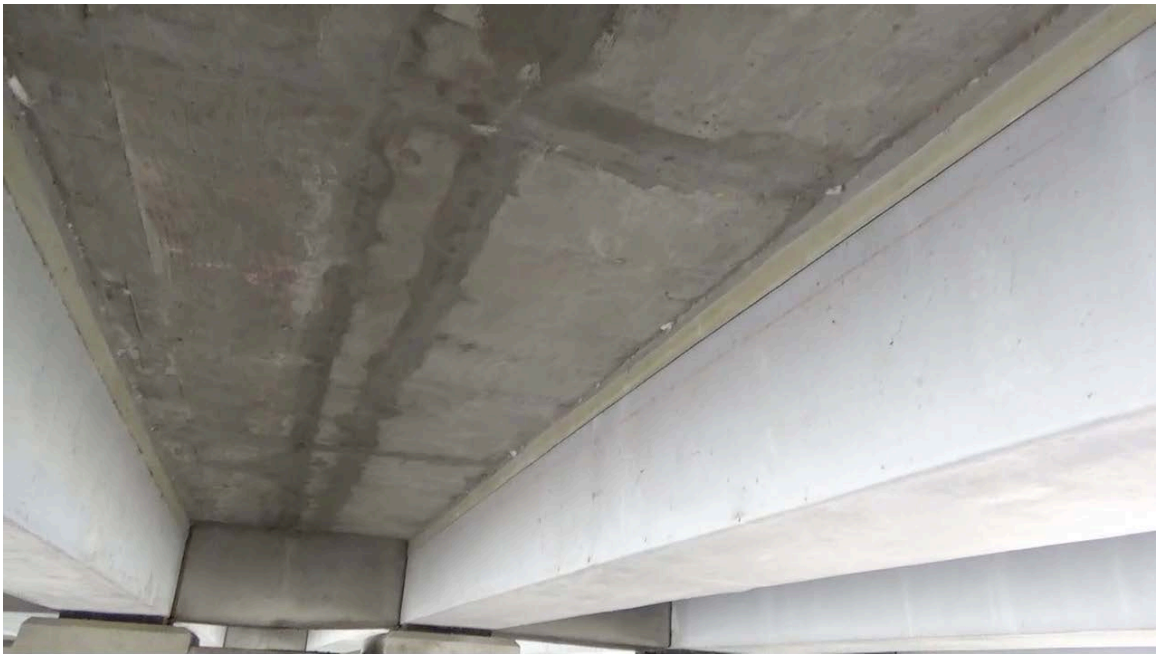
Figure 34: Bottom of slab at construction joint, Span 1; (a) looking northwest, at nine months, (b) looking east, at two years

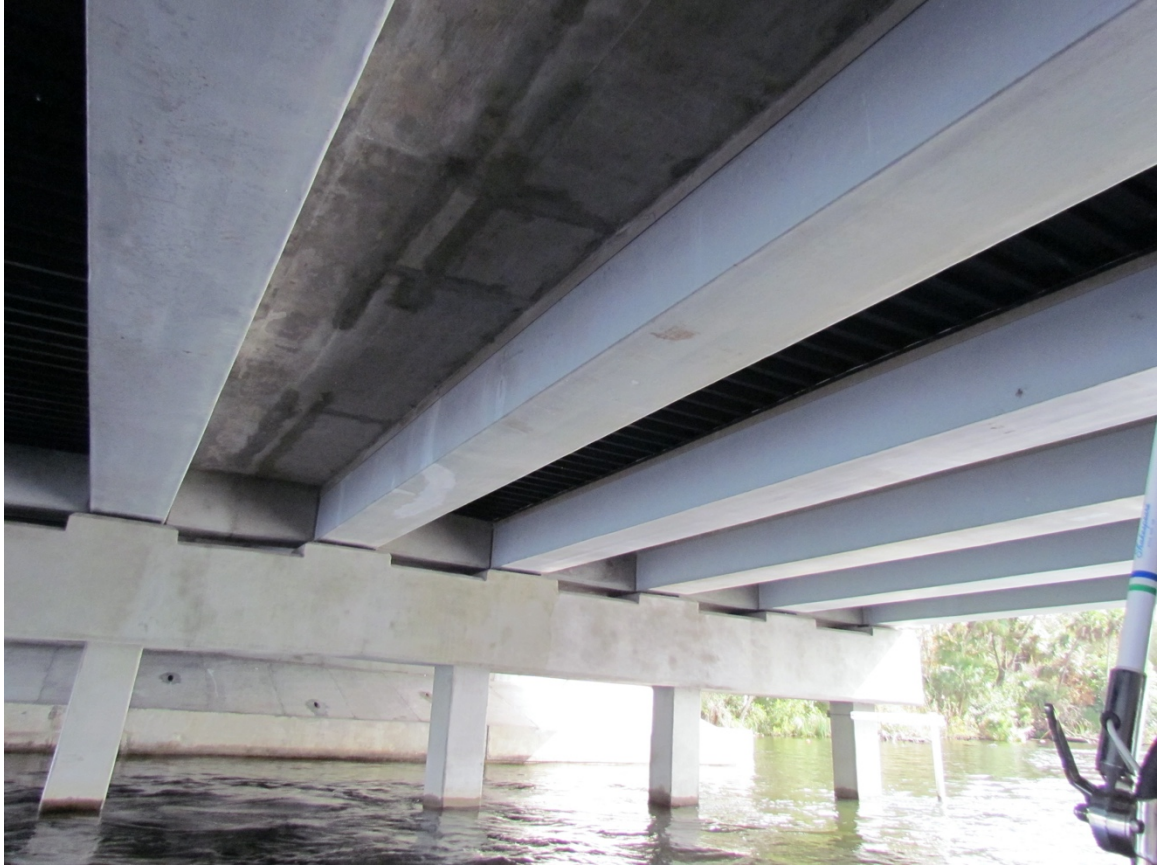
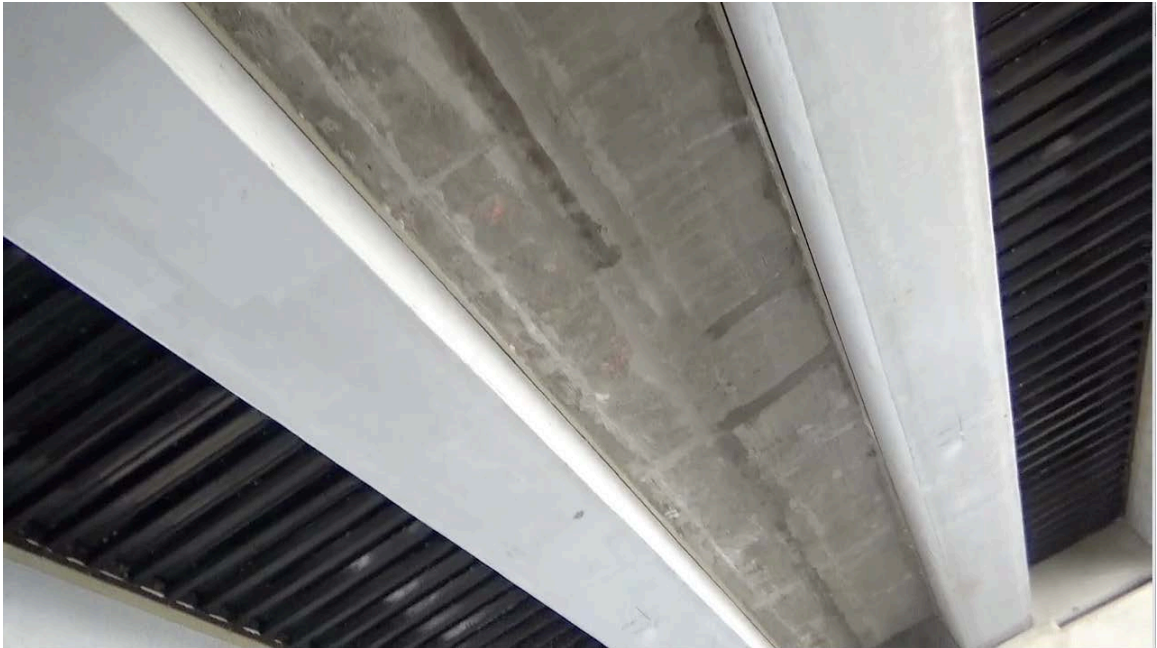
Figure 35: Bottom of slab at construction joint, looking east; (a) Span 4, at three months, (b) Span 5, at two years

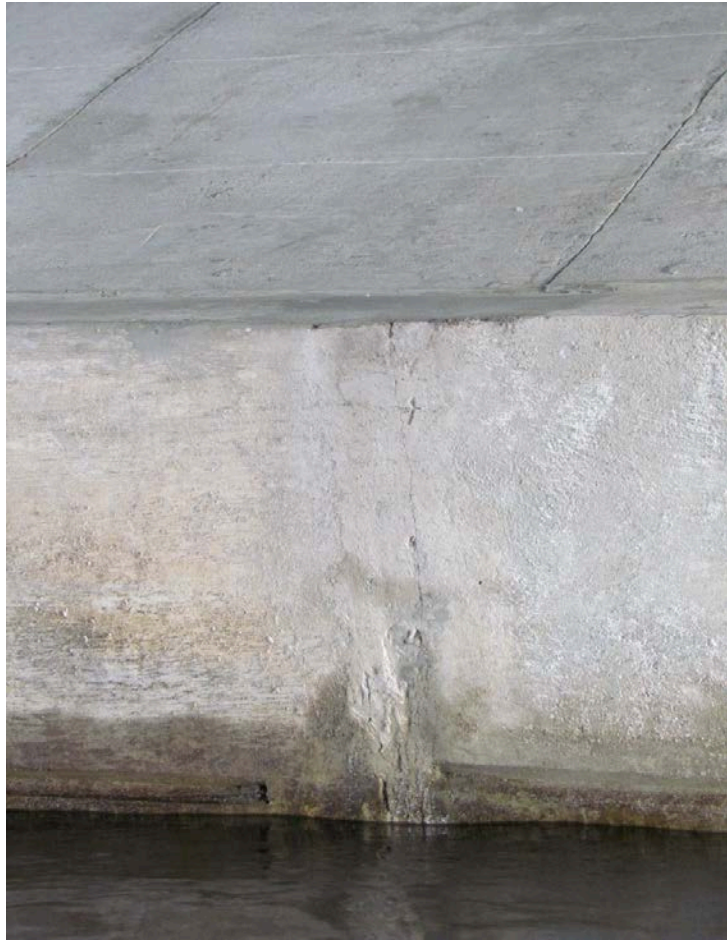
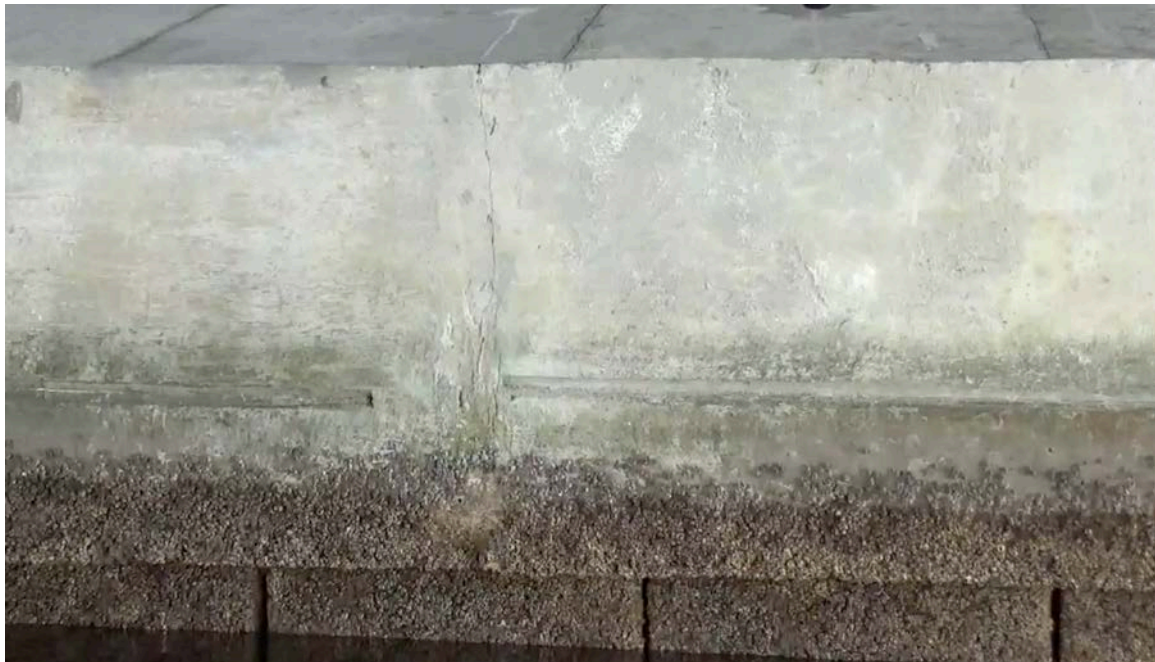
Figure 36: End Bent 6, crack in sheet pile wall cap; (a) at three months, (b) at two years
