**Materials Research Report  
Final Report**

**UNF Project  
Contract No. BDK82 977-03**

# **The Repair of Damaged Bridge Girders with Carbon-Fiber-Reinforced Polymer “CFRP” Laminates**

**Principal Investigator: Adel ElSafty, P.E., Ph.D.**

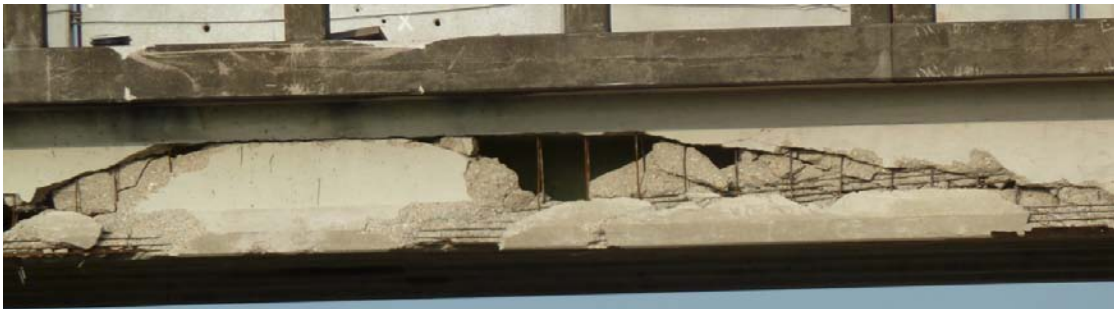
**Figure 1-1: Example of severe impact damage to prestressed concrete bridge girder**

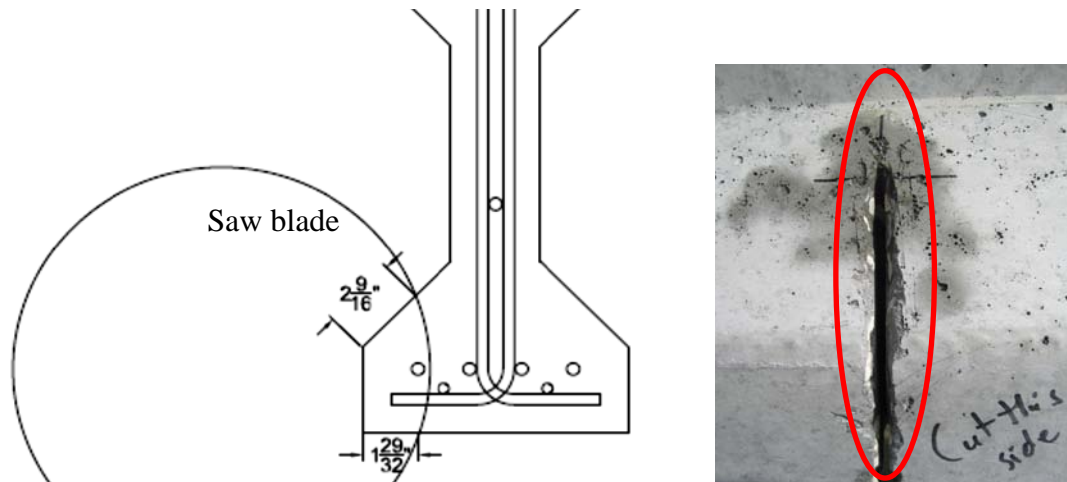
The lateral damage simulation for each girder was achieved by sawing through the concrete of the bottom flange and slicing through one of the prestressing strands. A schematic of this procedure and a picture of the resulting cut are shown in Figure 3-6.

**Figure 3-6: (left) Diagram of sawing used to simulate damage in the girders; (right) Photo showing resulting cut in actual girder sample**

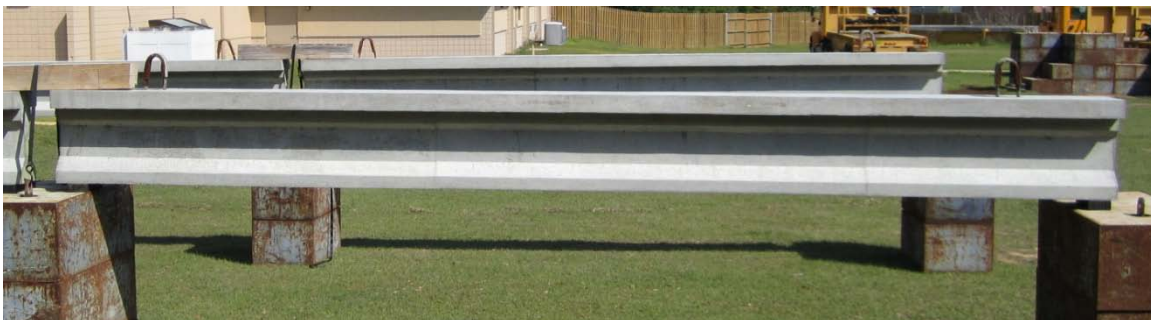
**Figure 3-7: Picture of half-scale girder with cut strands and concrete repair**

To repair the cut, the surfaces exposed by cutting were first roughened with chisels to improve bonding quality. These surfaces were then thoroughly cleaned with a water jet and pressurized air, as specified in both NCHRP 514 (NCHRP R-514) and ACI 440.2R-08. The cleaned cut was filled with a high-strength cementitious repair mortar, and a high-pressure epoxy injection procedure was performed after the mortar set. The procedure resulted in a near-perfect repair of the concrete cross-section. A repaired concrete section is shown in Figure 3-7.

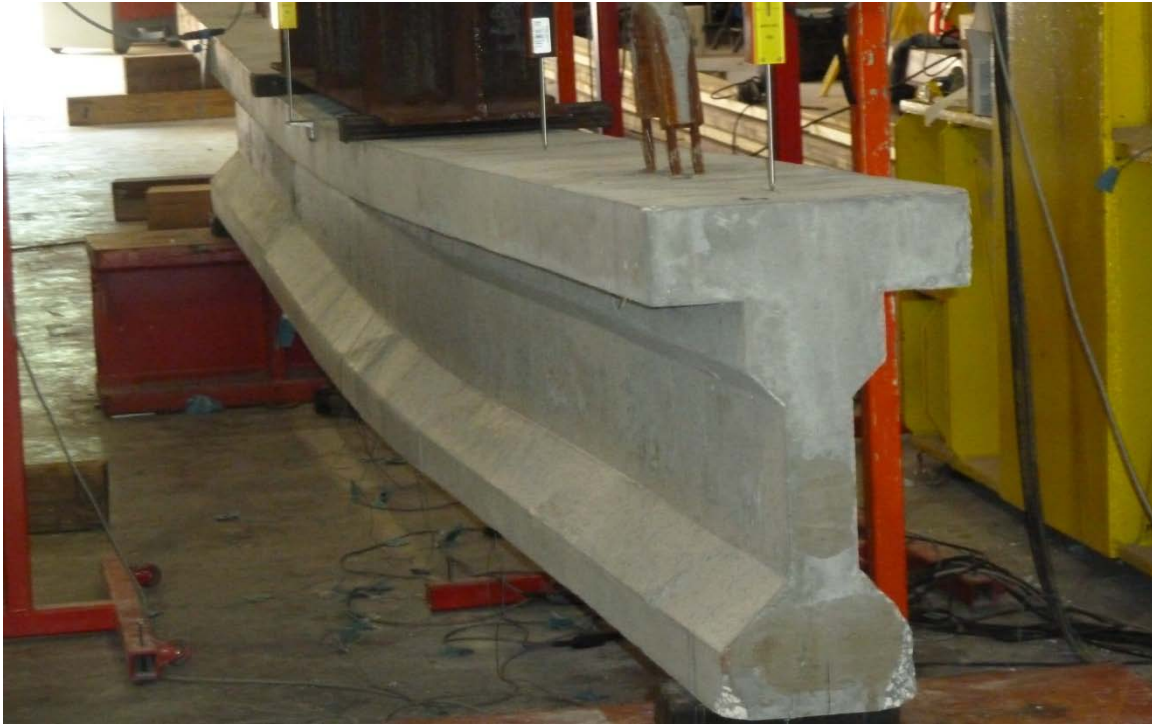
As seen in Table 4-11, the control girders experienced a classic flexural failure initiated by excessive deflection and widening of flexural cracks. A photo of a control beam experiencing excessive deflection is presented in Figure 4-21. As for the repaired girders, they experienced either CFRP debonding, CFRP rupture without debonding, or localized debonding followed by rupture of CFRP; as shown in Figures 4-22 to 4-24. Some repaired girders also experienced debonding of some of their U-wrappings, as shown in Figure 4-24 (right).

**Figure 4-21: Half-scale control girder displaying excessive deflection under loading**

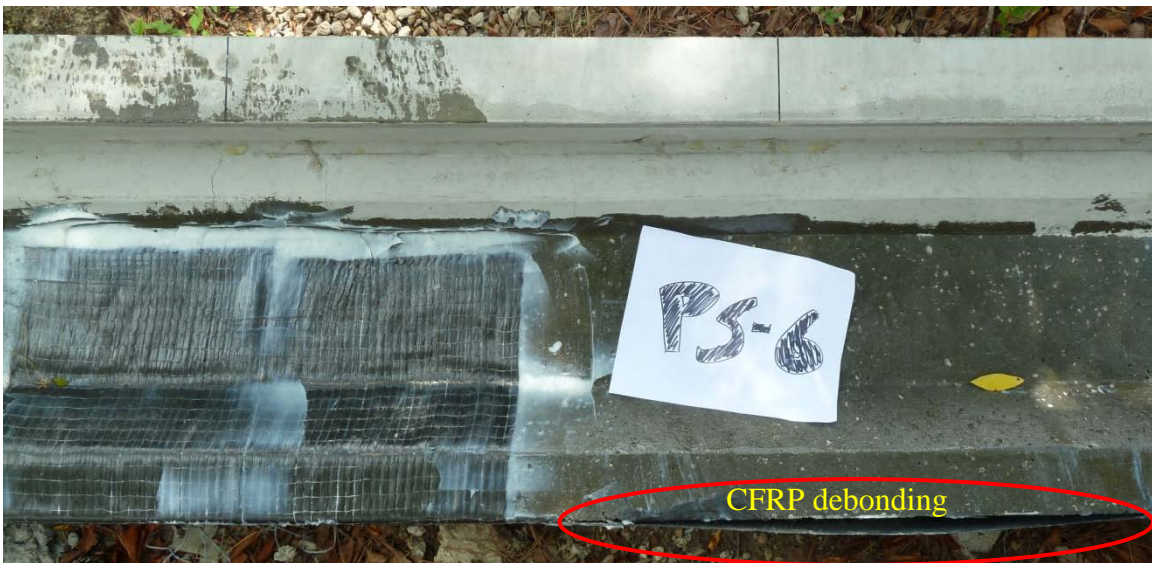
**Figure 4-22: Half-scale girder displaying debonding failure of CFRP laminates**

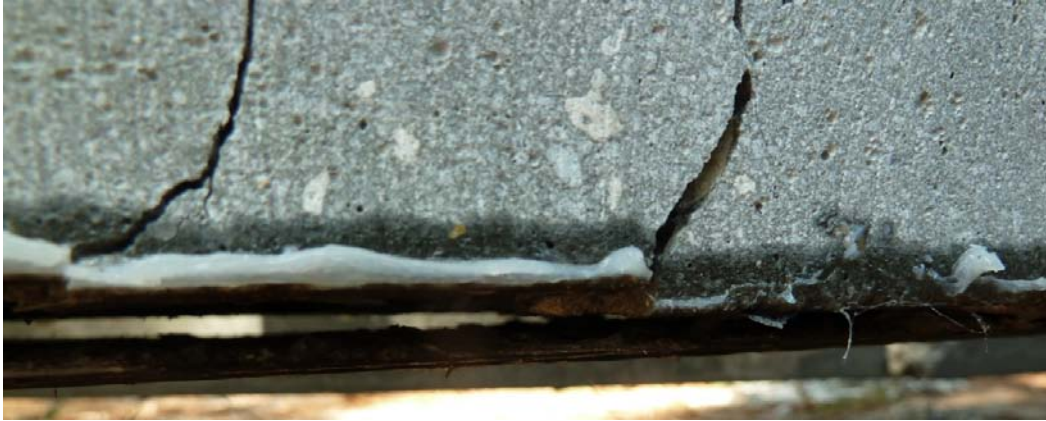
**Figure 4-23: Close-up of laminate debonding initiated by flexural crack development**

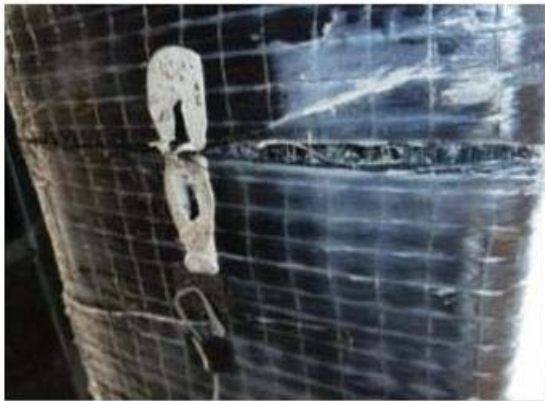
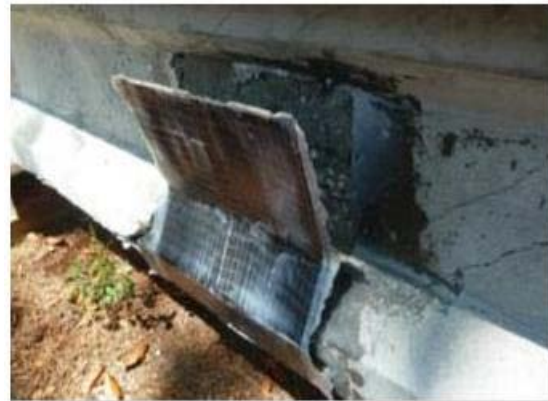
**Figure 4-24:(left) Rupture of longitudinal CFRP, (right) Debonding of CFRP U-wrapping**

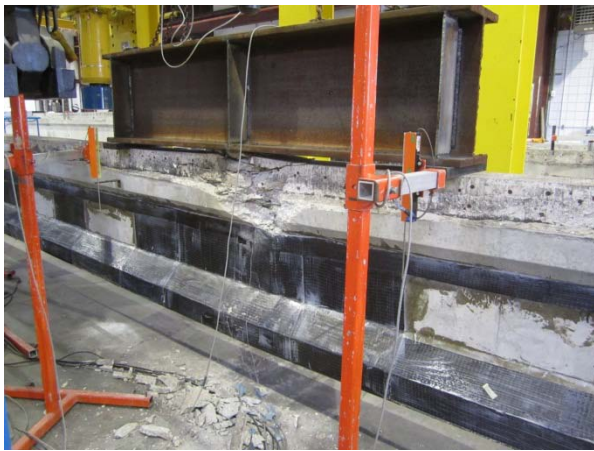
**Figure 4-44: Failure of full-scale PSC girder by static testing**

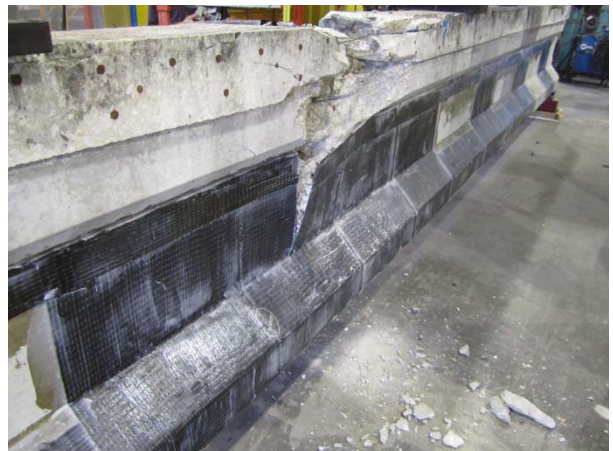
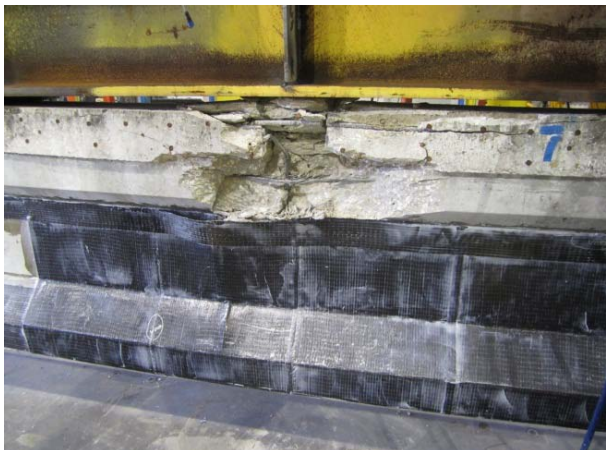
**Figure 4-45: Failure of full-scale PSC girder by static testing**

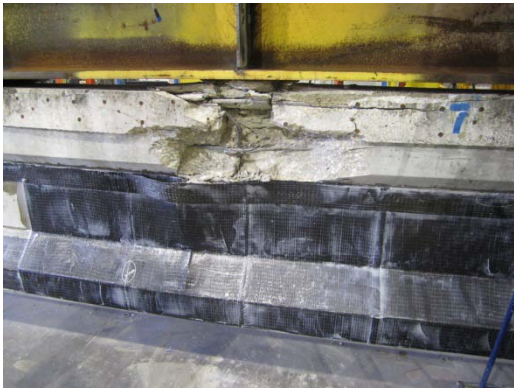
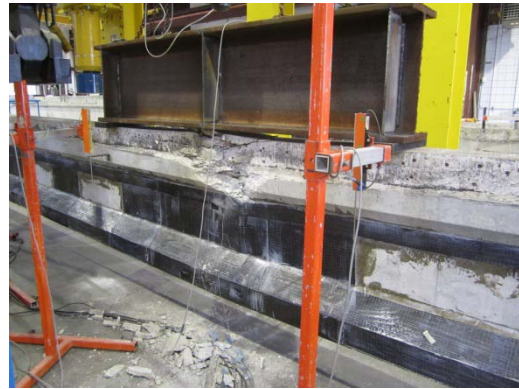
**Figure 9-6: Girder failure under loading**
