Precast Element Evaluation for the US 90 Bridges over Little River and Hurricane Creek

Contract Number BDV30-307-01
FSU Project ID 032819

July 2019
FINAL REPORT

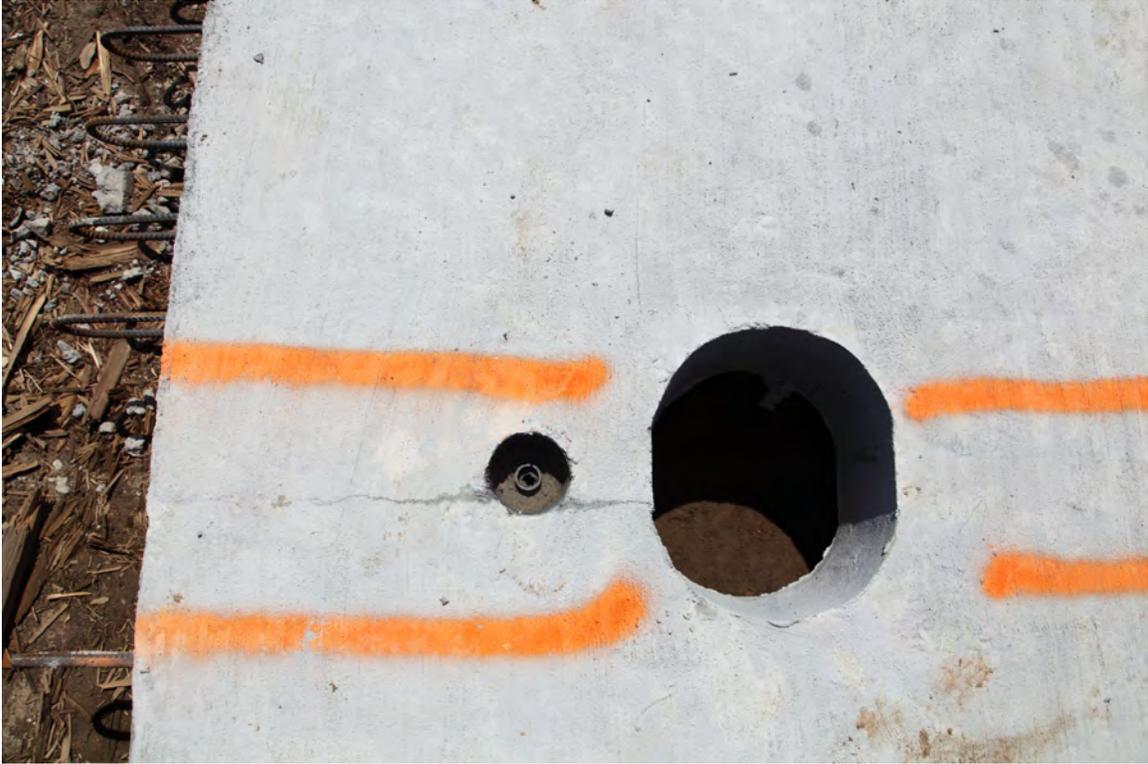
Photos of the twin, parallel casting beds are provided in **Figures 4-3 to 4-5.** **Figures 4-6 and 4-7** show the panels being transported around and stored in the casting yard. Soon after being cast, the panels experienced cracking, mostly along the short direction and particularly around the shear pockets, leveling bolts, and lifting devices (examples of cracks are shown in **Figures 4-8 and 4-9.**) Each panel was marked with its designation (**Figure 4-10**). When the researchers documented panel cracks with photos, they started on the marked end and worked left to right and towards the unmarked edge.

Fig. 4-8. Non-prestressed Precast Deck Panel , Example of Crack Adjacent to Shear Pocket

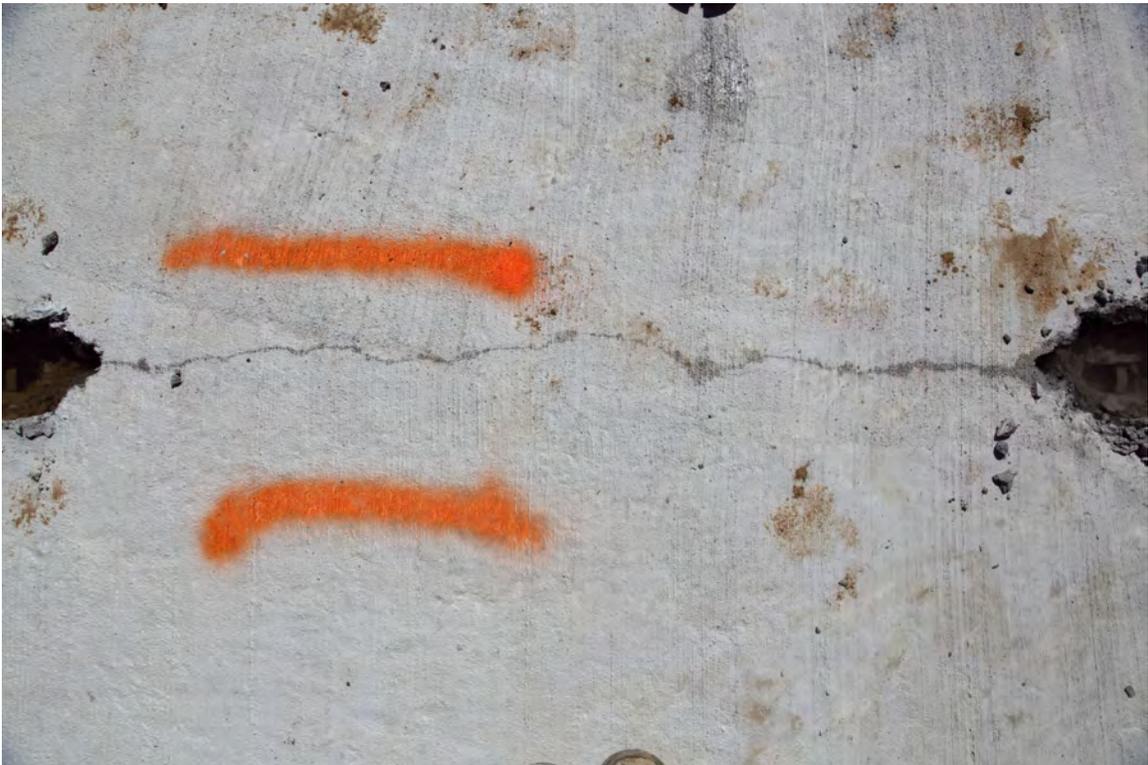
Fig. 4-9. Non-prestressed Precast Deck Panel, Example of Crack Adjacent to Lifting Loops

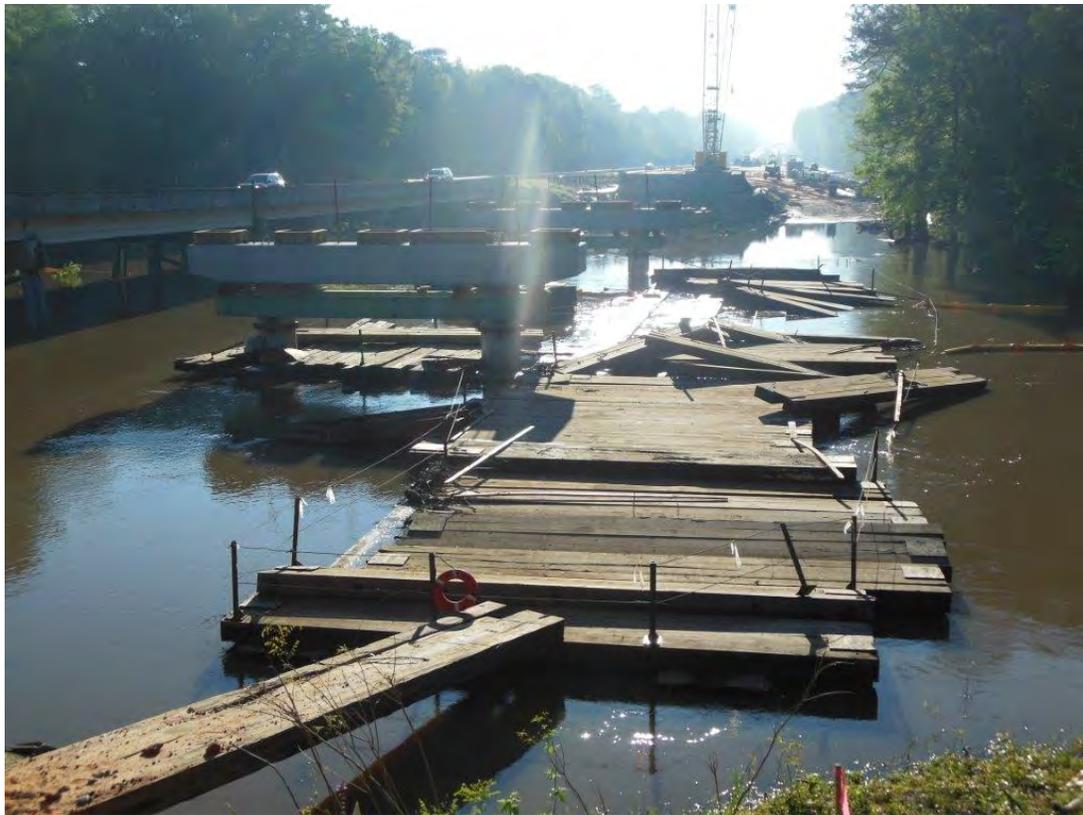
Fig. 1-13. Temporary Work Bridge Damaged by Flooding

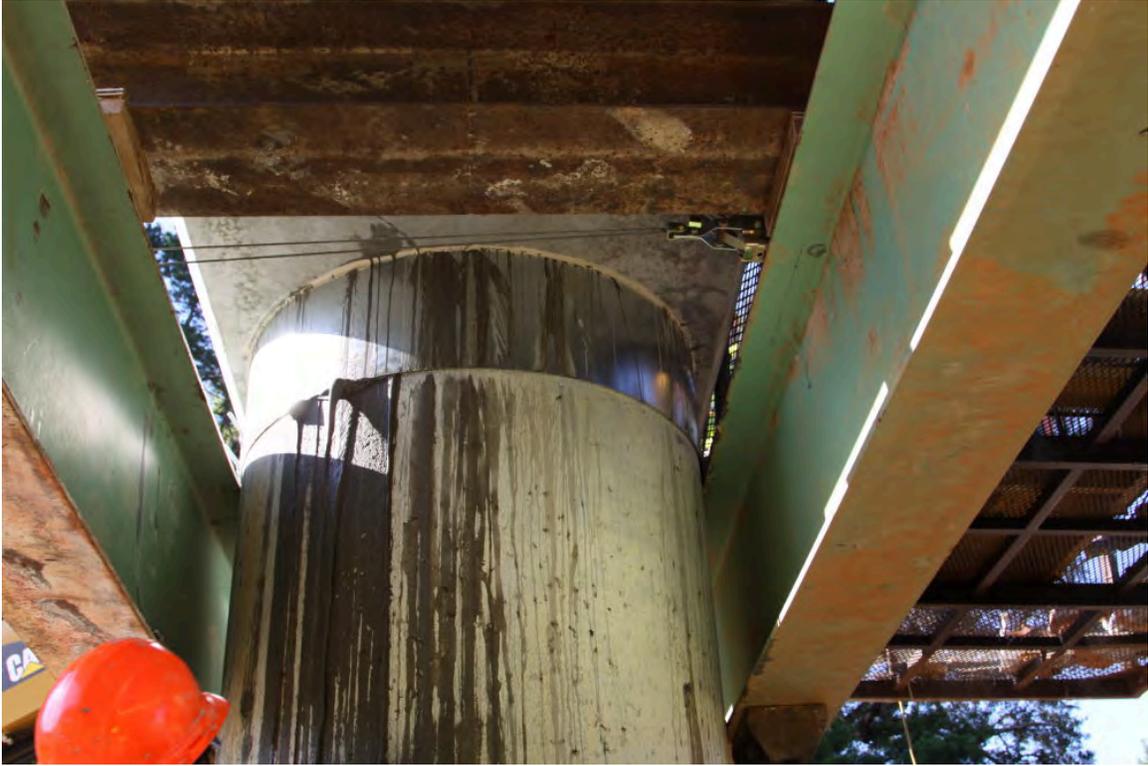
Getting a good seal on the forms was difficult. The forms often leaked (**Figure 2-35**) and had to be tightened “on the fly”, as shown in **Figures 2-36 and 2-37**. Sonotube forms were originally used, but they blew out. Then sonotubes with metal collars were used, but the metal leaked. The contractor ended up using sonotube – cut into two pieces to get it around the column – and clamped a two-piece sheet metal around it. They also caulked the top and bottom of the sonotube to help with the seal. The WB bridges had far less leakage than EB because of the improvements made in the process. The ability to freely tighten the forms, to stop leaks that occurred while grouting, was important.

Fig. 2-35. Leakage in Forms while Grouting Bent Cap on Little River EB (September 14, 2014)

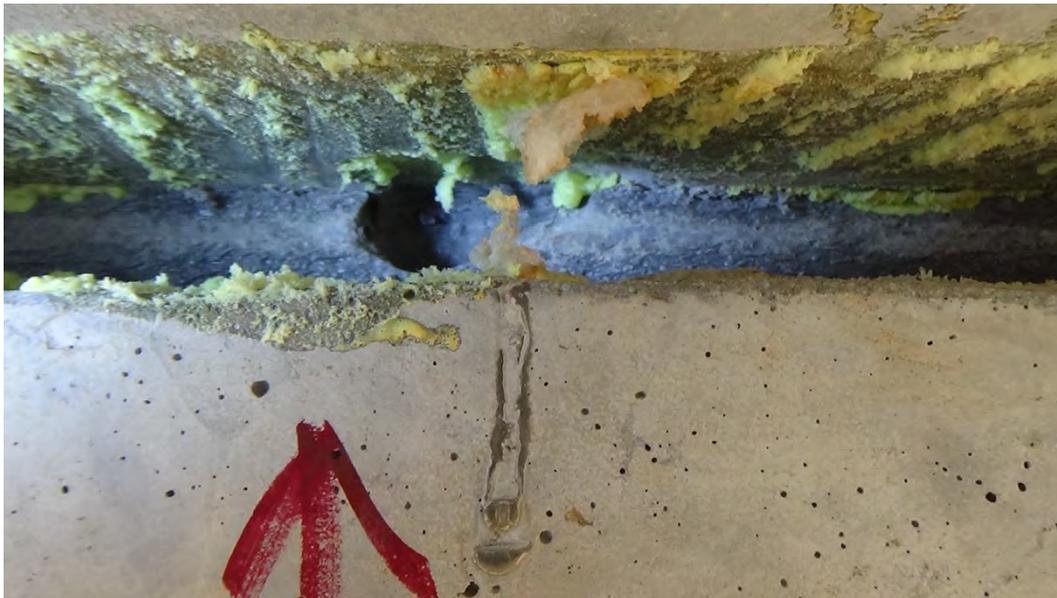
Figures 3-60 and 3-61 show the haunch after the polyethylene was removed. In **Figure 3-60**, the grout had fully filled the haunch, which was typically the case when spray foam sealant had not been added. However, in **Figure 3-61**, notice the yellow-colored remains: this is from the spray foam sealant that had been added to prevent grout leakage where the polystyrene did not form an adequate seal. The spray foam sealant expanded too much and caused the void that is visible in the photo. This is an example of the several voids that occurred as a result of overexpansion of the spray foam.

Fig. 3-61. Void in Haunch Left by the Spray Foam Sealant on Hurricane Creek EB

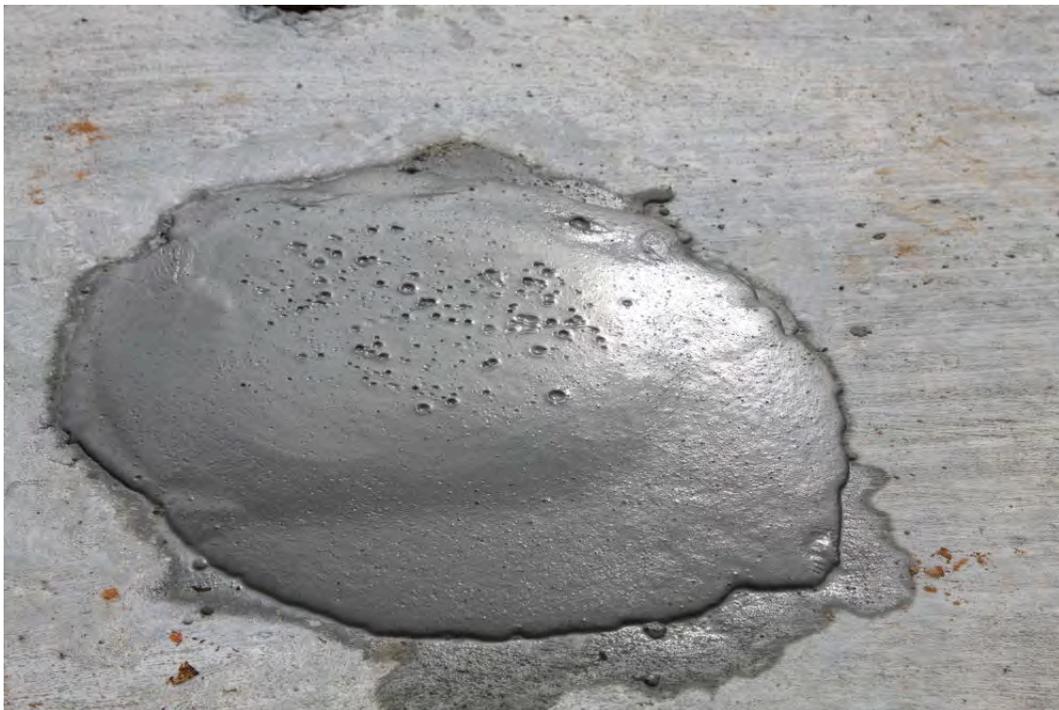
Fig. 4-27. Grout Expands After Setting

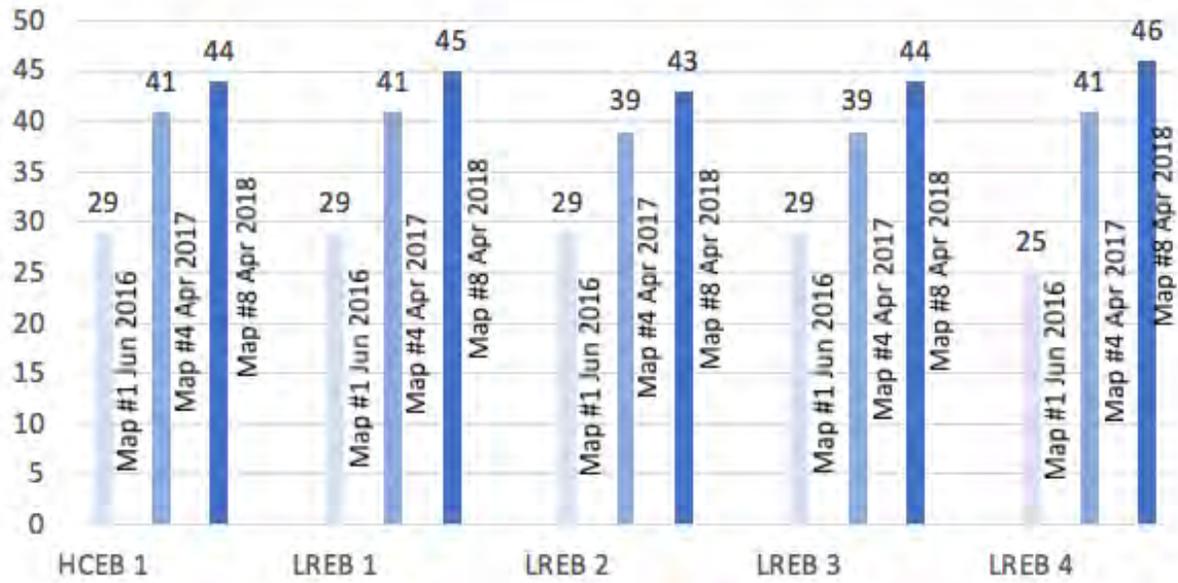
Fig. 3-11. Number of Cracked Shear Pockets on Eastbound Spans

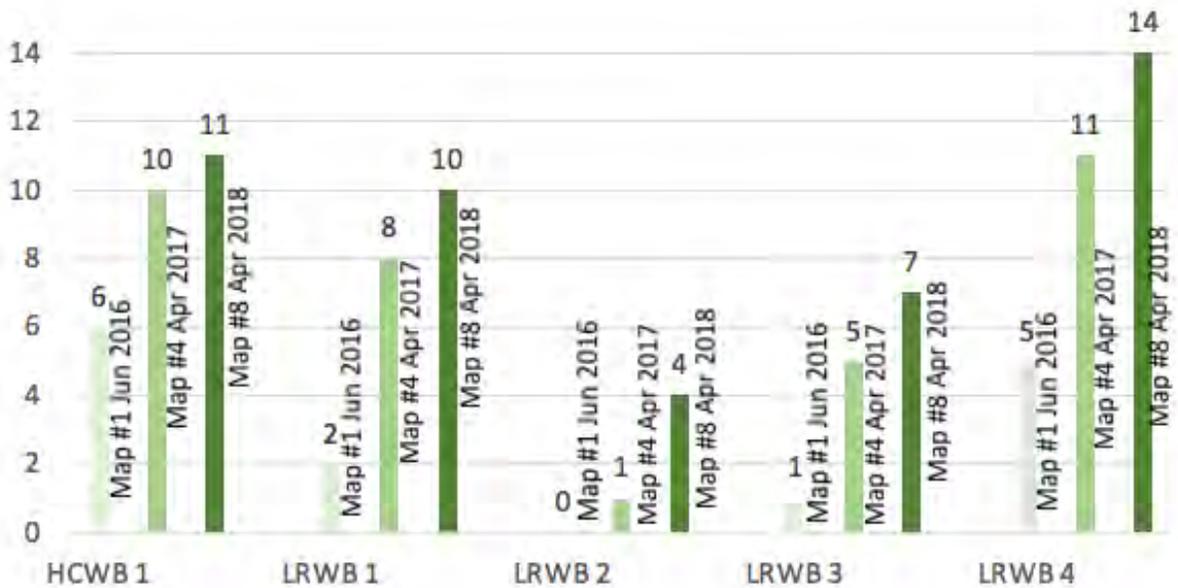
Fig. 3-12. Number of Cracked Shear Pockets on Westbound Spans
