Final Report for Research Project

**LONG-TERM MAINTENANCE MONITORING
DEMONSTRATION ON A MOVABLE BRIDGE**

**Mustafa Gul, H. Burak Gokce
and
F. Necati Catbas***

September 2011

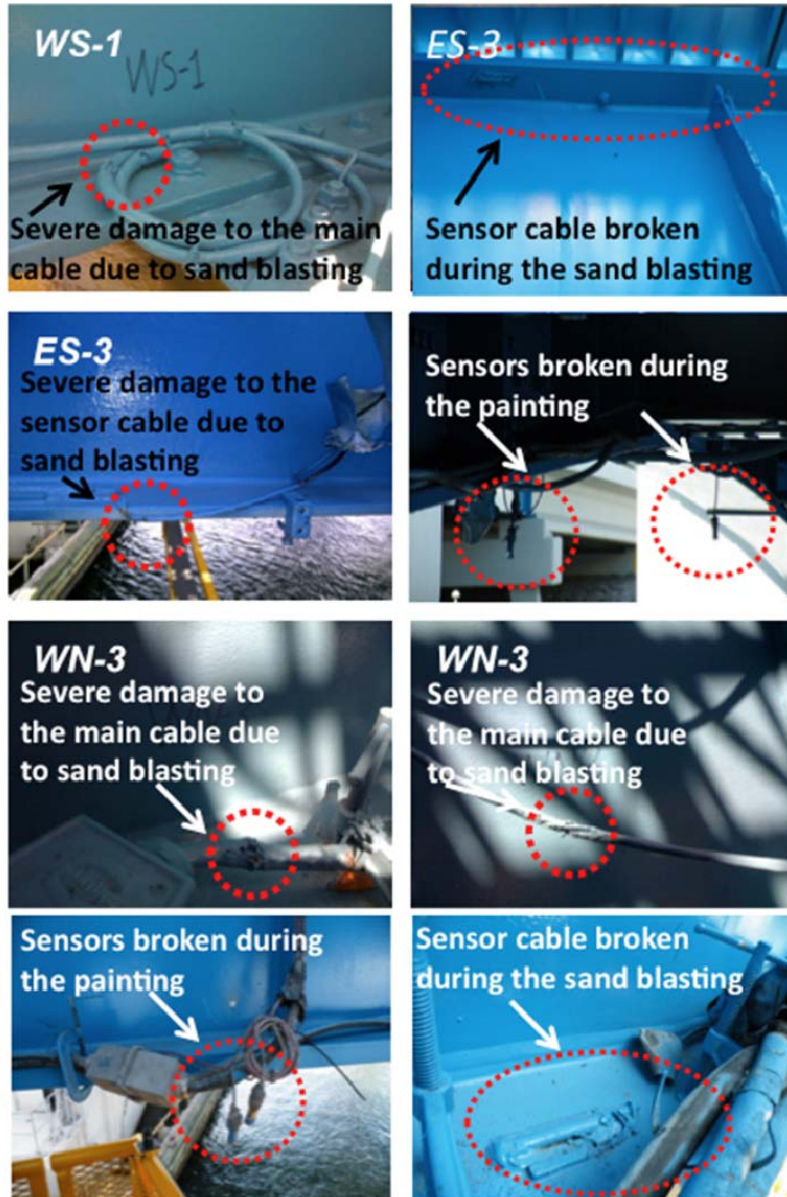
- Operations at the bridge and environmental issues: The maintenance operations, work at the machinery room, loss of power (tripping at the outlets due to rain, or simply disconnected power cords also caused damage in some sensors, which have been replaced accordingly. This system halt caused some missing data from the electrical and mechanical components. The sand blasting and painting operation caused significant damage to the sensors and cabling of the monitoring system. Repairs and/or replacement of these components were attempted during the several field visits conducted during the extension project (details about these field visits are presented in the monthly reports). Some pictures showing damage to the monitoring system due to the sand blasting and painting are presented in the following (Figure 7).

Figure 7: Sample pictures showing the severe damage to the monitoring components at different locations (WS: West-South, ES: East-South, WN: West-North)

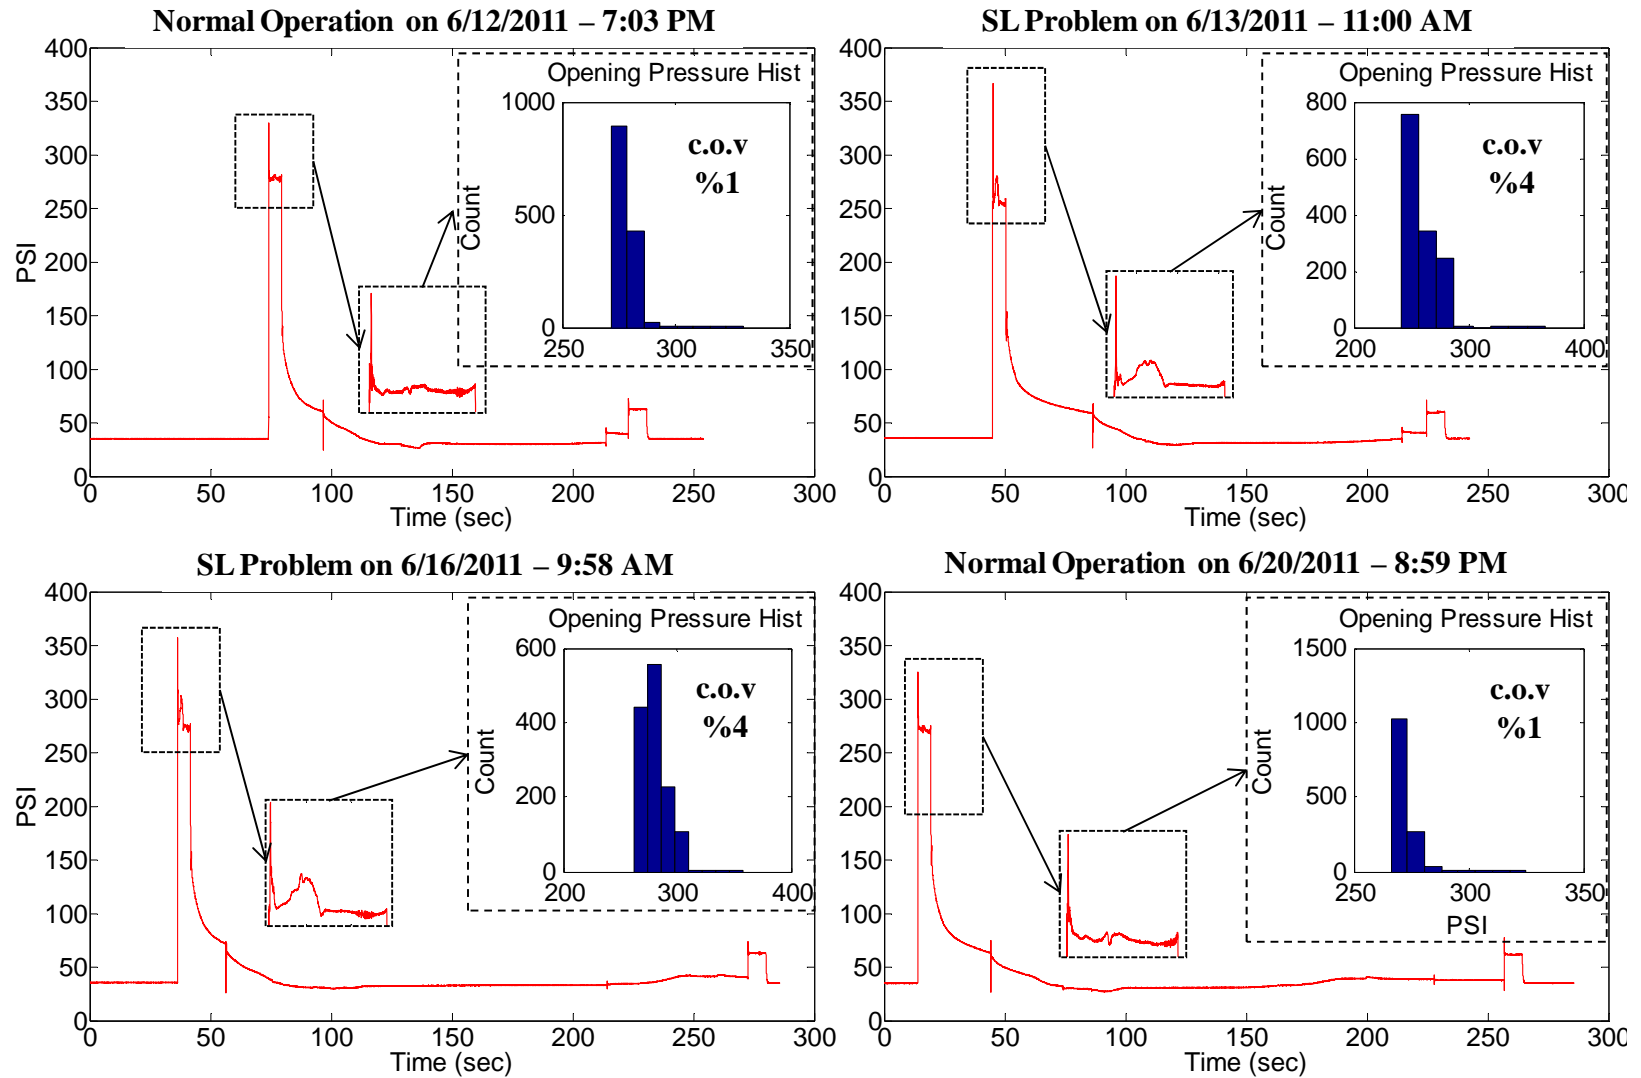
levels corroborate with the changes observed at the span lock pressure gages, these are also affected by the traffic on the bridge.

Figure 44: Behavior change of the pressure gage data

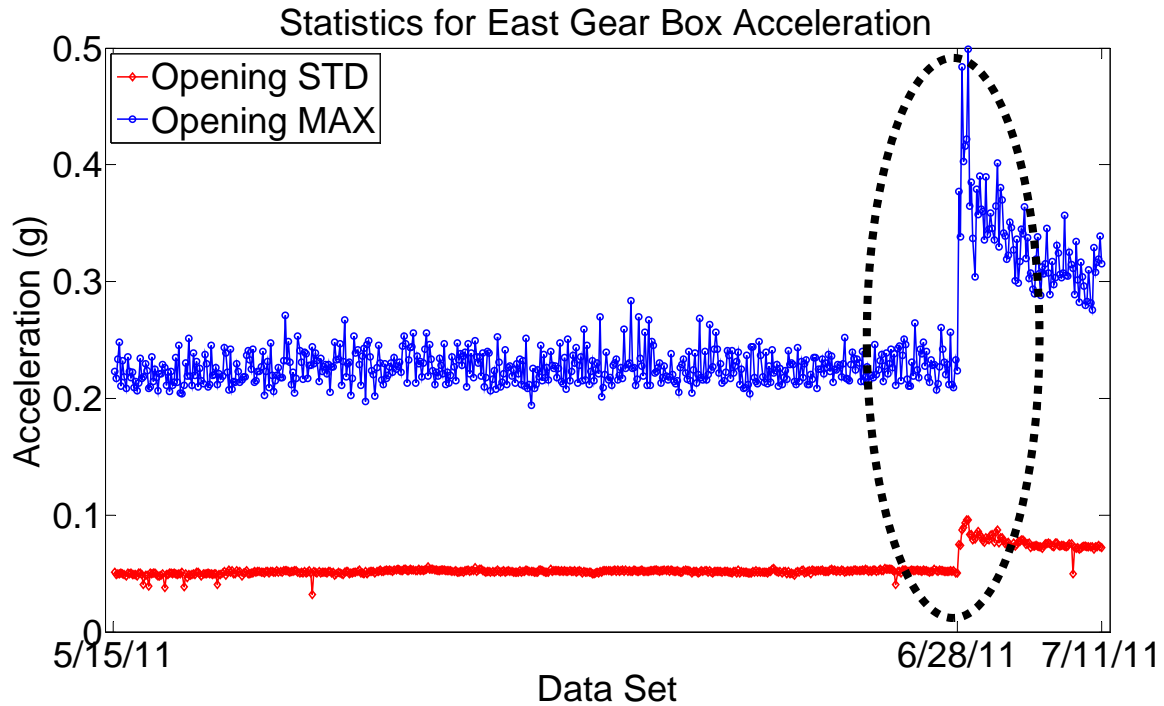
determine if the gearbox condition is satisfactory. While tracking the statistical properties of the gearbox accelerations, a significant increase in the vibration levels is seen on 6/28/2011 which is shown in Figure 48. Before this date, the maximum vibration levels are slightly higher than 0.2 g whereas the vibration levels increased to 0.3-0.5 g after 6/28/2011. The change in the standard deviation characteristics is also shown in Figure 48.

Figure 48: Gearbox acceleration statistical trend

The second case study is the gearbox shaft seal replacement on 6/28/11. In this case study, the effect of maintenance is evaluated with the help of monitoring data. Before this maintenance, the baseline acceleration level on gearbox was around $\pm 0.2g$ but after the replacement of the shaft seal on gearbox, the acceleration level is increased to $\pm 0.3g$. Excessive vibrations are one of the main problems for machinery components, and the effectiveness of the maintenance was demonstrated with the help of the monitoring system.
