Florida Department of Transportation

# STATEWIDE WRONG WAY CRASH STUDY

Final Report | April 2015

FDOT Central Office

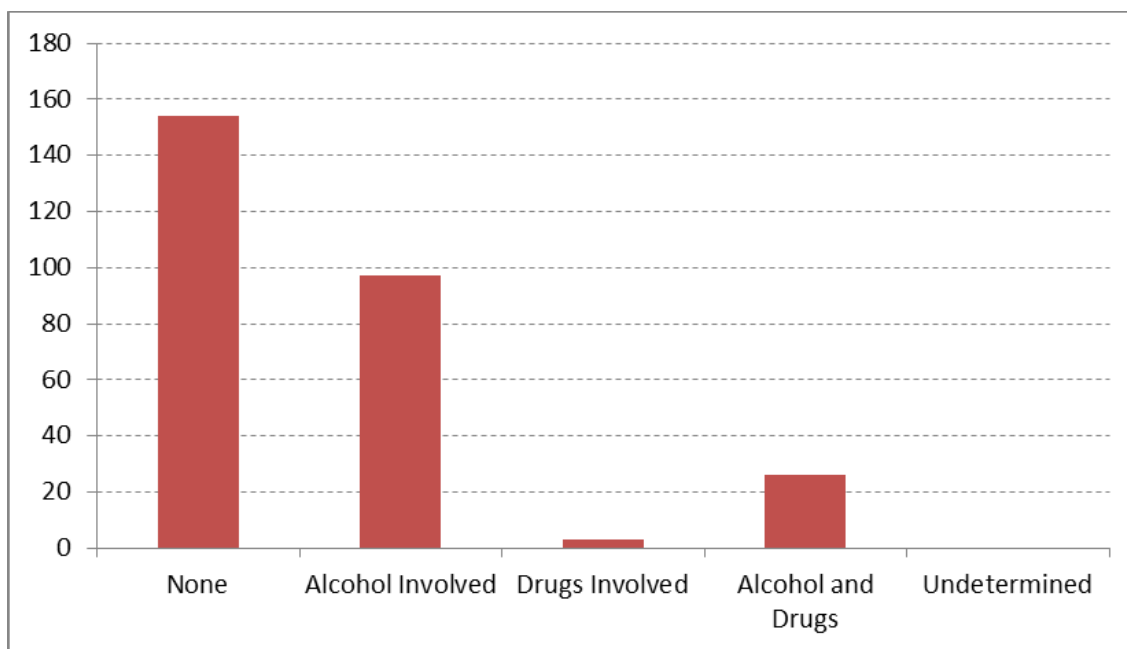
Figure 5 Crash Frequency by Alcohol/Drug Use

In addition to contributing causes (previously shown in **Table 3**), alcohol/drug use by motorists is coded separately in the crash reports. **Figure 5** displays the alcohol/drug use as noted in the police reports. Alcohol and/or drug use was present in 45 percent of the wrong way crashes. This is consistent with the literature review findings that approximately 50 percent of wrong way crashes involved the influence of alcohol/drugs. It is also noted that alcohol/drug use is generally believed to be under-reported. One example includes a scenario when the drivers die in the crash and no toxicology report is ordered. Compared to all crashes on freeways/expressways, in which less than 3 percent of crashes involve alcohol and/or drugs, wrong way crashes are 16 times more likely to involve alcohol and/or drugs.

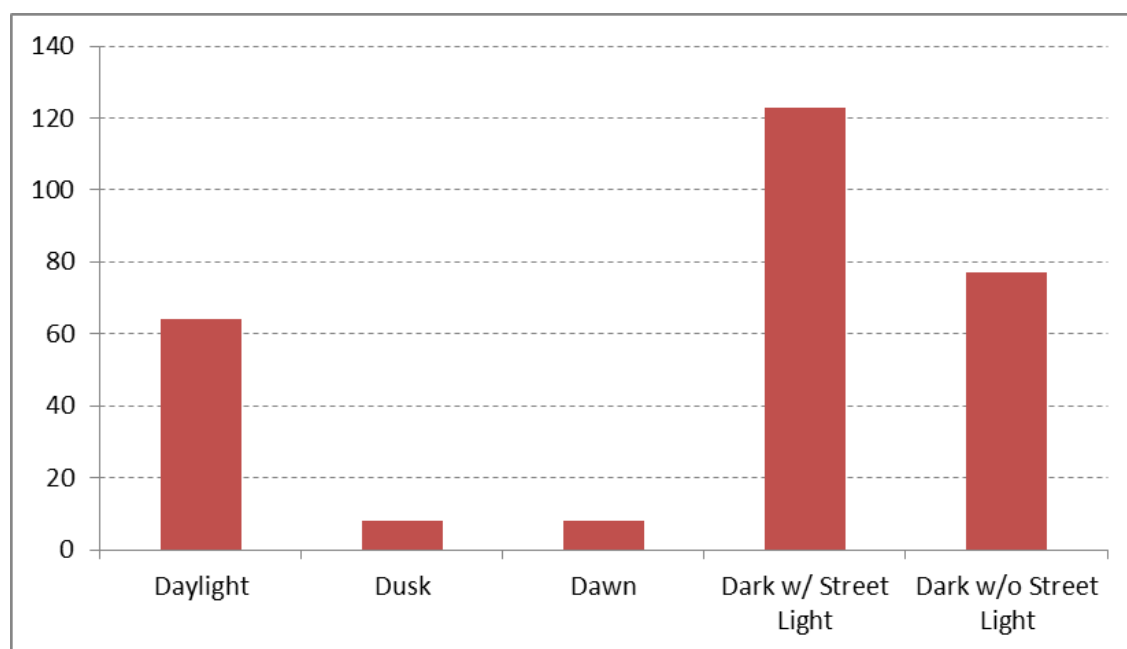
Figure 6 Crash Frequency by Lighting Condition

**Figure 6** displays the distribution of crash lighting conditions. Seventy-one percent of wrong way crashes occurred in dark conditions (44 percent with street lighting, 27 percent without street lighting). In contrast, only 29 percent of all freeway/expressway crashes occur in dark conditions (with or without lighting). Therefore, when a crash occurs in dark conditions (with or without lighting) the probability that it is a wrong way crash increases 2.4 times. Alternatively, when a wrong way crash occurs, it is 2.4 times more likely to have occurred in dark conditions than are other crash types.

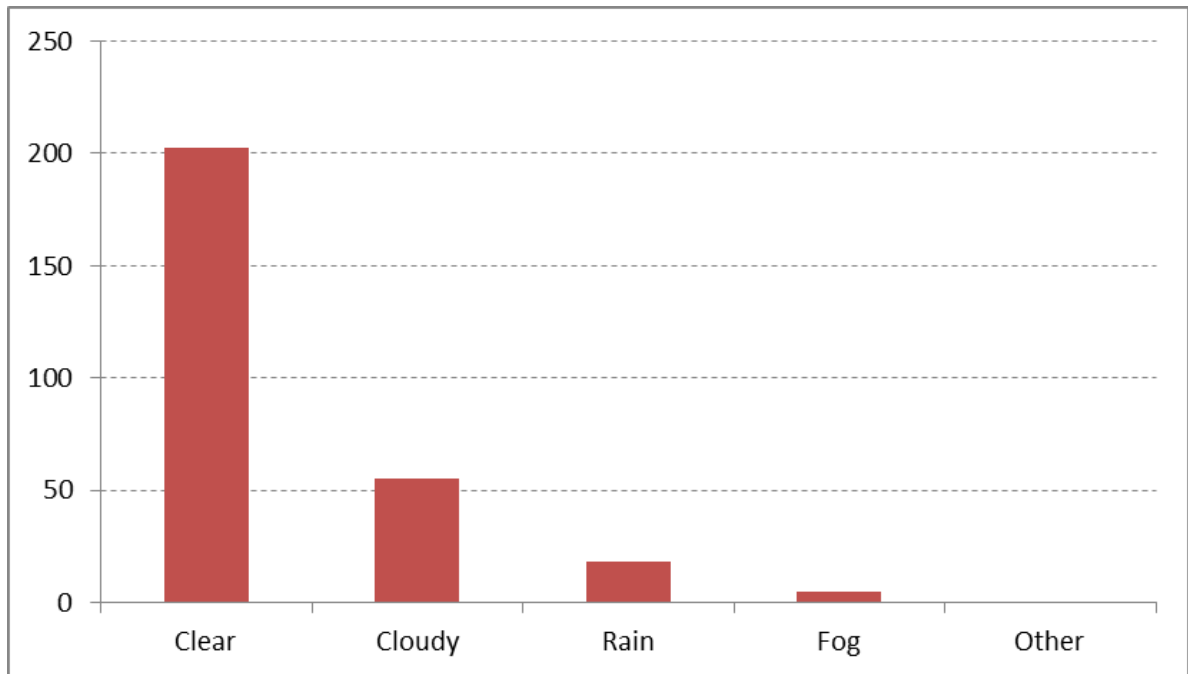
Figure 7 Crash Frequency by Weather Condition

**Figure 7** displays the distribution of crashes by weather condition. The vast majority (72 percent) occurred in clear weather conditions, and only six percent occurred in rain. Over the same time period, rain was present in 18 percent of freeway/expressway crashes in Florida. Therefore, a wrong way crash is three times less likely to occur in rainy conditions than other freeway/expressway crashes. This is likely correlated with the wrong way crash emphasis on midnight to 6am time period, and Florida rain showers tend to occur more often in the afternoon.

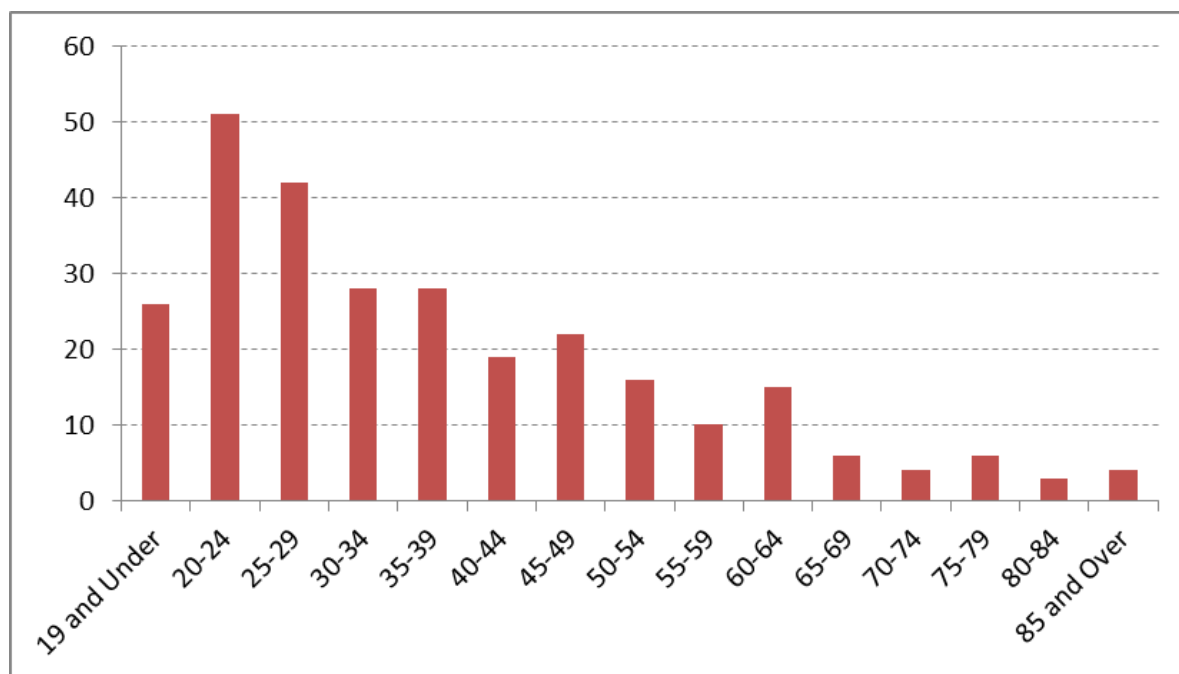
Figure 8 Crash Frequency by Wrong Way Driver Age

**Figure 8** displays the distribution of the wrong way driver's age. The literature review noted age groups 16 to 24 years old and over 65 years old are overrepresented in wrong way crashes. Approximately 43 percent of wrong way drivers were less than 30 years old. Compared to all freeway/expressway crashes in Florida, 50 percent involve drivers under the age of 30. Therefore, this age group does not appear to be overrepresented in wrong way driving as compared to other freeway/expressway crashes.

The proportions taper down moving into the older age groups, with drivers 75 years and older accounting for less than five percent of wrong way drivers. However, this is more than three times the expected proportion from statewide trends on freeway/expressway crashes (1.4 percent for drivers 75 years and older). Therefore, drivers aged 75 years and older are more susceptible (i.e. at higher risk) to a wrong way-related crash.

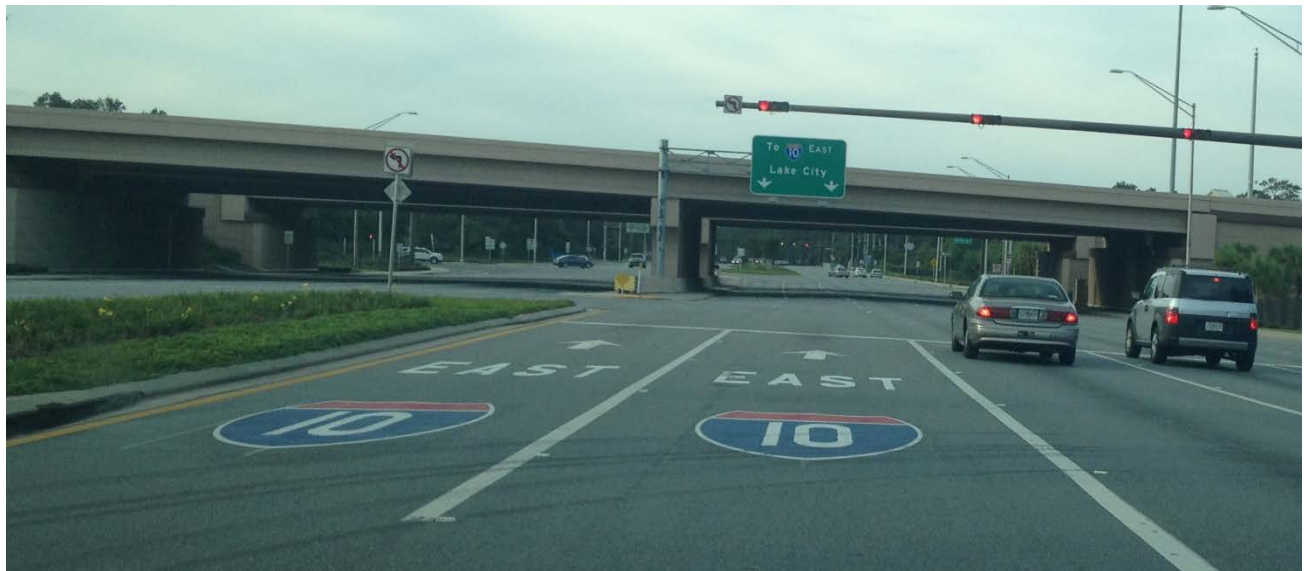
At locations with a left-turn bay extending through the cross-street/exit ramp intersection (such as a tight diamond interchange), left-turn arrows were occasionally observed that may misdirect a turning vehicle onto the exit ramp. In other instances, a through arrow with a RAMP pavement marking legend or interstate shield pavement marking was used in advance of the near-side ramp intersection, as shown below. The photo shown below with the use of an interstate shield pavement marking is the preferable treatment as it discourages a wrong way left-turn at the near-side ramp intersection.
