# DISPUTE REVIEW BOARD RECOMMENDATION

RE: FPN: 258861 1 5201  
Federal Aid No.: 2757 346 I  
SPN 15190-3401  
Contract No.: 20489  
SR-93 (I-275) from East of Gandy Blvd. to East of Roosevelt Blvd.  
Pinellas County

Subject: **Claim Issue – Replacement Cost for High Mast Lighting Conduit Conflict at Ramp D1**

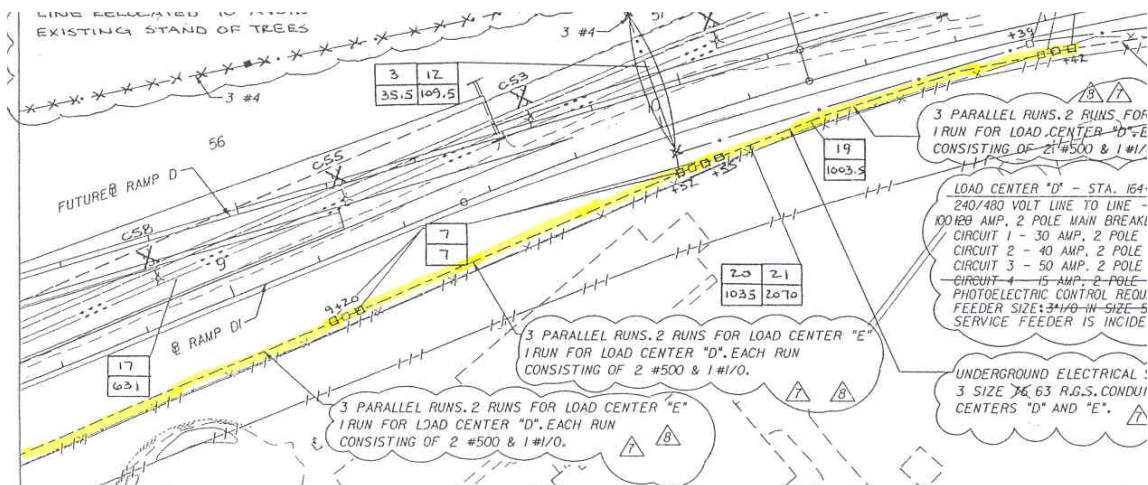
- In spite of the CEI's detailed daily reports, the Final Roadway Lighting Plans (**As Builts**) **do not depict the conduit in its installed location.**

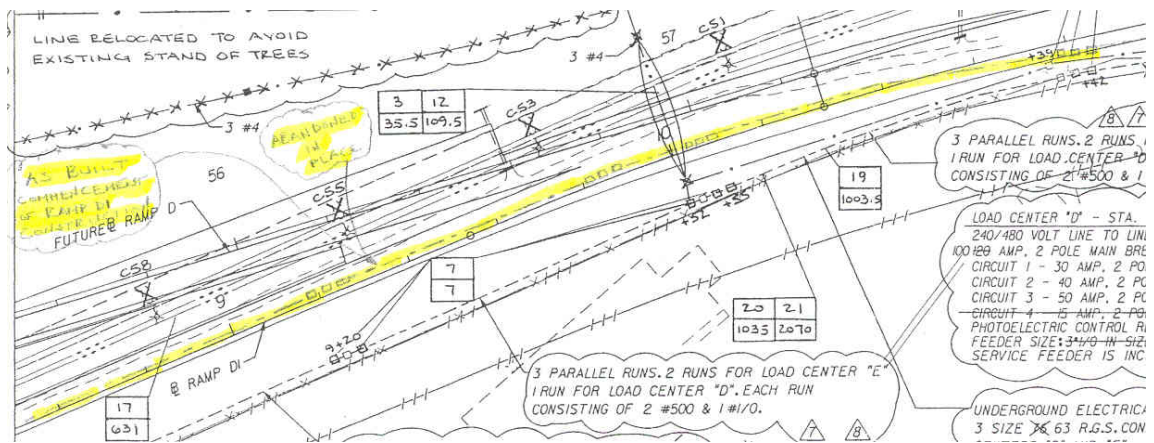
- A succeeding project located the **actual location** of the conduit.

- Since this work was clearly installed substantially away from the pre-existing RW line, which also was marked by an existing fence, **it is not logical that the CEI did not know what HSD was doing.**
- FDOT Specifications state in part:
