## **Origination Form** Proposed Revisions to a Standard Plans Index

Originator:	Turley, Joshua	Index Number:	455-031
Date:	5/15/2025	Sheet Number(s):	Sheet 1
E-mail:	Joshua.Turley@dot.state.fl.us	Index Title:	30" SQUARE PRESTRESSED CONCRETE PILE - HIGH MOMENT CAPACITY

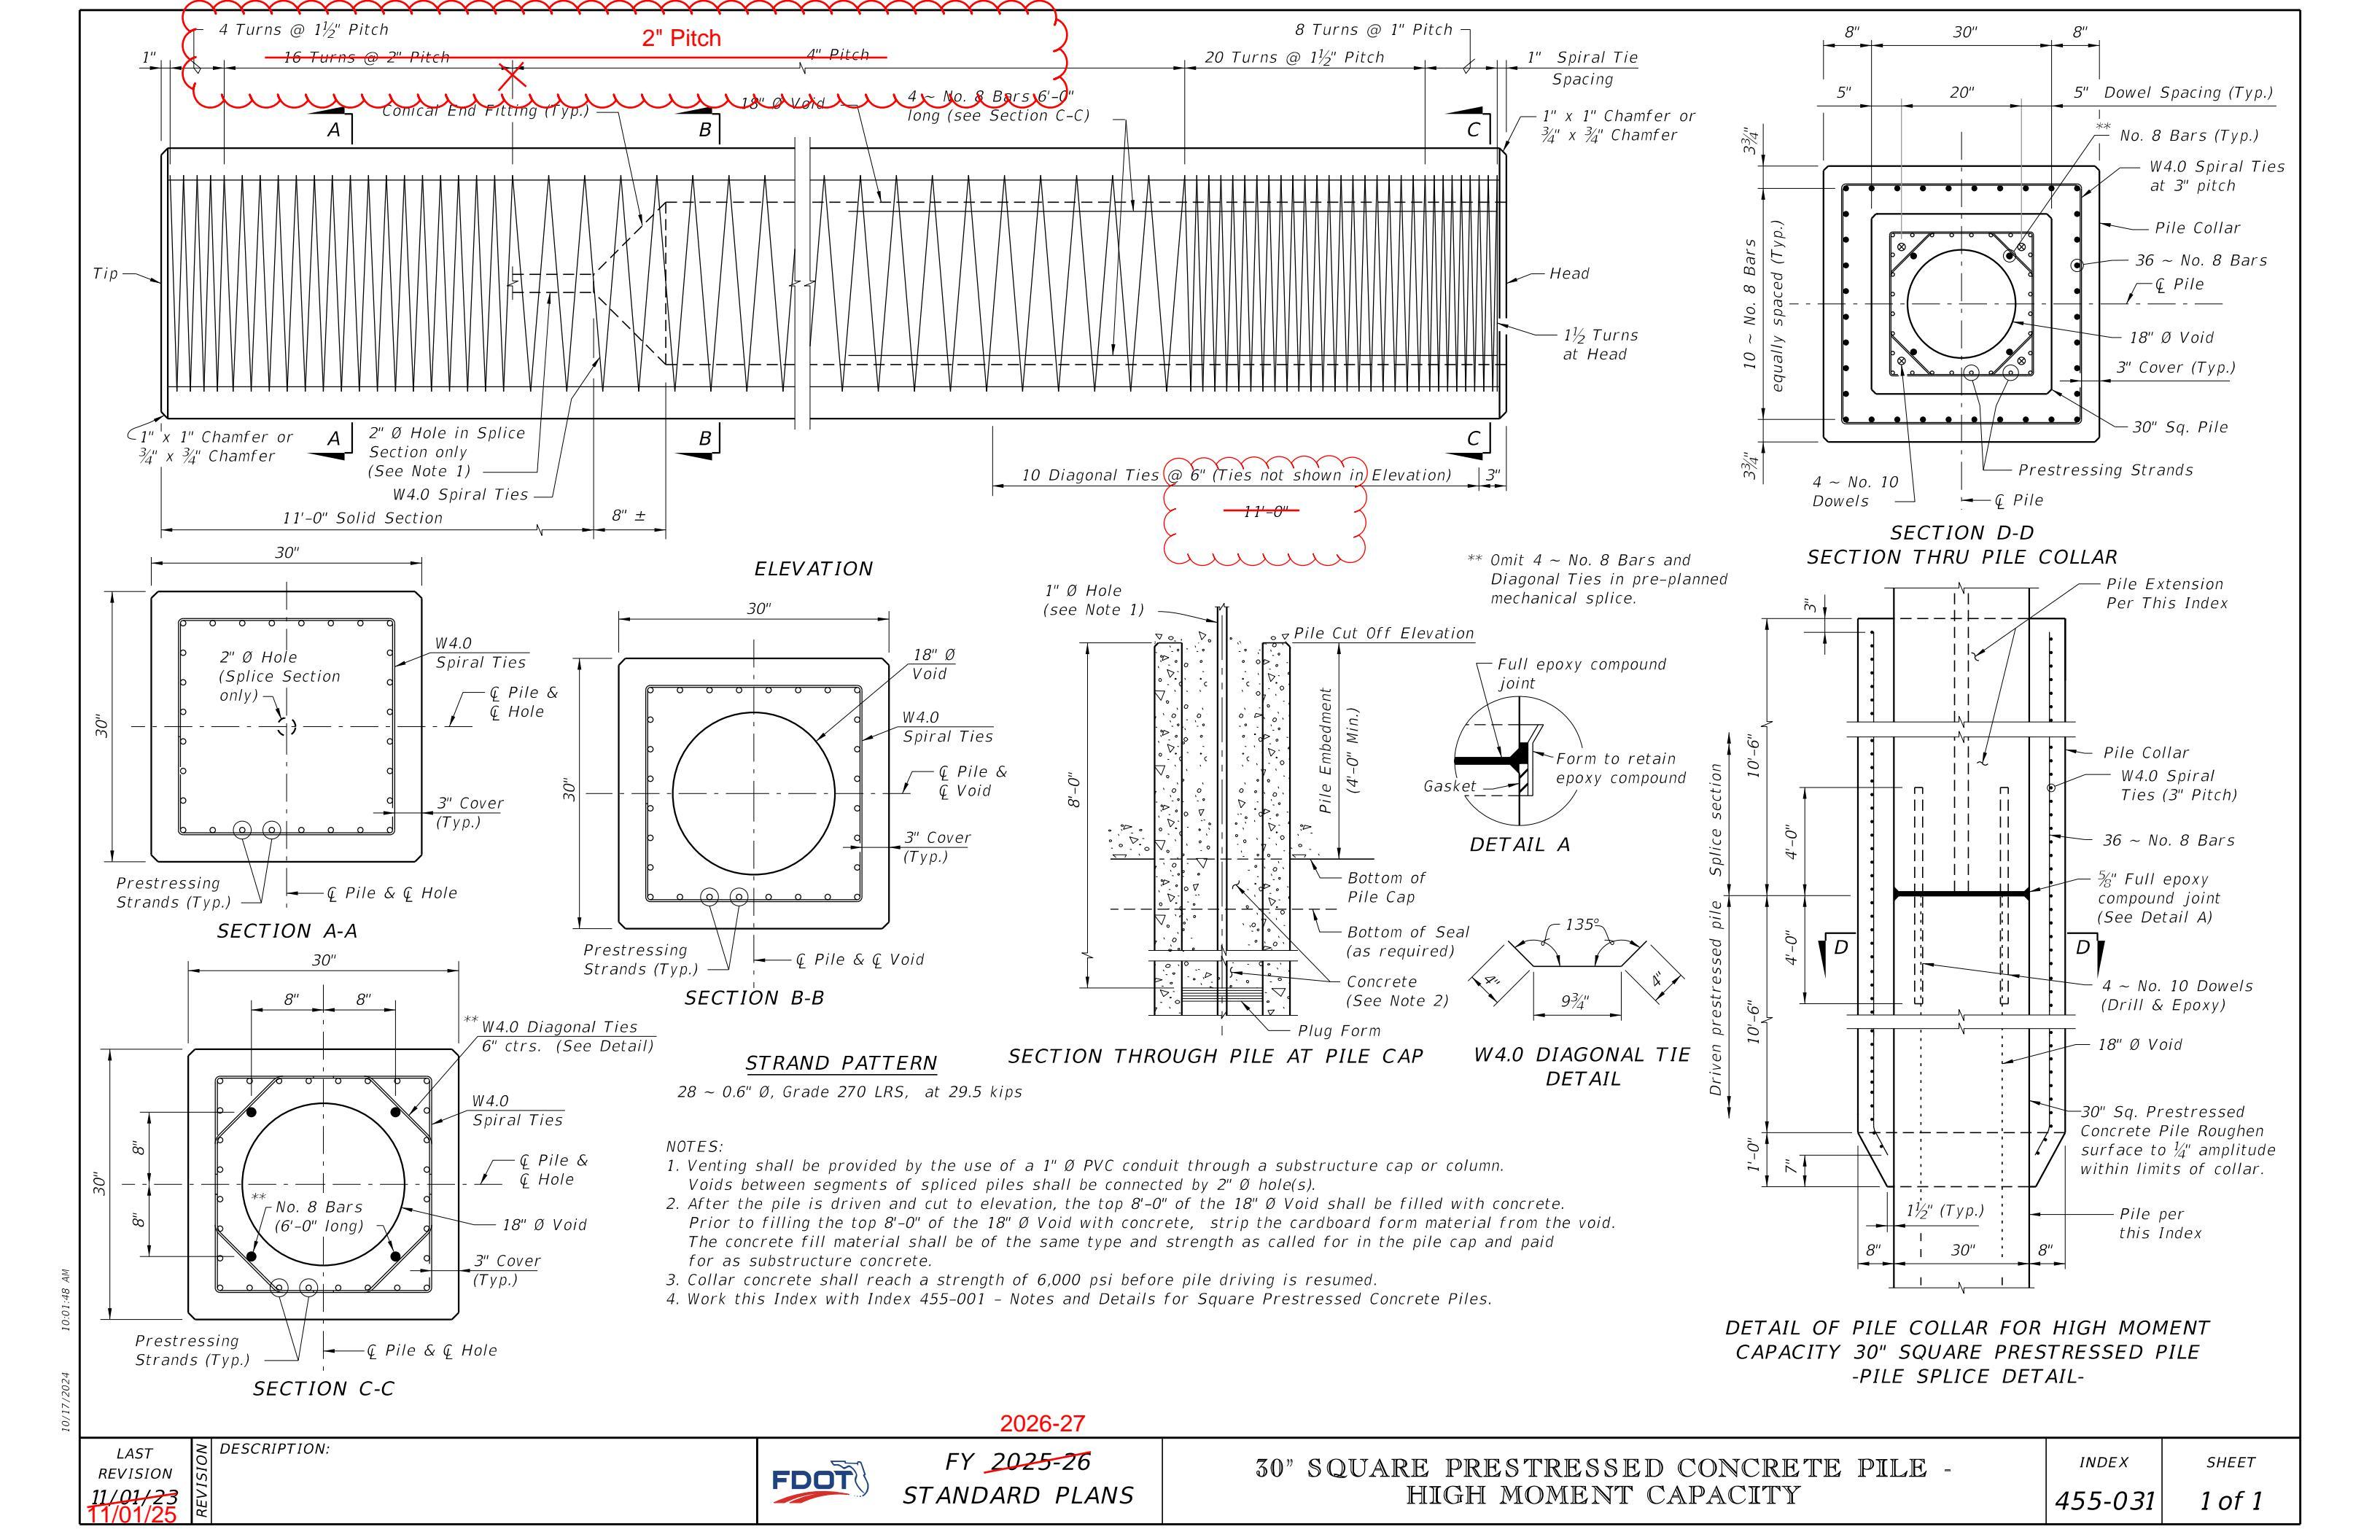
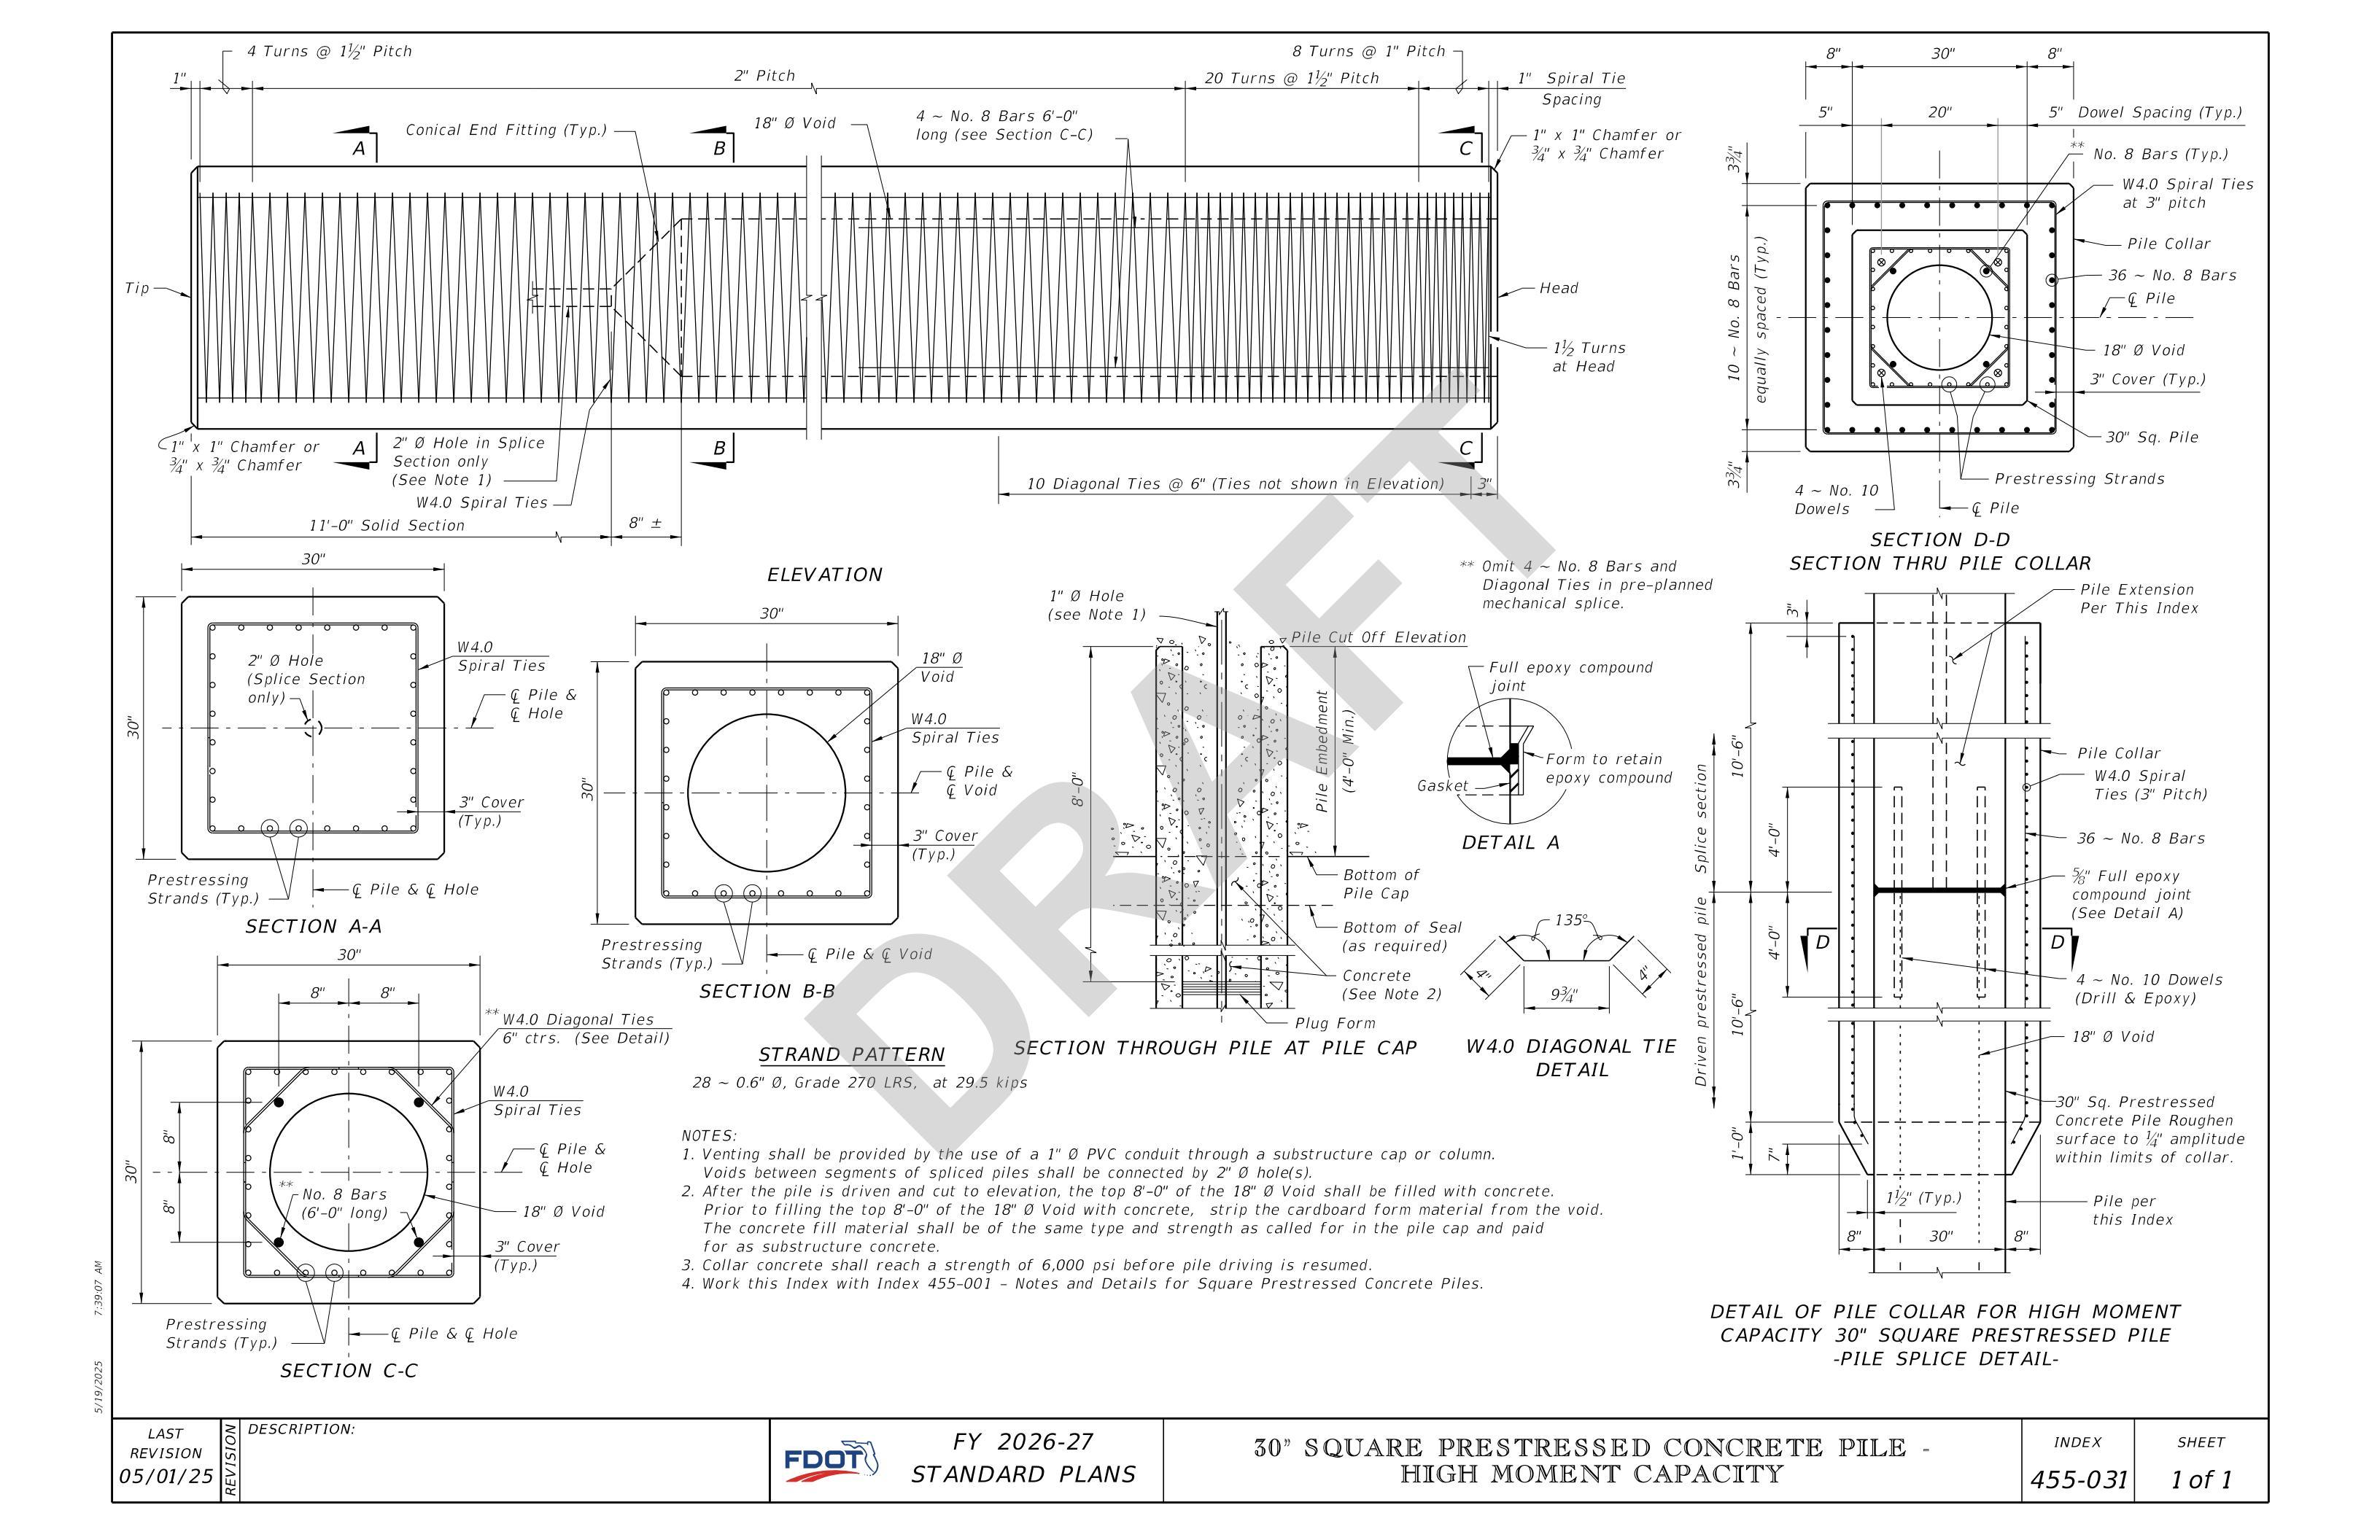
Sheet 1: Changed pitch spacing for spiral ties and removed errant 11' dimension which was a CAD error.

Vertical cracking has been observed in hollow core prestressed concrete piles, including 30-in. voided square HMC and conventional piles, and 60-in. hollow cylindrical piles, during installation and service. To address cracks frequently occur within the 4" stirrup pitch zone, a reduction in stirrup pitch to 2" is proposed to help mitigate cracking in these areas.
