Maintenance Guide for Stormwater Assets

May 2023

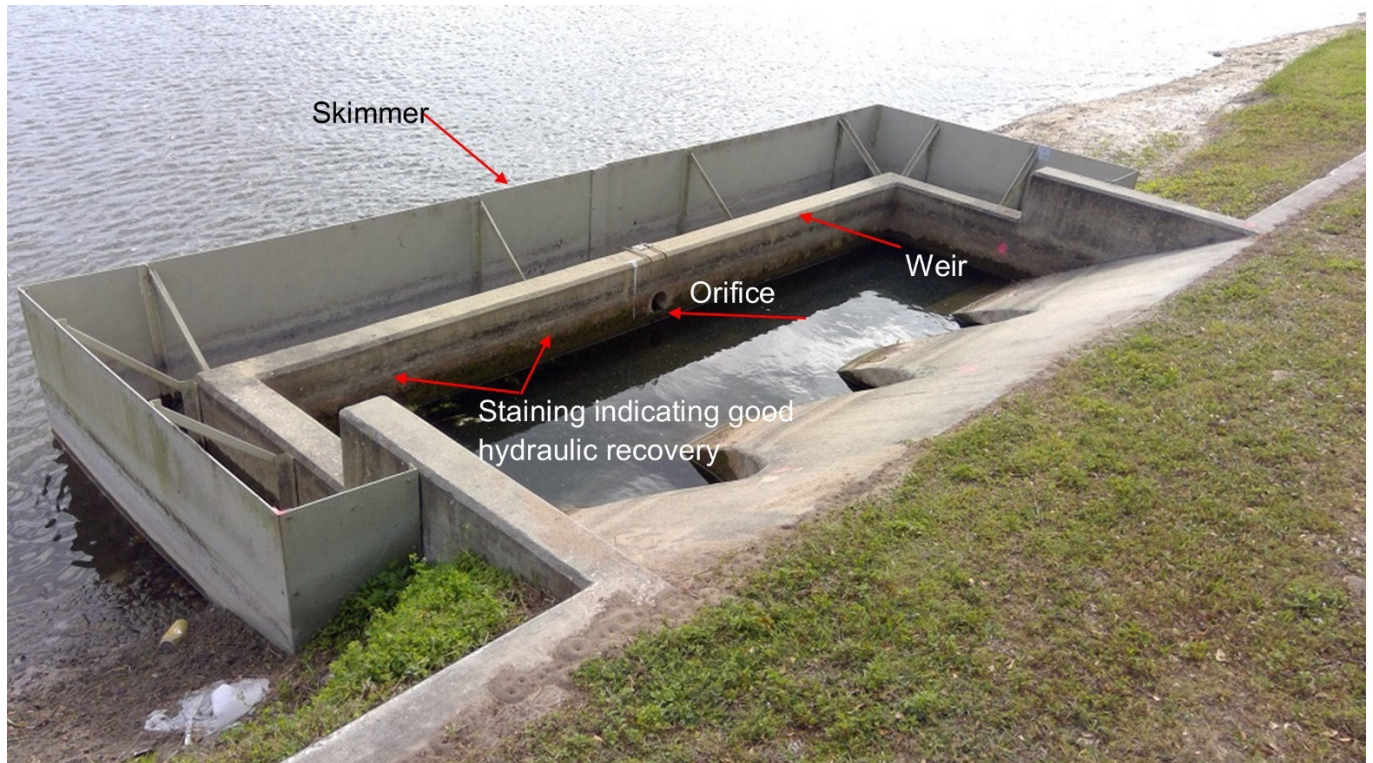
A-1

- Control Structure – Good
 - Chamber – Good – No accumulation of debris or vegetation, no visible damage
 - Orifice – Good - No obstructions restricting flow, structurally undamaged
 - Skimmer – Good – No damage or deterioration, less than 25 percent of opening is obstructed by vegetation or debris
 - Weir – Good – No obstructions or debris preventing flow, structurally sound
- Pipes – Good
 - No obstructions, no structural damage
- Hydraulic Recovery – Good
 - Permanent pool below control (orifice)
 - Staining near top of orifice indicates slow, but steady drawdown during recovery

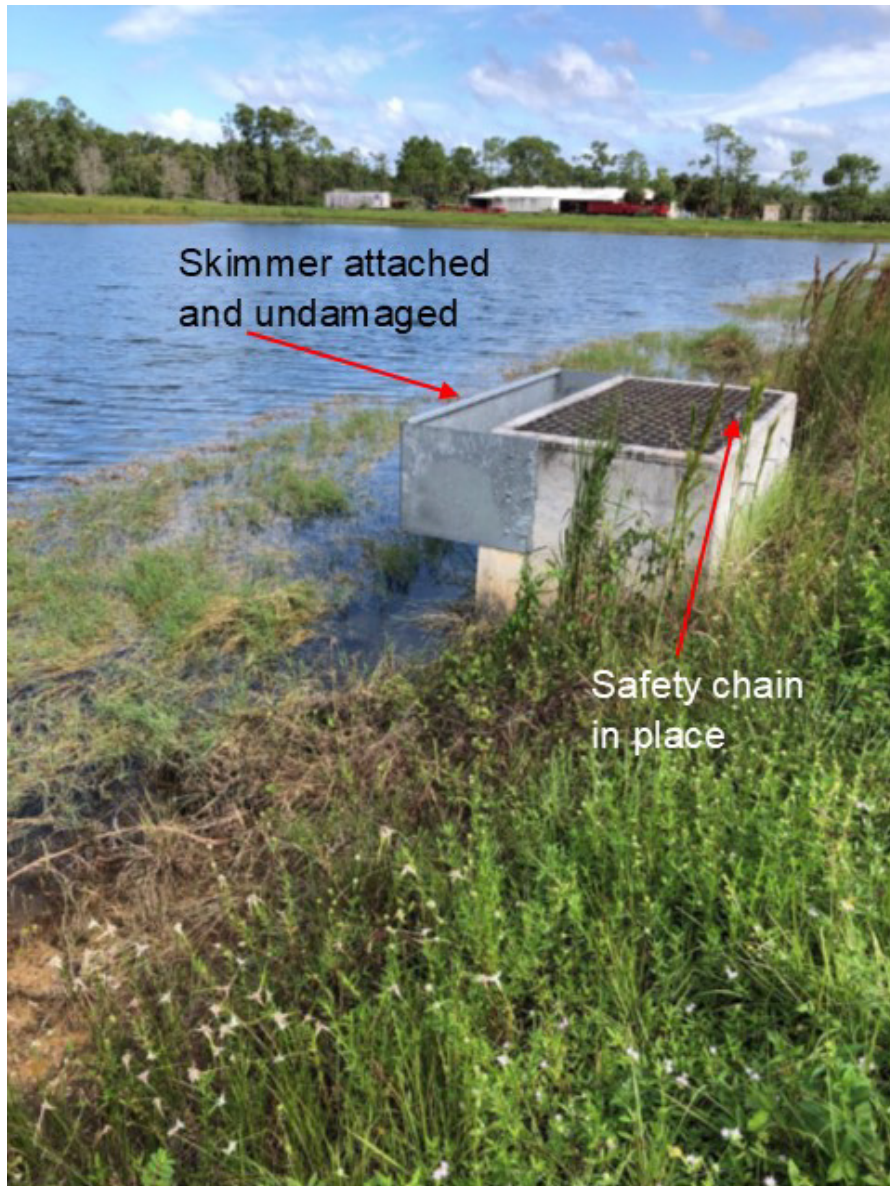
A-2

- Control Structure – Good
 - Skimmer – Good – No damage or deterioration, no obstructions
 - Chamber – Good – Grate undamaged and safety chain in place
- Vegetation Condition – Fair
 - Excessive vegetation on side slopes

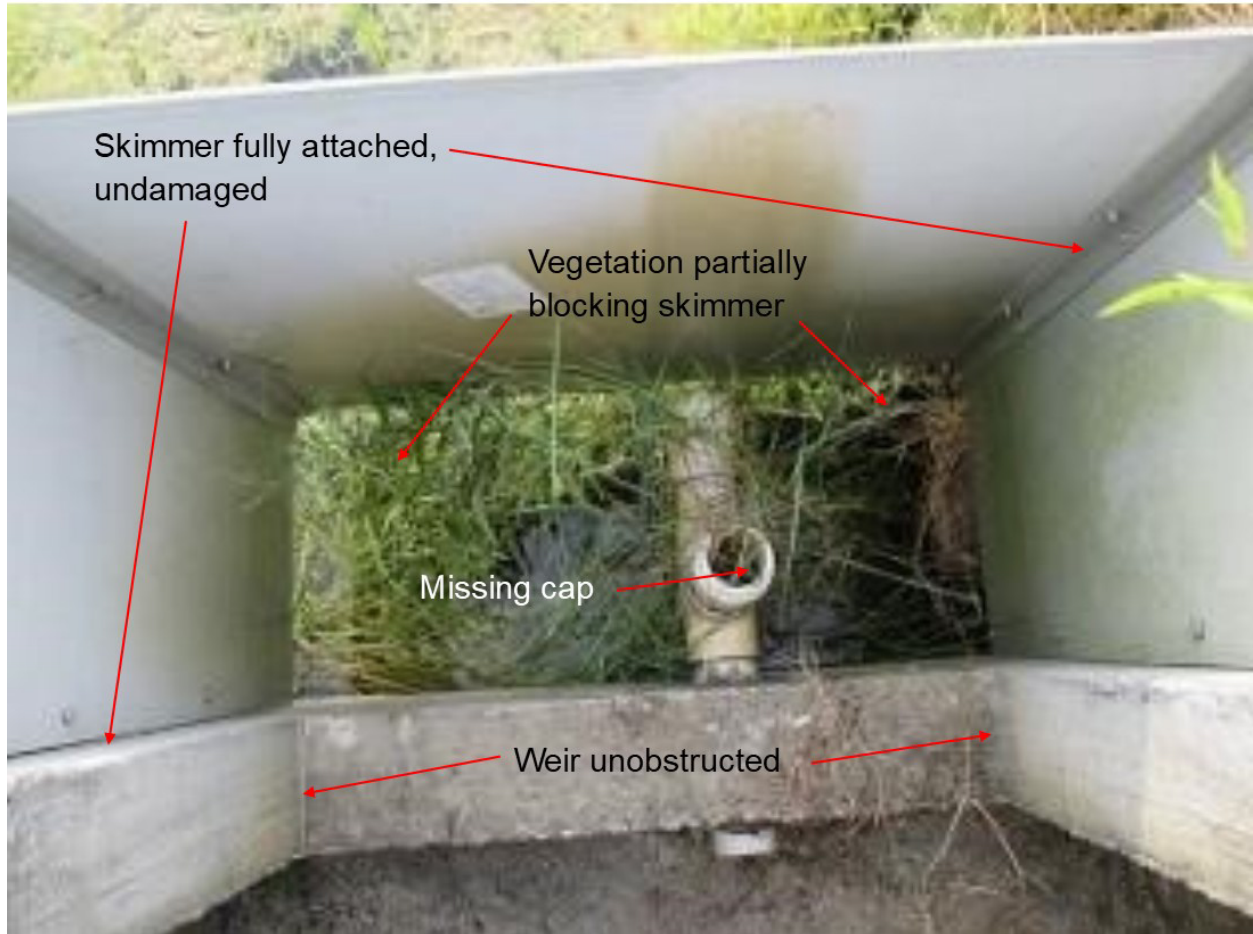
A-5

- Control Structure - Fair
 - Orifice – Fair – Threaded cap for bleed-down orifice cleanout is missing
 - Weir – Good – Free of obstructions
 - Skimmer – Fair – Opening less than 50 percent obstructed by vegetation

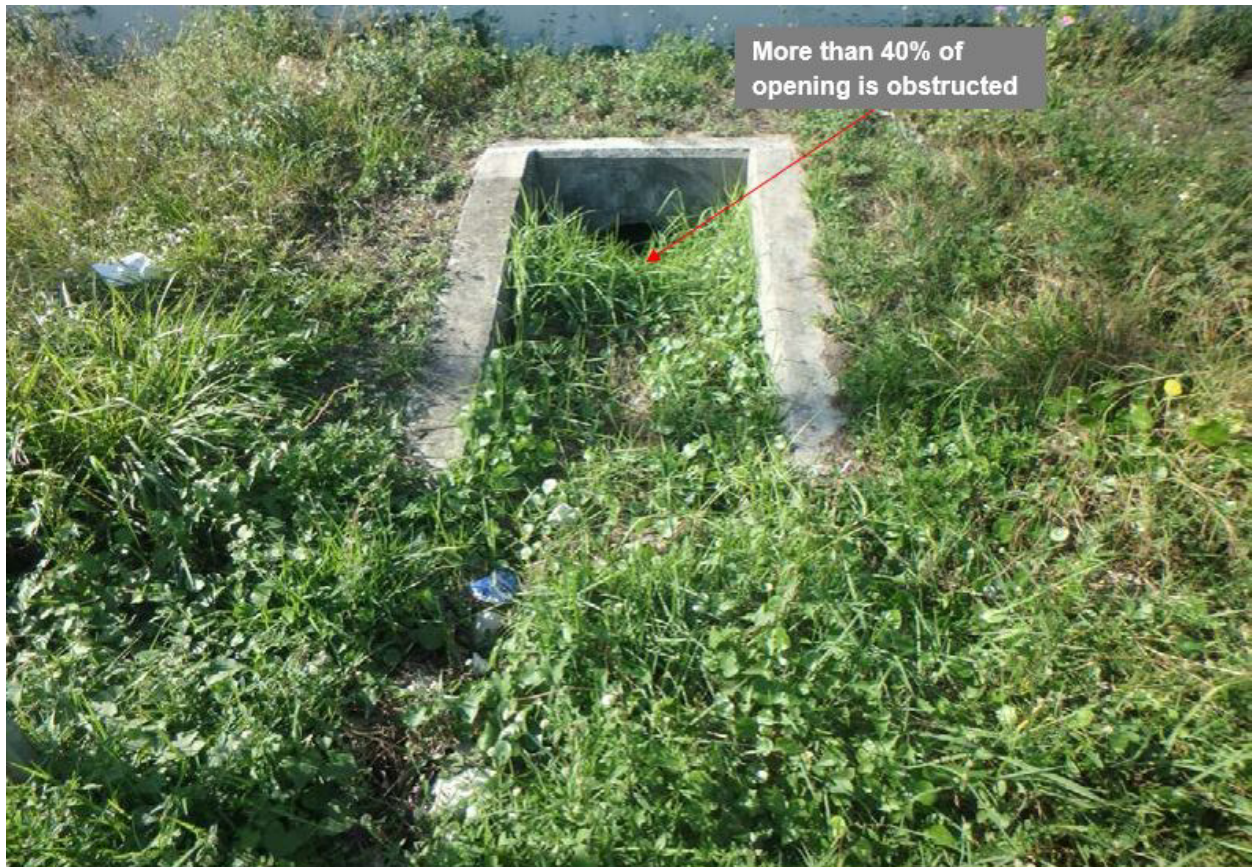
A-7

- Inflow and Outflow Pipes – Poor
 - More than 40 percent of pipe opening is obstructed
- Aesthetic Condition – Fair
 - Small amounts of trash present
- Sedimentation – Poor
 - Sediment accumulation is present
- Vegetation Condition – Fair
 - Vegetative cover is in fair condition
 - Side slopes need to be mowed

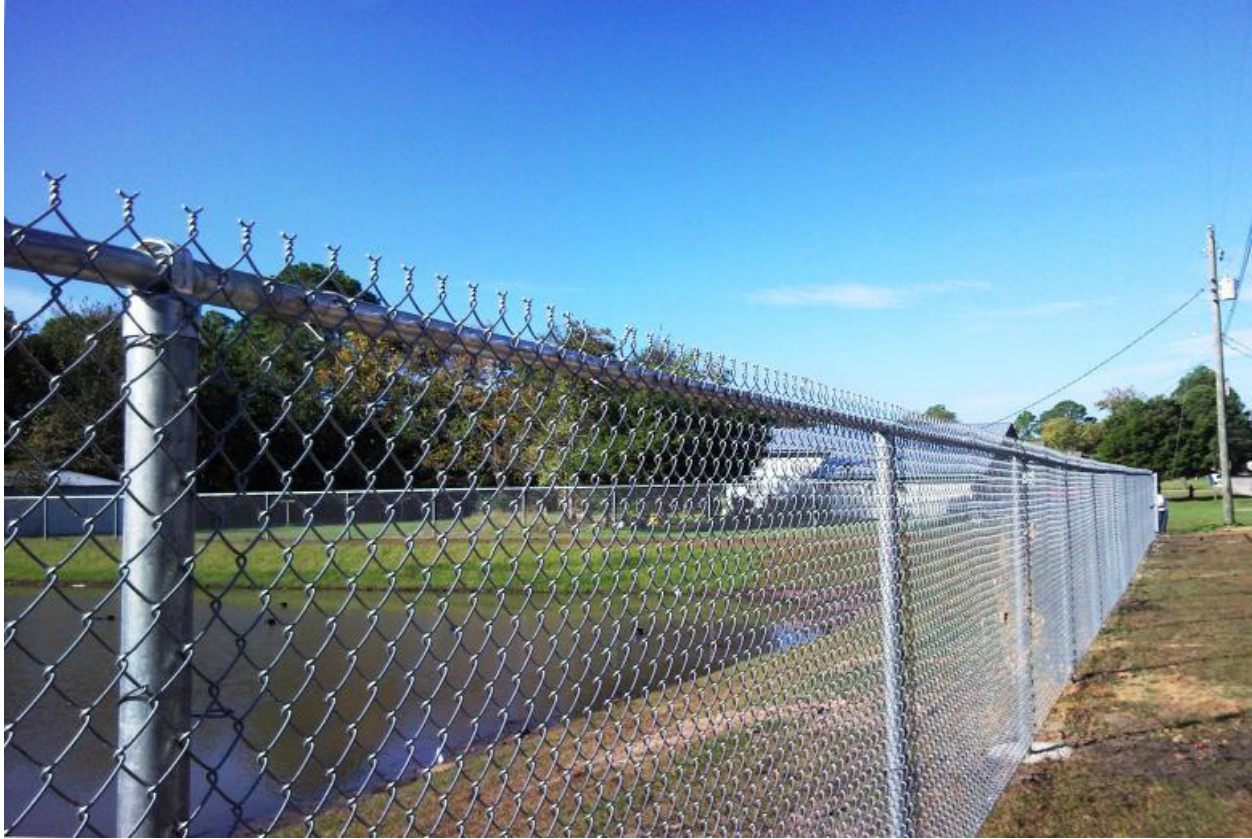
A-10

- Fence – Good
 - Sections and posts like new with no damage

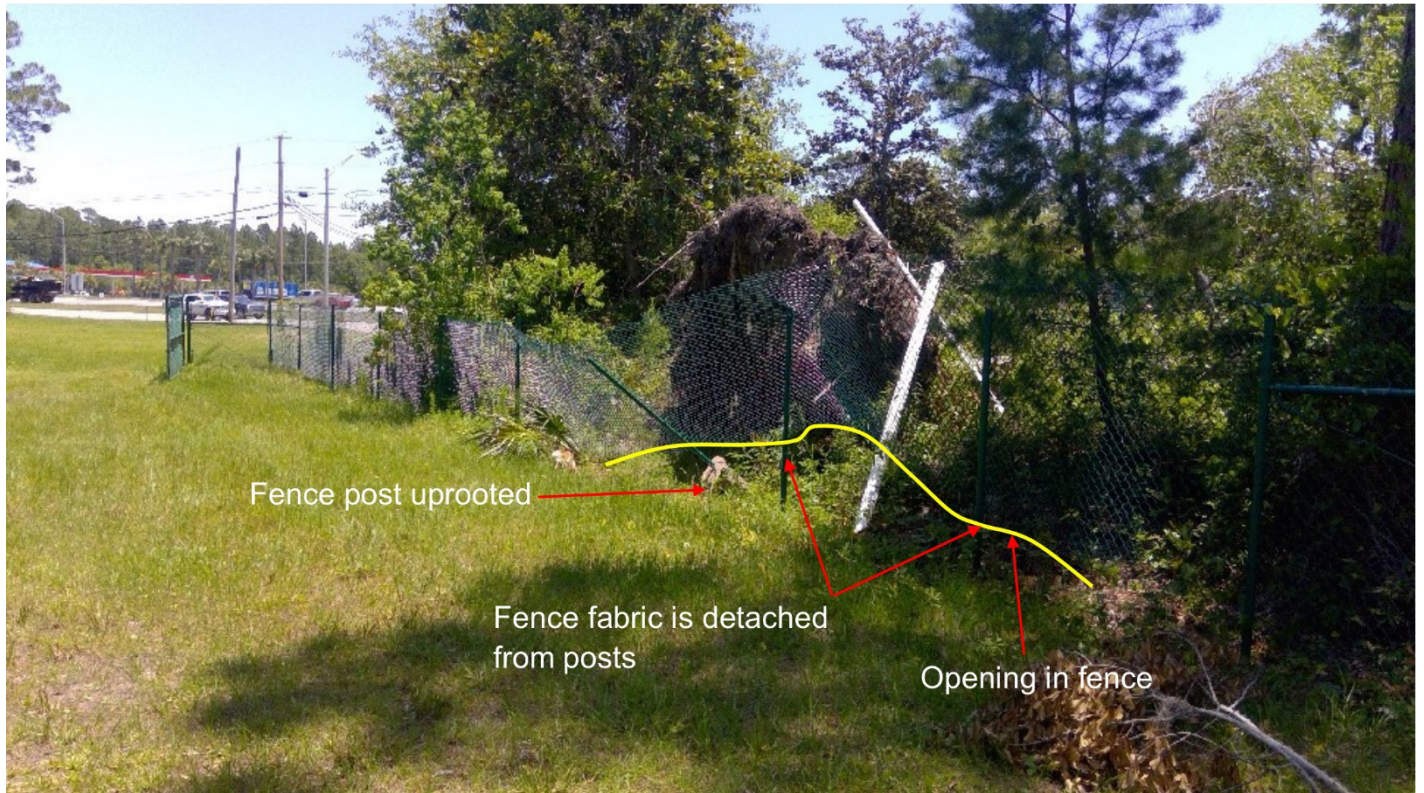
A-12

- Fence – Poor
 - Fence fabric is detached from consecutive fence posts
 - Opening in fence is greater than 2 square feet
 - Fence post is damaged
 - Site is not secure

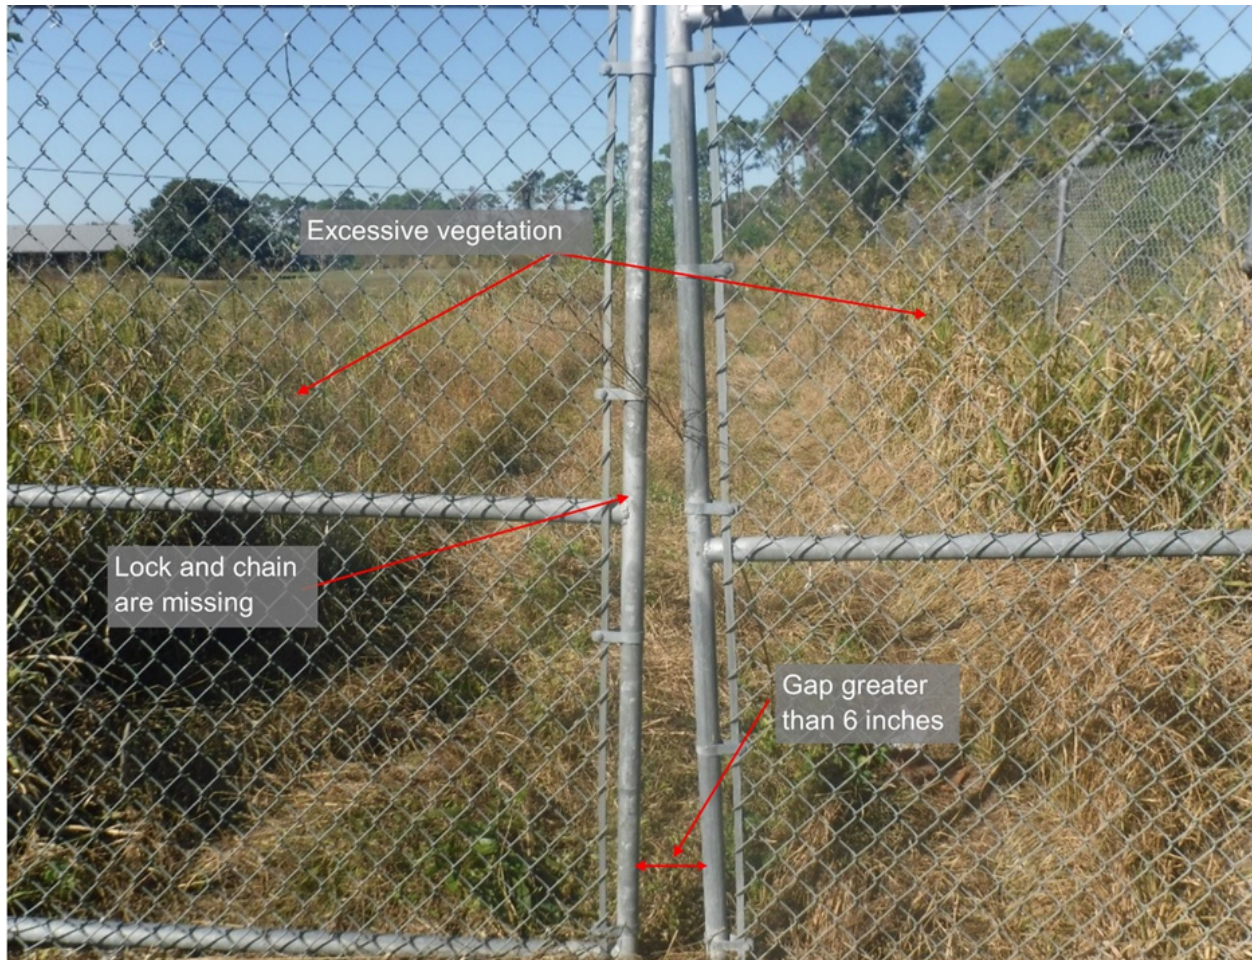
A-13

- Fence – Poor
 - Lock and chain missing
 - Gap in gate is greater than 6 inches
- Vegetation Condition – Fair
 - Excessive vegetation on side slopes and along fence line

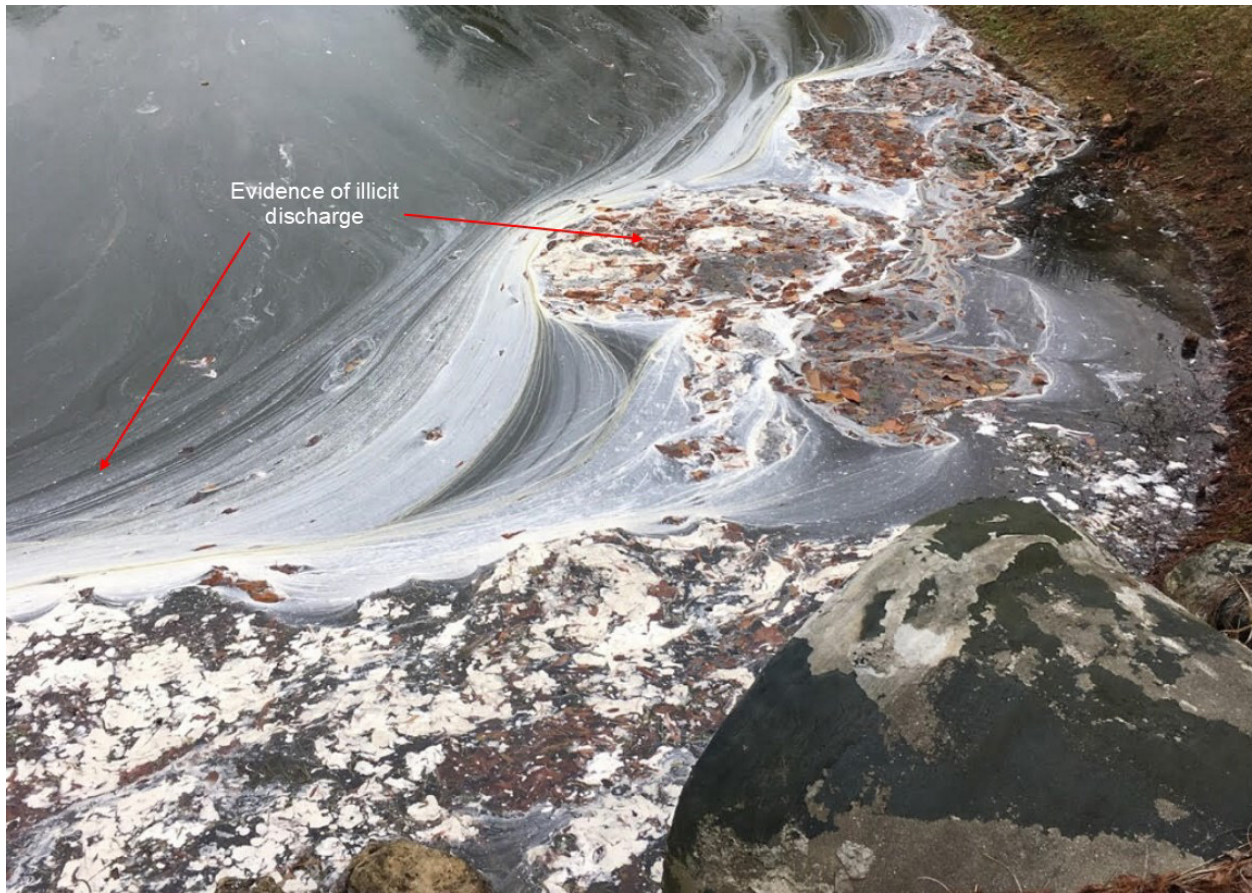
A-16

- Aesthetic Condition – Poor
- Water Condition – Poor
 - Evidence of illicit discharge

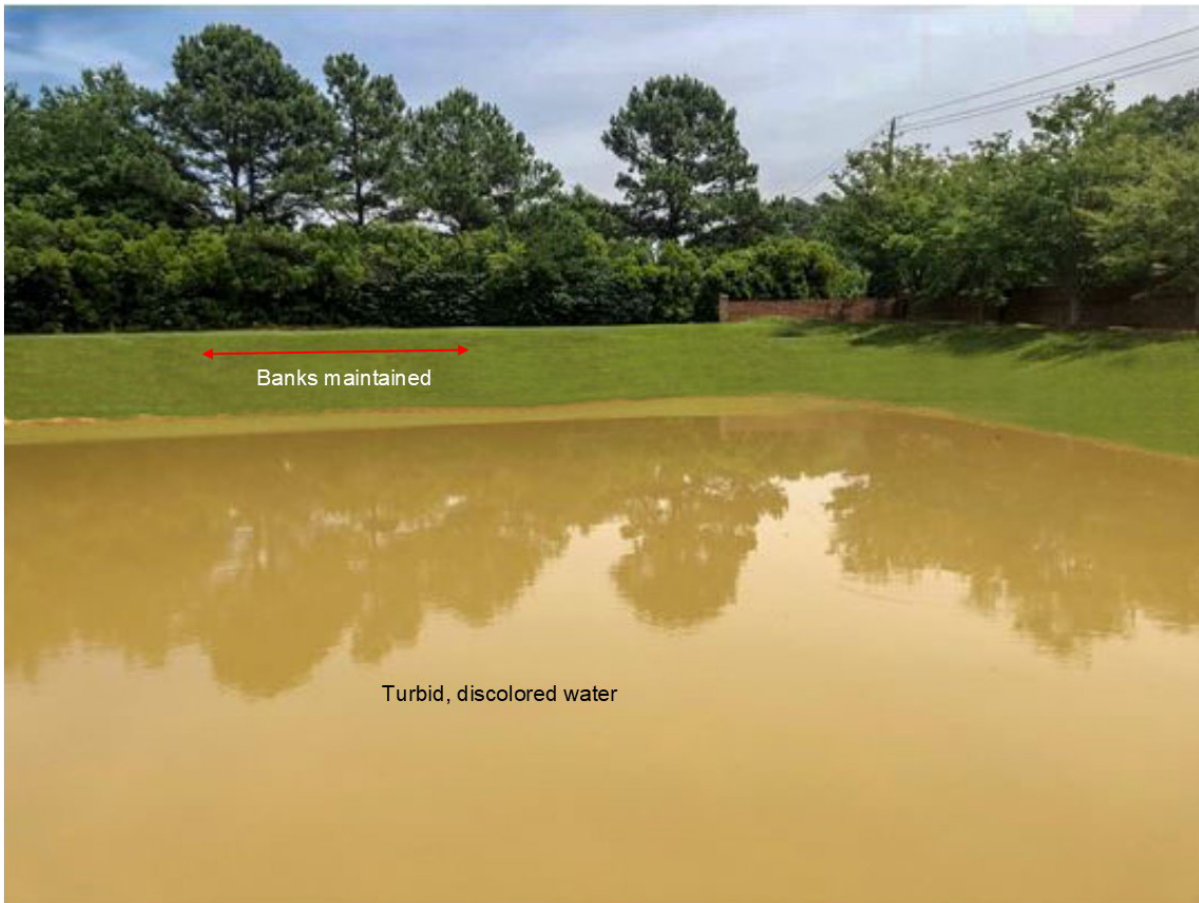
A-17

- Aesthetic Condition – Poor
 - Water is turbid and discolored
 - Banks maintained and mowed regularly
 - Free of trash and debris
- Erosion Condition – Good
 - No rills, gullies, or bare spots
- Water Condition – Poor
 - Water is dark and turbid
- Vegetation Condition – Good
 - Vegetative cover is well maintained
 - Slopes mowed regularly
 - No invasive or nuisance species

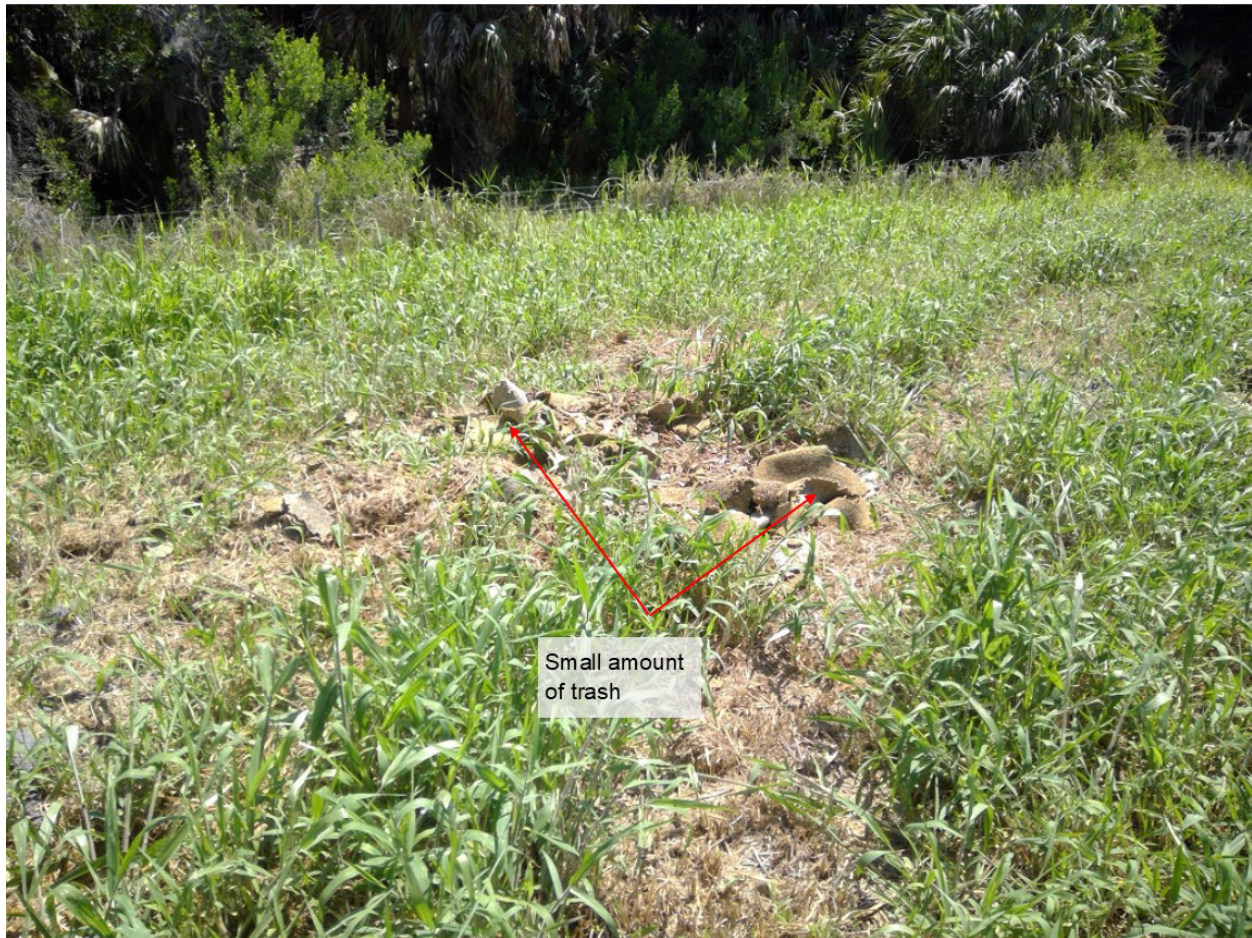
A-20

- Aesthetic Condition – Fair
 - Minor amounts of trash
 - Needs to be mowed
- Vegetation Condition – Fair
 - Needs to be mowed

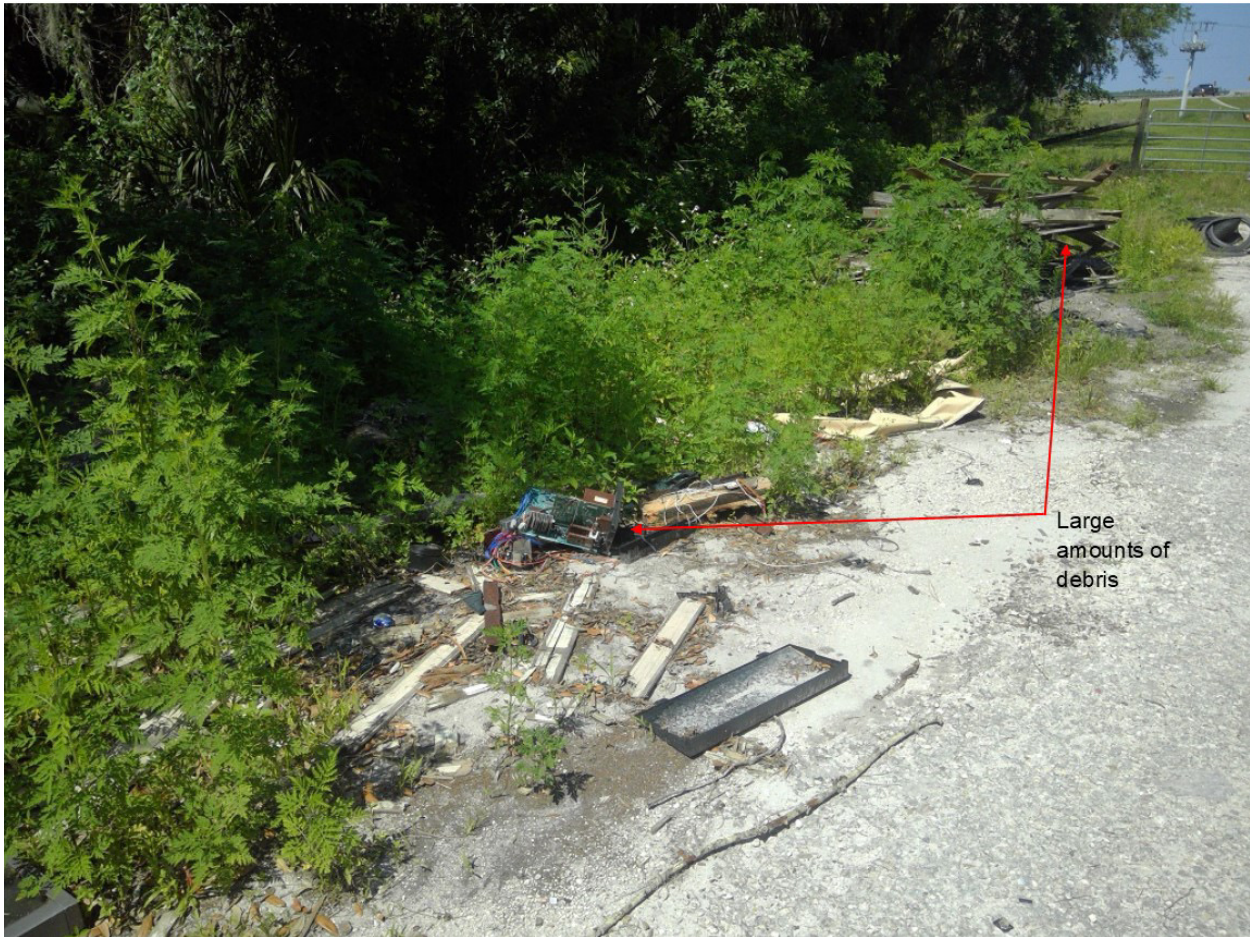
A-21

- Aesthetic Condition – Poor
 - Large amounts of trash and debris
 - Needs to be mowed

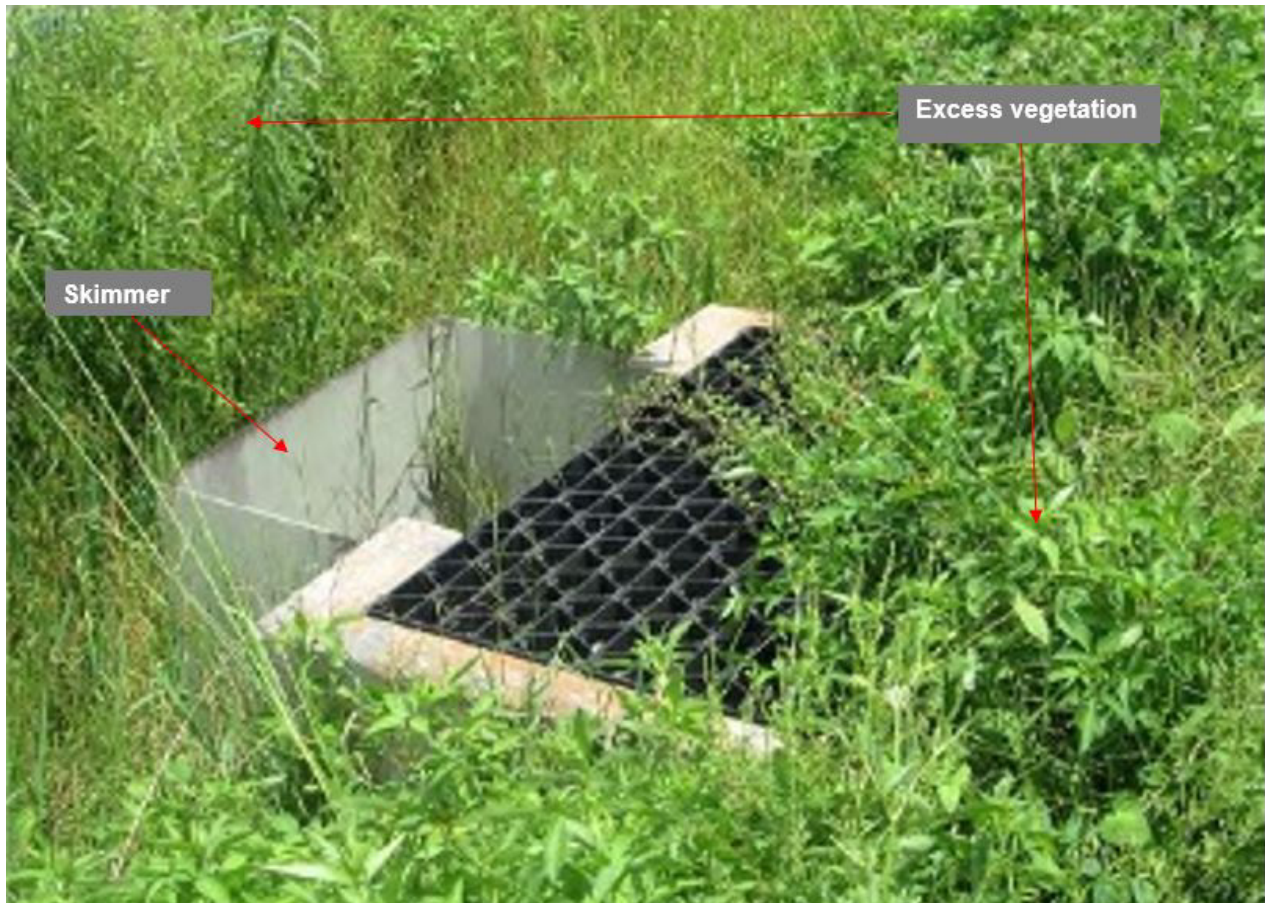
A-30

- Control Structure – Good
 - Skimmer present and intact
 - Grate present
- Hydraulic Recovery – Good
 - System dry, indicating the system is recovering its treatment volume
- Vegetation Condition – Fair
 - Excessive vegetation growth present around control structure
 - Pond does not appear to be mowed regularly

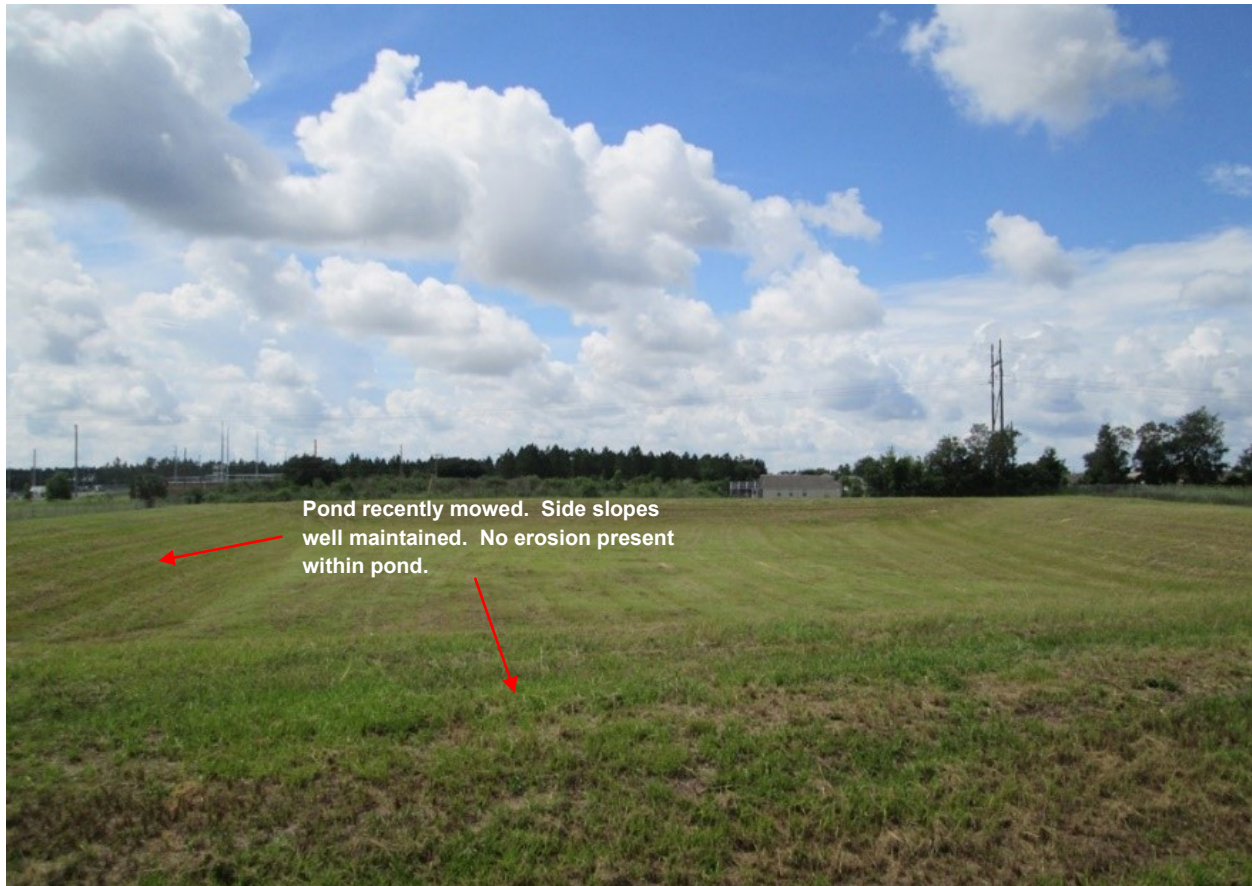
A-34

- Aesthetic Condition – Good
 - No debris or trash present
 - Side slopes well maintained
- Erosion Condition – Good
 - No erosion on side slopes observed
- Hydraulic Recovery – Good
 - System dry, indicating the system is recovering its treatment volume
- Sedimentation – Good
 - No evidence of sedimentation problems observed
- Vegetation Condition – Good
 - Vegetation cover is intact with no bare areas
 - Pond is mowed regularly

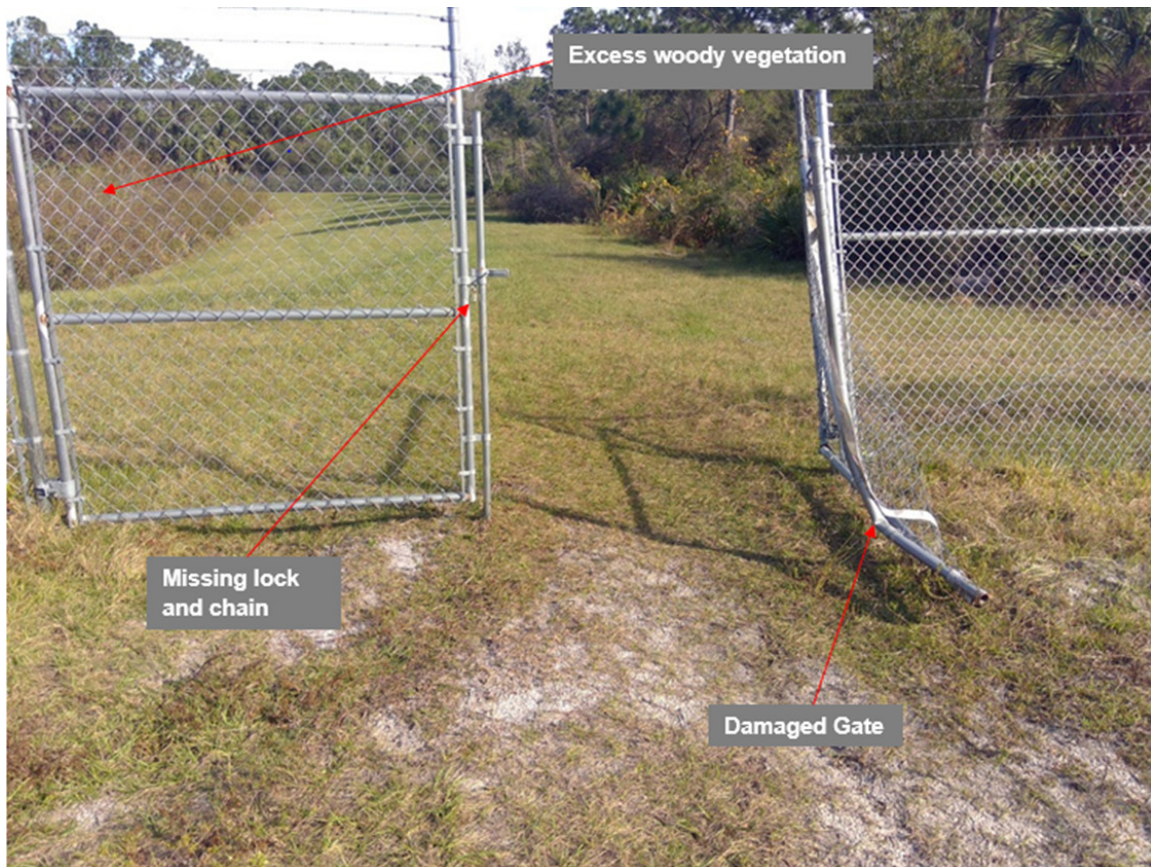
A-37

- Fence Condition – Poor
 - Gate open and no longer secure
 - Chain and lock missing
 - Fence gate has significant damage with gap greater than 6 inches
- Vegetation Condition – Poor
 - Woody vegetation present within pond bottom.

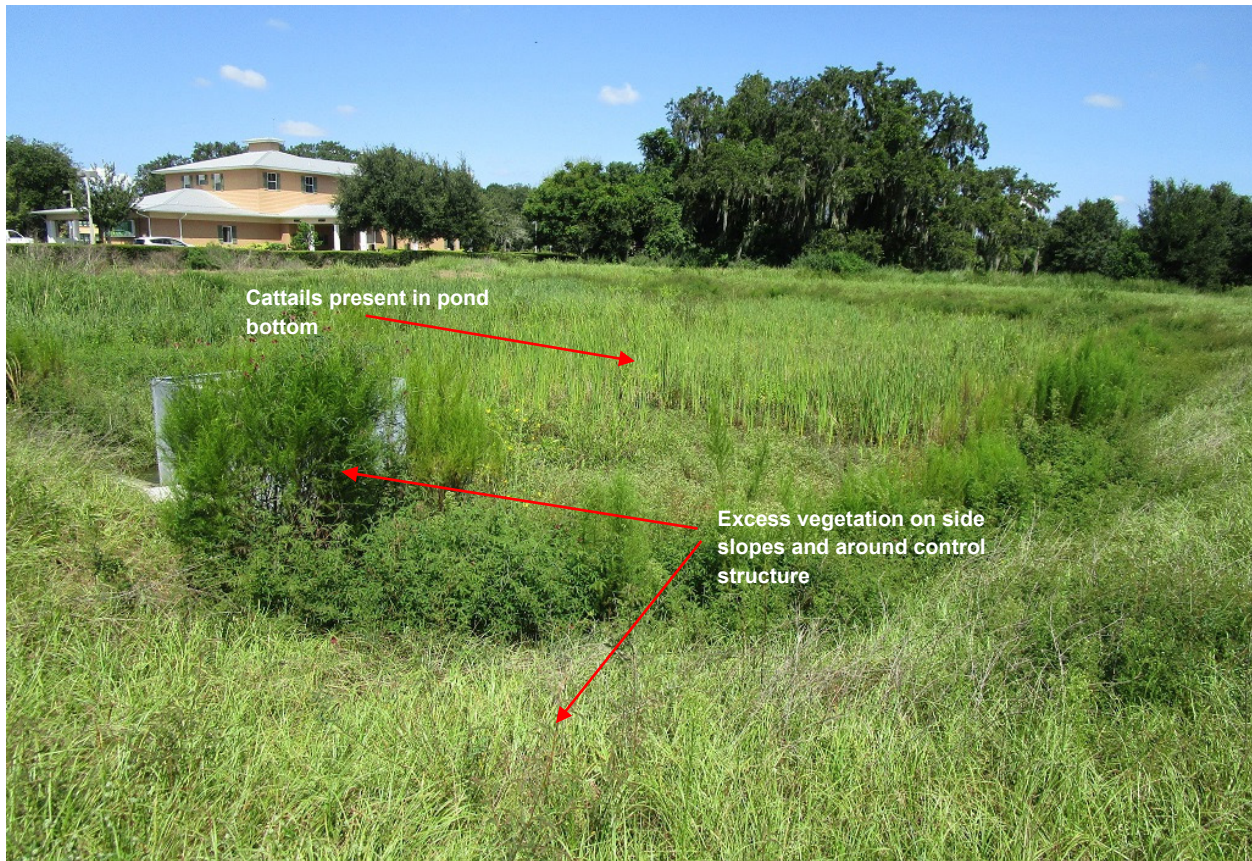
A-39

- Aesthetic Condition – Poor
 - Excess vegetation on side slopes and within pond bottom
 - Vegetation growth around control structure
- Hydraulic Recovery – Poor
 - System does not appear to be fully recovering its treatment volume
 - Cattails in pond bottom indicate prolonged presence of water
- Vegetation Condition – Poor
 - Side slopes need to be mowed
 - Vegetation around control structure present

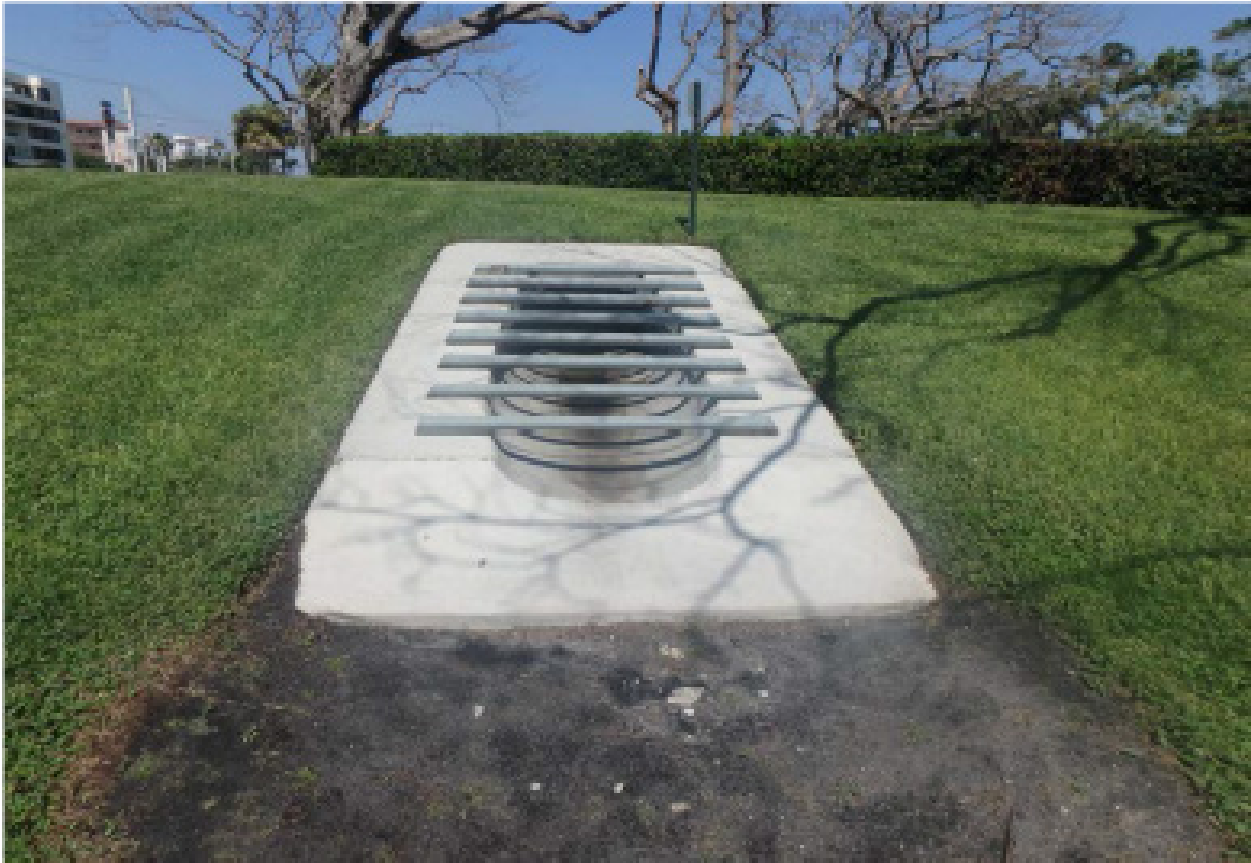
A-41

- Inflow and Outflow Pipes – Good
 - Like-new condition
 - No significant cracks or undermining observed
 - Pipe is open and no obstructions observed
 - Pipe appears to be functioning as designed
- Aesthetic Condition – Good
 - No trash and debris present
 - Side slopes are regularly mowed and well maintained
- Vegetation Condition – Good
 - Vegetative cover is in good condition and well maintained

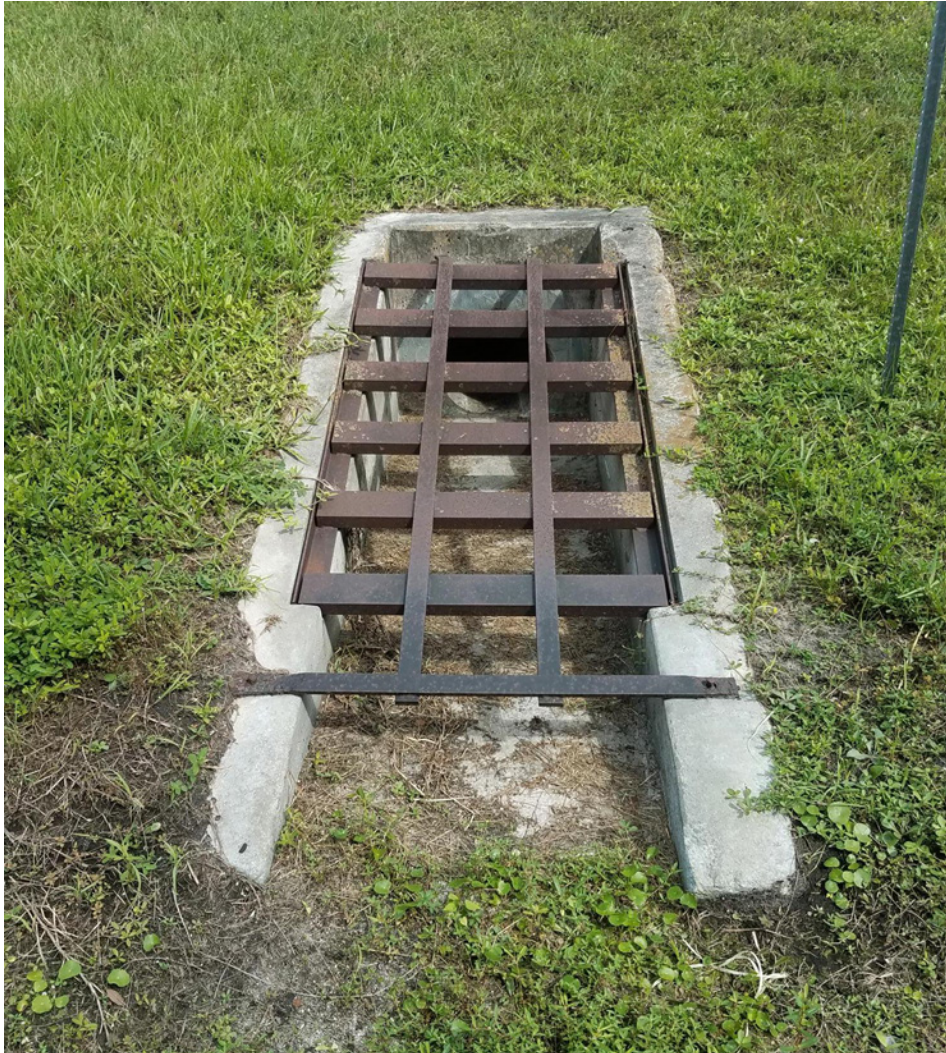
A-42

- Inflow and Outflow Pipes – Good
 - Like-new condition
 - No significant cracks or undermining observed
 - Pipe is open and no obstructions observed
 - Pipe appears to be functioning as designed
- Aesthetic Condition – Good
 - No trash or debris present
 - Side slopes are regularly mowed and well maintained
- Vegetation Condition – Good
 - Vegetative cover is in good condition and well maintained

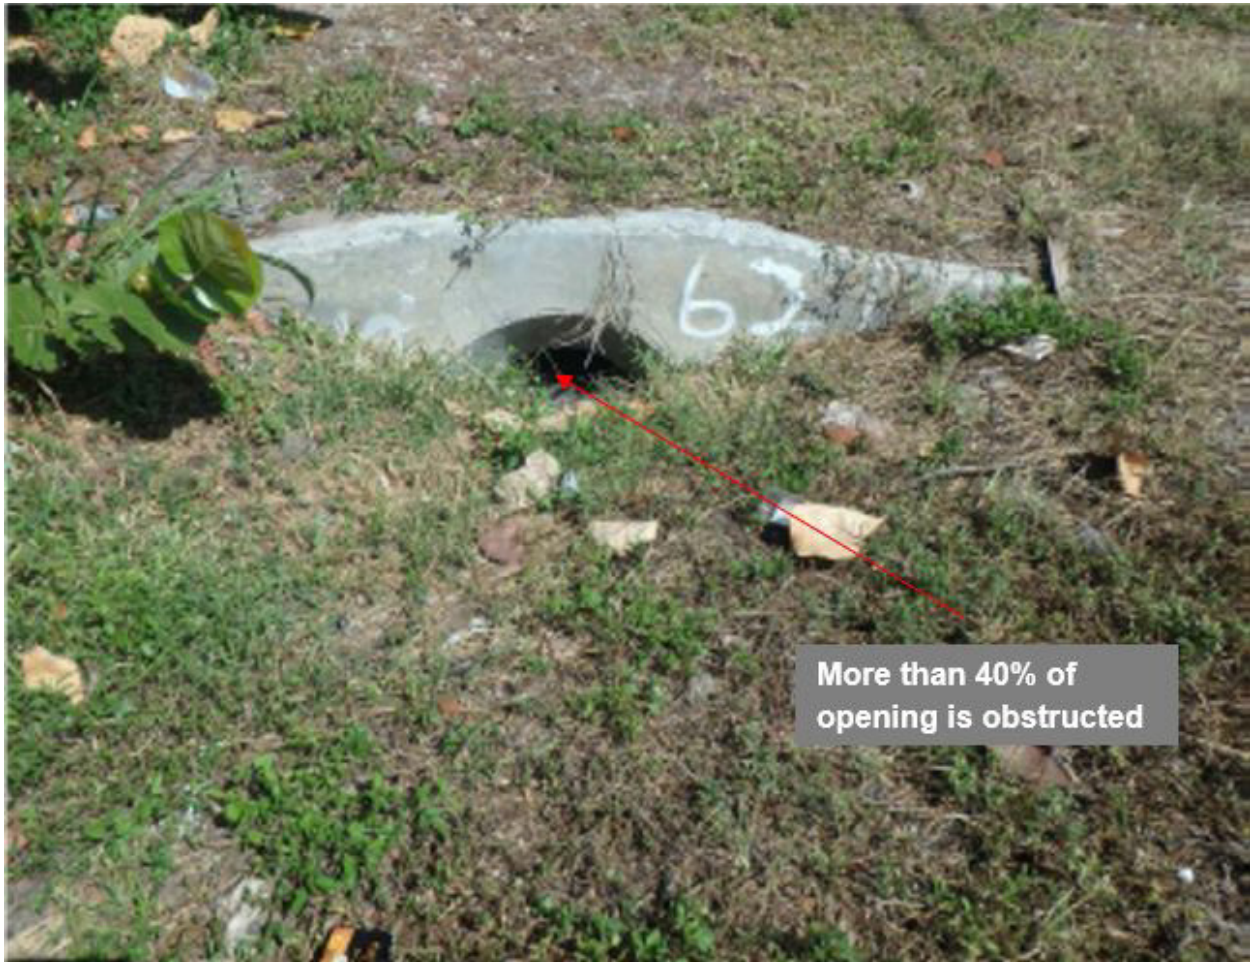
A-44

- Inflow and Outflow Pipes – Poor
 - More than 40 percent of pipe opening is obstructed
- Aesthetic Condition – Good
 - No trash or debris present
- Vegetation Condition – Good
 - Vegetative cover is in good condition and recently mowed

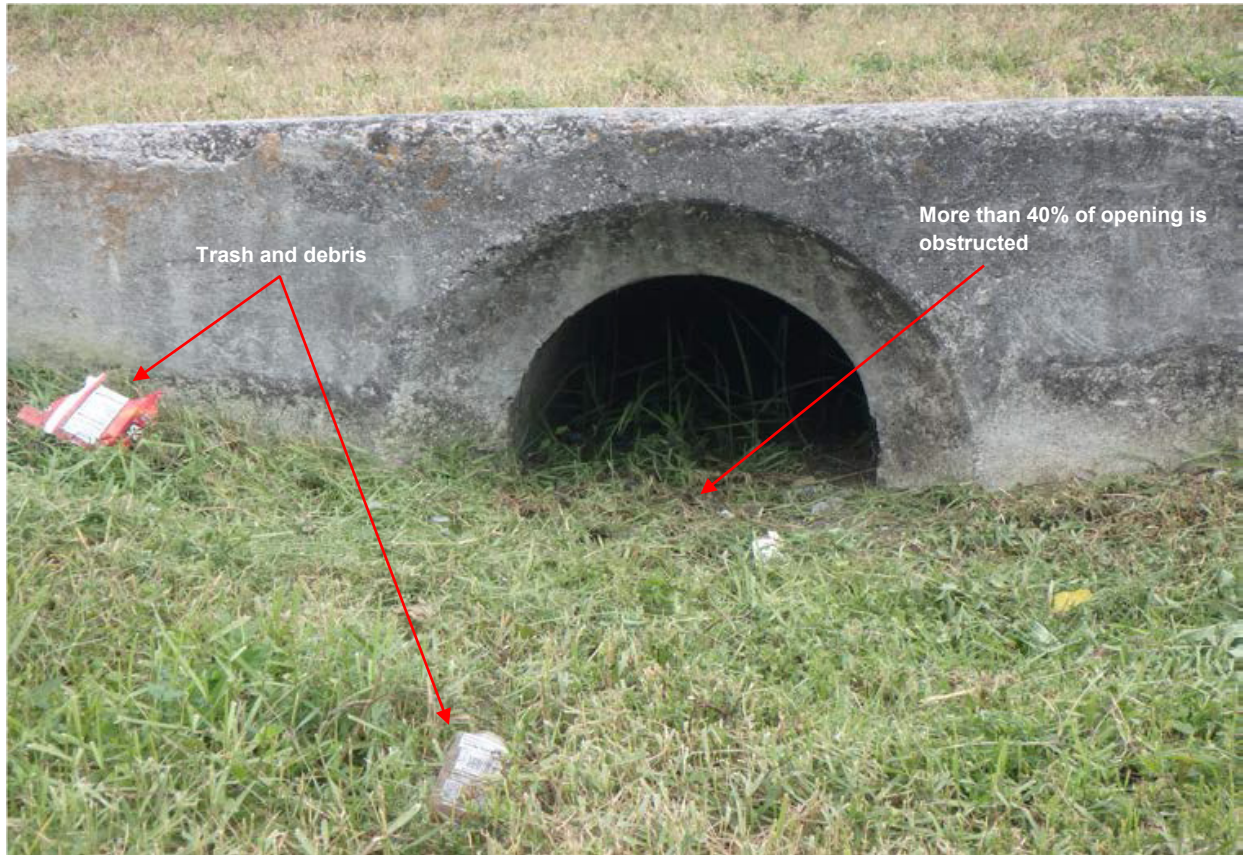
A-45

- Inflow and Outflow Pipes – Poor
 - More than 40 percent of pipe opening is obstructed
- Aesthetic Condition – Fair
 - Minor amounts of trash and debris present
- Vegetation Condition – Good
 - Vegetative cover is in good condition and recently mowed
