Maintenance Guide for Stormwater Assets

May 2023

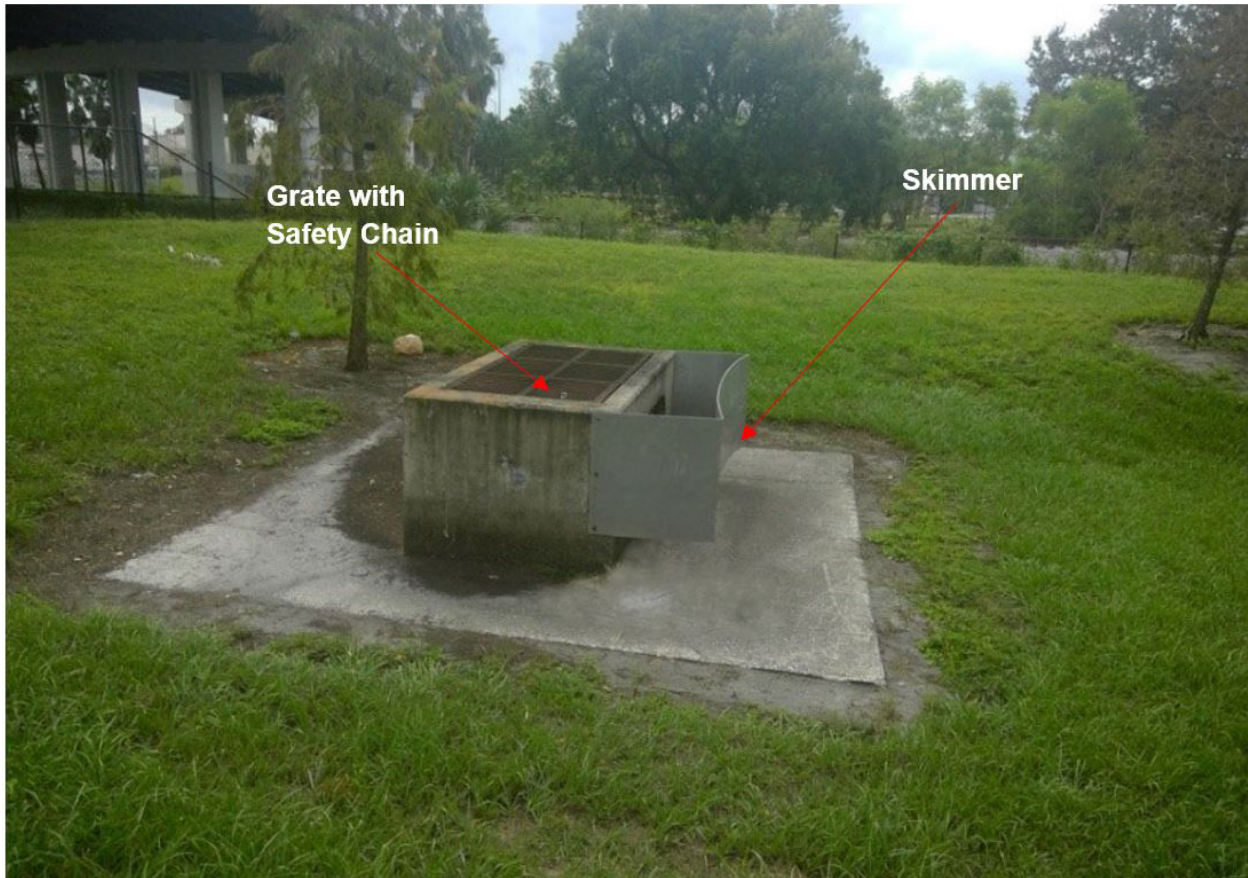
A-46

- Control Structure – Good
 - Skimmer present and intact
 - Grate and safety chain present
- Aesthetic Condition – Good
 - No debris or trash present
 - Side slopes are well maintained
- Erosion Condition – Good
 - No slope erosion or rills observed
- Hydraulic Recovery – Good
 - System dry, indicating the system is recovering its treatment volume
- Vegetation Condition – Good
 - Pond appears to be mowed regularly

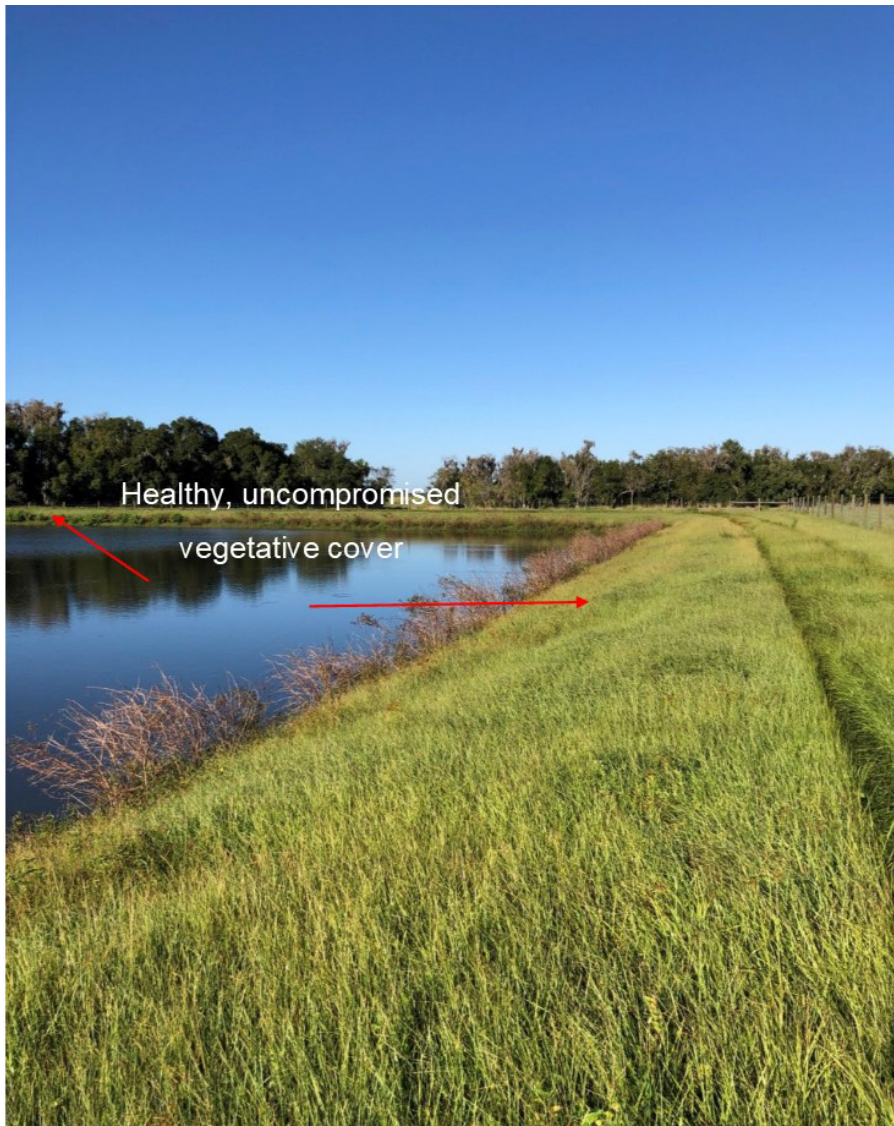
A-51

- Aesthetic Condition – Good
- Erosion Condition – Good
 - Healthy, complete vegetative cover
- Vegetation – Fair
 - Side banks need to be mowed
- Water Condition – Good
 - Water is clear, free of trash, vegetation, and visible sheens

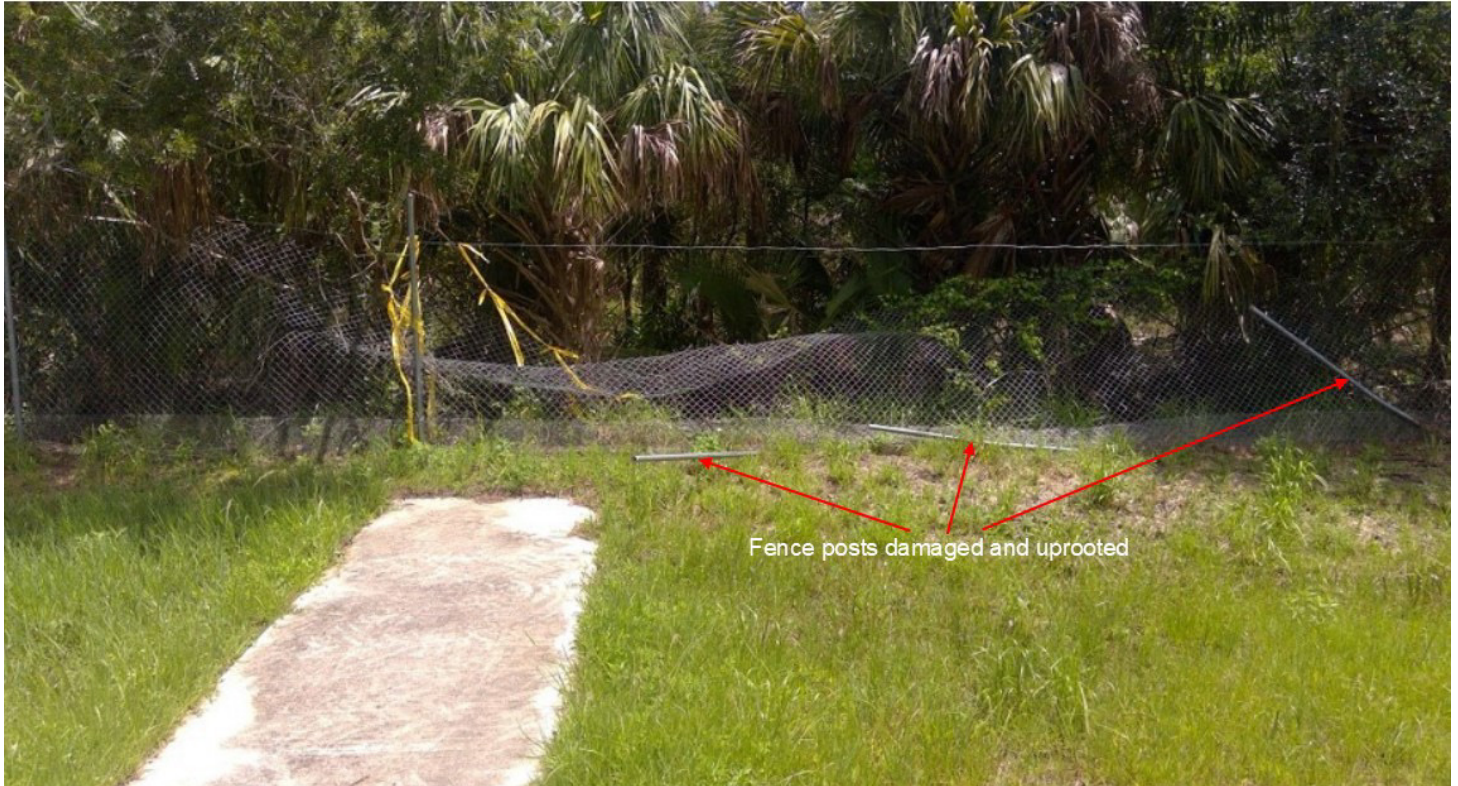
A-56

- Fence – Poor
 - Consecutive broken and damaged fence posts
 - Opening at sagging fence section is greater than one-third original fence height
 - Site is not secure

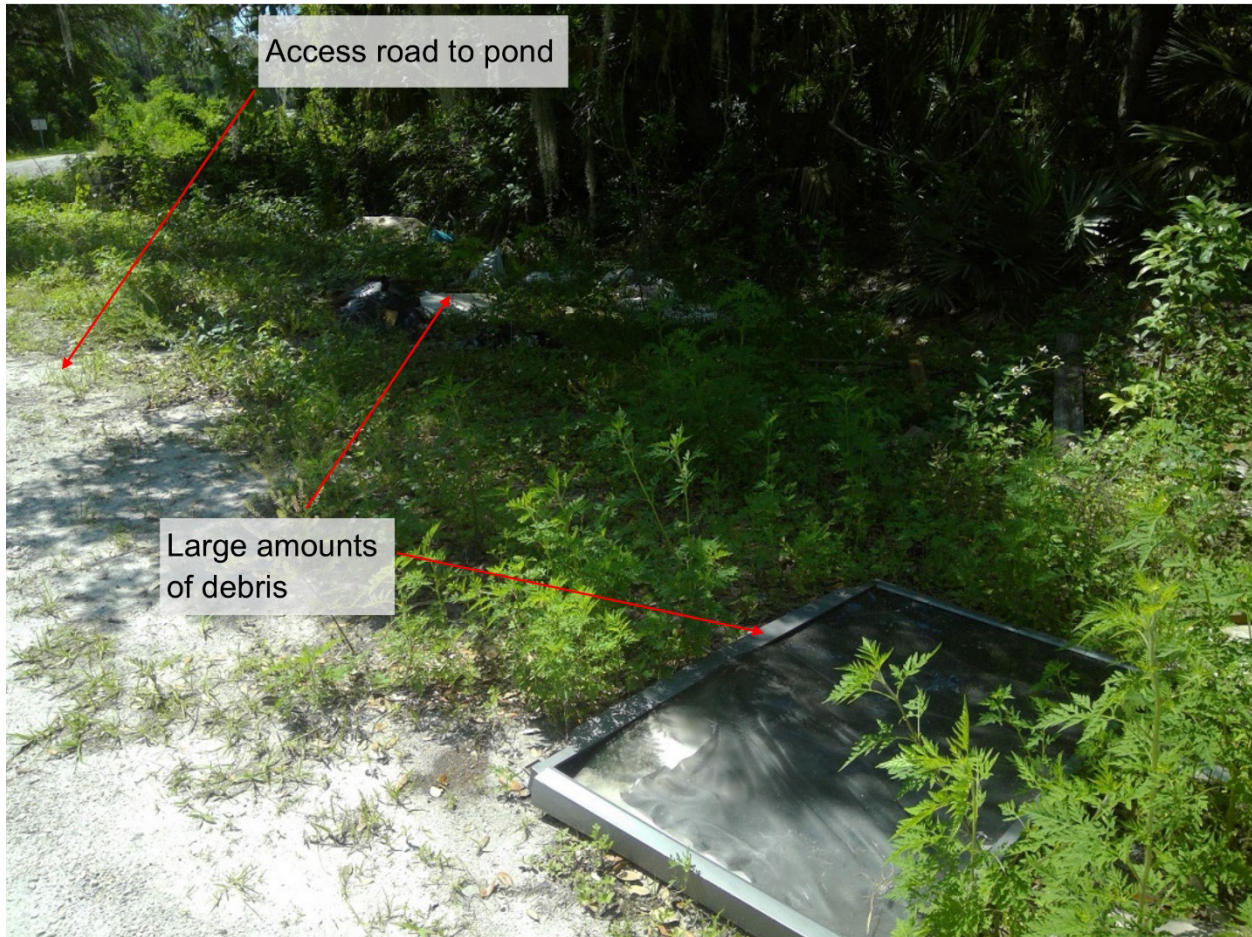
A-58

- Aesthetic Condition – Poor
 - Large amounts of trash and debris
 - Access road vegetation is overgrown

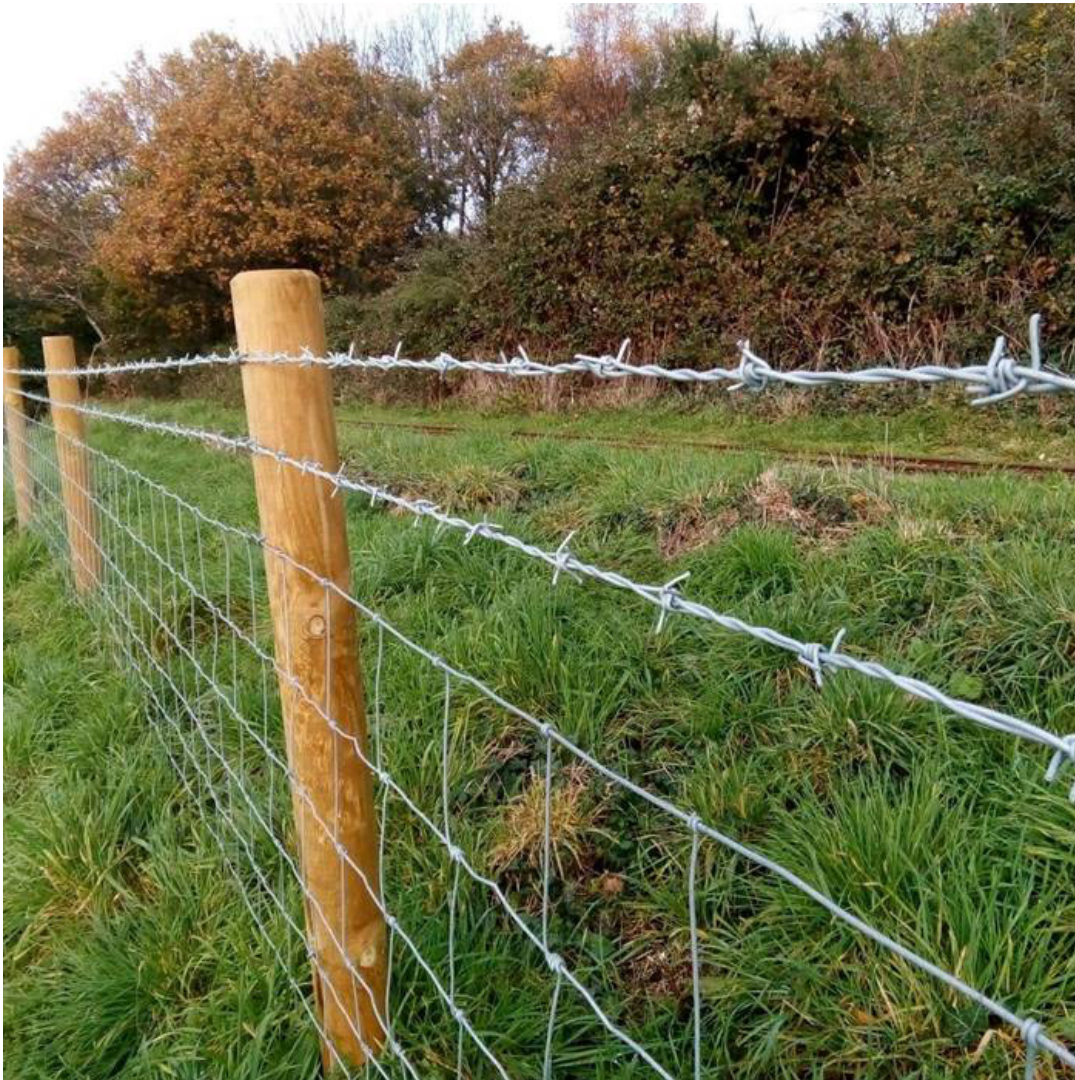
A-60

- Fence – Good
 - Sections and posts like new with no damage
 - Strands of barbed wire continuous and unbroken

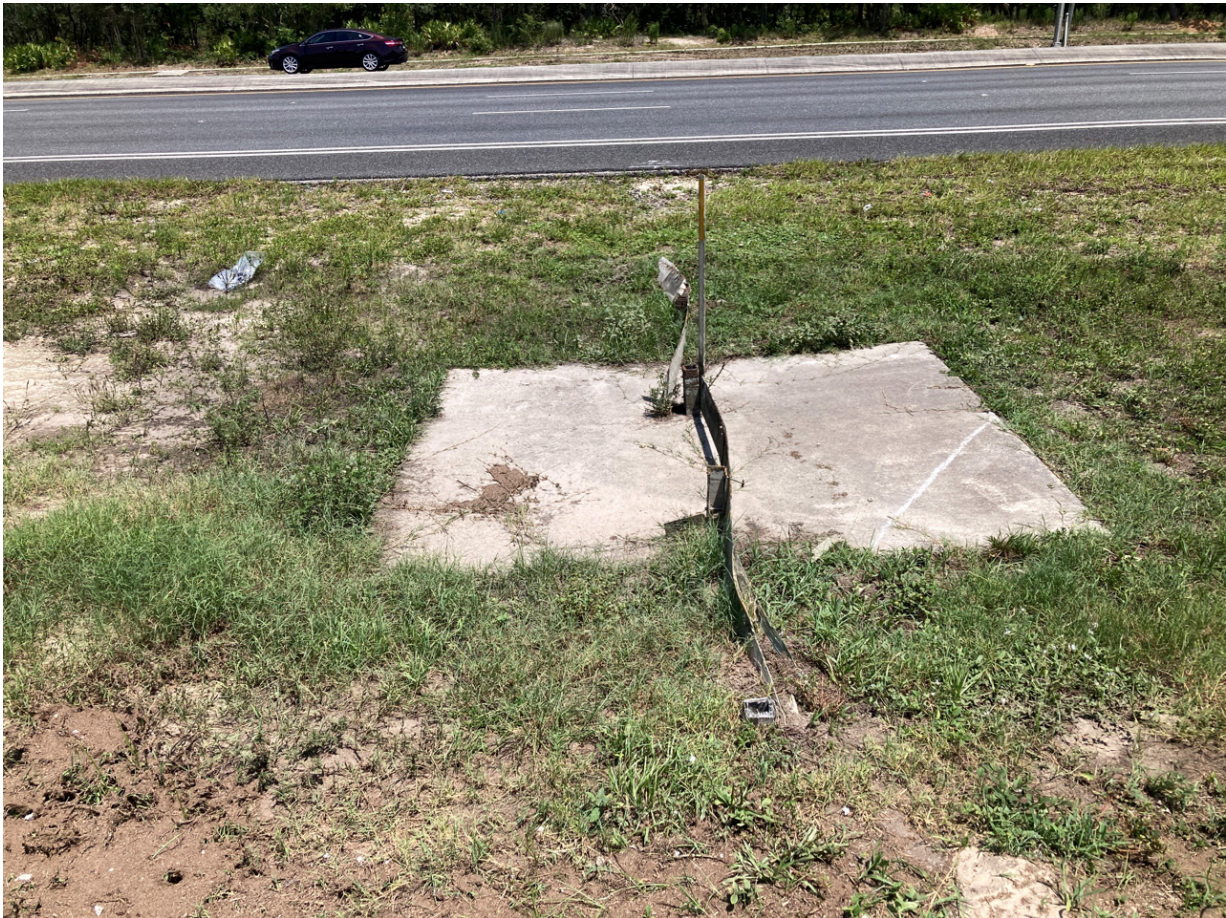
PHOTO 21 LOOKING EAST AT DB-13 SKIMMER (DAMAGED).JPG

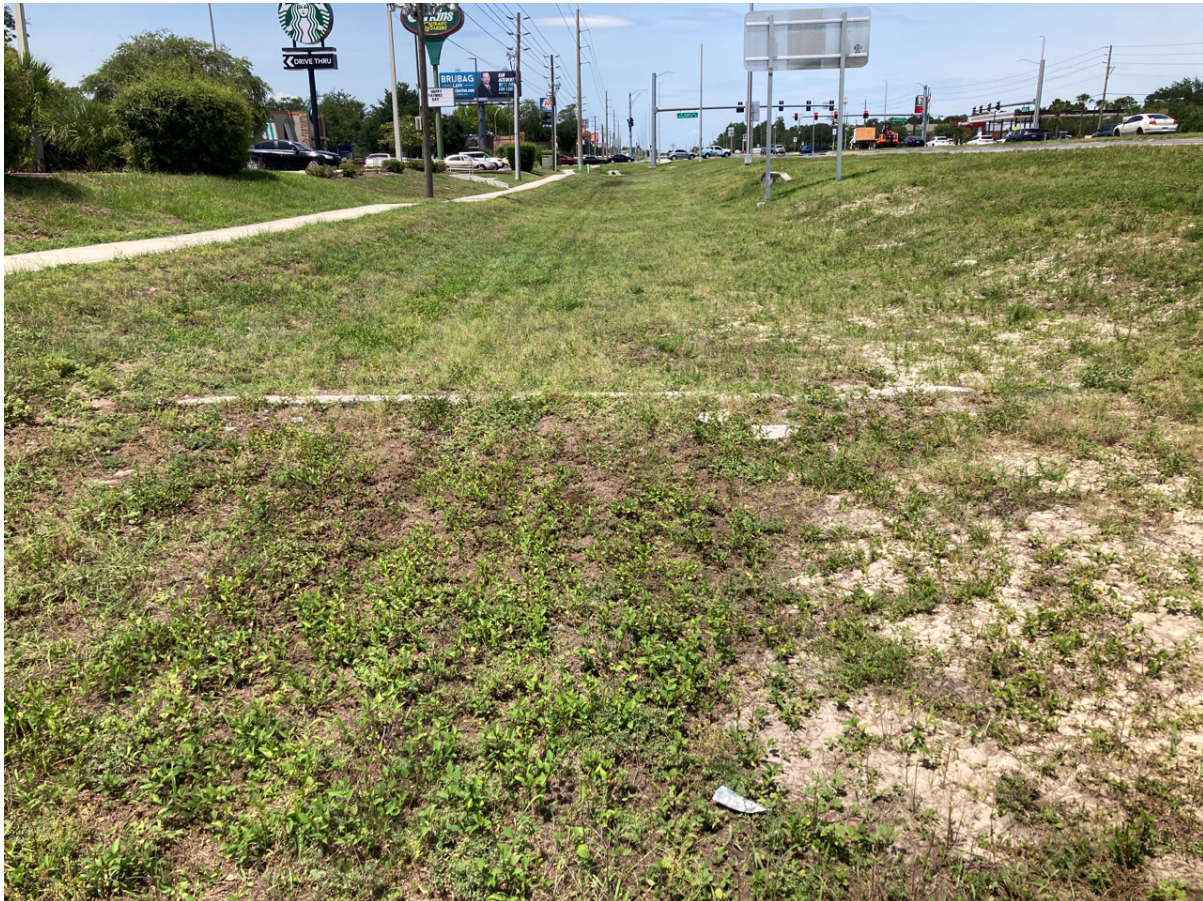
PHOTO 27 LOOKING AT DB-8 STA 431+60 LT (LINTEL DAMAGED).JPG

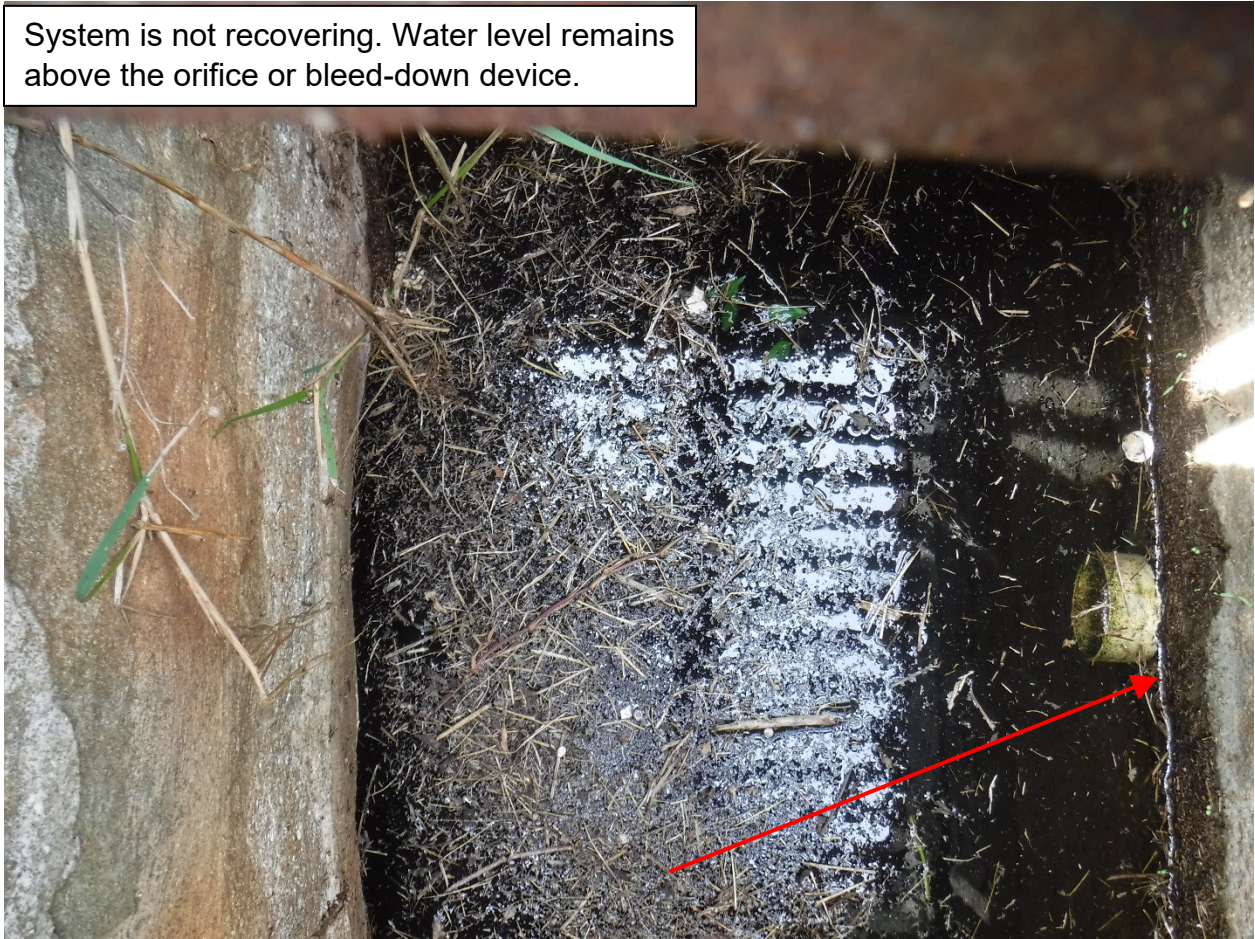
System is not recovering. Water level remains above the orifice or bleed-down device.

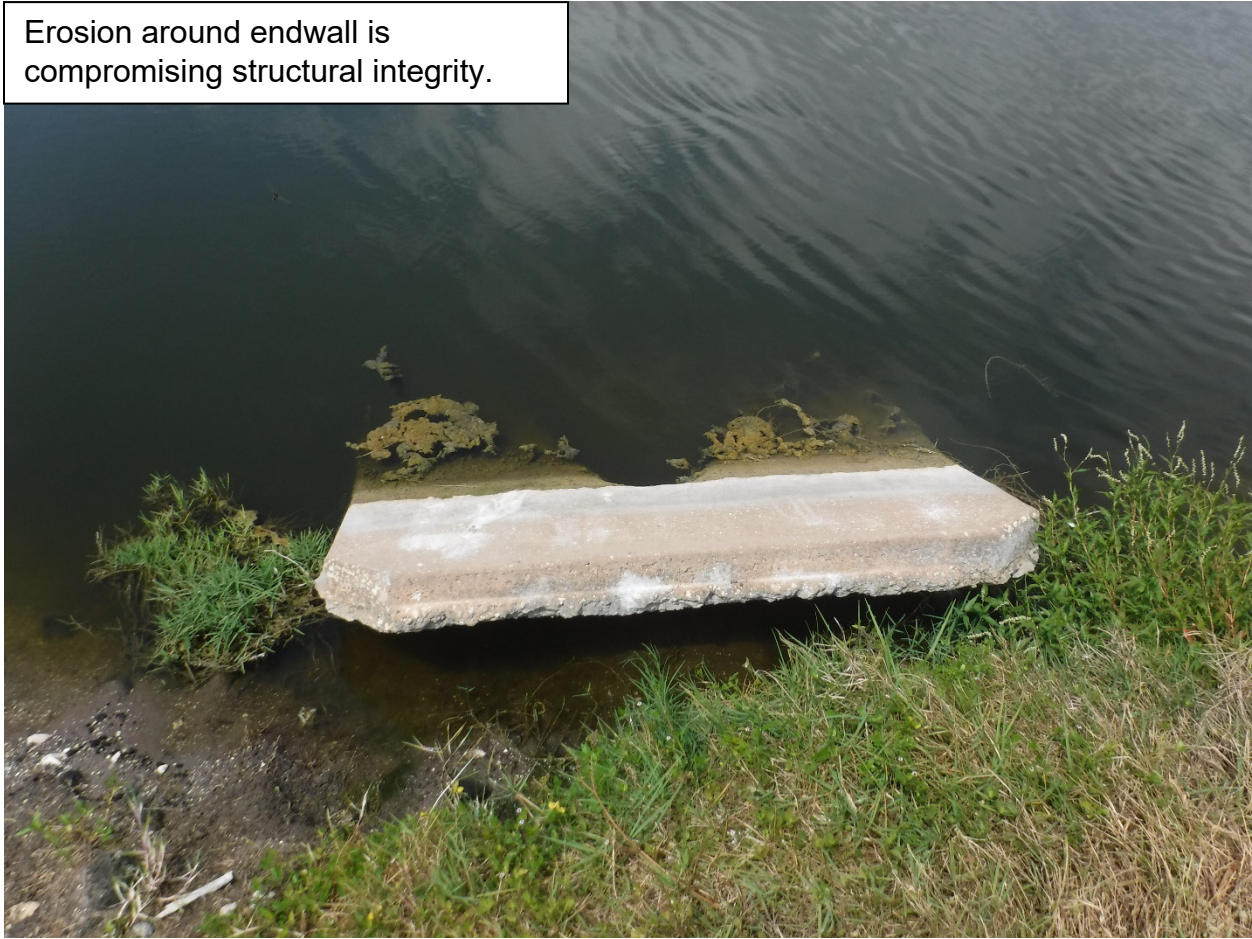
Erosion around endwall is compromising structural integrity.

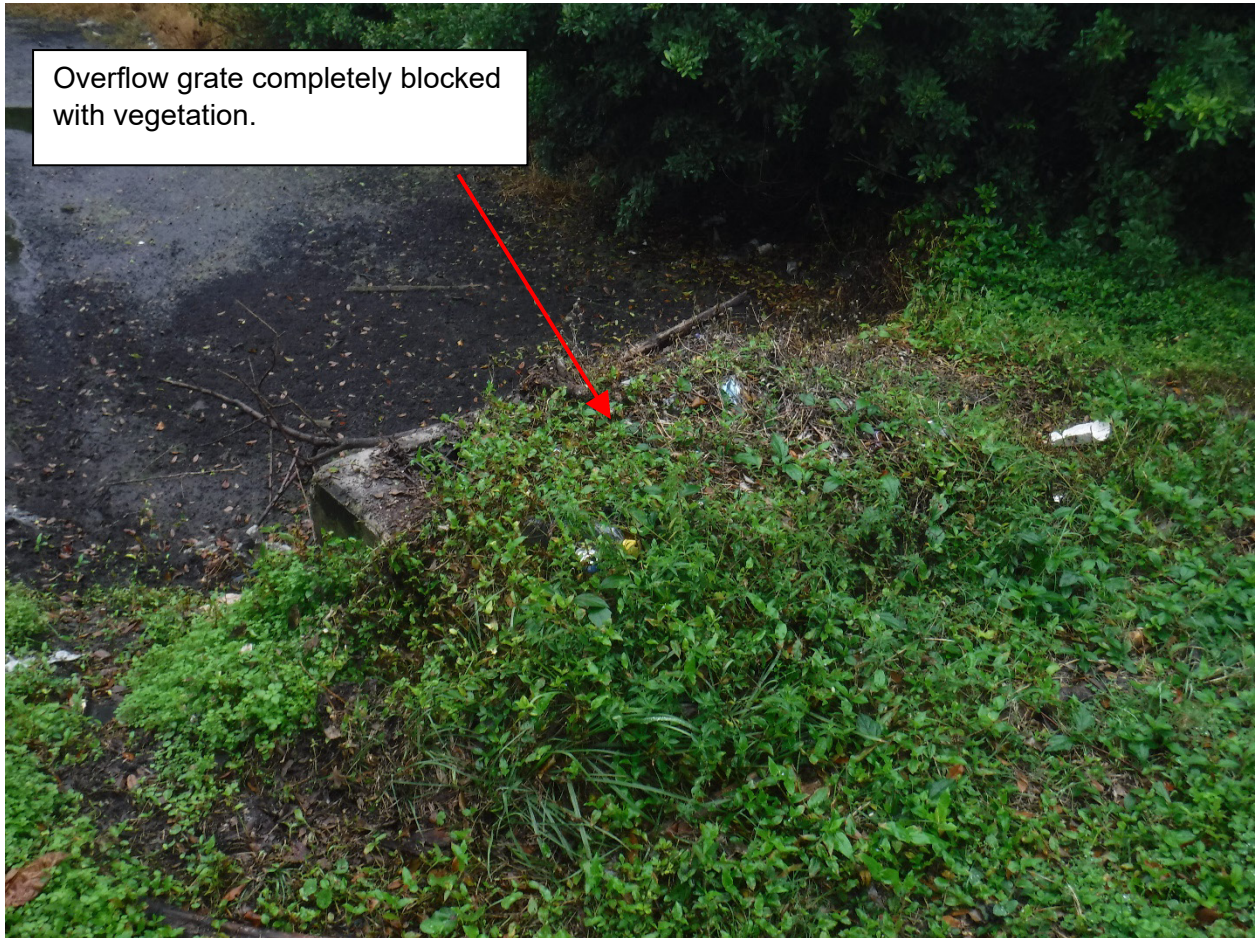
Dry Detention Pond – Control Structure – Poor Condition

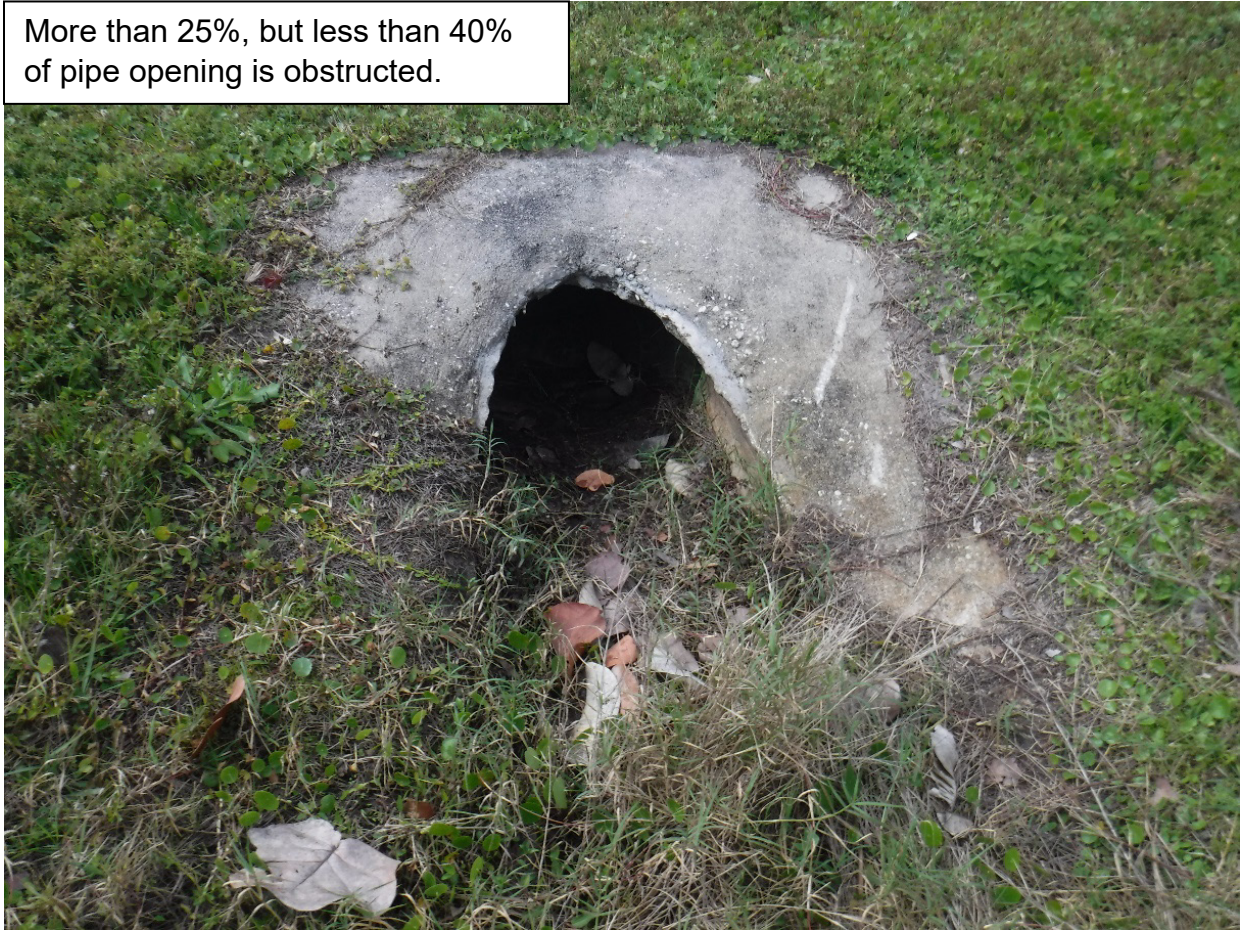
More than 25%, but less than 40% of pipe opening is obstructed.

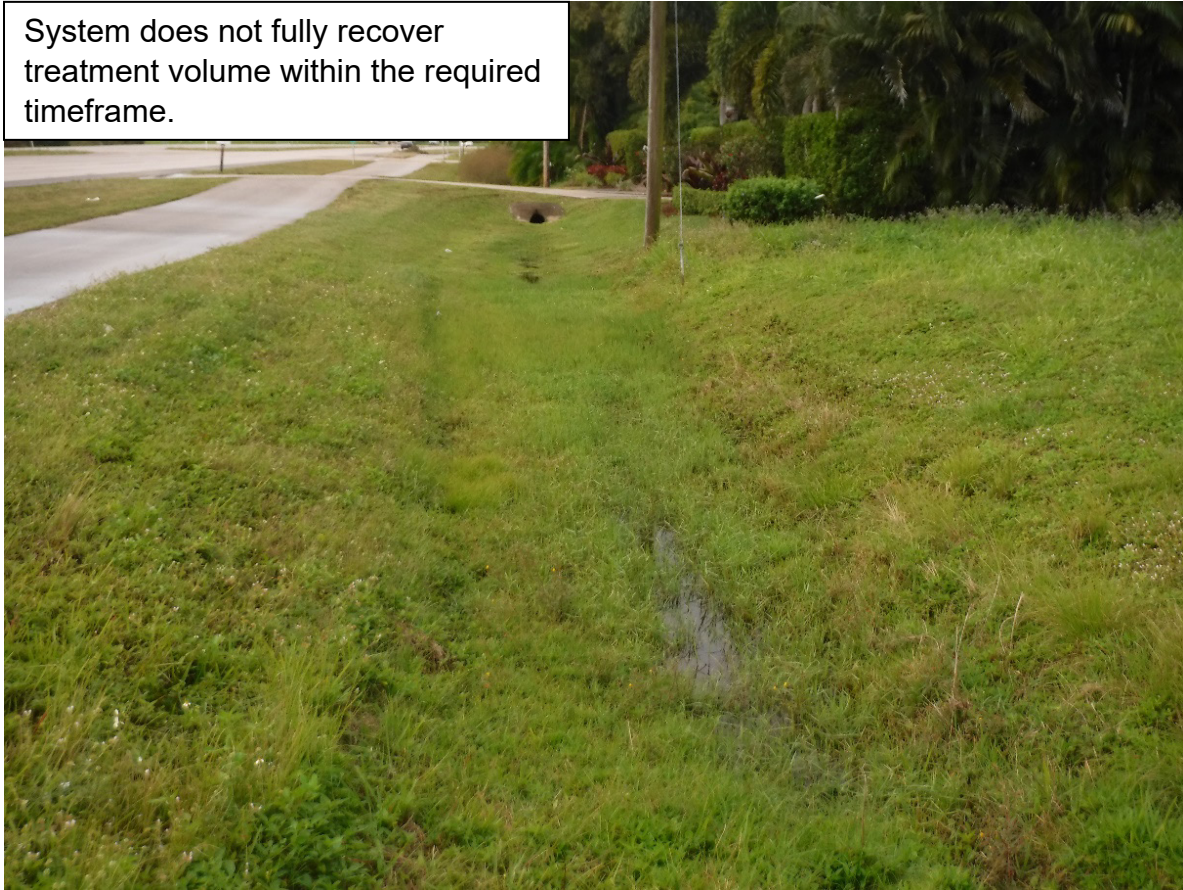
System does not fully recover treatment volume within the required timeframe.

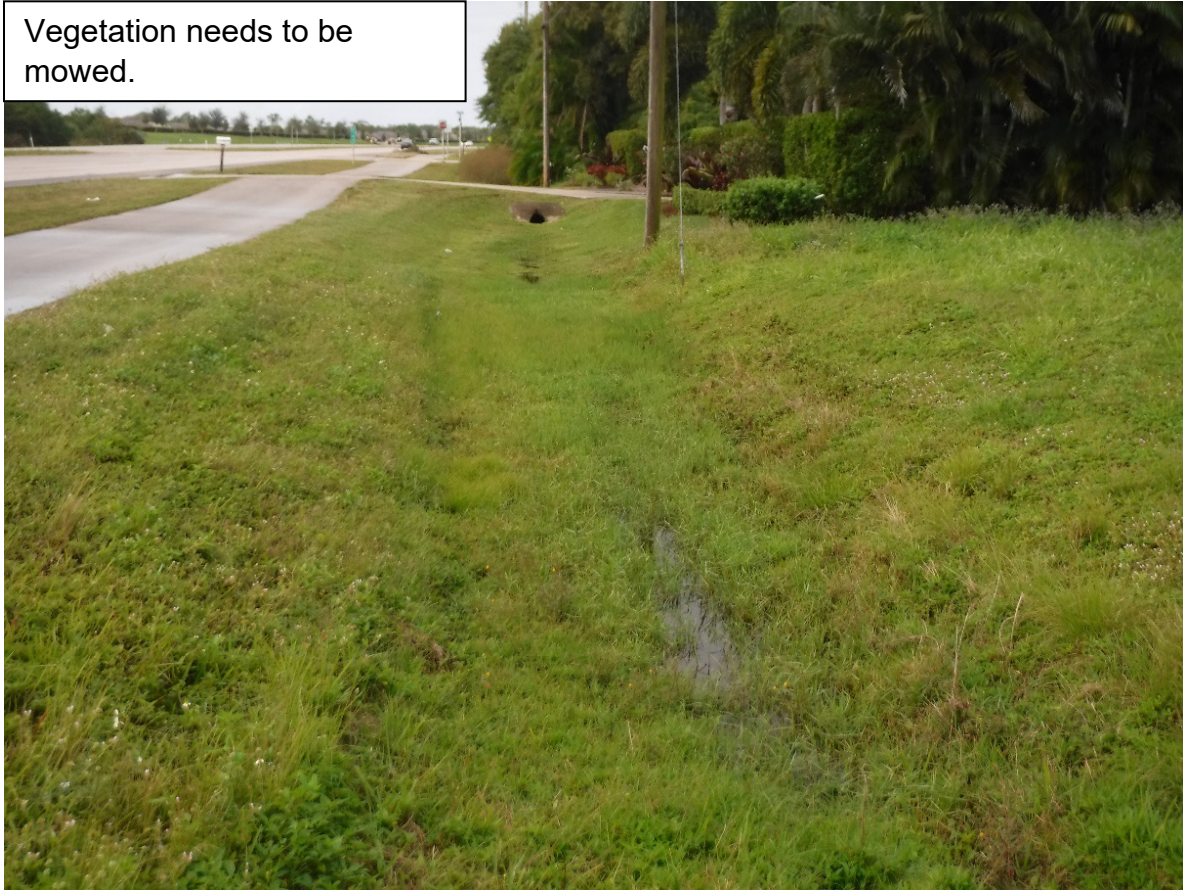
Vegetation needs to be mowed.

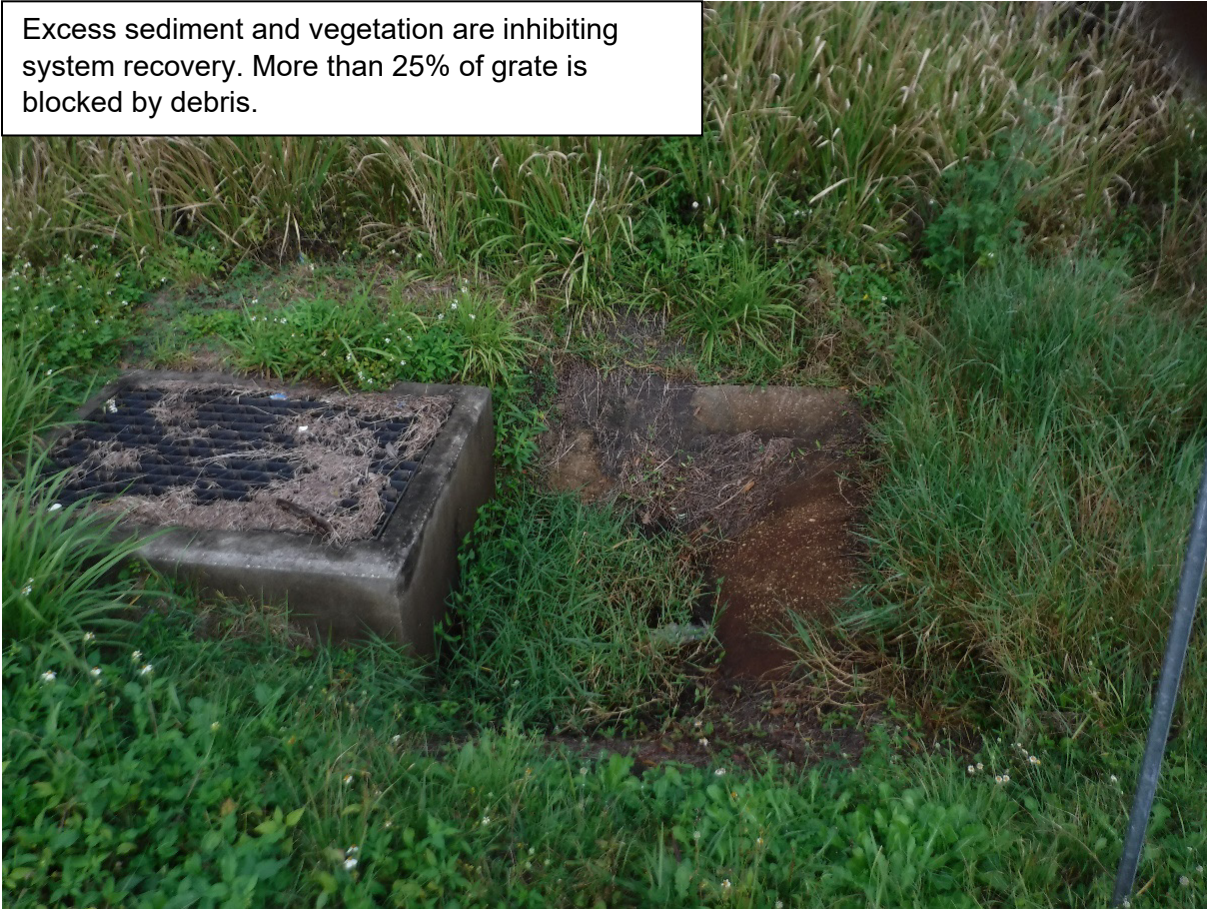
Excess sediment and vegetation are inhibiting system recovery. More than 25% of grate is blocked by debris.

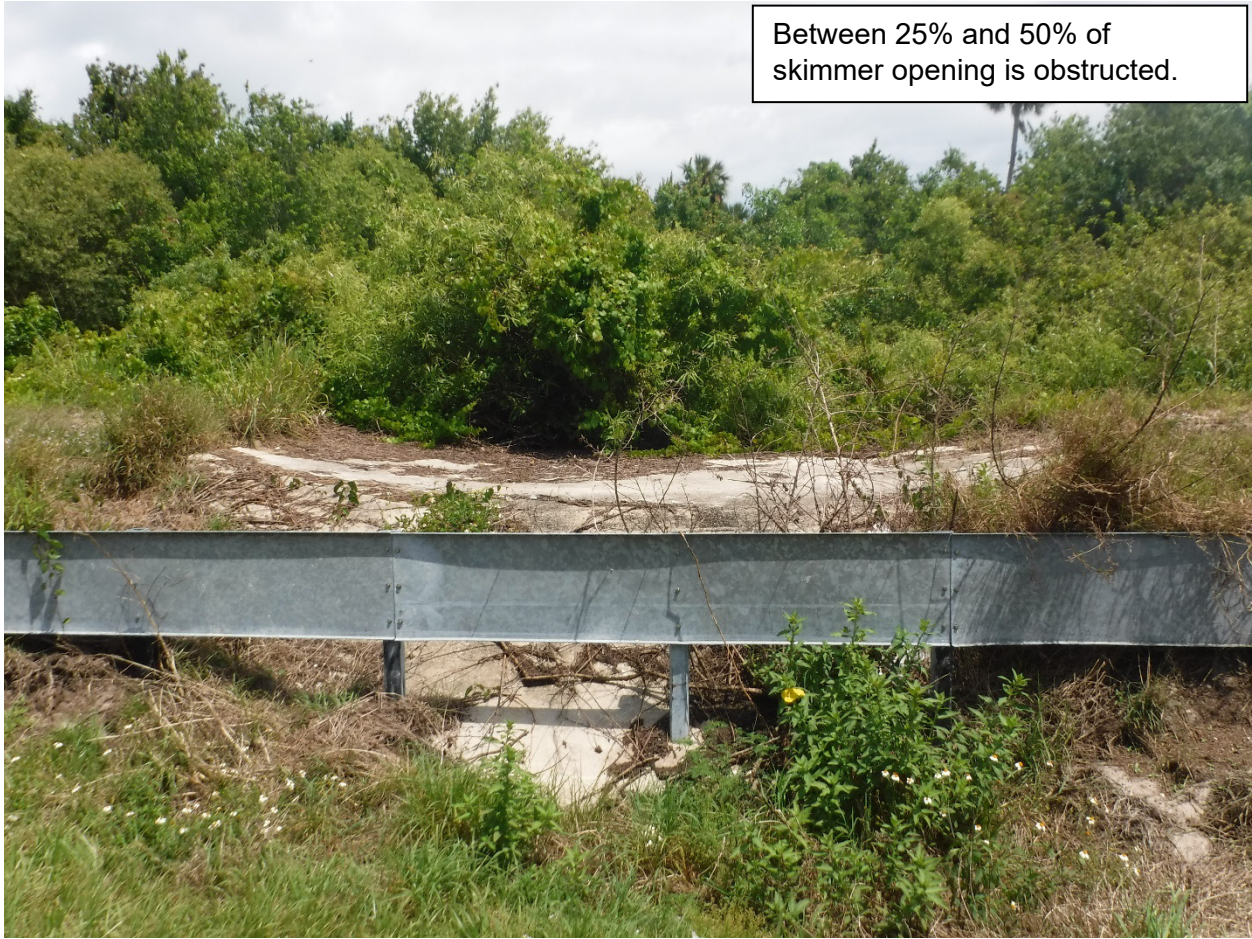
Concrete Ditch Block with Skimmer – Structural Condition – Fair

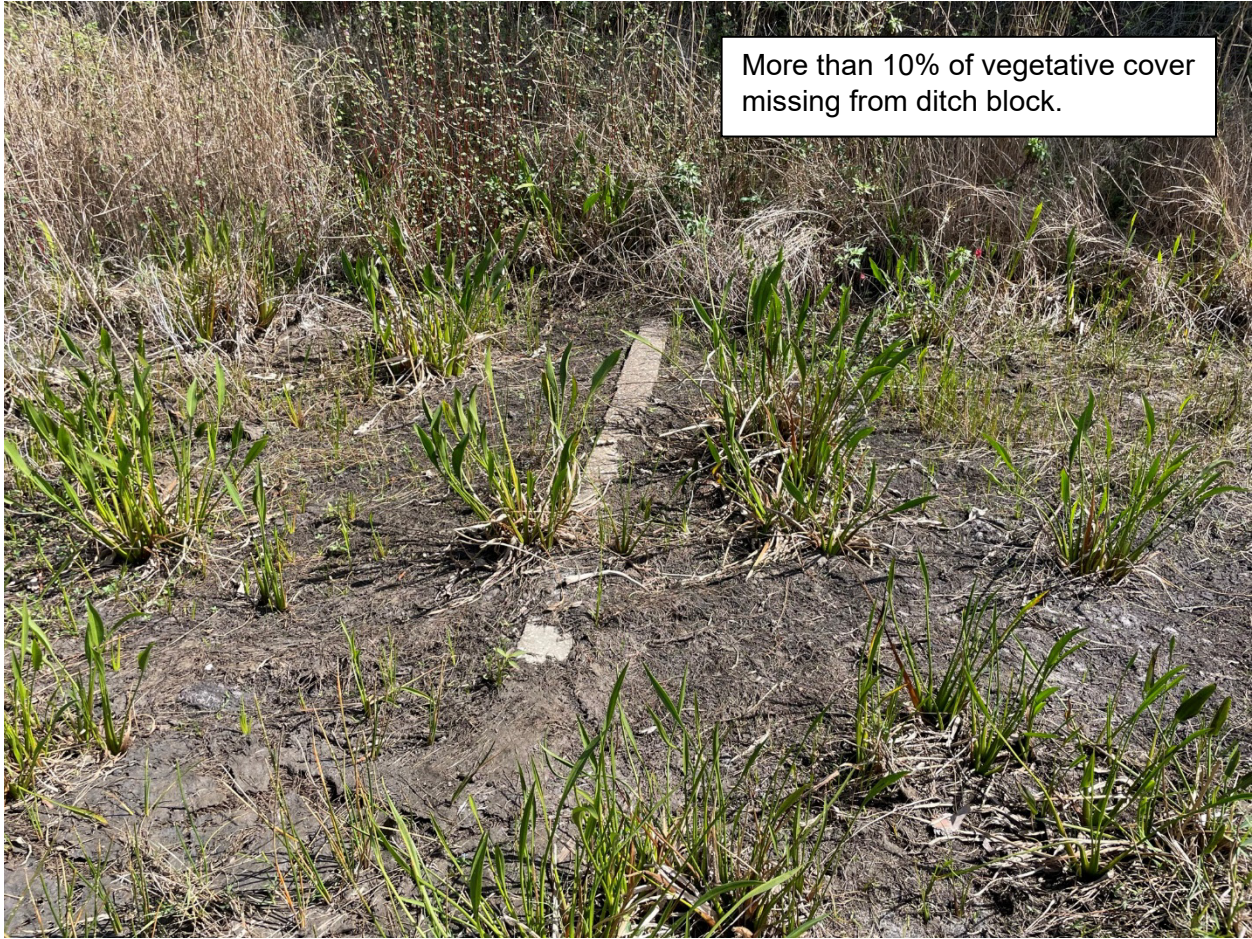
Earthen Ditch Block with Concrete Core – Structural Condition – Poor

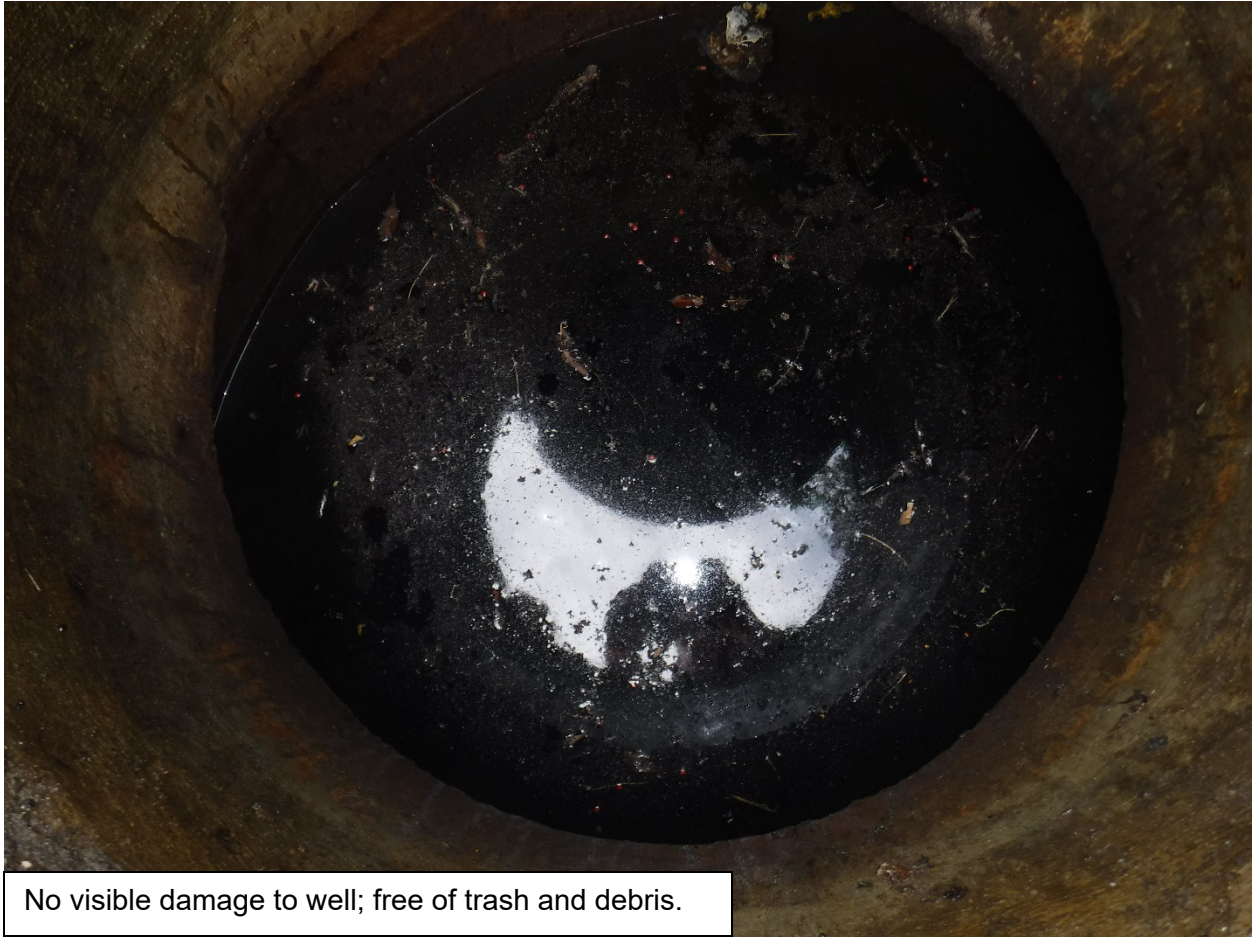
Drainage Well – Structural Condition – Good

No visible damage to well; free of trash and debris.

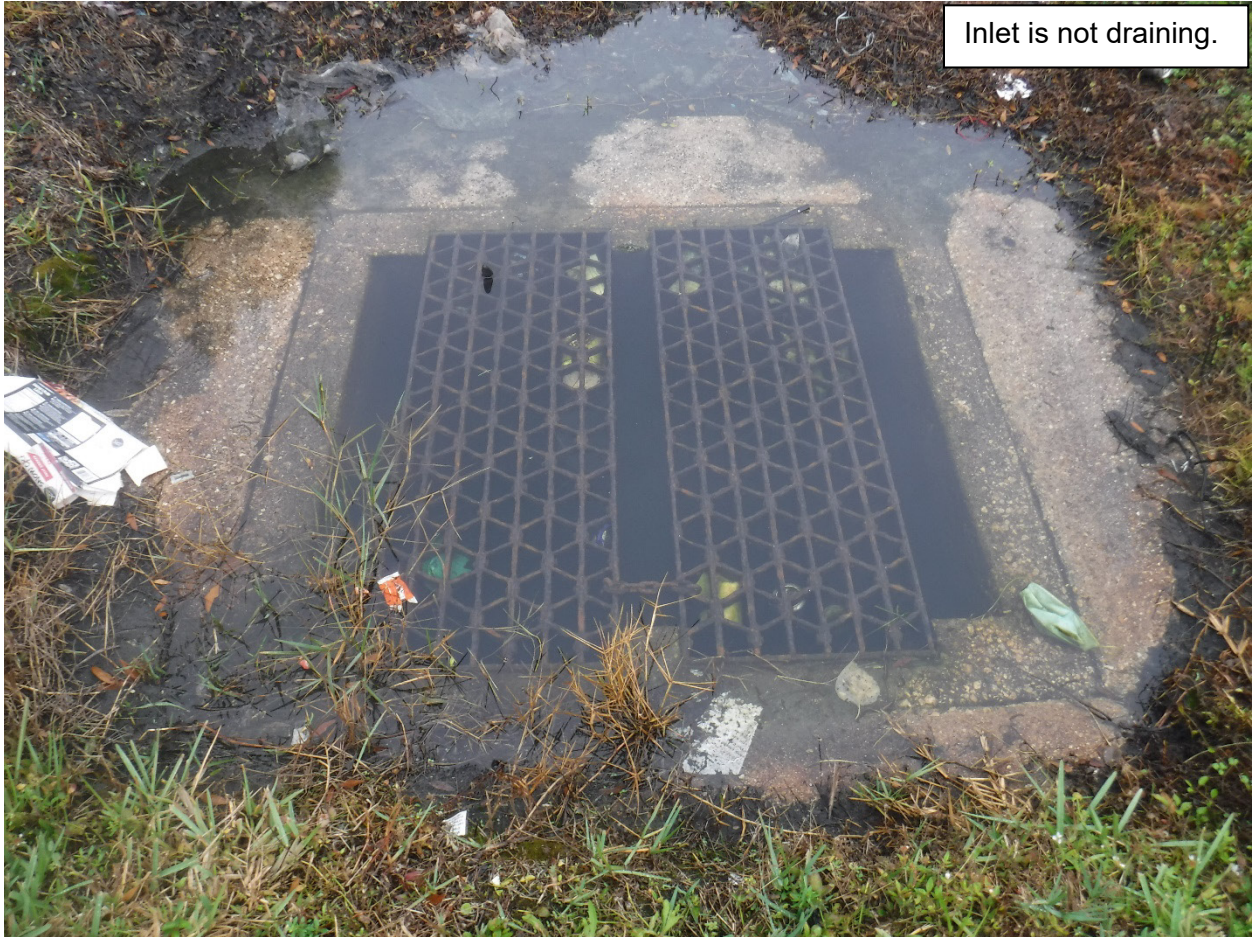
Conveyance Swale – Ditch Bottom Inlet – Poor Structural Condition

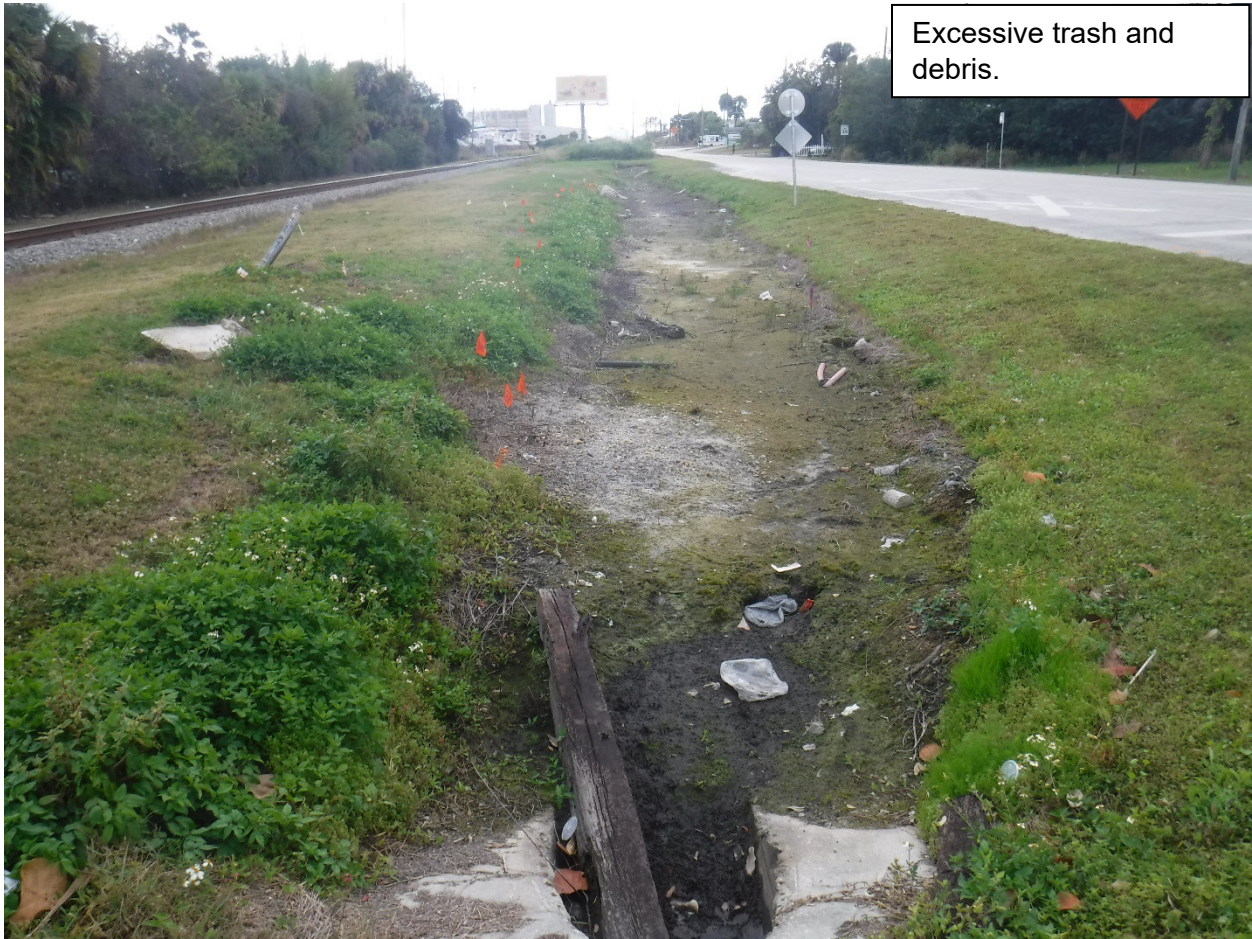
Conveyance Swale – Aesthetic Condition – Poor

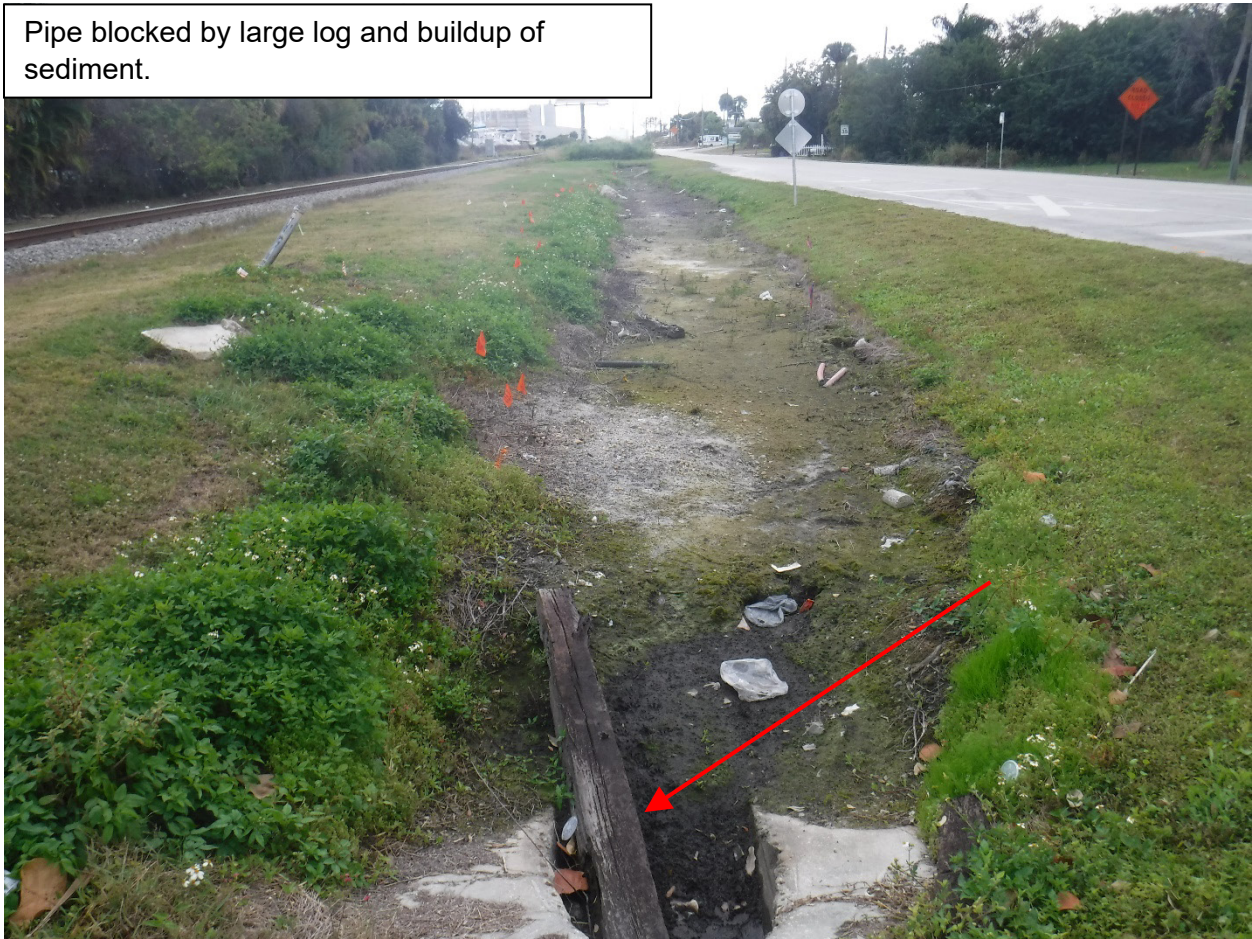
Pipe blocked by large log and buildup of sediment.
