Maintenance Guide for Stormwater Assets

May 2023

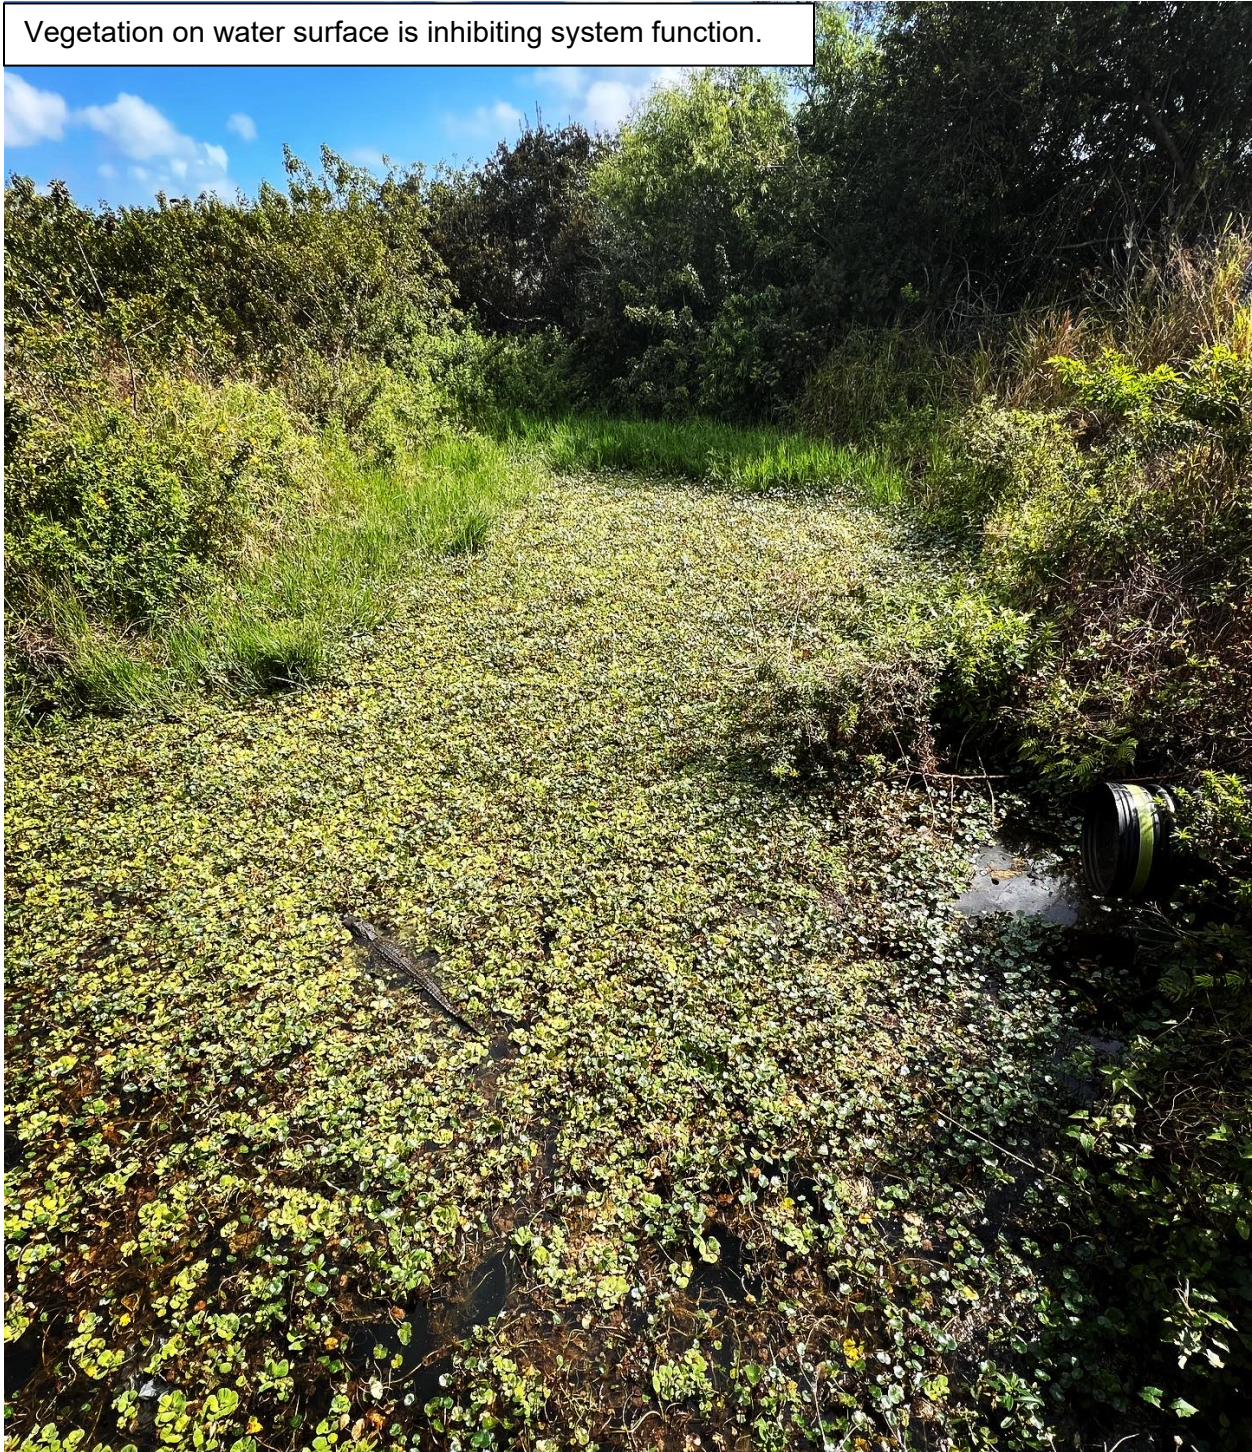
Vegetation on water surface is inhibiting system function.

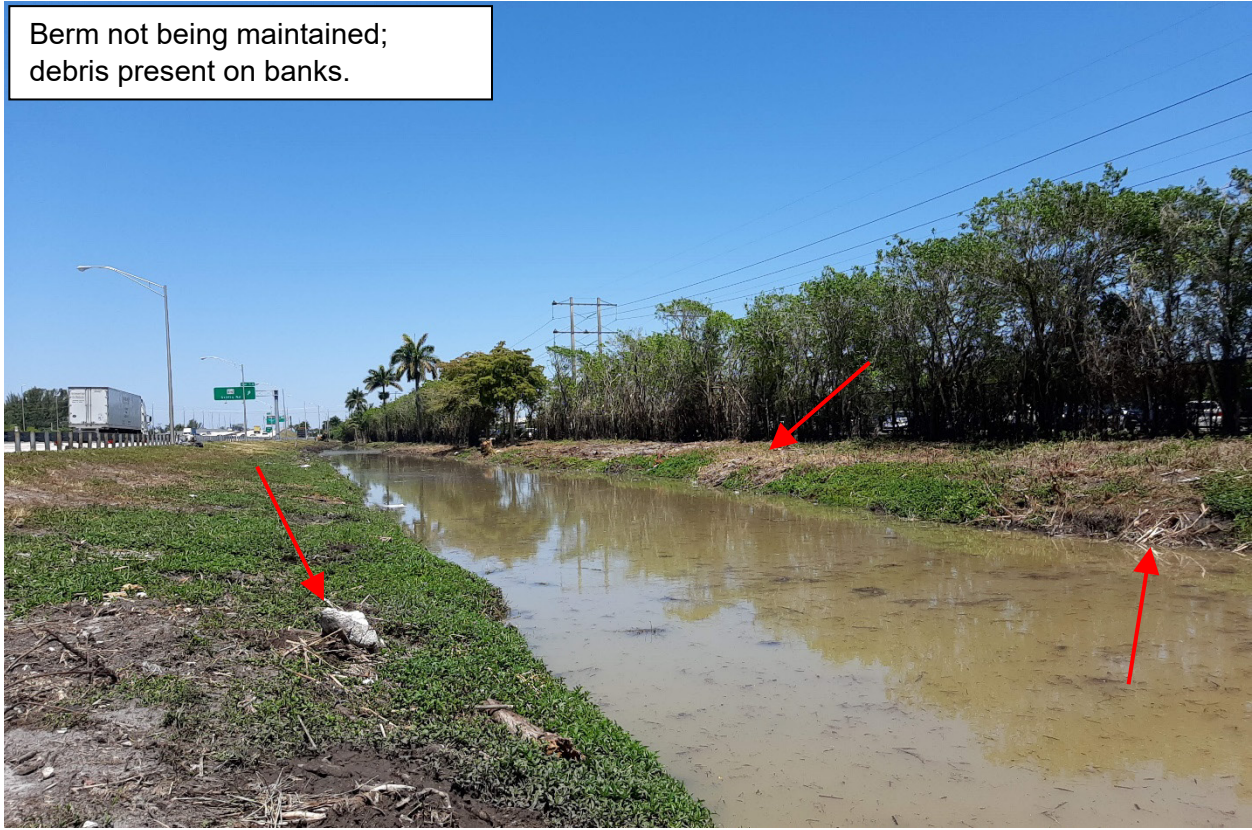
Berm not being maintained;
debris present on banks.

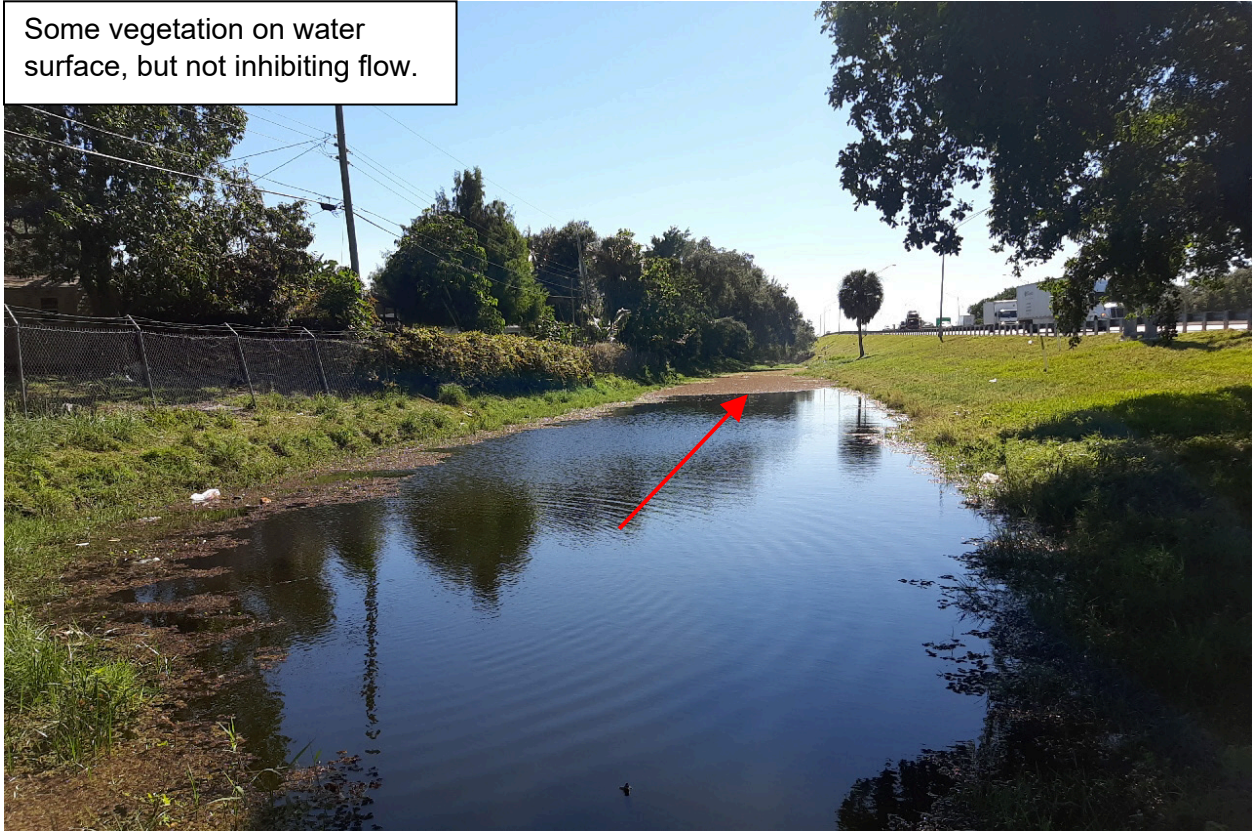
Some vegetation on water surface, but not inhibiting flow.

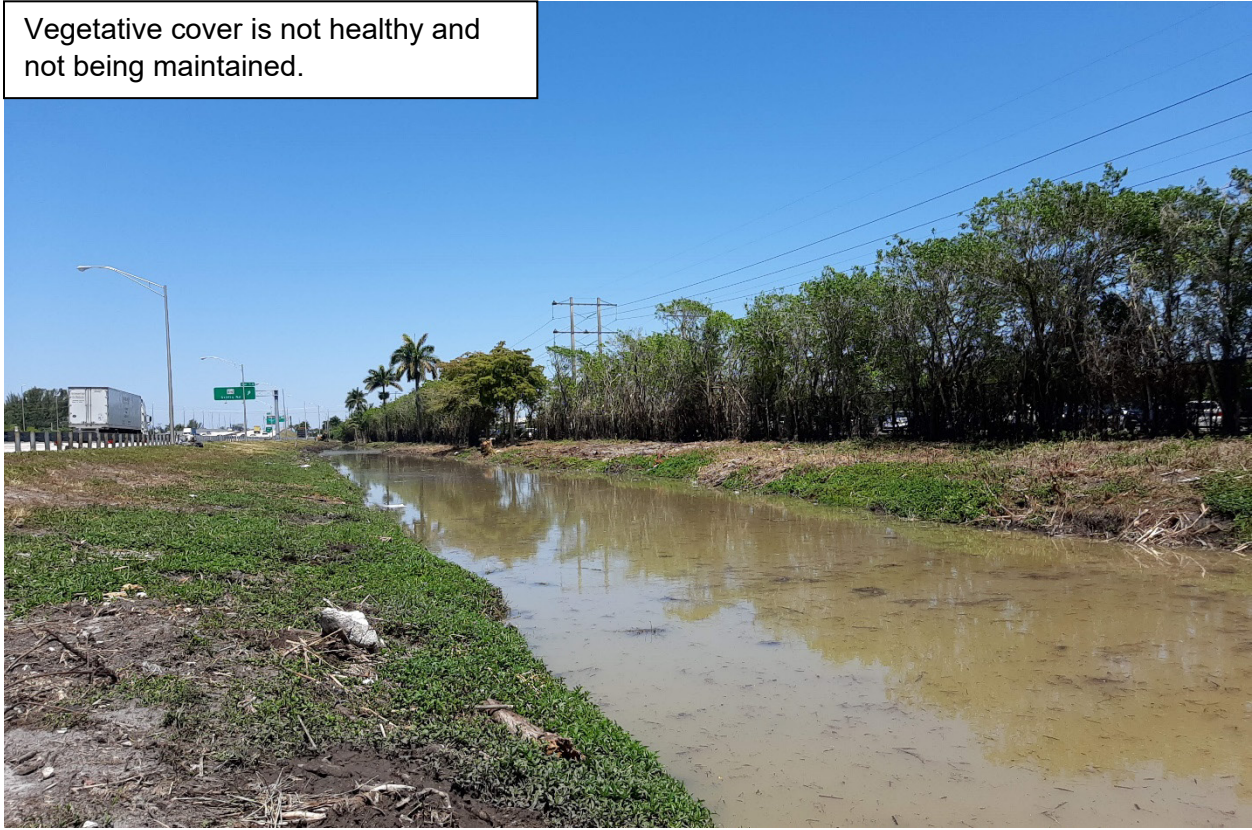
Vegetative cover is not healthy and not being maintained.

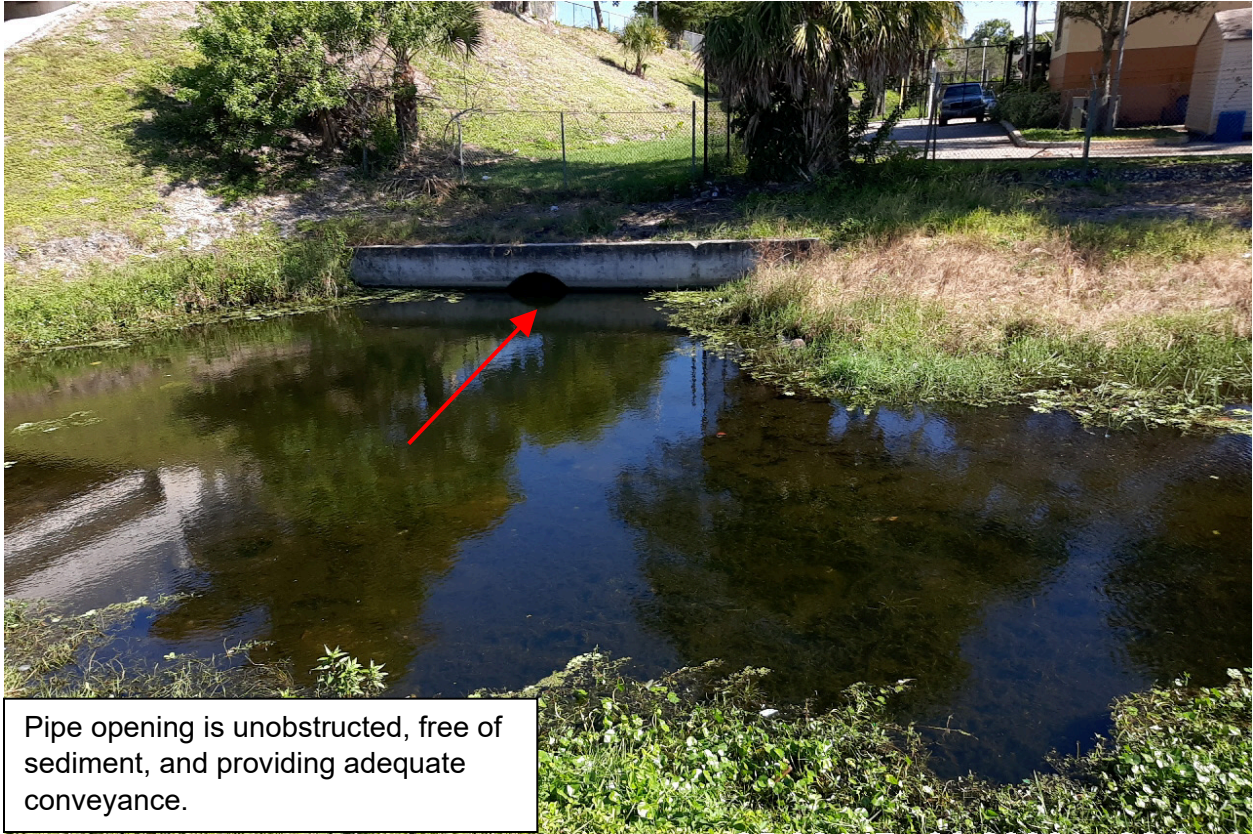
Canal – Inflow/Outflow Pipe – Good Condition

Pipe opening is unobstructed, free of sediment, and providing adequate conveyance.

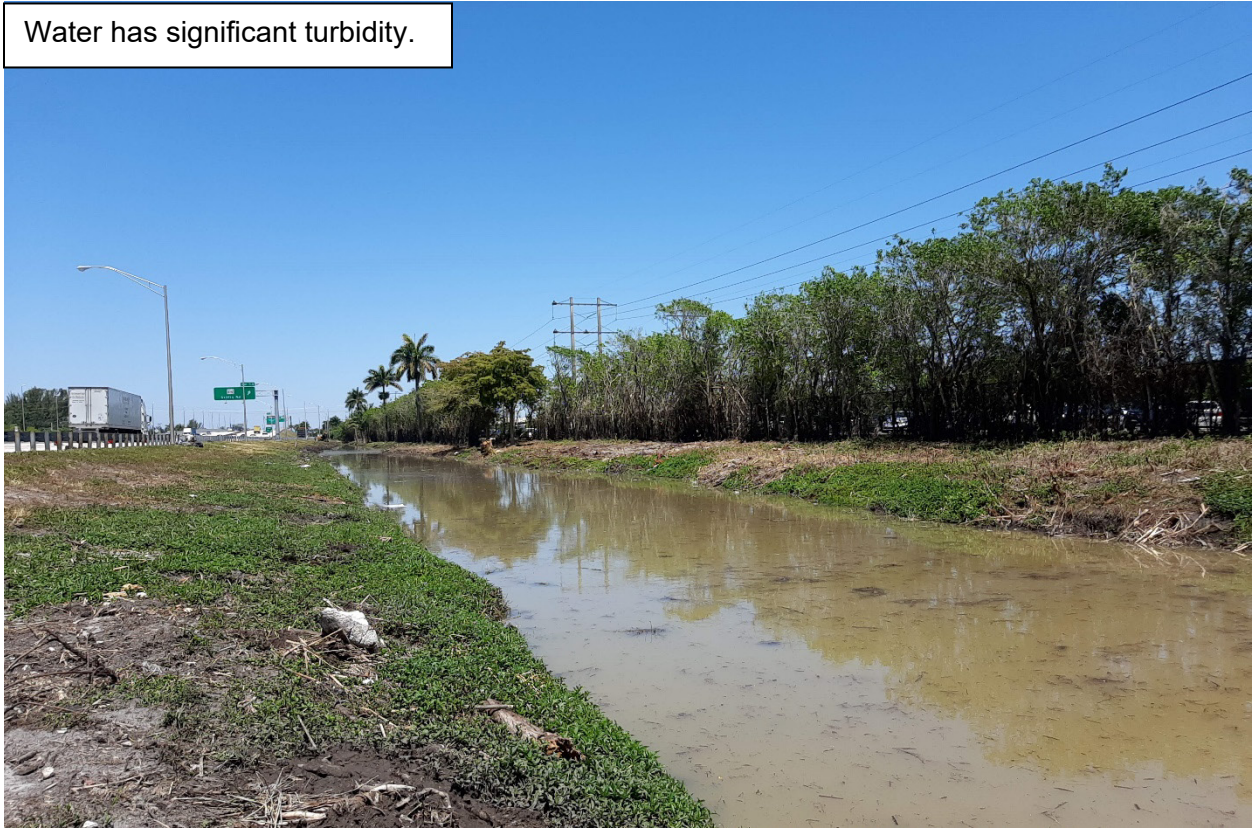
Water has significant turbidity.

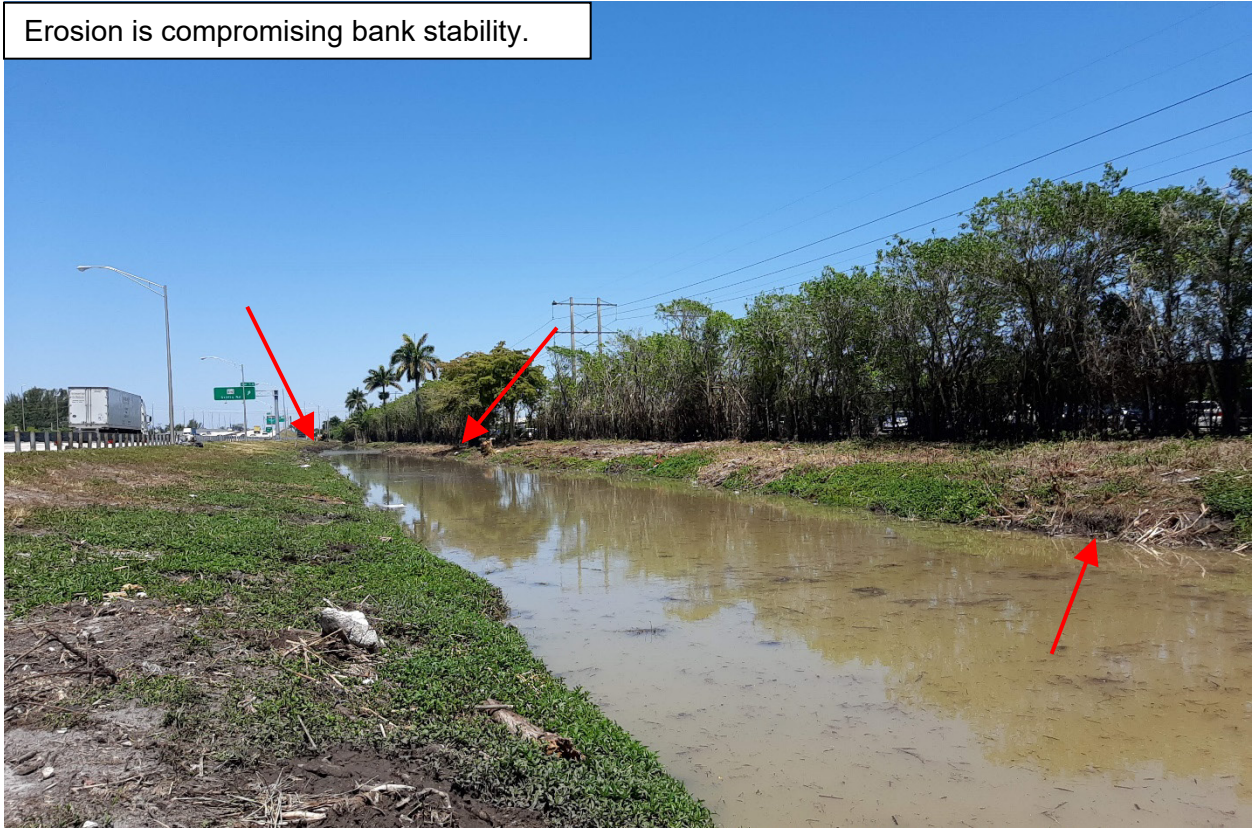
Erosion is compromising bank stability.

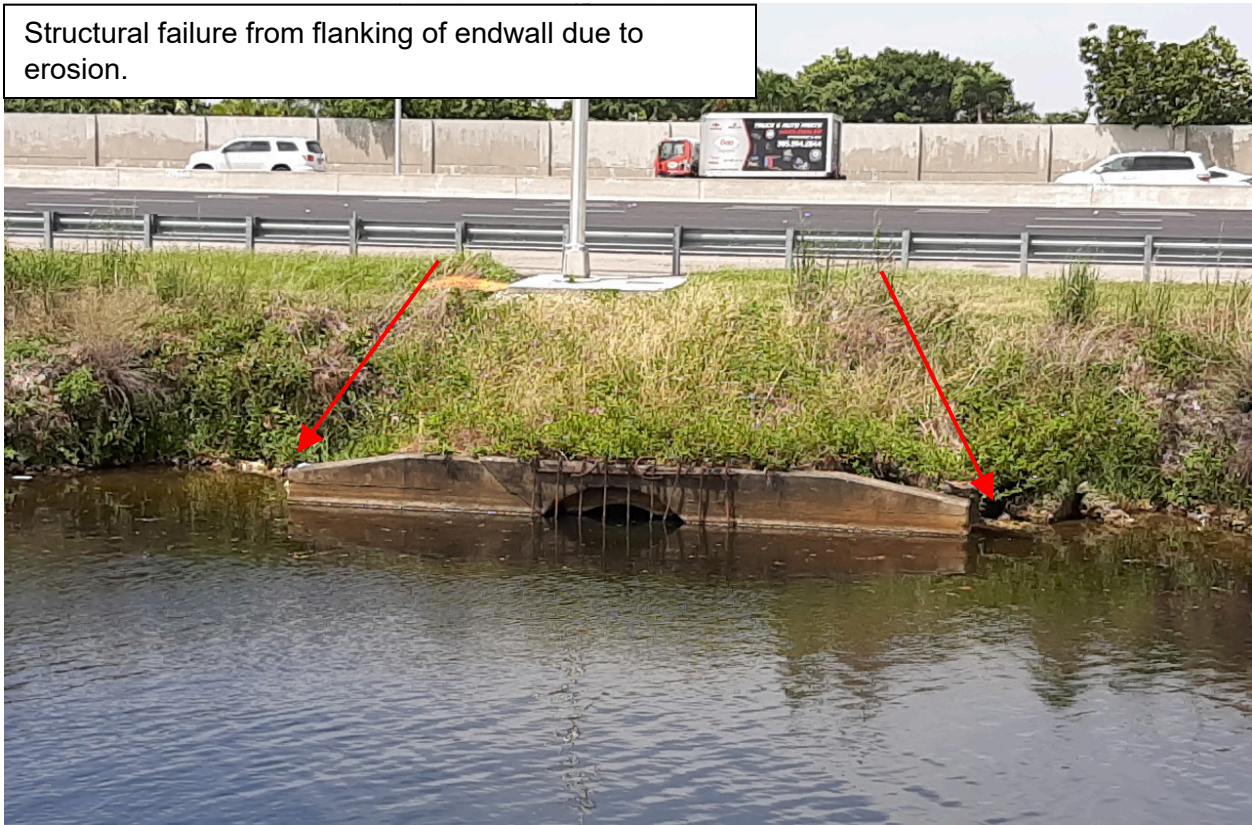
Structural failure from flanking of endwall due to erosion.

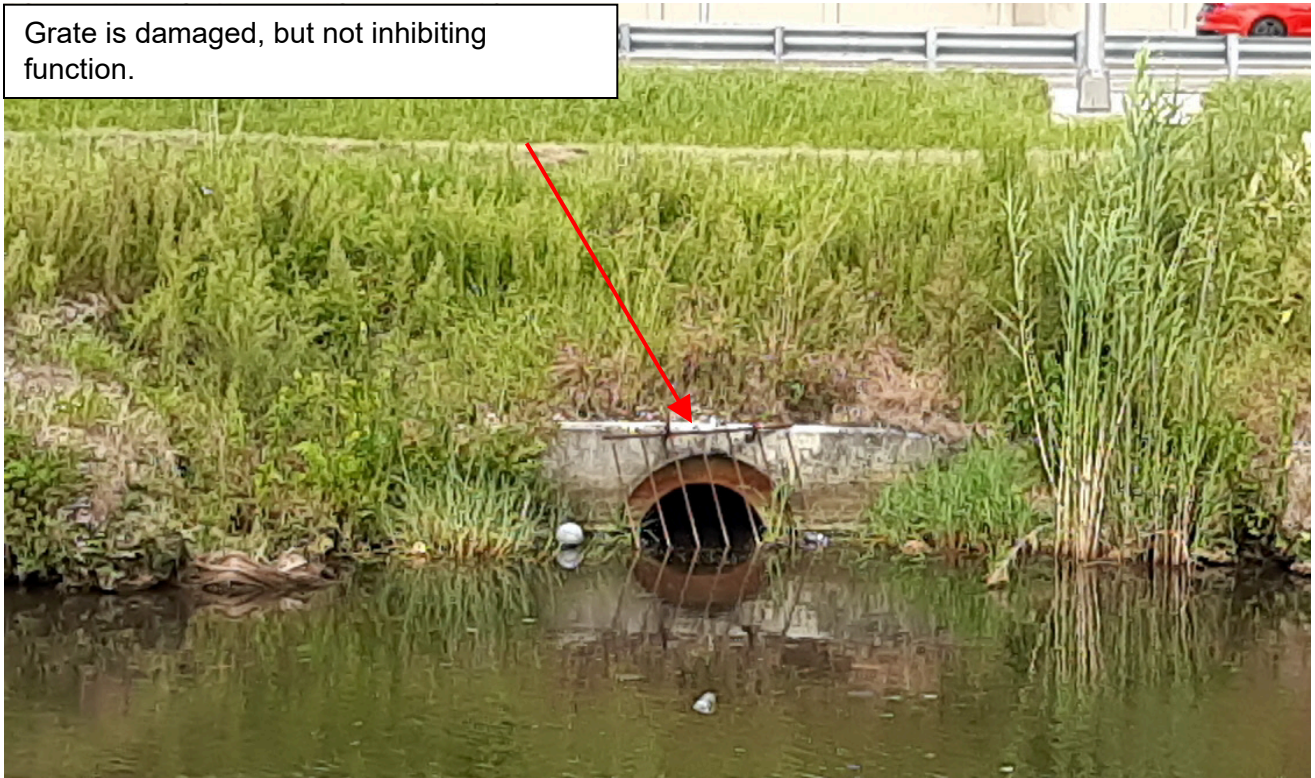
Grate is damaged, but not inhibiting function.

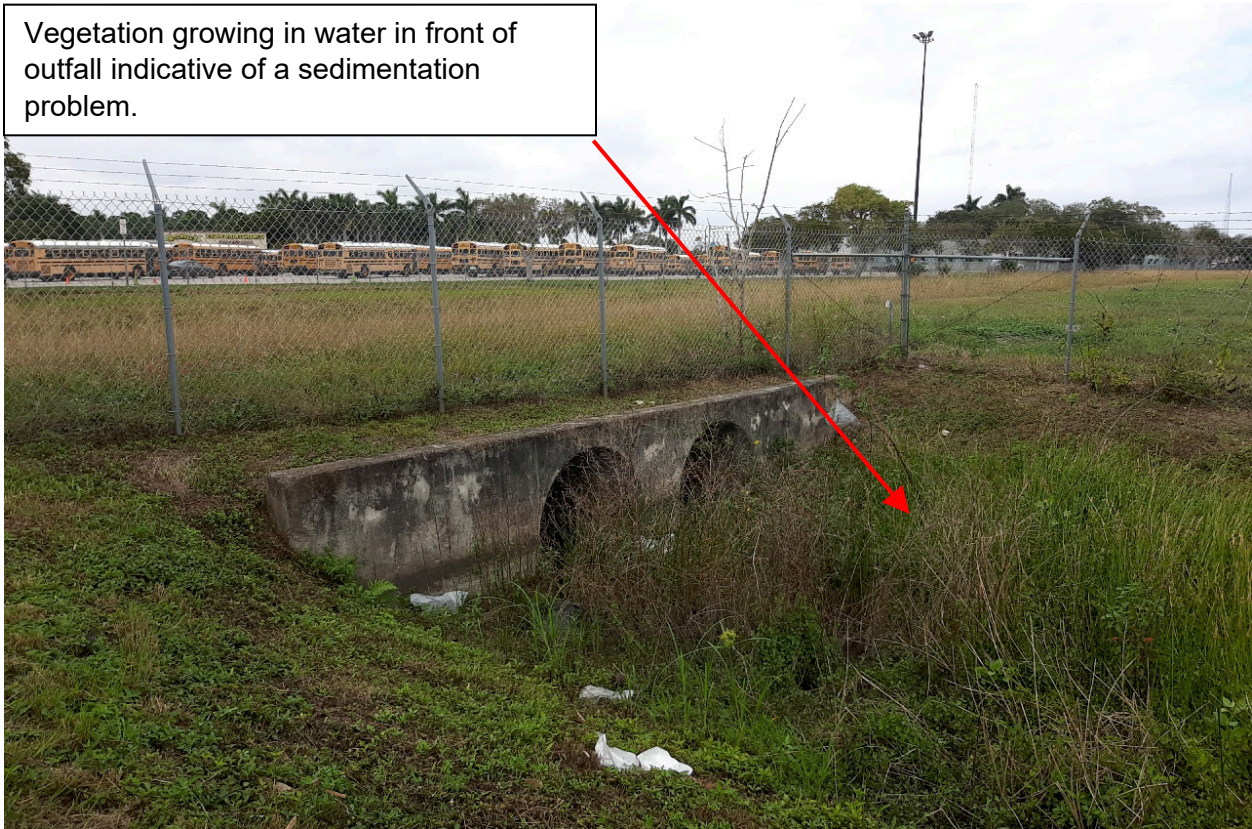
Vegetation growing in water in front of outfall indicative of a sedimentation problem.

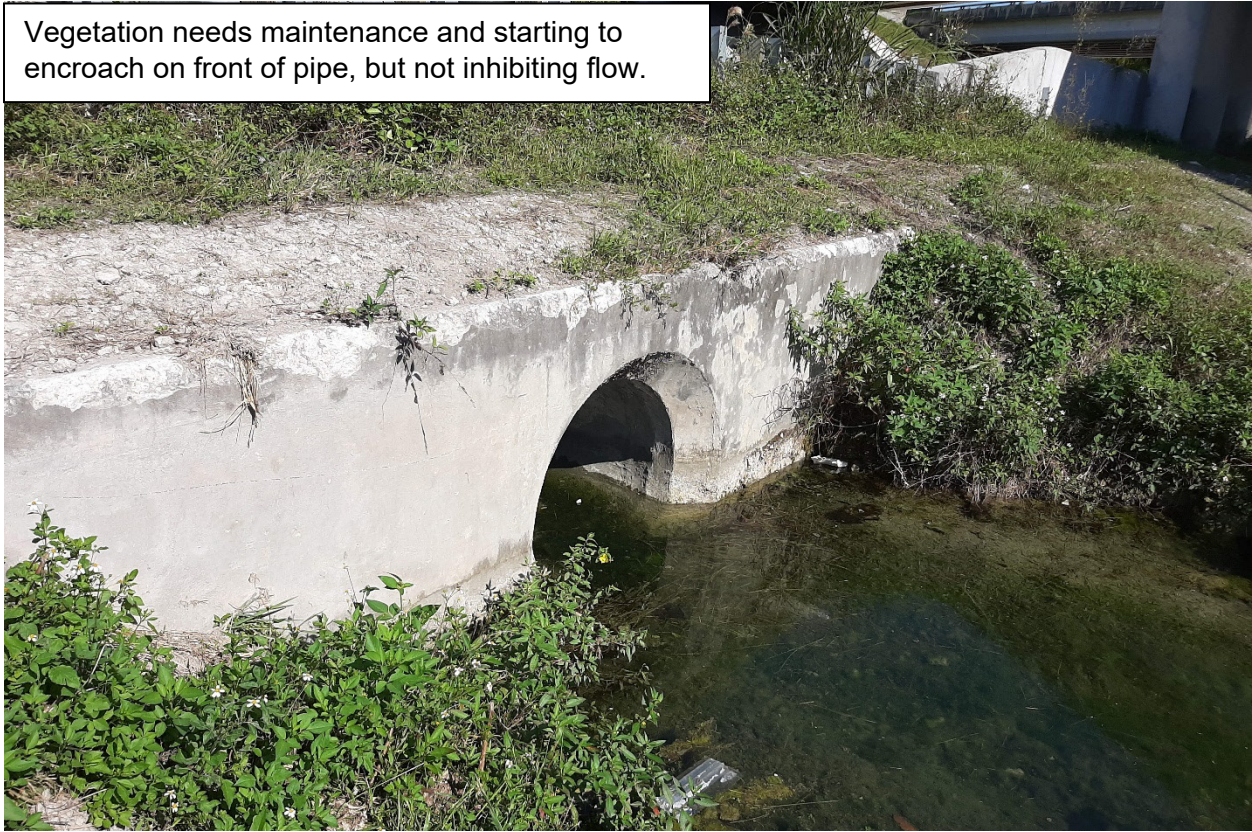
Vegetation needs maintenance and starting to encroach on front of pipe, but not inhibiting flow.

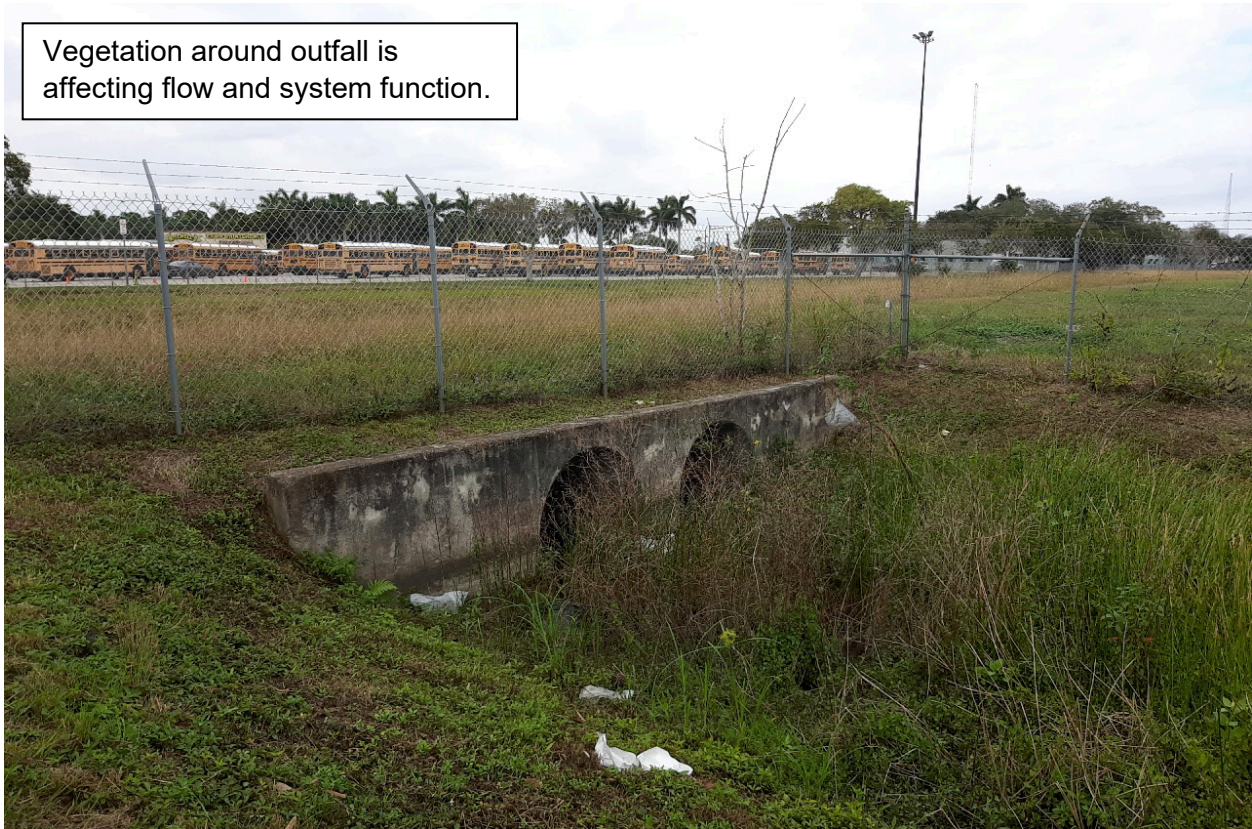
Vegetation around outfall is affecting flow and system function.

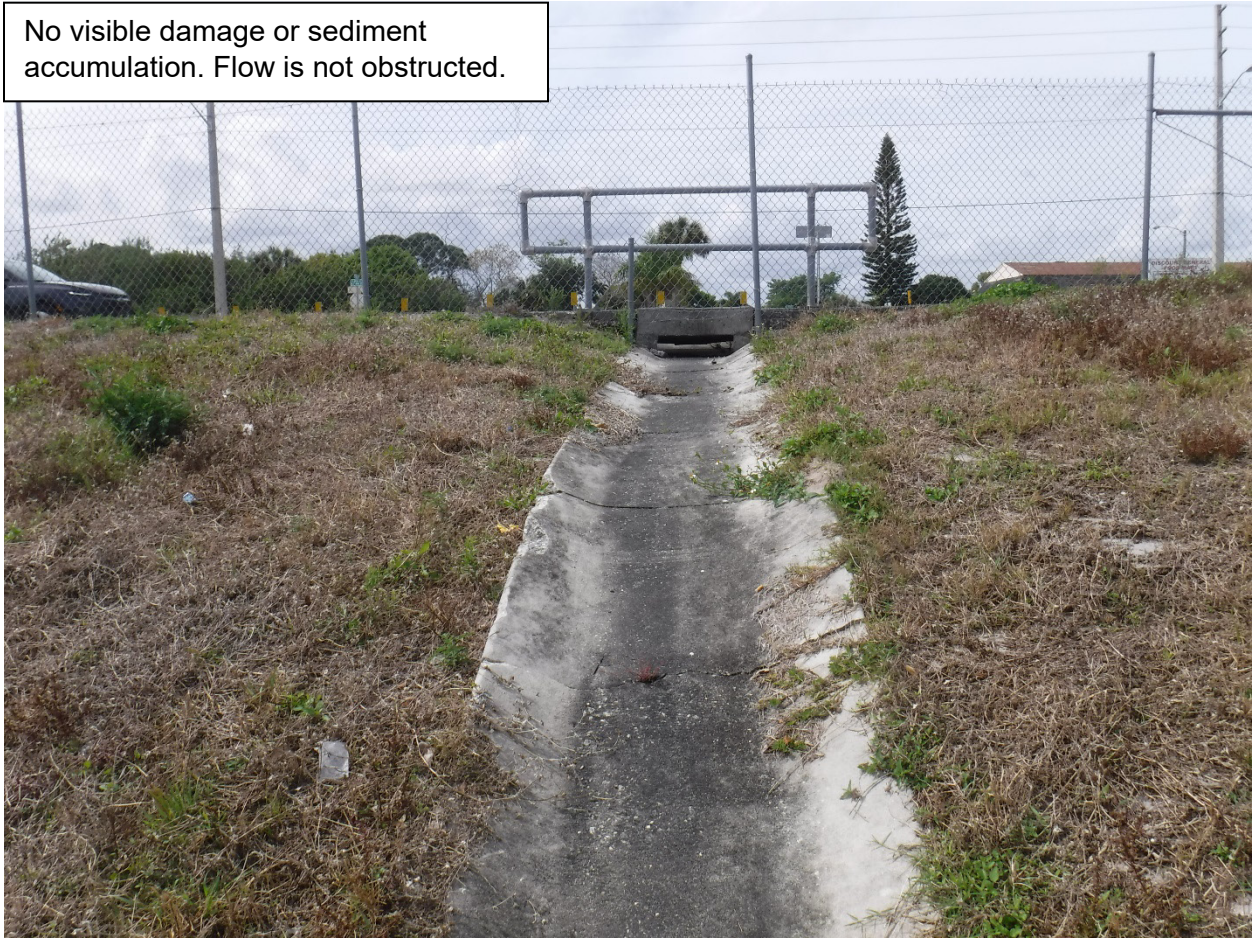
No visible damage or sediment accumulation. Flow is not obstructed.
