Report Prepared by:

**Michael T. Walsh
Alberto A. Sagüés**

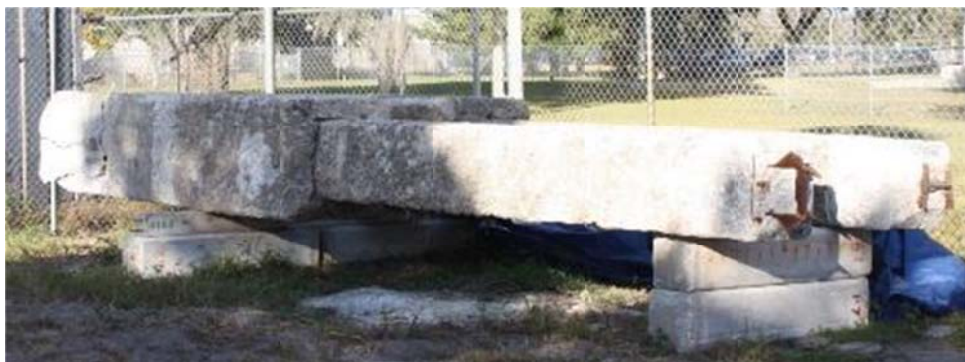
Figure 1. Piles resting side-by-side on horizontal concrete columns. Note jackets on upper area (left) of piles and H-beams visible at each pile bottom end (right).

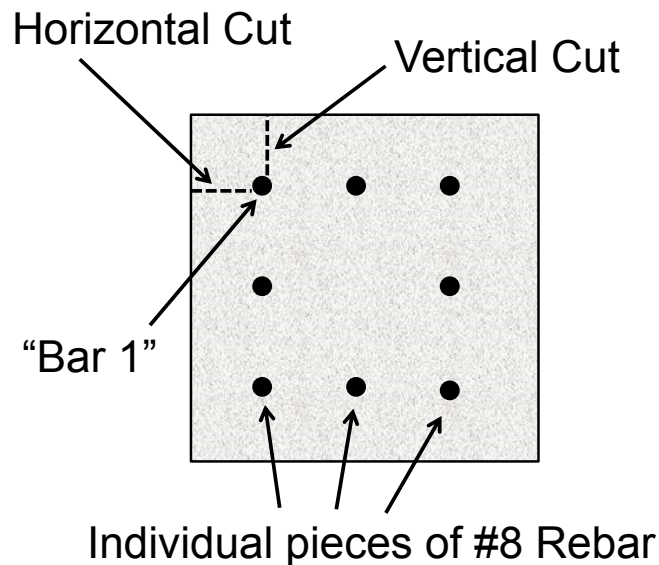
Figure 4. Cross-section of Pile #2 showing vertical and horizontal saw cuts. H beam not shown.

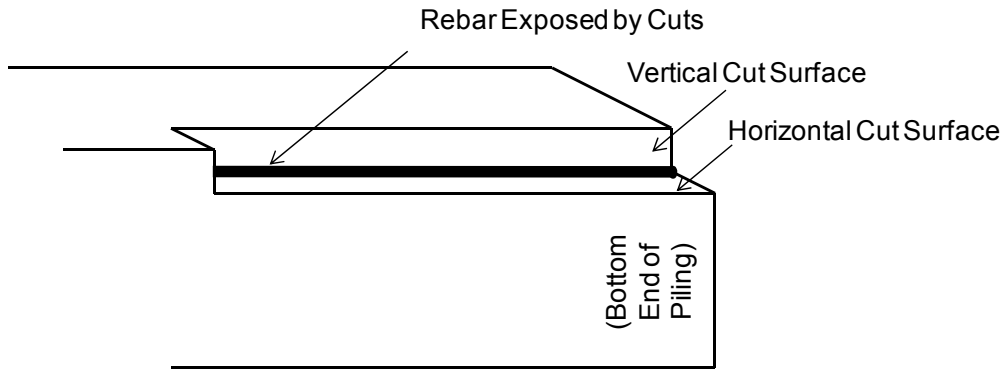
Figure 5. Rebar exposed by 11'-long vertical and horizontal saw cuts (not to scale).

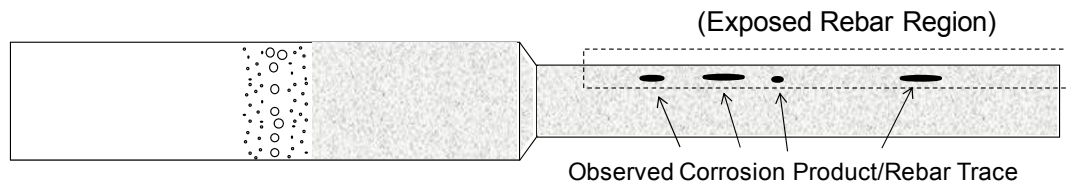
Figure 6. Approximate locations of observed corrosion products and rust trace on removed concrete bar 1.

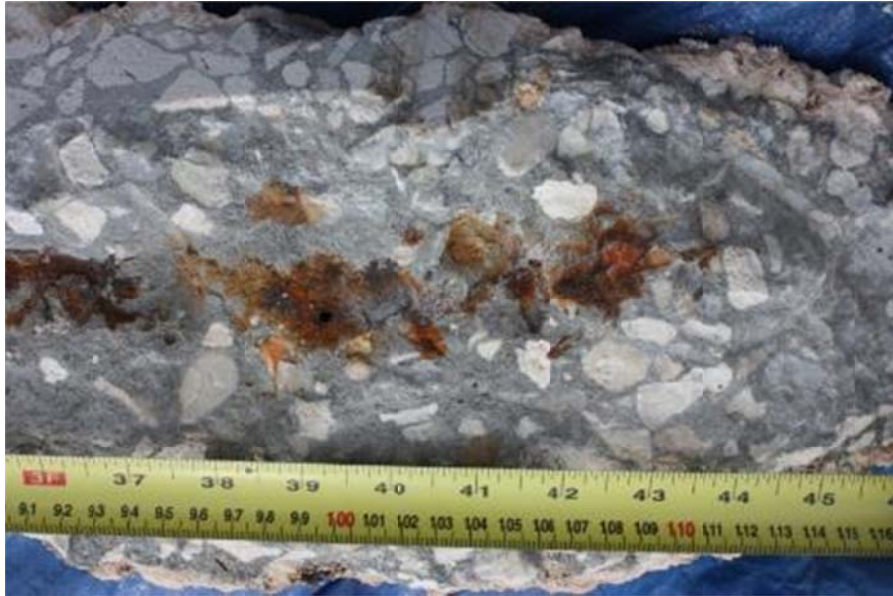
Figure 7. Rebar rust trace on portion of concrete removed from Pile #1. Tape measure indicates distance from bottom of pile.

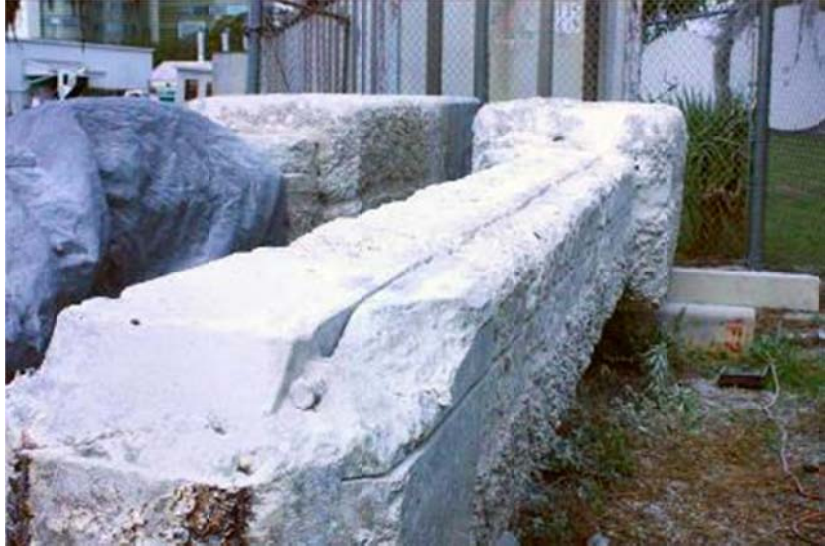
Figure 8. Vertical and horizontal saw cuts in the submerged portion of Pile #2.

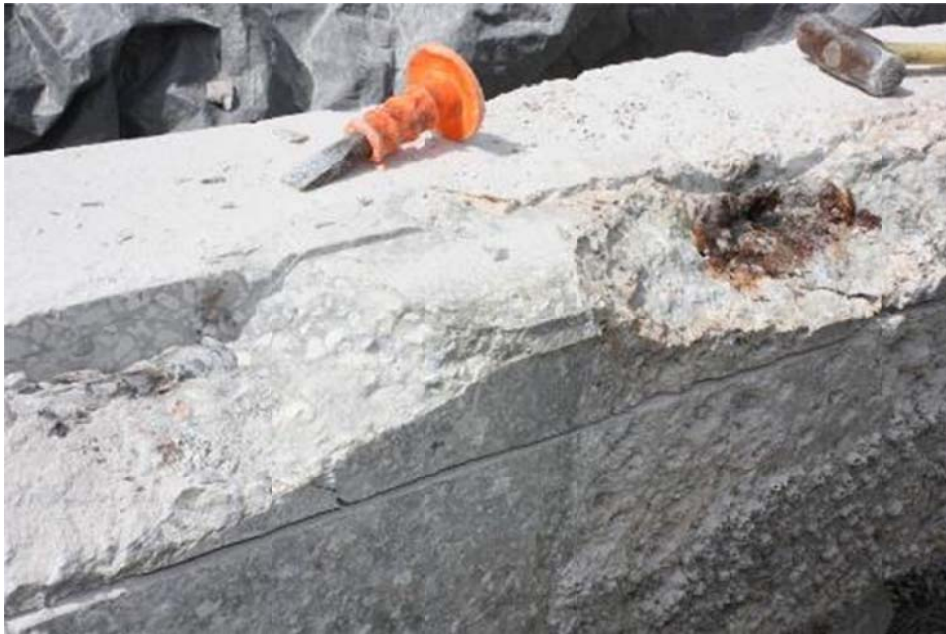
Figure 9. Oxide stains in concrete cover observed during removal of embedded bar.

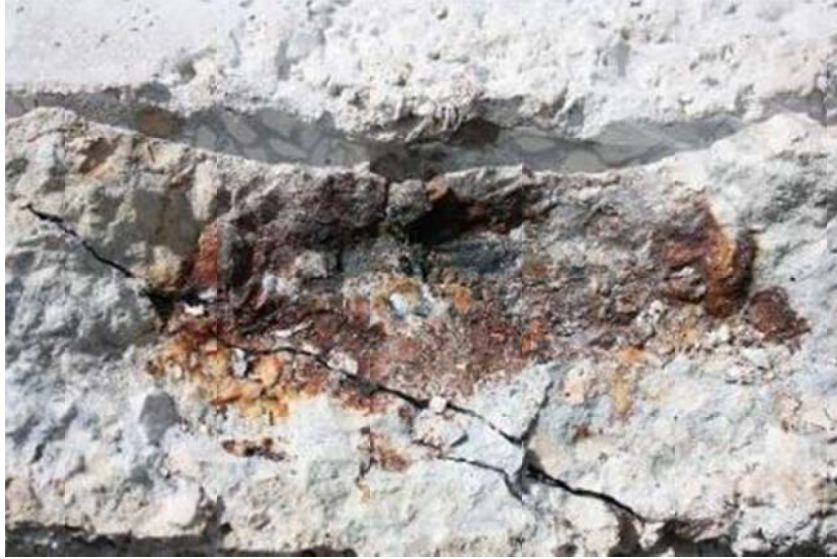
Figure 10. Close-up view of oxide stains in concrete cover observed during removal of embedded bar. Note that a small portion of the bar itself can be seen in the center of the photo.

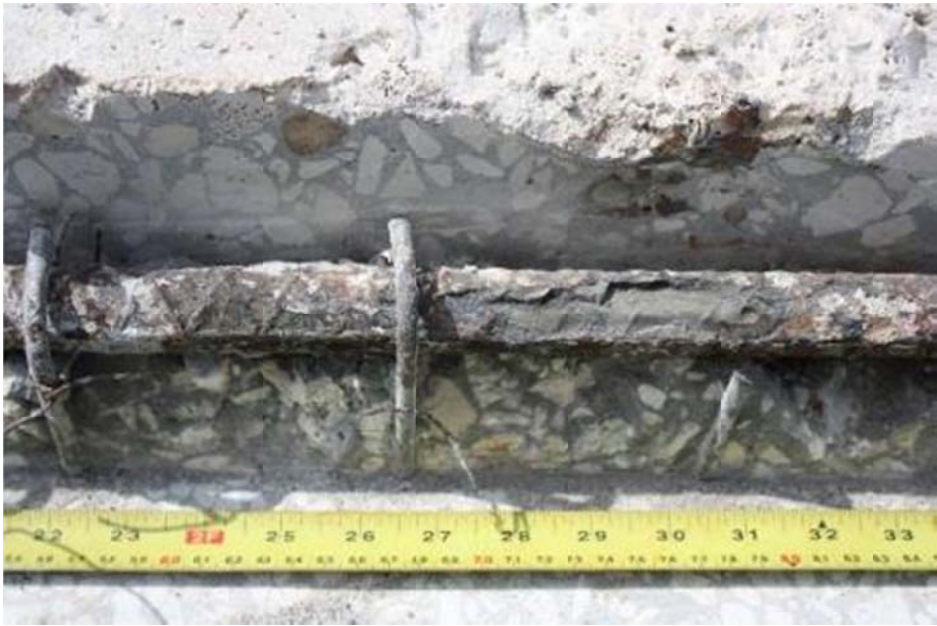
Figure 11. Rebar in situ following removal of the concrete shown in Figures 9 and 10.

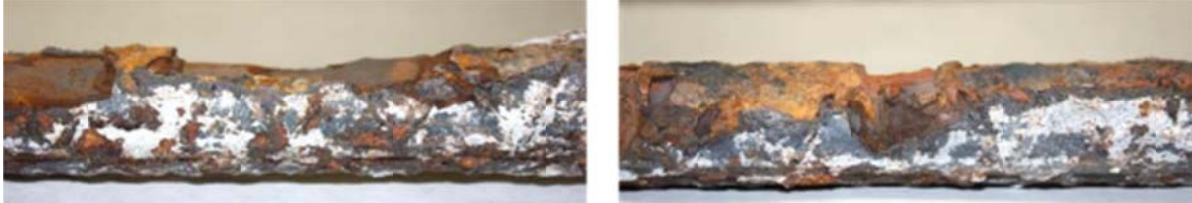
Figure 12. Apparent corrosion-related cross-section loss observed in bar #1.

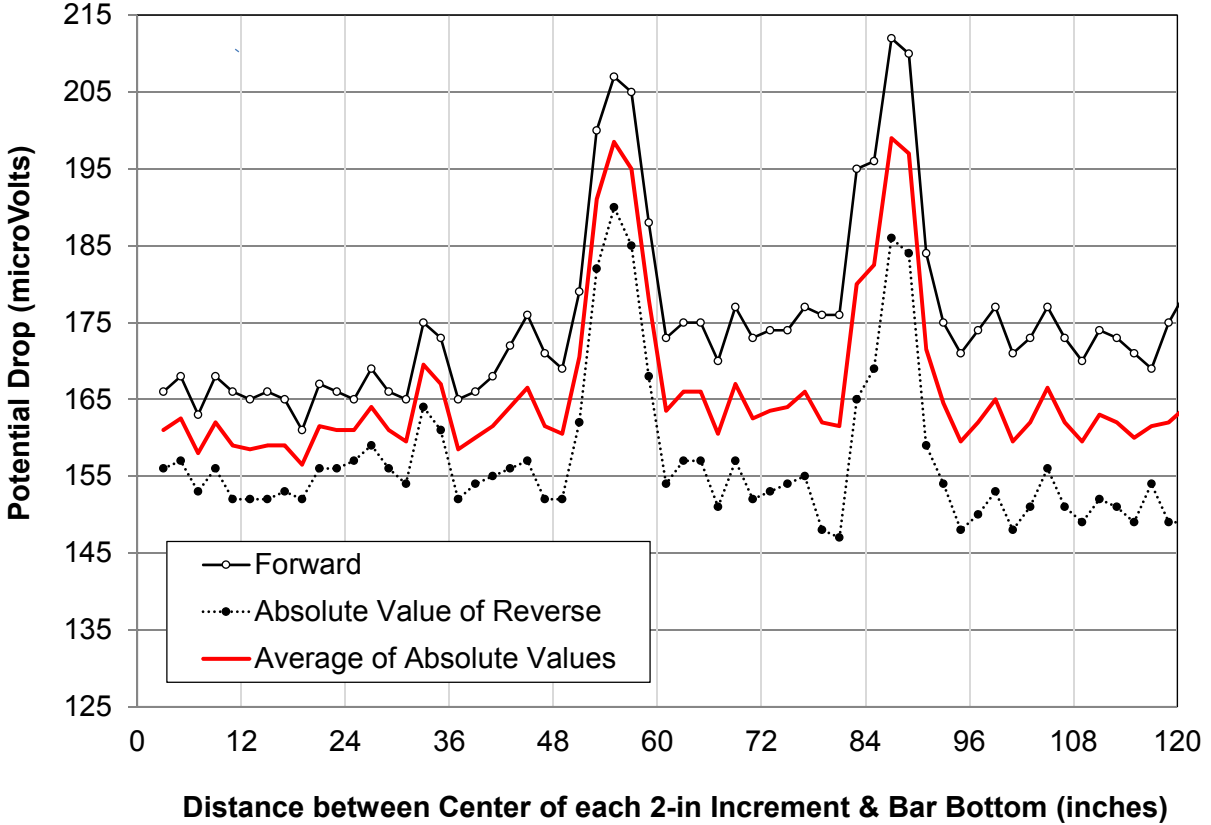
Figure 13. Cross-section loss survey. Voltage Drop at 2-inch intervals along the length of Bar #1 with DC current of 10 amperes.

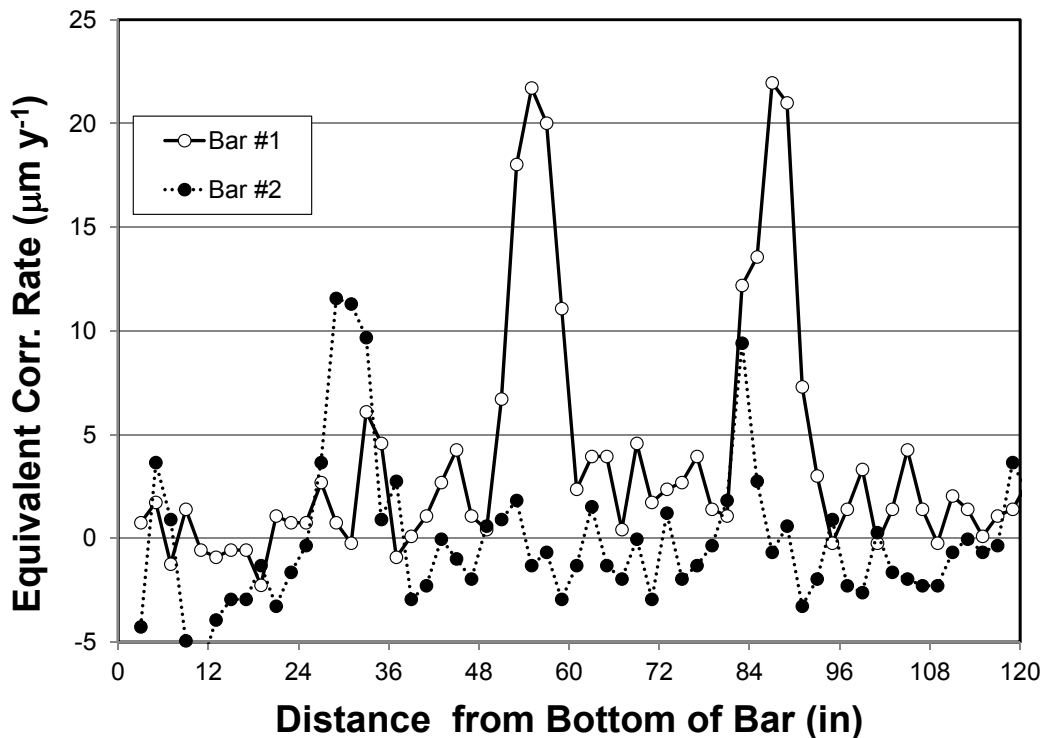
Figure 14. Equivalent corrosion rate as a function of the distance between the vertical midpoint of a 2-inch increment and the bottom of the bar.

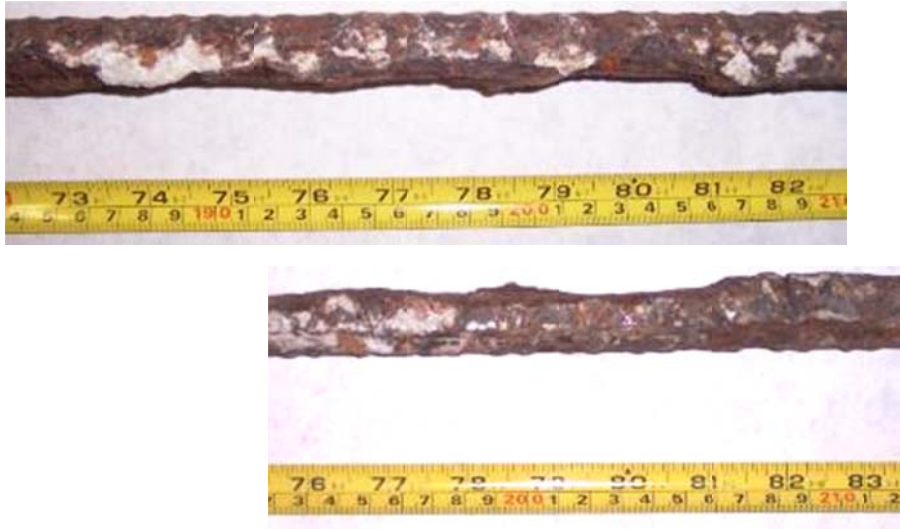
Figure 15. Corrosion-related cross-section loss in Bar #5.

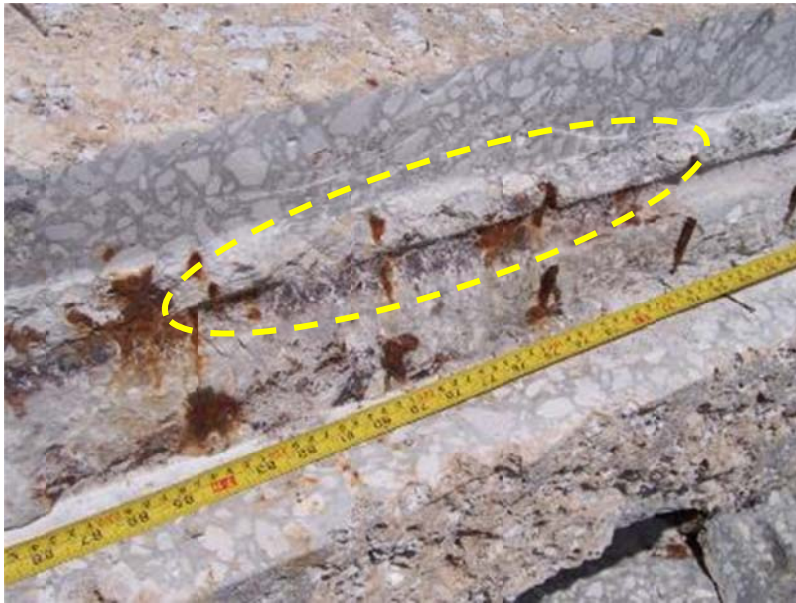
Figure 16. Rebar trace corresponding to underside of the corroded region of Bar #5.
Marked zone corresponds approximately to bar segments pictured in Figure 15.

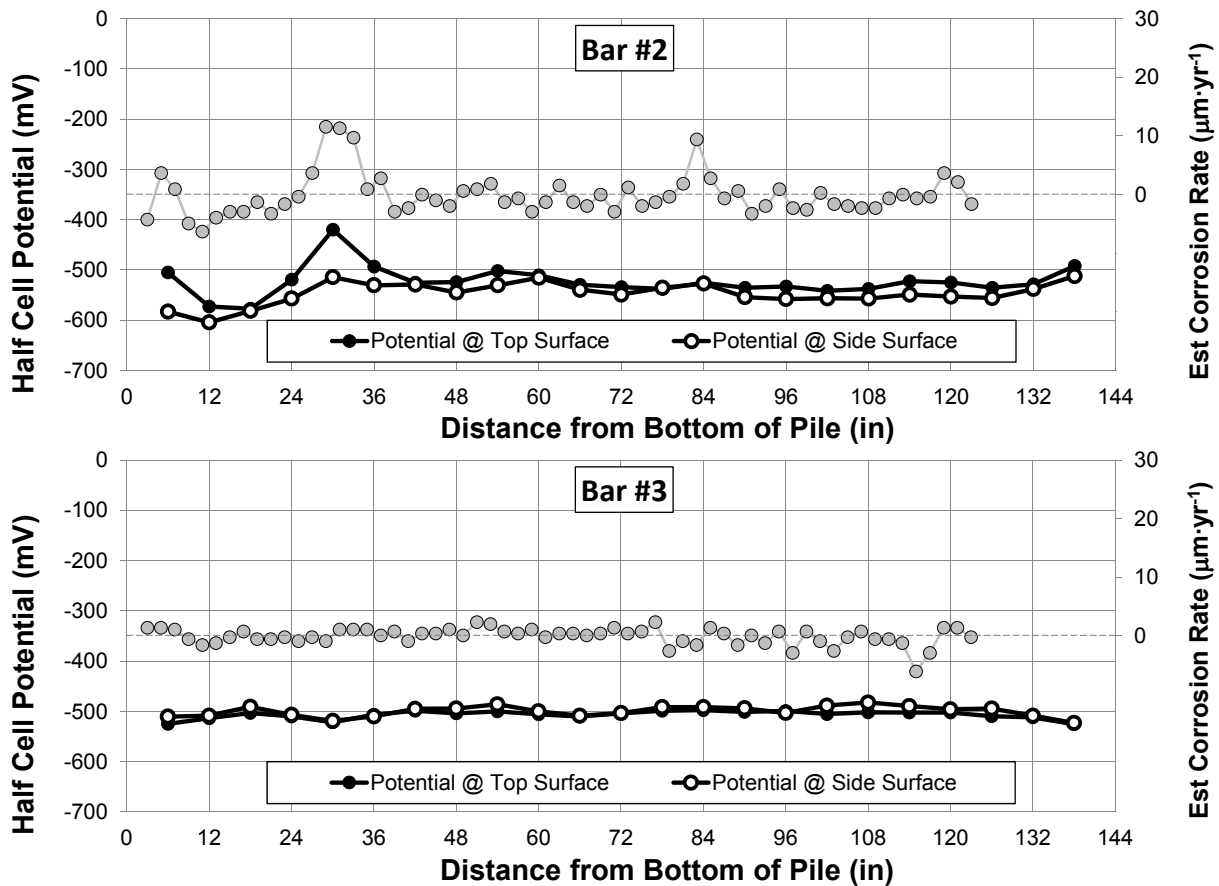
Figure 17 a and b. Half-cell Potential at 6-inch intervals and estimated corrosion rate (average decrease in radius divided by 60 years) at 2-inch intervals along the length of Bar #s 2 and 3 respectively.

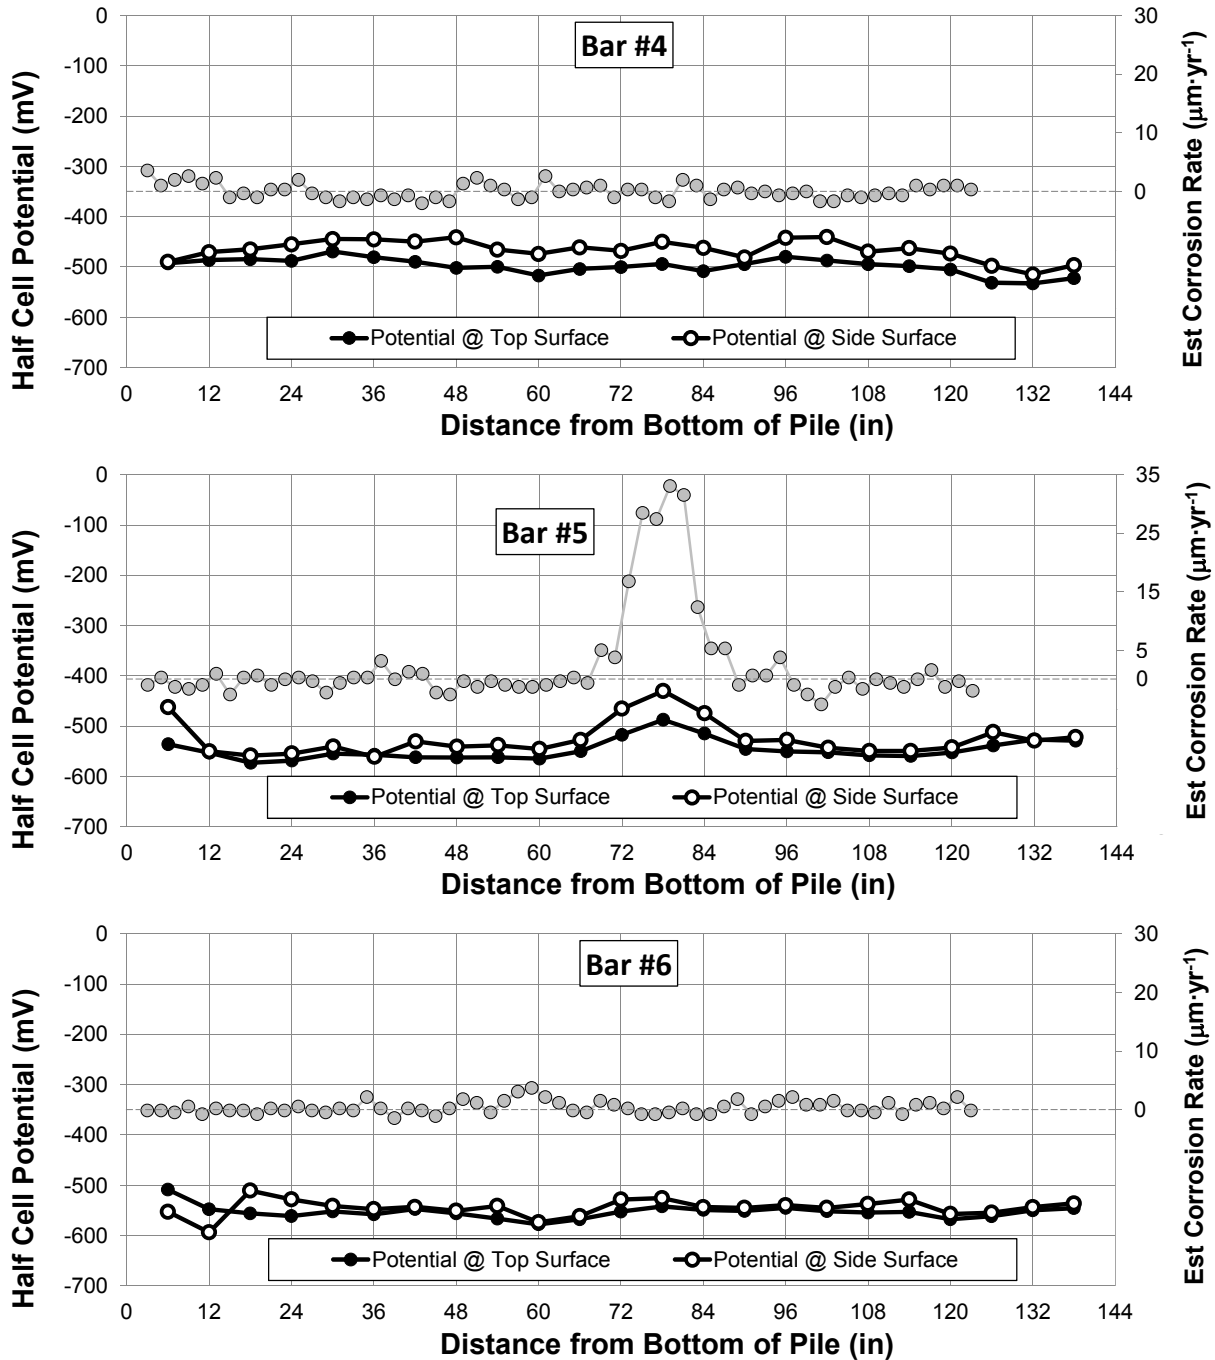
Figure 17 c, d, and e. Half-cell Potential at 6-inch intervals and estimated corrosion rate (average decrease in radius divided by 60 years) at 2-inch intervals along the length of bar #s 4, 5, and 6 respectively. The corroded regions showed the greatest metal loss on the side of the bar closest to the concrete surface, while the inward-facing side (toward the bulk of the concrete) showed little or no corrosion.

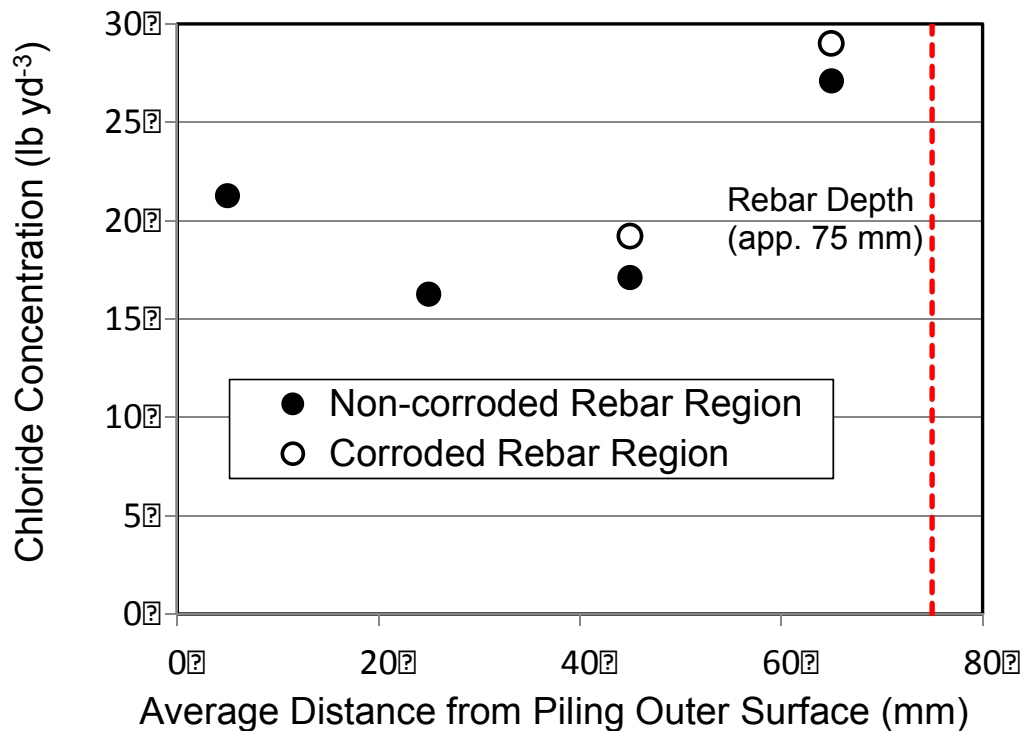
Figure 18. Observed chloride concentrations.

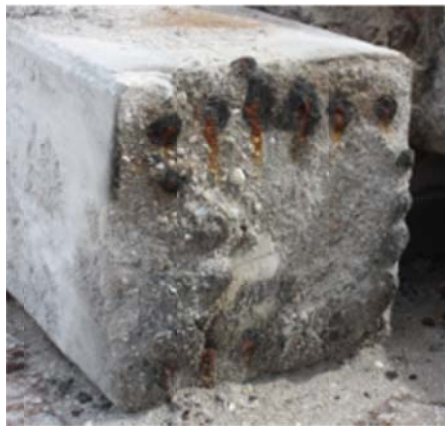
Figure 20. Atmosphere-exposed (i.e., top) end of extracted pile.

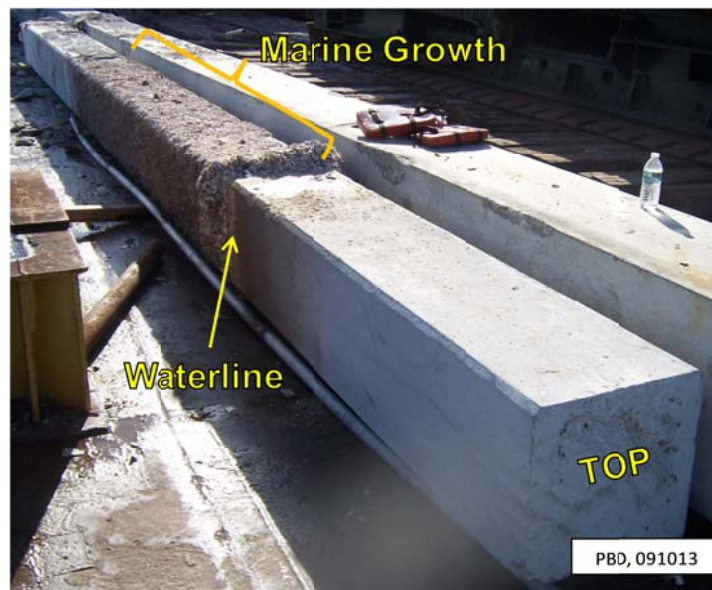
Figure 26. Pinellas Bayway Drawbridge pile selected for autopsy. Atmospheric air-exposed end of pile (i.e., top) is in the foreground. Note marine growth between waterline and mudline.

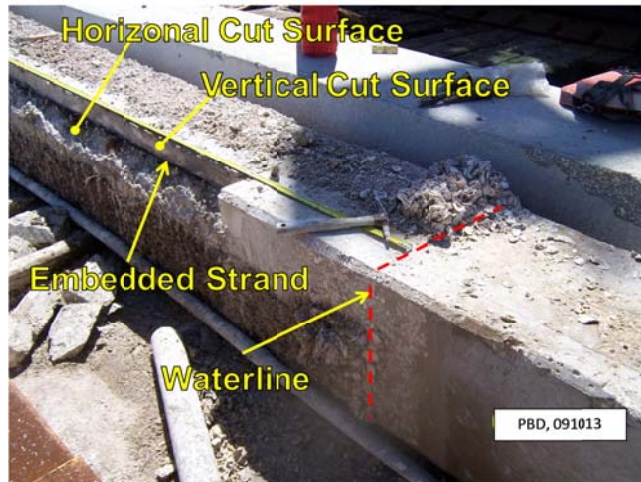
Figure 27. Autopsied pile. Note concrete chunks on deck removed from pile with a hammer and chisel after vertical and horizontal saw cuts were made.

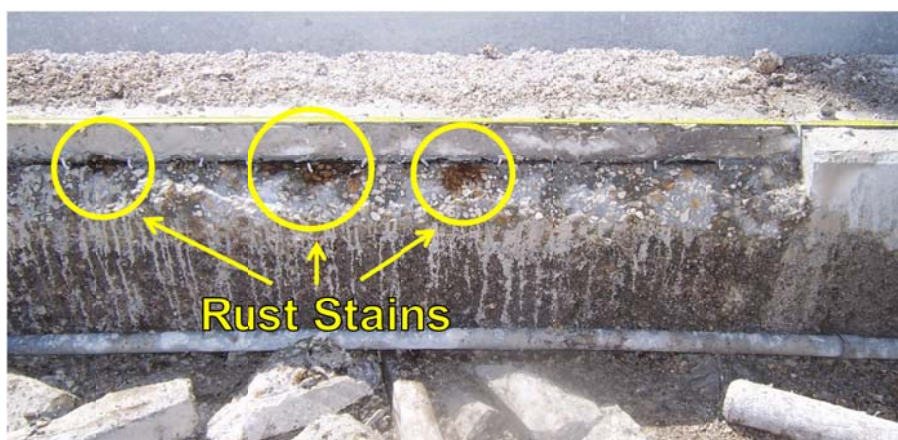
Figure 28. Exposed strand in uppermost region (nearest waterline) of autopsied pile. Note rust stains. (Photo was taken immediately after strand was exposed.)

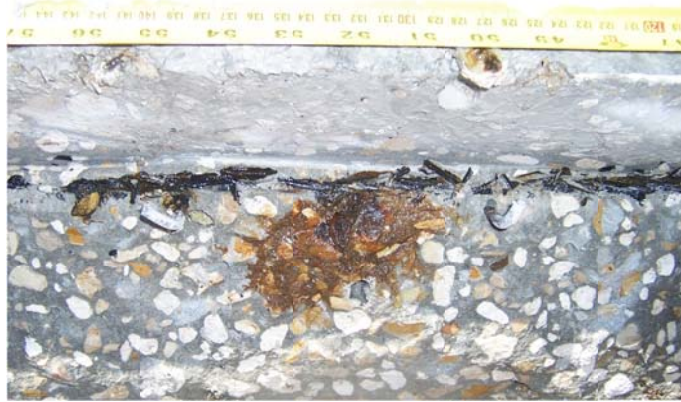
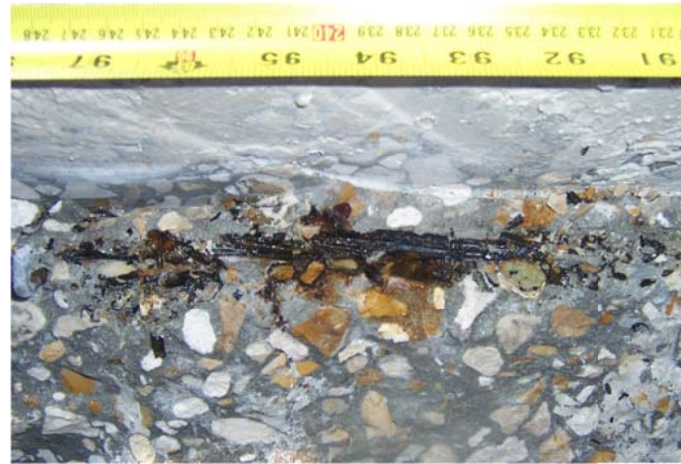
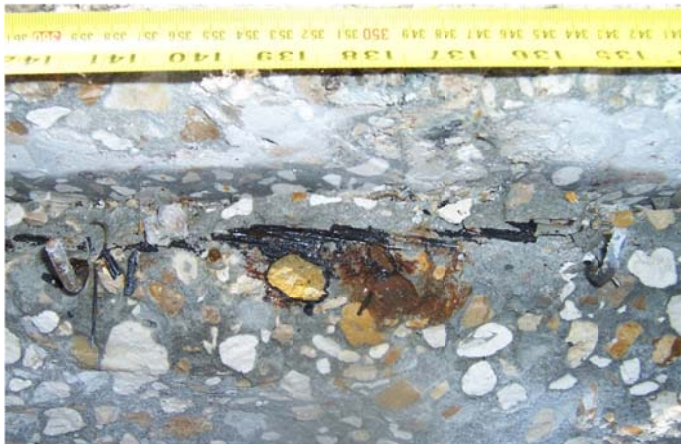
Figure 29 top, middle, bottom. Three different instances of localized corrosion. Note that the measurement datum for the indicated distances was the waterline.

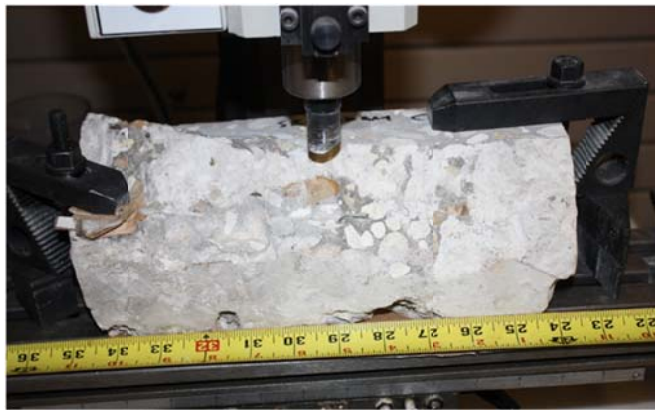
Figure 30. Pinellas Bayway Drawbridge pile concrete sample mounted on mill table for chloride analysis specimen collection. Note that the measurement datum for the indicated depth was the waterline of the in-service pile.

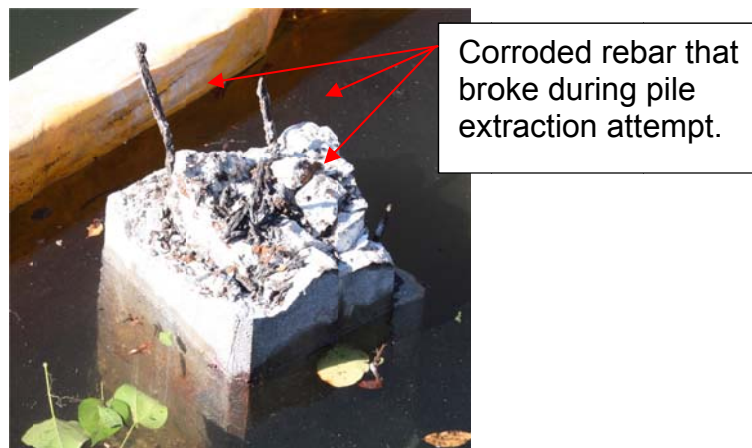
Figure 32. Bottom half of pile left in place as a result of breakage during extraction attempt. Visible rebar corrosion and section loss in splash zone.

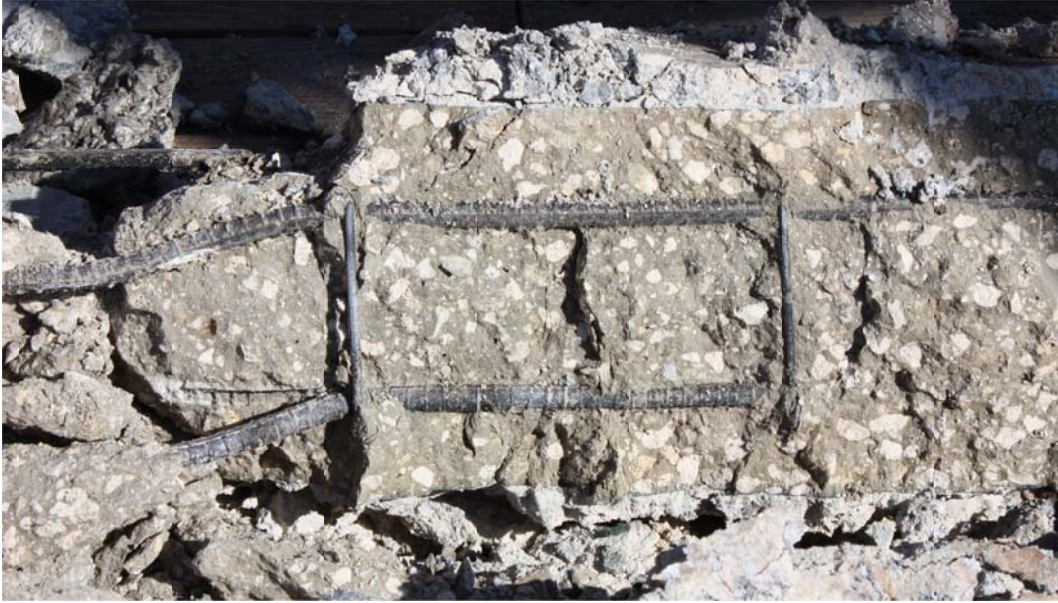
Figure 33. Corrosion-free steel in much of the submerged region. Note that pile in photo was lying on its side.

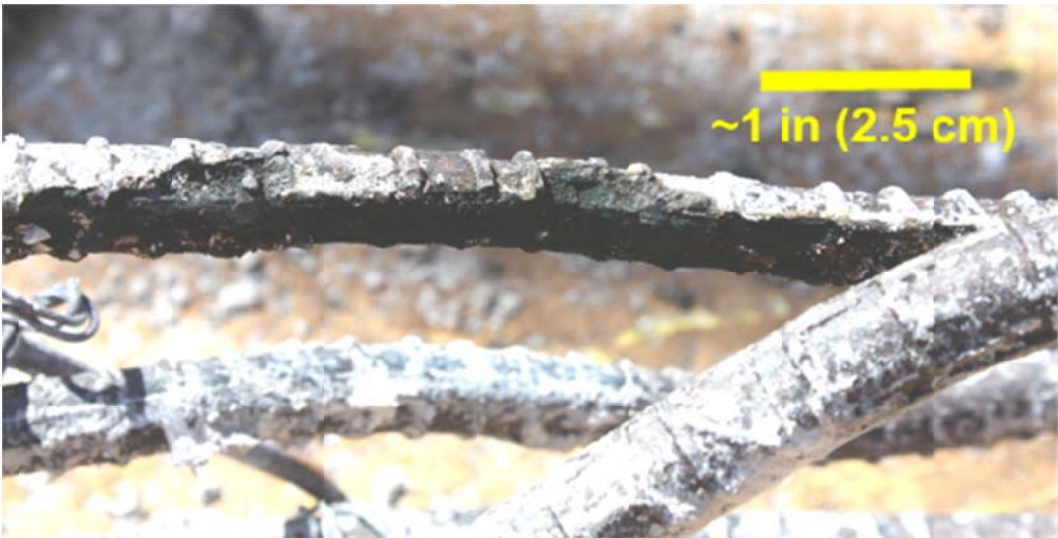
Figure 34. Locally corroded steel in region below mudline. Note corrosion-related cross-sectional area decrease of bar near top of photo.

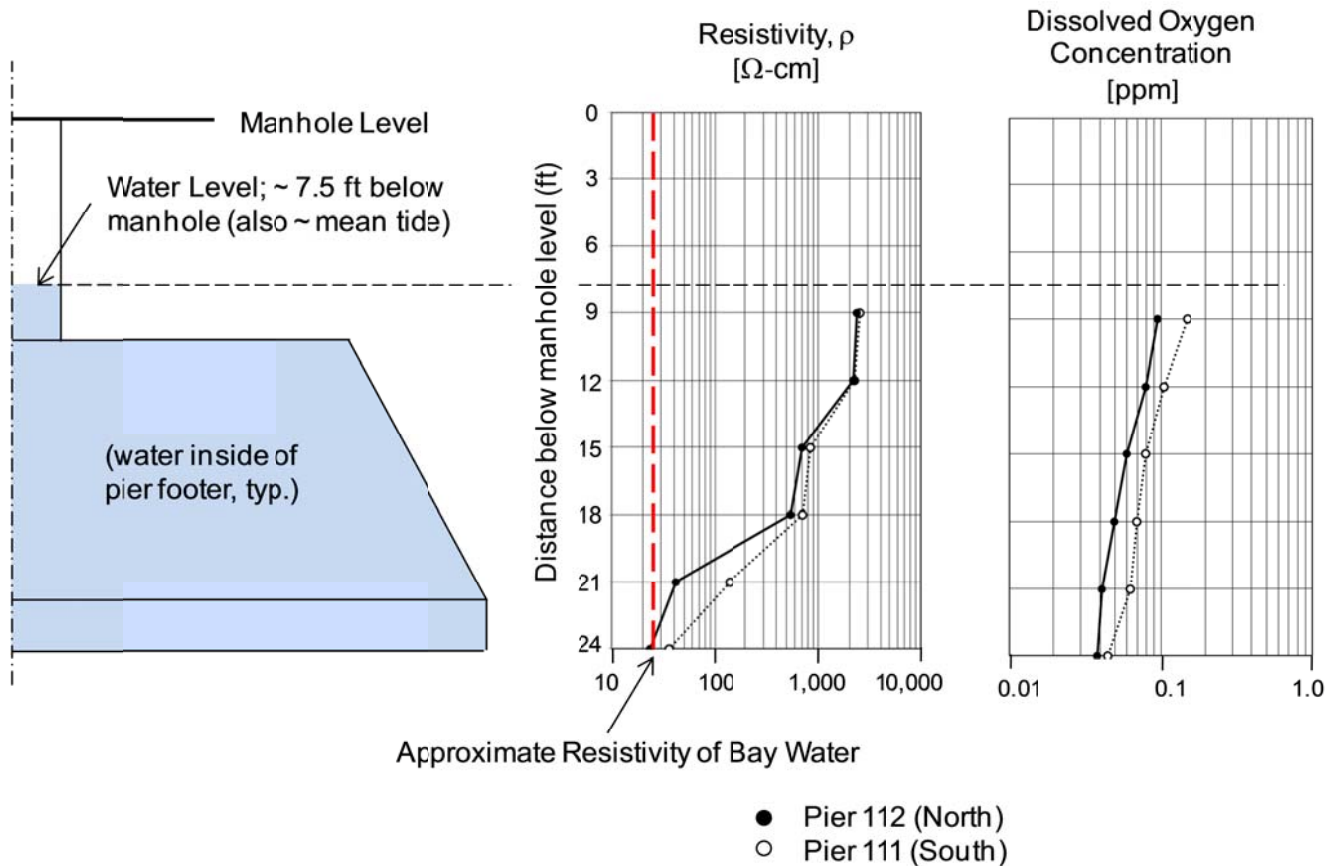
Figure 35. Resistivity and dissolved oxygen profiles; October 12, 2012.

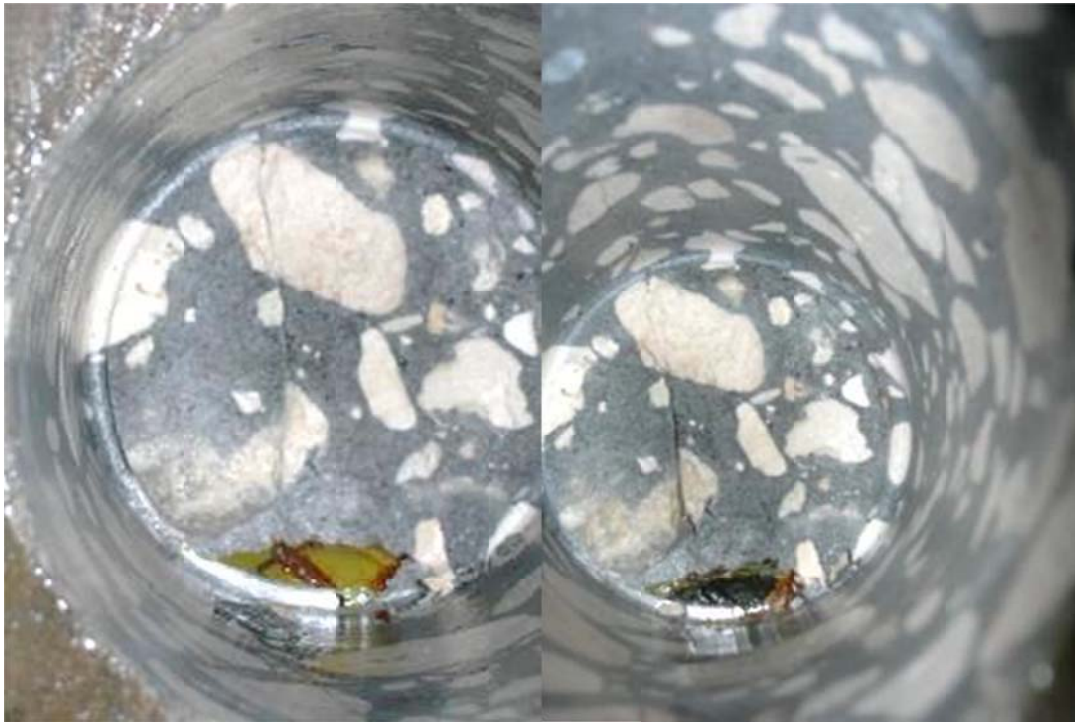
Figure 36. Rebar at the bottom of hole at core #1; before and after scraping epoxy coating.

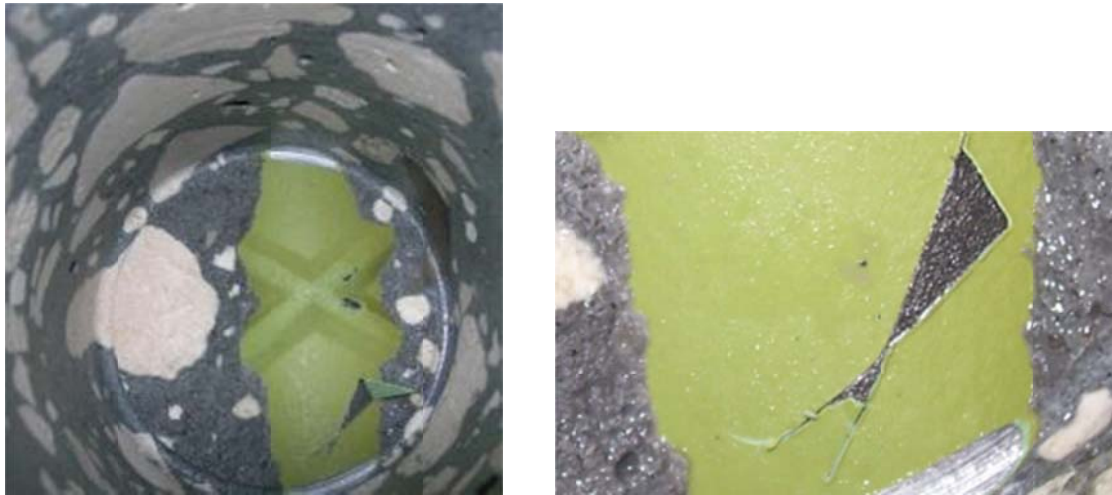
Figure 37. Rebar at core #4 site; Note epoxy cut and easily peeled showing poor adhesion.

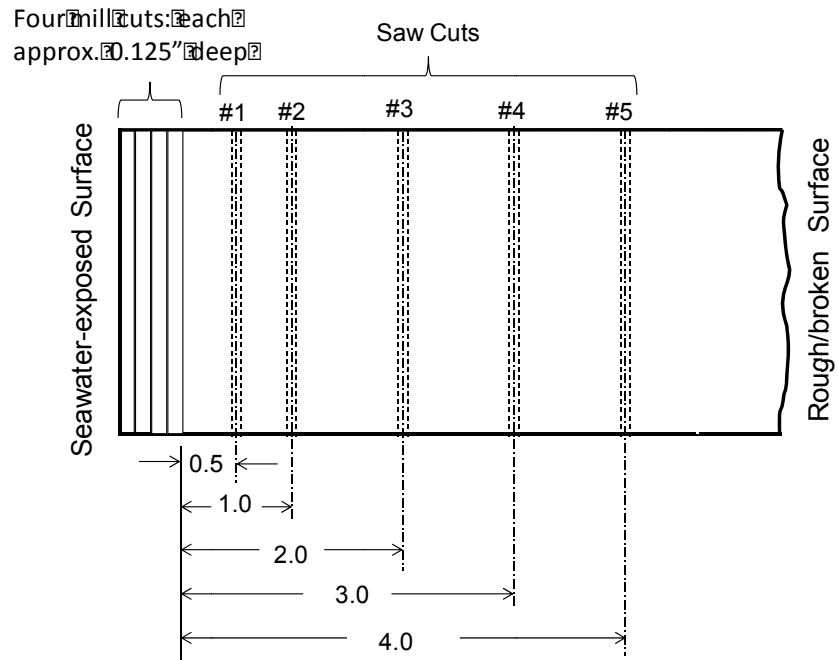
Figure 39. Core slicing scheme.

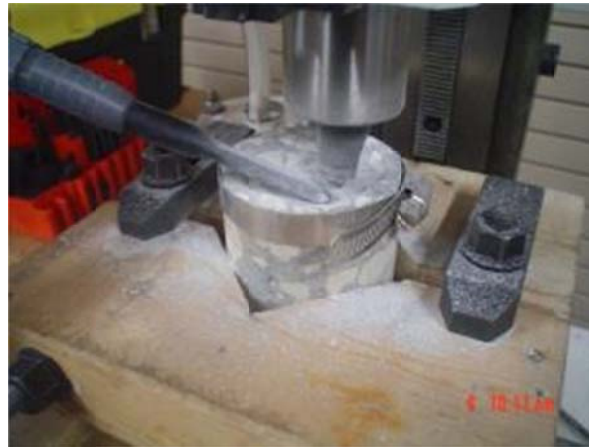
Figure 40. Core mounted on mill table.

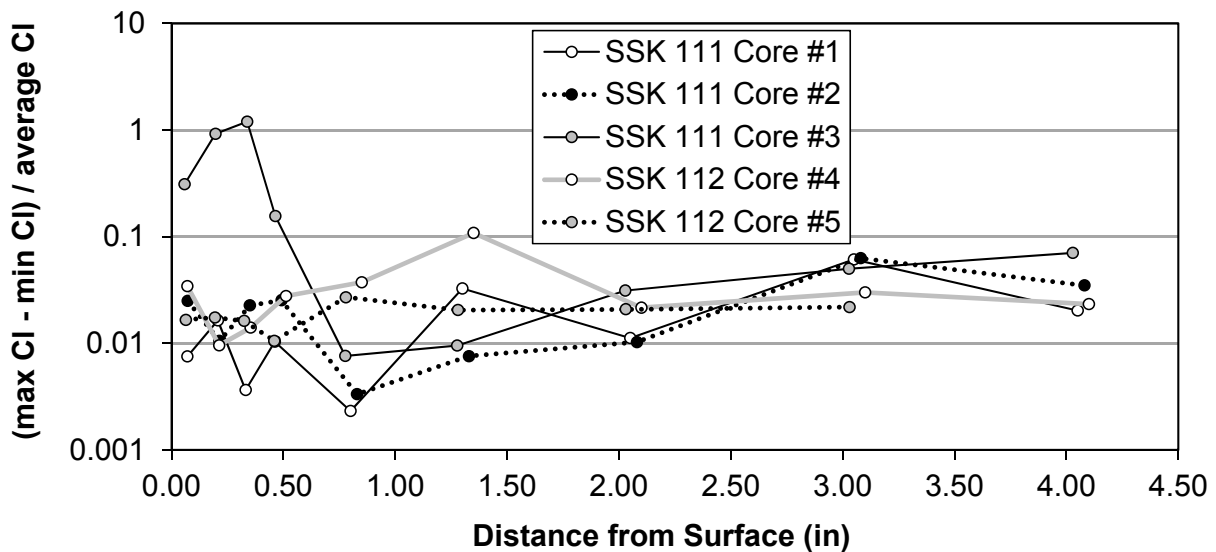
Figure 41. Ratio of the difference between the maximum and minimum chloride concentration values to the average chloride concentration value.

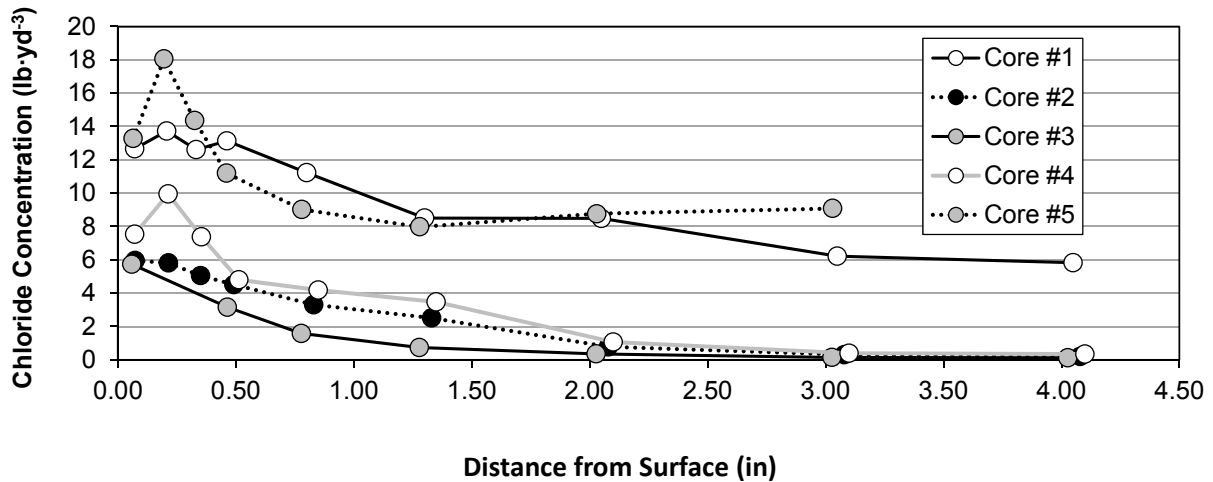
Figure 42. Chloride concentration as a function of distance from the outer/exposed surface.

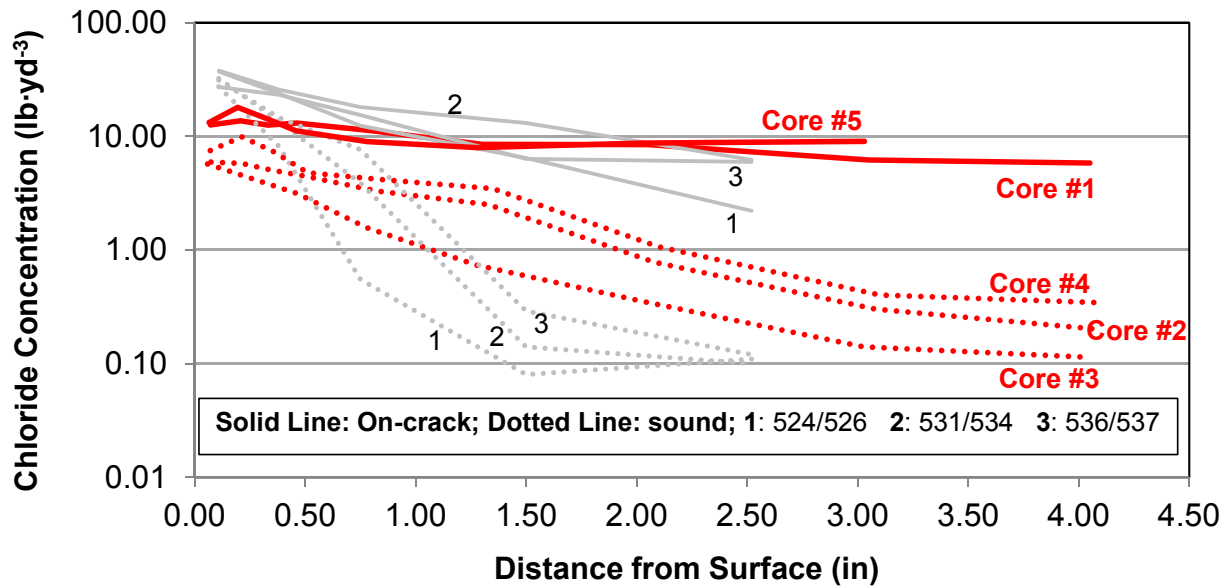
Figure 43. Comparison of chloride penetration in cores: on-crack and from sound concrete. Red lines indicate results from the current cores extracted from the chamber wall of Sunshine Skyway pier footers 111 and 112. The data associated with core pairs 1, 2, and 3 (extracted in 1997) and the numbers next to each pair (core designation codes) were taken from Sunshine Skyway splash-evaporation regimes in Sagüés et al. [11], Table 5. The two cores from each pier were taken from locations in close proximity to each other.

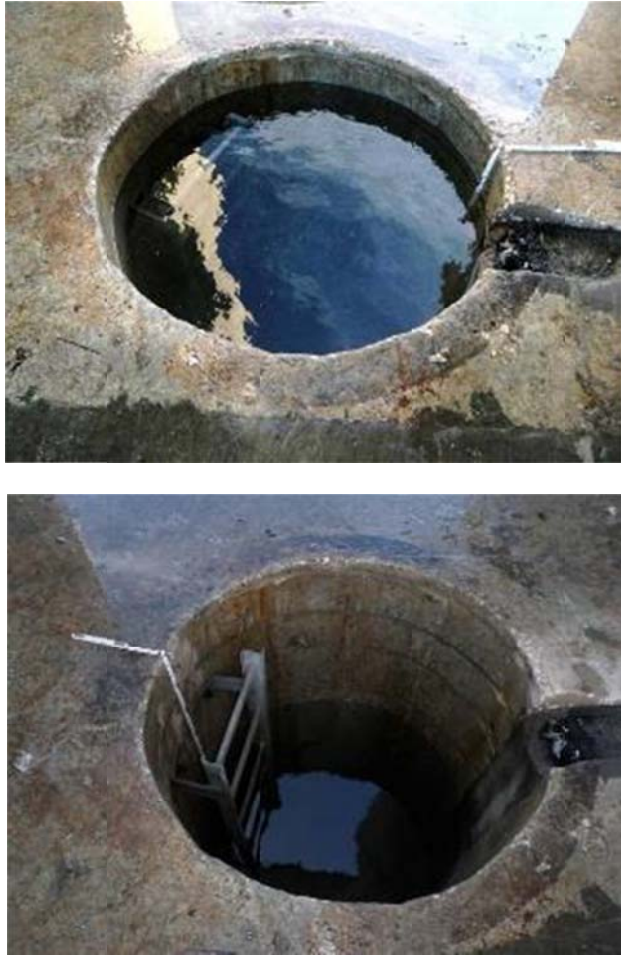
Figure 44. Top: Water level 30 minutes after filling, Pier 112. Bottom: Water level approximately 2 hours after filling, Pier 112.

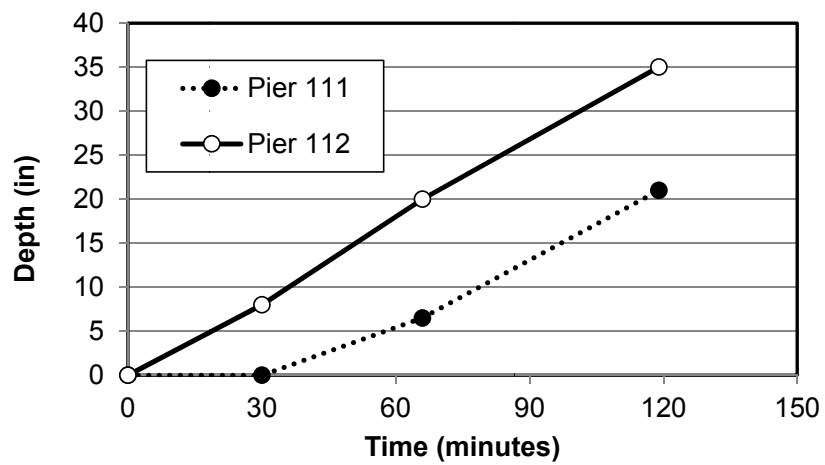
Figure 45. Water depth from manhole opening as a function of time.

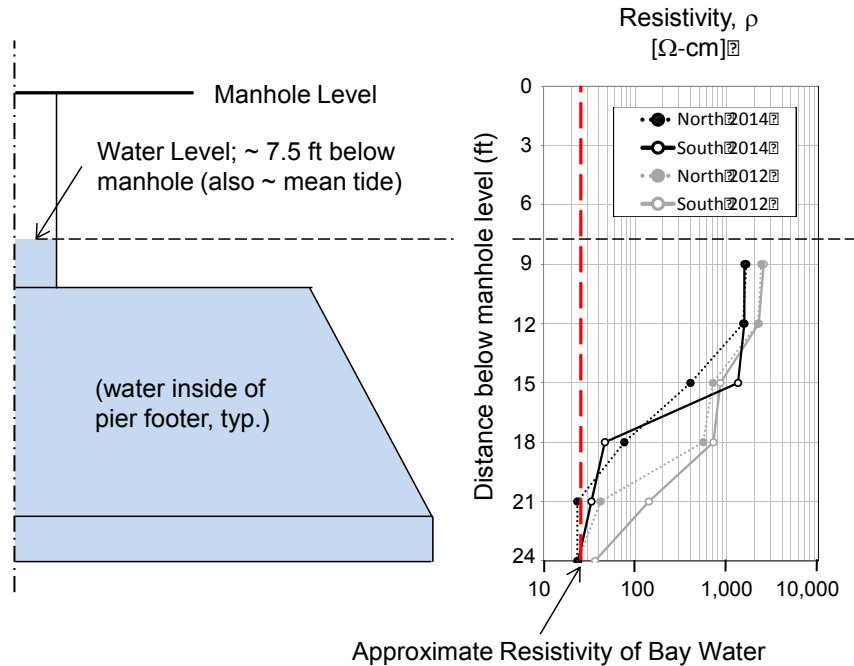
Figure 46. Resistivity of pier footer water; November 7, 2014

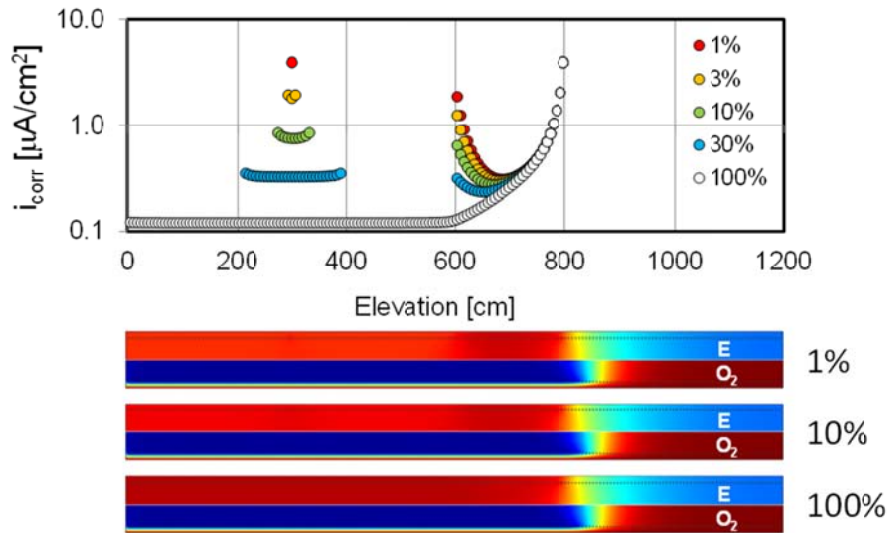
Figure 50. Top: Predicted corrosion current densities associated with active rebar (of indicated percentage) centered at $z = 3$ m and in the splash zone ($z = 6$ to 8 m); Bottom: Electrical potential and oxygen concentration profiles in each scenario color coded as in Figure 48. Note localized dark regions of high anodic current density in the electrical potential profiles
