Report Prepared by:

**Michael T. Walsh
Alberto A. Sagüés**

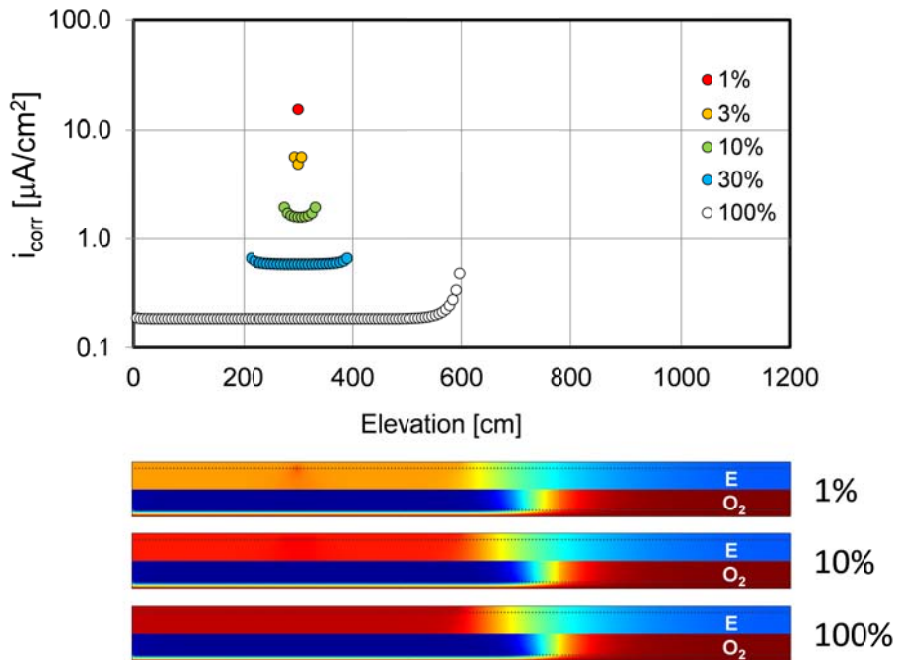
Figure 51. Top: Predicted corrosion Current Densities associated with Active Rebar (of indicated percentage) Centered at $z = 3$ m; Bottom: electrical Potential and Oxygen Concentration profiles in each scenario color coded as in Figure 48. Note localized dark regions of high anodic current density in the electrical potential profiles.

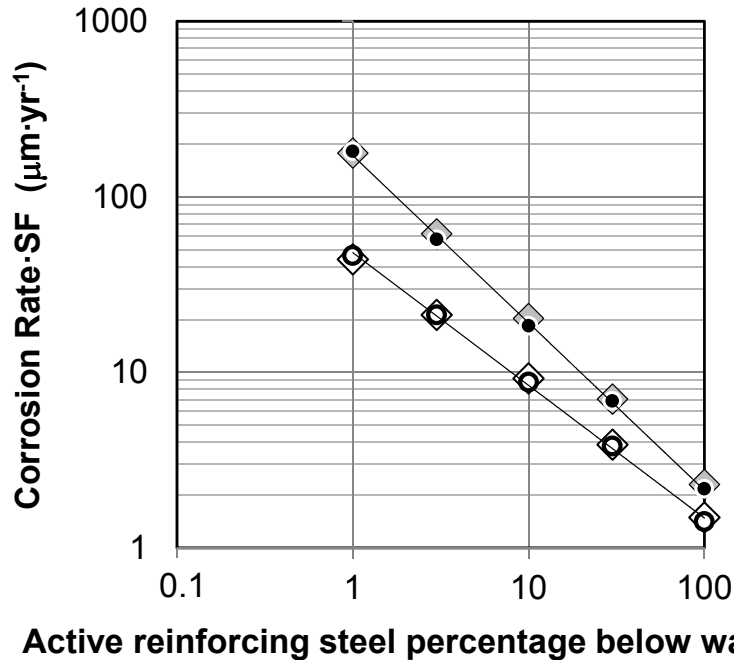
Figure 52. Corrosion rate of actively corroding steel in submerged zone as a function of active rebar percentage. Open symbols: cases with activation above waterline. Filled symbols: no activation above waterline, resulting in higher corrosion rates in submerged zone. Circles: Main calculations with SF = 1. Diamonds: exploratory SF = 2 cases with adjusted parameter values, scaled as indicated in the text for appropriate comparison.

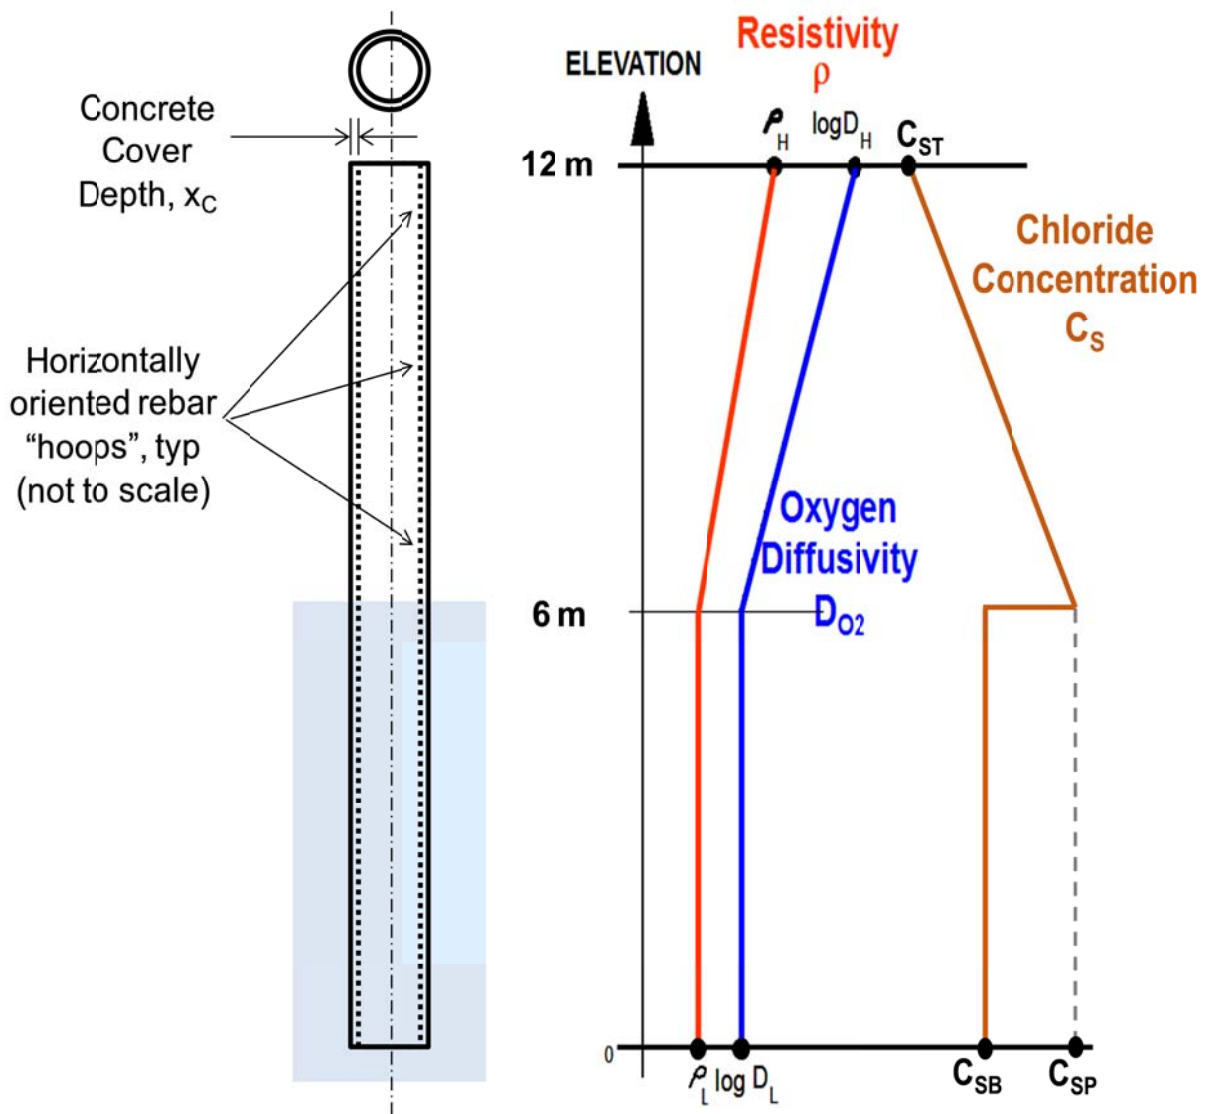
Figure 53. Chloride concentration profile at exterior surface of concrete (brown) used for Stage 2 calculations. Other pattern shapes are same as those in Stage 1 simulations.

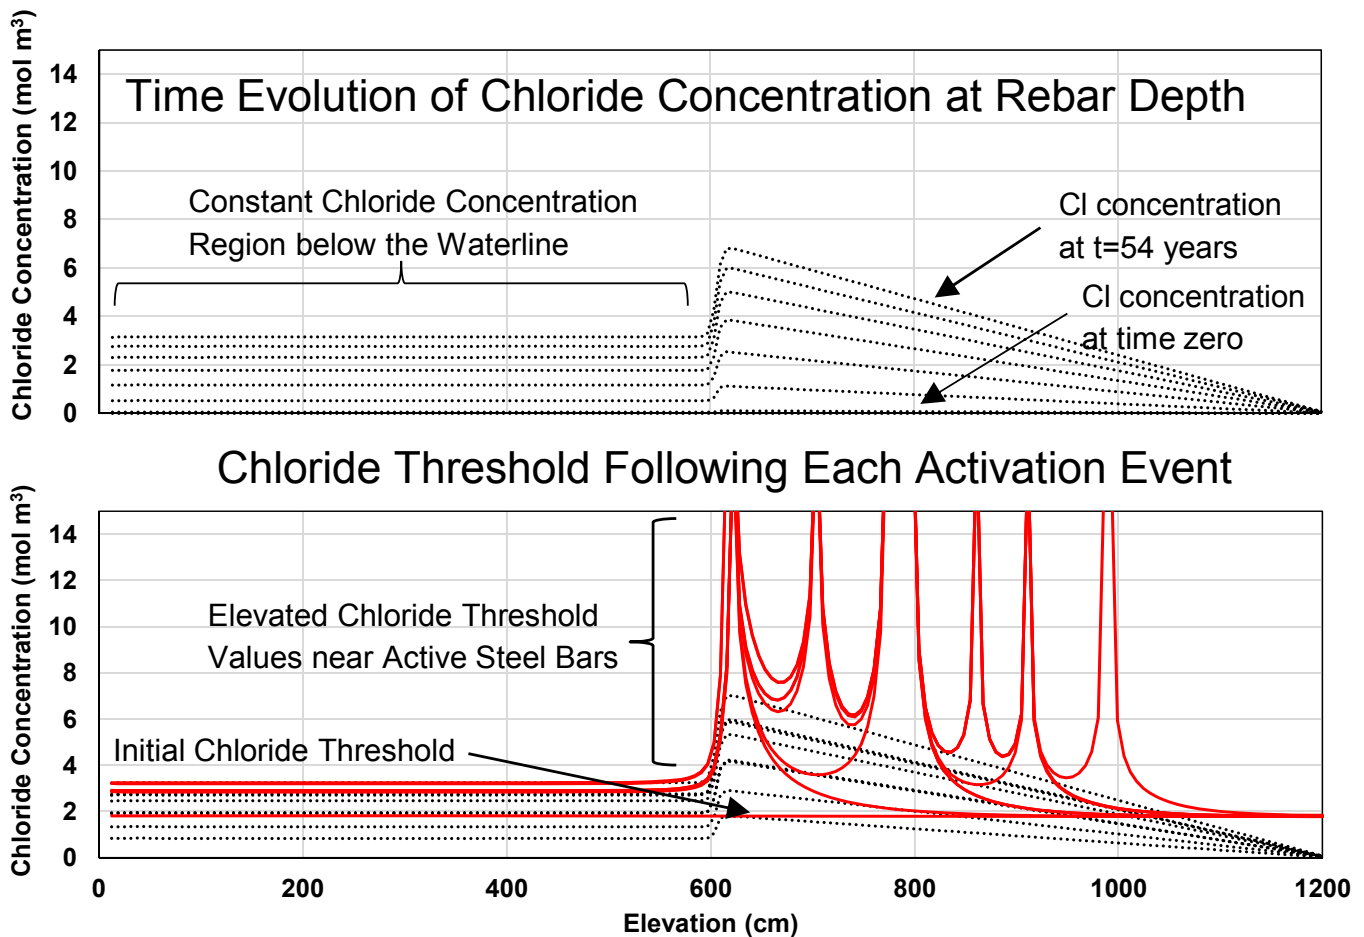
Figure 55. Time evolution of chloride concentration (top) and chloride threshold following each activation event (bottom). Medium chloride ion diffusivity for a simple surface chloride profile without random variability.

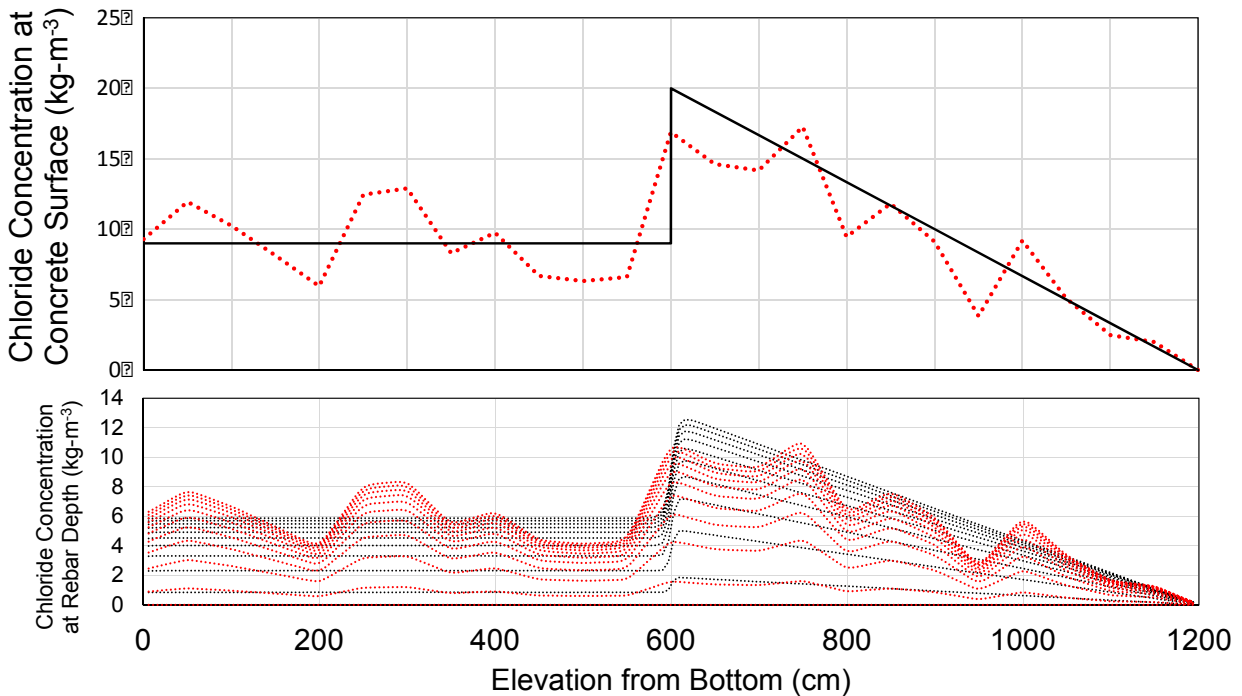
Figure 56. Top: Pattern of chloride concentration at the concrete surface for both the simplified initial surface profile (black solid line), and for the randomly altered pattern (red dotted line). Bottom: Evolution of the concentration profile at the rebar depth for both cases, illustrated for 10-year intervals for a medium chloride diffusivity realization.

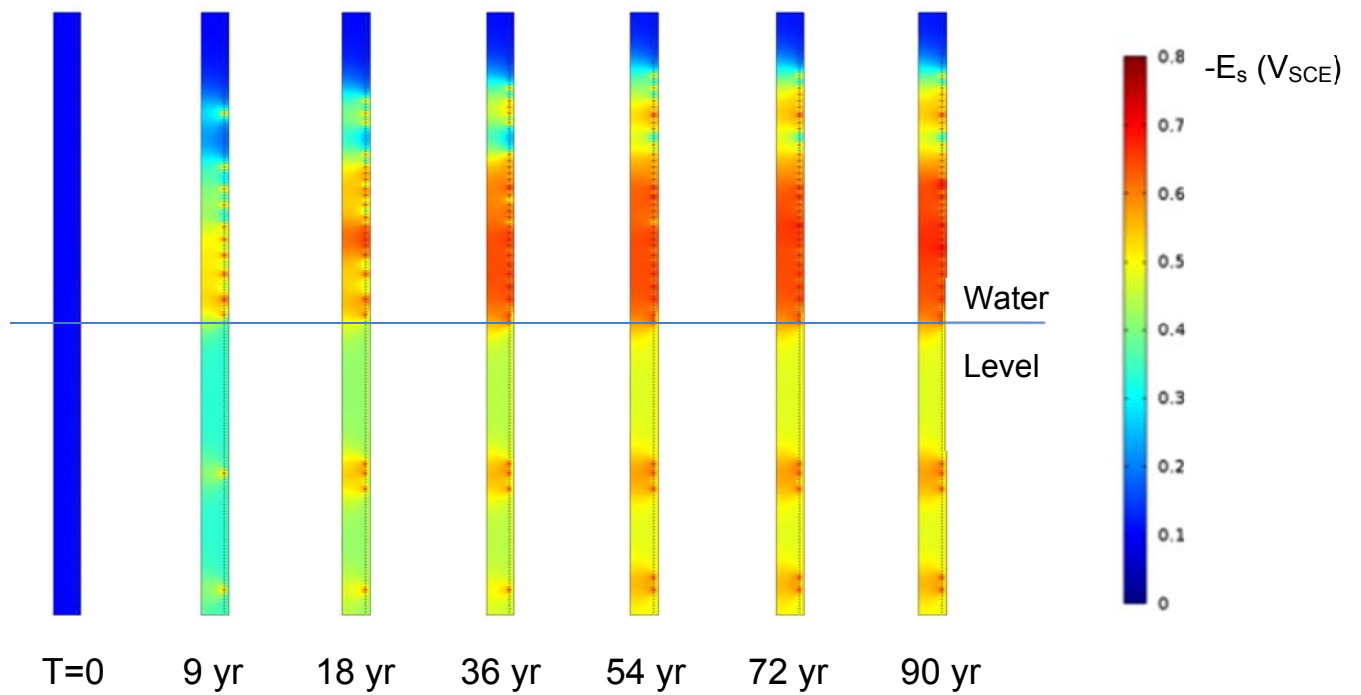
Figure 57. Potential distribution evolution with time for Case 1 (Table 11) with the randomly altered C_S pattern. Note early onset of corrosion in the submerged zone. Potential maps are shown on the vertical column cross section with the cylindrical symmetry axis on left.

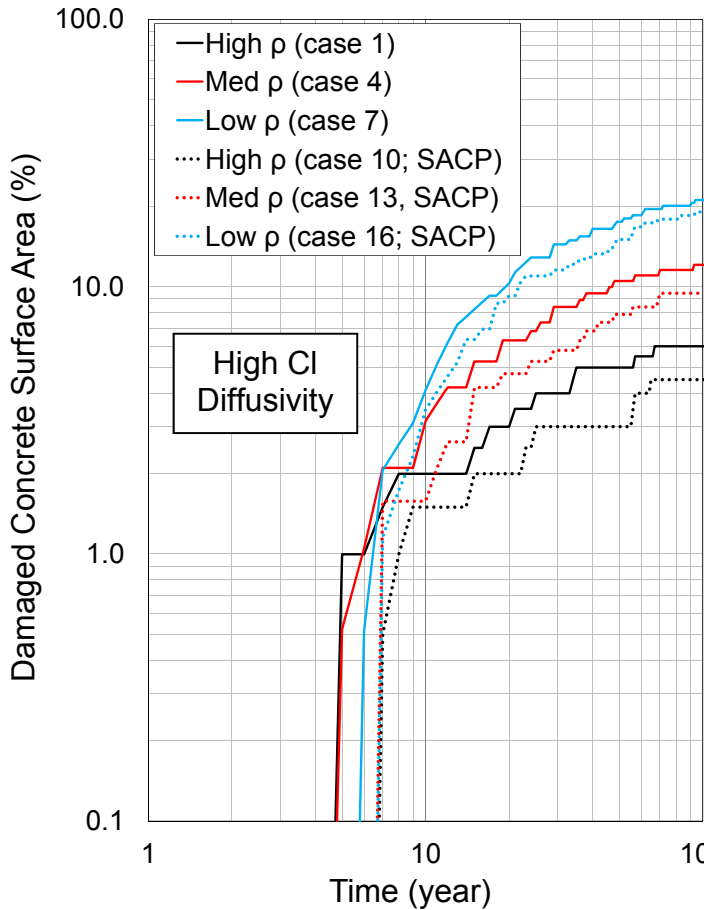
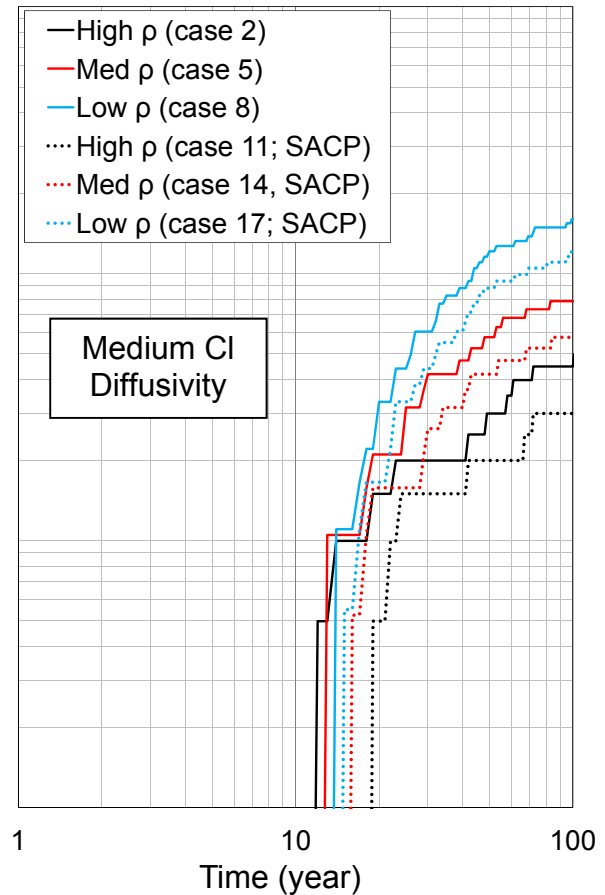
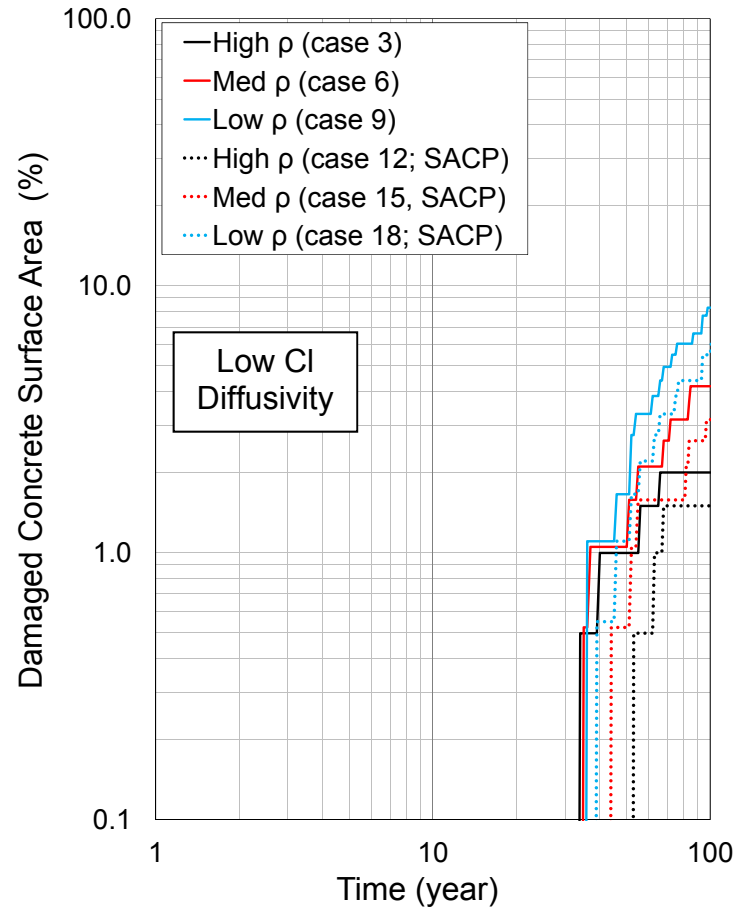
Figure 58. Damage function outputs for the entire column using the above-water damage declaration criterion. Numbers in parentheses are keyed to cases listed in Table 11. The three charts represent damage under three different chloride diffusivities.

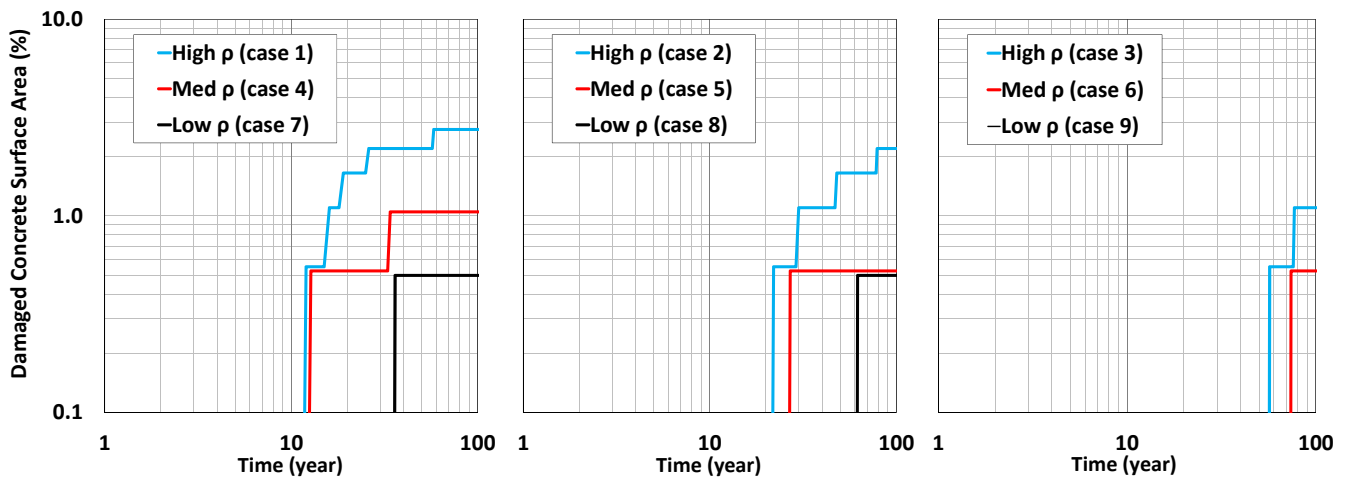
High Chloride Diffusivity

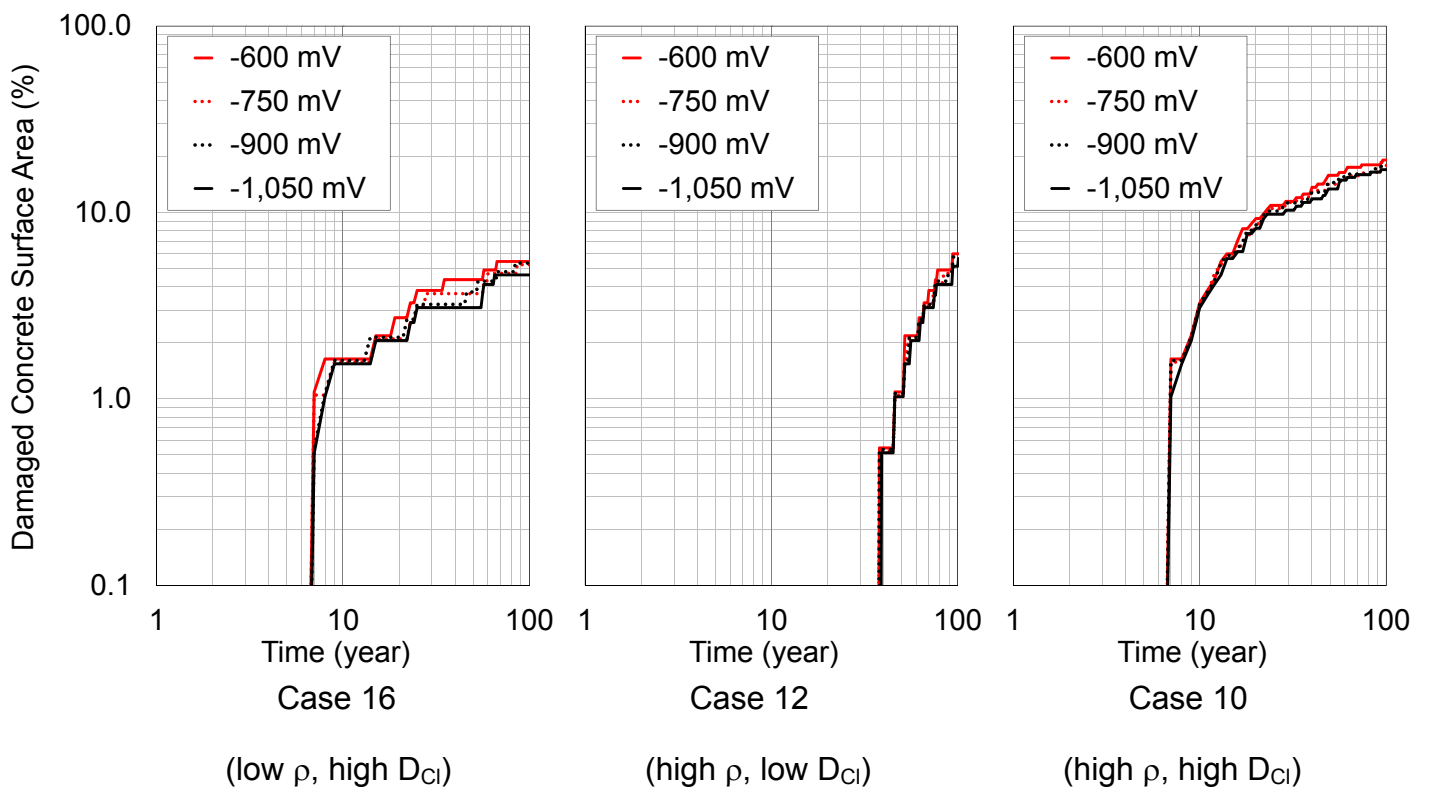
Figure 60. Damage functions based on anode potentials of -600, -750, -900, and -1,050 mV for selected cases. Note minimal sensitivity of damage projections to anode potentials in the given range.
