Florida Department of Transportation  
Aviation Office  
Statewide Airfield Pavement  
Management Program

**Update to Methodology and  
Procedures for Data Collection  
and Condition Analysis for  
Whitetopping Pavement**

Version 2.0 July 2020  
Contract No. CA653

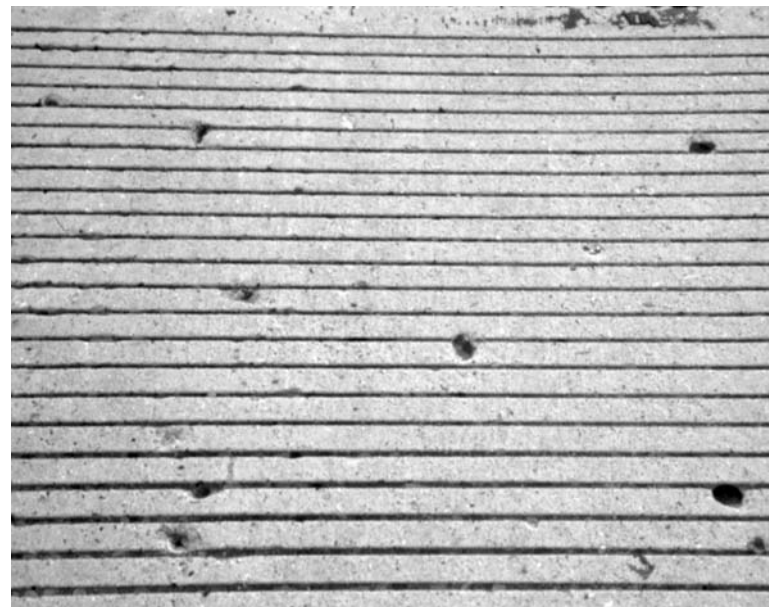
► Several pop-outs in a new slab.

► Extensive pop-outs of large aggregate from surface.

**Pop-Outs** – Individual pieces of large aggregate may pop out of the surface. This is often caused by chert or other absorbent aggregates that deteriorate under freeze-thaw conditions. Pop-outs alone do not usually affect pavement serviceability. However, damage to aircraft from the debris may occur. For severe areas, a patch, overlay, or slab replacement may be necessary.

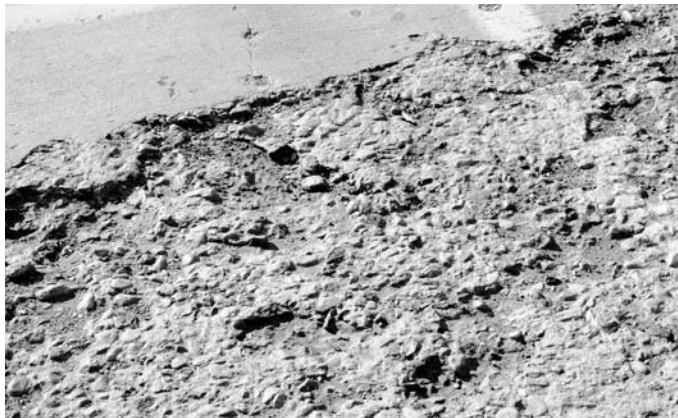
◀ Severe scaling. Some larger aggregate is loose.

**Scaling** – Scaling is surface deterioration that causes loss of fine aggregate and mortar. More extensive scaling can result in loss of large aggregate. The cause often is using concrete which has not been air-entrained, making the surface susceptible to freeze-thaw damage.

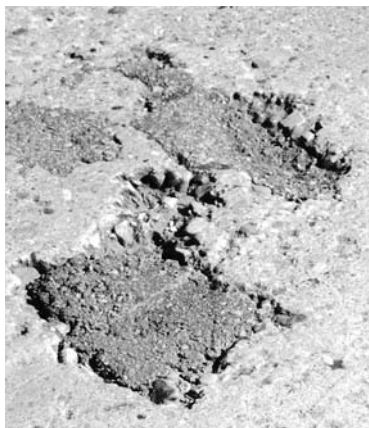
◀ Small surface spall that has been patched.

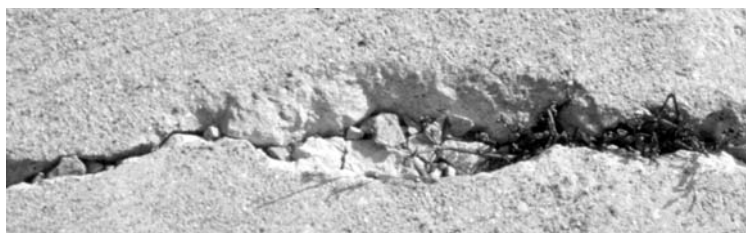
◀ Spall at crack. Creates dangerous debris.

◀ Spalling along a joint.

**Spalling** – Spalling is the loss of a piece of the concrete pavement from the surface or along the edges of cracks and joints. Cracking or freeze-thaw action may break the concrete loose, or spalling may be caused by poor quality materials. Spalling may be limited to small pieces in isolated areas or be quite deep and extensive. Large pieces of loose concrete can cause serious damage to aircraft.

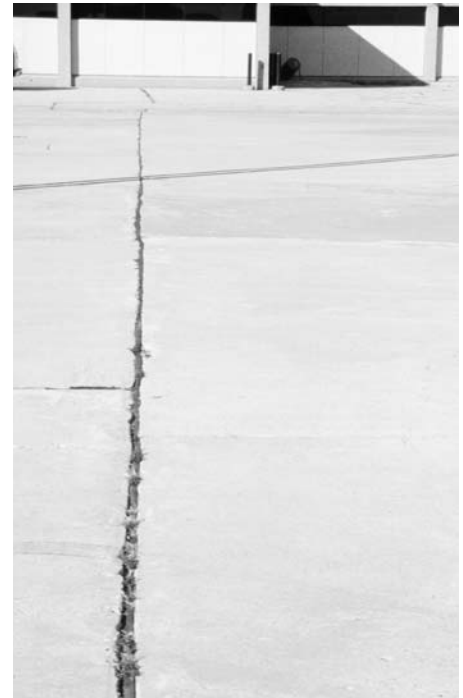
▲ Joint sealant deterioration on apron. Slab is in good condition.

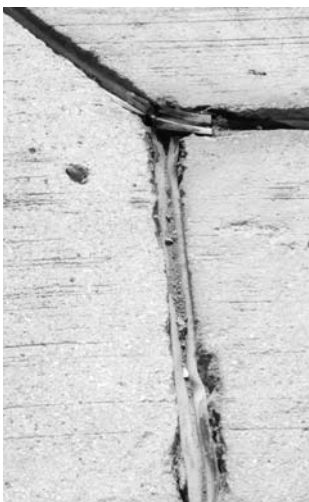
▲ Joint sealant in poor condition. Loss of bond to edge allows water into pavement.

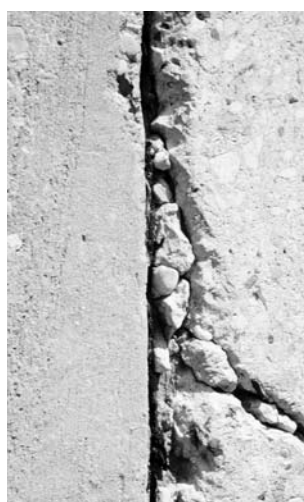
▲ Severe spalling along joint and crack. Creates debris.

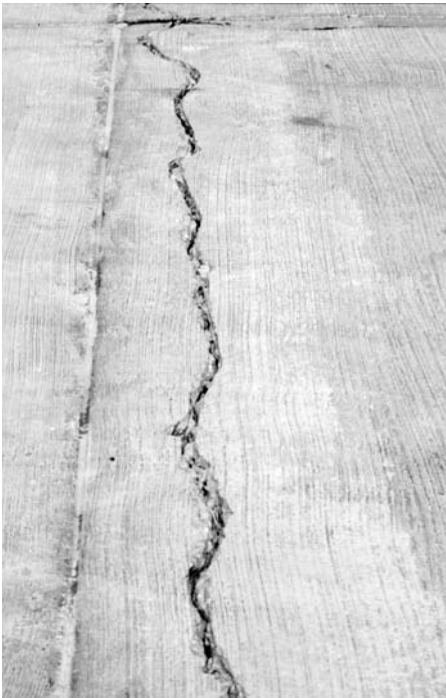
▲ **Hairline slab crack. Tight with no spalling.**

◀ **Crack next to joint often caused by late sawing. Crack shows early signs of spalling.**

▼ **Slab crack with grass, no sealant, and spalls developing.**

Slab cracks divide the slab into 2 or more pieces. They can be caused by thermal stresses, poor subgrade support, or heavy loadings. They are sometimes related to slabs with joints spaced too widely. Slabs with a length-to-width ratio greater than 1.25 are more likely to develop mid-slab cracks.

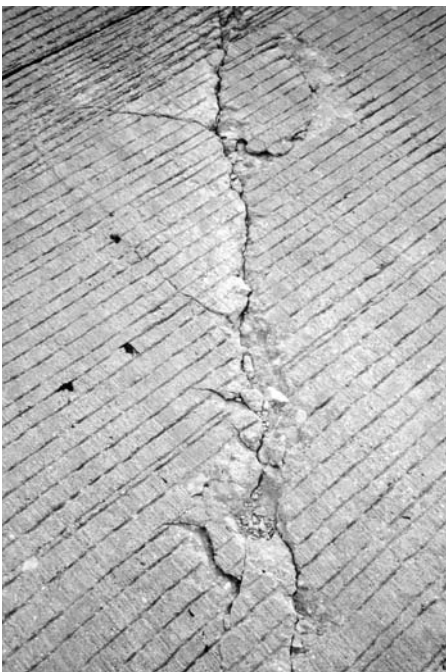
◀◀ **Slab crack with spalling and debris.**

▼ **Multiple slab cracks and broken pavement. Replacement needed.**

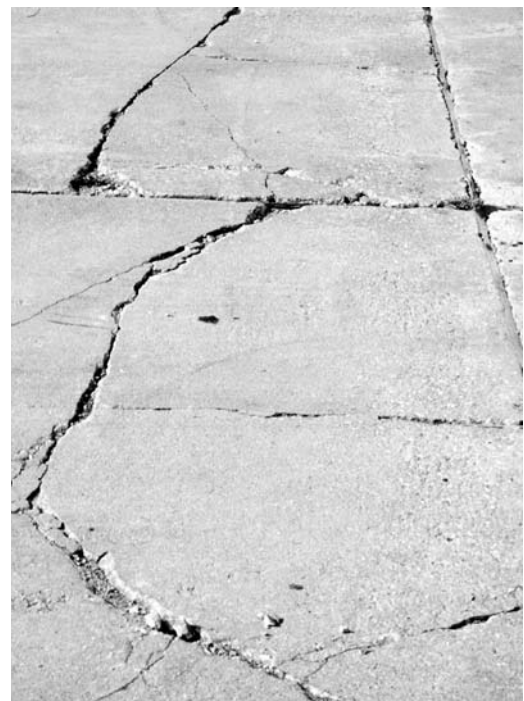
◀ **Closely spaced, hair-line, transverse cracks indicate slab is broken and needs replacing.**

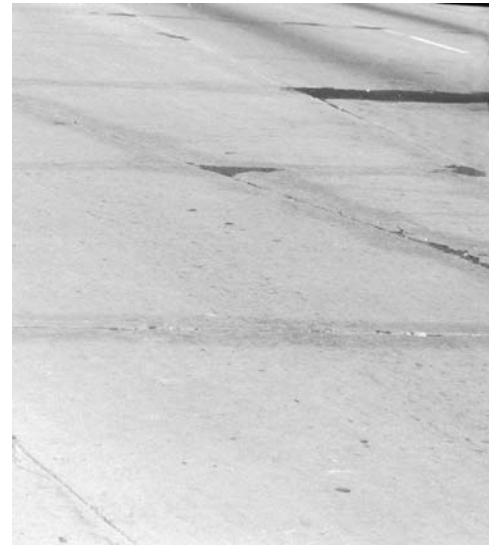
**Surface discoloration near joints and cracks indicates D-cracking and severe slab deterioration.**

Joint or crack sealing helps slow D-cracking deterioration. This is a serious defect because it may indicate a material quality problem throughout the pavement. Milling and patching has proven successful as a short term repair.

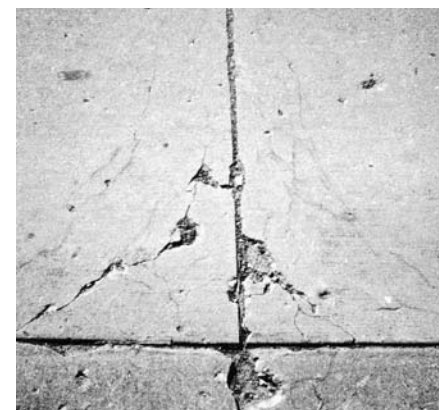
**Multiple crack patterns adjacent to joints. Common D-cracking pattern.**

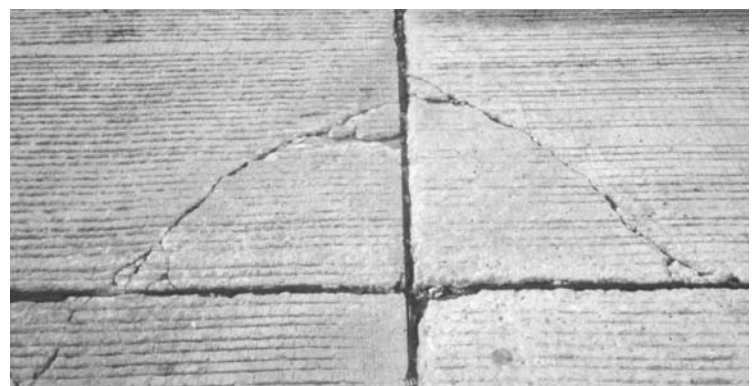
**Corner cracking with slight spalling.**

Diagonal cracks may develop near the corner of a concrete slab, forming a triangle with the joint. Usually these cracks are within a foot or two of the slab corner and are caused by insufficient soil support or concentrated stress due to temperature-related slab movement. The corner breaks under traffic loading. They may begin as hairline cracks.

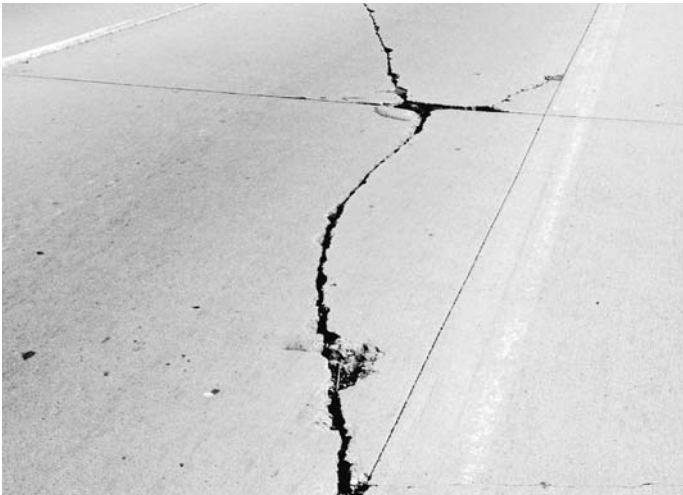
◀ **Meander crack caused by settlement. Lack of maintenance allows water to intrude and debris to collect in crack.**

Some pavement cracks appear to wander randomly. They may cross a slab diagonally or meander in a random manner. Meander cracks may be caused by settlement due to unstable subsoil or drainage problems. Frost heave and spring thaw can also cause them. They are often local in nature and may not indicate general pavement problems.

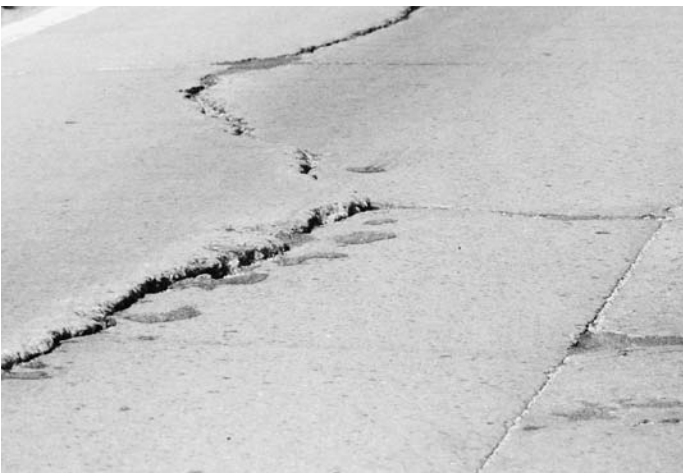
◀ **Faulting and spalling of a meander crack.**

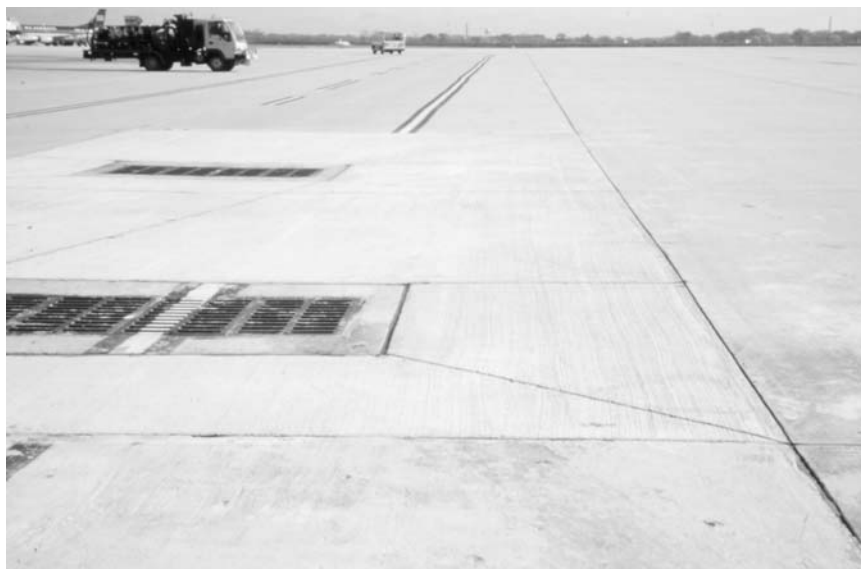
▲ **Slabs replaced next to inlet. Good joint design.**

The pavement adjacent to a light can, manhole, or storm sewer inlet often cannot accommodate normal pavement movement due to frost heaving and temperature changes. Cracks and faulting may develop and the concrete slab may deteriorate further. These are often localized design defects that may not indicate a general pavement problem. Sealing and patching may slow the deterioration. Eventually full depth repairs may be required.

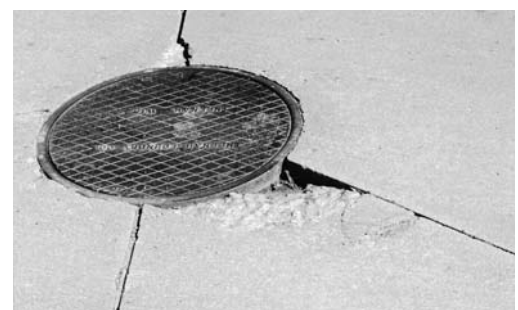
▼ **Two spalls at manhole in a new pavement. Partial depth patching would be beneficial.**

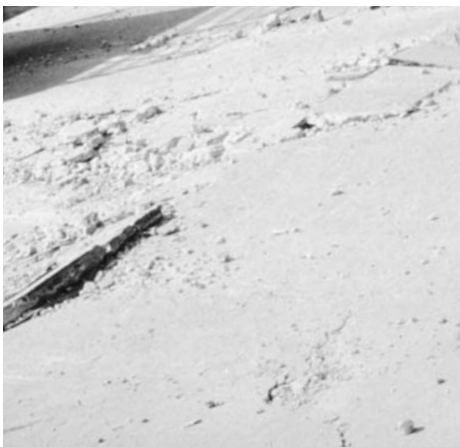
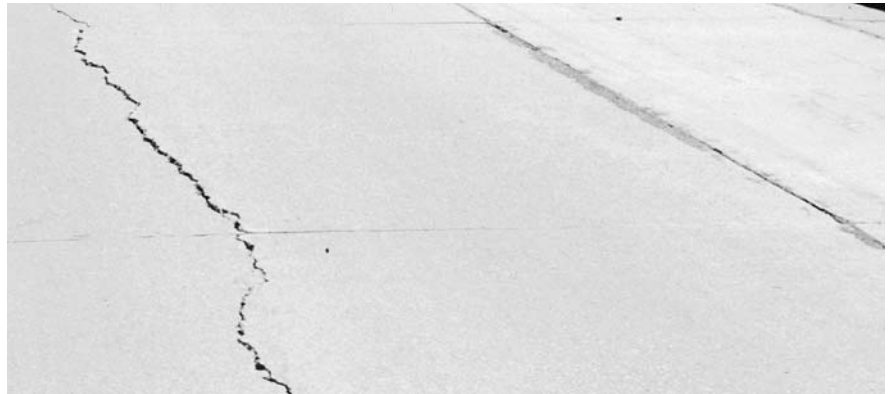
- ▼ **Pavement blowup in progress—concrete is crushed and slab buckled.**

- ▲ **Settlement caused meander crack with faulting.**

Concrete slabs may push up or be crushed at a joint. This is caused by expansion of the concrete where incompressible materials (sand, debris, etc.) have infiltrated into poorly sealed joints. As a result, there is no space to accommodate expansion. It is more common in older pavements with long joint spacing. Pavements that have aggregate susceptible to ASR may experience more frequent blowups. Pressure relief joints can be installed and blowup areas must be patched or reconstructed. Cleaning and sealing joints will help prevent blowups.

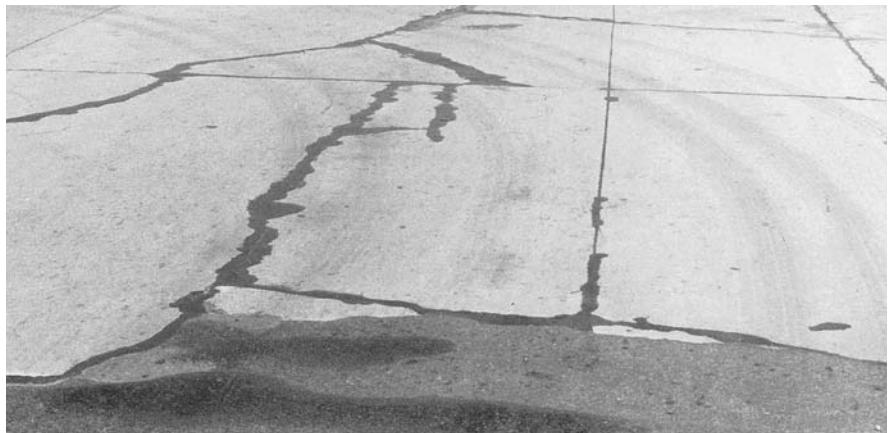
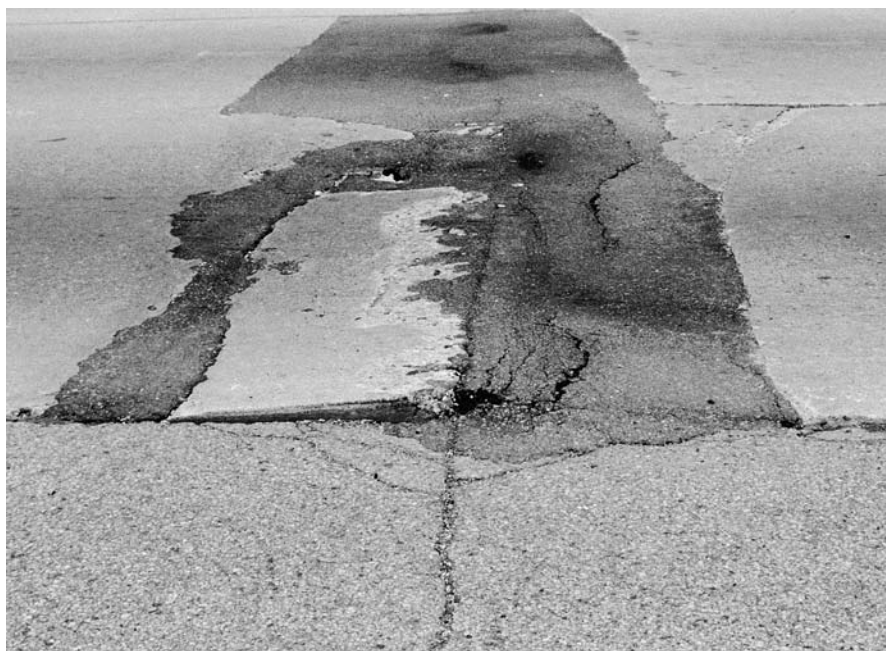
- ▼ **Extensive cracking and patching caused by settlement. Pavement was built on unstable sub-grade soils.**

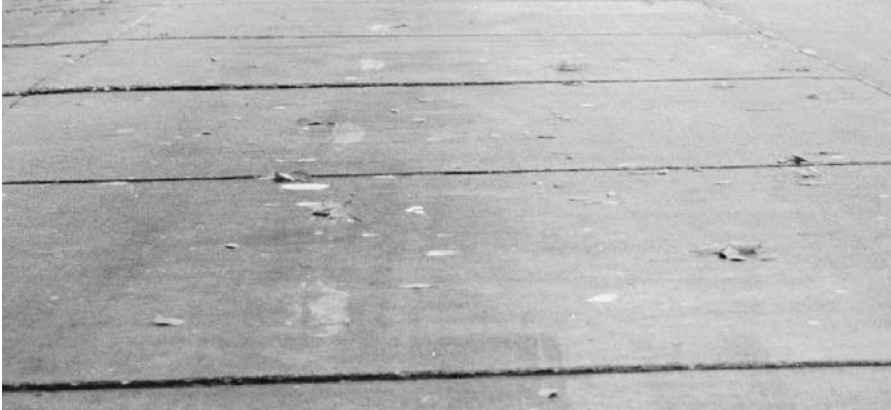
- ▲ **Internal pressure has partially raised slab at the joint. Complete replacement is required.**

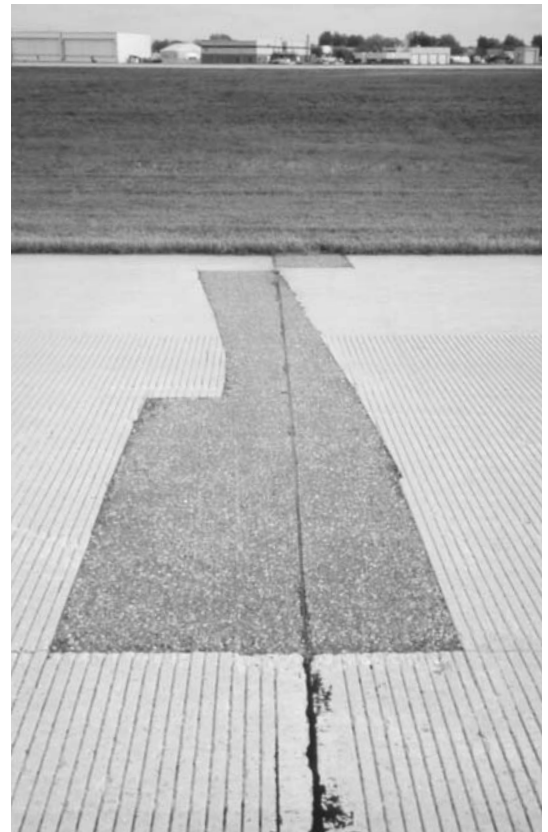
▶  
**Joint repair with asphalt. Very good condition.**

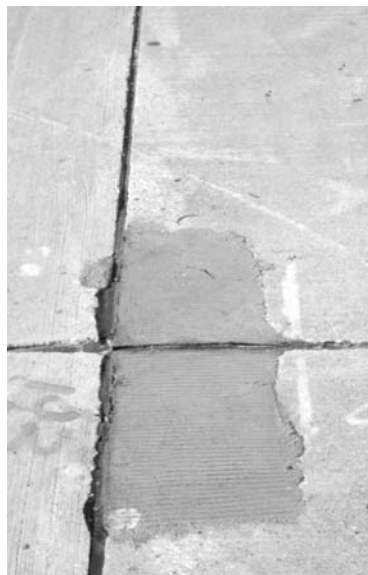
▶  
**Partial depth concrete patch to repair corner cracks. Good condition.**

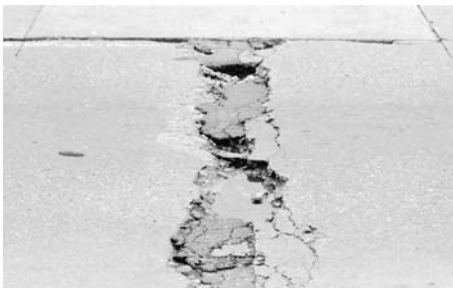
▼  
**Potholes caused by severe joint deterioration. Need repair.**

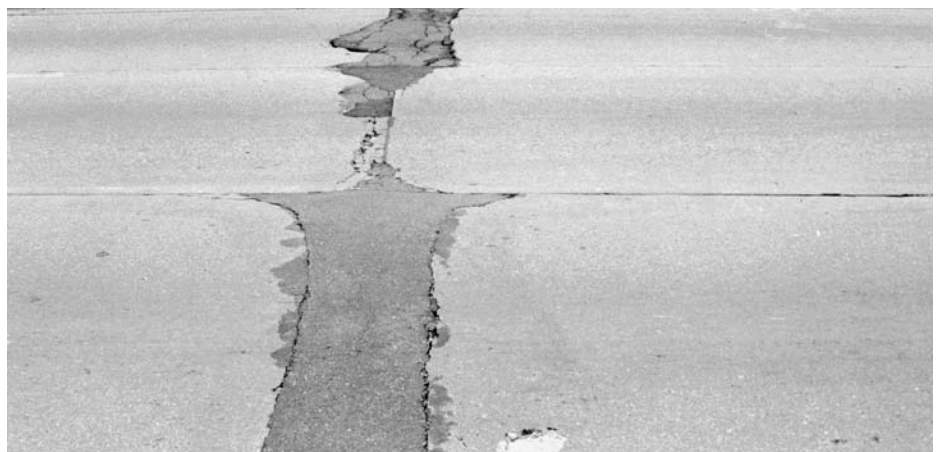
▶  
**Asphalt patches. Poor (top) and fair (bottom) condition.**

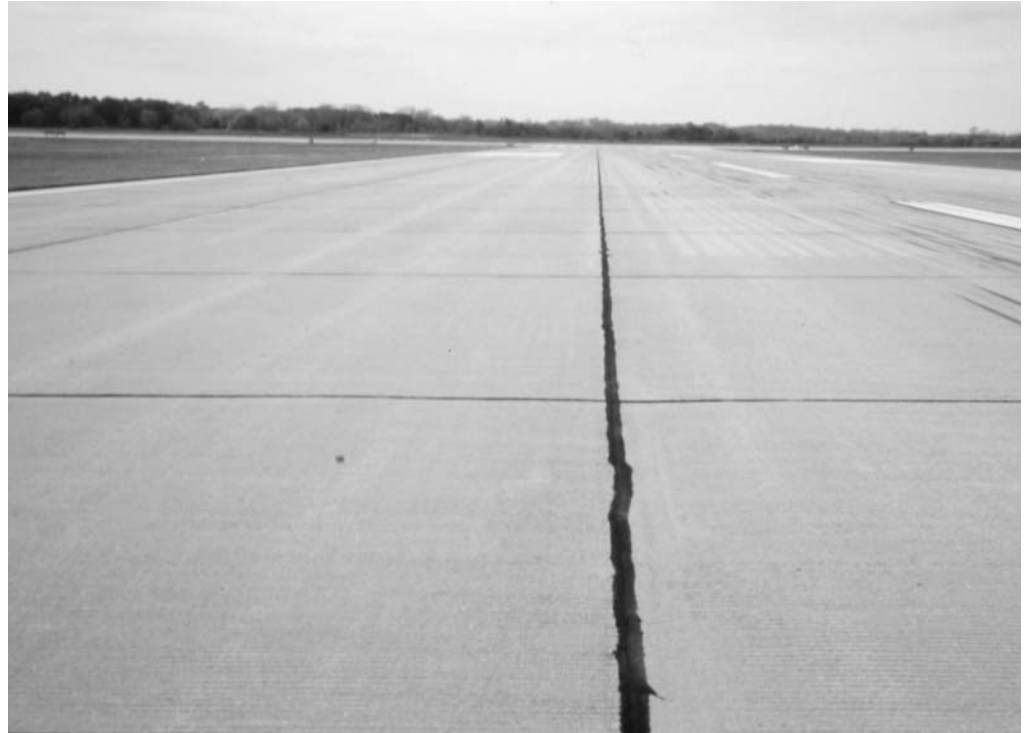
▶  
**New or like-new pavement condition.**

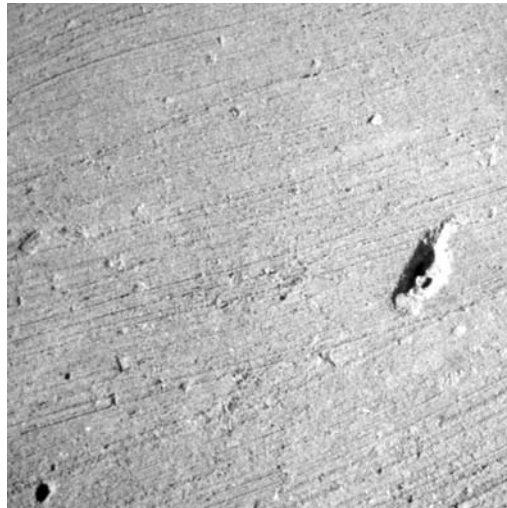
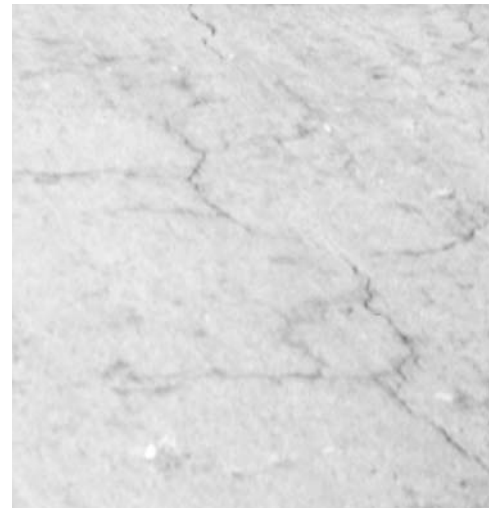
▶  
**Surface wear and pop-outs.**

▲ **Partial loss of joint sealant.**

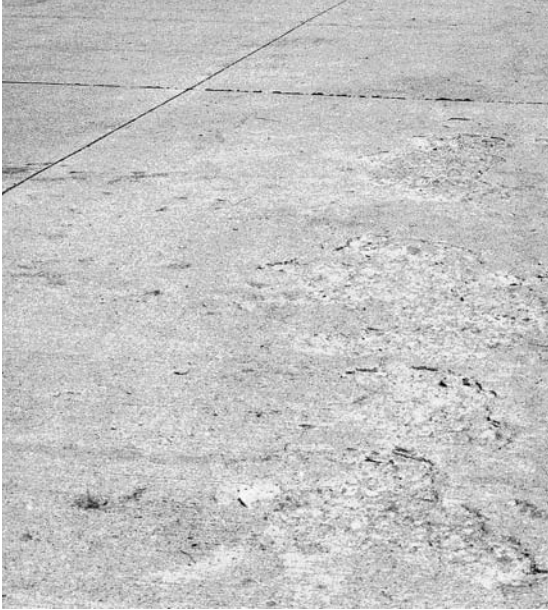
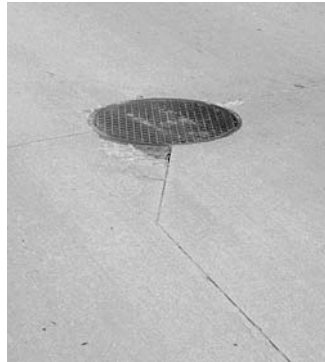
◀ **Isolated meander crack, tight and well sealed.**

▲ Isolated spall at manhole.

◀ Moderate scaling.

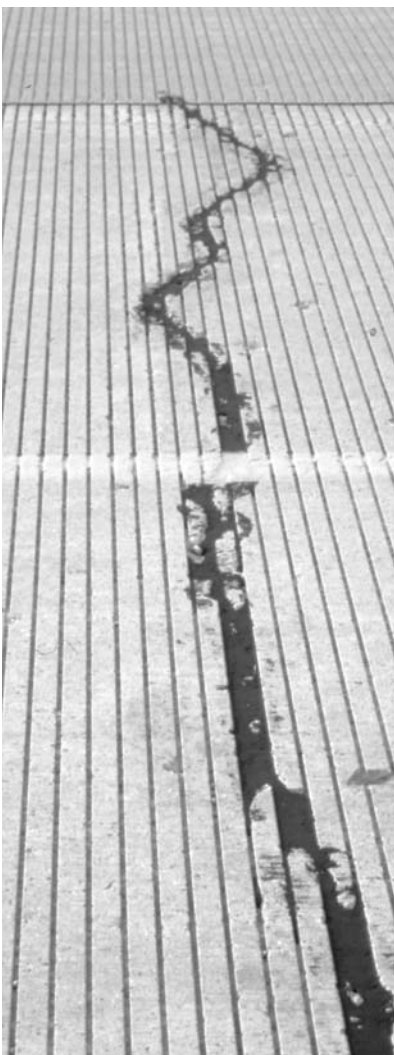
▲ Crack breaks slab into two pieces. Well sealed.

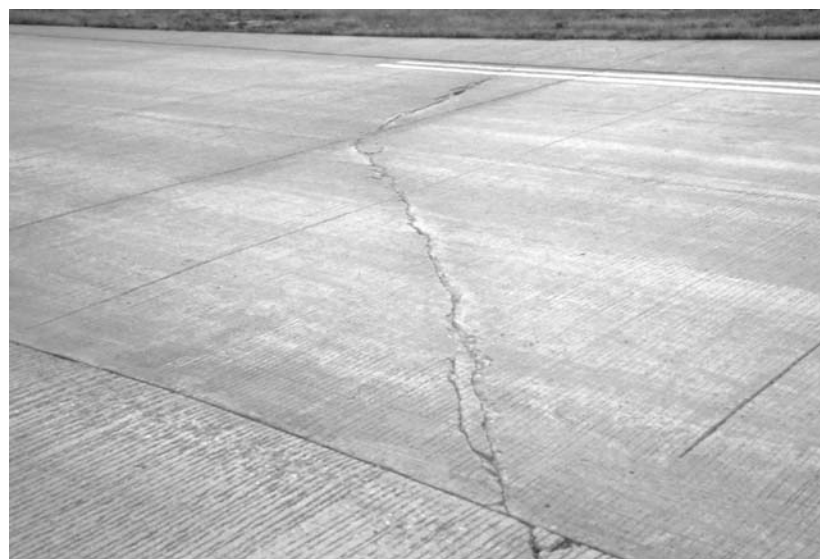
◀ Crack breaks off large corner of slab.

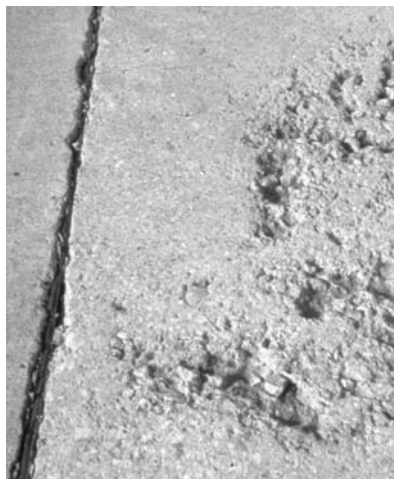
▲ Severe scaling. Joint and sealant in fair condition.

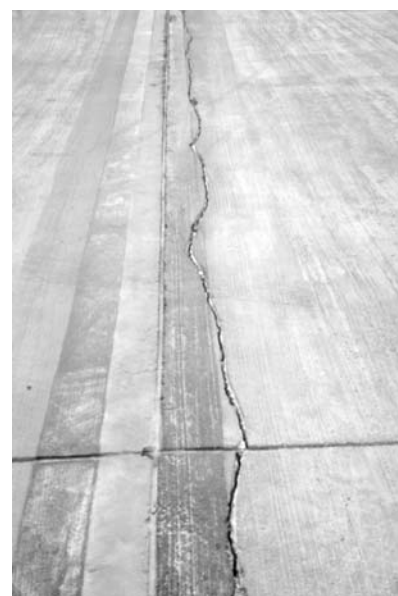
◀ Crack parallel to joint. Open 1/4". No spalling.

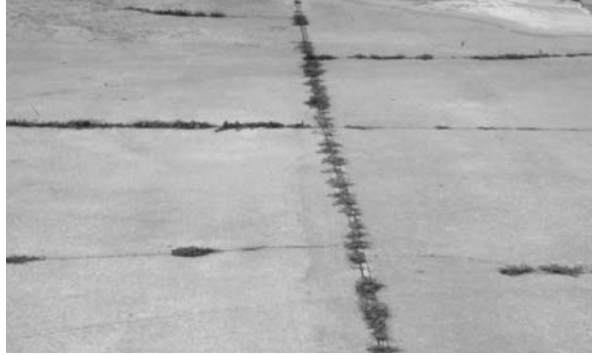
▲ Open joints and cracks. Need sealant on more than 10% of joints.

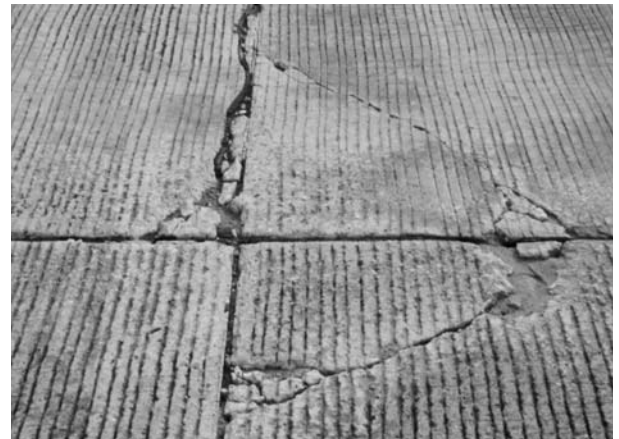
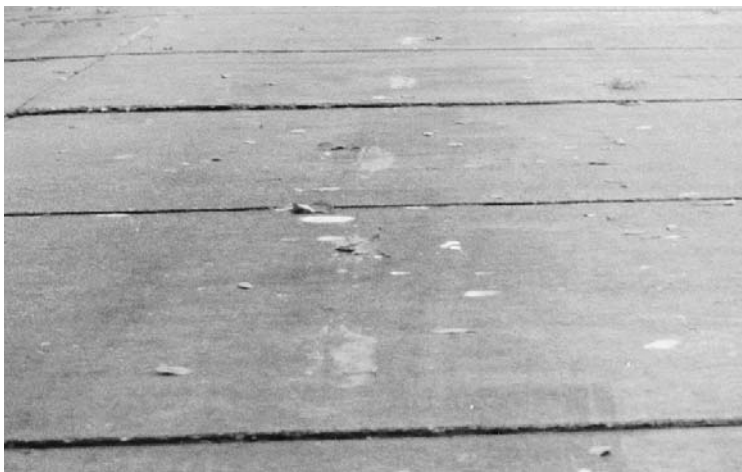
▲ Faulting of joints aggravated by heavy traffic in one direction.

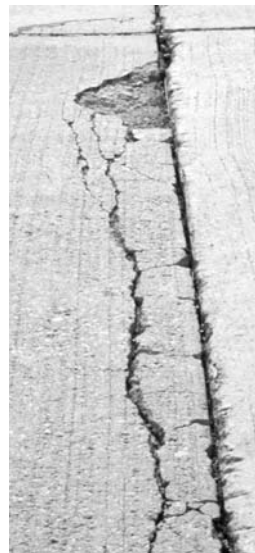
▲ Full depth joint repair required.

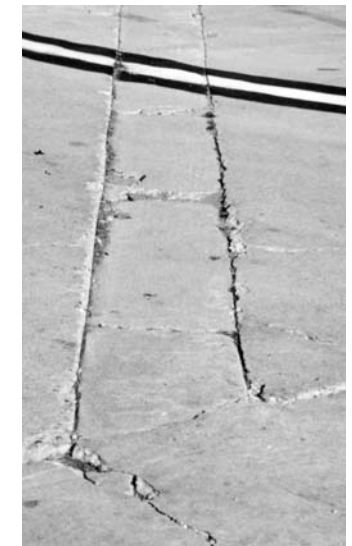
▲ Concrete patch in poor condition.

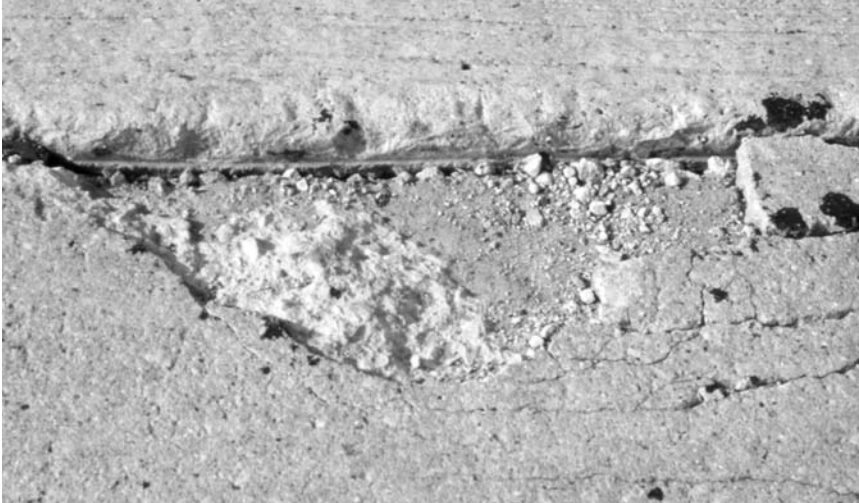
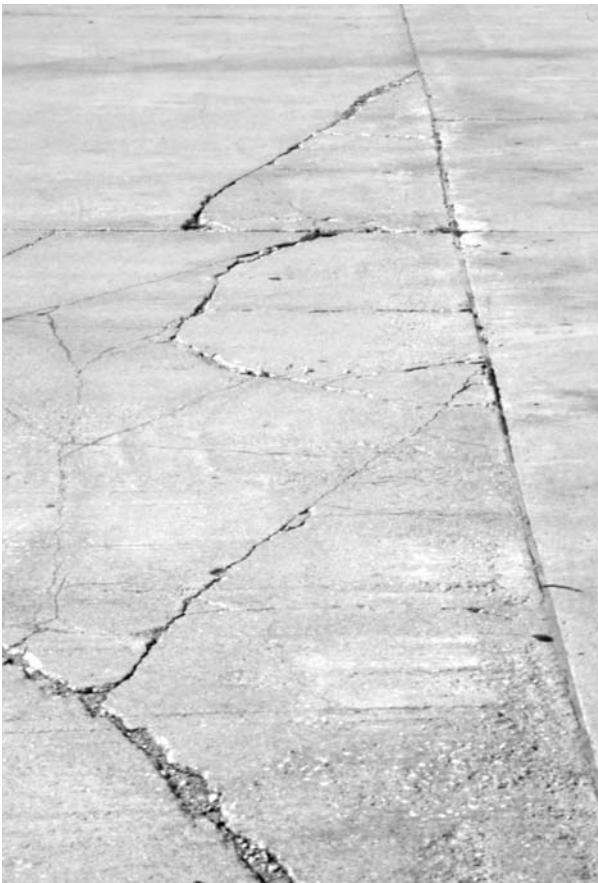
▲ Multiple slab cracks, spalling and shattered slabs.

▲ Failed joint with severe spalling and pothole.

▼ Inlet with severe cracking and spalling. Full depth slab repair required.

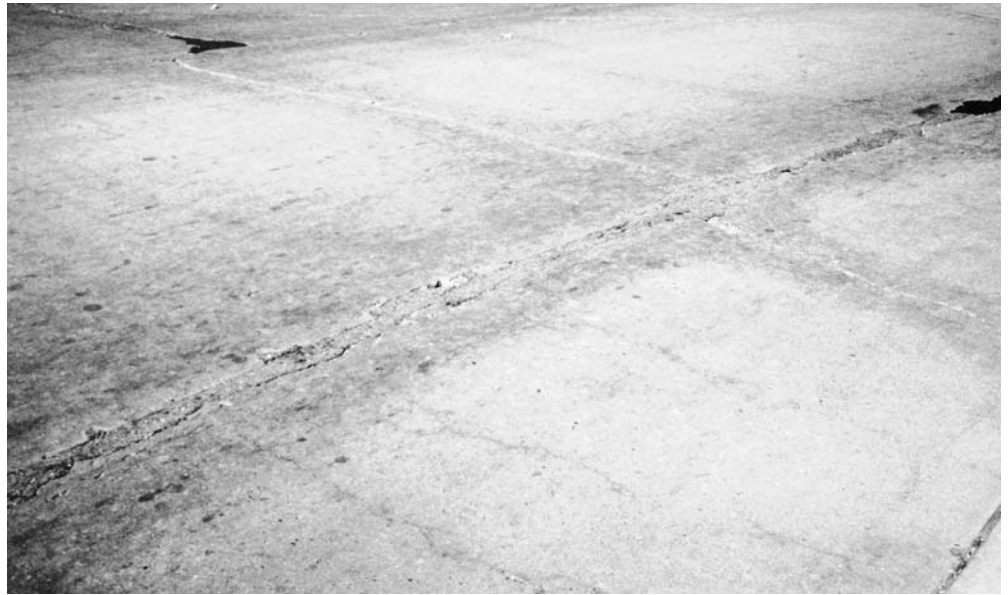
▶  
Closely spaced cracks and poor joint. Reconstruct.

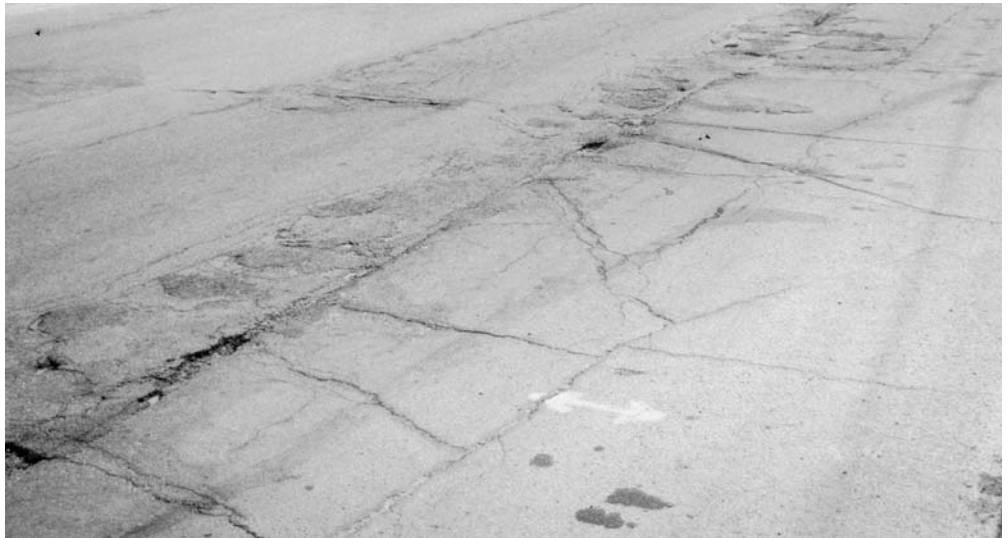
▶  
Severe deterioration. Requires reconstruction.

▶  
Severe scaling over extensive areas. Reconstruction required.
