Preliminary Investigation of a Test Method to Evaluate Bond Strength of Bituminous Tack Coats

**Research Report
FL/DOT/SMO/02-459**

October 2002

STATE MATERIALS OFFICE

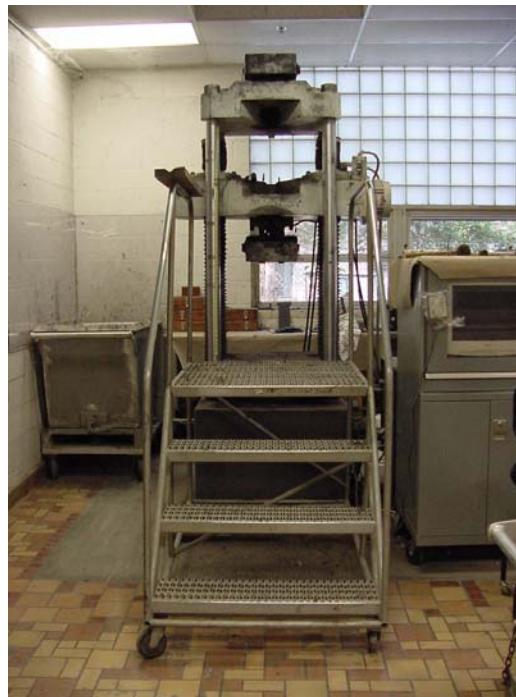
Figure 2 – Tinius Olsen Load Frame

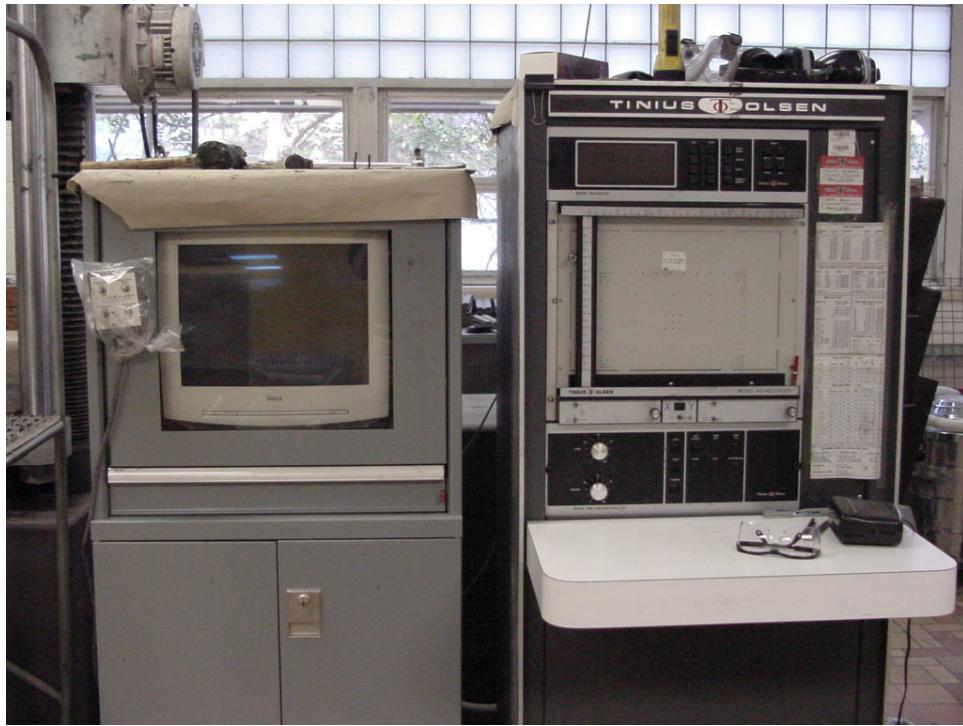
Figure 3 – Tinius Olsen Data Acquisition System

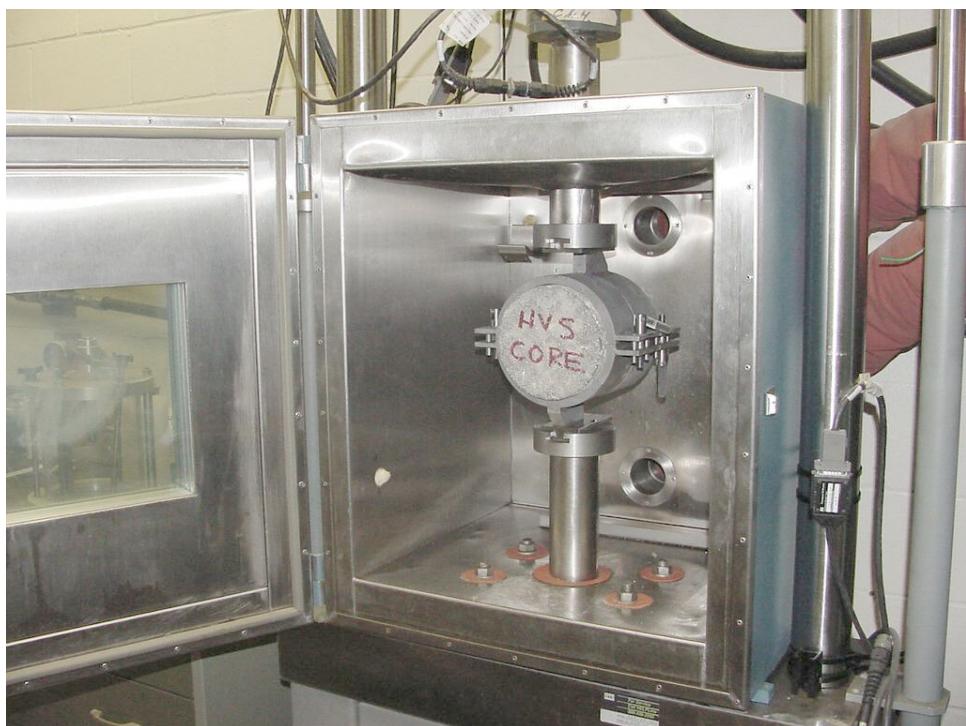
A simple direct shear device was designed and constructed that would operate in the Materials Testing System (MTS) located in the Bituminous Research Lab (Figures 4 and 5). The device holds six-inch nominal diameter roadway cores or laboratory fabricated specimens. Roadway cores do not need to be trimmed due to the design of the device and the large size of the MTS testing chamber. The device was manufactured so that the gap width between the shearing platens is adjustable. In addition, the MTS equipment has the flexibility of strain or stress modes

Figure 4 – Final Shearing Apparatus

Figure 5 – Final Shearing Apparatus

of loading, adjustable loading rates and temperature control. The shear device is simple to use and the data acquisition and reporting has been automated with software modified for this application.
