## **Forensic Investigation SR-471 Hot-in-Place Recycled Project Sumter County, Florida**

**Research Report  
FL/DOT/SMO/06-490**

**Michael I. Hammons, Ph.D., P.E.  
James Greene**

**February 2006**

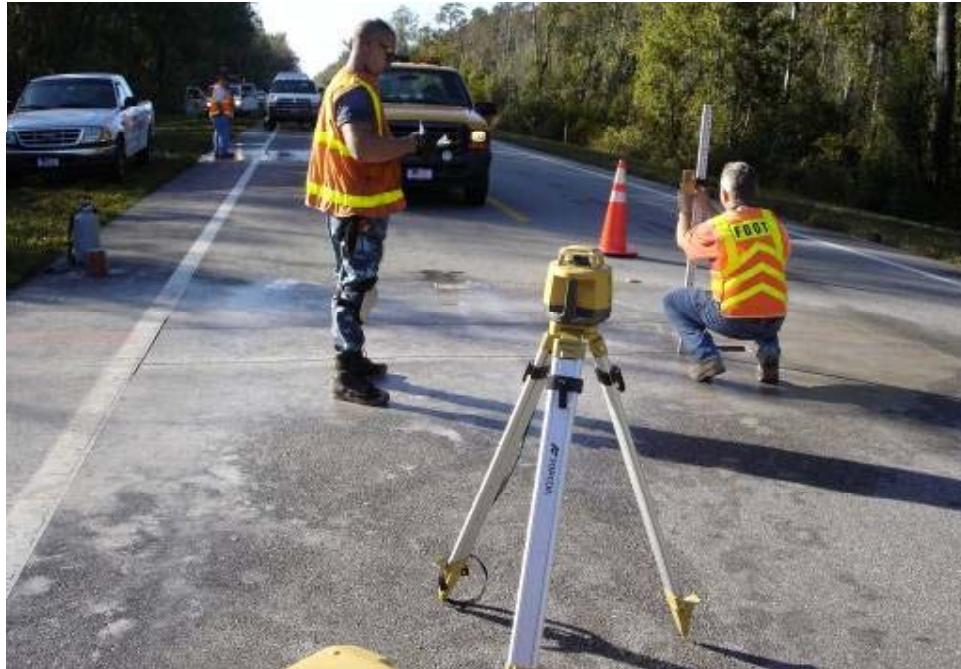
*Figure 9. Measuring surface profile with laser level*

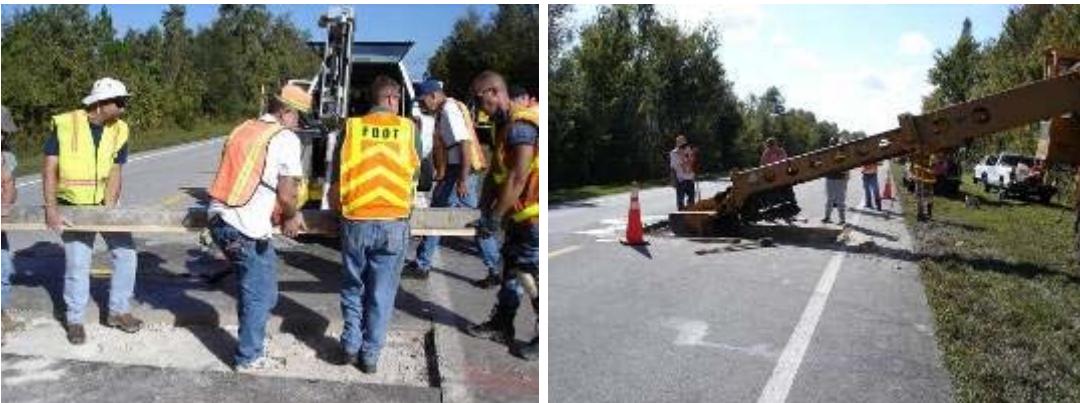
*Figure 10. Excavating trench*

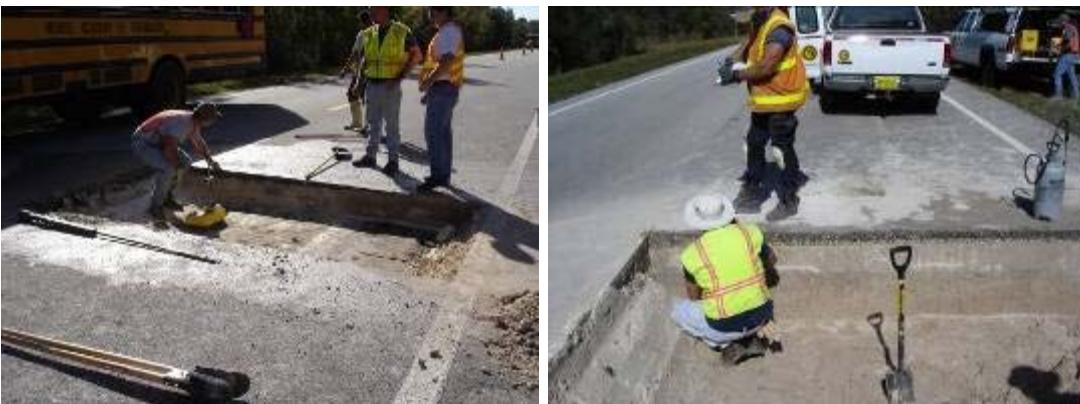
*Figure 11. Nuclear density tests and layer thickness measurements in trench*

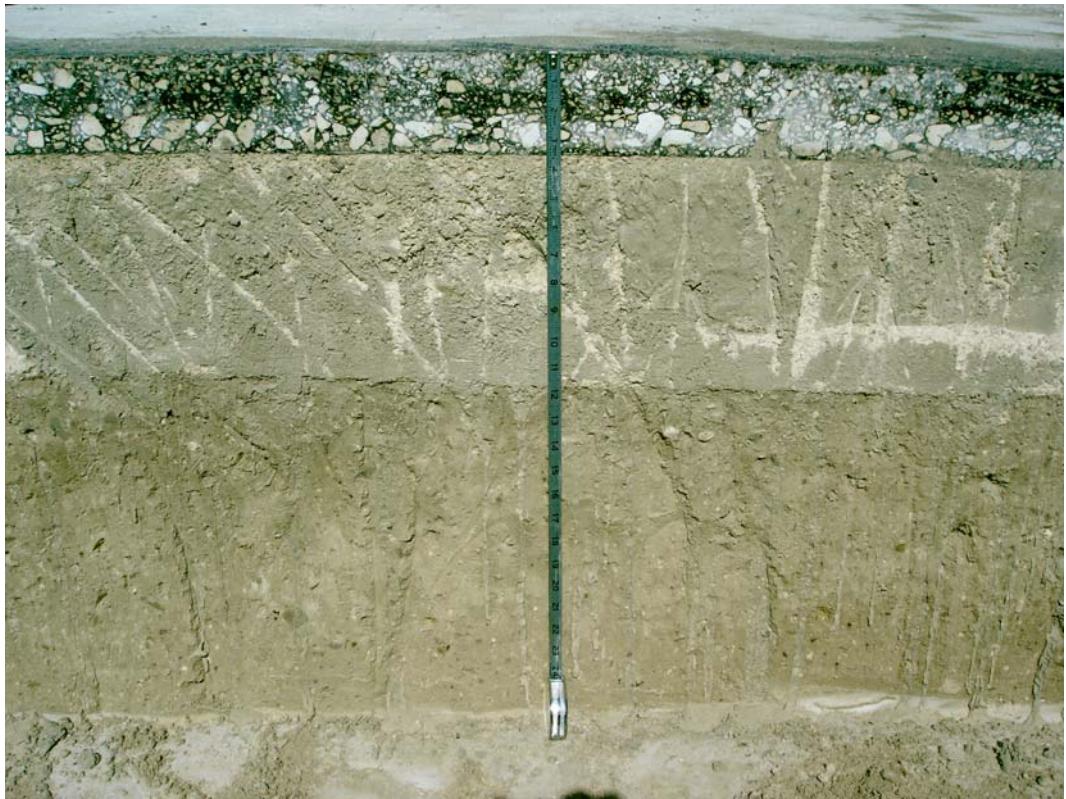
A photograph of a typical trench cross section showing the layering of the pavement structure is shown in Figure 12. The results of these measurements are shown in the figures indicated in Table 11. It can be observed that there are some variations in the layer thicknesses. For example, the thickness of the HIPR layer is varying along the width of the roadway, particularly at MP 4.15; however, this thickness variation is probably caused by correction of the cross-slope during rehabilitation. There are also some differences in the total pavement thickness above the subgrade ranging from approximately 25 inches at MP 3.65 to over 30 inches at MP 0.55. The asphalt/base interfaces do not indicate significant rutting. The irregular interfaces between the binder and HIPR layers do not allow a determination of which asphalt layer contributed to the rutting.

*Figure 12. Photograph of a typical trench cross-section*

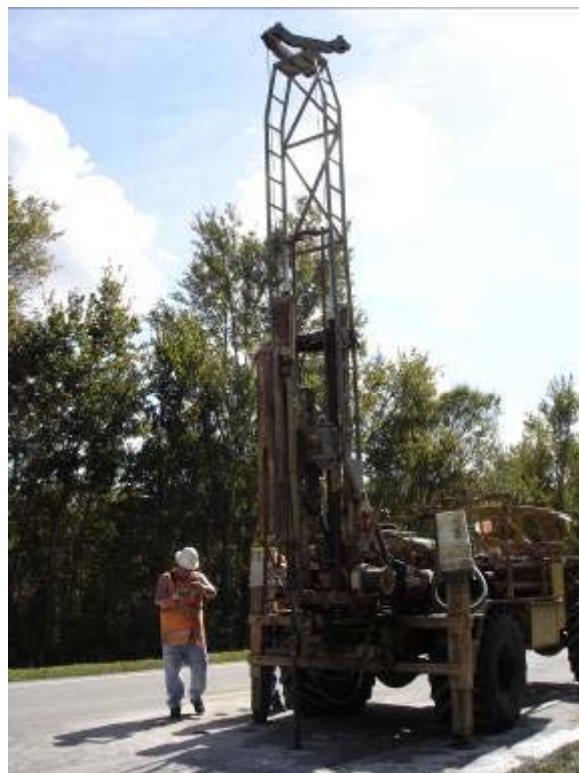
A standard penetration test (SPT) test using a split-spoon sampler, as seen in Figure 17, was conducted in accordance with AASHTO T 206 to a depth of approximately 15 feet. Data collected from the SPT test includes soil description based on samples retrieved, depth to water table, and a penetration resistance profile. The logs from these tests are contained in Appendix A. The depth of the water table at each trench site is tabulated in Table 12.

*Figure 17. Standard penetration test using a split-spoon sample*

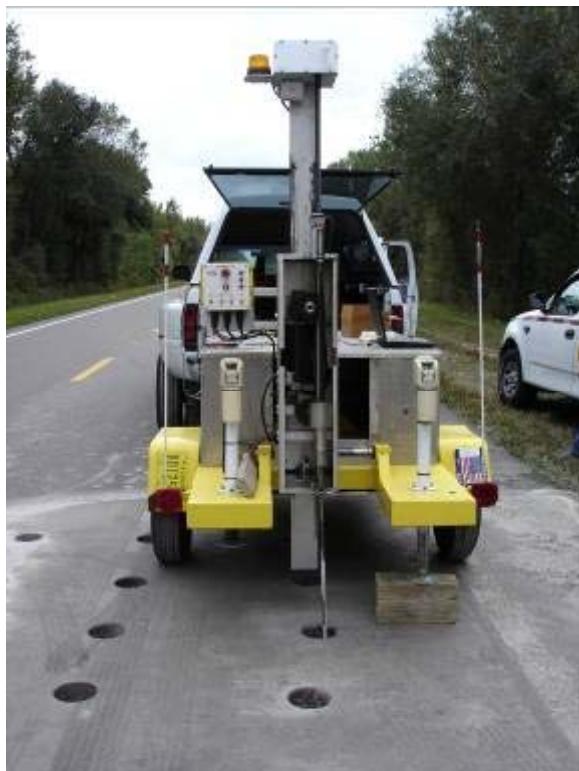
DCP tests were conducted at two locations in the trench openings and through five core holes near each trench in the HIPR section (Figure 18). In addition, DCP tests were conducted through core holes at MP 6.5 SB in the control section. Appendix C presents tabulated results from each DCP test.

*Figure 18. DCP test through core hole*
