Mobile Retroreflectivity Unit (MRU) Surveying of Maintenance Rating Program (MRP) Sites

**Research Report
FL/DOT/SMD/06-491**

STATE MATERIALS OFFICE

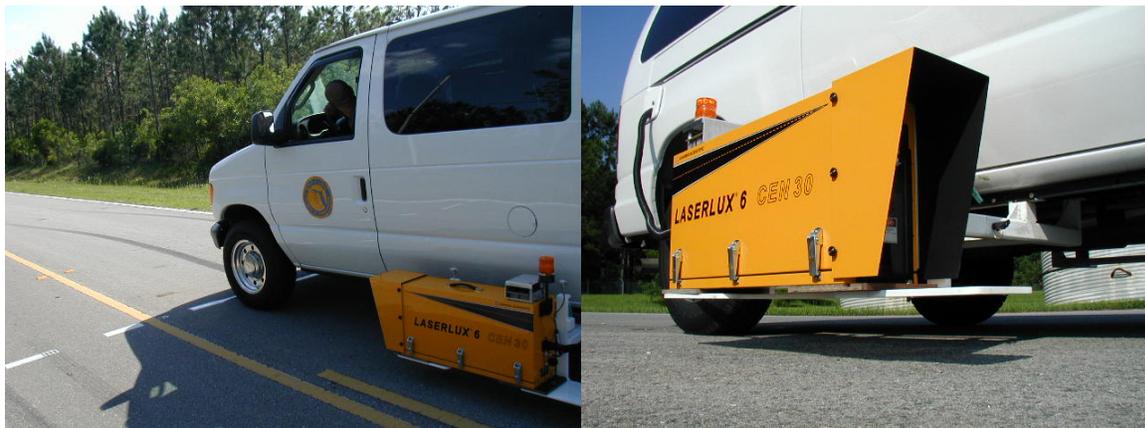
Figure 1. A Photographic Illustration of a Mobile Retroreflectometer Unit.

The present report focuses on retroreflectivity data collected using a device commonly referred to as a “mobile retroreflectometer unit”, or MRU. The present state-of-the-art retroreflectometer is fully automated. It consists of a full-sized van and a laser based retroreflectometer scanning device which can be mounted to either side of the vehicle. A photographic illustration of a mobile retroreflectometer unit is shown in Figure 1. The vehicle supplies all the electrical power required to perform testing with the retroreflectometer. Additionally, the vehicle houses all support systems, including a control panel and a data acquisition system to collect and store information from the traveled surface. A distance-measuring instrument (DMI) is provided to determine the position along the road. This longitudinal distance measurement is needed to associate the precise locations of the retroreflectivity measurements. An onboard GPS system and video monitoring equipment are also housed in the vehicle.

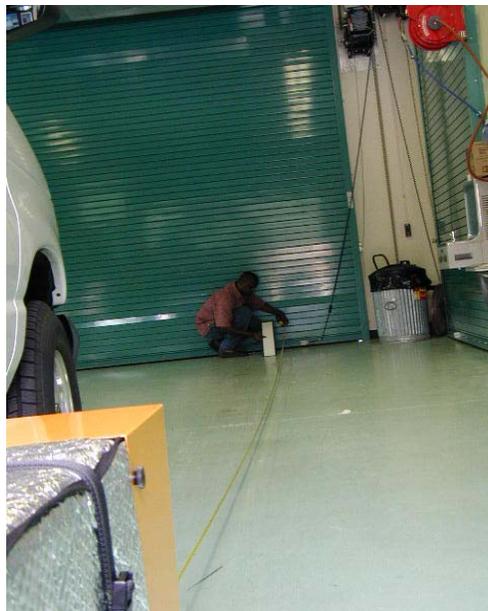
Figure 6. Placement of Striping Standard for MRU Calibration

To ensure measurement precision, calibration of the equipment is performed each time testing is performed with the unit. The calibration procedure calls for placing a manufacturer provided striping standard with a known retroreflectivity 10 meters in front of the unit on a flat surface and measuring its retroreflectivity (separate standards are used for the measurement of yellow and white striping). Figure 6 shows this process. A correction factor is then applied (if necessary) to the measured retroreflectivity to ensure good correlation with the standard used. Calibrations are performed each time a new stripe is run and each time the unit is moved from one side of the vehicle to the other.

Additionally, the retroreflectivity of the calibration standards used are verified on a monthly basis by taking 40 measurements on each standard using an FDOT approved handheld retroreflectometer. The average of these readings is used as the calibration value.

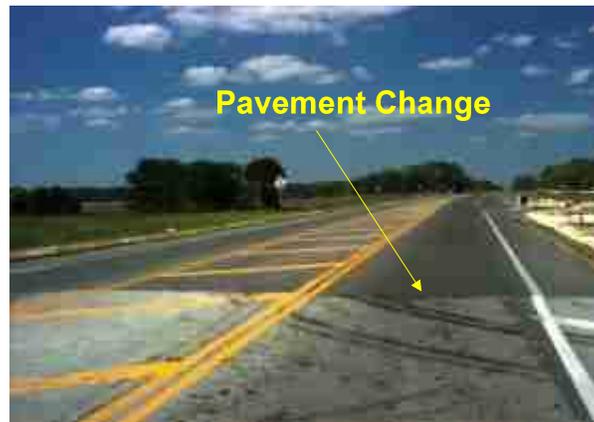
Figure 11. Example of Logged Pavement Change

For the purposes of this investigation, it was assumed if a given stretch of pavement was uniform, the retroreflectivity values would be very similar. The purpose of doing this is to define the performance of the section as a whole. If a chemical spill caused the striping to deteriorate in a small area of that same pavement stretch, it would not be highlighted by this method. However, it also would not be seen by an MRP inspection unless it just happened to be in the area that was randomly selected for inspection. Figure 11 shows an example of a pavement change that was logged during testing.
