IMPACT OF WIDE-BASE SINGLE TIRES ON PAVEMENT DAMAGE

Research Report

FL/DOT/SMO/09-528

STATE MATERIALS OFFICE

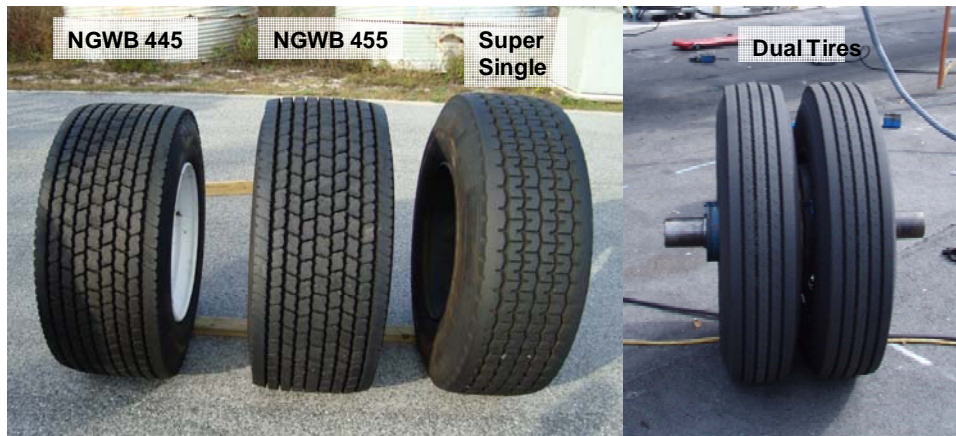
FIGURE 1 Photograph of tire used in the study.

1. Goodyear Unisteel G149 RSA, 11R22.5 (Dual Tire)
2. Goodyear G286 A SS, 425/65R22.5 (Super Single)
3. Michelin X One XDA-HT Plus, 445/50R22.5 (NGWB 445-mm)
4. Michelin X One XDA-HT Plus, 455/55R22.5 (NGWB 455-mm)

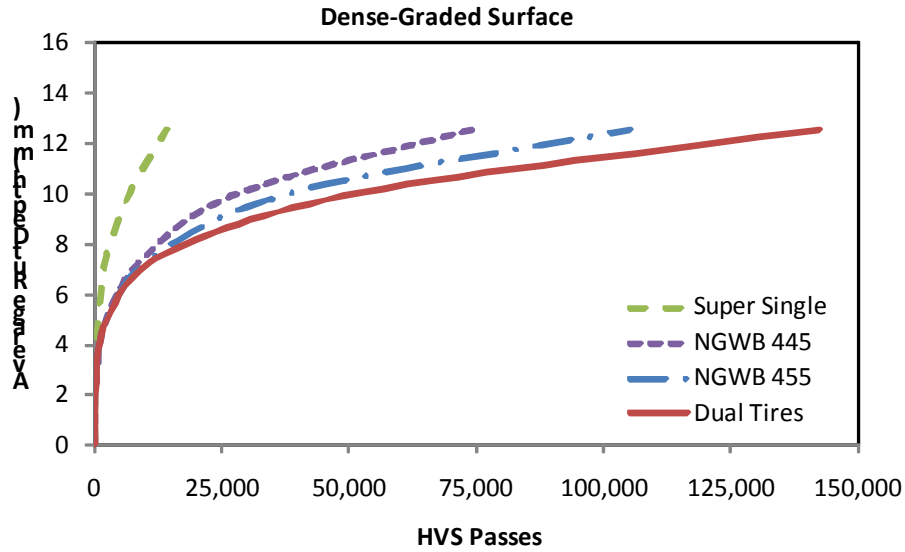
A.) Dense-graded surface rut depth measurements.

FIGURE 3 reports the rut depth and the rut damage ratio. The rut damage ratio is simply the ratio of the average number of passes required for a standard tire (in this case, the dual tires) to that of the other respective tires tested to achieve an approximate rut depth of 0.5 inch (12.5-mm).

| Statistic | Passes Required for a 12.5-mm Rut Depth | | | |
|---|---|---|---|---|
| Average | 169,000 | 16,000 | 72,000 | 133,000 |
| Rut Damage Ratio | 1.0 | 10.6 | 2.3 | 1.3 |

For both pavement types, the dual tire configuration allowed a greater number of passes before reaching the critical rut depth while the Super Single tire resulted in the least number of passes. In general, the NGWB 455-mm tire required a similar number of passes on the open-graded surface and slightly less for the dense-graded surface (when considering the variability in tests) as compared to the dual tires. The NGWB 445-mm tire reached the critical rut depth with less passes than the dual for both surface types, particularly for the dense-graded surface. The Super Single tire reached the critical rut depth with significantly less number of passes than the duals for both asphalt mixtures.

It is believed that the large difference in rate of rutting between the dense-graded pavement and open-graded pavement is likely due to the lower modulus of the open-graded friction course and effects from the accelerated nature of the test. While not measured in this study, literature indicates that the modulus of an open-graded pavement is approximately 50 to 80 percent lower than conventional dense-graded mixtures (12). Furthermore, a previous FDOT funded study showed that open-graded friction courses tend to rut faster during accelerated testing than typically observed in the field (13). This study indicated that the open-graded aggregate structure was not allowed time to stabilize due to the increased loading frequency and shortened evaluation period during testing with the asphalt pavement analyzer.

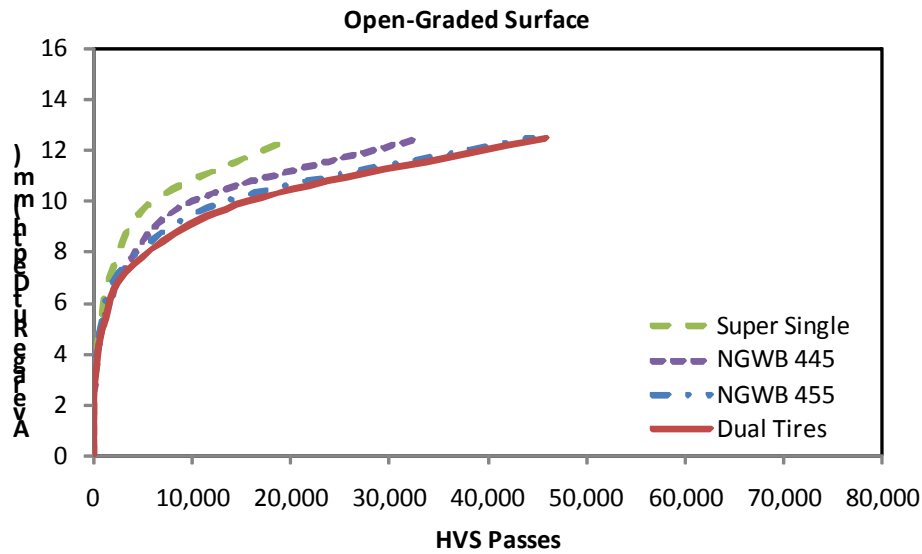
B.) Open-graded surface rut measurements.

| Statistic | Passes Required for a 12.5-mm Rut Depth | | | |
|---|---|---|---|---|
| Average | 46,000 | 20,000 | 33,000 | 44,000 |
| Rut Damage Ratio | 1.0 | 2.3 | 1.4 | 1.0 |

FIGURE 3 Rut depth summary.

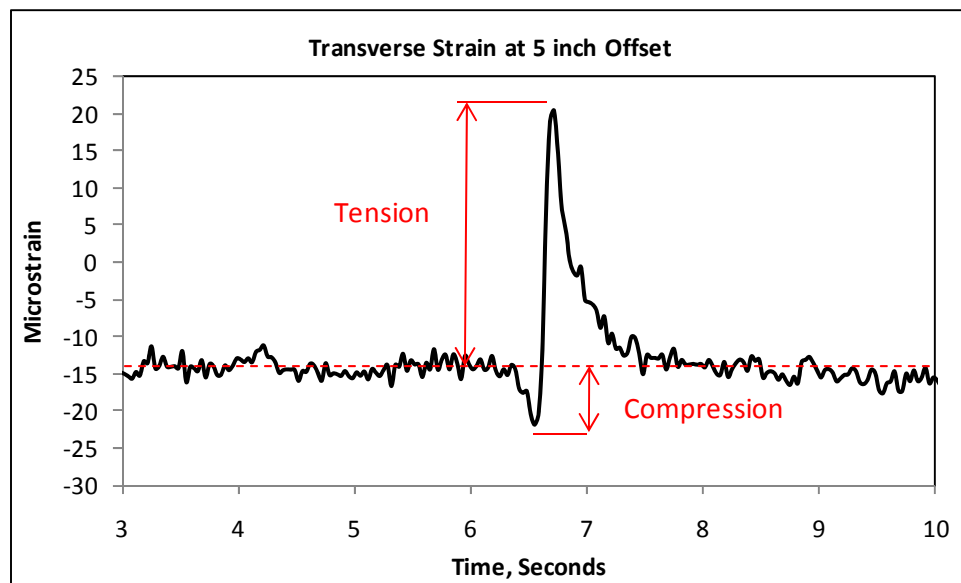
A representative strain profile made 5 inches (127-mm) from the dual tire edge is shown in FIGURE 4. In general, the strain measurements exhibited slight compressive strain as the wheel approached the gauge and tensile strain and reversal as the wheel moved away from the gauge. The strain magnitudes for each tire and speed are shown in FIGURE 5. The dual and Super Single generated the greatest transverse strain. As expected, transverse strain was reduced when the speed increased. While the magnitudes of measured strain are not likely to induce top-down cracking on a new pavement, these strains may be enough to generate cracks on older pavements subjected to aging and repeated loading. Additionally, some researchers suggest that load location in combination with asphalt stiffness gradients are critical to crack propagation (14).

FIGURE 4 Typical dual tire strain profile at 8 mph (13 kph).

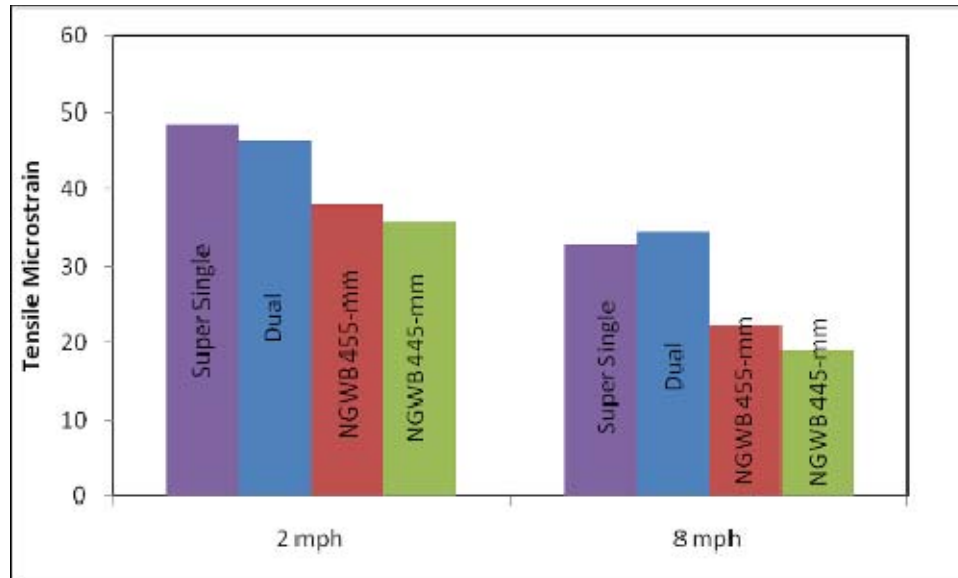
FIGURE 5 Surface transverse strain measurement on dense graded surface.

Top-down cracking is one of the primary distresses observed on Florida pavements. Top-down cracks are thought to form due to tensile and shear stresses generated by repeated loading in combination with stiffness gradients from aging and thermal effects. In order to determine the potential for top-down cracking, tensile strain measurements were made on the dense-graded surfaced pavement. Two transverse 1.2 inch (30-mm) foil surface strain gauges were placed 5 inches (127-mm) from the tire edge, a location where it was thought tensile strain would dominate. Five HVS wheel passes were made with each tire at 2 mph (3 kph) and 7 mph (11 kph). Strain measurements were not corrected for temperature, since the pavement surface temperature at the time of testing was $78 \pm 2^\circ \text{F}$ for all tire and speed combinations.

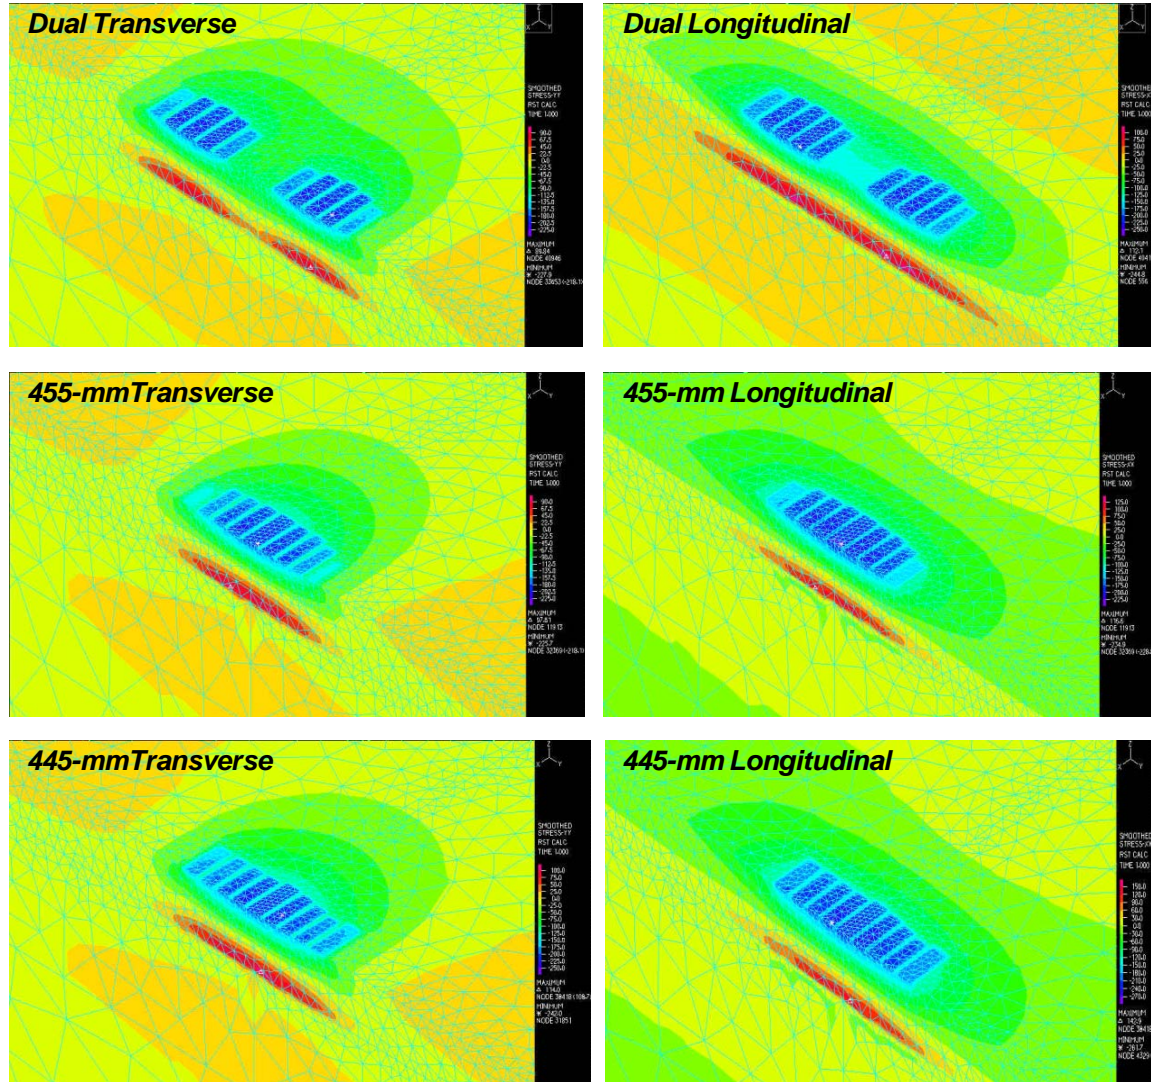
The stress distributions along the symmetrical transverse face for each tire are shown in FIGURE 8. As expected, the greatest tensile stress was predicted at the bottom of asphalt layer (shown in red) even with non-uniform tire pressures. On the pavement surface, the greatest compressive stress occurred below the tire treads. . A more detailed description of each investigated parameter is included in the following paragraphs.

Vertical tensile stresses developed near the surface due to lateral compressive stresses induced by the treads. The dual tire induced a greater tensile stress at the surface between the tires due to a more dominant effect from shear stresses. As found in the FE models reviewed in the literature, similar vertical compressive strains were predicted for each of the modeled tires. However, the 445-mm wide-base tire produced rut damage much quicker than the 455-mm and dual tires for the dense-graded pavement surface in the APT experiment. This indicates that a simple elastic model may not provide an accurate method to evaluate rutting potential. Viscoelastic parameters, loading frequency, and deformation accumulation should be accounted for as well.

FIGURE 8 Predicted stress distributions.

Top-down cracking in Florida is primarily observed as longitudinal cracks inside or just outside the wheel path. As with the measured surface strains presented earlier, the dual tire was predicted to induce the greatest surface strain. The maximum transverse tensile strain was predicted to occur approximately 9 to 10 inches (230-mm to 255-mm) from the tire edge regardless of tire type. The magnitudes of the predicted strain were smaller than those measured. However, the predicted strain values and predicted locations of maximum tensile strain were not necessarily expected to match since a greater load was used in the HVS experiments. A recent FDOT study also indicated that the maximum surface strain would occur approximately 10 inches (250-mm) from the tire edge (16). The 455-mm wide-base tire was predicted to generate the least amount of shear strain below the tire edge. The dual and the 445-mm wide-base tire generated similar shear strains. The maximum shear strain for all of the tires was determined to occur at a depth of approximately 2 inches. However, the shear strains at shallower depths were still greater than the surface tensile strain. The actual critical location for top-down cracking found

Tensile strain measured at the bottom of the asphalt was used to indicate bottom-up fatigue cracking potential. The NGWB 445-mm tire was predicted to induce slightly more tensile strain and create more bottom-up fatigue cracking damage. The NGWB 455-mm tire and the dual tire produced similar tensile strains and could be expected to produce similar bottom-up fatigue crack damage. TABLE 2 summarizes the FE model predicted strains

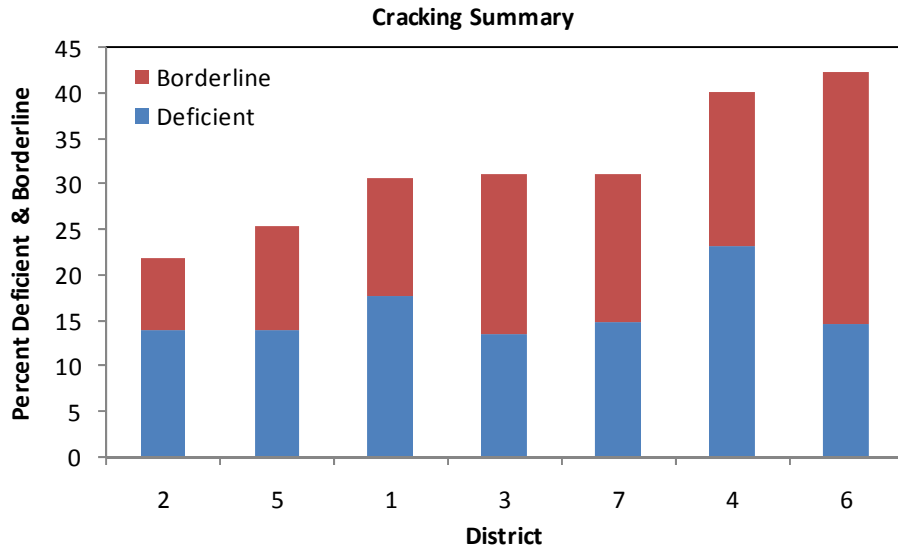
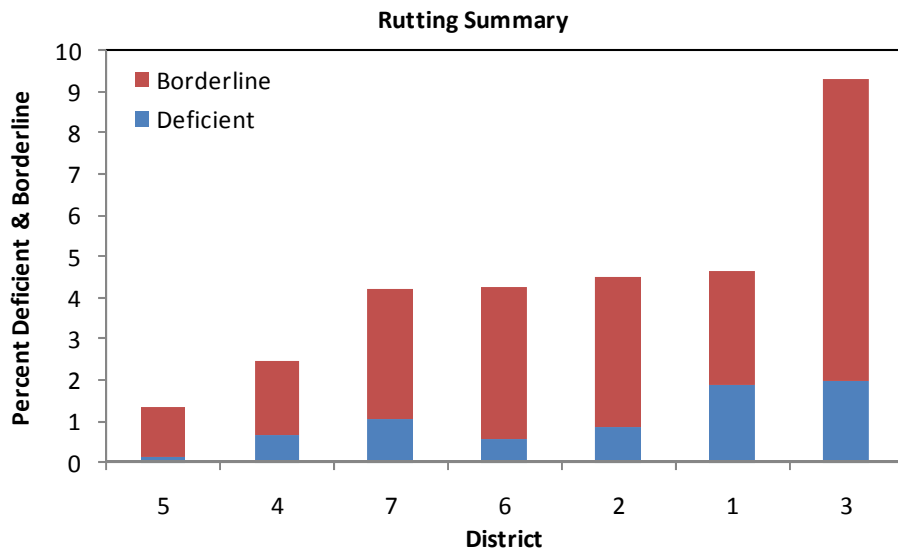
Dual tires have been predominantly used on Florida roadways. Pavement damage on Florida roadways is documented through annual surveys conducted by the State Materials Office (SMO). Crack and rut damage is determined on a scale of 1 to 10, with 10 representing a pavement with no damage. A rating of 6 or less indicates a deficient pavement that is eligible for rehabilitation. A rating of 7 may be considered borderline deficient. In 2008, more than 30,000 miles were surveyed statewide. A summary of the 2008 survey is shown in FIGURE 9 (17). Cracking is the predominant distress and in general, is more widespread in South Florida (Districts 4 and 6). Rutting is more common in the Panhandle (District 3).

FIGURE 9 2008 Pavement Condition Survey Summary.

Based on the results of this study, the pavement damage induced by the 455-mm wide-base tire could be considered similar to that of the dual tire in terms of rutting and bottom-up cracking and slightly improved in terms of top-down cracking. On the contrary, the 445-mm tire was shown to rut dense-graded pavement surfaces more than twice as fast as a standard dual. The 445-mm tire was also predicted to create slightly more bottom-up cracking damage than a dual tire, but less or similar surface cracking damage. The pavement damage trends shown in 2008, particularly rutting damage on dense-graded surfaces, would likely increase if the 445-mm tire is included in the future.
