State of Florida Department of Transportation

Effect of Asphalt Rubber Membrane Interlayer (ARMI) on Instability Rutting and Reflection Cracking of Asphalt Mixture

FDOT Office
State Materials Office

Research Report Number
FL/DOT/SMO/12-552

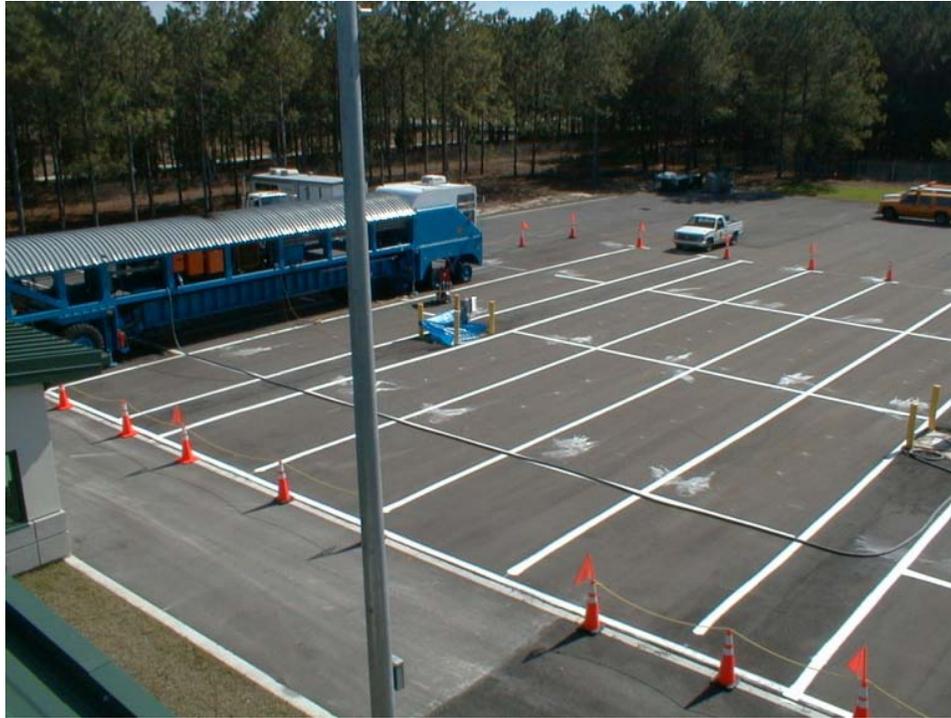
FIGURE 1 FDOT'S HVS and APT test tracks.

In FDOT's APT program, accelerated loading is performed using a Heavy Vehicle Simulator (HVS), Mark IV model. The HVS can apply wheel loads between 7 and 45 kips along a 20-foot test strip. The HVS is electrically powered (using an external electric power source or electricity from an on-board diesel generator), fully automated, and mobile. A complete description of the test facility has been presented elsewhere (3). The HVS and test tracks are shown in FIGURE 1.

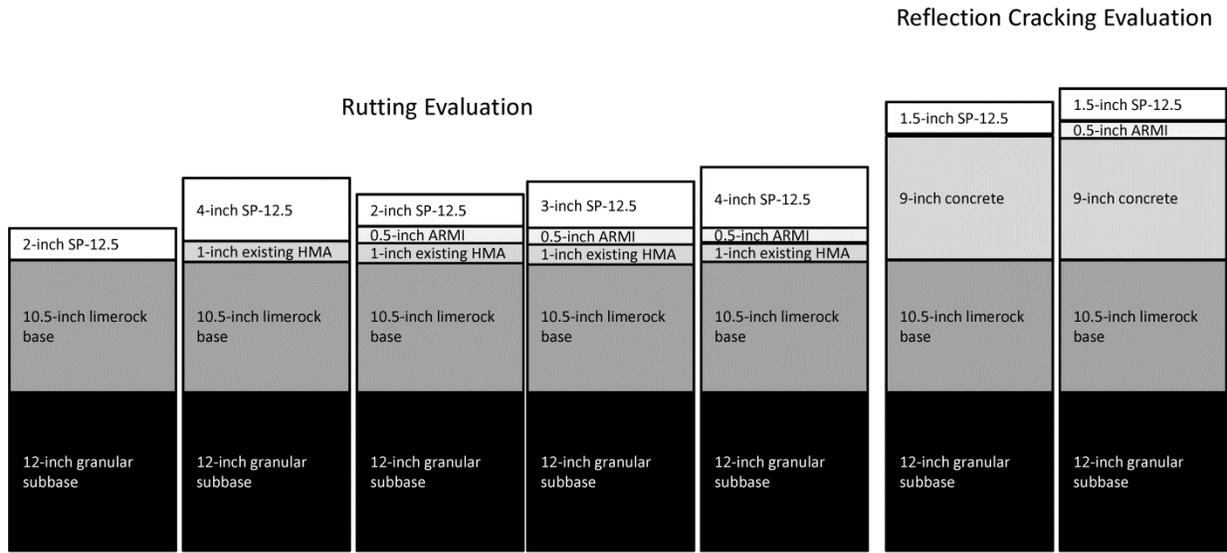
FIGURE 2 Pavement structures evaluated in the APT study.

Five test lanes were designed and constructed to evaluate an ARMI's role in instability rutting. The existing asphalt was milled from four lanes so that only 1 inch remained. An ARMI was placed on the milled surface of three of the lanes. Hot mix asphalt (HMA) overlays of 2, 3, and 4 inches were then placed over the ARMI. A 4 inch overlay was placed without an ARMI as a control lane. In addition, a new 2 inch HMA pavement was built with an identical base and subgrade. The HMA was designed as a 12.5 mm Superpave mixture and included granite aggregate and 5.1 percent PG76-22 asphalt binder.

Two additional HMA overlays were constructed over a 9 inch plain jointed concrete pavement to investigate reflection cracking mitigation. The original slabs had a joint spacing of 12 to 16 feet. Additional joints were cut so that each test section would include 4 to 5 joints. An ARMI and 1.5 inch HMA overlay using the same design previously discussed was placed over one concrete lane and a HMA overlay without an ARMI was placed over the second concrete lane. FIGURE 2 illustrates each of the pavement structures evaluated for instability rutting and reflection cracking.

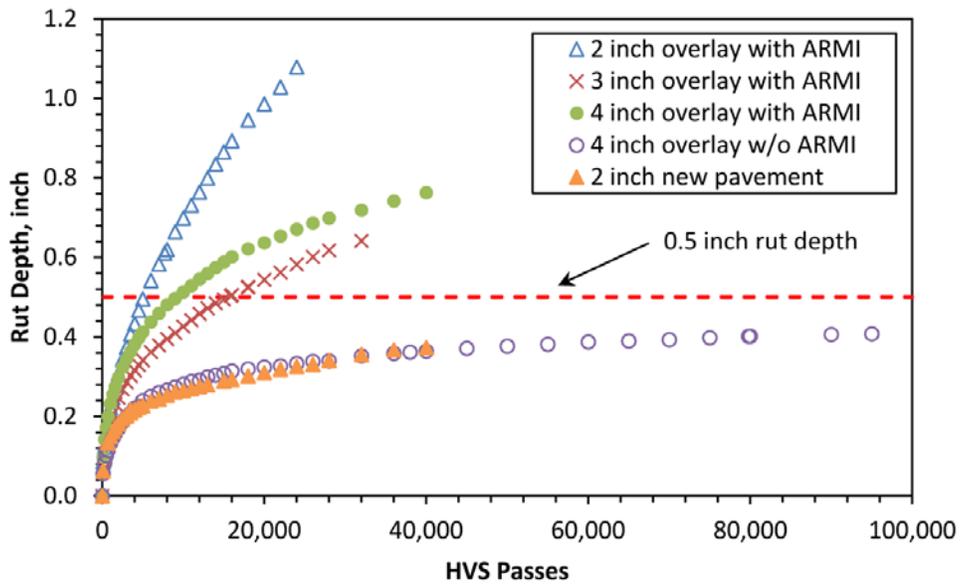
FIGURE 3 APT rut profiles.

FIGURE 3 shows the average rut history for each test lane. The APT rut profile data showed that the rate of rutting increased considerably when an ARMI was present. On average, all test lanes with an ARMI exhibited a 0.5 inch rut depth within 15,000 HVS repetitions while tests on the control lanes without an ARMI were projected to reach a 0.5 inch rut depth after approximately 250,000 passes. Given this projection, the test lane with the 2-inch overlay with an ARMI attained the critical rut depth (i.e. 0.5 inch rut depth) 50 times faster than control lanes. The test

sections of 3-inch and 4-inch overlays with an ARMI reached the critical rut depth approximately 20 times faster than control lanes.

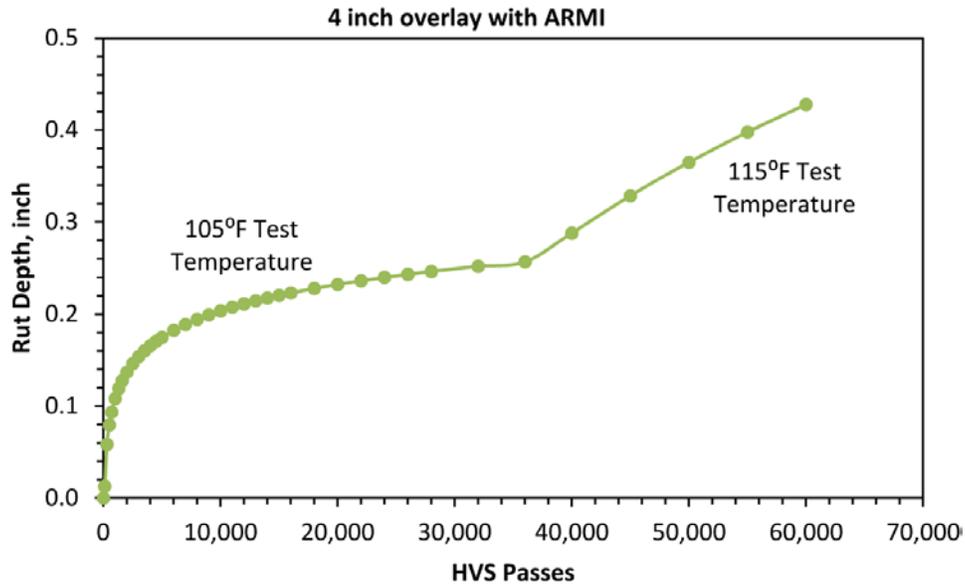
FIGURE 4 Temperature effect on instability rutting due to an ARMI.

To assess the influence of pavement temperature, an additional test was performed on the section with a 4 inch overlay and ARMI. The test was initiated at 105 °F and then increased to 115 °F. The test temperature was measured at a depth of 4 inches which corresponded to the location of the ARMI.

FIGURE 4 shows that rutting increased significantly when the temperature increased from 105 °F to 115 °F. Thermocouples were placed in the 4 inch overlay section with an ARMI and monitored at depths of 2 inches and 4 inches during the month of August to assess how frequent the in-depth asphalt pavement reaches this critical temperature during the summer. Pavement temperatures were found to be greater than 115 °F for 25 and 30 percent of the day at depths of 4 inches and 2 inches, respectively. Furthermore, pavement temperatures were greater than 120 °F for 8 and 19 percent of the day at depths of 4 inches and 2 inches, respectively.

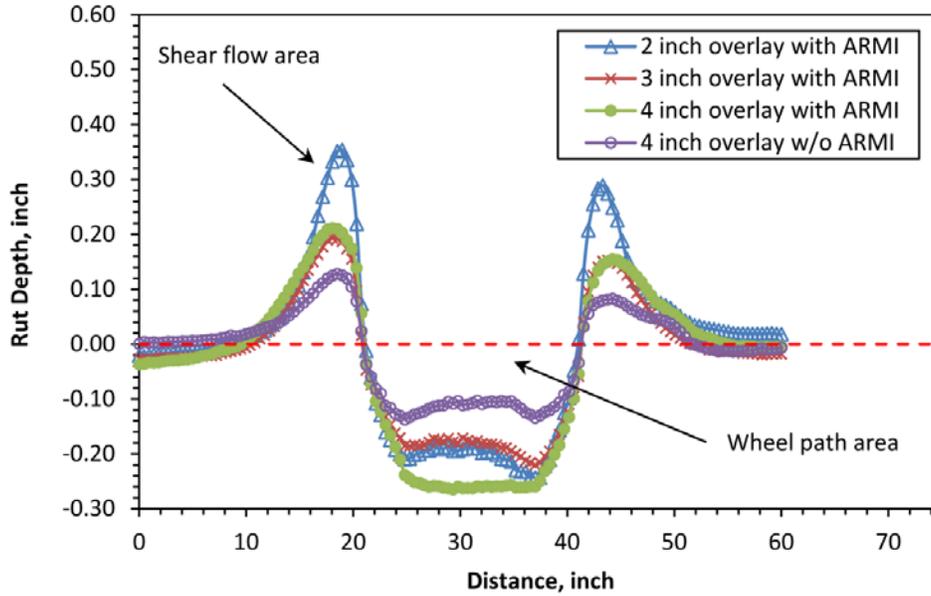
FIGURE 5 Transverse rut profiles after 10,000 passes.

The portion of rutting due to shear, or instability, may be estimated within a transverse rut profile by estimating the area of accumulated material at the edge of the rutted wheel path and comparing the sheared area to the empty area or volume below the wheel path (5, 6, 7). For instance, a larger shear to wheel path area ratio indicates a greater portion of rutting is due to shear flow and mixture instability as opposed to densification. FIGURE 5 shows transverse rut profiles for each pavement section except for the 2 inch new pavement at 10,000 passes and summarizes the rut and shear information for several other pass levels. The new 2 inch pavement was not included since only one test was conducted and the general trend appeared to be similar to that of the 4 inch overlay without an ARMI. The sections with an ARMI had larger shear to wheel path area ratios indicating a greater portion of rutting is due to instability.

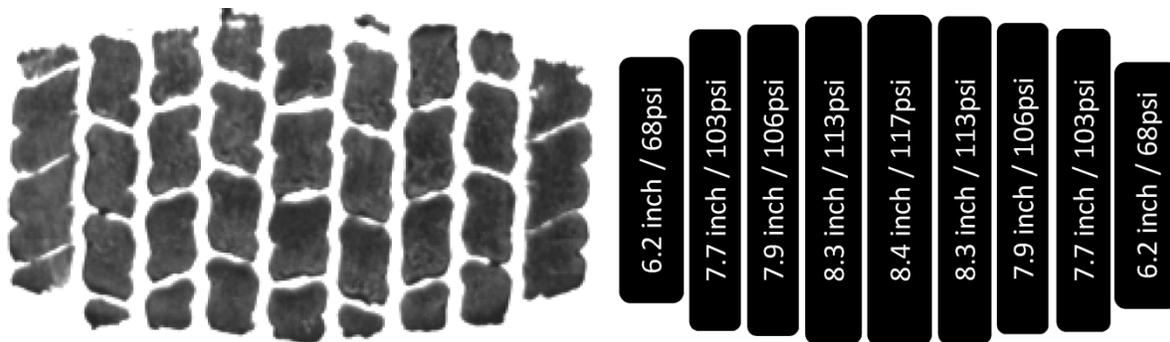
FIGURE 6 Tire imprint and contact stress.

The modeled pavement structures included the 2 and 4 inch overlay sections with an ARMI and the 4-inch overlay without an ARMI. The asphalt modulus was estimated using deflection analysis of the pavement lanes and confirmed with laboratory resilient modulus testing. The modulus of ARMI was estimated based on a composite modulus method (12). The stabilized subgrade and embankment were combined in the model to simplify the analysis. In order to more accurately model the true tire contact area, the imprint of the 455 mm tire tread was measured at the load and inflation pressure used during testing (9 kip and 100 psi). Vertical contact stresses of each tread were taken from another. (13). An image of the imprint and the contact stresses used are shown in FIGURE 6.

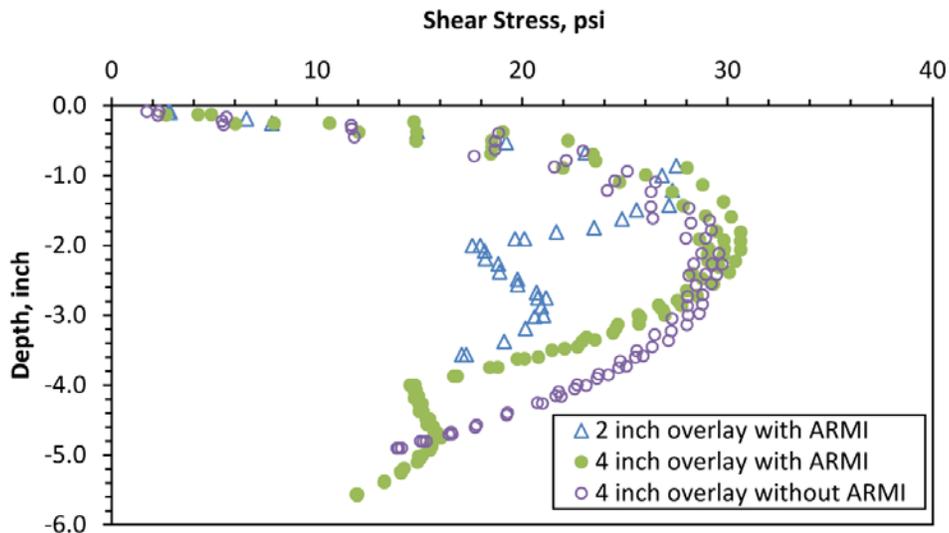
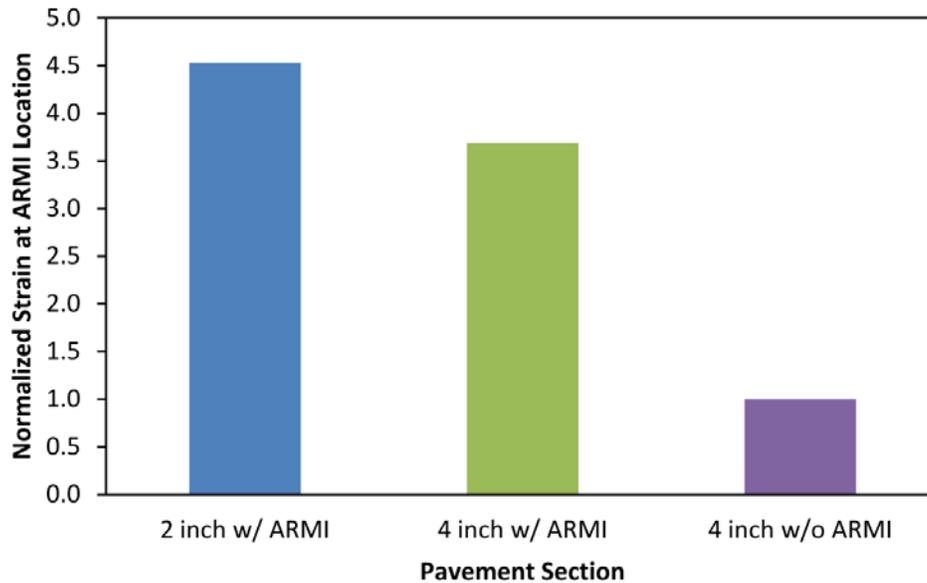
(a) Shear stress at tire edge

(b) Normalized strain at ARMI

FIGURE 7 Shear stress at the tire edge and normalized strain at the ARMI location.

The FE model showed that the maximum shear stresses occurred just above the ARMI and below the outside tire edge. Shear stress below the tire edge increased with depth and reached a maximum at approximately 2 inches for the 4 inch overlays with and without an ARMI and approximately 1 inch for the 2 inch overlay with an ARMI. Instability rutting usually refers to rutting in the top two to three inches of the asphalt layer. However, since the ARMI was placed 4 inches in depth, stress states for the total pavement thickness above the ARMI were calculated. Stress states were also determined for the top 4 inches of the asphalt in the control pavement without an ARMI. FIGURE 7 shows the shear stress at the tire edge and the normalized transverse strain at the location of the ARMI at 120 °F. Based on FIGURE 7, it was found that the 2 inch and 4 inch overlay sections with ARMI exhibit approximately 4.5 and 3.7 times greater transverse strain at the location of the ARMI, respectively.

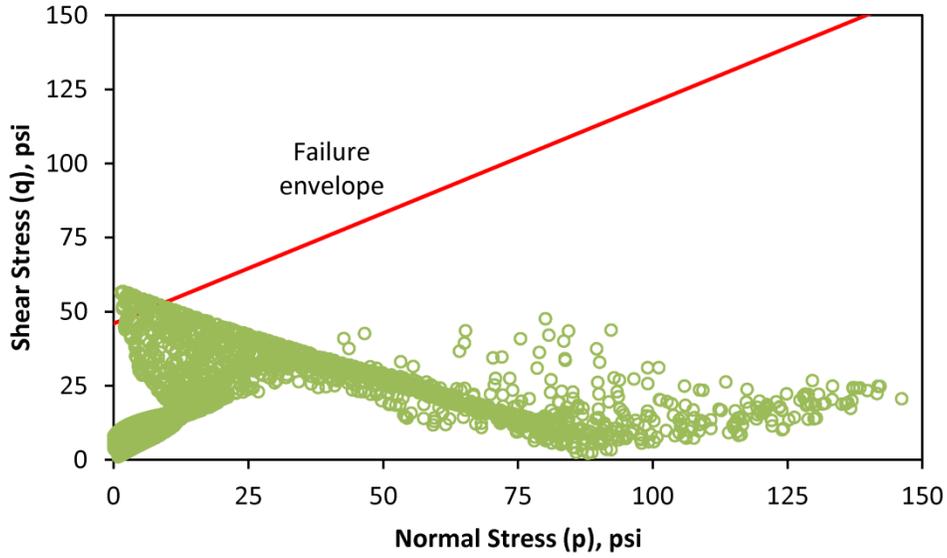
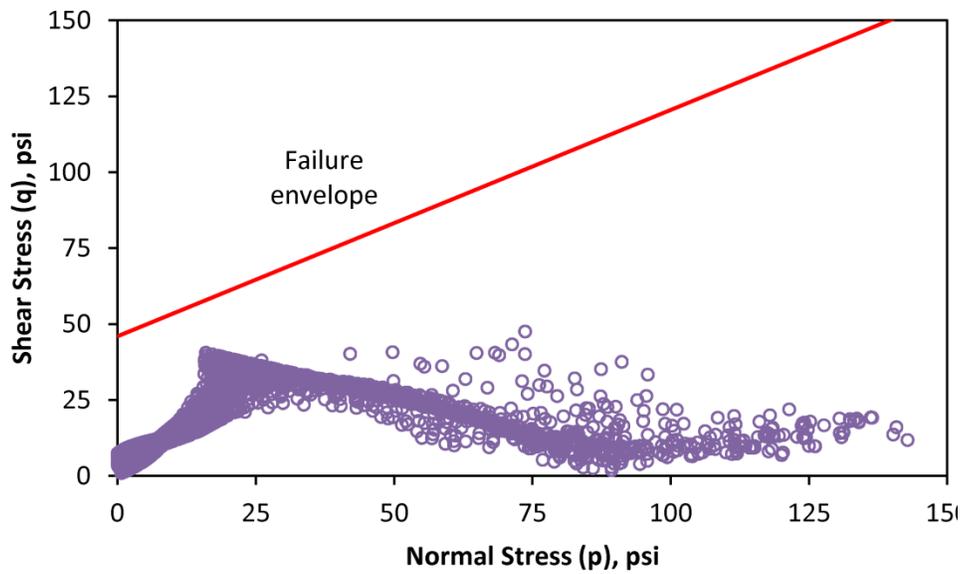
(a) 4 inch overlay with ARMI

(b) 4 inch overlay without ARMI

FIGURE 8 p-q diagram of the 4 inch overlay with and without ARMI

The concept of stress ratio (i.e. yield ratio) can be used to determine the degree of criticality of each stress state. The Mohr-Coulomb criterion assumes that the material will fail if q is equal to q_{failure} (i.e. stress ratio is equal to 1). Since the stress states are symmetrical with respect to the tire center, only half of the pavement section is shown with half of the tire treads indicated in the top left corner of each figure. FIGURE 9 illustrates the ratios for the estimated stress and stress at failure using Mohr-Coulomb criteria for the 4-inch overlay sections with and without an ARMI at 120°F . Critical stress ratios are found just above the ARMI and just outside of the tire edge for the section with an ARMI.

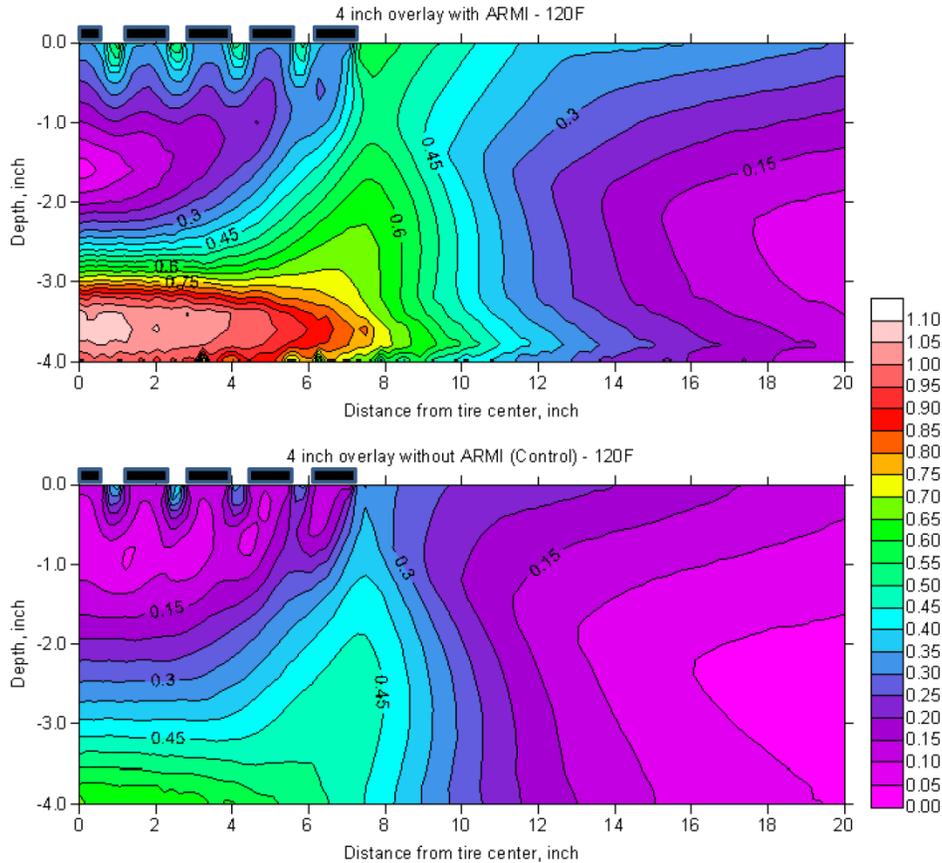
FIGURE 9 Stress ratios (q/q_{failure}) of the 4-inch overlay with ARMI and without ARMI

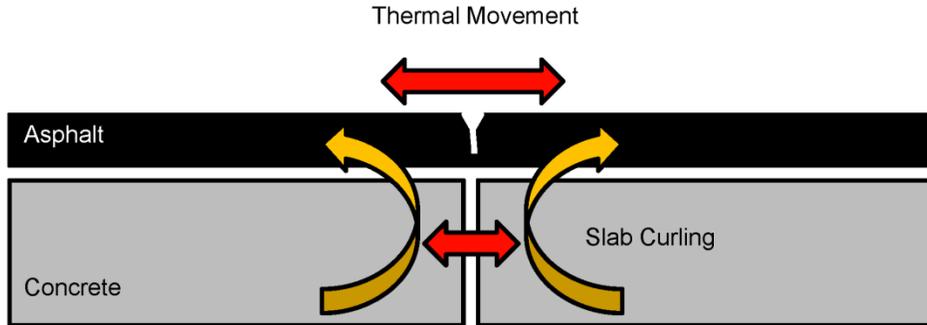
FIGURE 10 Top-down reflection cracking due to thermal movement.

Reflection cracking test sections were intended to be monitored for development of cracks reflected from the differential movement of the concrete slab joints under HVS loading. However, within two weeks after placement of the overlay, reflection cracks appeared on all of the joints on the test lane without an ARMI and approximately 25 percent of the joints on the test lane with an ARMI. Three weeks after construction, 50 percent of the joints on the test lane with an ARMI had reflection cracks. Cores showed that the cracks were shallow and originated from the surface, indicating that excessive tensile stress due to curling of the concrete slabs initiated the surface cracks. Literature has shown that top-down reflection cracking can be caused by a combination of thermal contraction and curling of the pavement as indicated in FIGURE 10 (16).

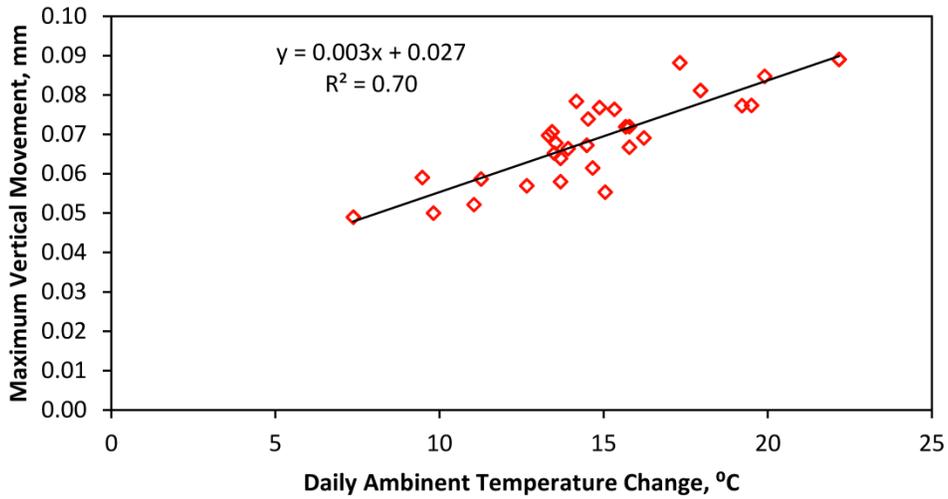
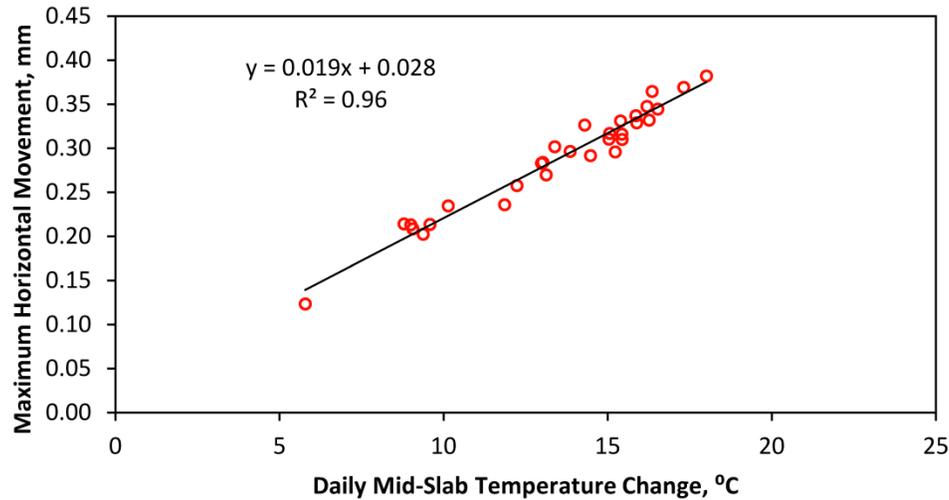
(a) Daily vertical movement

(b) Daily horizontal movement

FIGURE 11 Concrete joint movement due to thermal change.

Linear variable differential transducers (LVDTs) were installed at several joint edges to measure the average horizontal and vertical movement of the concrete slabs during the months of

June and July. During this time period, the average maximum daily horizontal and vertical movement was 0.29 mm and 0.07 mm, respectively. FIGURE 11 shows the movement of the concrete joint due to thermal change.

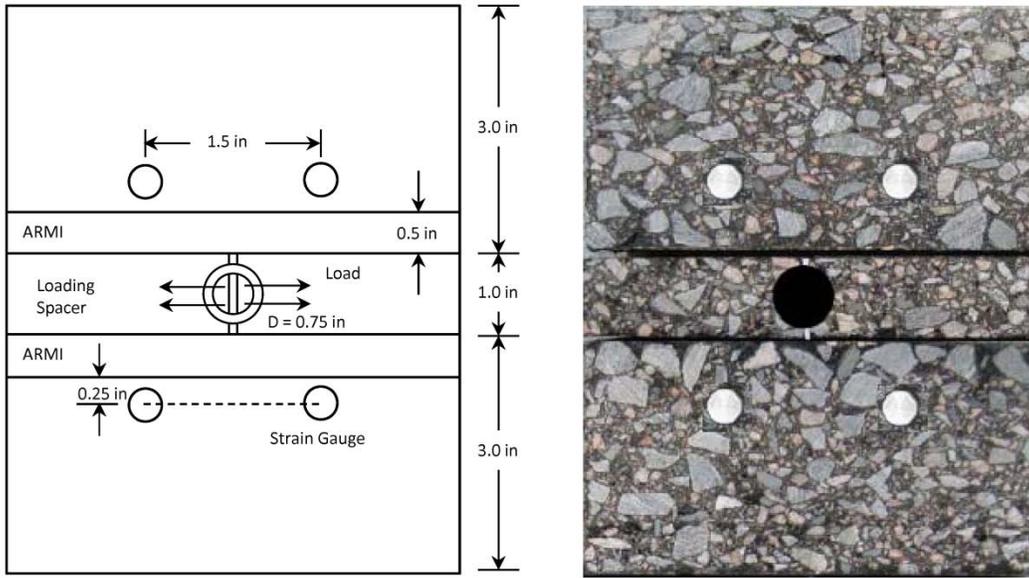
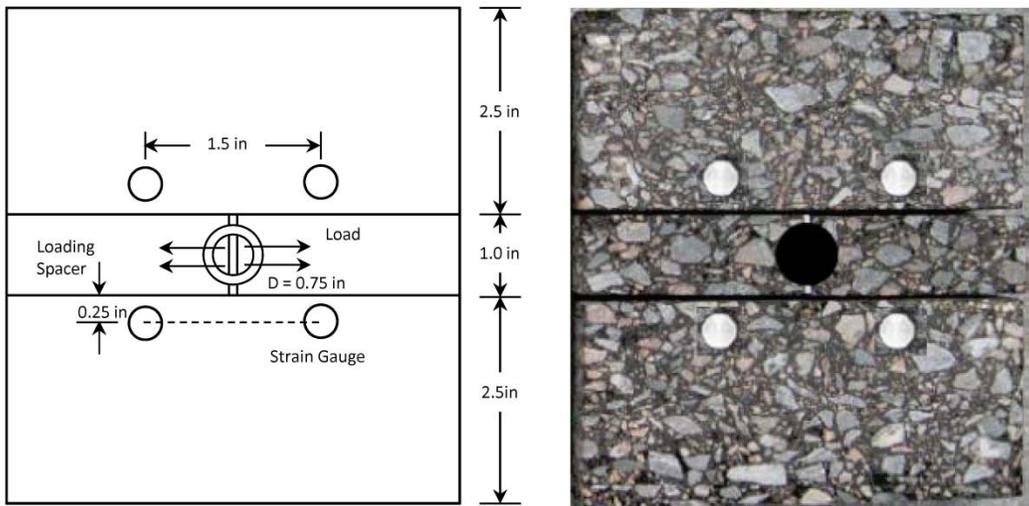
(a) Composite specimen with an ARMI layer.

(b) Composite specimen without an ARMI layer.

FIGURE 12 CSIC test specimens with and without an ARMI layer

The Composite Specimen Interface Cracking (CSIC) test recently developed at the University of Florida was used to evaluate the reflective cracking mitigation potential of the pavement sections constructed with and without an ARMI (17). The CSIC test was developed to simulate crack initiation and propagation of bonded interface conditions (18). The test monitors the damage rate (reduction in stiffness) on composite specimens subjected to repeated tensile loading. A complete description of the test procedure is presented elsewhere (17, 18). The CSIC tests were conducted with field cores obtained from the test tracks that included a 4 inch overlay with and without an ARMI. The cores were trimmed to remove the original existing asphalt pavement. A 1 inch layer was cut from the top parts of cores and used as central loading spacer. Two half specimens were epoxied to the central loading spacer to form a completely symmetrical composite specimen as shown in FIGURE 12. A Teflon spacer was introduced to represent an existing crack, which more effectively concentrated stress at the interface. A diamond-tip coring tool was used to create a 3/4-inch hole through which loading was applied. The specimen's curved ends were reinforced with carbon fiber to eliminate a potential bending failure.

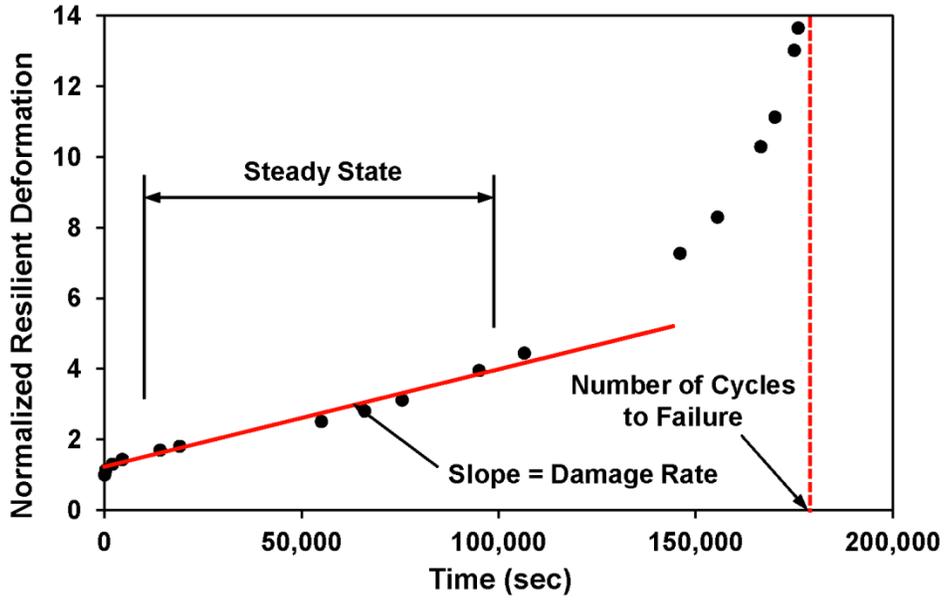
FIGURE 13 Typical recoverable deformation and damage rate.

such that damage and fracture developed gradually (i.e. not catastrophically) to optimize the ability to identify the effects of an ARMI layer on damage and fracture. To eliminate specimen-to specimen variations, recoverable deformation was normalized to its value at the beginning of the test. Since the recoverable deformation measurement is inversely related to the stiffness, the change in recoverable deformation can be used to monitor damage. FIGURE 13 shows a typical plot of a recoverable deformation versus time. FIGURE 14 summarizes the test results including the number of loading cycles to failure and damage rate. It was found that specimens without an ARMI generally exhibited better performance than specimens with an ARMI in terms of reflective cracking resistance. This type of performance matches the mixed field observations and suggests that an ARMI is often not effective in mitigating reflection cracks.

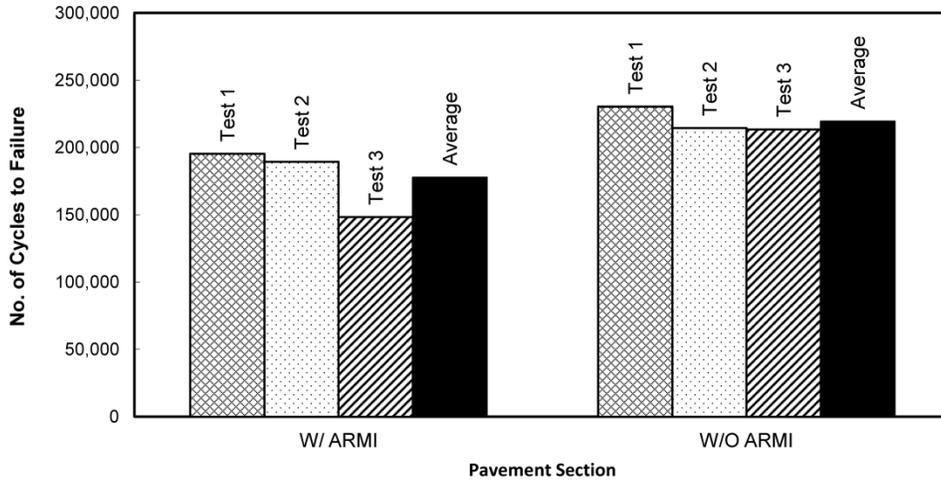
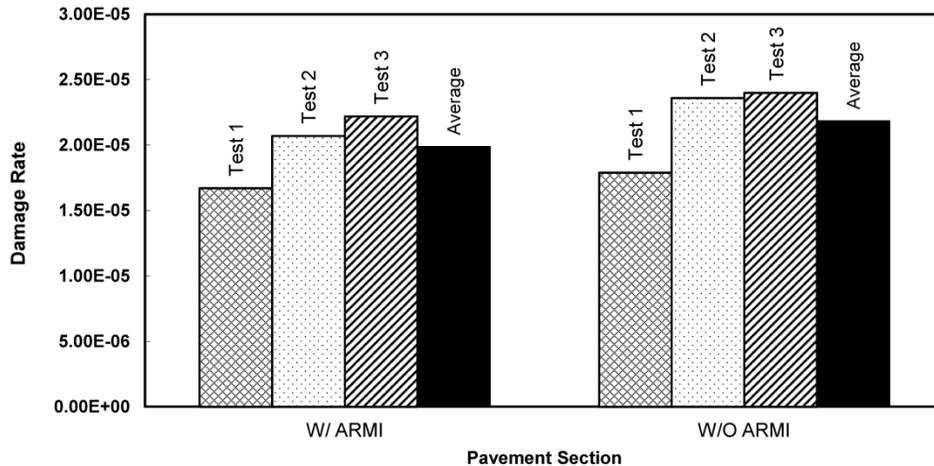
(a) Number of cycles to failure

(b) Damage rate

FIGURE 14 CSIC test results.
