State of Florida
Department of Transportation

**Evaluation of Soil Stabilized Columns Used
for Flexible Pavement Embankment
Support and Settlement Control**

State Materials Office

FL/DOT/SMO/13-561

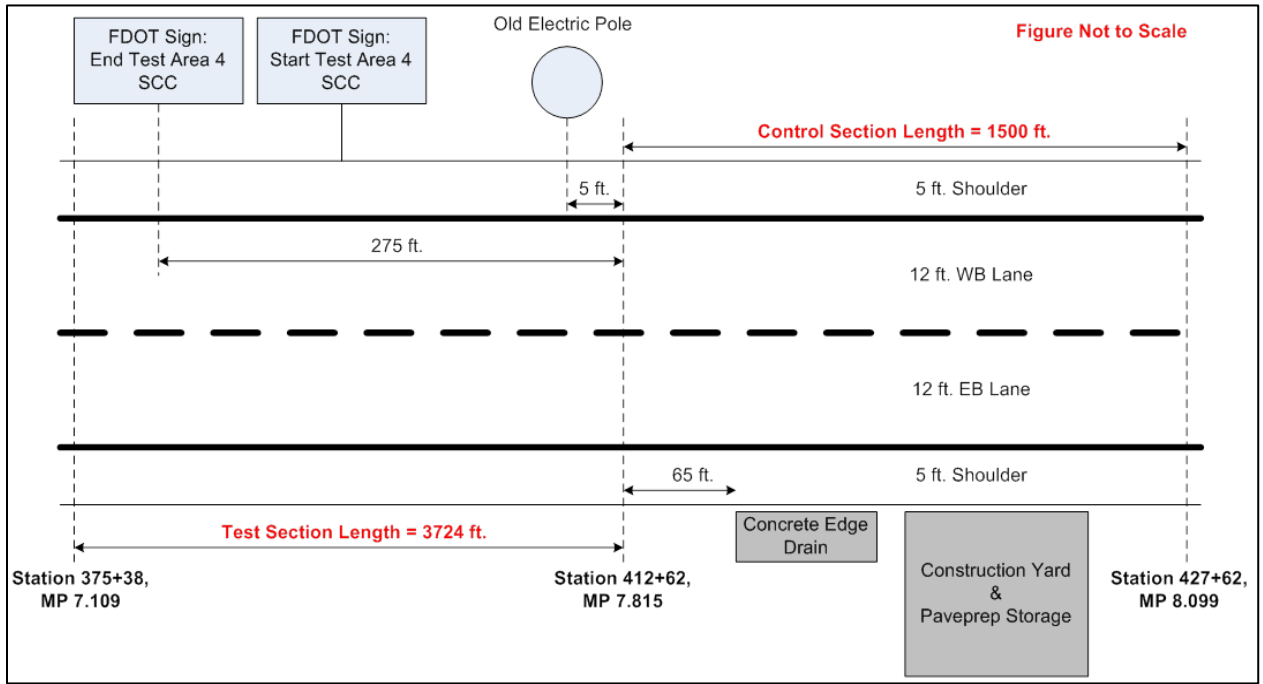
Figure 1 Section layout for SR-100 in Putnam County

SR-100 is a two-lane rural roadway in Putnam County with a history of settlement one mile east of Flora Home, between milepost 7.000 and 8.000, due to a 5 feet thick compressible peat layer located 6 feet below the pavement surface. Repeated patching of the asphalt surface over the years resulted in placement of more than 12 inches of asphalt, whereas the asphalt thickness of the surrounding area is approximately 5 inches. In 2011, a test section including Soil Stabilized Columns (SSC) and a high-strength geocomposite Stress Absorbing Membrane (SAM) also known as PavePrep was constructed in the Eastbound (EB) and Westbound (WB) lanes between mileposts 7.109 and 7.815 (i.e. between stations 375+38 and 412+62). A control section without SSC and SAM in the EB and WB lanes was also constructed between mileposts 7.815 and 8.099 (i.e. between stations 412+62 and 427+62). The layout of the project sections, schematic of grout columns arrangement and pavement structures are shown in Figures 1 through 3.

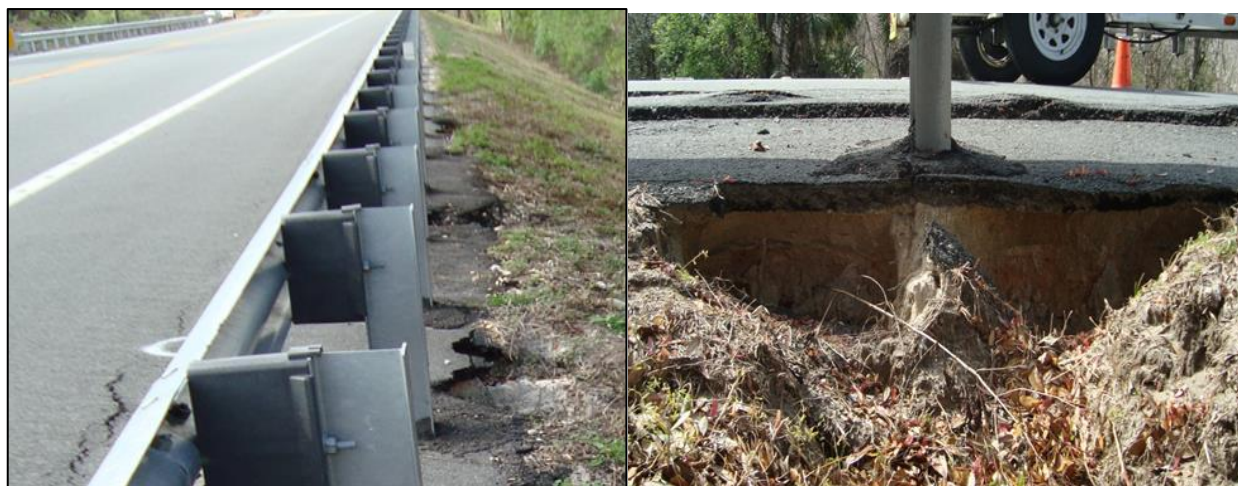
Figure 5 Unstable shoulder conditions

A visual field inspection was conducted to identify any observed condition(s) related to SSC effects on future pavement performance. Signs of pavement settlement around the SSC protrusions were noted in both the eastbound and westbound test sections. These protrusions were more evident in the shoulders than in the mainlines. Figure 4 shows the surface protrusions/deformations were observed in the westbound test section and paved shoulder. The severity and extent of deterioration of paved area and natural soil along the guardrails is illustrated in Figure 5.

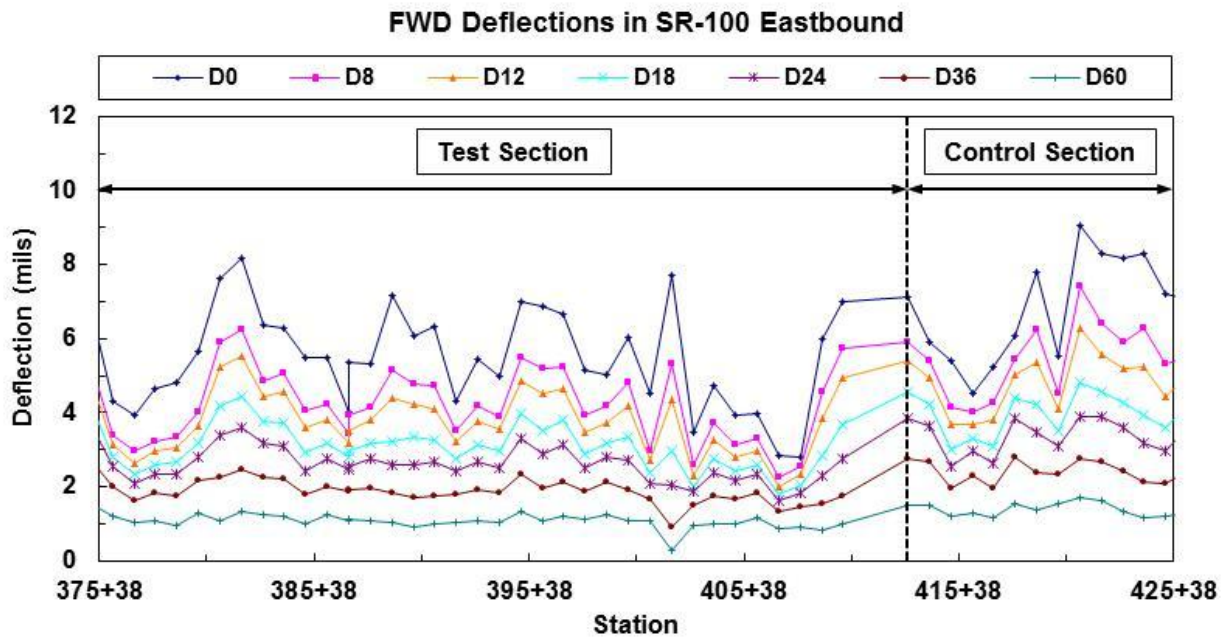
To evaluate pavement support response, a Falling Weight Deflectometer (FWD) was used to apply an impact load onto the pavement surface, which is similar in magnitude and duration to a single moving truck wheel load. Seven geophone sensors placed at preset distances from the center of the loading plate along the pavement surface measure the pavement deflection. Figures

6 and 7 show the deflections measured in the eastbound and westbound lanes of SR-100 project section on January, 2013, respectively.

The relative stiffness of a pavement system may be inferred through the determination of several different deflection parameters. Deflections measured near the load plate are primarily influenced by the response of the pavement layers and near the surface, while deflections measured further from the load

plate are indicative of subgrade and embankment response. Therefore, portions of the FWD deflection basin may be used to estimate the relative stiffness of individual layers. Table 1 summarizes these deflection parameters, while Table 2 summarizes the design embankment modulus and pavement surface temperature obtained from the latest (i.e.; 2013) and previous FWD surveys.

The results in Table 1 and Table 2 indicate that deflection response of the upper layers (i.e. asphalt and base layers) tend to fluctuate with temperature. The results also show that the SSC and PavePrep SAM treated test section provided relatively higher stiffness to the overall pavement system indicated by lower deflections and higher embankment moduli compared to the non-treated control section.

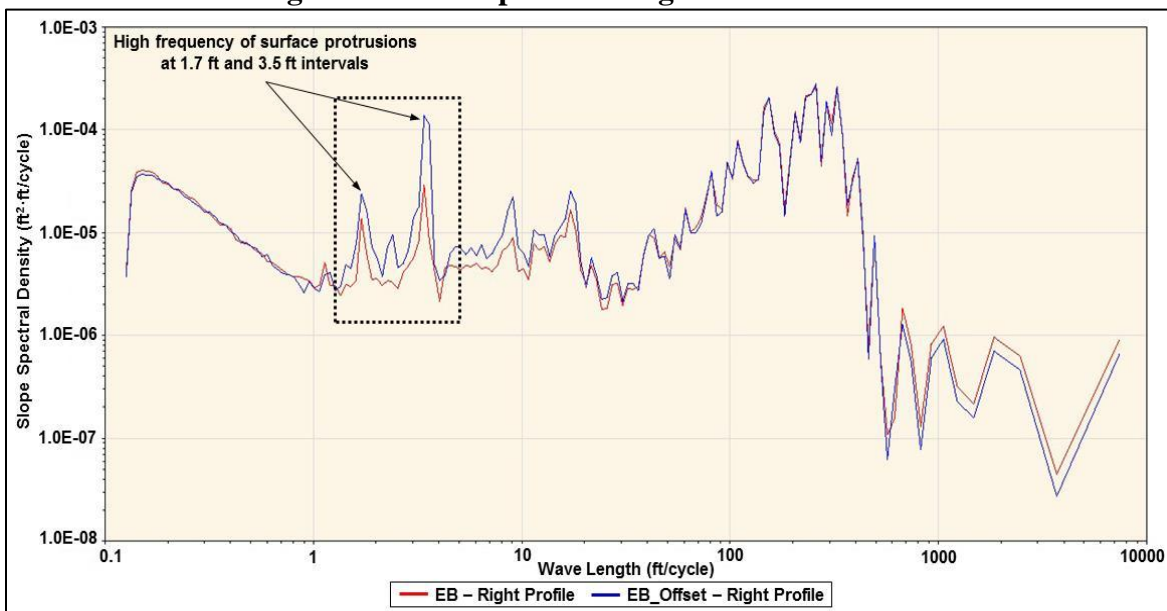
(a) Eastbound right profile

(b) Westbound right profile

Figure 8 Surface protrusions depicted by higher frequency of short wavelength features

generally smooth and comparable for test and control sections. However, lower ride quality was obtained over the deformations offset from the wheelpaths (EB_Offset and WB_Offset) represented by lower RN and higher IRI, with the lowest numbers in the RWP. The surface deformations offset from the wheelpaths resulted in increased pavement roughness. This is further verified by the Power Spectrum Density (PSD) plots in Figure 8 showing a higher frequency of 1.7 feet and 3.5 feet wavelength features, which appear to correspond to the spacing of surface protrusions and grout columns. The difference in profile elevations in the EB and WB eastbound shown in Figure 9 further illustrate the effect of these surface protrusions on ride quality. In general, the measured rut depths were not significant (i.e. less than 0.1 inch for both test and control sections) but relatively higher in the test section compared to the control section.

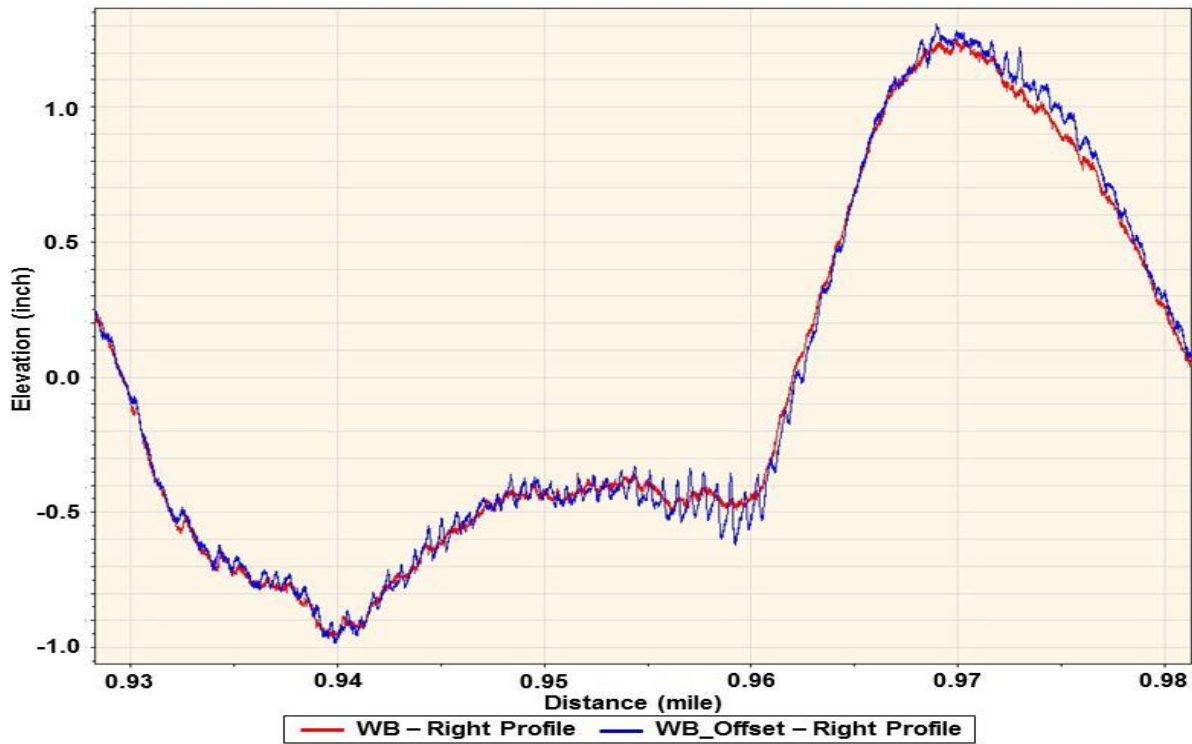
(a) Eastbound right profile

(b) Westbound right wheelpath profile

Figure 9 Test section sample profile elevation in right wheelpath and offset from right wheelpath

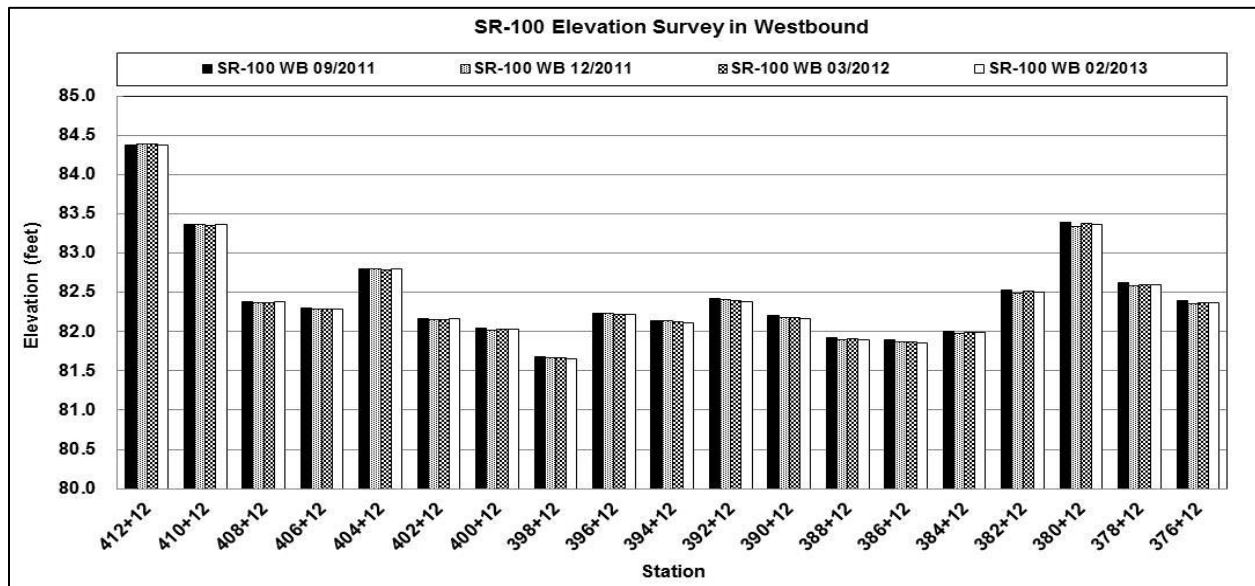
Figure 11 Elevation measurements of SR-100 westbound

Elevation measurements using stadia rod and level were performed to determine whether the roadway continued to settle after the installation of SSC and PavePrep SAM. Figures 10 and 11 show the elevation measurements in the center of each lane for the eastbound direction and westbound direction, respectively.
