REHABILITATION OF ELLAVILLE WEIGH STATION WITH ULTRA-THIN WHITETOPPING

FL/DOT/SMO/99-429

April 1999

STATE MATERIALS OFFICE

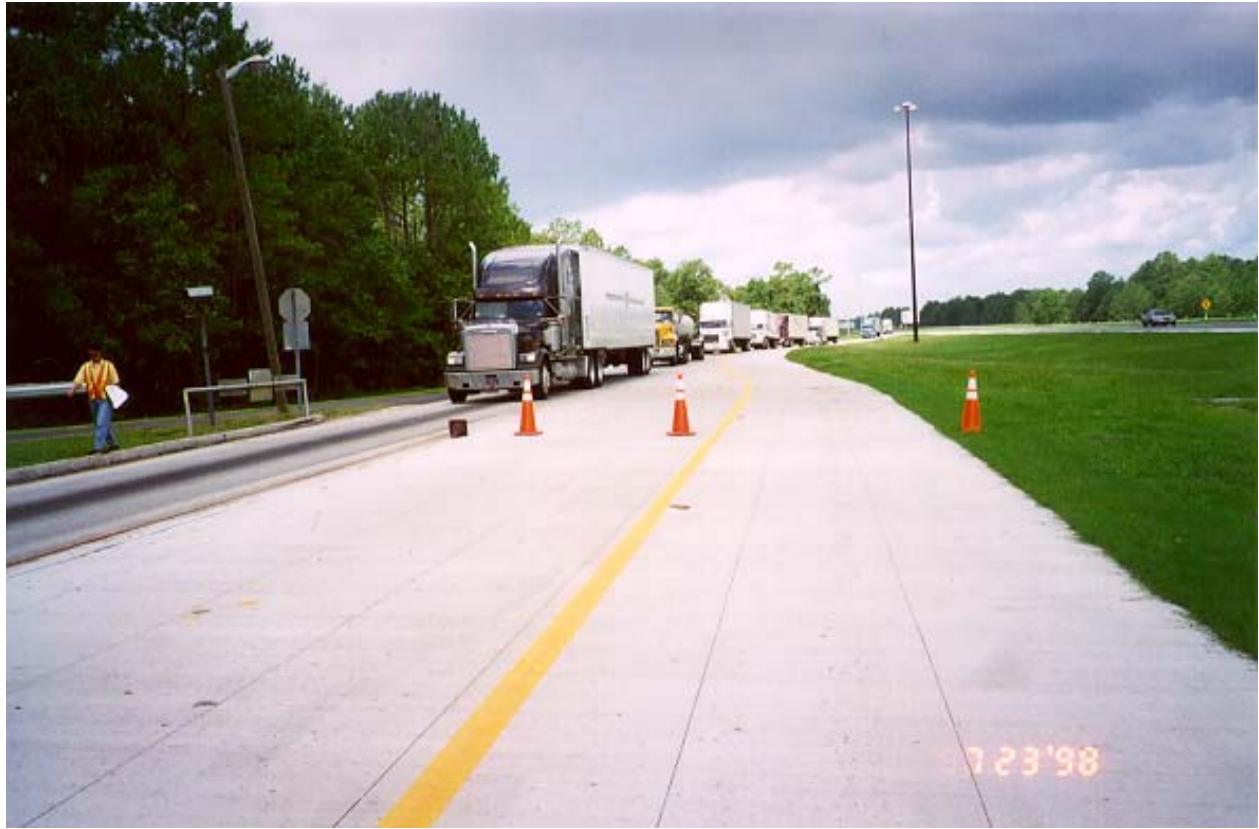
Figure 2 - View of the UTW at Ellaville Weigh Station

The weigh station was opened to truck traffic on December 17, 1997. Figure 2 is a view of the Ellaville Weigh Station showing a sample of the heavy truck traffic through the station. On average, more than 1430 trucks pass through the station each day. With such a high traffic volume

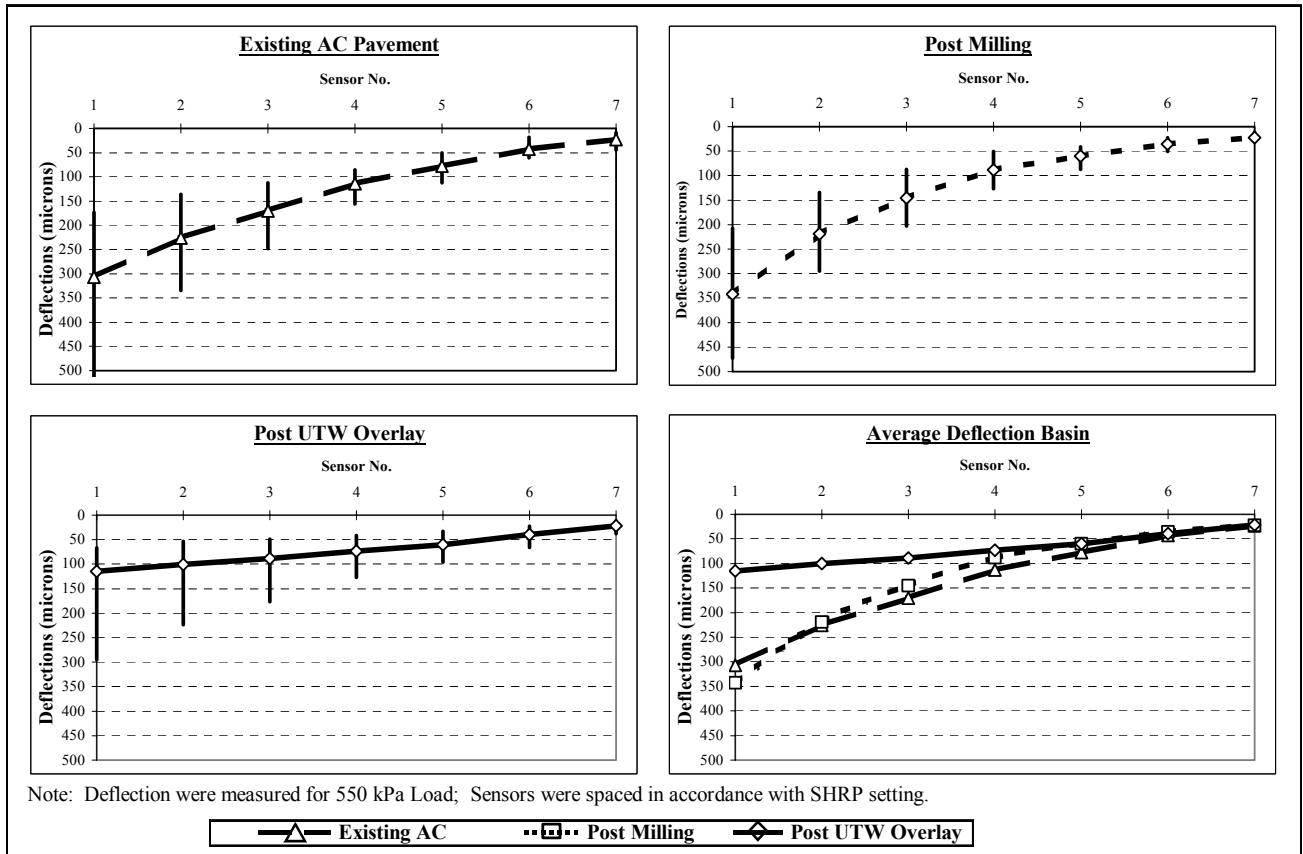
Figure 3 - FWD Deflections

The FWD tests were performed on the surface of the UTW at the same test spots as the previous tests on the original and the milled asphalt surfaces. This test pattern provided a direct comparison between the deflections on the three surfaces. Figure 3 shows the range and the average deflection measurements by the seven sensors of the FWD for the three surfaces. Average deflection basins for the three layers is also shown in Figure 3. It is evident that the deflections on the UTW were significantly lower than the deflections on the original and milled asphalt pavements. Table 6 shows the change in deflection in reference to the original asphalt layer as measured by FWD sensor number one. The average deflection was increased by 12 percent after milling the pavement.

However, after placement of the UTW, the deflection decreased by 63 percent, suggesting dramatic improvement in the load carrying capacity of the monolithic and composite UTW-asphalt pavement. After six months the FWD tests were repeated on the original test spots. The deflections were still 56 percent lower than what they were on the original asphalt layer. This indicates that the pavement is still acting as a composite of two bonded layers with sufficient support to carrying the high volume and heavy trucks.

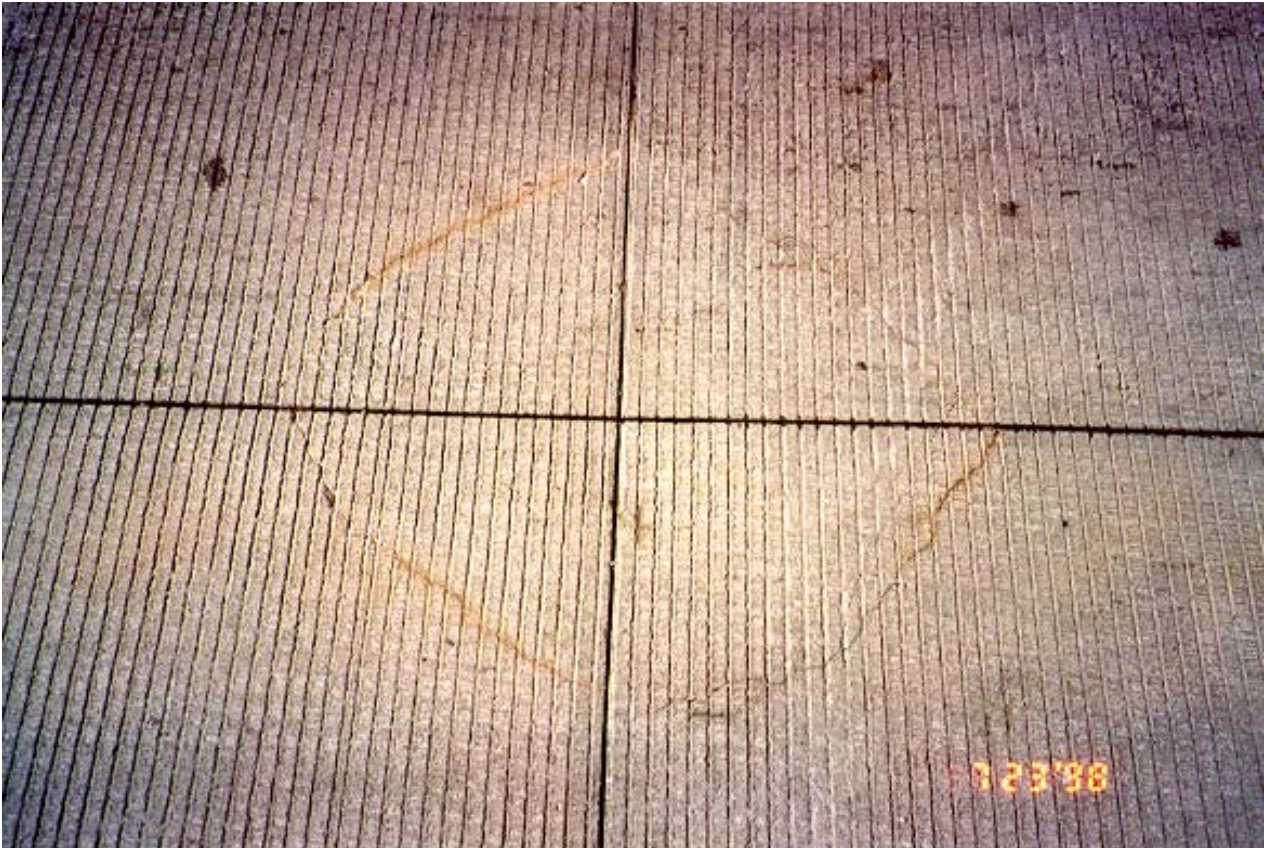
Figure 4 - Diamond Cracking

section and location (traffic lane, shoulder, bypass or parking). All the cracks which were observed prior to opening to traffic were on the shoulder or parking areas. These were hairline cracks running along the joint groove. Almost all cracks observed on the July 23, 1998 survey were corner cracks. These corner cracks are most likely due to delaminations at the interface between the asphalt surface and the UTW. The most likely cause for of these delaminations is delayed joint sawing, which allowed the concrete layer to curl at a very early age when the bond with the asphalt had not been sufficiently developed. Figure 4 shows diamond shaped cracking formed by corner cracks of four panels. This was a typical cracking pattern on 8 consecutive clusters of panels close to the exit. A review of the record indicated that these panels were the last to be saw cut.
