Optimizing the Use of Thermal Integrity System for Evaluating Auger-Cast Piles

Presented by:
Kevin R. Johnson, MCE

USF UNIVERSITY OF
SOUTH FLORIDA

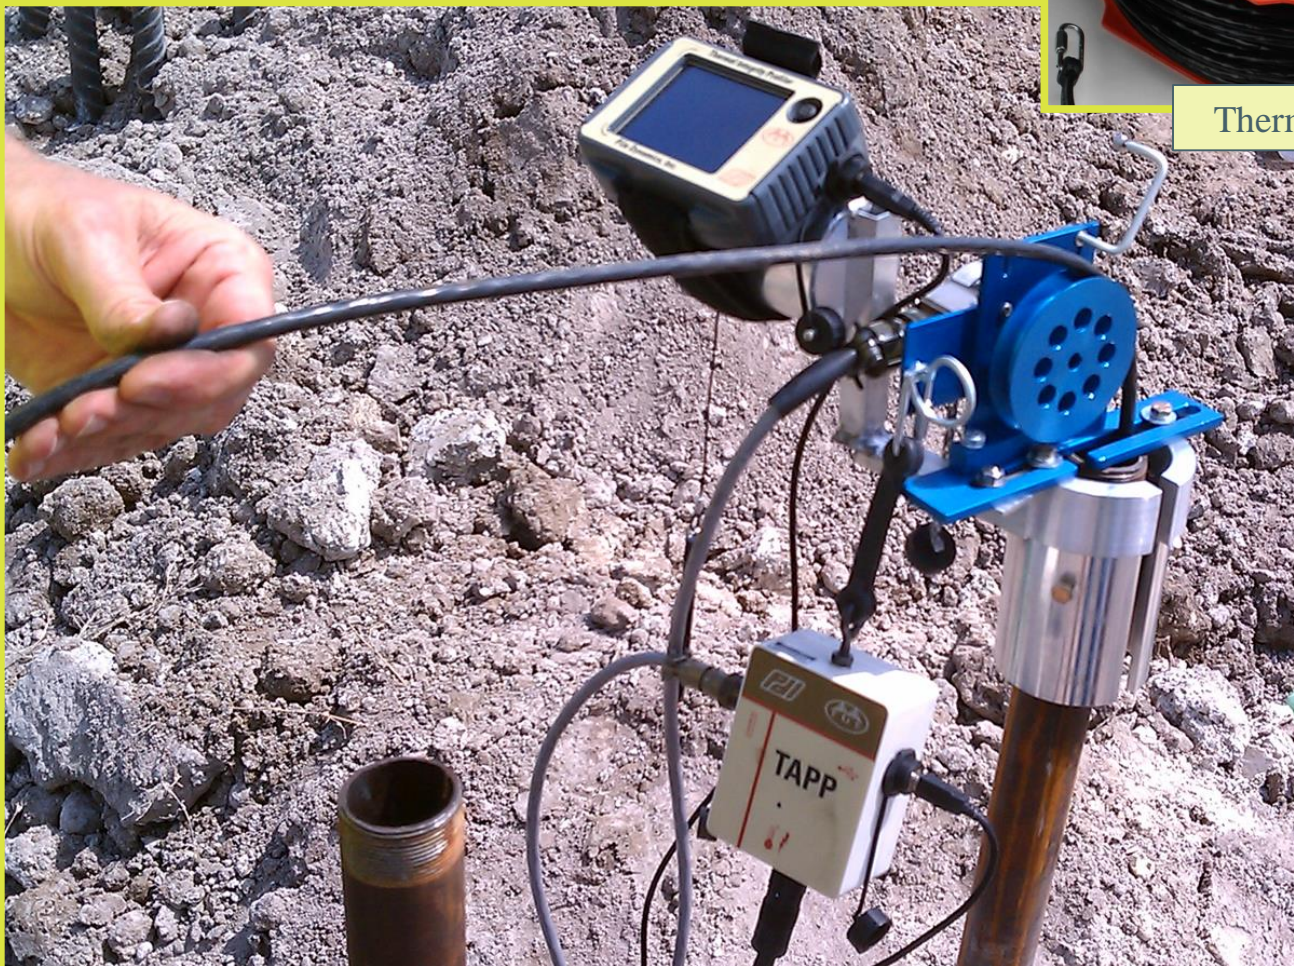
Thermal Probe w/ Infrared Sensors

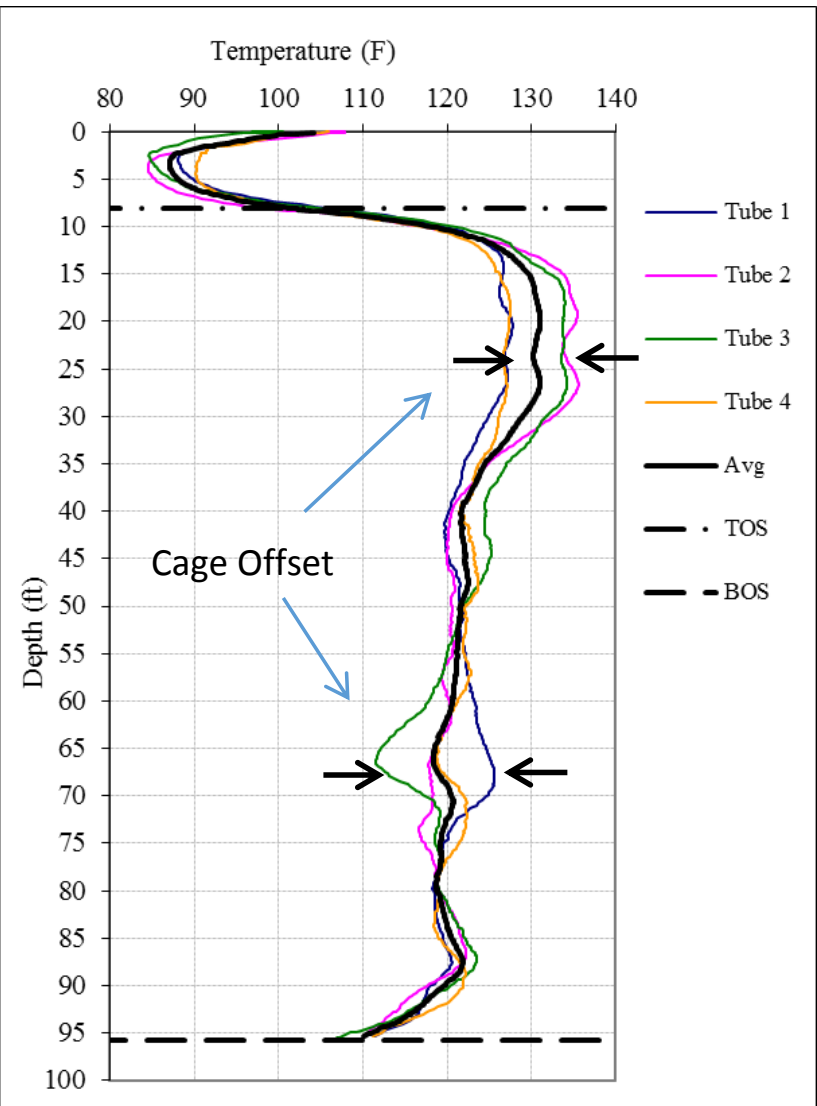
Level 1: Direct observation of the temperature profiles.

TIP Analysis - Direct Observation

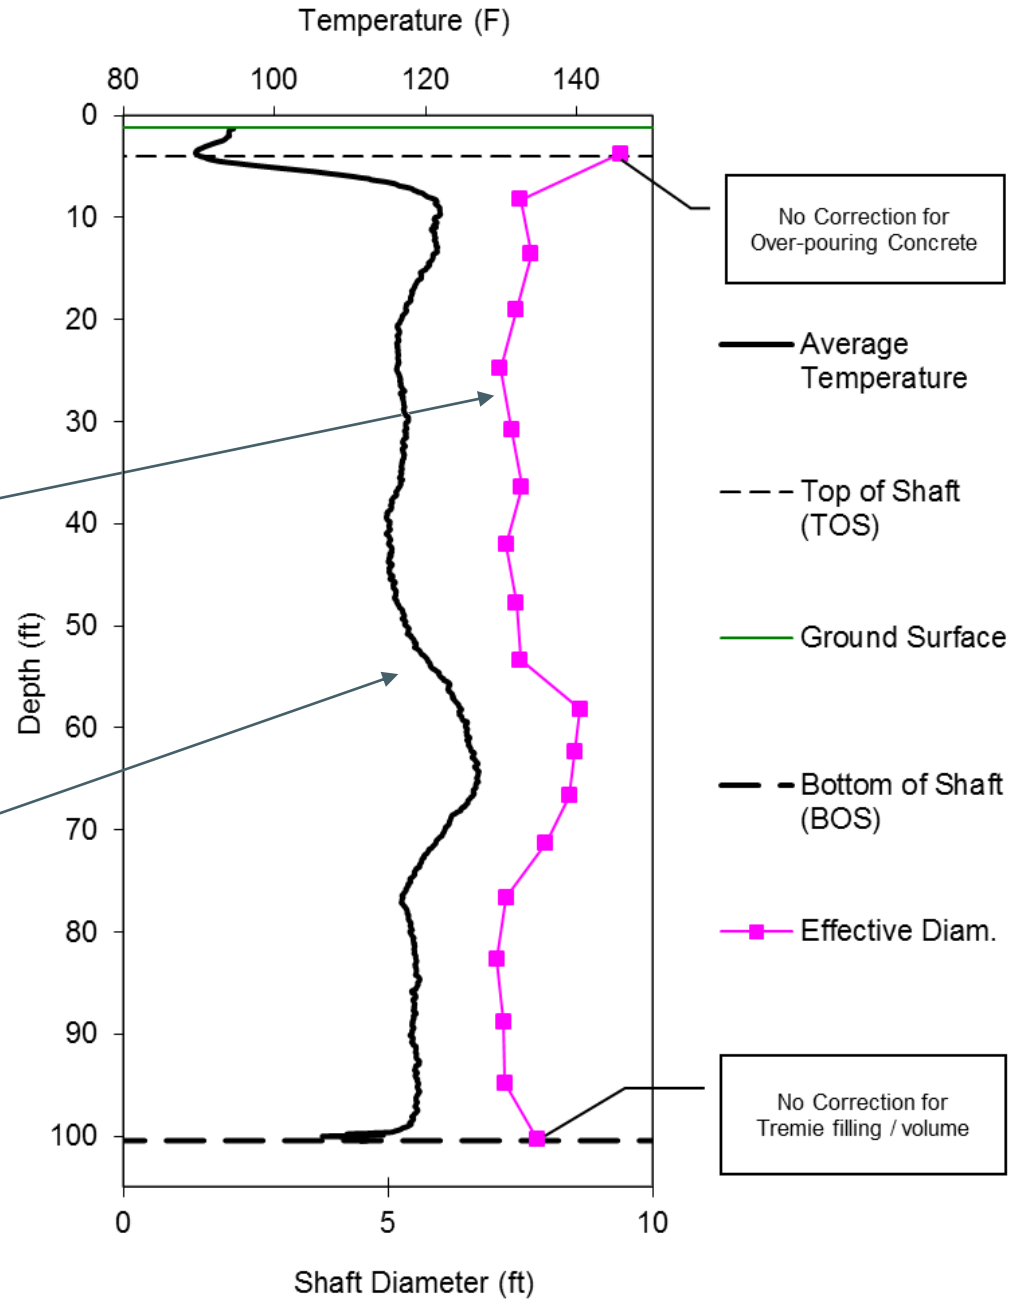
Yield plot converted to effective diameter vs. depth

Measured temperature profile

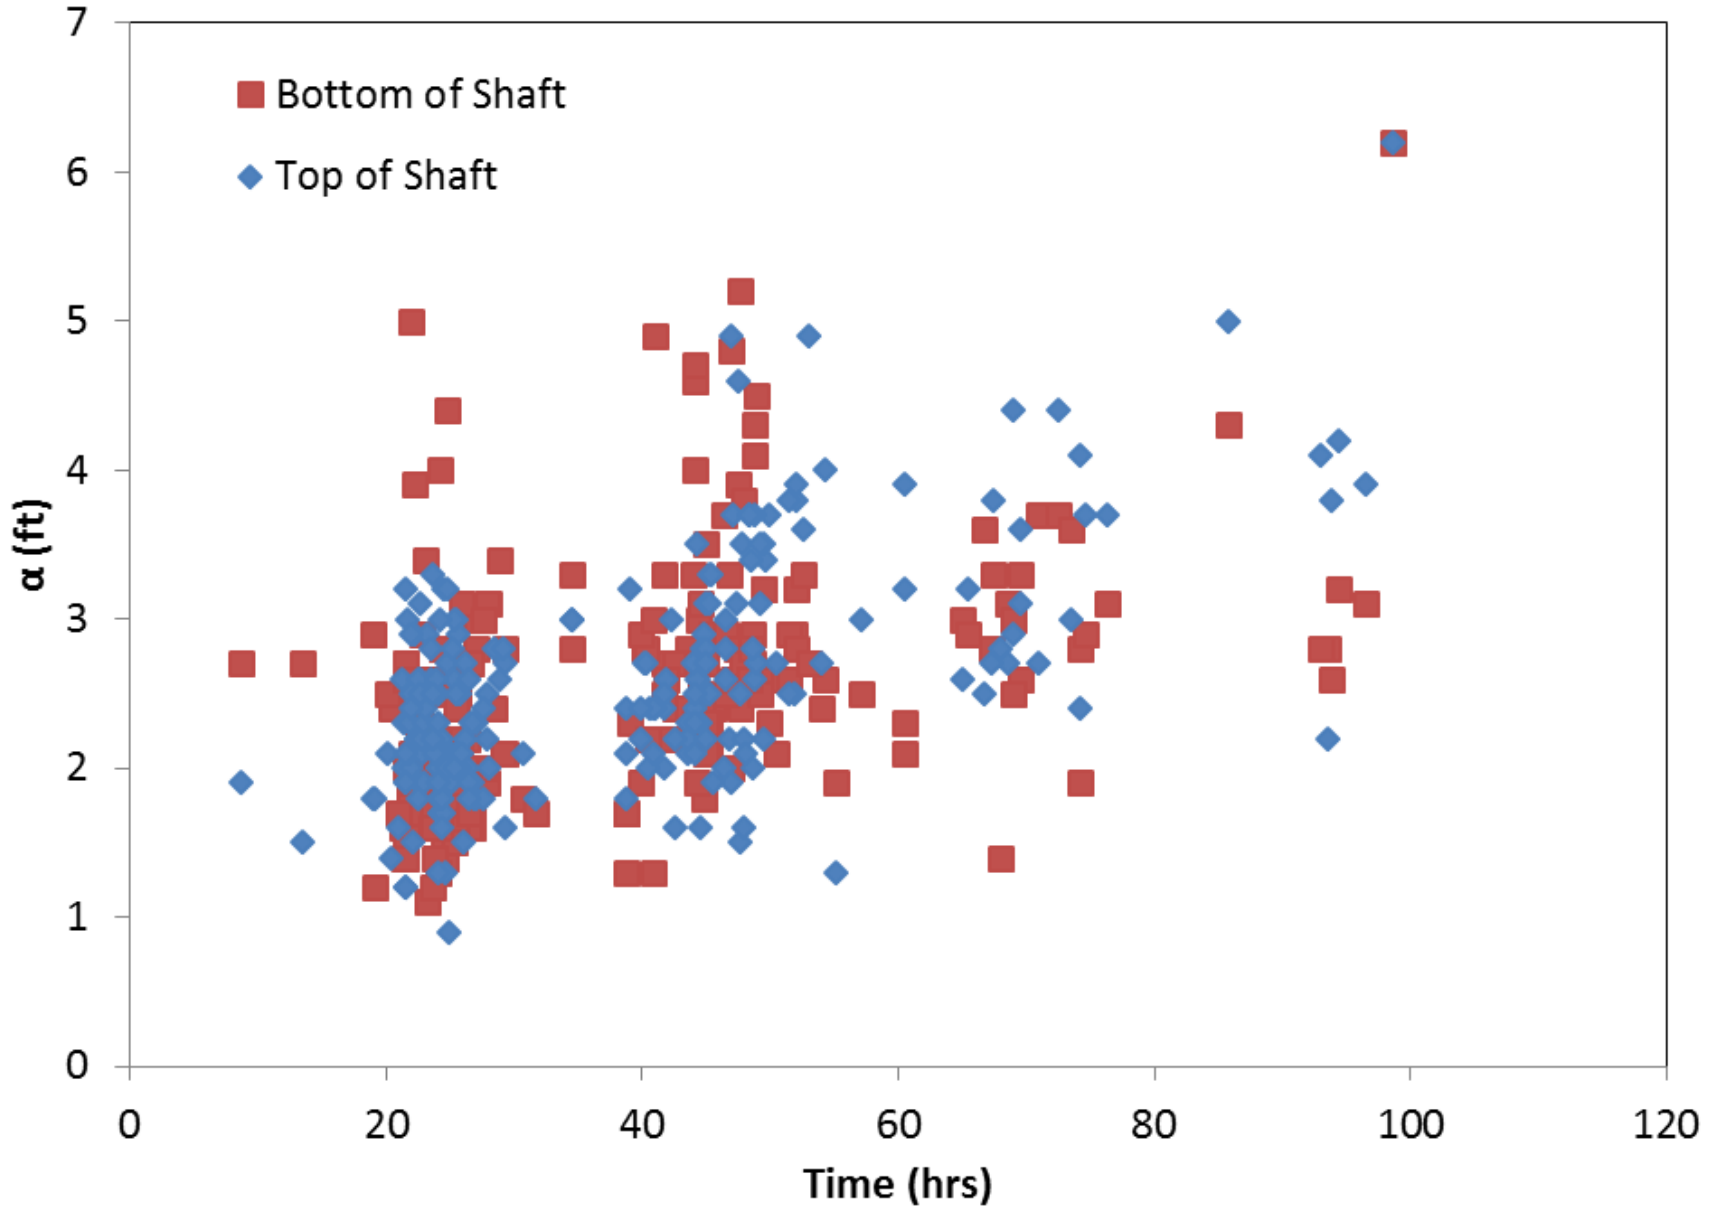
α vs. time of testing

$$\alpha = c\sqrt{t}$$

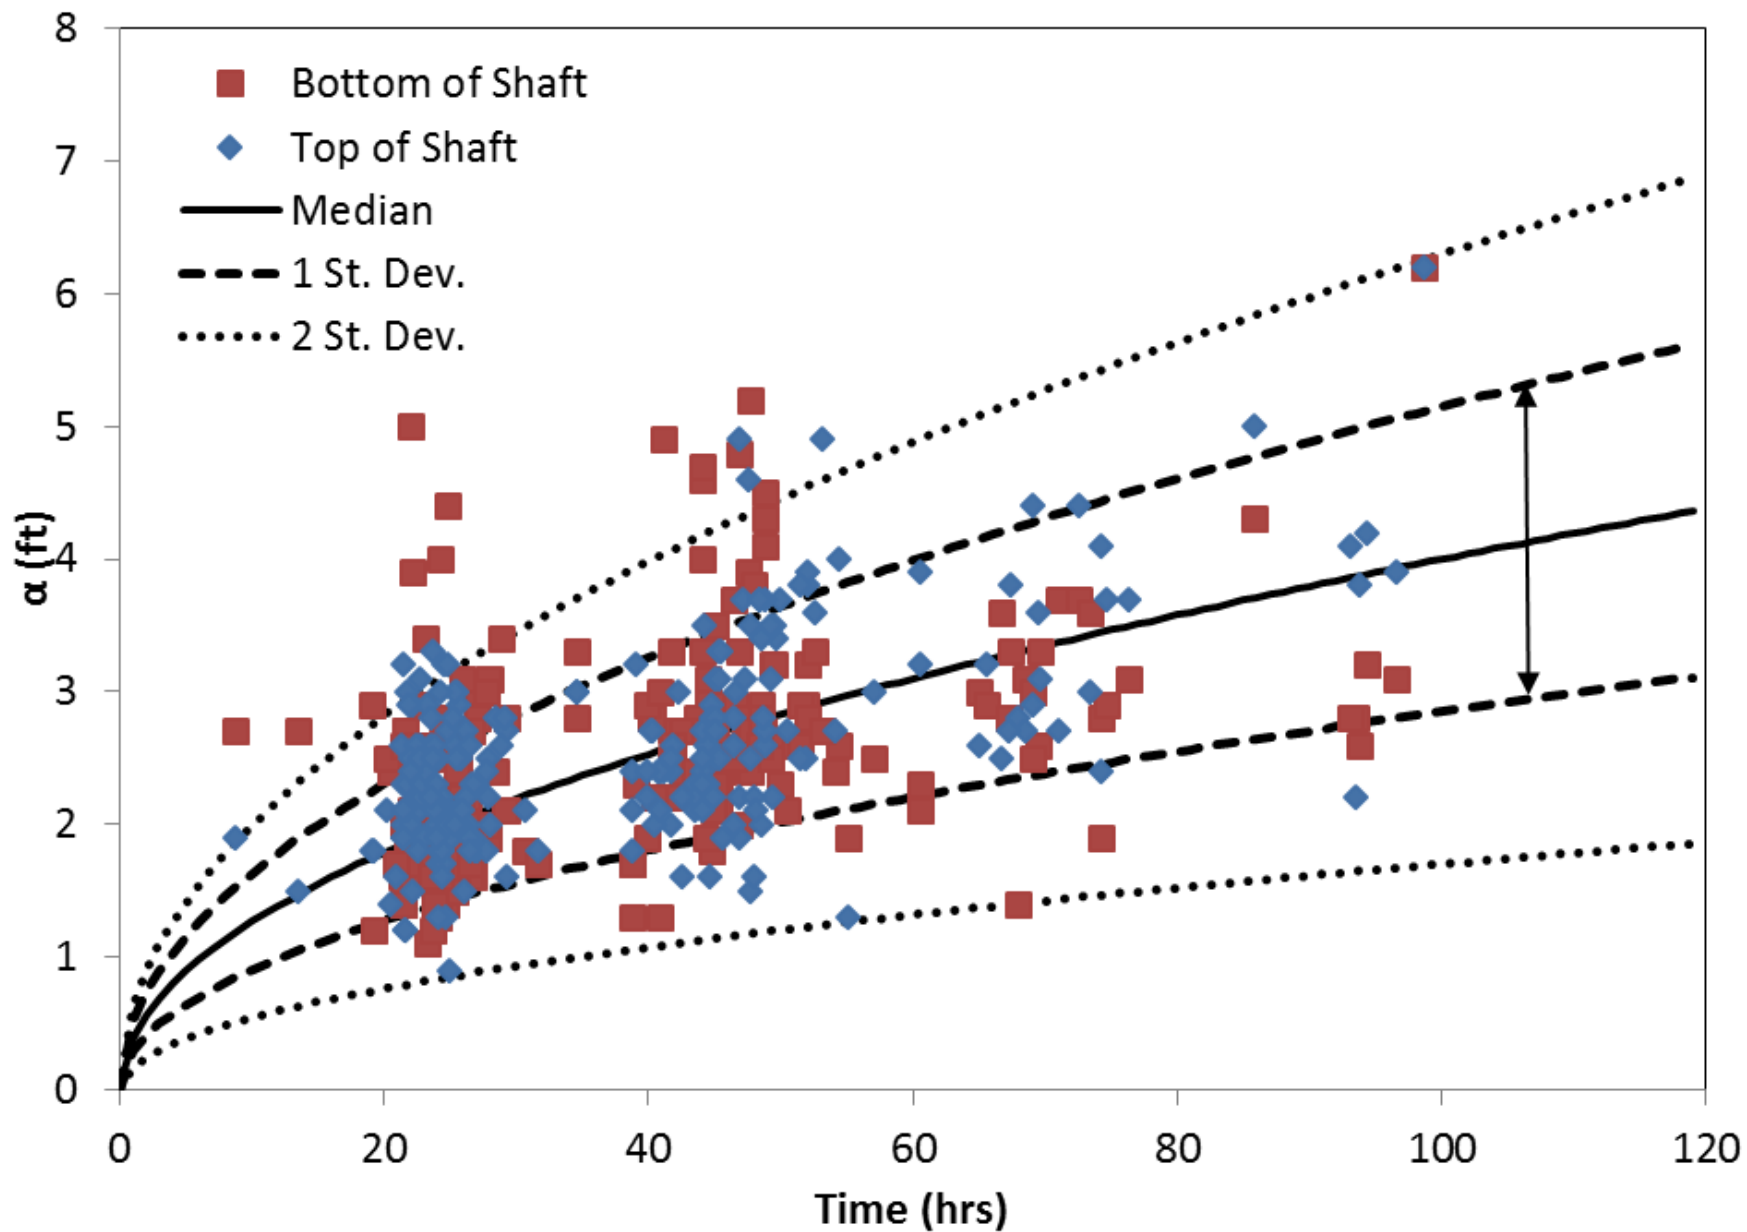
$$\alpha = 0.4\sqrt{t}$$

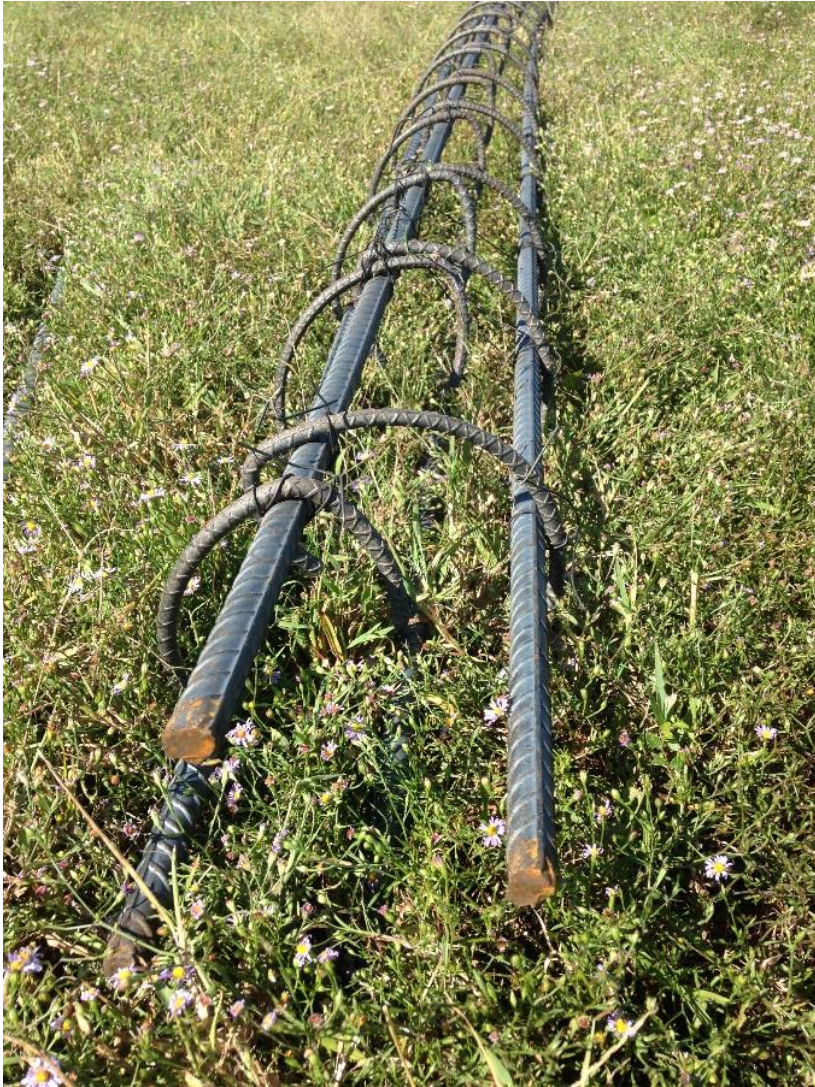
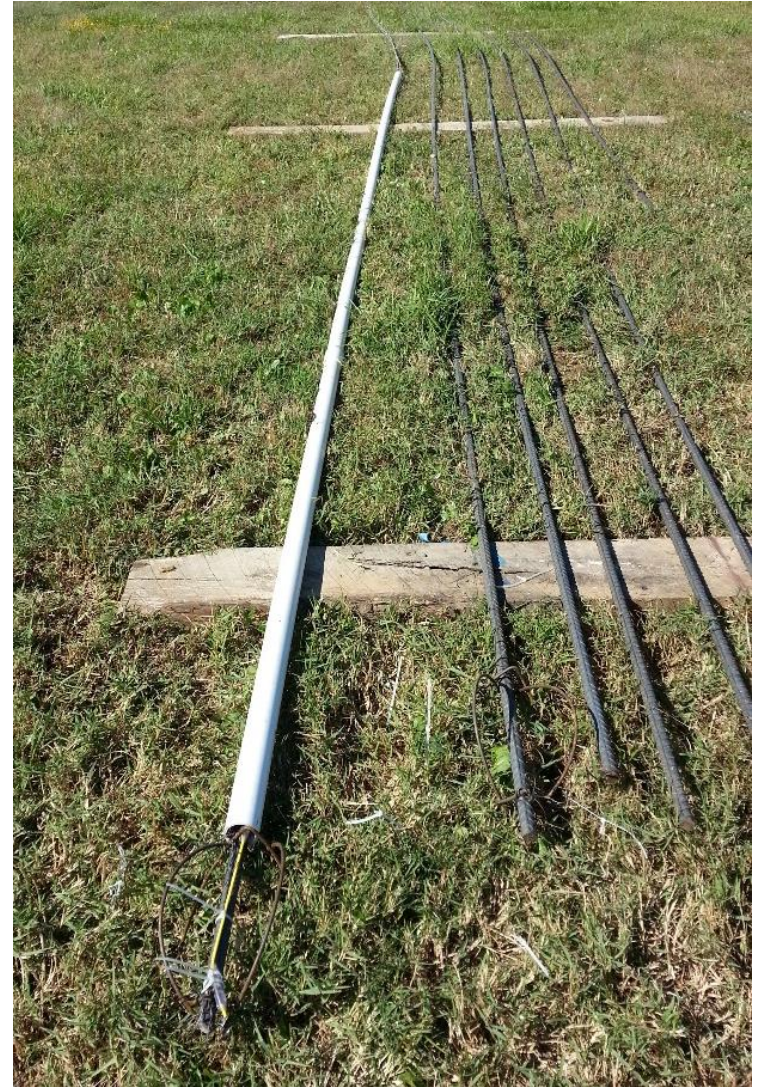
Case Study: 14" ACIP piles with a single wire on single center bar

Of 14 piles instrumented, 3 experienced complete data loss and 4 produced only partial data, likely due to damage from internally protruding hooks on the upper reinforcing cage. All other piles yielded reasonably straight profiles with little to no indication of bar movement.

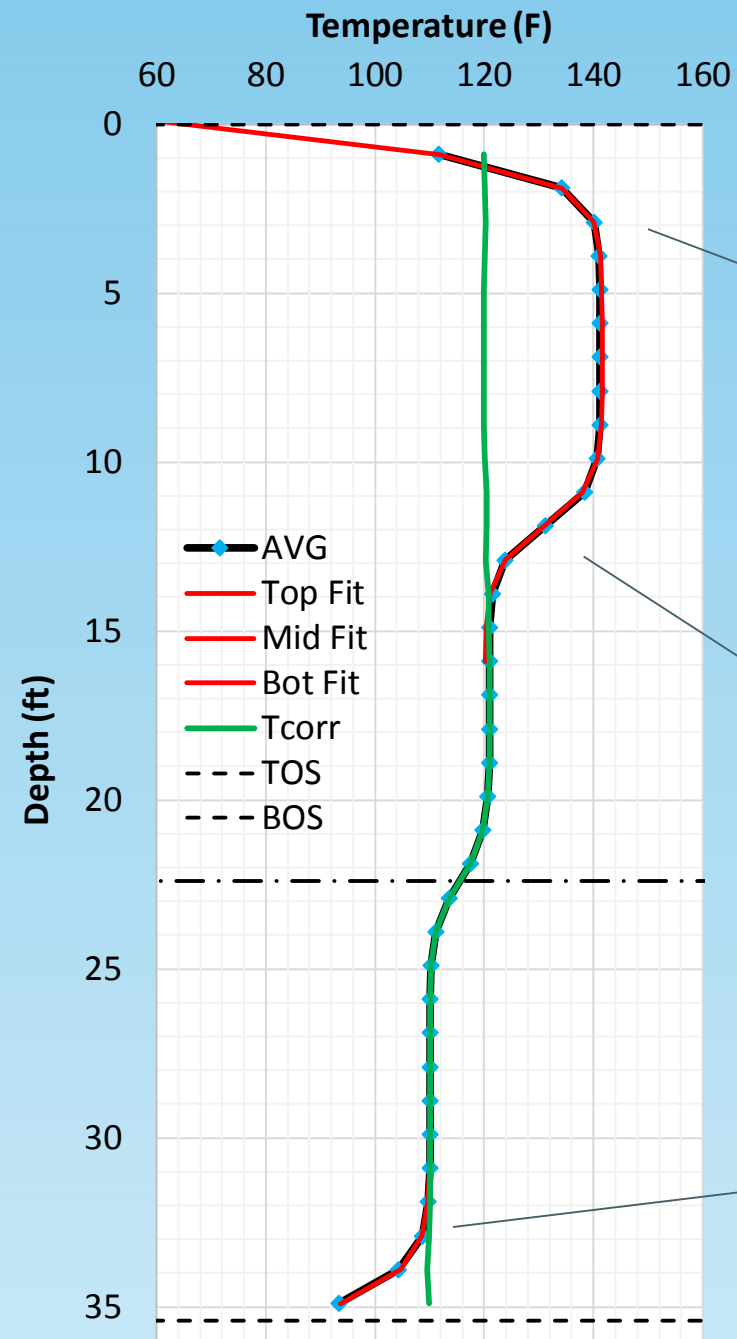
Top Roll-off

$Z_0 = 0$ ft
 $T_{\max} = 141.6$ °F
 $T_0 = 66.3$ °F
 $\alpha = 1.28$

Soil Transition

$Z_0 = 11.9$ ft
 $T_{\max} = 141.6$ °F
 $T_{0\min} = 120.2$ °F
 $\alpha = 1.25$

Bottom Roll-off

$Z_0 = 35.4$ ft
 $T_{\max} = 110$ °F
 $T_{\min} = 60$ °F
 $\alpha = 1.4$

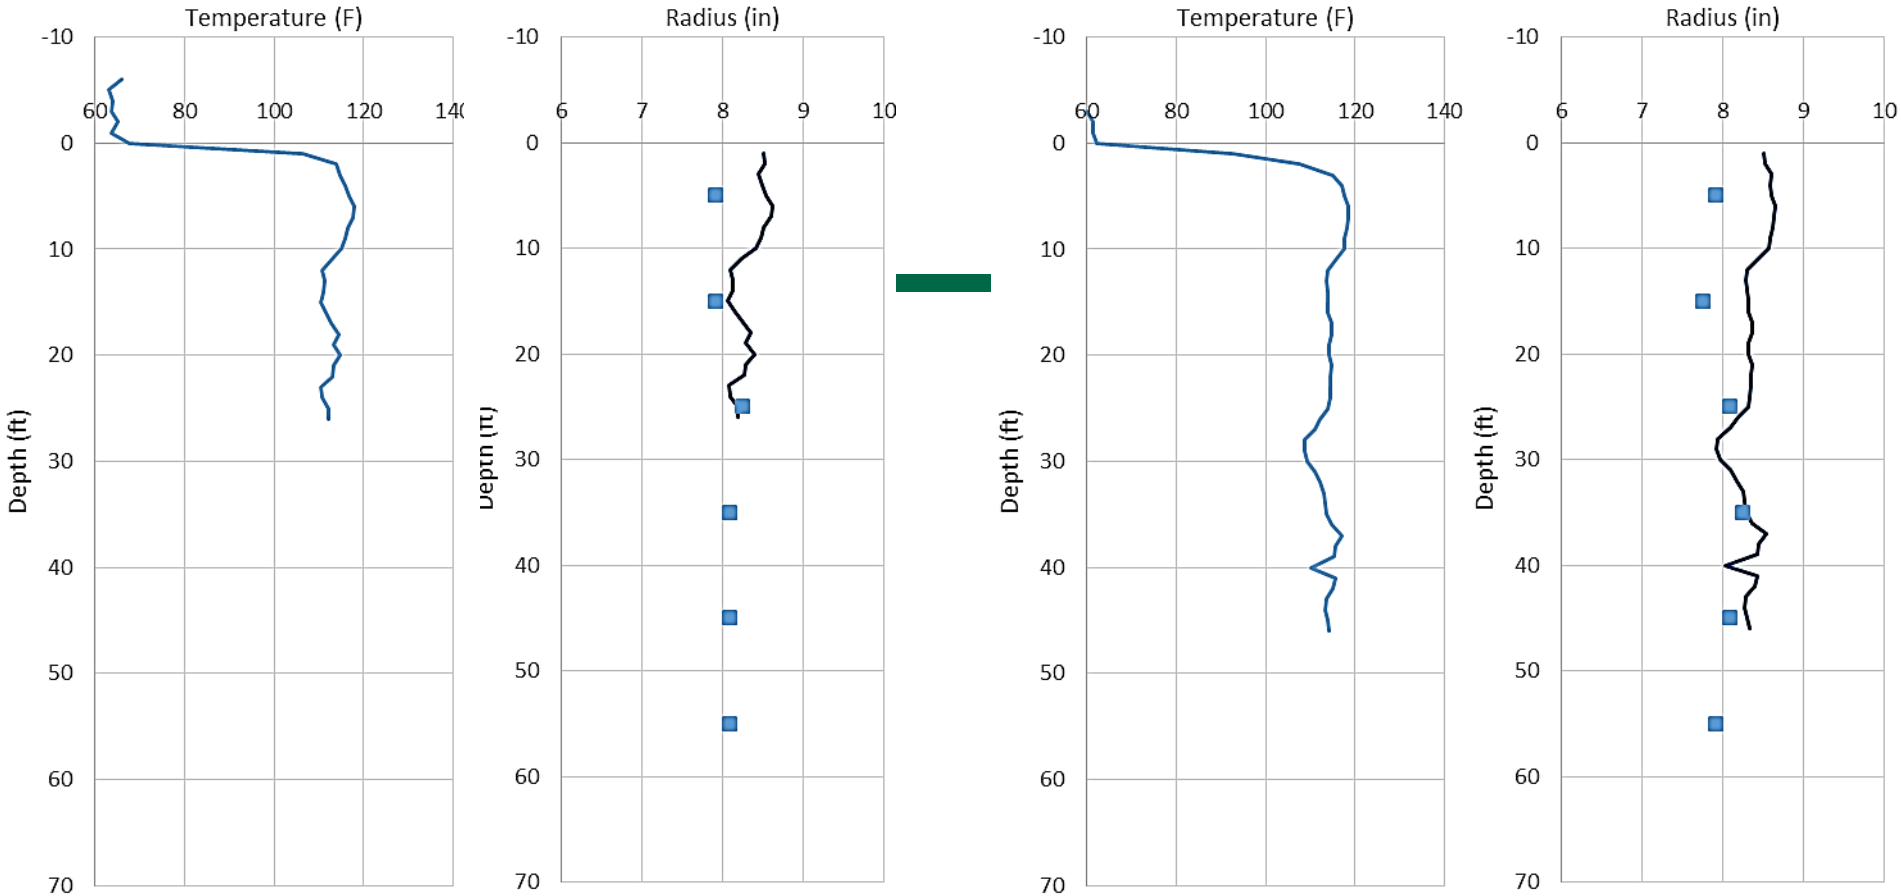
- Thermal data only shows top of pile which appears normal
- Only subtle variations in temperature versus depth for first 25ft (left) and 45ft (right); no bar inclination evident
- Pump stroke computed radius generally agrees with predicted radius
- Integrity assessment unsuccessful; broken wire prevented full analysis

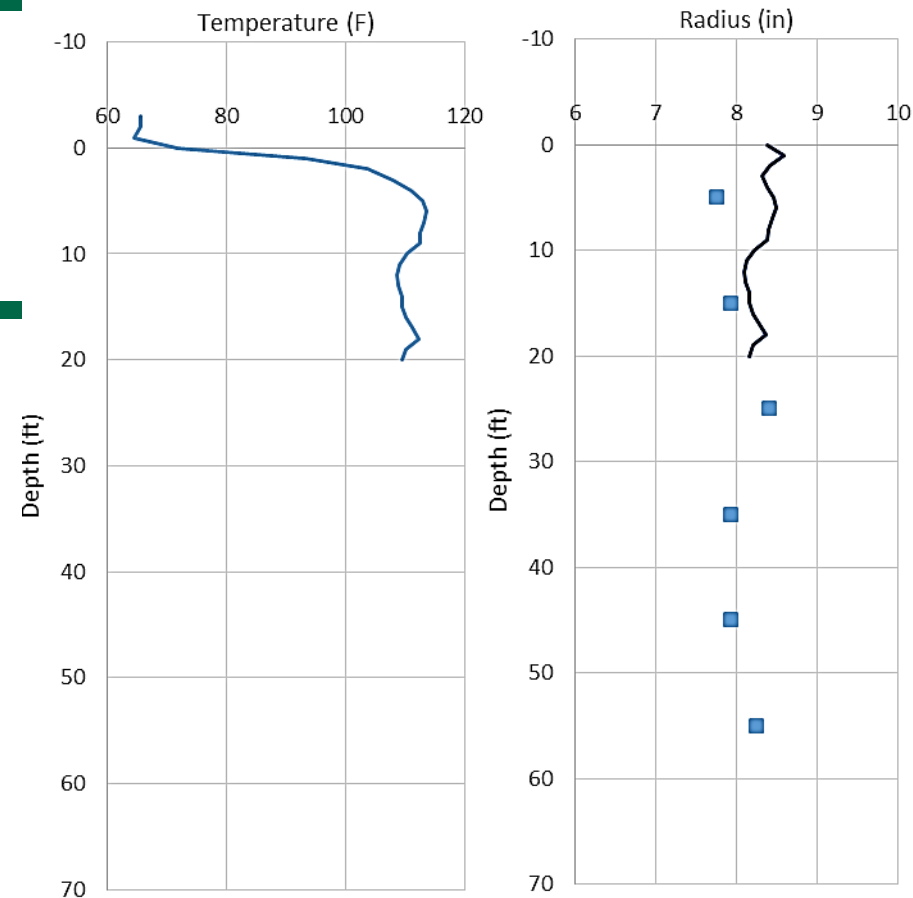
- Thermal data only shows top of pile which appears normal
- Only subtle variations in temp vs depth for first 20ft; no apparent bar inclination over that depth
- Pump stroke computed radius versus predicted radius inconclusive
- Integrity assessment unsuccessful; broken wire prevented full analysis
