# THERMAL INTEGRITY PROFILING FOR AUGERED CAST-IN-PLACE PILES - *IMPLEMENTATION PLAN*

*BDV25 977-34*

*GRIP 2017*

*Presented by Kevin Johnson, PhD*

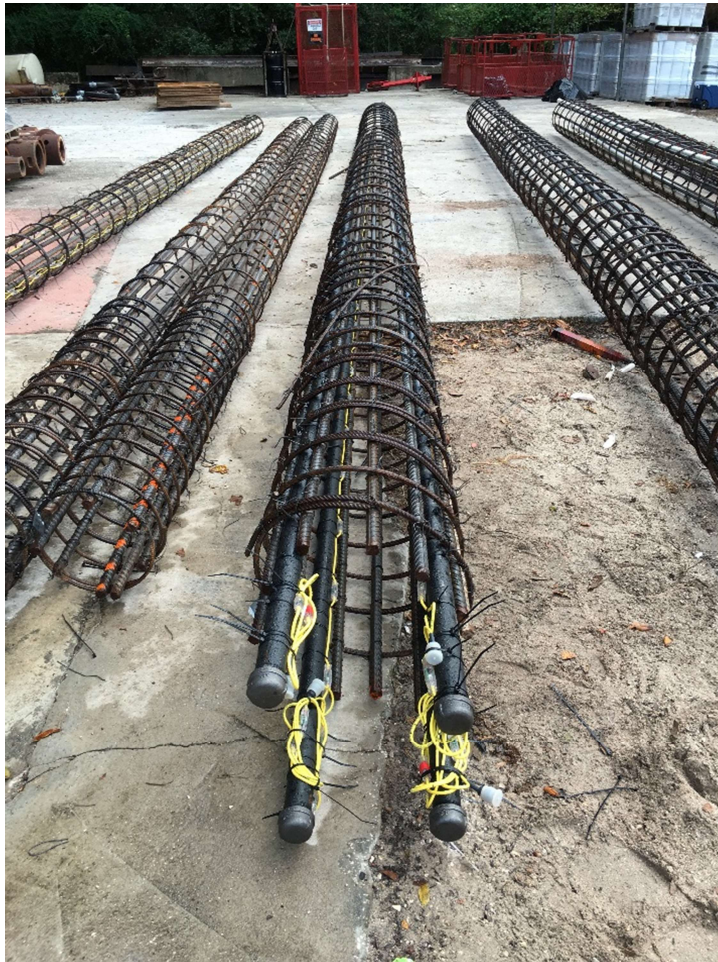
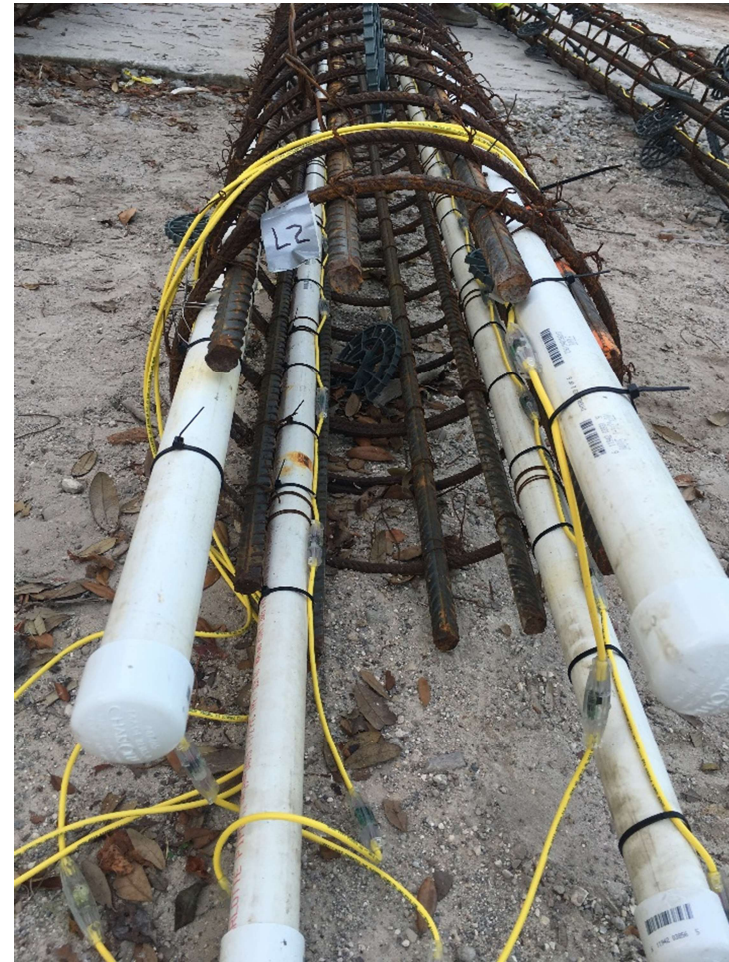
C-2 24in (left) L-2 24in (right)

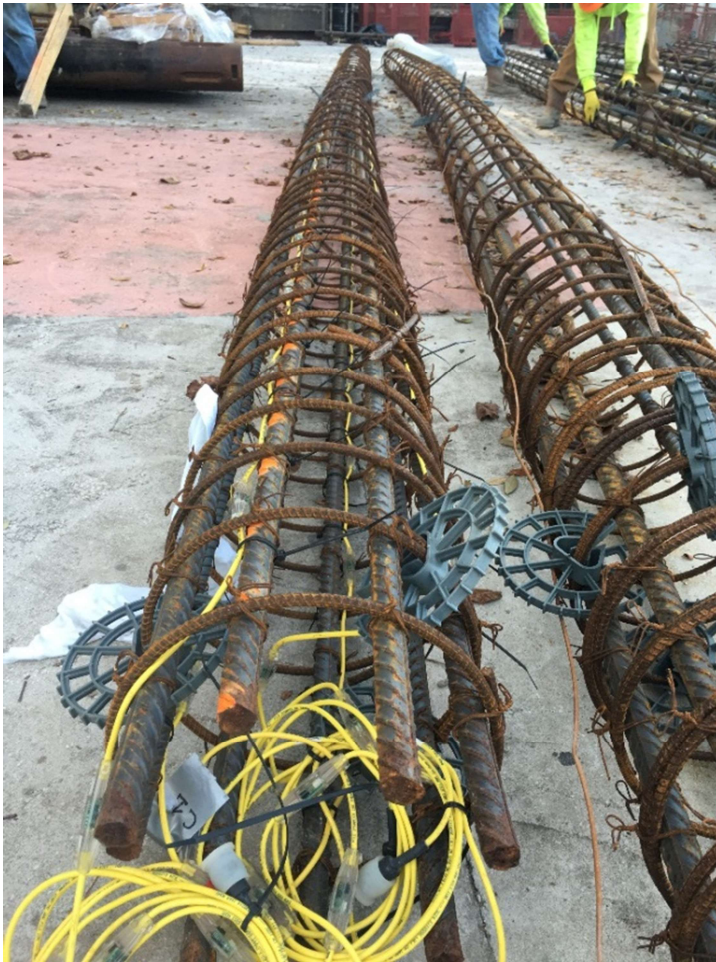
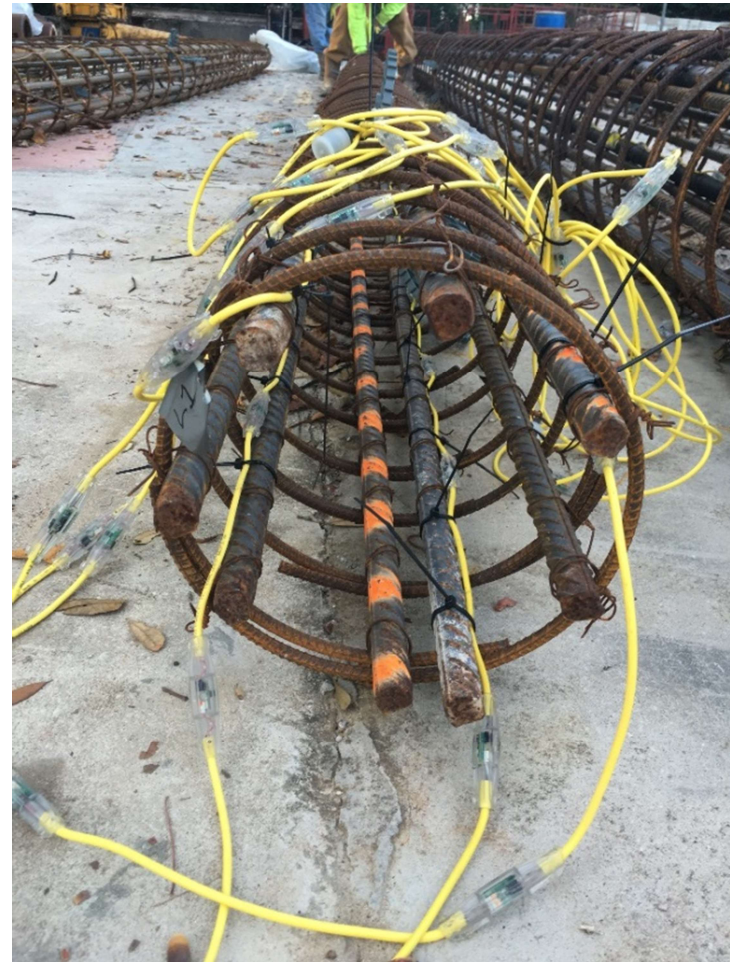
C-1 18in (left) L-1 18in (right)

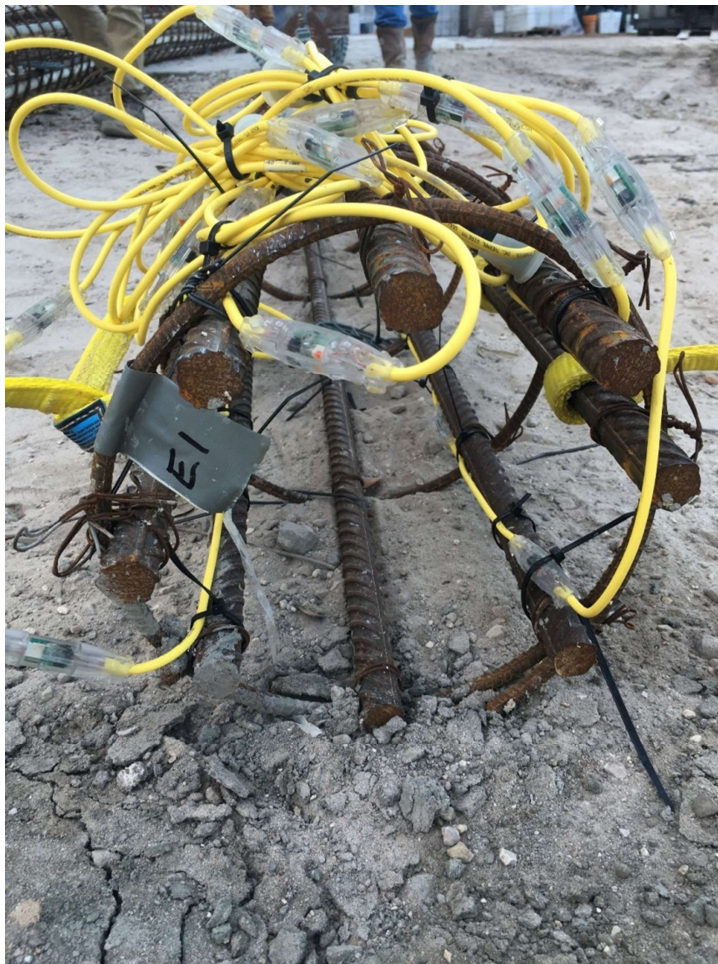
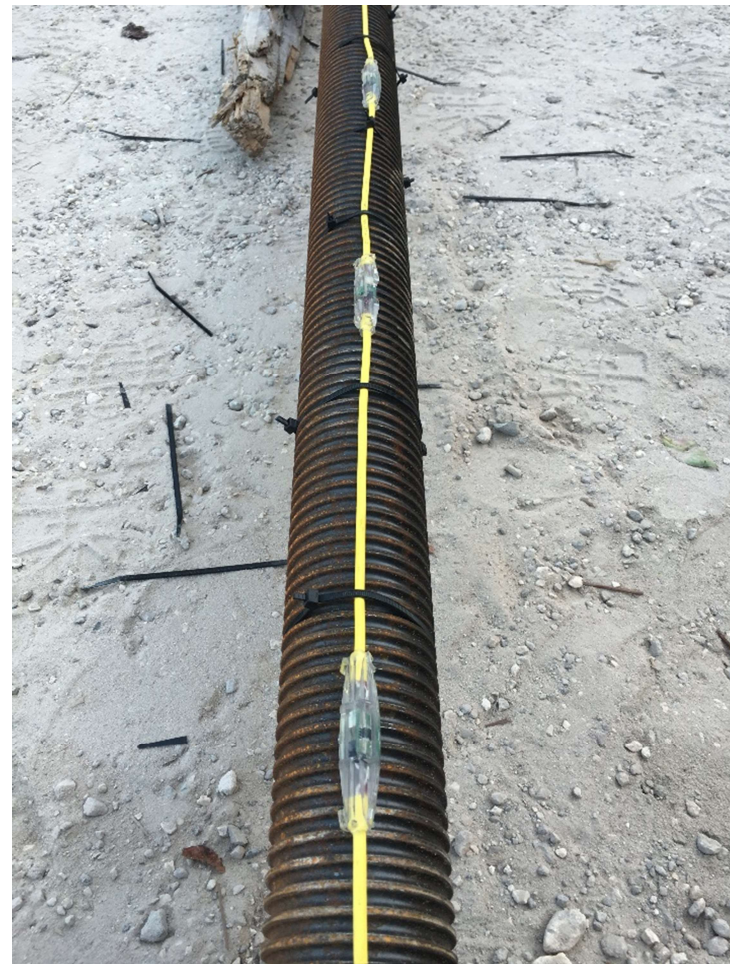
E-1 18in cage (left) 3in center bar (rt.)

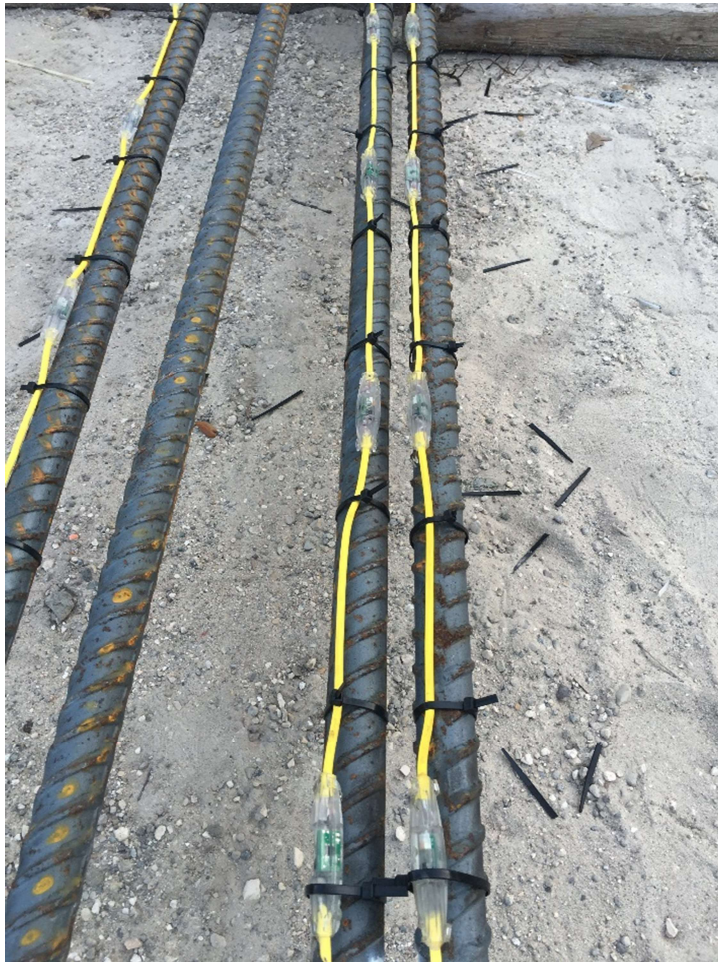
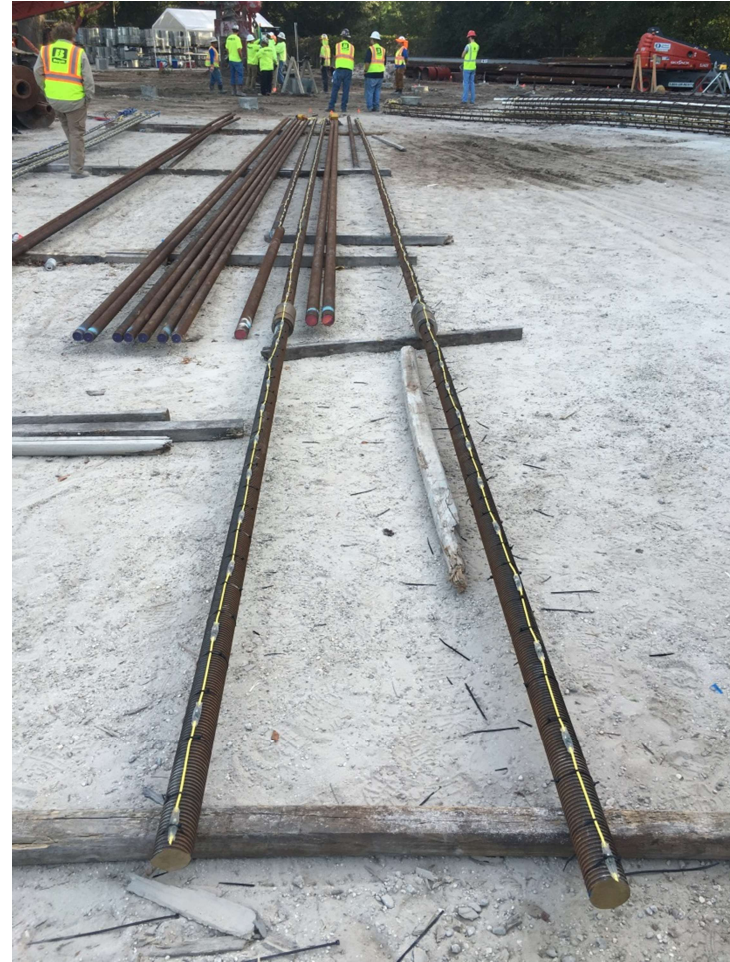
#11bars (left) 3in threaded bars (rt.)

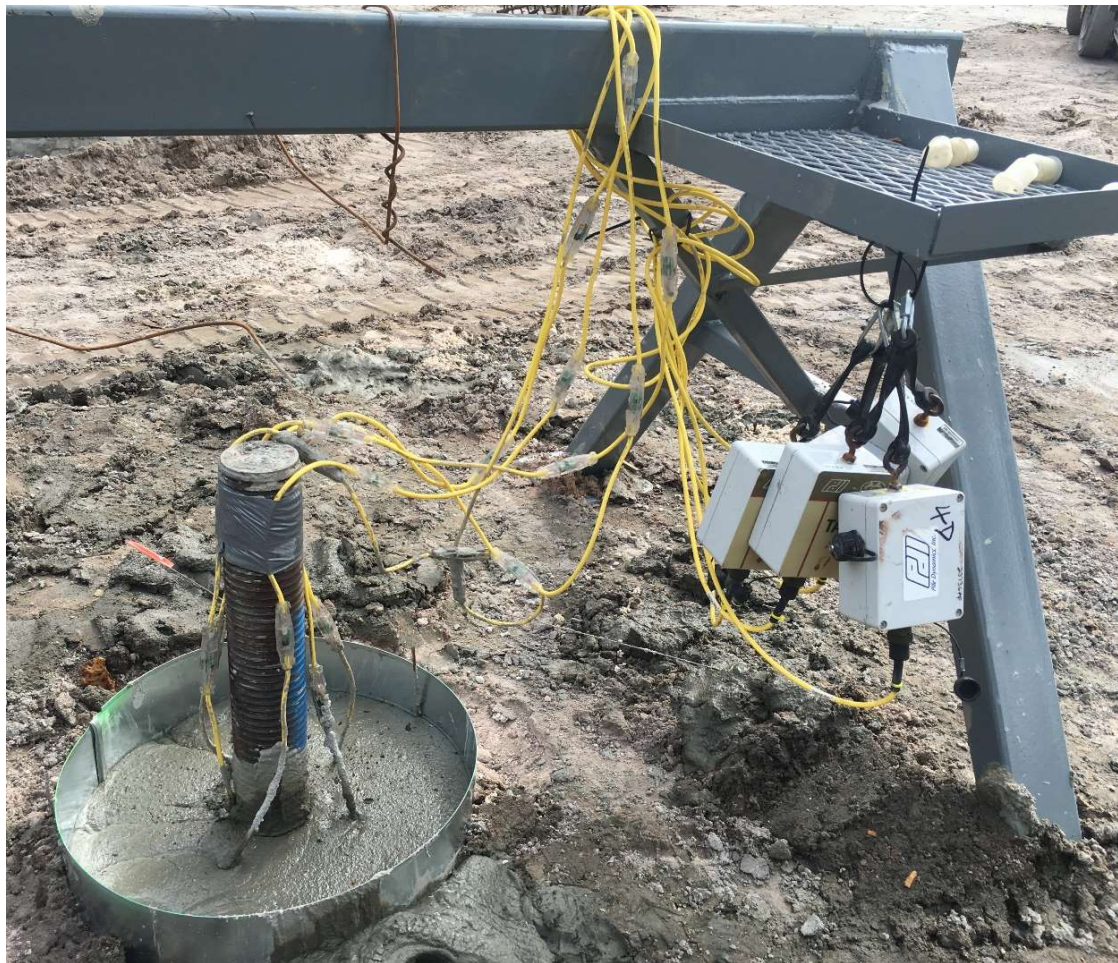
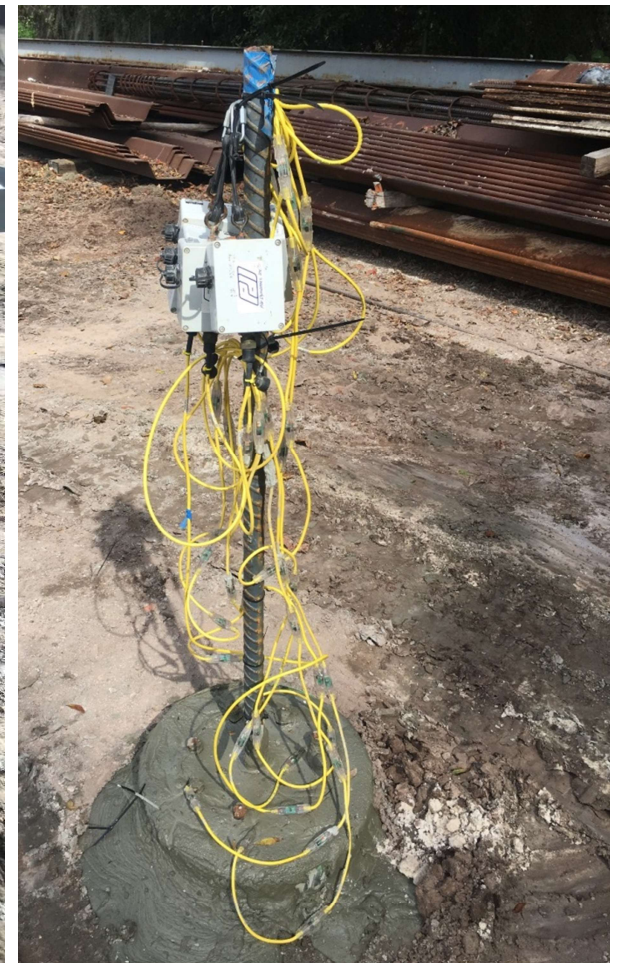
E1 (left) and L1 (right)

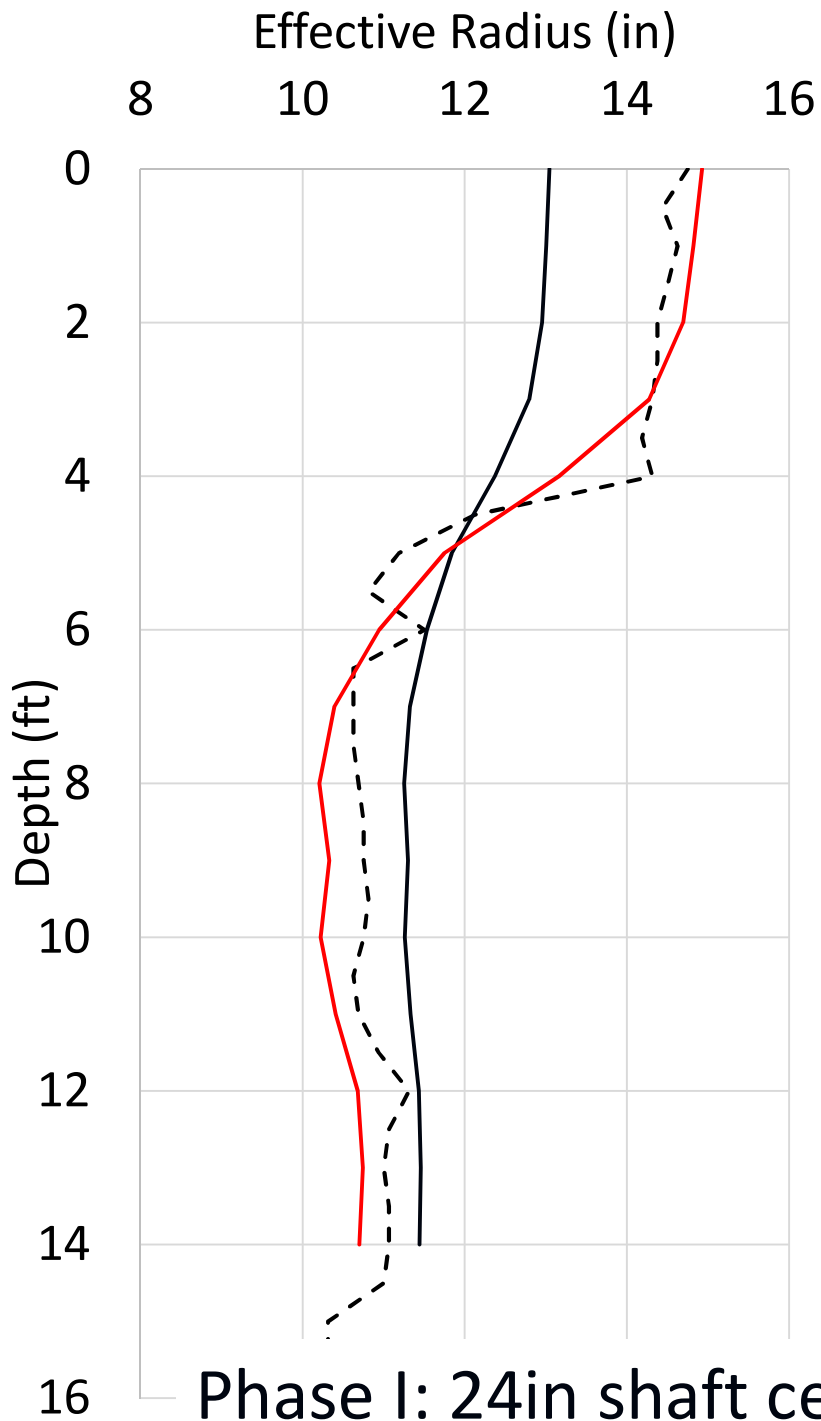
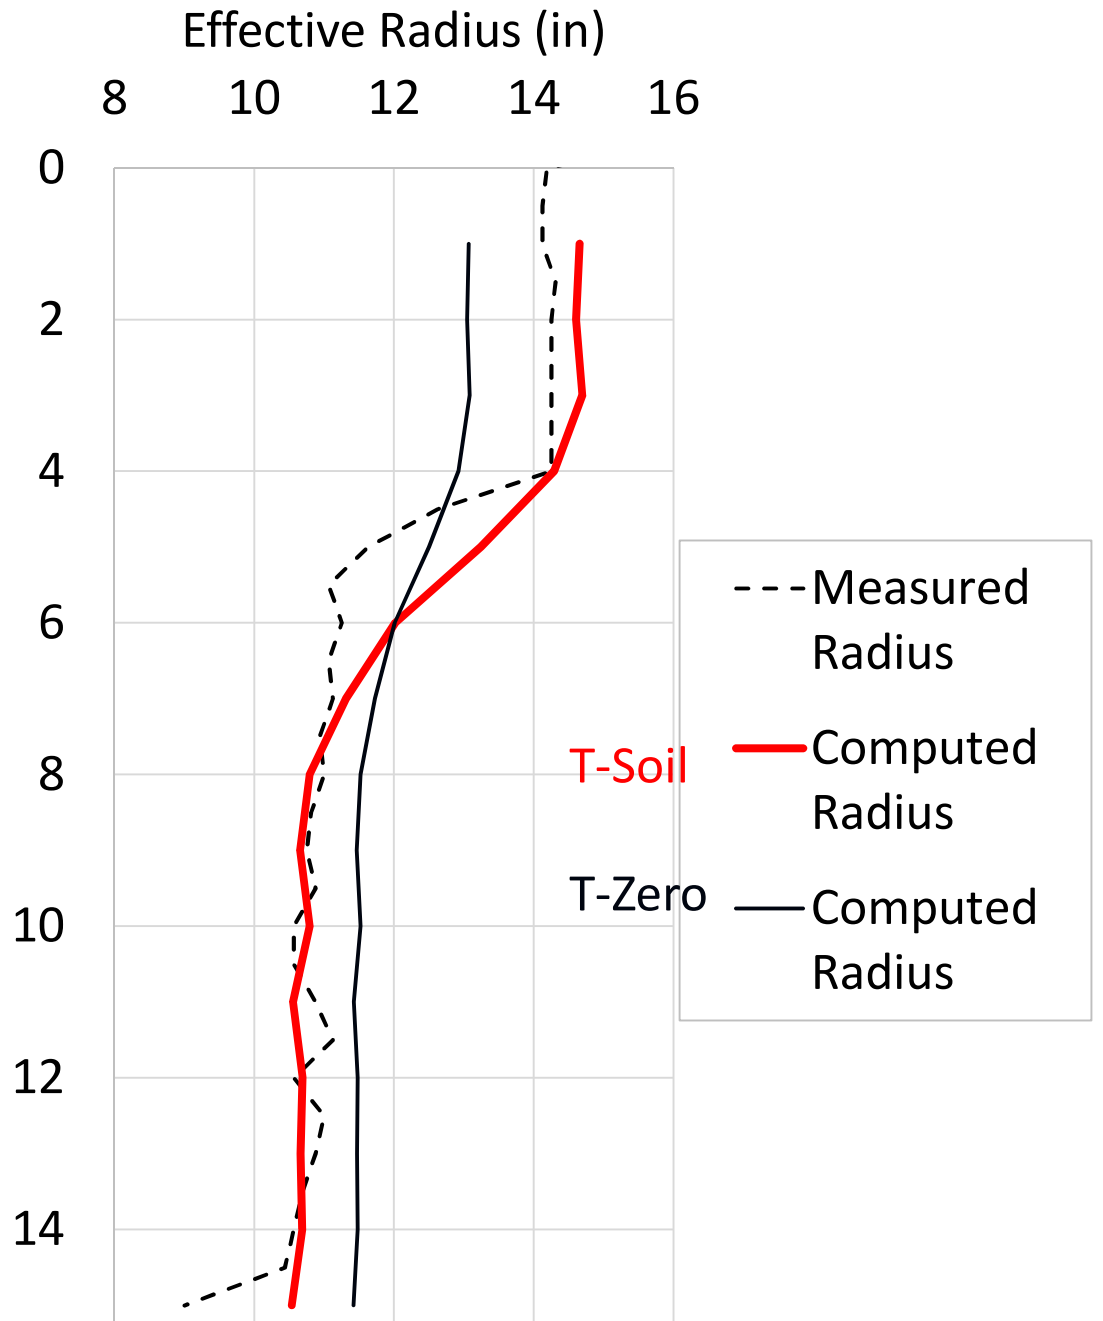
Phase I: 24in shaft center-bar measurements

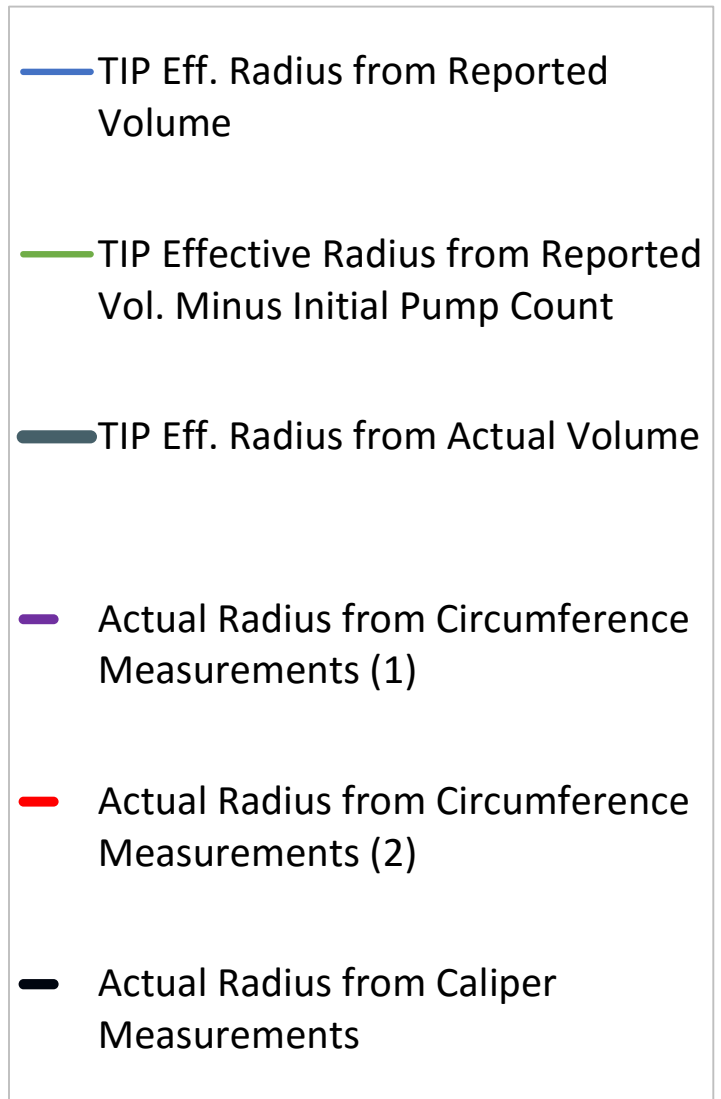
# Predicted Radius of E1

- Total Grout
- Total minus initial pump count
- Total minus vol. after grout return
- Total minus vol. after return plus auger vol.

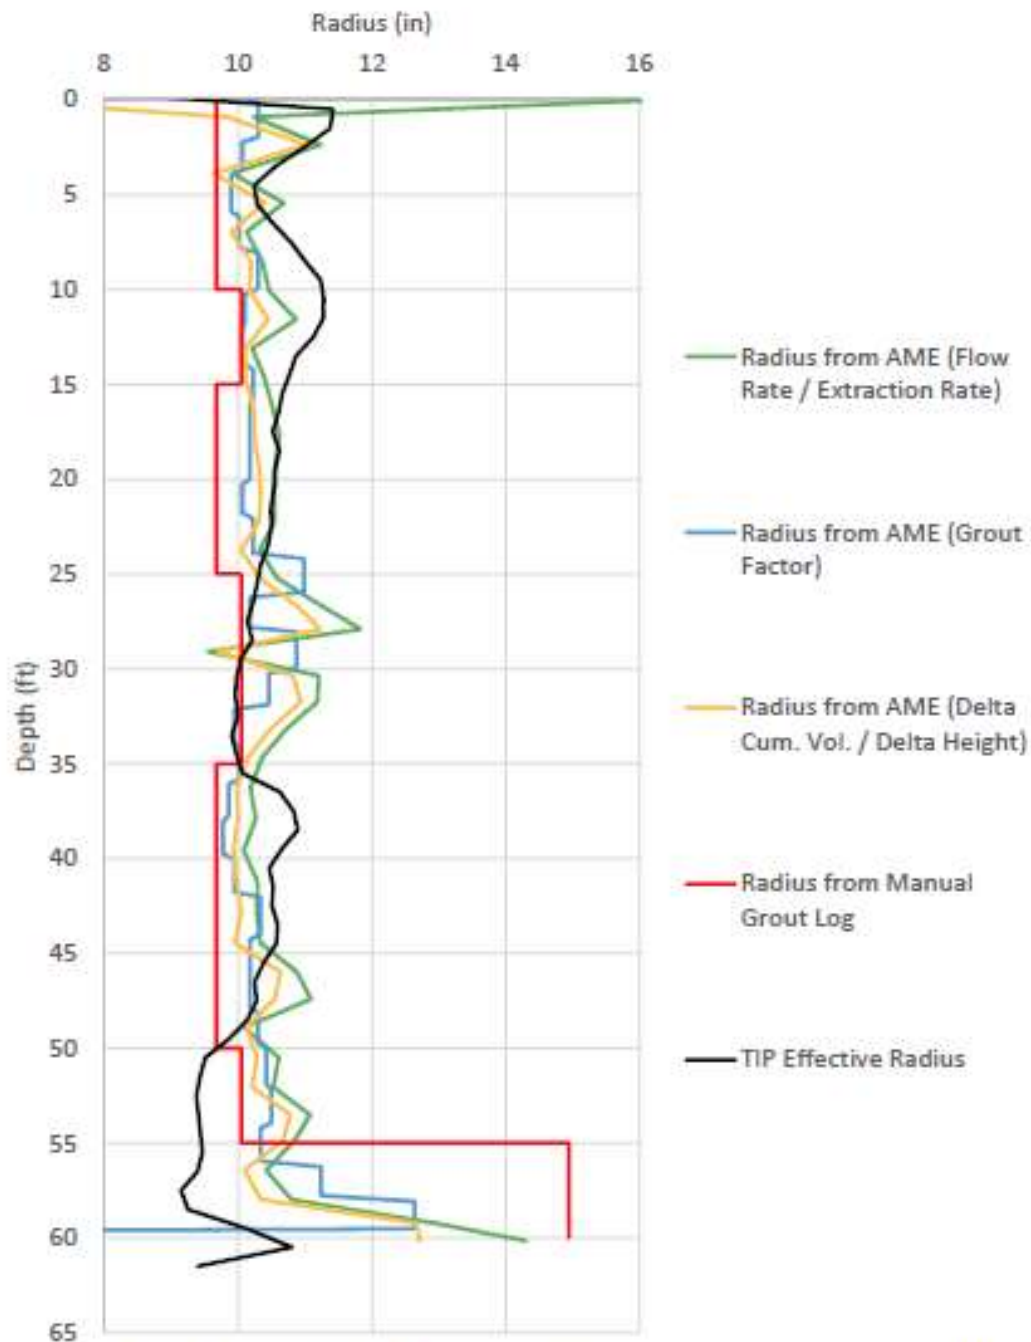
Figure F.1 Pile C1 Computed Radius from AME Data, Manual Grout Log, and TIP Data.

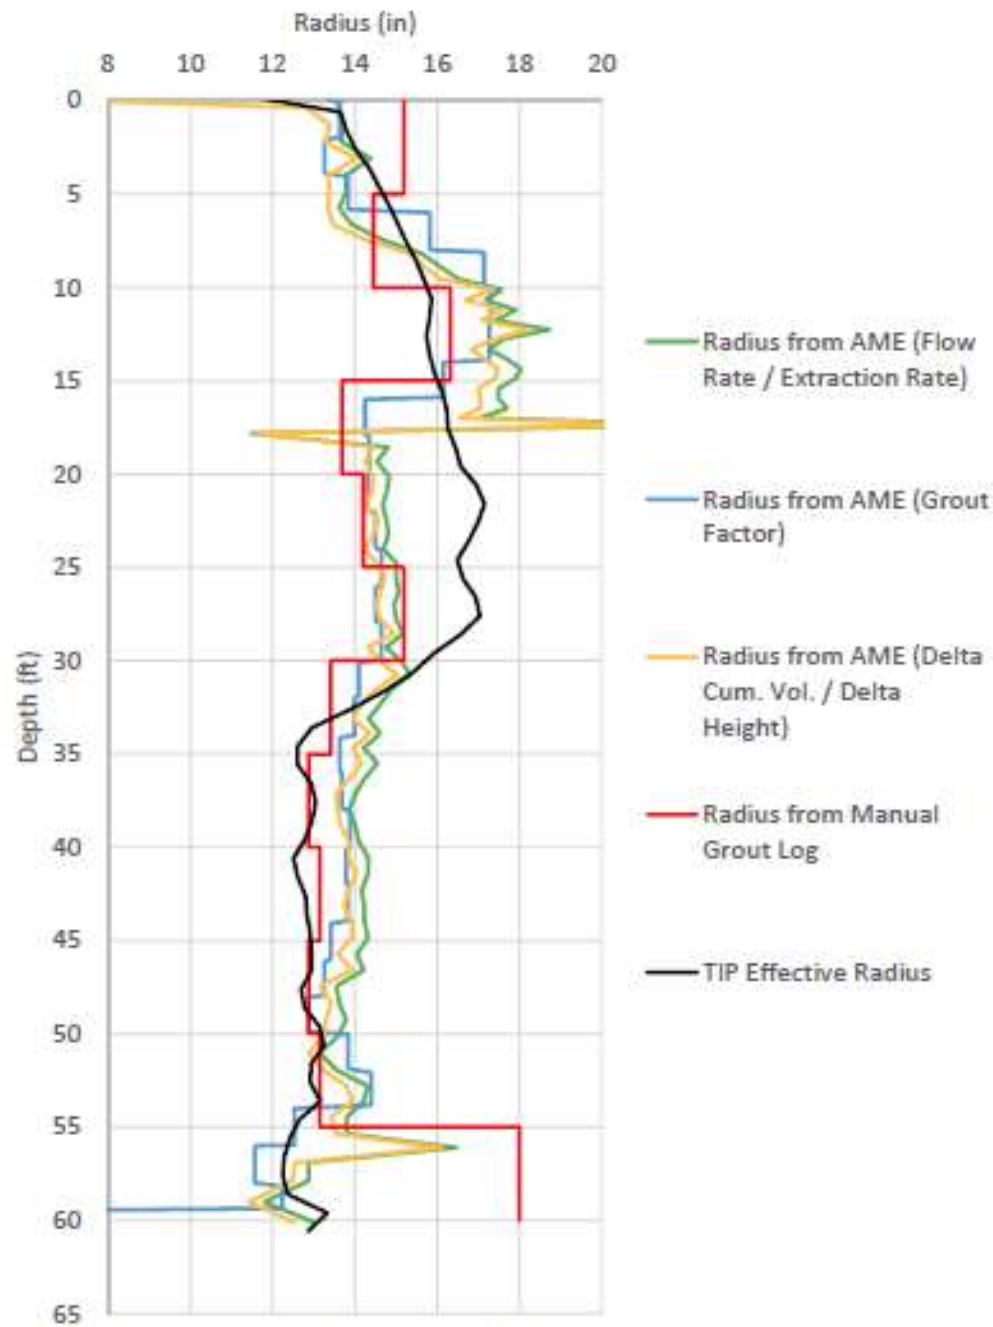
Figure F.2 Pile C2 Computed Radius from AME Data, Manual Grout Log, and TIP Data.

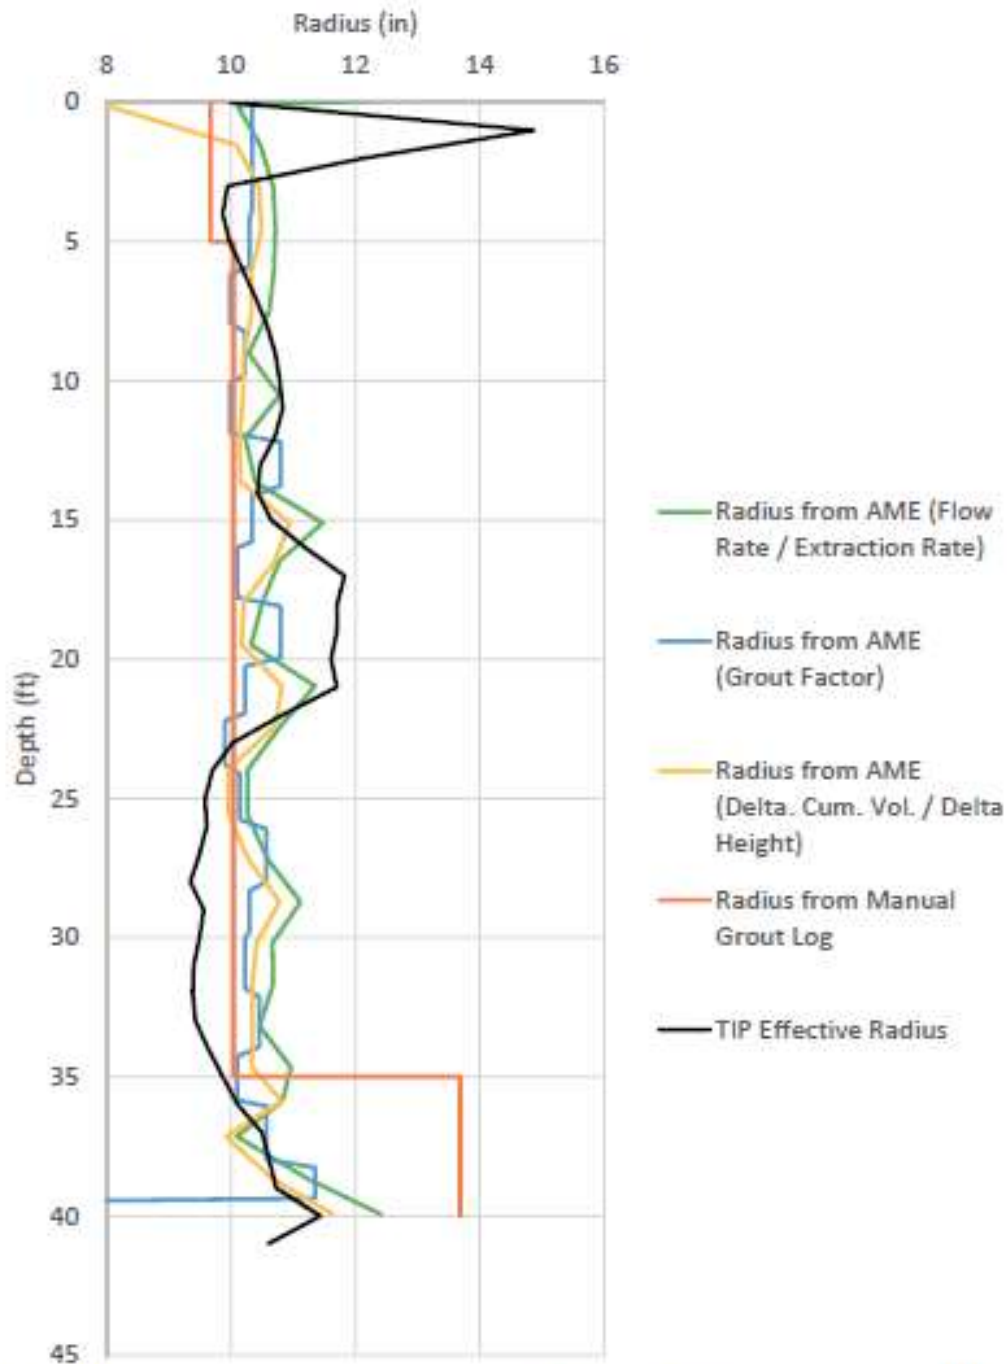
Figure F.3 Pile L1 Computed Radius from AME Data, Manual Grout Log, and TIP Data.

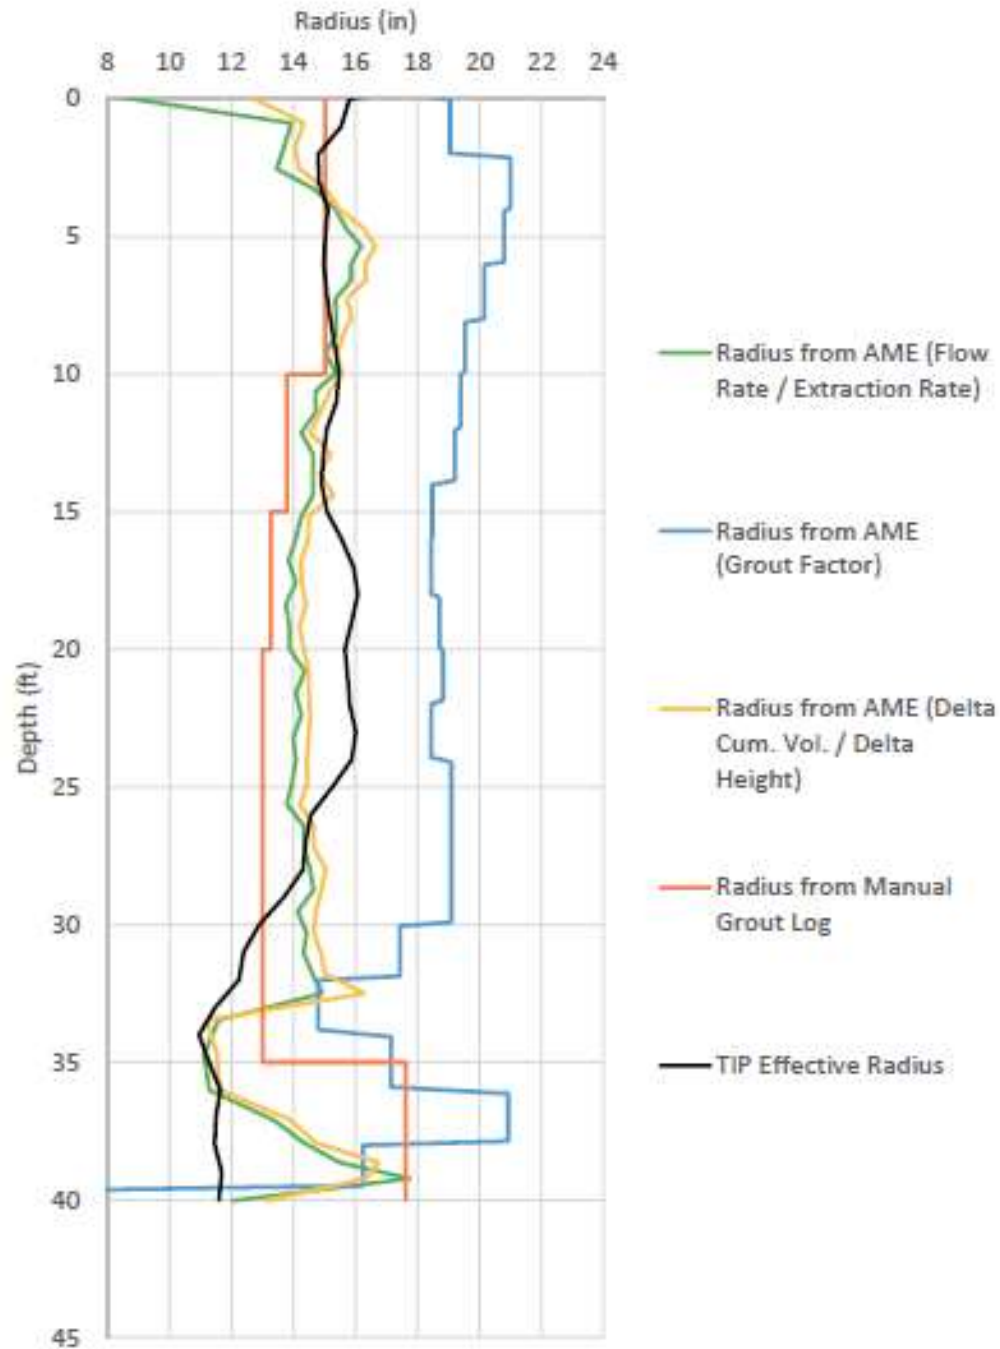
Figure F.4 Pile L2 Computed Radius from AME Data, Manual Grout Log, and TIP Data.

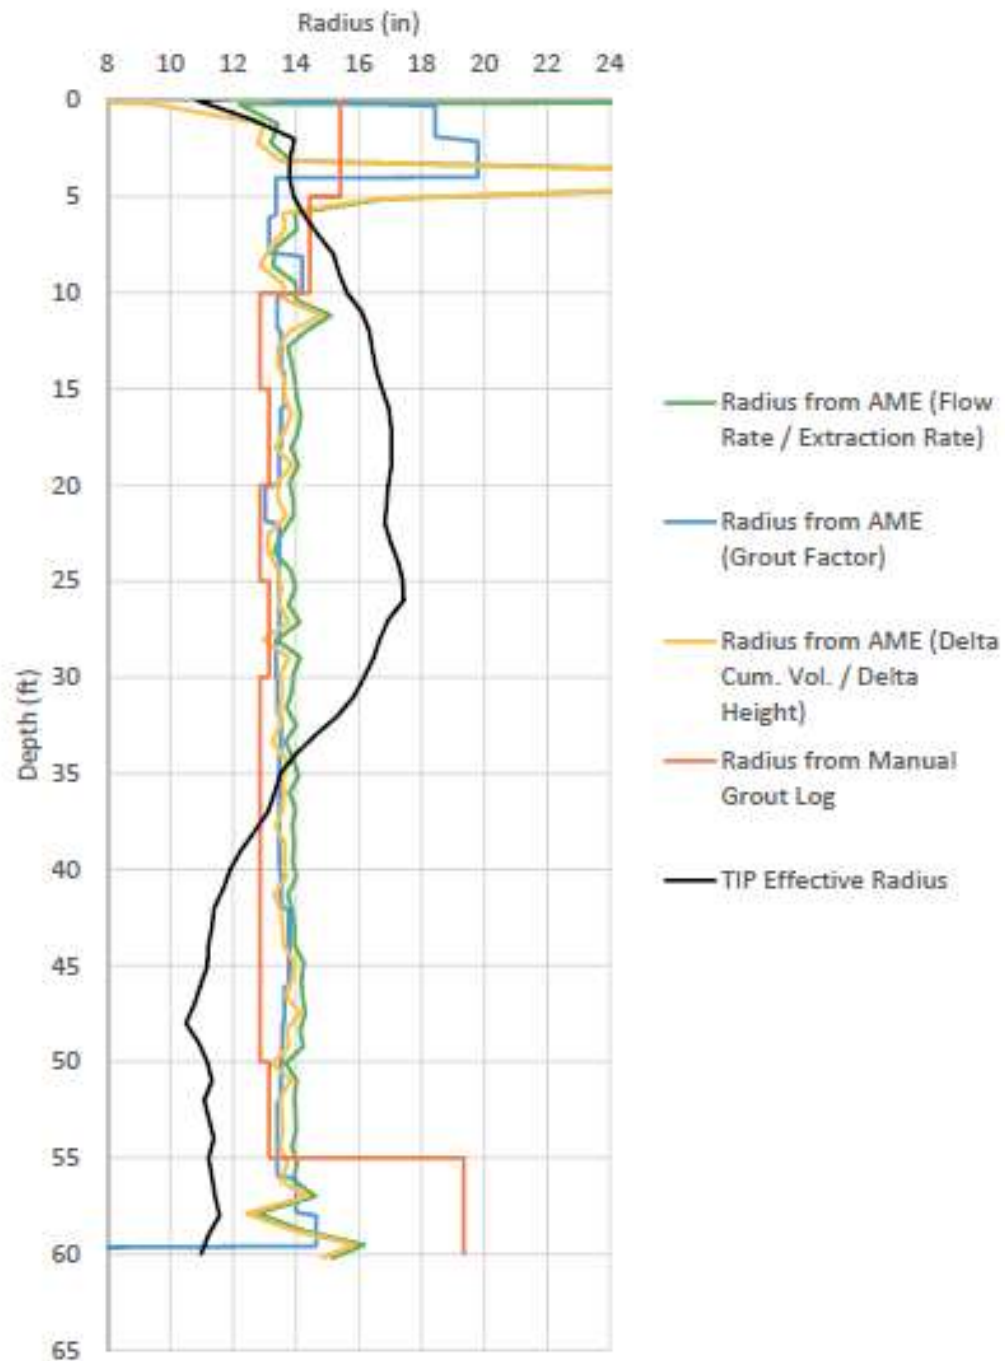
Figure F.6 Pile T2 Computed Radius from AME Data, Manual Grout Log, and TIP Data.

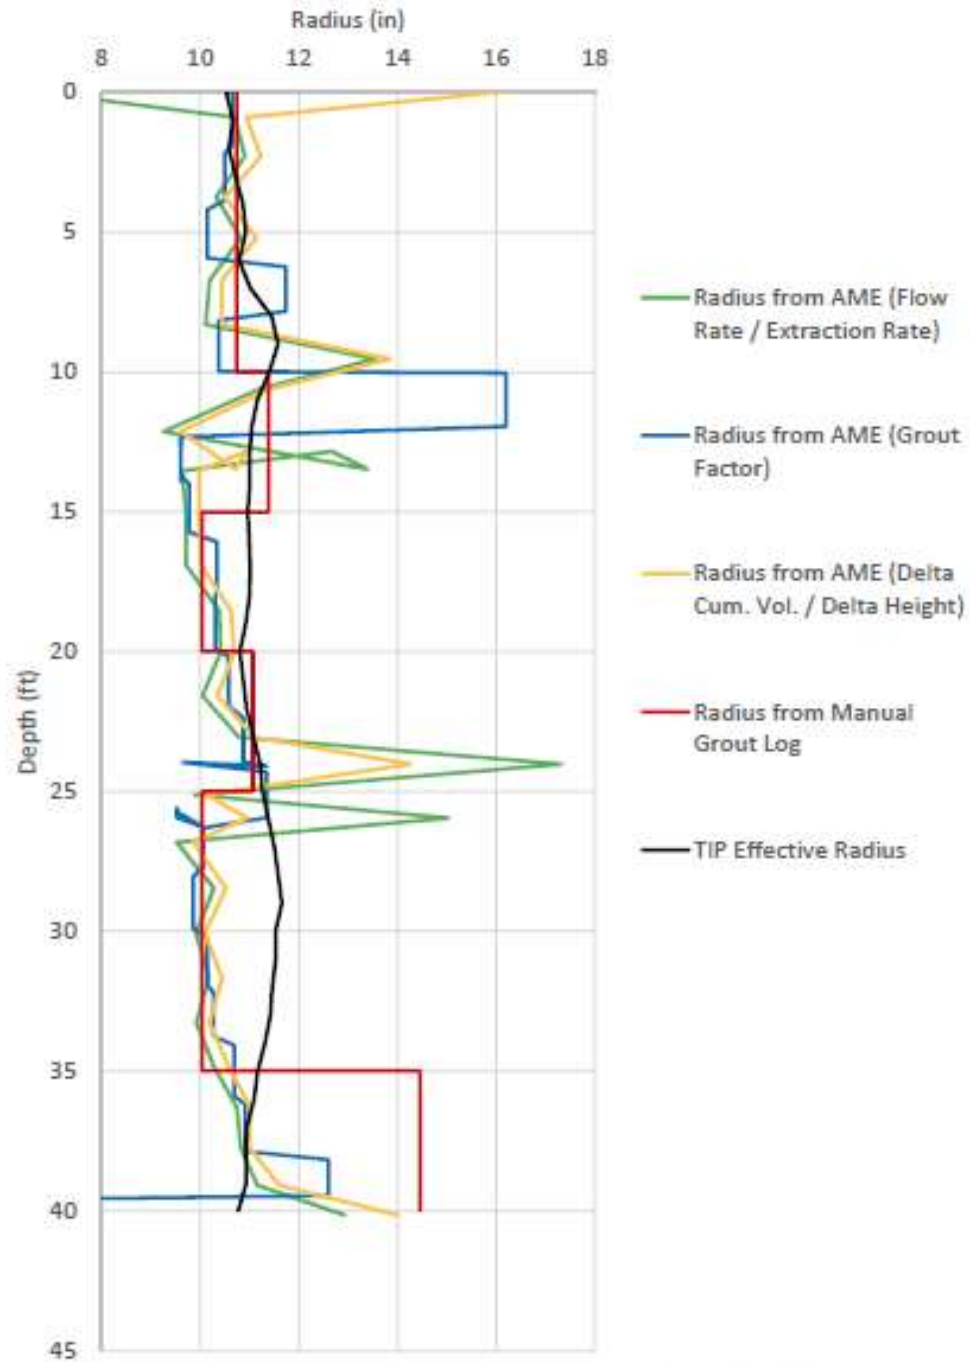
Figure F.7 Pile E1 Computed Radius from AME Data, Manual Grout Log, and TIP Dat
