Experimental Project Status Report

County Palm Beach
Section/Subsection No. 93130-3508
State Road 15
Project Description Geosynthetic Reinforcement Evaluation

UPDATED August 2011
State Materials Office
Gainesville, Florida

Geosynthetic Reinforcement Evaluation

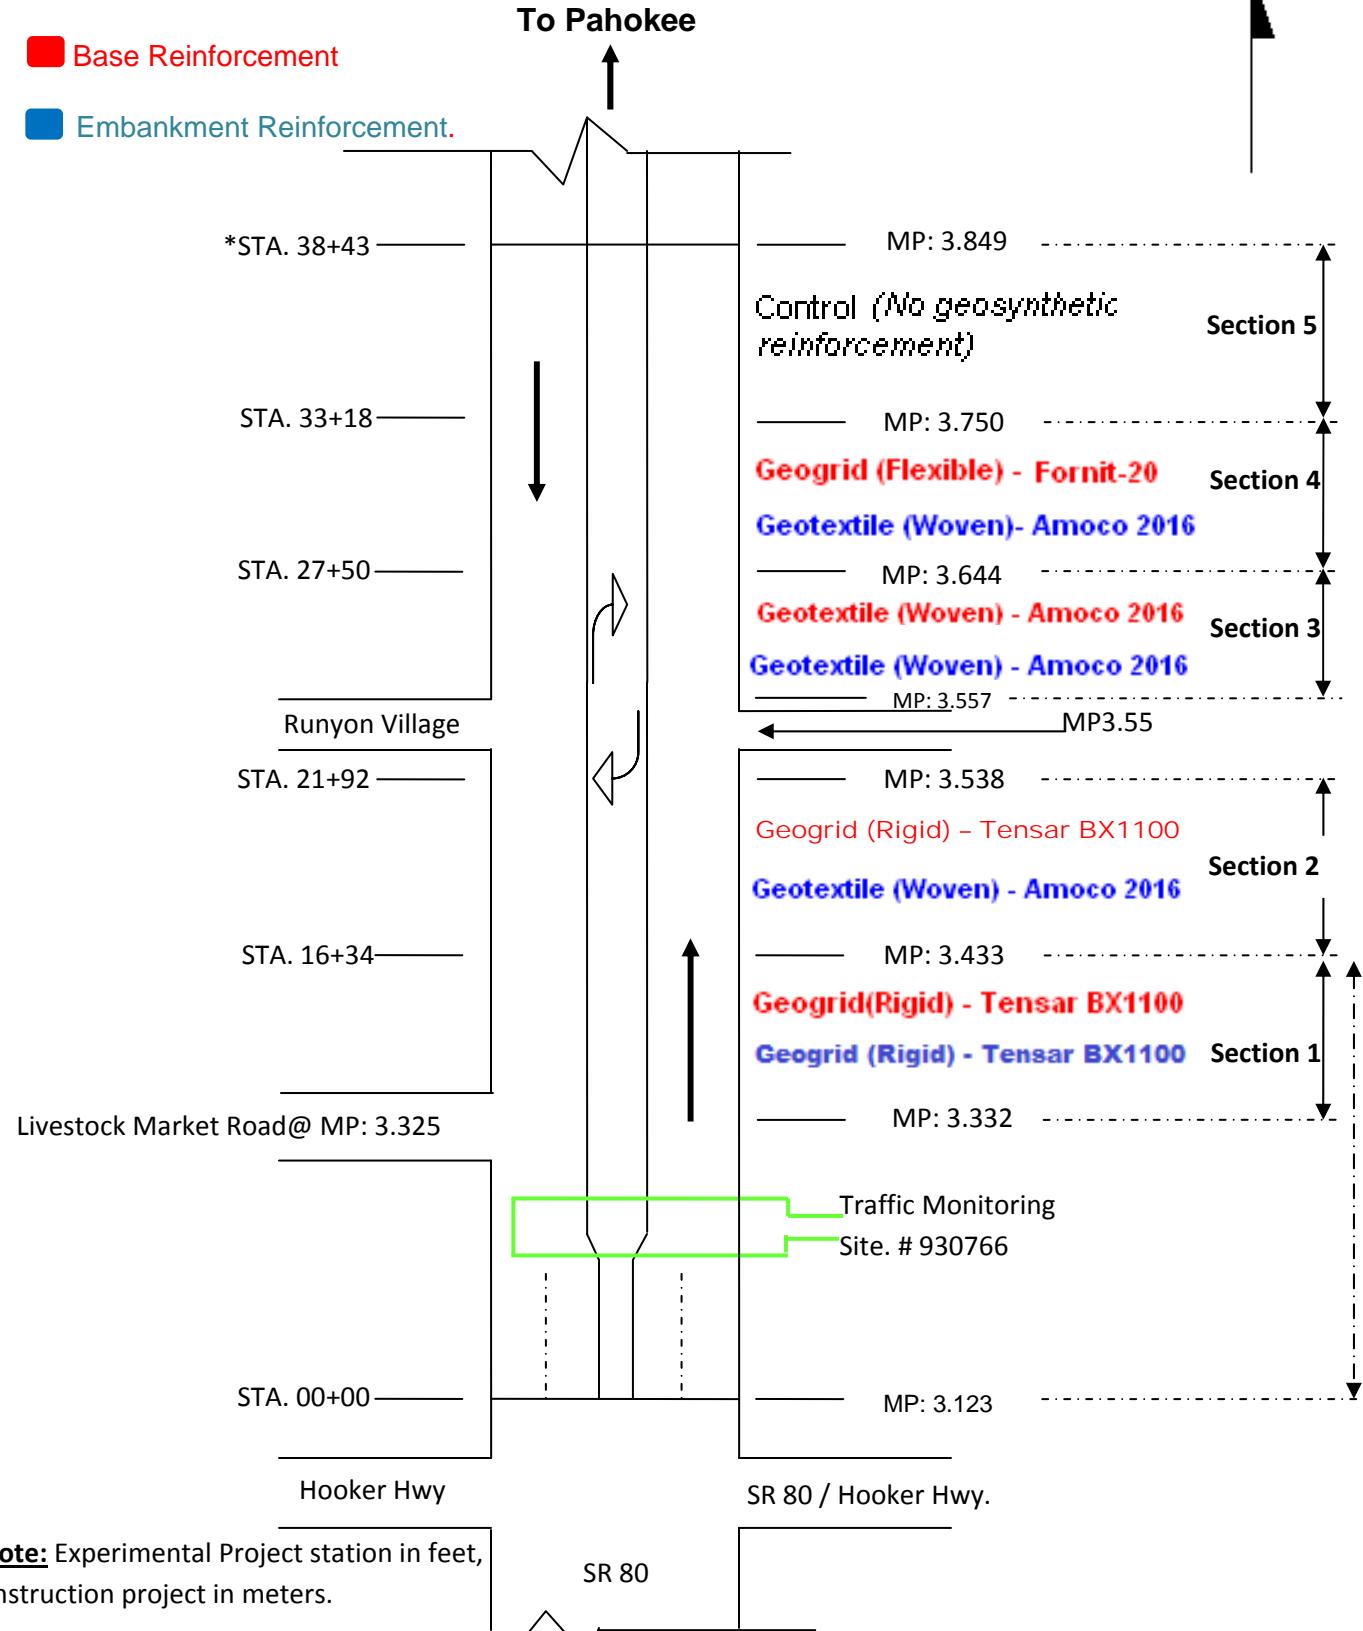
Experimental Project Site Layout

This project was constructed in 1999 to evaluate the performance of geogrid and geotextile materials as base/subgrade reinforcement layers and separation barriers. Four sections were laid out in the north and southbound direction. A fifth section on the north end of the project without geotextile or geogrid serves as the control section.

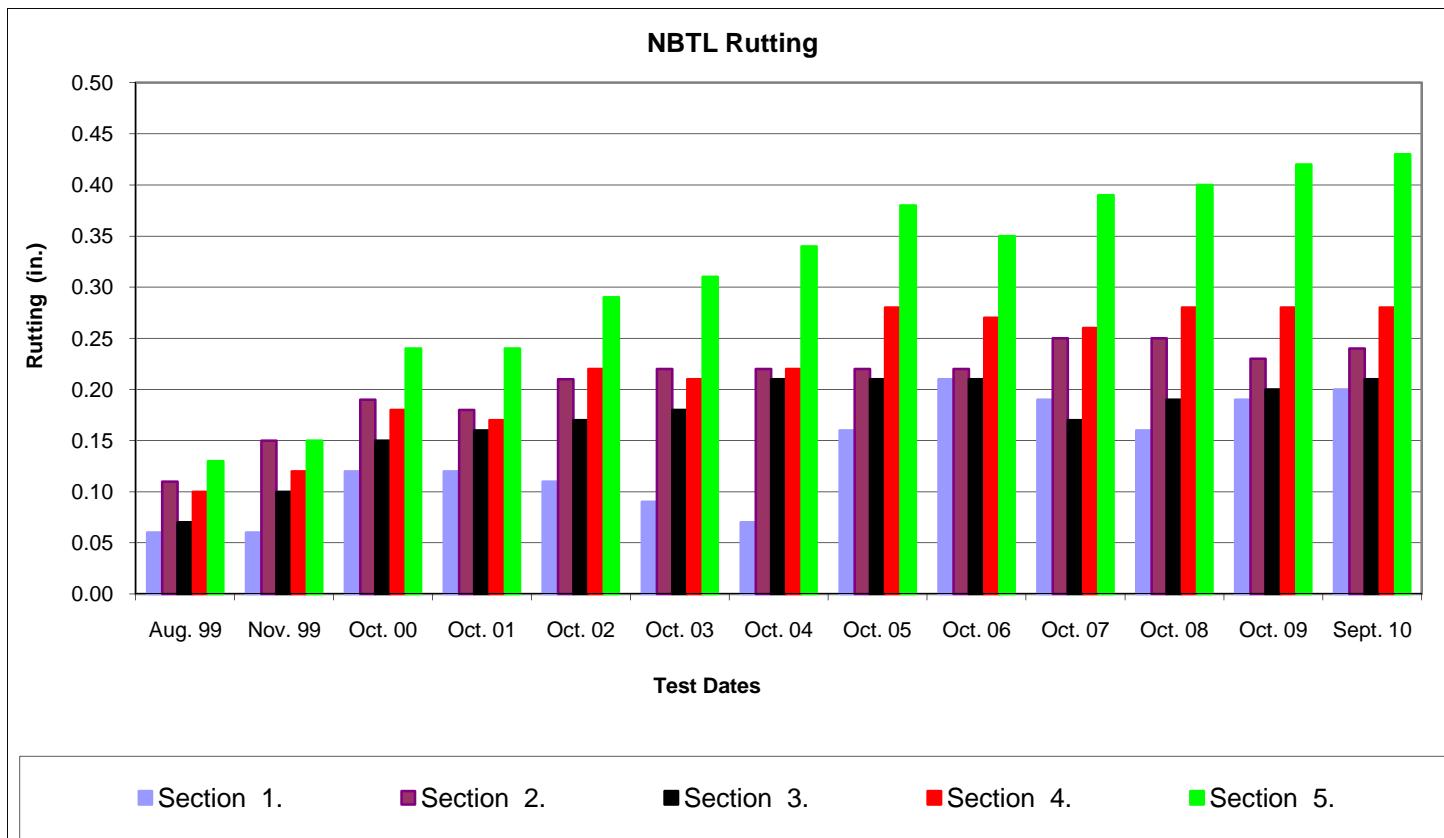
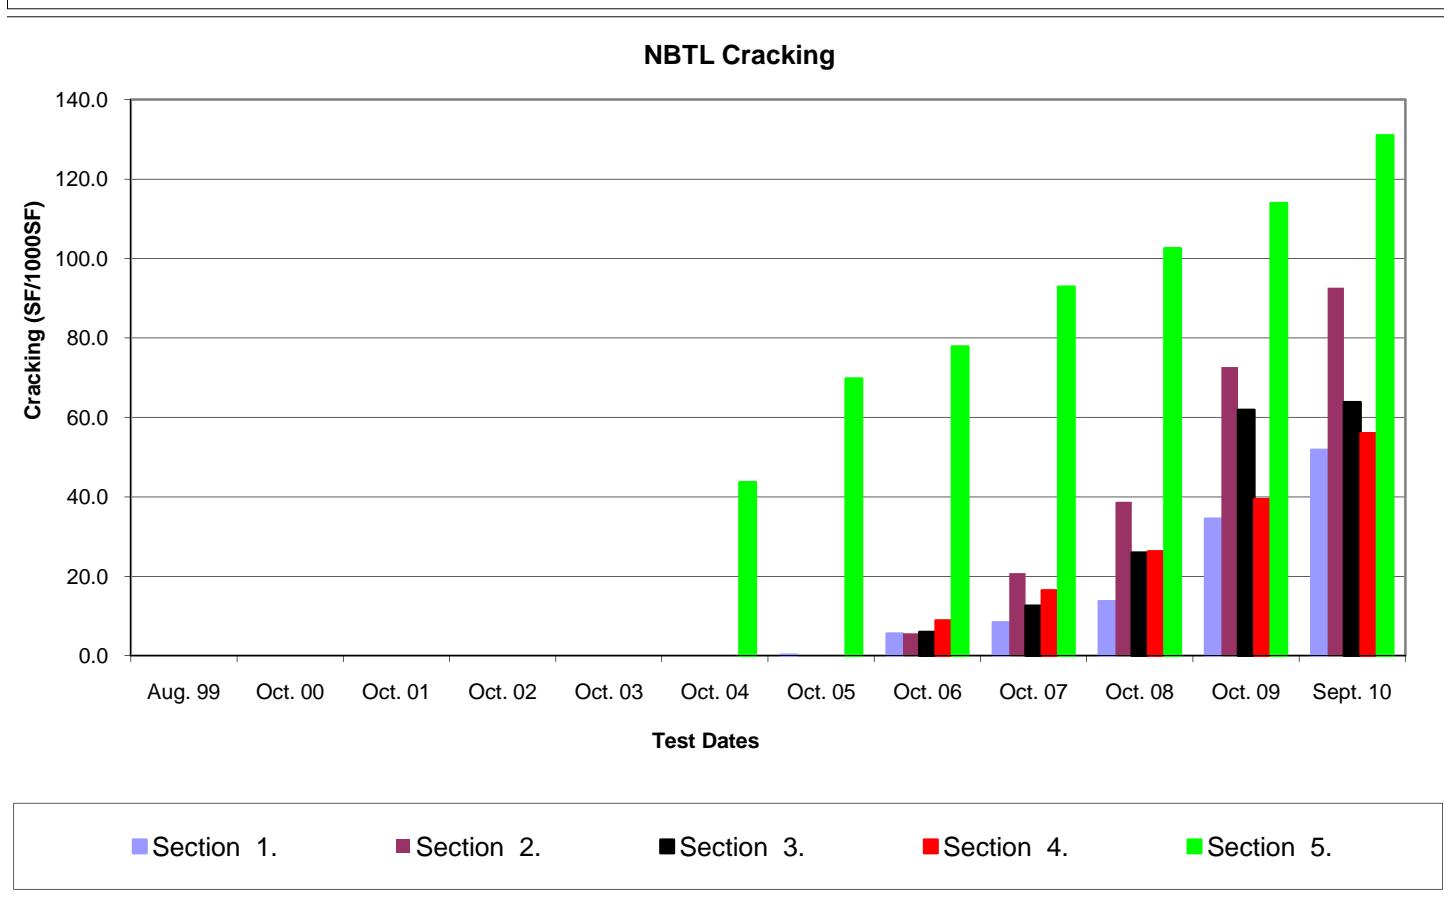
Pavement Distress

NBTL

The performance is evaluated in terms of deflection, ride, rutting and cracking. To date, the reinforced sections have shown better performance than the unreinforced control section. Long term performance will continue to be monitored.

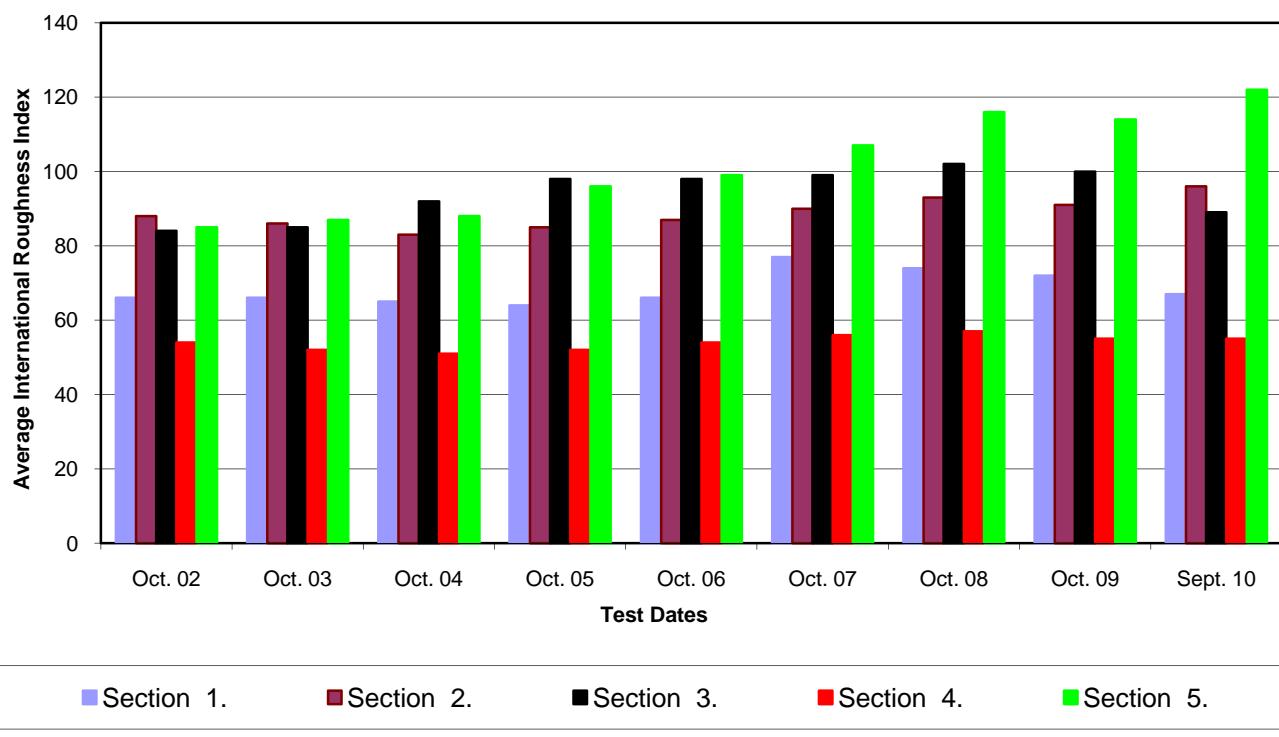
NBTL

Pavement Distress Ride
