FDOT Pavement Performance

PAVEMENT CONDITION SURVEY UNIT

PAVEMENT CONDITION SURVEY

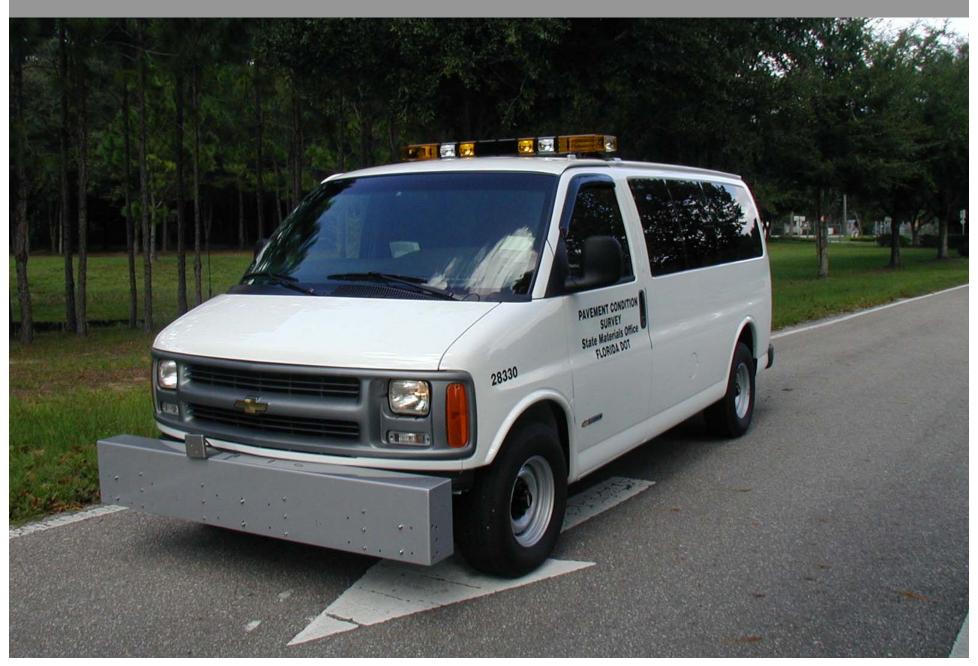
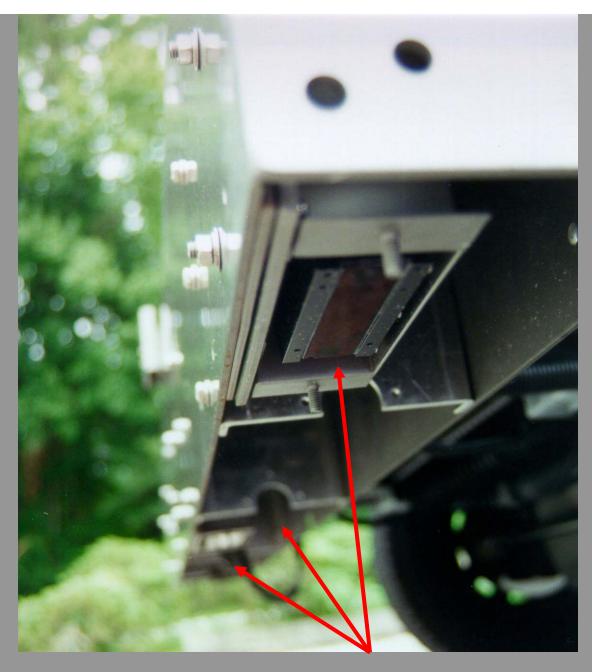
LASER PROFILER

• HIGH SPEED PROFILER Class 1 by ASTM E-950

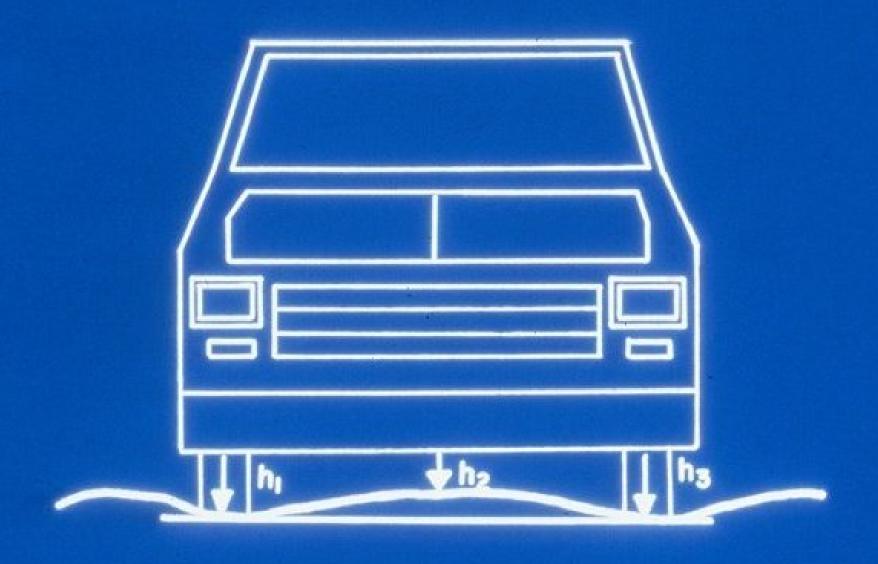
We Measure Ruts With Precision

Using a Road Profiler

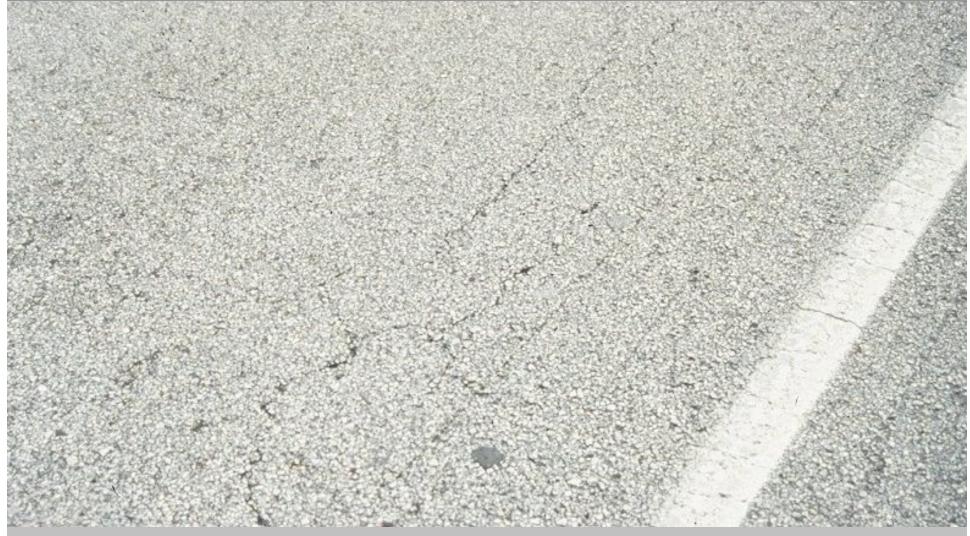
CLASS 1B CRACKING

HAIRLINE CRACKS ≤ 1/8 INCH (3.18 mm).

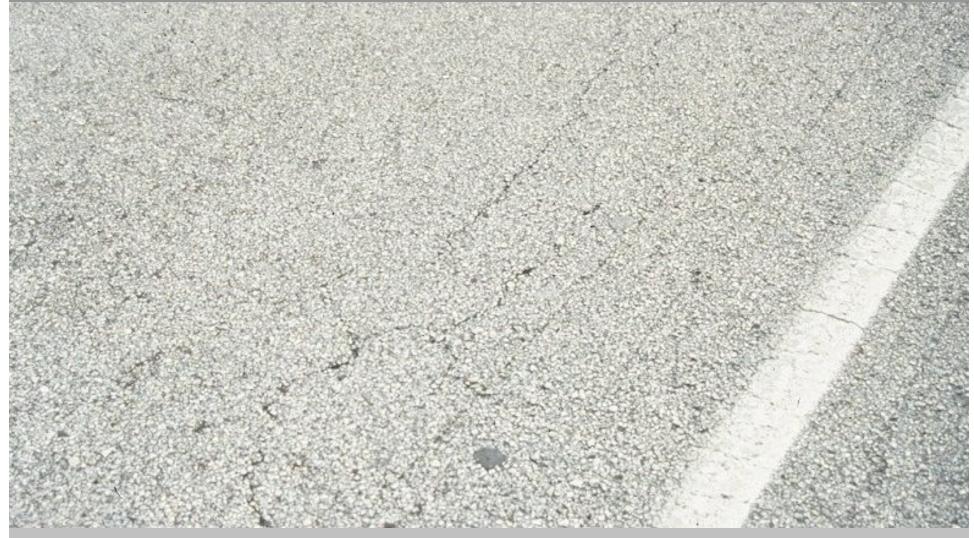
CLASS 1B CRACKING

MAY HAVE SLIGHT SPALLING AND SLIGHT TO MODERATE BRANCHING.

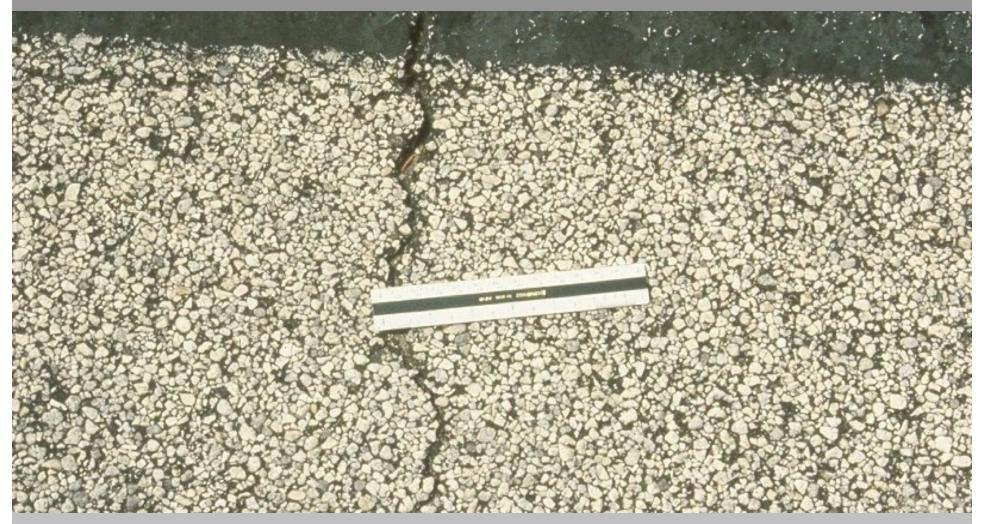
CLASS II CRACKING

CRACKS >1/8 INCH (3.18 mm) TO ≤1/4 INCH (6.35 mm) WHICH MAY HAVE SPALLING OR BRANCHING

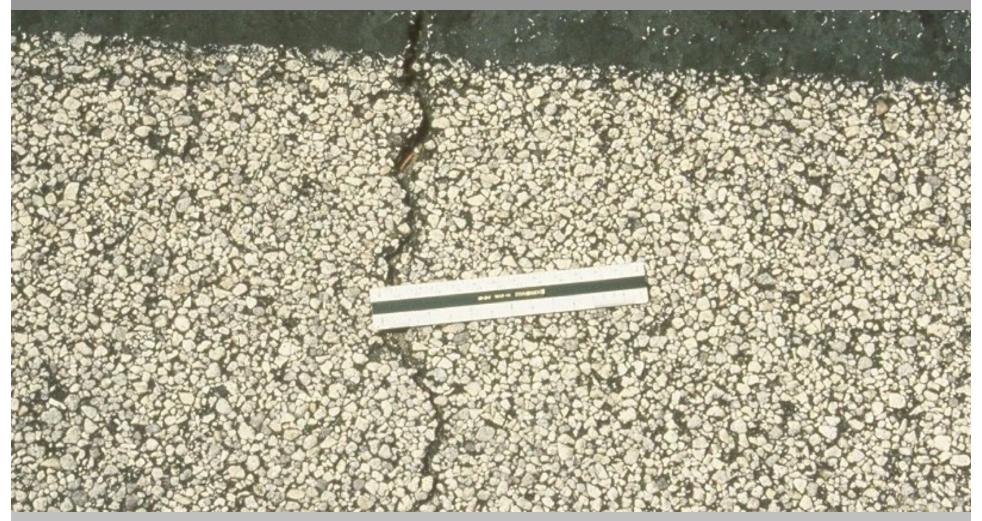
CLASS II CRACKING

CRACKS LESS THAN 1/4 INCH (6.35 mm) WIDE WHICH HAVE FORMED CELLS LESS THAN 2 FEET (0.61 m) ON THE LONGEST SIDE (ALLIGATOR CRACKING).

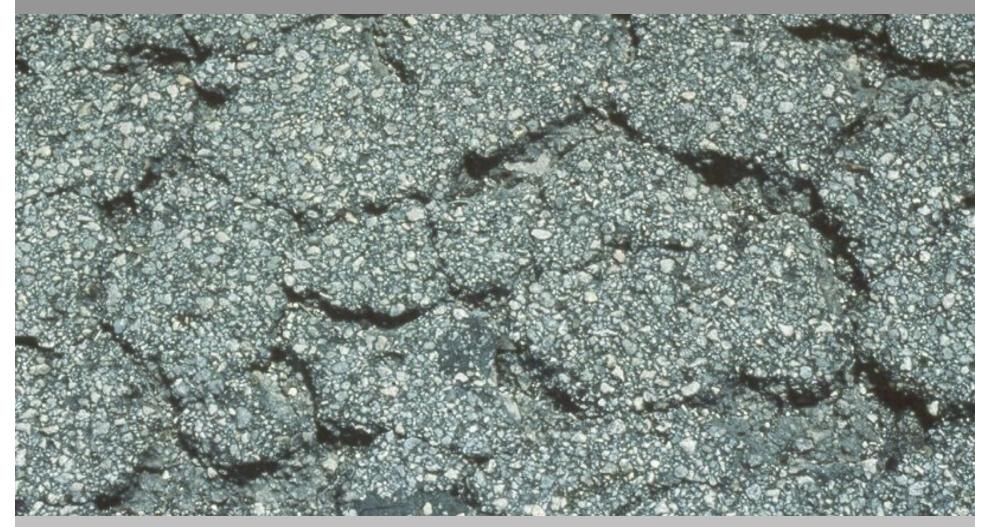
CLASS III CRACKING

CRACKS >1/4 INCH (6.35 mm) REACHING DOWN TO THE BASE OR UNDERLYING MATERIAL

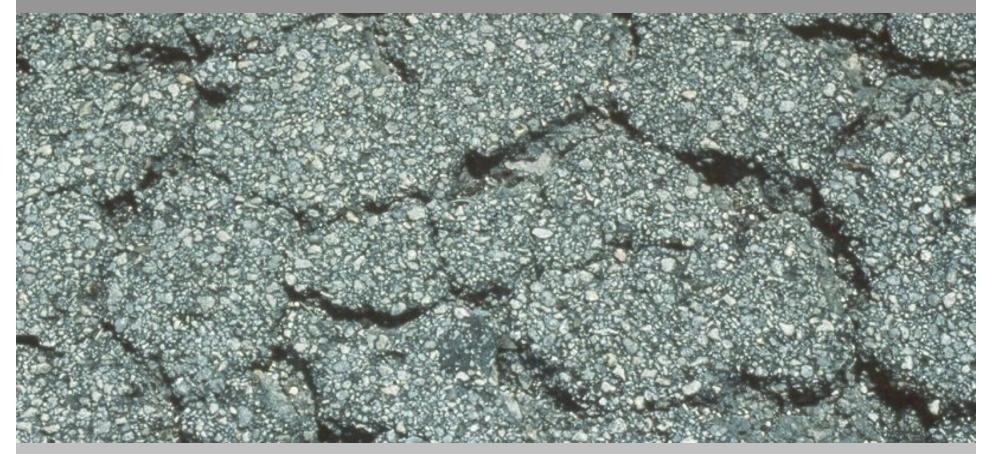
CLASS III CRACKING

PROGRESSIVE CLASS II CRACKING RESULTING IN SEVERE SPALLING WITH CHUNKS OF PAVEMENT BREAKING OUT, AND SEVERE RAVELING (LOSS OF SURFACE ND

SEVERE RAVELING (LOSS OF SURFACE AGGREGATE).

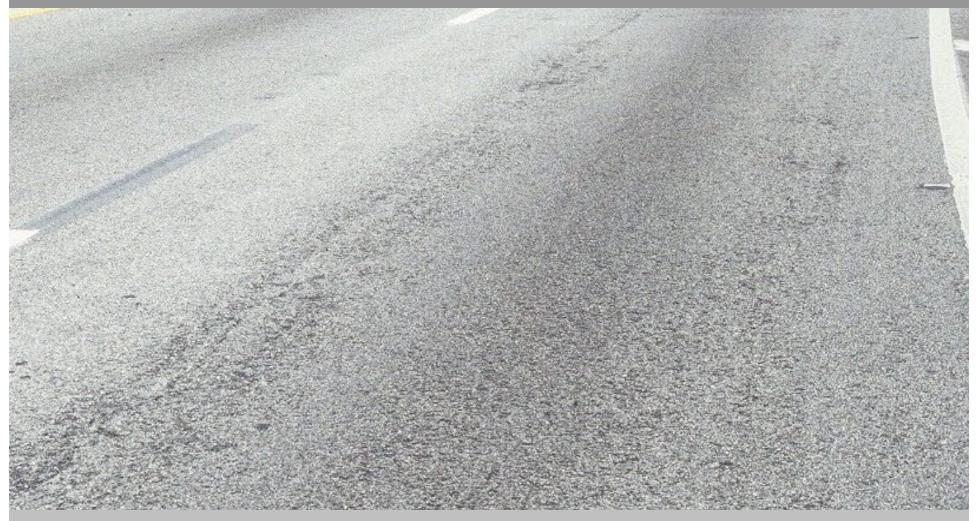
RAVELING

THE DISLODGING OF AGGREGATE PARTICLES AND LOSS OF ASPHALT BINDER.

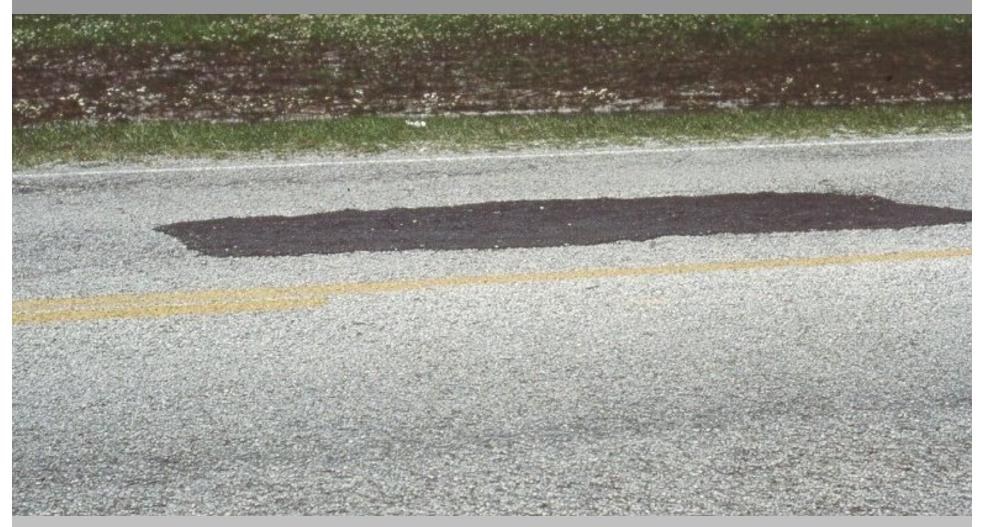
PATCHING

PORTION OF PAVEMENT SURFACE > 0.1 SQ. FT THAT HAS BEEN REMOVED AND REPLACED.

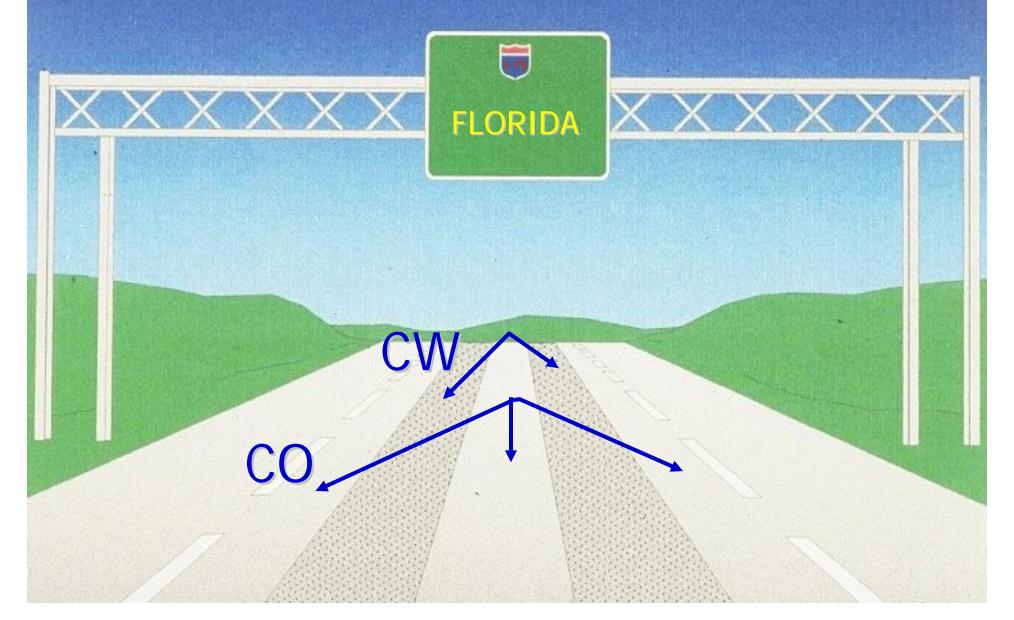
WHEEL PATH AREAS

CONFINED TO THE WHEEL PATHS (CW)

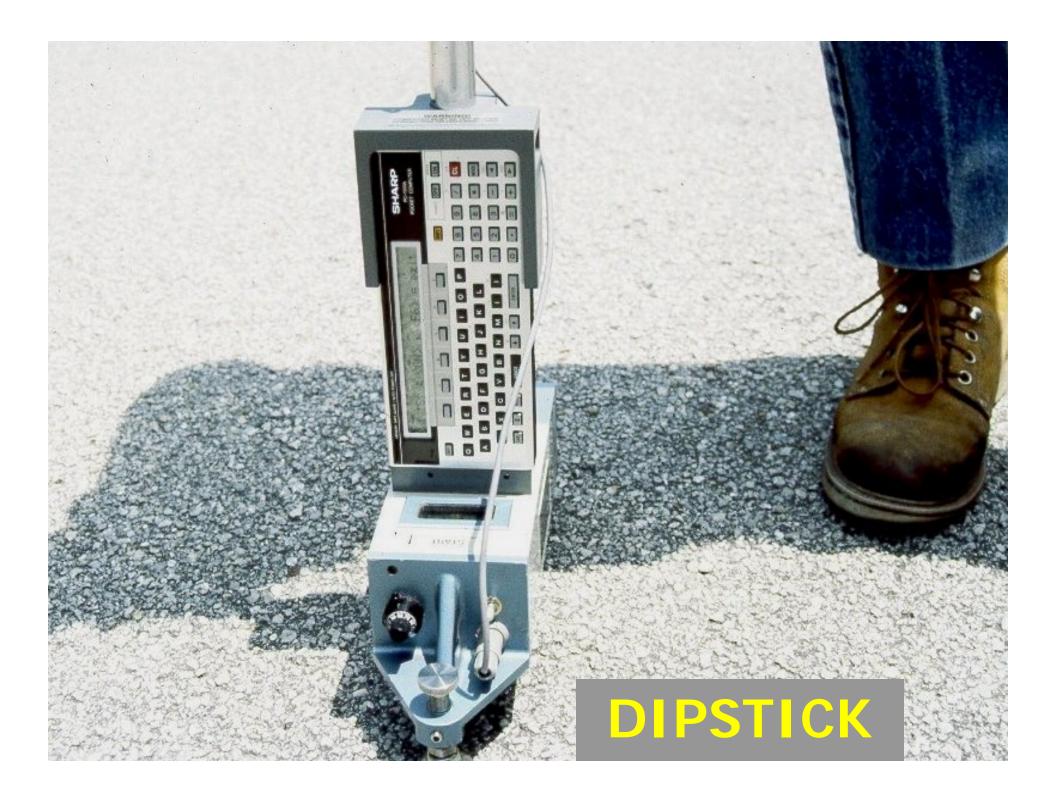
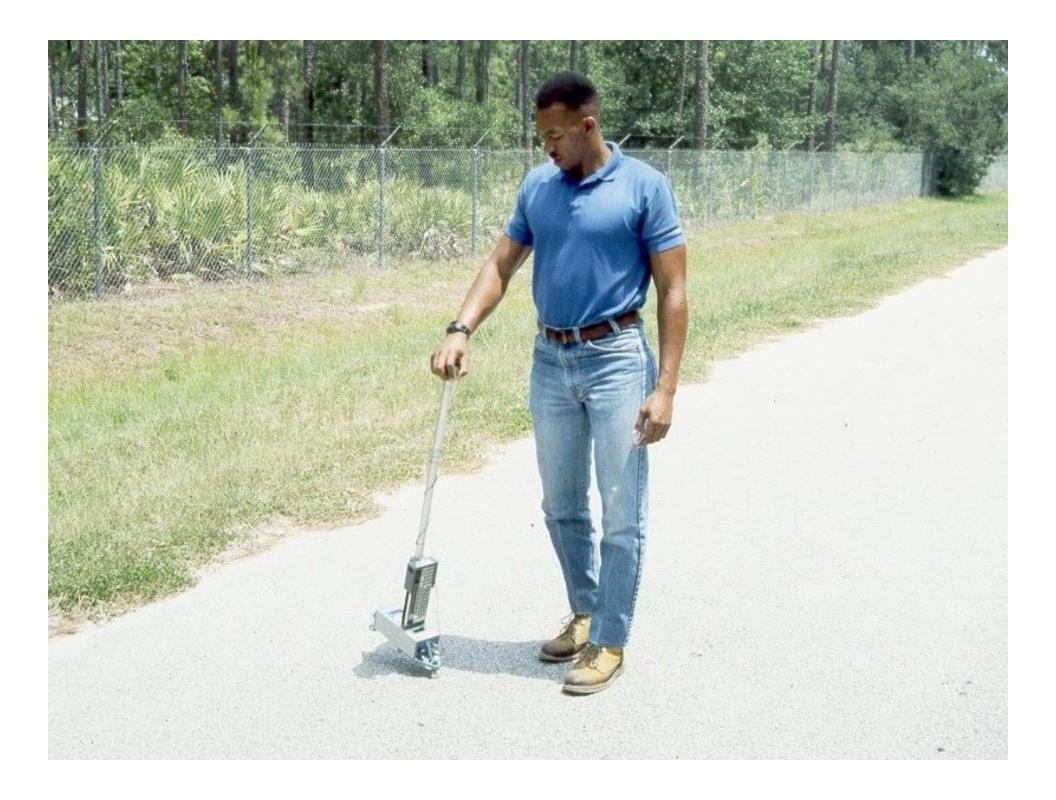
- PROFILERS RECEIVE ELABORATE CALIBRATION
- STRAIGHTEDGE CALIBRATION
- PLATE CALIBRATION
- SECTION CALIBRATION WITH DIPSTICK

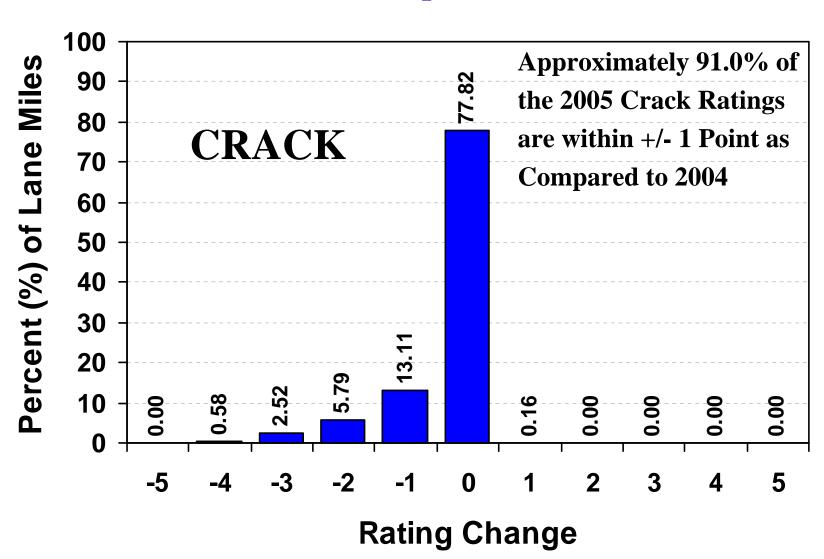
Crack Changes

2005 as Compared to 2004

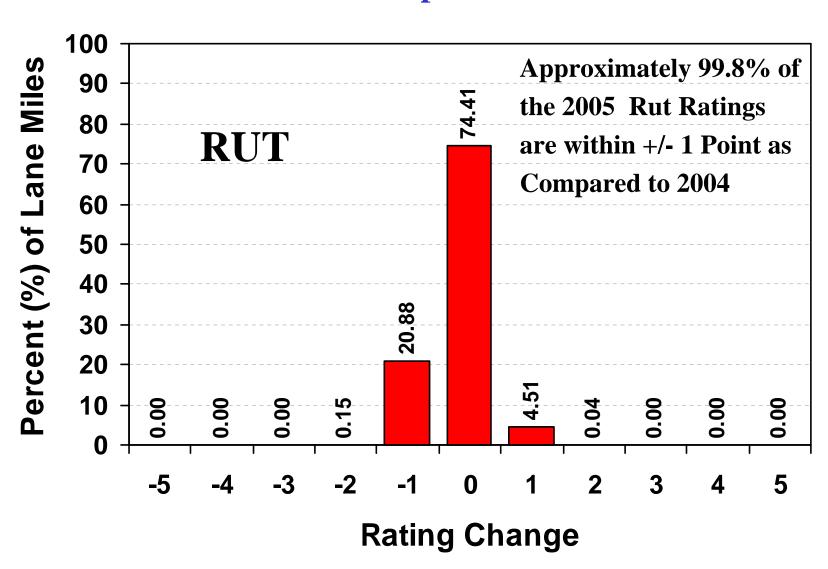
Rut Changes

2005 as Compared to 2004

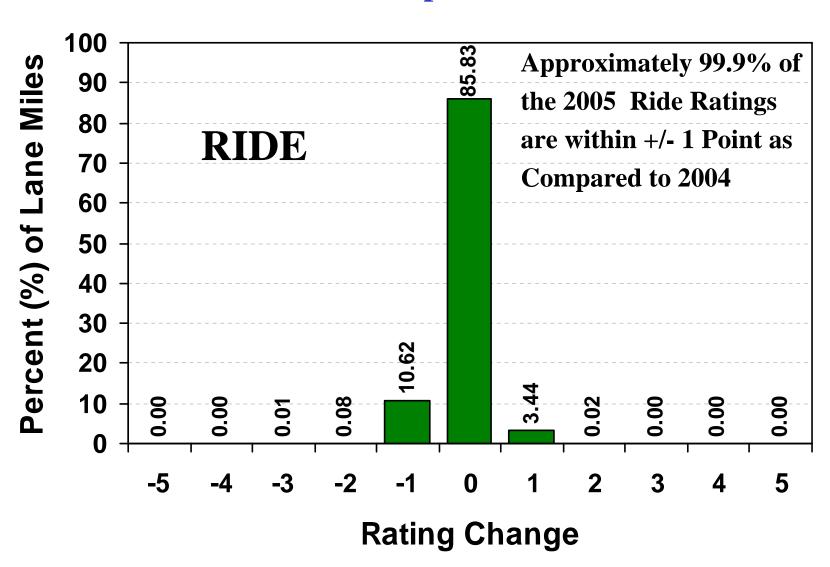
Ride Changes

2005 as Compared to 2004

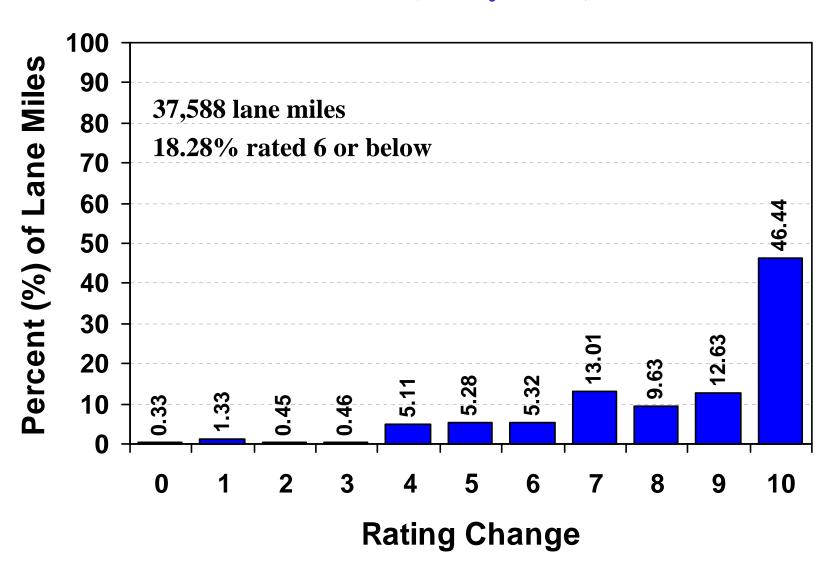
2005 Crack Distribution

Statewide (All Systems)

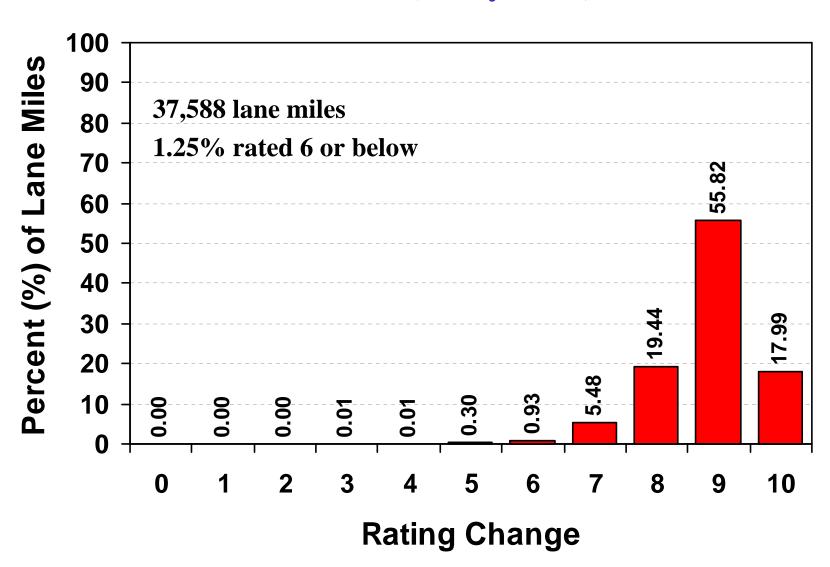
2005 Rut Distribution

Statewide (All Systems)

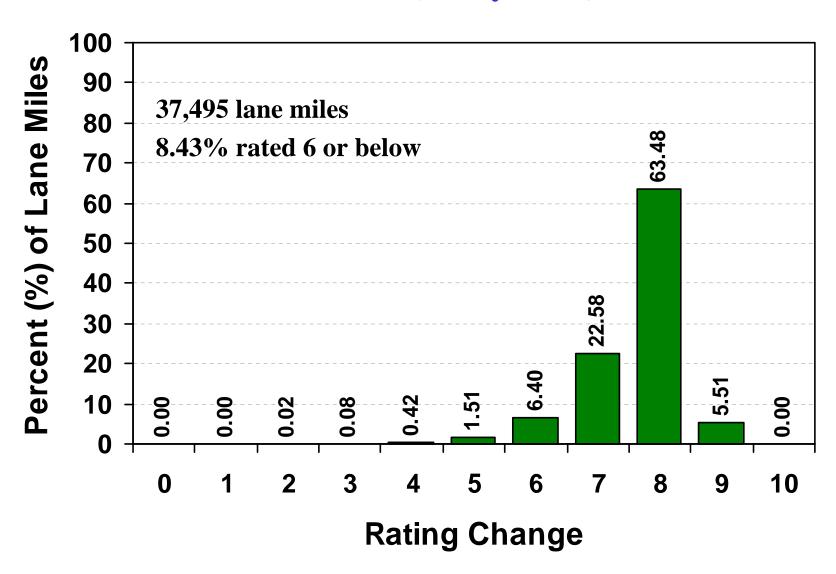
2005 Ride Distribution

Statewide (All Systems)

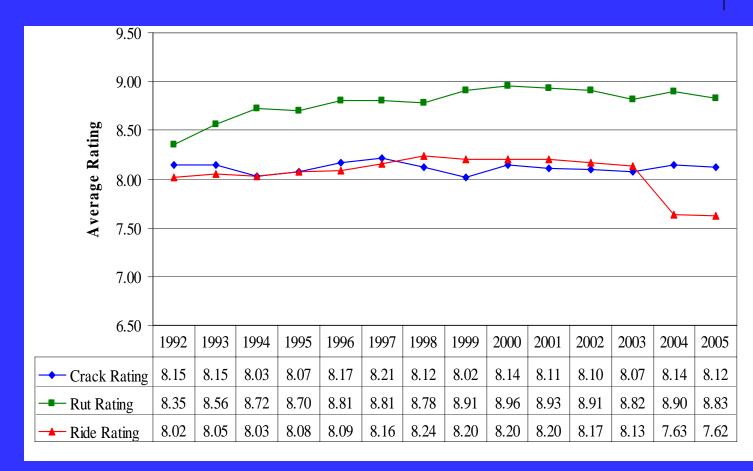
Historical Distress Ratings

All Systems (All Districts)

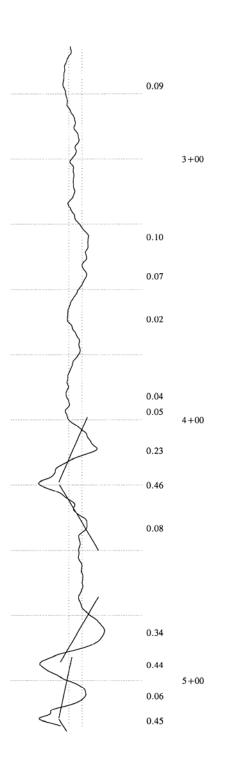
LIGHTWEIGHT PROFILER TRACE

PROSCAN - PROFILOGRAM SCANNING SYSTEM VERSION V4.56 - DEVORE SYSTEMS, INC.

Station 0+00.0 to 5+28.0 Segment length 21.12in (528ft, .100mi)

Scallop (Filter 15)

minimum height 0.020 in minimum width (300:1) 0.08 in resolution 0.01 in Blanking band 0.20 in Defect template height 0.30 in

Profile Roughness Index 29.8 in/mi

Defect at 4+11.5 Bump 4+39.0 Bump

4+82.0 Bump 5+05.5 Bump

5+25.0 Bump
