## **Strength of Repaired Piles**

**Jeffrey Fischer, Gray Mullins and Rajan Sen**  
Department of Civil and Environmental Engineering

**March 2000**

**A Report on a Research Project Sponsored by the  
Florida Department of Transportation  
Contract BB-036  
Tampa, Florida**

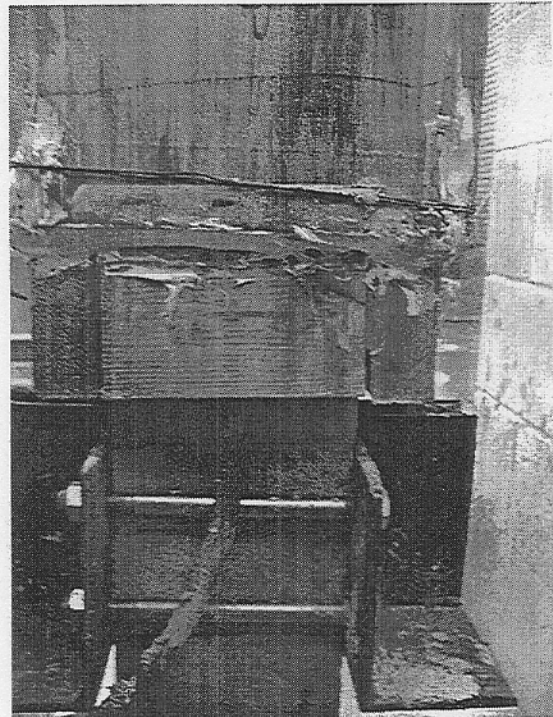
**Figure 5.5** Details of Repair Formwork

Pile Jacket Formwork

Water Tube for Filling and Draining

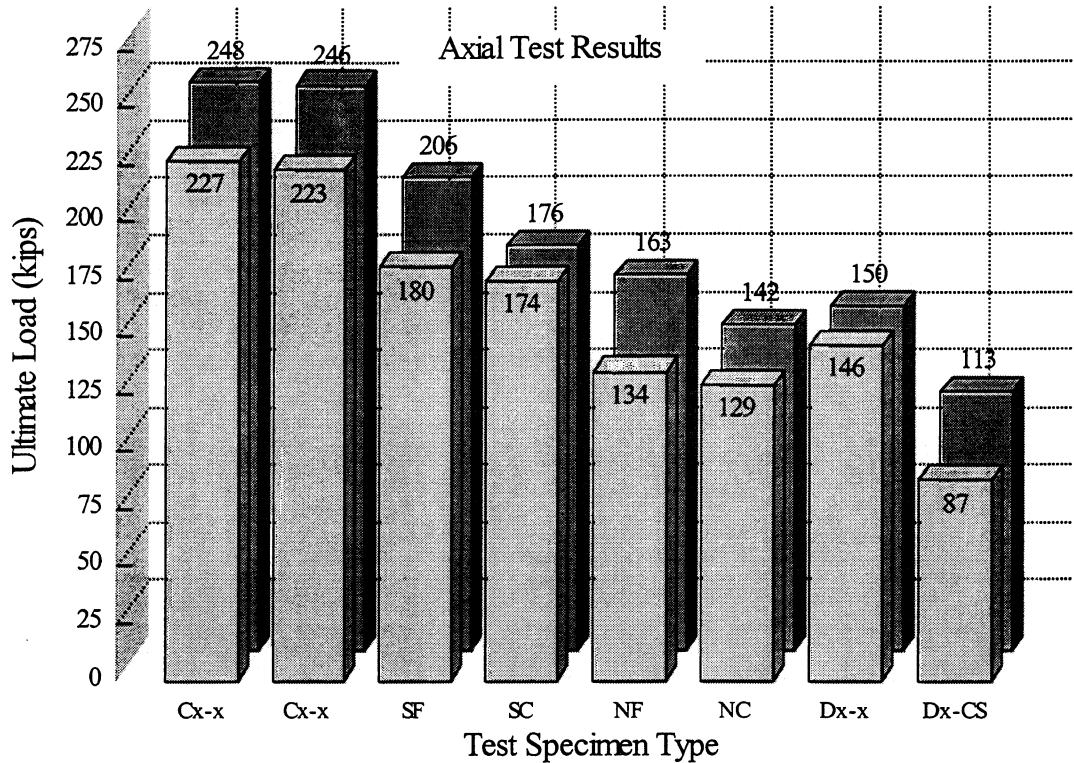
**Figure 6.2** Summary of All Phase I Axial Test Capacities.

Inspection of Table 6.3 shows that Type V structural repairs are quite effective regaining over 70% of the original capacity. In contrast, the Type II non-structural repairs were far less effective. In particular, Type II repairs for formed surfaces showed practically no gain in capacity (148.7 vs 147.8 kips). As a result of this, the axial response of non-structural repairs was the focus of the Phase II investigation (see Chapter 9).
