Load Test on Sure-Lock Square Pile Splice

April 24, 2002

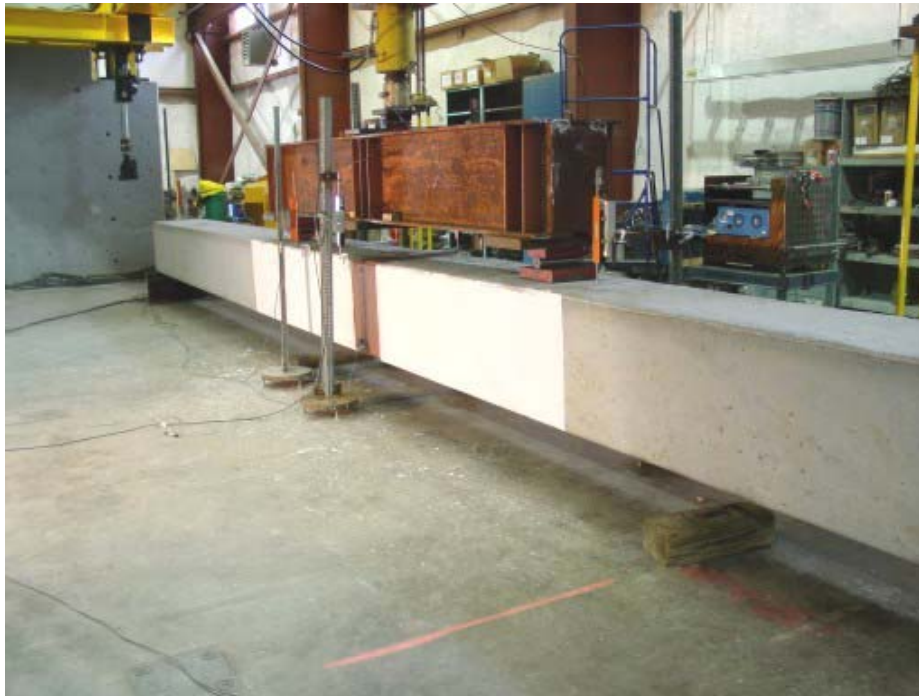
Figure 2

A single actuator provided the two point loads through the use of a steel beam as can be seen in Figure 2. The steel distribution beam was composed of two W 21x68 sections connected together.

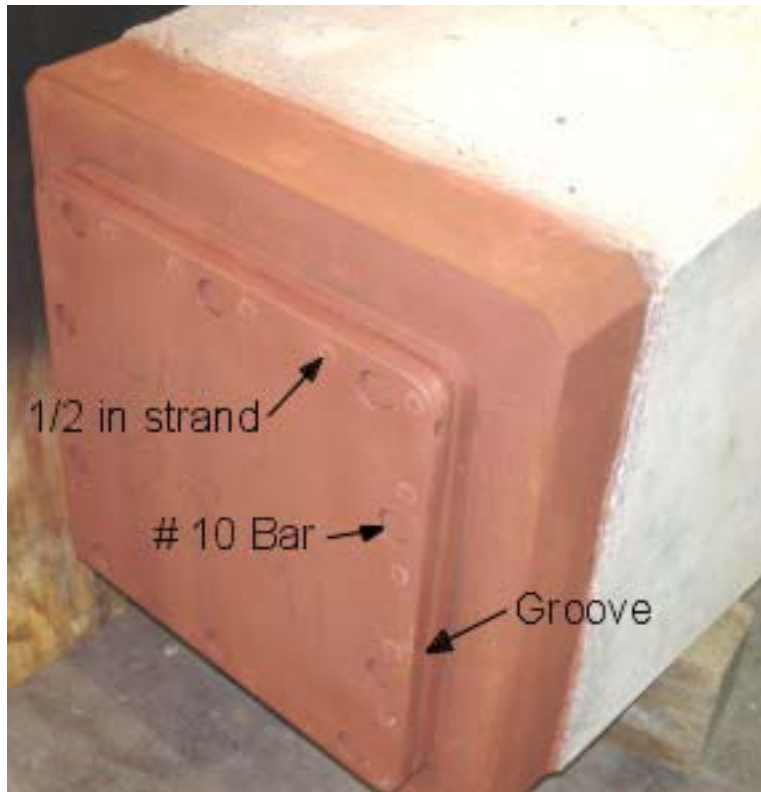
Figure 3

The splice is composed of 3 components, a male end, shown in Figure 3, a female end, shown in Figure 4 and the locking bars, also shown in Figure 4.

The locations of the # 10 reinforcing bars, the prestressing and the groove for the locking bars are noted in Figure 3. The reinforcing bars extend up to 7 feet into the pile to compensate for the development length of the strands.

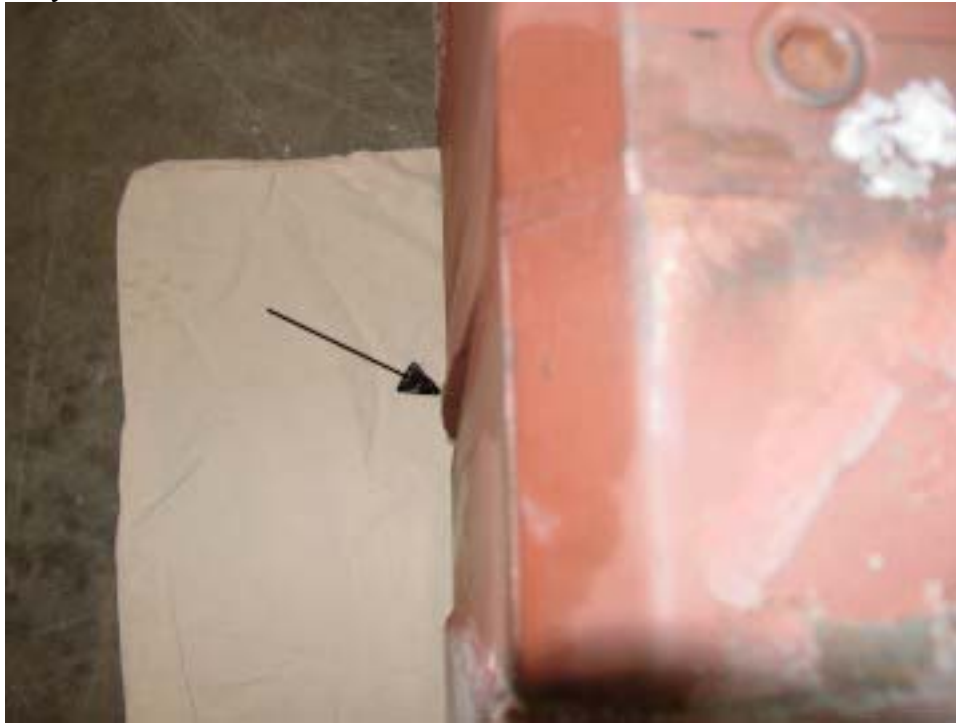
The specimens were limited in capacity by the splice. Figure 7 and Figure 8 show the condition of the splice at the conclusion of testing. The relative displacement between the halves of the splice is evident. This displacement is due to the rotation of the ring bar that comprises the female section of the splice. It is believed that the rotation of this section allowed the lock bars to slip out of the groove formed by the joining of the splice halves. The male section of the splice did not rotate since that would require bending a 2 inch plate with an effective cantilever of 1.1 inches over an 18.5 inch width. The torsional

stiffness of the ring bar in the female section over an unsupported length of 18.6 inches is significantly less.

The rotation of the female section of the splice was the limiting component of the splice moment capacity. However, another aspect of concern was the behavior of the concrete

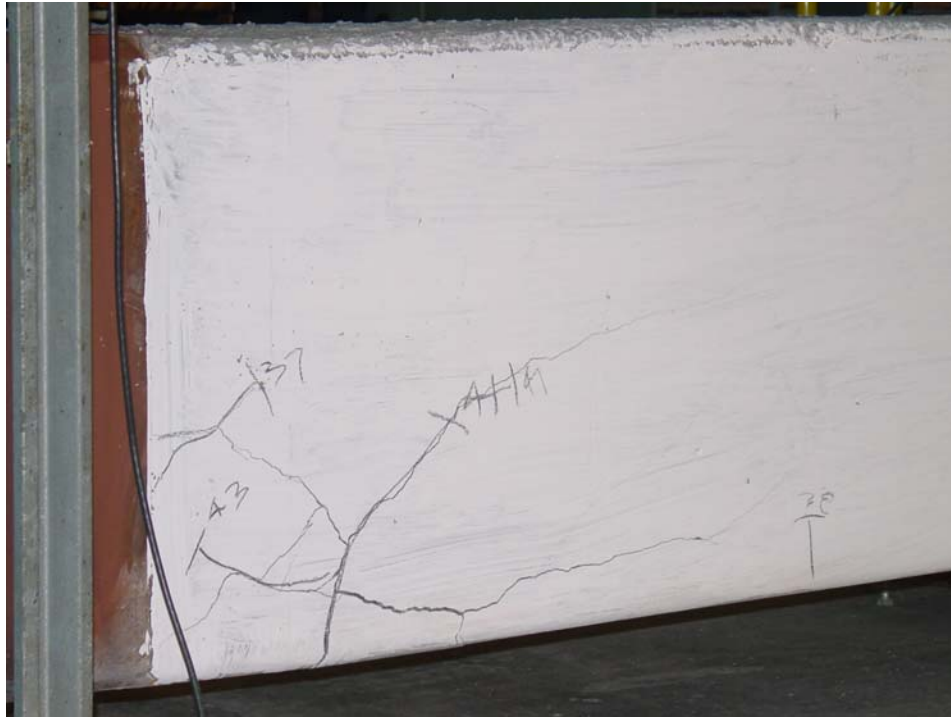
section of the pile adjacent to the female half of the splice. Figure 9 shows the cracking on the side of the pile with the female splice section. This can be contrasted with Figure 10, which shows the cracking on the male side of the splice.
