Aluminum Picket Weld Test

Written By: Will Potter, E.I.

Overview:

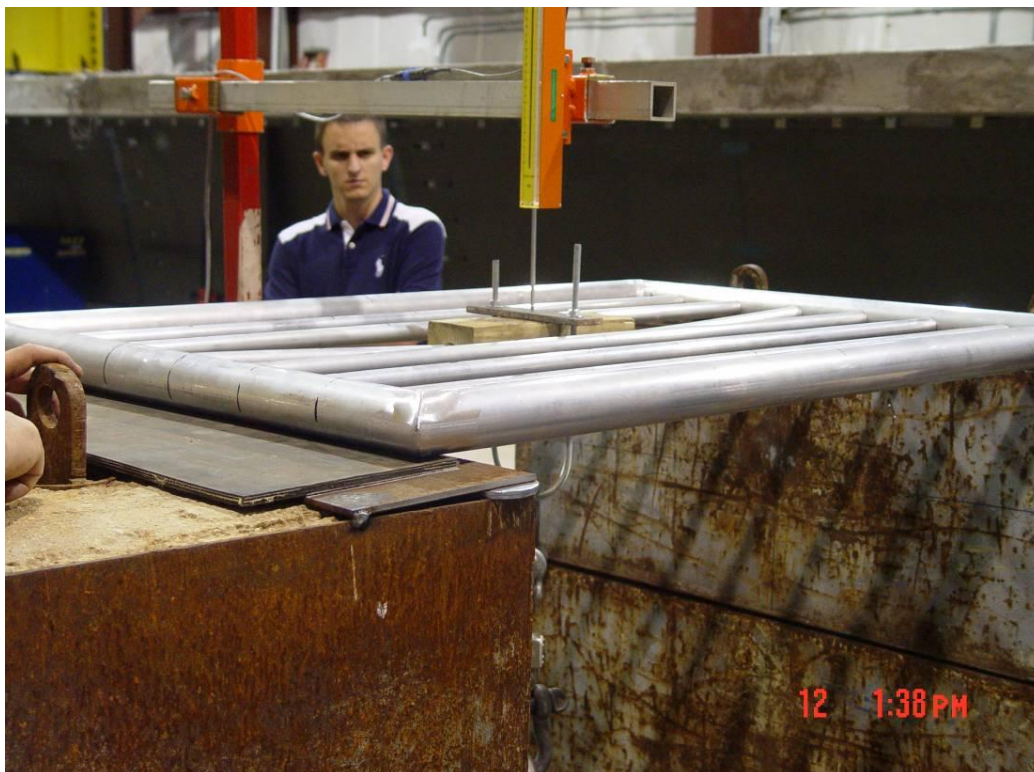
Figure 1: Panel and Test Layout

To perform the tests, two aluminum railing panels were built according to the *Design Standards*, one welded with 5356 filler wire and the other with 4043 filler wire. The picket connections were welded with a 3/16" fillet weld; however, further observations show that it is more of a penetration weld on two sides due to the lack of coping and beta limitation. The panels were constructed with a Type B connection, which allows one end to be non-welded. Each panel contains six 3/4" NPS Schedule 40 pickets. Each rail (outer tube) is a 2" NPS Schedule 40 pipe. All pipes were aluminum alloy 6061 – T6. The test setup consisted of placing 12" timber block centered on the length of the picket and applying a point load in the center of the block with a hydraulic actuator. The load and center displacement were recorded with a data acquisition system. The panel and test layout is shown in Figures 1 and 2.

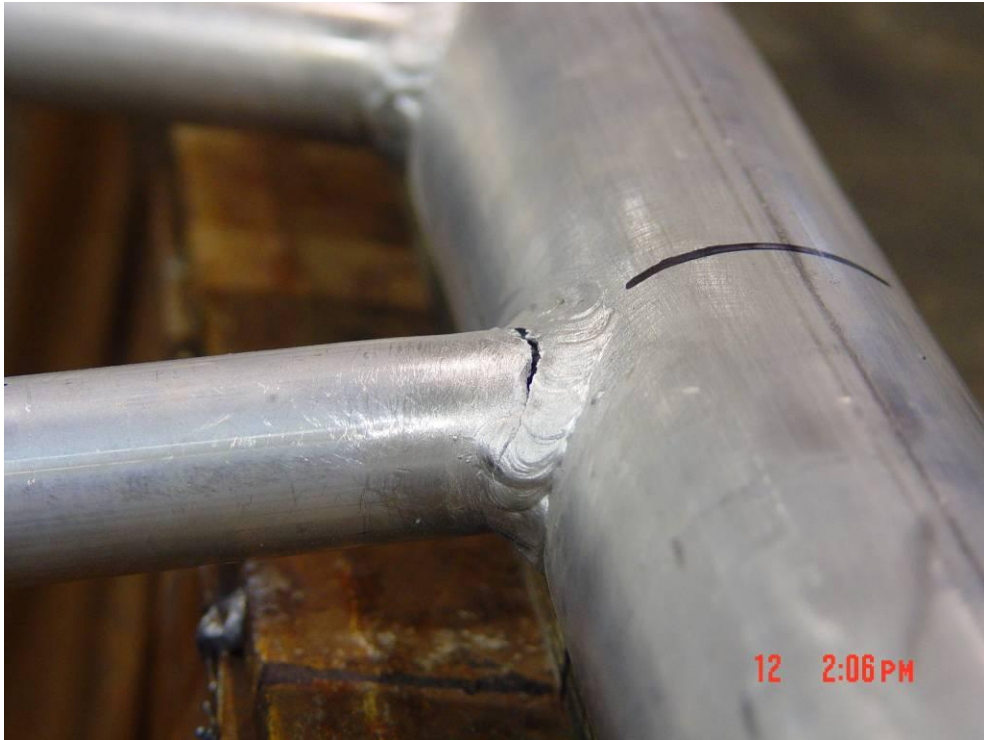
Figure 3: Fracture at base of weld – 4043 filler wire

The results of the tests revealed that the response of the picket to the applied load varies slightly with the type of weld metal used. Of the 11 tests that were performed, five on the 4043 filler wire and 6 on the 5356 filler wire, only two instances occurred where the base of the weld metal fractured. The fractures were on the pickets that had 4043 filler weld, shown in Figure 3. The other tests were halted based on a drop in load due to the non-welded end slipping out of the rail as shown in Figure 4. The test data given in Table 1 provides the maximum attained load with the failure type. Figures 5 and 6 plots the load versus displacement for all tests. The test data indicates that the maximum load values are disparate on the tests when the picket slips, which is due to the inside roughness of each pipe socket being inconsistent.

The maximum loads, 986 lbs and 980 lbs, for the 4043 weld metal occurred on the pickets with the fractured weld. The 5356 weld metal had more strength exceeding these values by 6% or more on three separate tests before slipping. The load versus displacement graphs on both types of welds suggest that the pickets yielded between 400 and 600 lbs. Some of the pickets, once yielded, began to slip and eventually developed membrane action before the load drop (Test 2 and 4 – 4043 and Test 3,5, and 6 – 5356). Three tests also demonstrated membrane action immediately after yield with very little slip (Test 1 and 3 – 4043 and Test 1 – 5356). Membrane action occurs once a large amount of deflection has taken place and the picket end is locked in the rail socket, thus allowing the applied load to be resisted axially by the member. Once the load is large enough the weld metal fractures as in the two 4043 welds or slip occurs.
