FDOT Research Project Number BDV29-977-05

**NON-DESTRUCTIVE TESTING (NDT) OF A SEGMENTAL CONCRETE BRIDGE
SCHEDULED FOR DEMOLITION, WITH A FOCUS ON CONDITION ASSESSMENT
AND CORROSION DETECTION OF INTERNAL TENDONS**

Florida International University

May, 2017

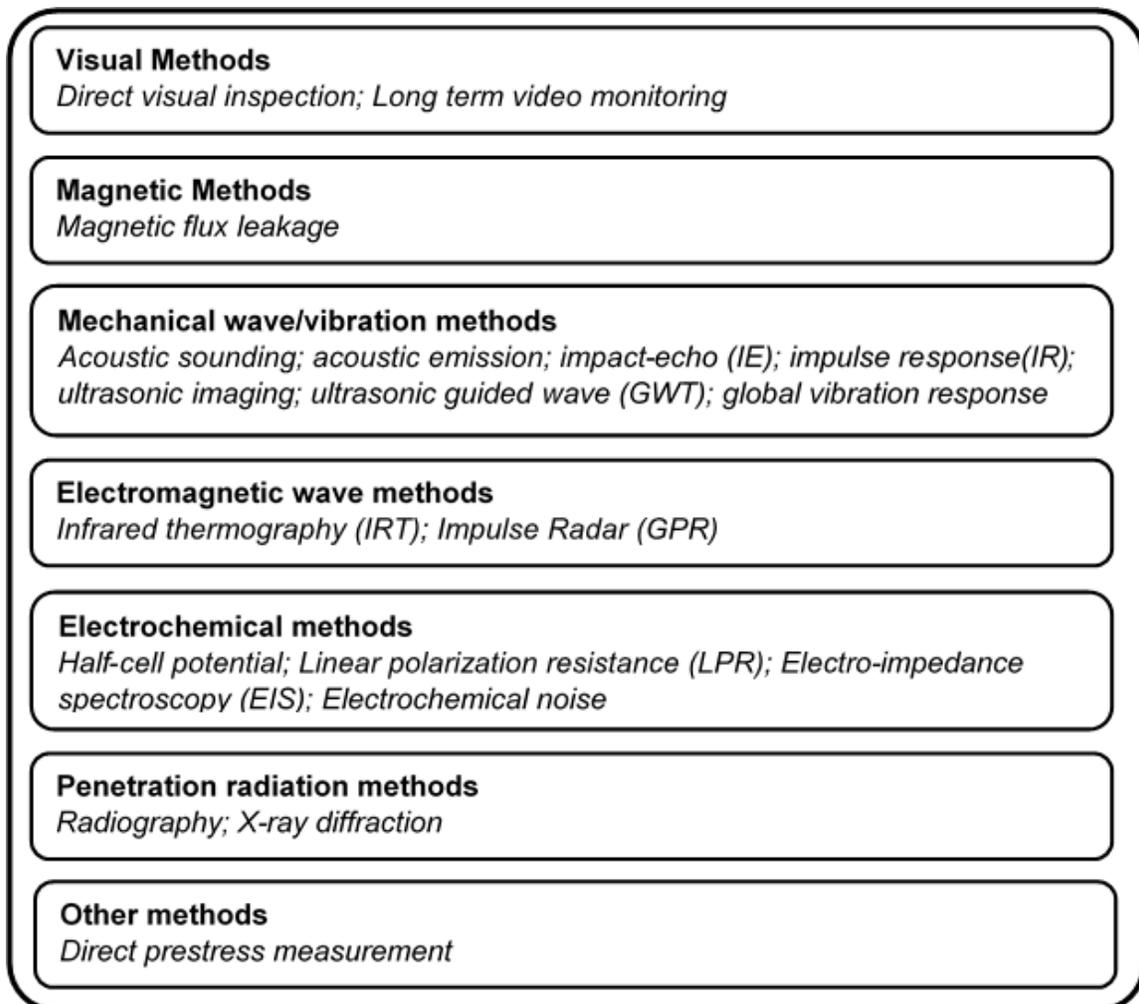
Figure 1-1: Overview of NDE methods applied to inspect condition of PT systems (Azizinamini & Gull, 2012b).

In general, NDE technologies can be grouped per their underlying phenomenological basis, as illustrated in Figure 1-1. In the following sections, select meritorious, commercially available and commonly applied NDE technologies for condition assessment of PT and stay cable systems are reviewed. In the following sections, conventional applications of these technologies and their reported advantages and limitations in structural systems with cementitious materials (including prestressed bridge components) are highlighted. However, the current work sought to identify possible novel applications of these technologies to assist in bridge health assessment.

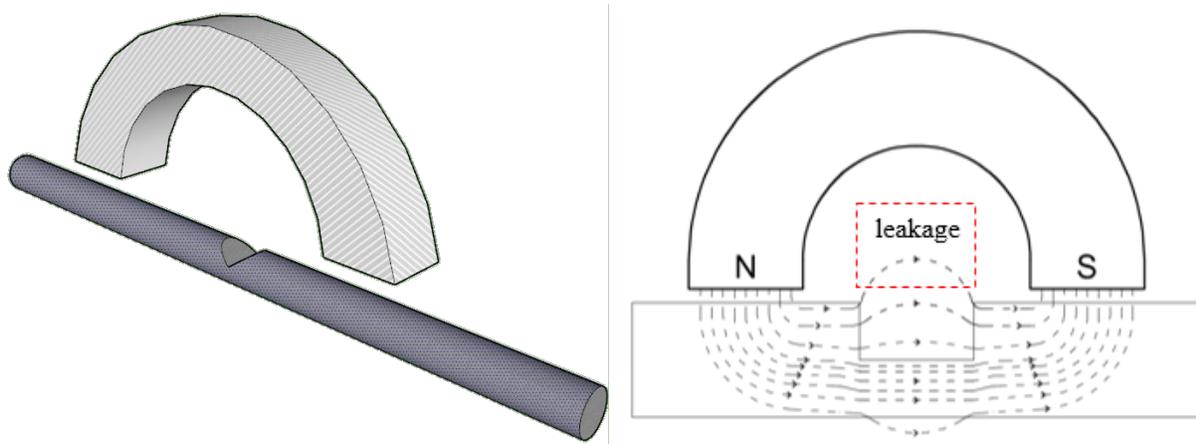
can be used to detect the location and the size of the defect. The extent of metal loss can be identified by the corresponding intensity of the defect leakage flux signals.

Figure 1-4: Magnetic flux leakage.

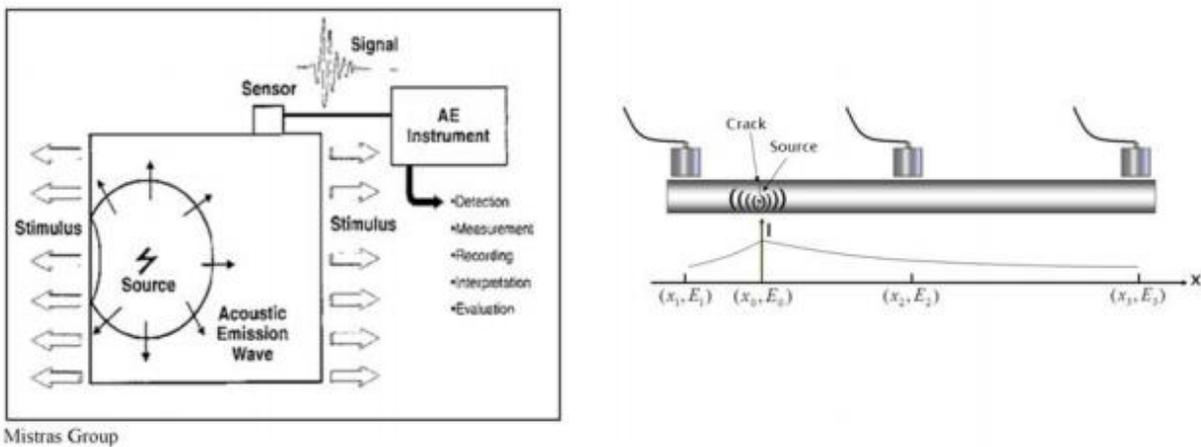
The corrosion process induces defects (in service wire fractures) in PT tendons, which generate acoustic emissions. These radiated “acoustic emissions” are detected by surface mounted sensors and the data acquired by several sensors is used to locate the defect and, in some cases, provide additional information about the defect. AE is well established technology and field studies have demonstrated its utility. Although the theory of this technique is simple and well established, the main problem in field application is to distinguish the emission caused by defects from ambient emissions. Only breaks occurring after the installation of equipment can be detected. Vibration sensors are strategically mounted on structural members. These vibration sensors are monitored to “listen” for fracture events due to corrosion of wire strands in the tendons. With multiple sensors, the locations of such events can be detected through triangulation, as illustrated in Figure 1-5.

Figure 1-5: AE concept (left) and source location with multiple sensors (right).

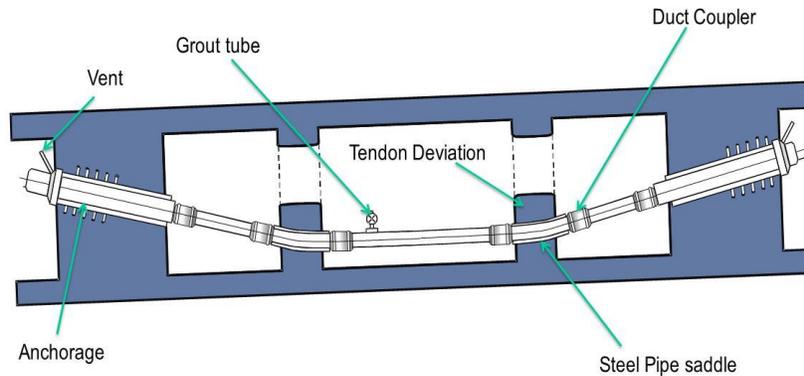
In PT systems there are two types of tendons, internal and external. The external tendons in segmental systems are used to provide: (1) primary tendons in span by span construction, (2) supplemental tendons in balanced cantilever bridge construction, (3) future tendons, and (4) added tendons for repair. The main elements of external duct system in segmental post tension systems (in span-by-span construction) are shown in Figure 2-4.

Figure 2-4: Elements of external ducts in segmental post-tensioning systems.

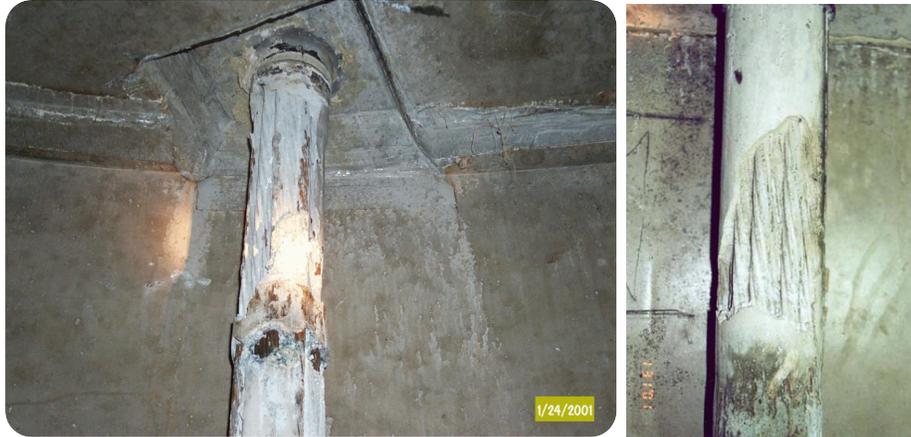
Major problems observed with external ducts are: (1) cracked duct, (2) grout voids, (3) un-set, wet, soft, and chalky grout, (4) contaminated grout, (5) strand corrosion, and (6) tendon failure. The existence of void does not necessarily translate to having corrosion at those locations. Figure 2-6 (left) and Figure 2-6 (right) show examples of strand conditions in vicinity of voided areas in duct.

Figure 2-6: Corrosion activity in voided area (left) lack of corrosion activity in void area (right).

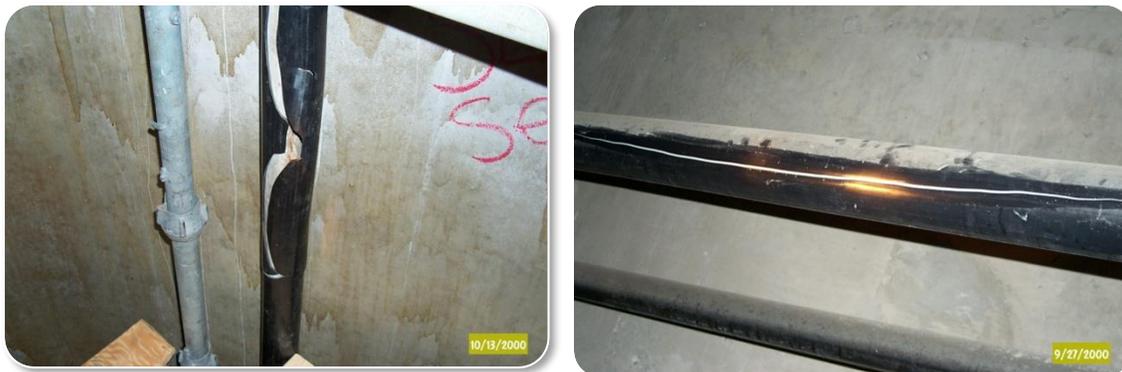
Figure 2-7 shows examples of cracking of the duct. These observed cracking are mainly related to old duct types used and were not created by grouting process. Cracking is mainly attributed to age and durability of the types of materials used. In some cases, corrosion of strands is observed at the vicinities of duct cracking. This is especially true when steel strands are exposed at cracked locations.

Figure 2-7: Examples of types of observed cracking of ducts.

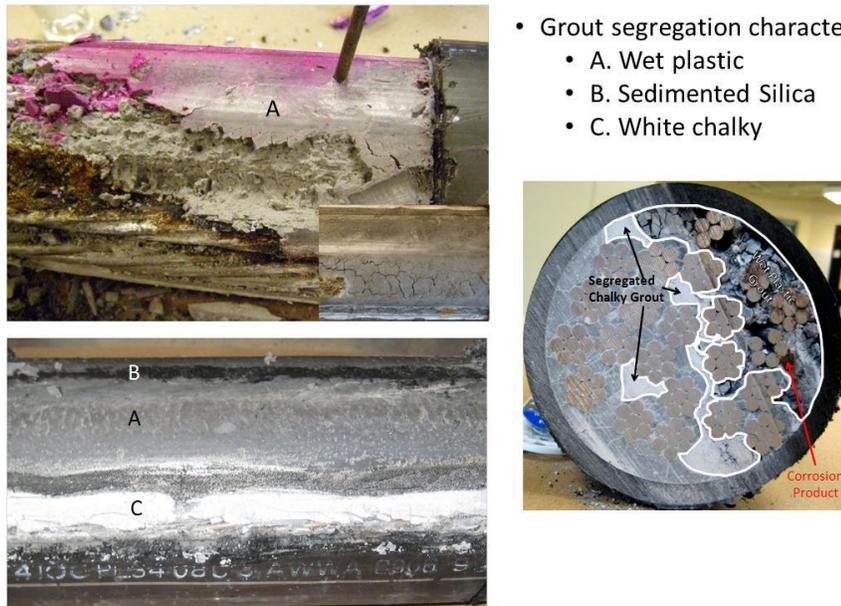
Figure 2-8: Condition of grout ten years after construction (photo courtesy of FDOT).

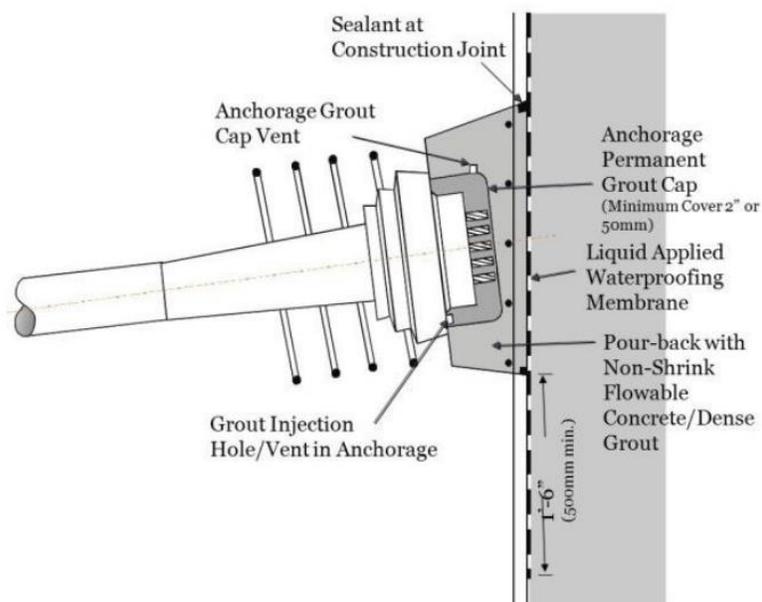
Similar to multiple protection layers for steel strands, recent practices are calling for multiple protection of anchorage regions, as shown in Figure 2-12.

Figure 2-12: Multiple layer protection system for anchorage regions.

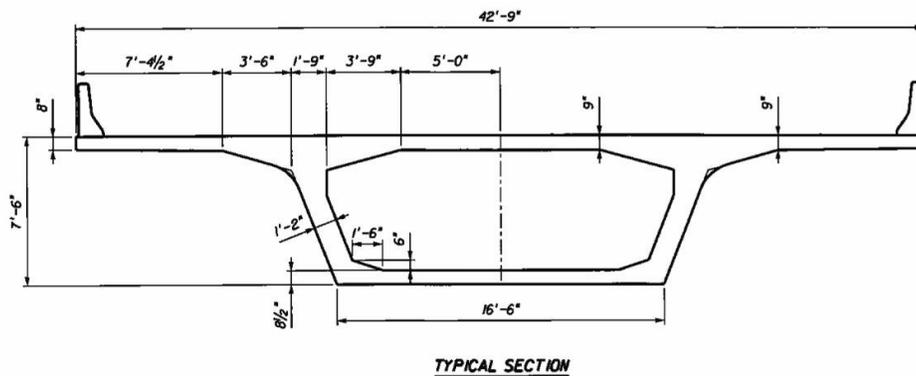
The deconstruction sequence plan was engineered by Finley Engineering Group, Inc. To properly evaluate the in-service structural condition of the bridge, the model by Finley Engineering Group, Inc., included a simplified construction sequence. To account for any locked-in effects, a time-dependent calculation was run. The construction sequence of the bridge was simulated, as per the plans, using the balanced cantilever method. Once the construction was finished, the effects of creep and shrinkage due to the 30-year service time frame were evaluated putting the structure in its current state so that the stress levels could be investigated. The deconstruction sequence was modeled step-by-step, as to produce accurate results ensuring stability and capacity at each stage. The AASHTO LRFD bridge design specifications, 2010 were used in the analysis (AASHTO, 2010). Figure 3-3 shows the box girder cross-section.

Figure 3-3: Dimensional drawing of typical box girder cross-section.

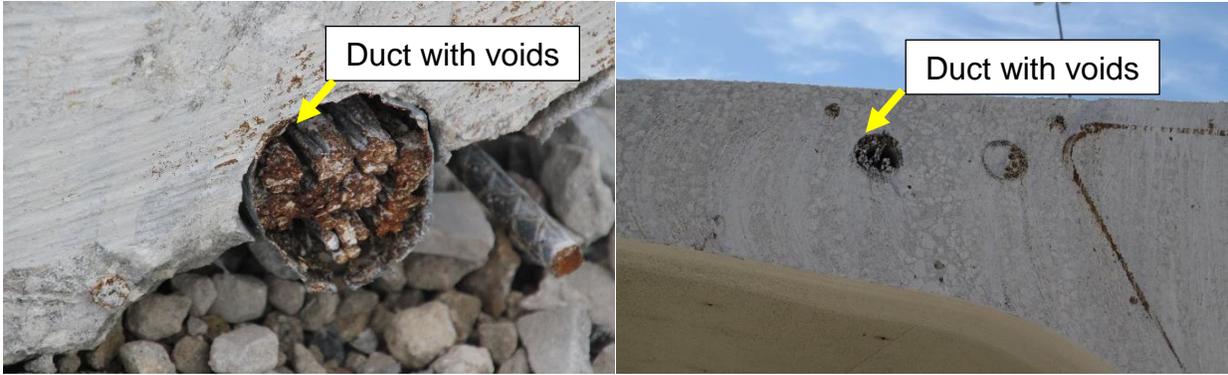
Cutting span 2 segment by segment allowed the FIU research team to perform an investigation of the post-tensioning system for voids and honeycombing in the concrete. Figure 3-9 shows photos of the duct exposed during the demolition. It is clear that voids exist in the ducts. These voids are where corrosion can easily occur.

Figure 3-9: Some ducts were fully grouted, and some other ducts were partially grouted.

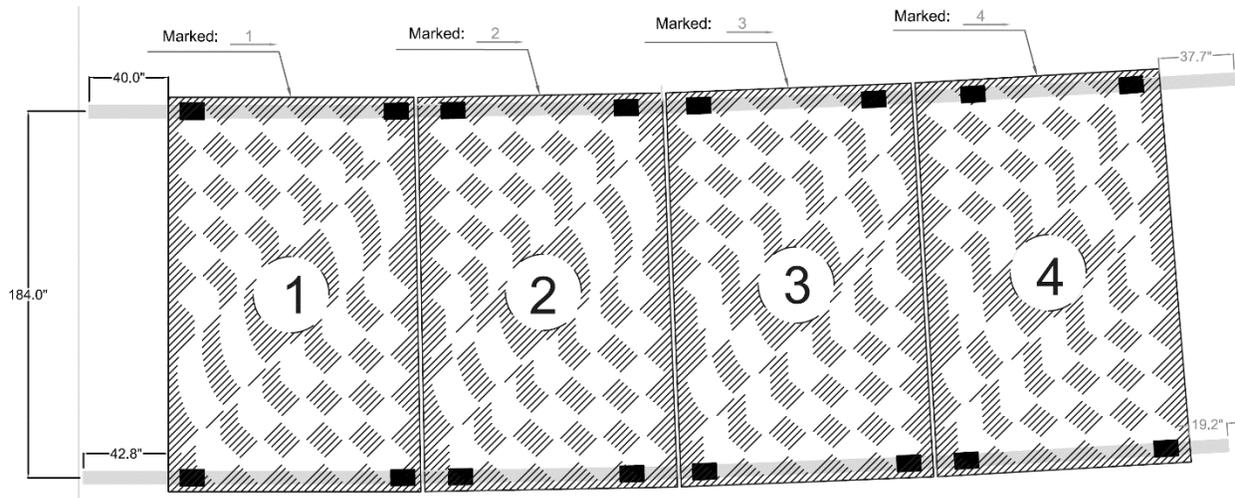
segments. The segments are shown with the shaded area and number as 1, 2, 3 and 4 for their proper arrangement.

Figure 3-14: Segment numbering and placement on barrier.

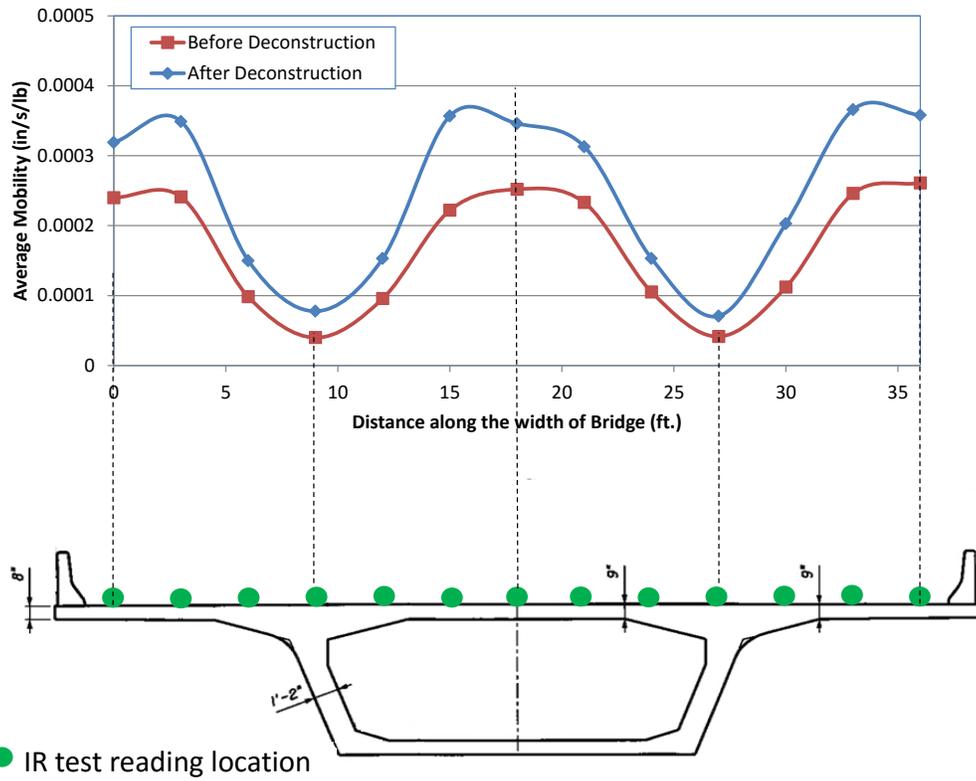
This fact is more clearly illustrated in Figure 4-7, which shows mobility across the width of the bridge over a typical cross-section of the bridge. Mobility values are low near the junction of the deck to the web of the section. High mobility values are noticed at the middle and edges of the section. At the connection of deck and webs of the box, we have more thickness and the mobility decreased in these regions. The reason is reduction in plate thickness corresponds to a large increase in mean mobility, because flexural rigidity is proportional to the thicknesses raised to the third power.

Figure 4-7: Mobility along the bridge width at 45 ft along the length of span 3.

Figure 4-7 also show mobility curves for the first test (before demolition) and second test (after demolition). The blue curve shows that mobility in the second test is higher than the red curve, which plots mobility in first test. This may arise from a decrease in global stiffness of the bridge system due to the partial deconstruction at the time of the second test. A similar increase in the mobility of the bridge along the length of the bridge is observed in Figure 4-8, which plots similar data for the centerline along the length of the bridge.

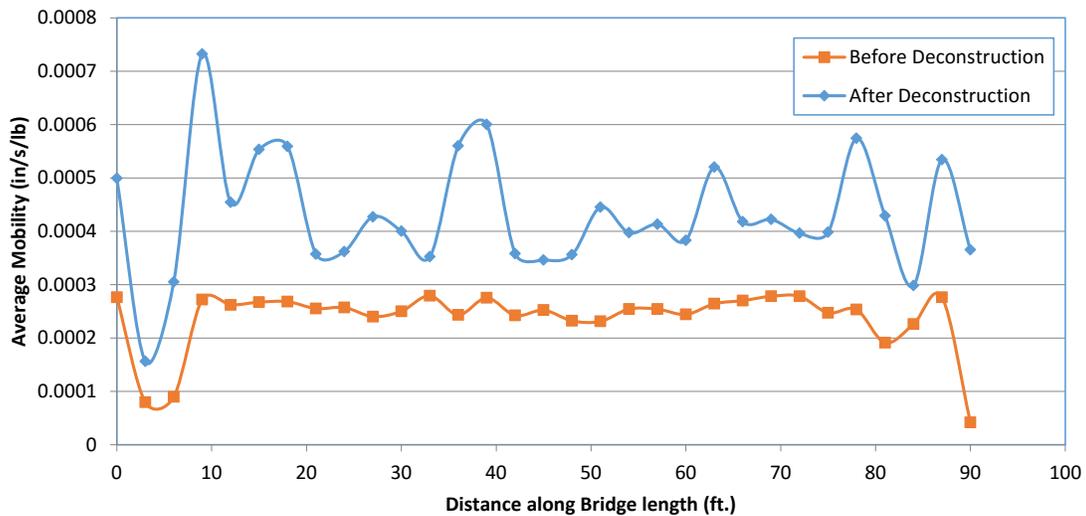
Figure 4-8: Mobility along the length of span 3 of bridge at the middle of section.

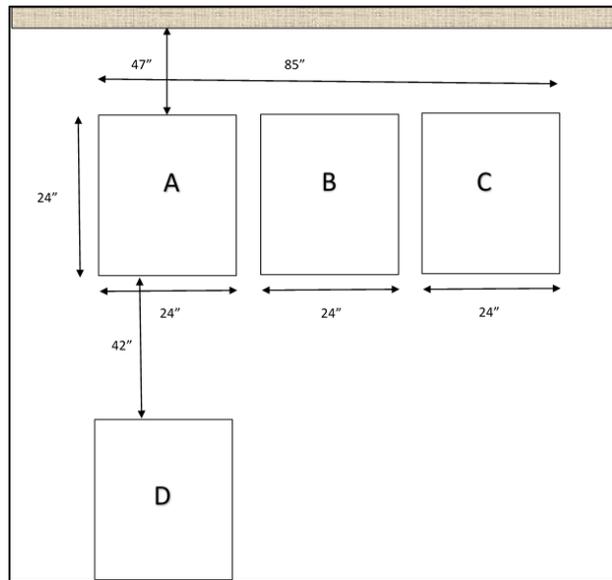
Figure 4-9: Schematic of surface IRT.

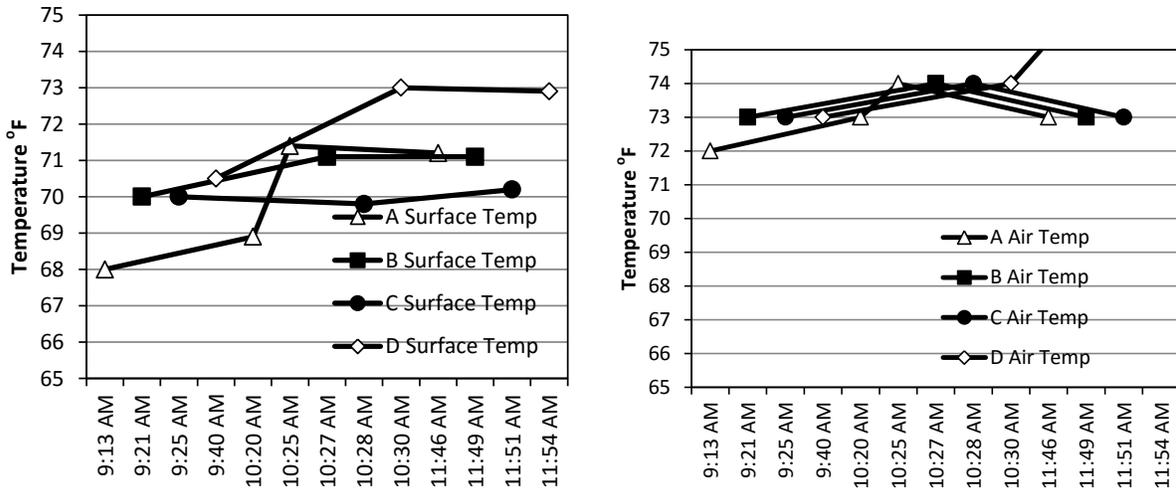
interval of several hours. Figure 4-11 (left) gives the surface temperature readings for each test location after approximately 2 hours and ambient air temperature using thermometer given in Figure 4-11 (right).

Figure 4-11: Evaluation of surface temperature from infrared camera (left) and ambient air temperature from thermometer (right).

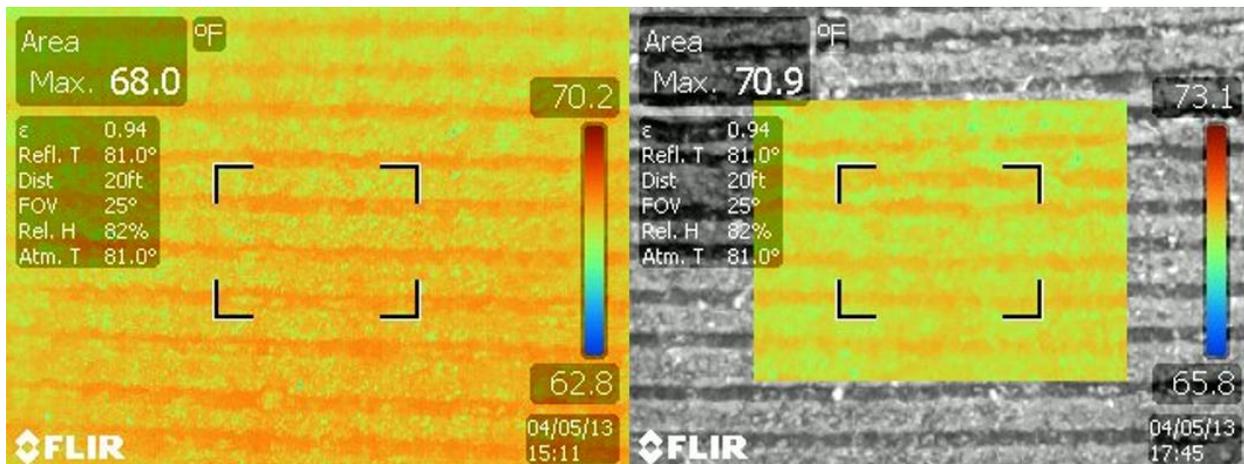
The texture on the bridge deck was apparently visible in the thermal images in Figure 4-12 and Figure 4-13. The images at point A and B as well as the surface temperature evolution in Figure 4-11 (left) shows the expected temperature increase due to ambient heating. Whereas the uncovered deck surface increases to near ambient air temperature, the covered regions remained a few degrees cooler than the covered regions indicative of the shading and partial moisture retention.

Figure 4-12: Recorded thermal image at point A at 9:13 am (left) and 11:46 am (right).

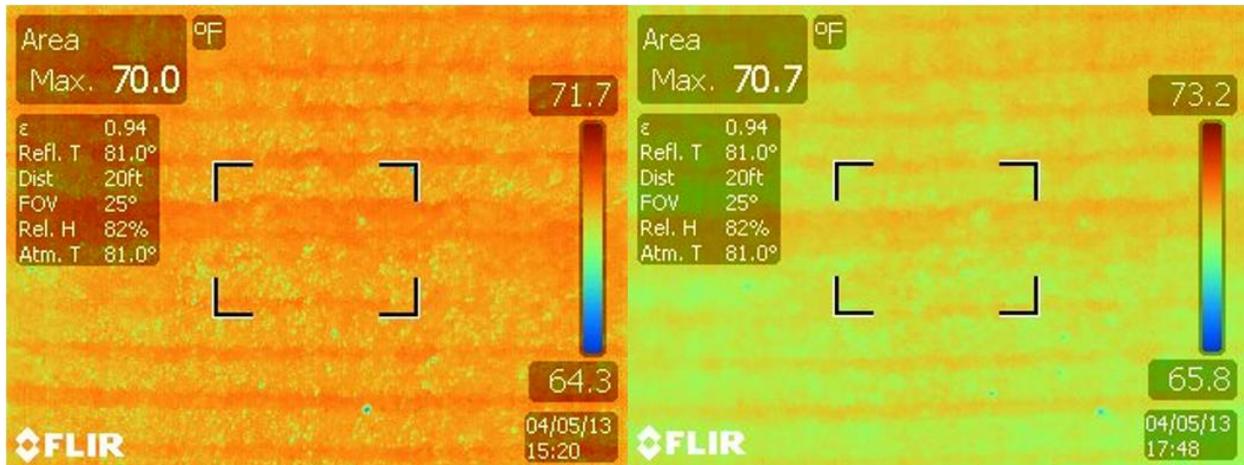
Figure 4-13: Recorded thermal image at point B at 9:21 am (left) and 11:49 am (right).

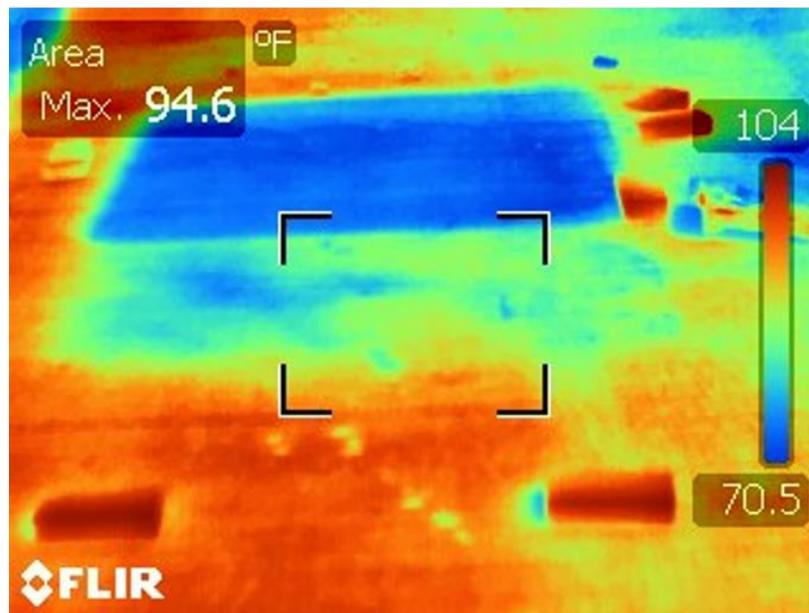
Figure 4-14 shows sensitivity of the thermal camera to differences in temperature. Test locations can be seen in the figure with A in red and C in dark blue. In natural heating condition, it is shown that differential cooling conditions can be achieved. However, the lack of apparent defects at the concrete deck did not allow for discrimination for surface anomalies.

Figure 4-14: Thermal image of test site. Colors show differential surface temperatures of test locations A-C where the cooler covered regions are shown in blue (~70°F); the warmer exposed surfaces are shown in orange/red (~73°F).

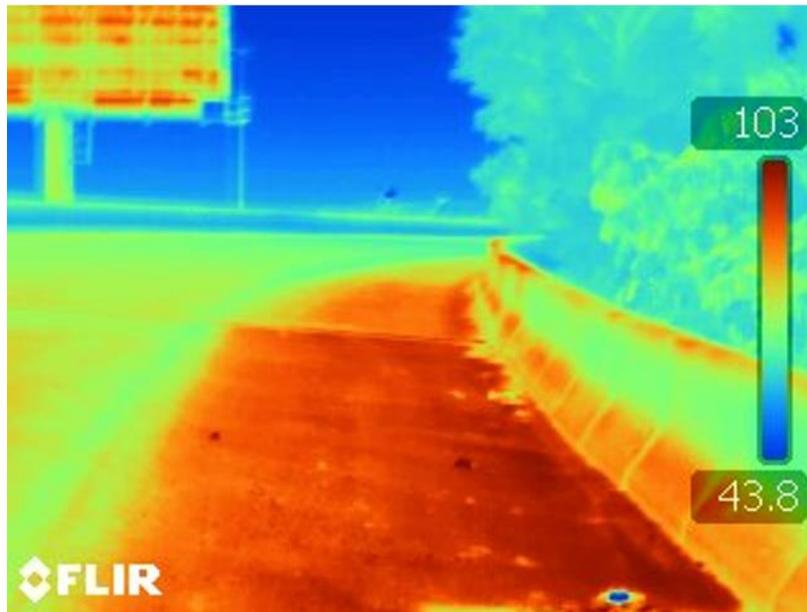
A typical infrared image is shown in Figure 4-15. Features readily visible include the lane striping, drainage hole and segment joints. Variations in moisture on the deck and barrier walls were apparent as well.

Figure 4-15: Typical infrared image on bridge deck.

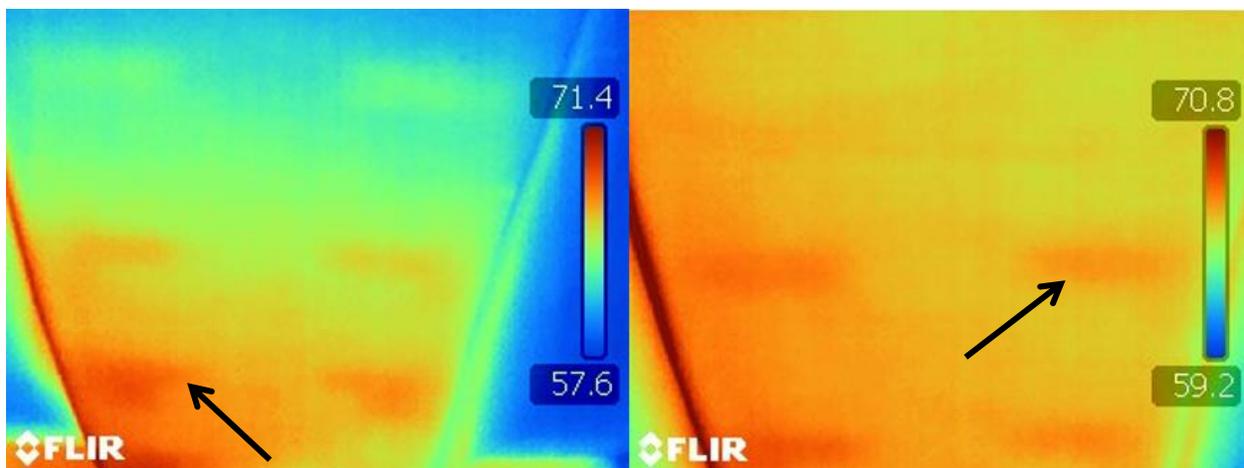
Figure 4-16: Infrared image of bottom of bridge segments captured from below bridge deck. Arrows point to expected locations of concrete deviators.

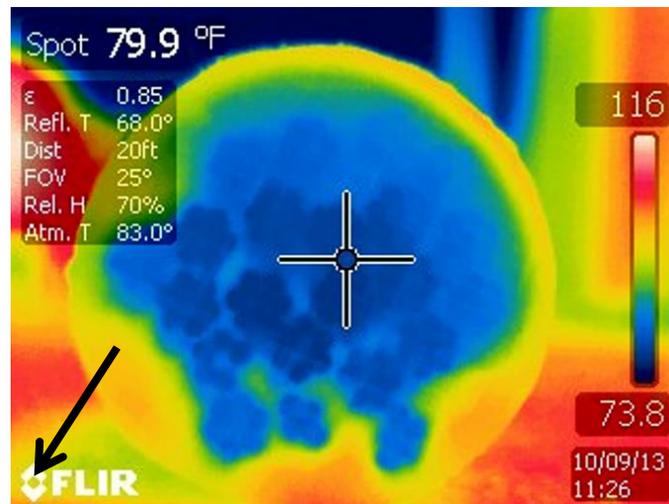
Figure 4-17: Infrared thermography of tendon cross-section with deficient grout. Arrow shows location of deficient grout.

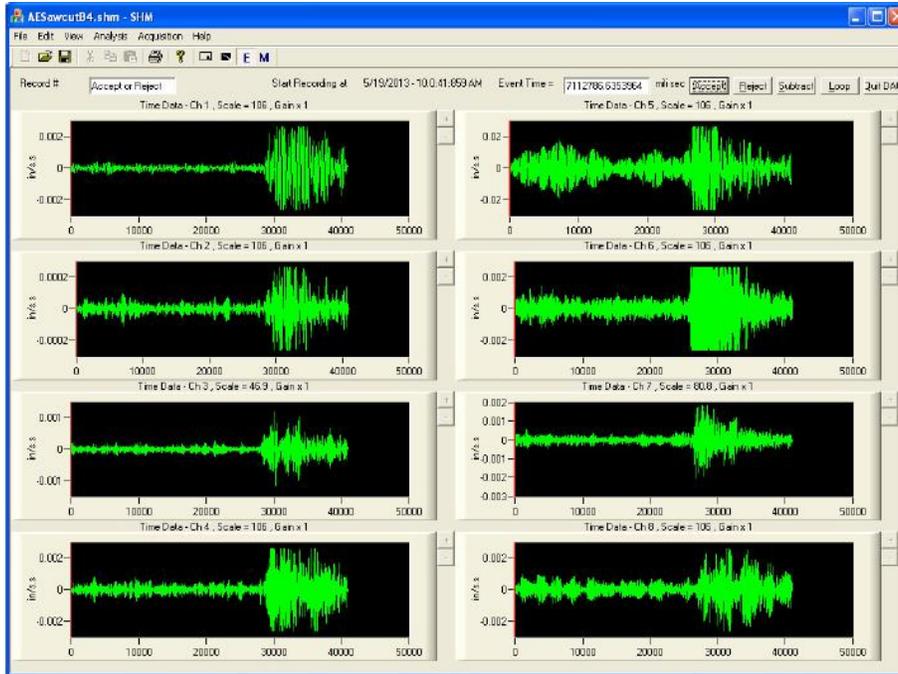
Figure 4-23: Example data during saw cutting for all 8 accelerometers.

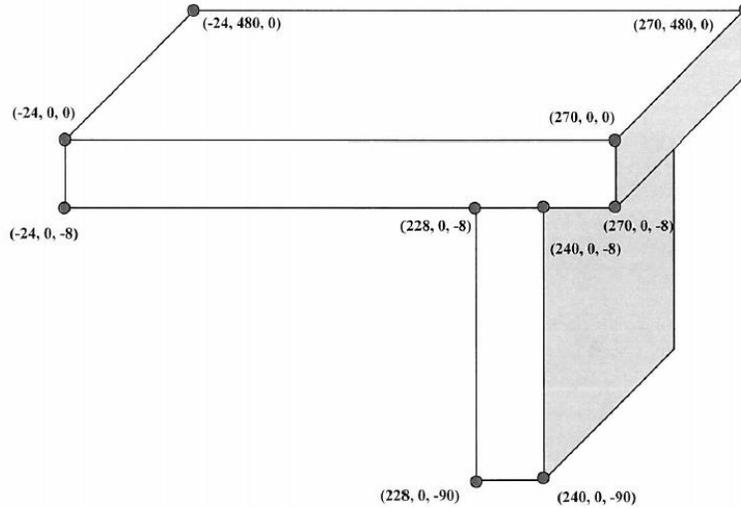
Figure 4-24: Simplified 3-D model schematic, coordinates in inches, referenced to accelerometer positions (not to scale).

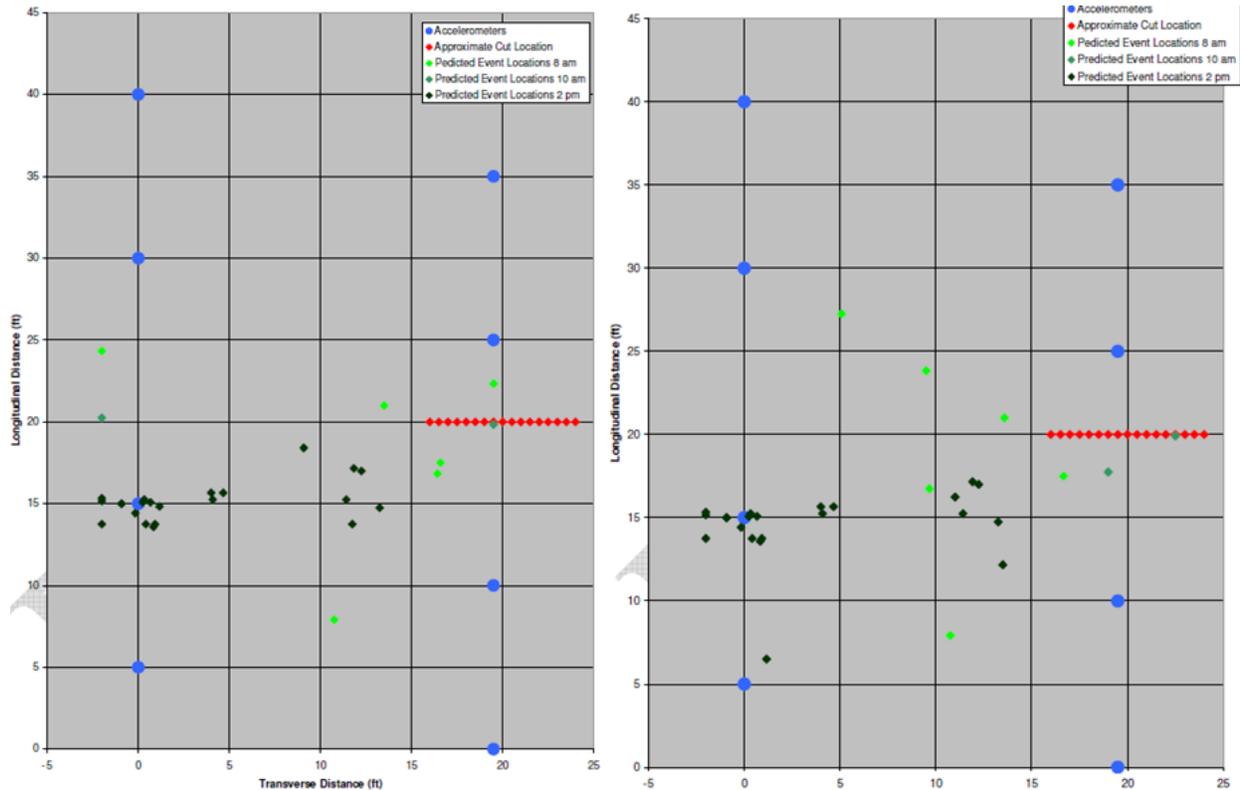
Figure 4-25: Predicted AE tendon saw-cut break event locations, plan view, using 2-D (left) and 3-D (right) model.

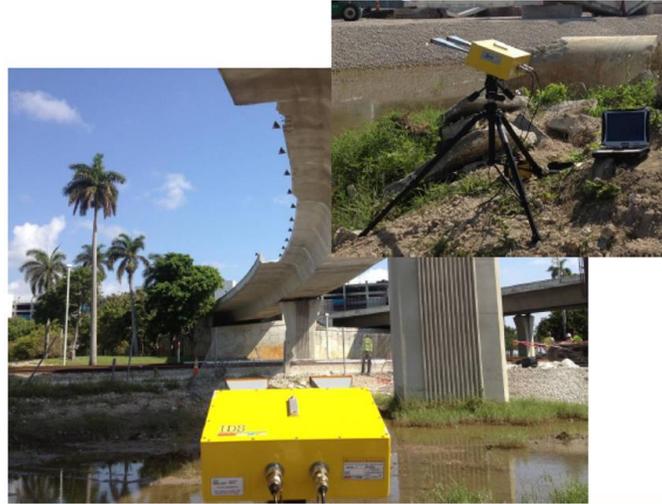
Figure 4-26: IBIS-S antenna shows system orientation and corner reflectors.

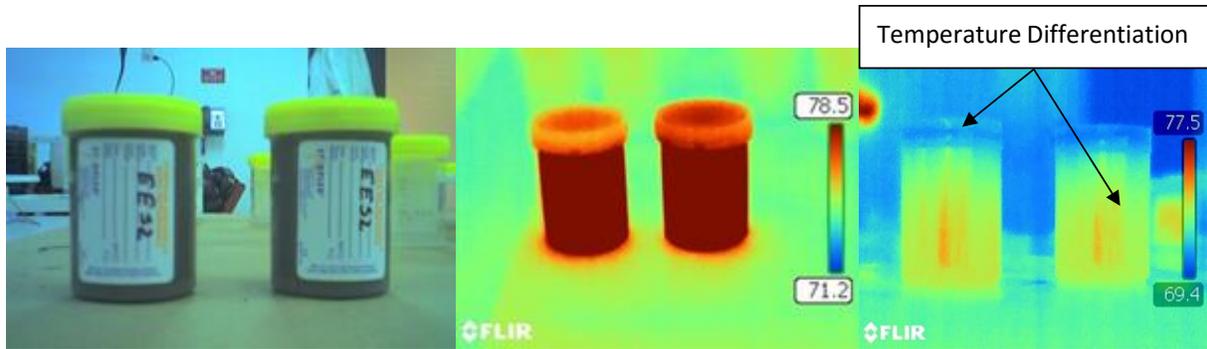
Figure 5-10: Laboratory sample (left) and temperature variation: at the time of casting (center); after 4 hours of casting (right).

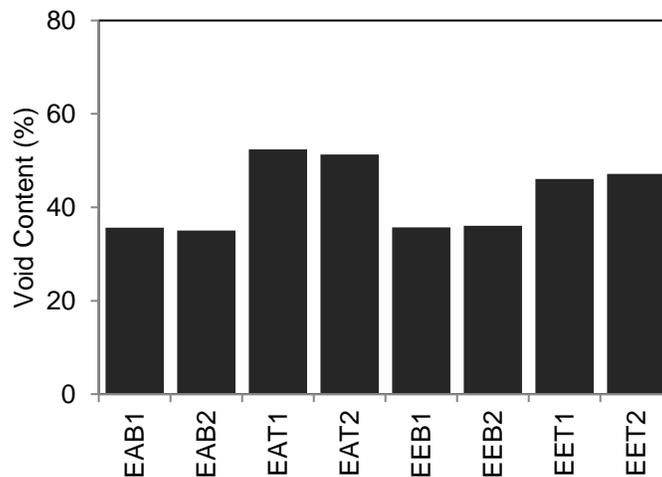
Figure 5-14: Void content within the test sample.

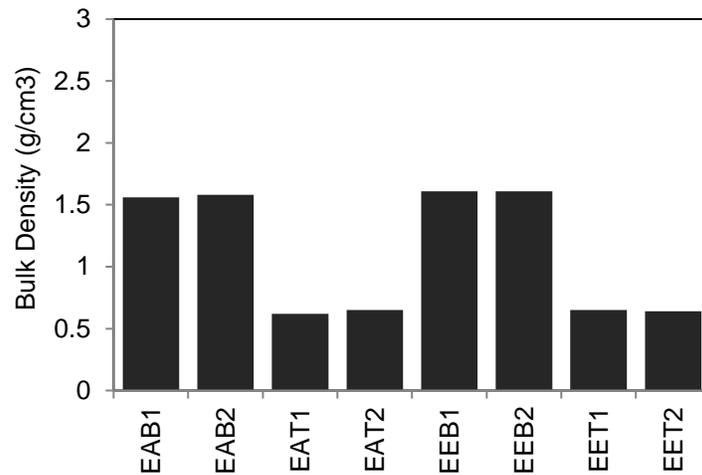
Figure 5-15: Density variation within the test sample.

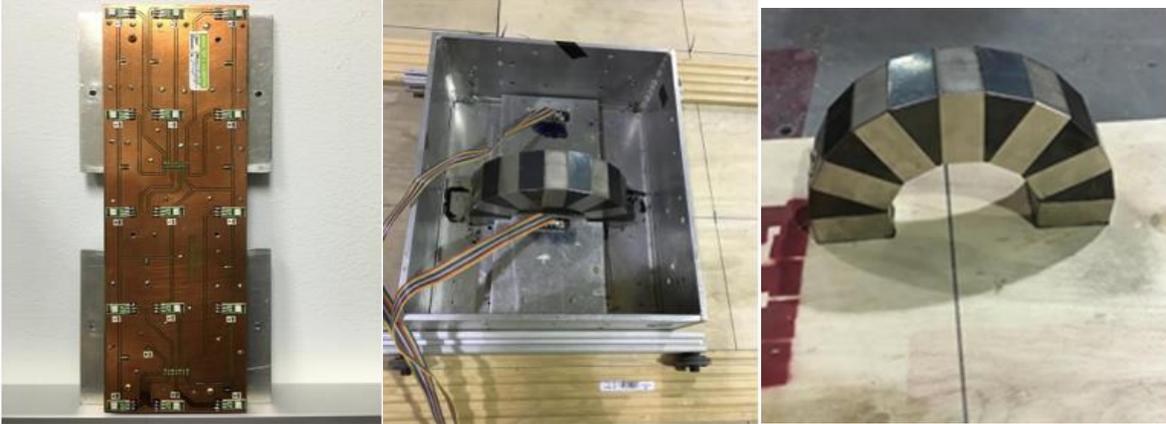
Figure 5-27: Sensor instrumentation: hall effect sensor array (left); carriage (center); and permanent magnet (right).

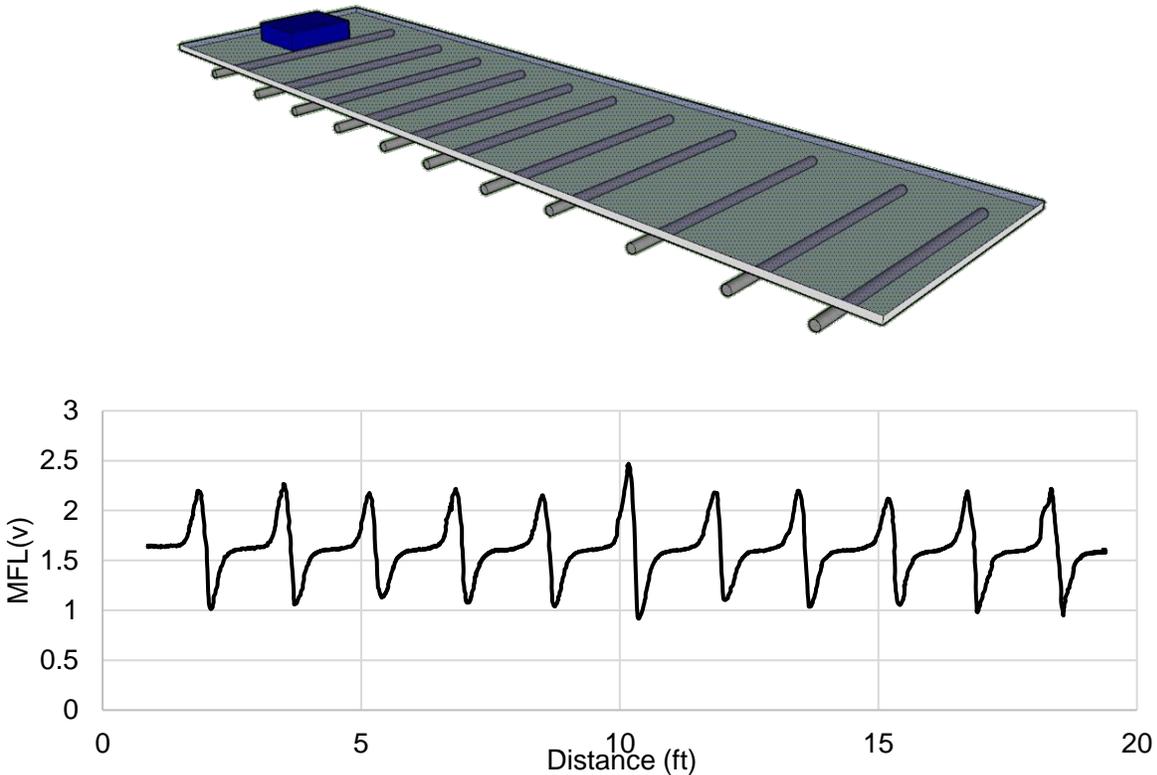
Figure 5-30: Schematic test layout (top) and mild reinforcement leakage field (bottom).

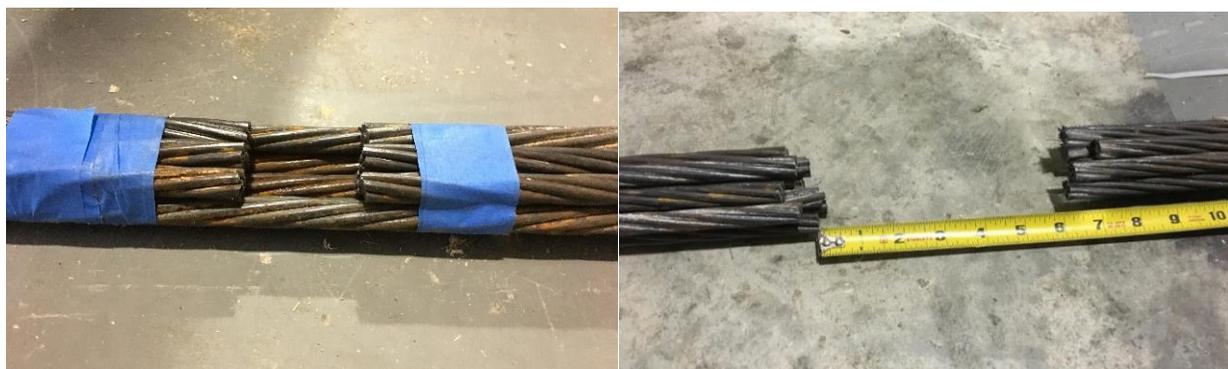
Figure 5-32: Complete and partial physical discontinuity.

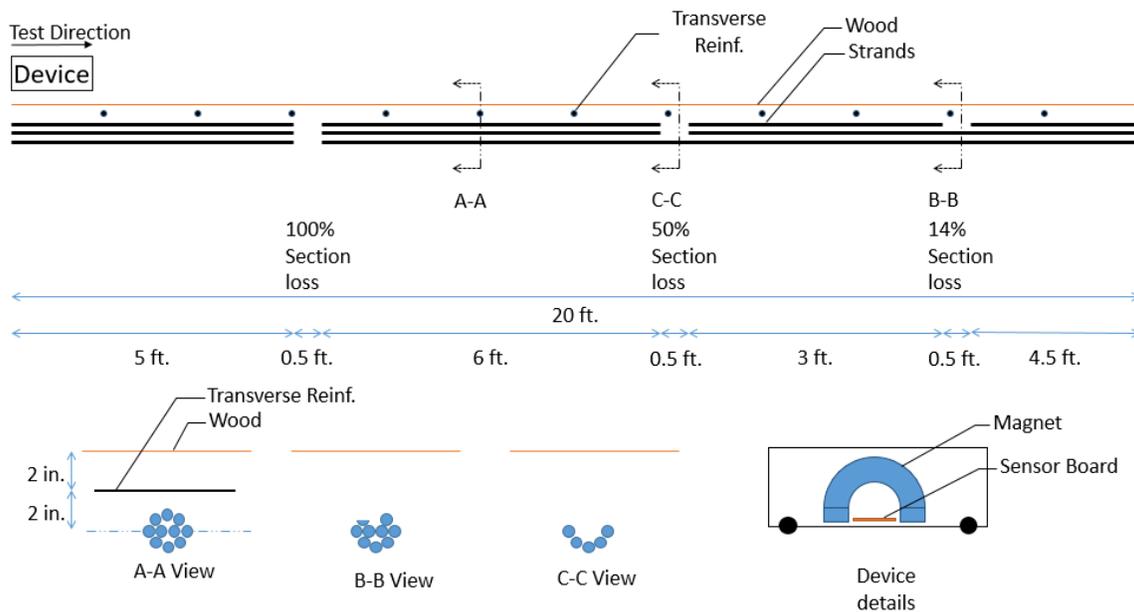
Figure 5-33: Laboratory test setup.

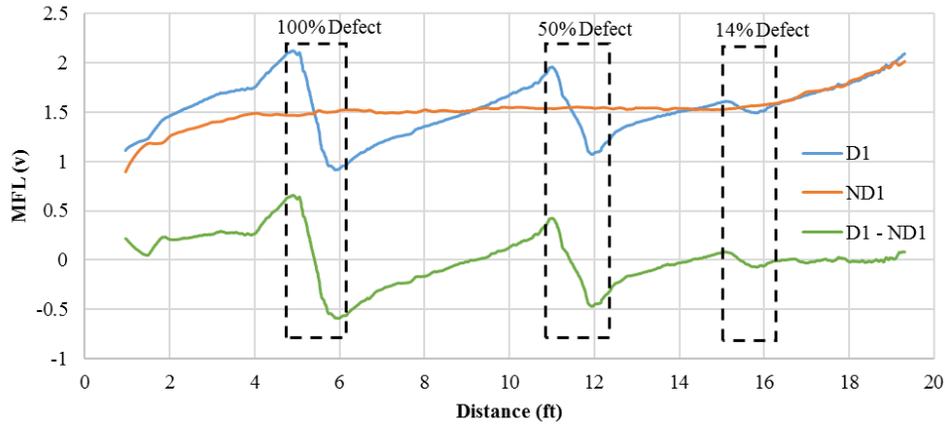
Figure 5-35: Results of MFL tests for test D1, ND1, and their difference (D1-ND1).

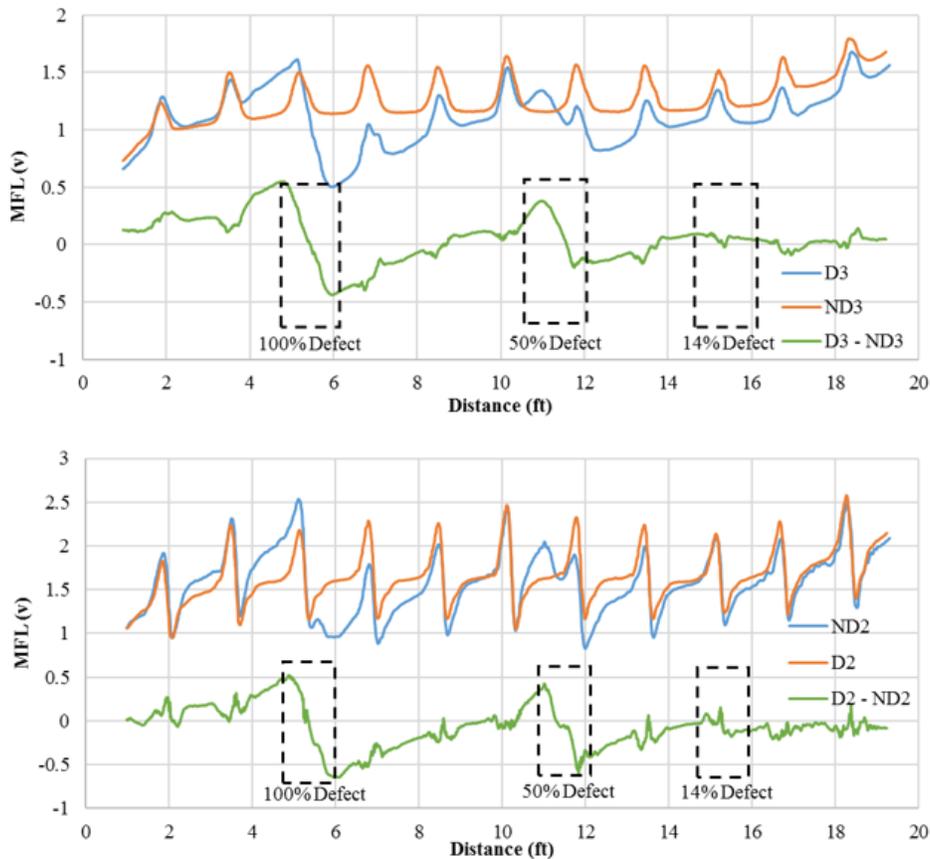
Figure 5-36: Laboratory test results with residual (top) and active (bottom) magnetic field.

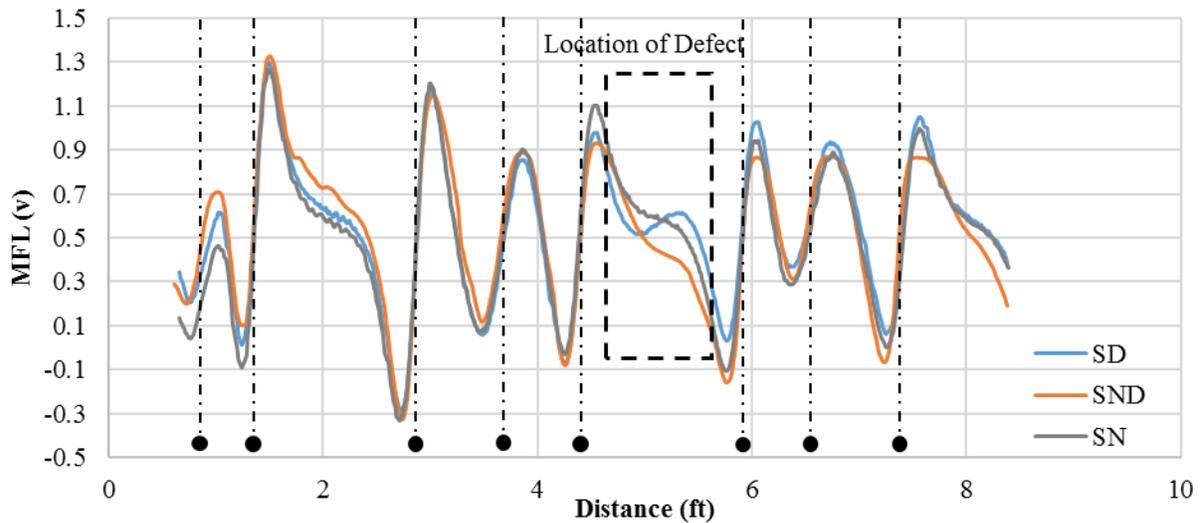
Figure 5-39: Test results of bridge segment.

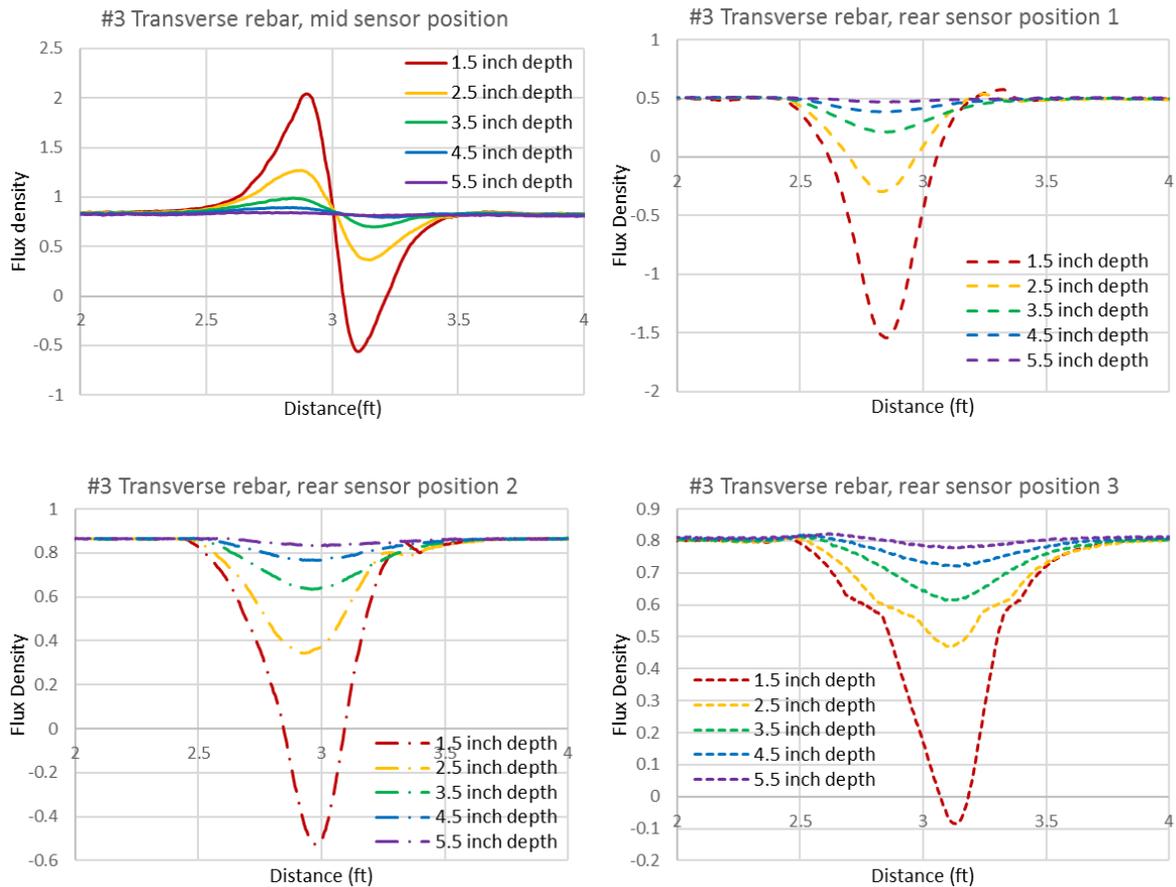
Figure 5-42: Effect of transverse rebar depth on signal strength as captured by sensors in four locations.

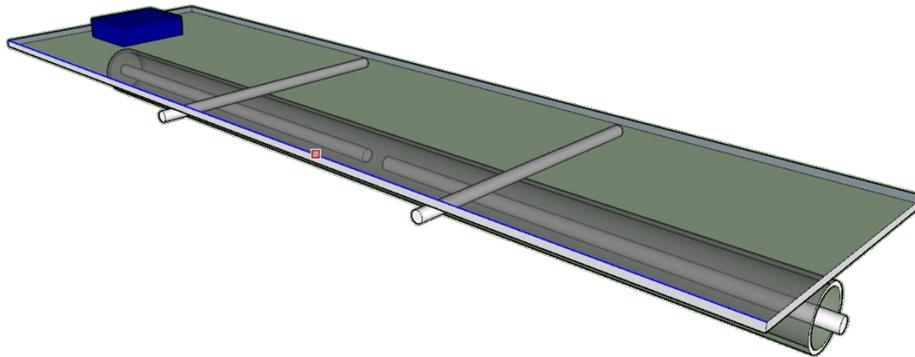
Figure 5-44: Schematic view of defect in presence of transverse rebar.
