FDOT Research Project Number BDV29-977-05

**NON-DESTRUCTIVE TESTING (NDT) OF A SEGMENTAL CONCRETE BRIDGE
SCHEDULED FOR DEMOLITION, WITH A FOCUS ON CONDITION ASSESSMENT
AND CORROSION DETECTION OF INTERNAL TENDONS**

Florida International University

May, 2017

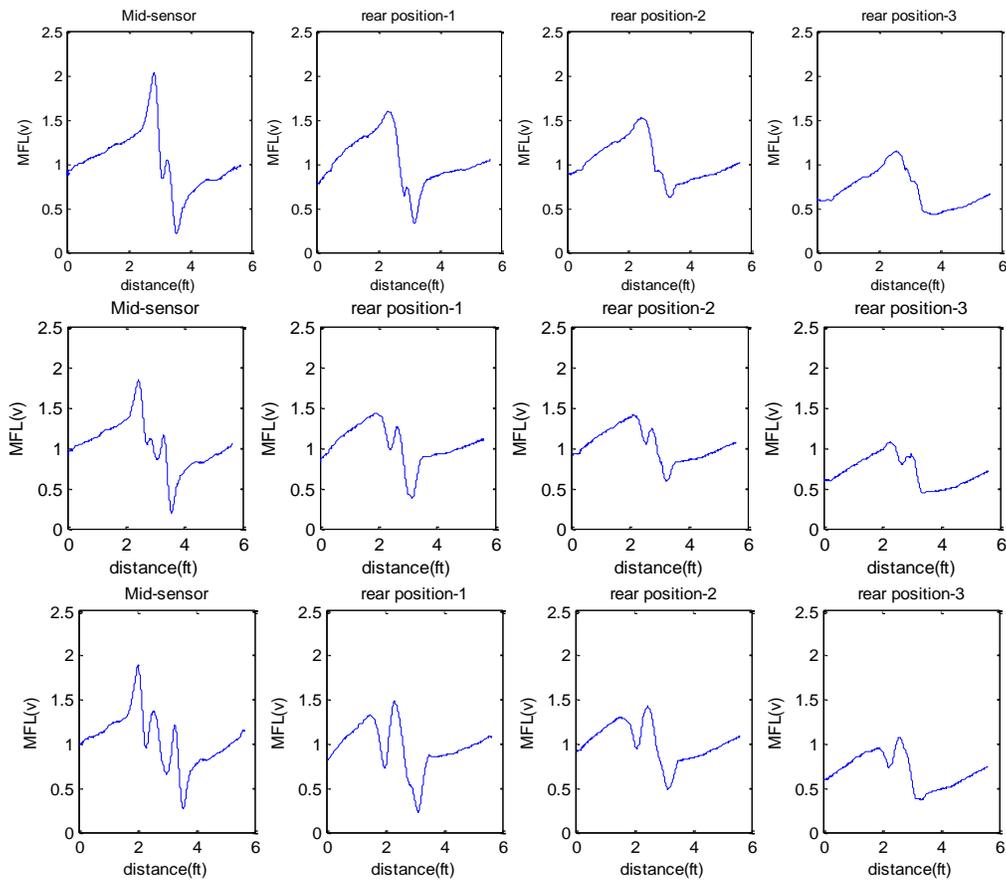
Figure 5-45: Variation of flux density for complete damage as captured by sensors placed at four locations; transverse rebar spacing at 5 inches (top), 10 inches (middle) and 15 inches (bottom).

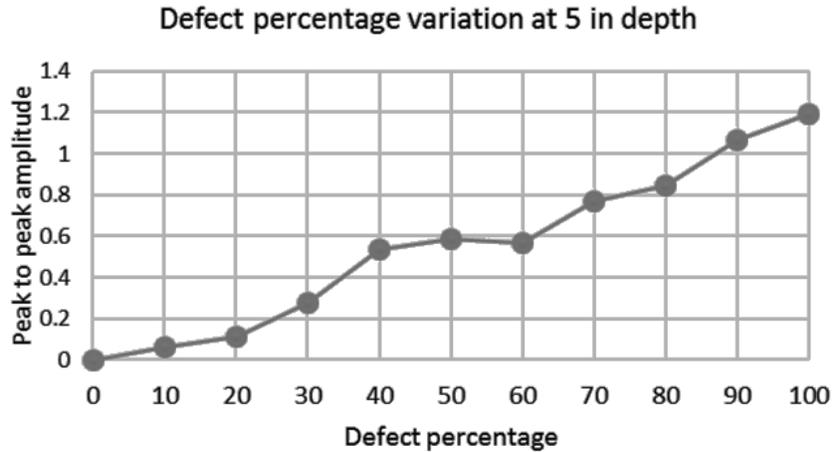
Figure 5-47: Change in amplitude for defect percentages.

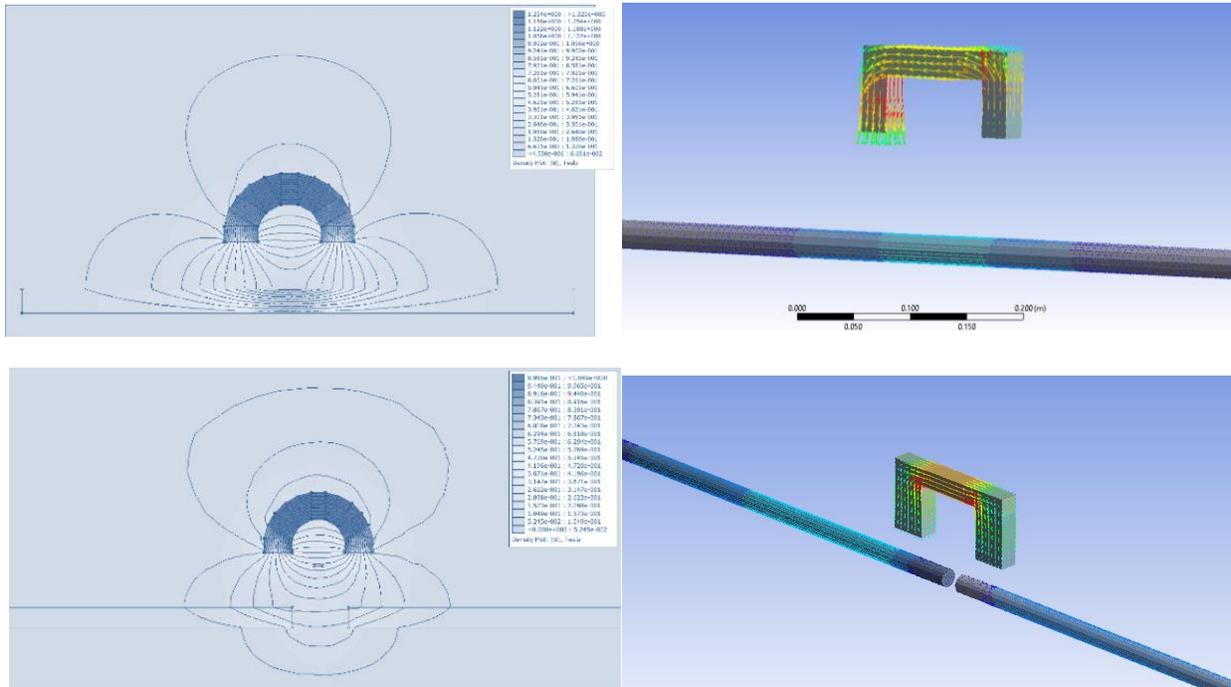
Figure 5-48: Magnetic flux through intact (top) and defect strand (bottom).

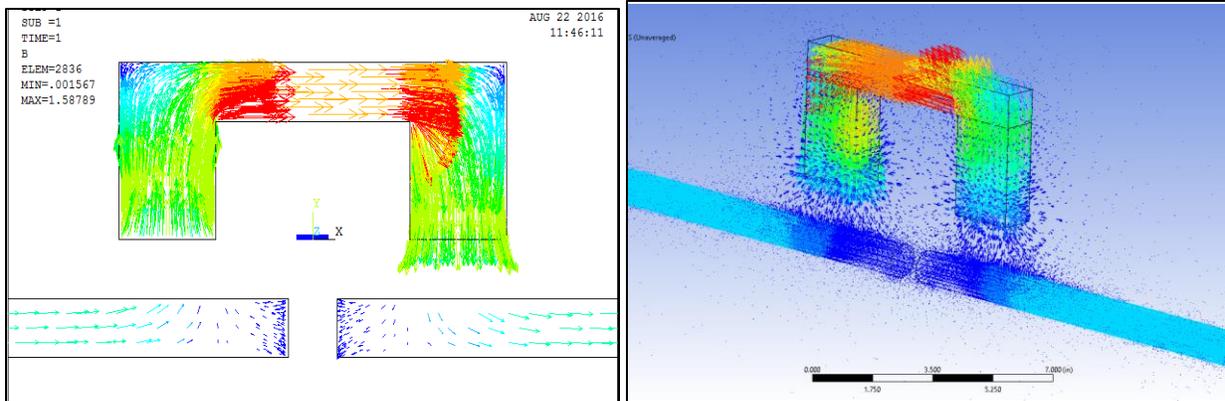
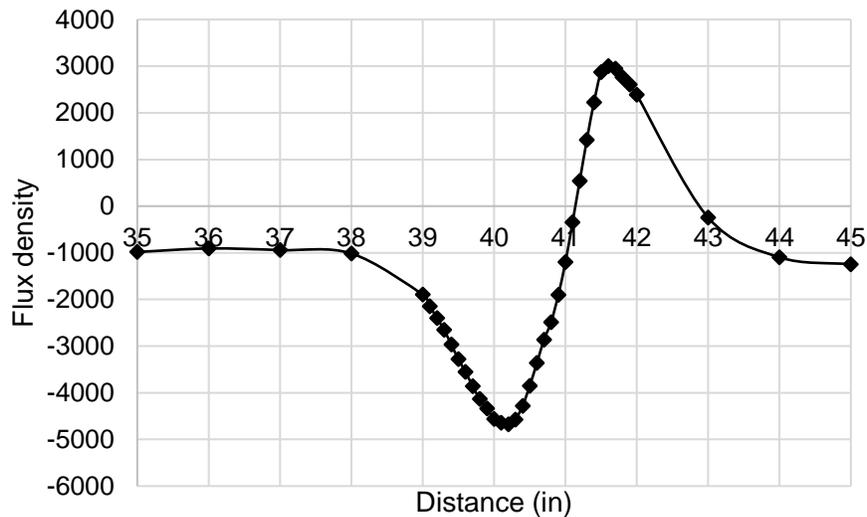
Figure 5-49: MFL through damaged strand (top) and resultant flux density plot (bottom).

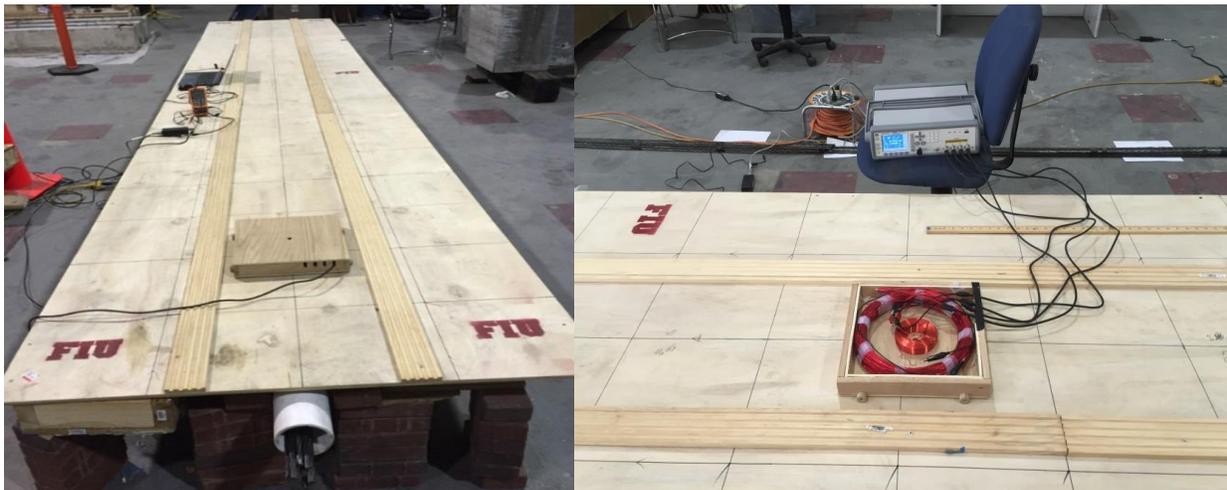
Figure 5-51: Laboratory setup (left) Inductance coil and inductance meter (right).

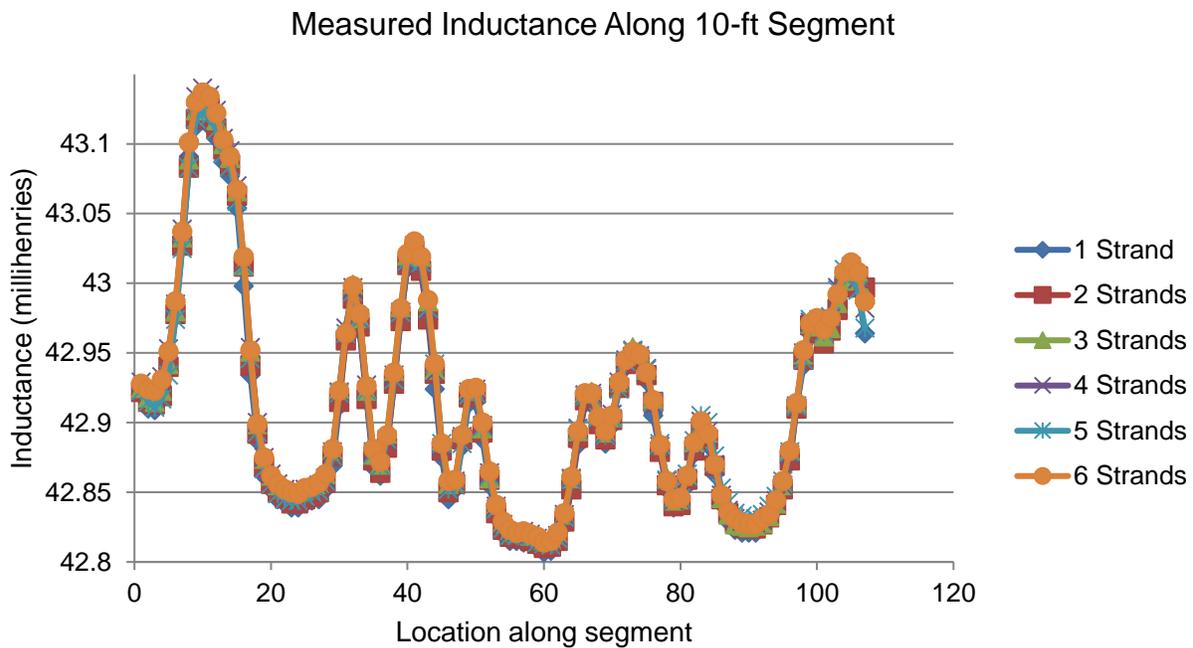
Figure 5-54: Plot of inductance values along the length of the segment for cases of 1, 2, 3, 4, 5, and 6 strands.

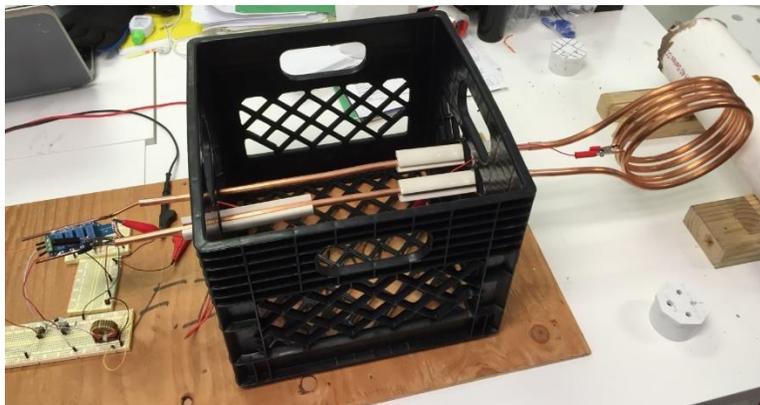
Figure A-1: Induction heater with the copper coil (inductor).

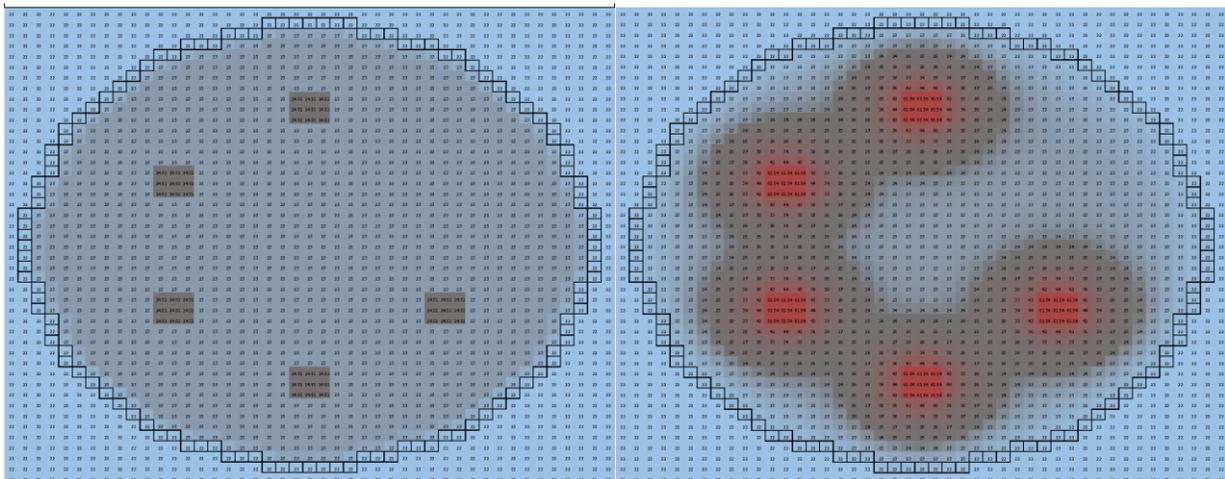
Figure A-13: Temperature of finite difference model at time T = 0 minutes and 1.8 minutes.

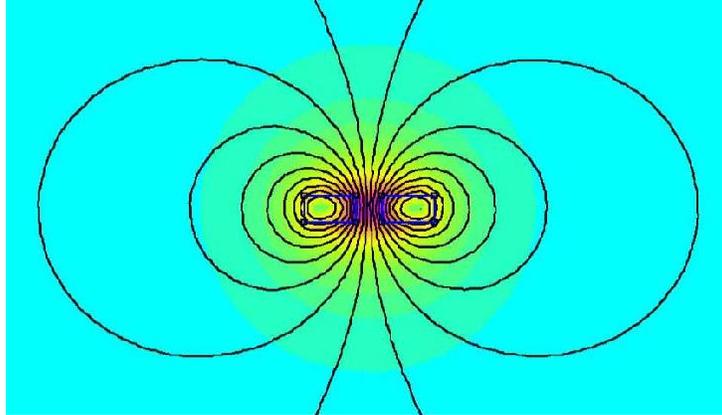
Figure B-1: Magnetic flux field of a multi-loop inductor coil excited by a sinusoidal alternating current.
