Draft Final Report

Rheology Limits for Grout Materials used for Precast Bent Cap Pile Pockets in Hot Weather

Contract Number BDV30 TWO 977-16 FSU Project ID: 037124

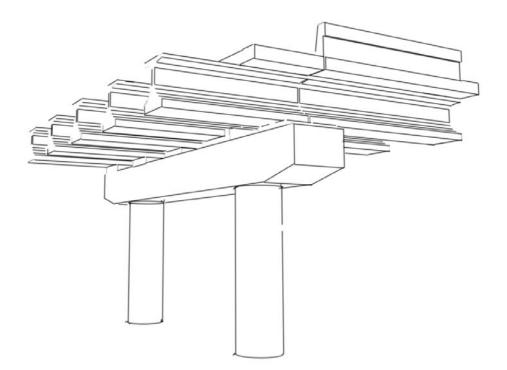
Figure 1.1: 3D model - PBES system (Ebbing, 2016)

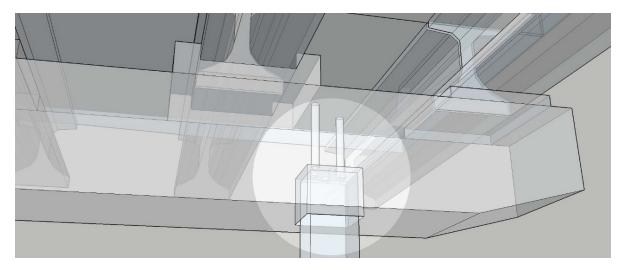
Figure 1.2: 3D model - connection detail

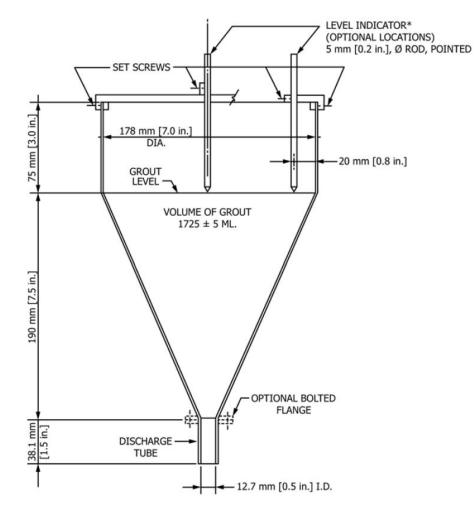
The following Figure 2.2 illustrates the flow cone, which is suitable for use in the field or in the laboratory. The cone in the picture is made from cast iron that holds a stainless steel orifice on the bottom. The cone

Figure 2.2: Side view flow cone (ASTM-International, 2016b)

rods are mounted inside of the cone and 0.8 in. (20 mm) or 3.5 in. (89 mm) from the outside wall. Before filling the cone, it has to be leveled and moistened at all inner surfaces. Then the orifice is closed and the cone can be filled with grout material so that it reaches up to the lower tips of the threaded rods. After a short resting period, the orifice is opened and the time measurement begins. The time measurement is stopped at the moment light passes through the bottom orifice. To guarantee proper equipment conditions, a trial run with water — $1725\pm5 \text{ mL}$ — is performed before actual grout testing. The equipment is acceptable for ASTM testing, if the water discharges from the cone within 7.8 s to 8.2 s. Afterwards the actual test procedure is conducted twice for two (2) different grout samples and the efflux time of each test run is recorded (ASTM-International, 2016b).

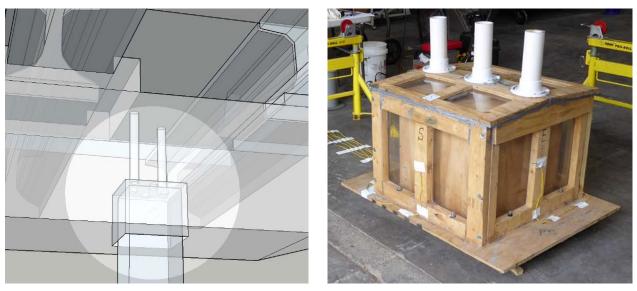
Figure 3.1 compares the on-site bent cap-to-pile head connection to the laboratory formwork that was constructed for each mockup specimen. On the left, Figure 3.1(a) shows a wire model rendering of the actual

(a) Wire model (of actual connection)

(b) Mockup specimen

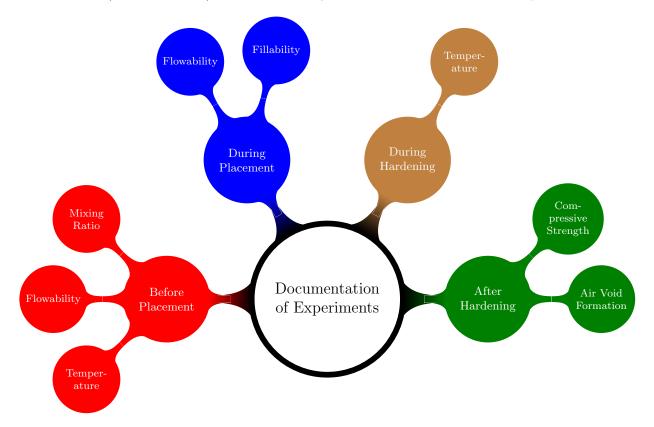
Figure 3.2: Experimental Monitoring

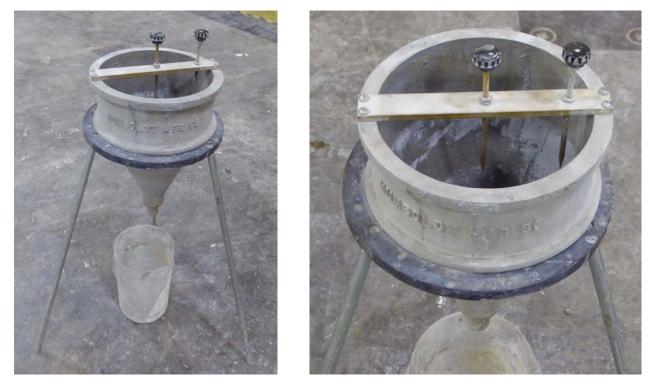
The procedure idea behind the flow cone method according to ASTM C 939 (ASTM-International, 2016b) is described in the previous chapter. Figure 3.6 shows the equipment, that was used twice — directly after each batch was mixed — to quality control the targeted fresh grout properties. As shown in Figure 3.6(a),

(a) Overview

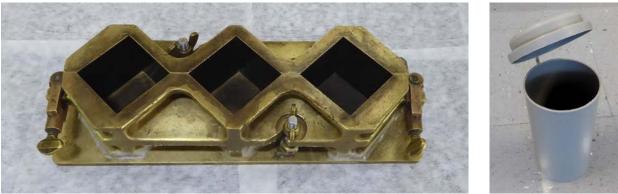
To evaluate the compressive strength of the grout material at different maturity levels, grout subspecimens — cubes and cylinders — were produced. Figure 3.7 shows two (2) different types of molds, that were used for this research. Figure 3.7(a) illustrates the 2 in. (50 mm) cube molds. Each brass mold system (Humboldt

(a) Cube molds

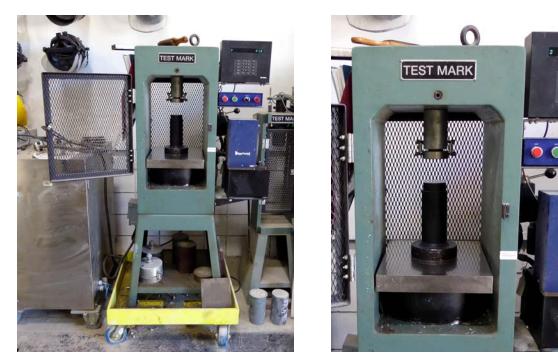
(75 mm) diameter and a length of 6.0 in. (150 mm), the black steel cylinder was replaced by a smaller stand. For all tested samples — cubes and cylinders —, the load rate for these compressive strength tests was set up to 300 lbs./s. The machine was thoroughly cleaned after each cube or cylinder test, to prevent stress concentrations at the compression interfaces.

(a) Front view

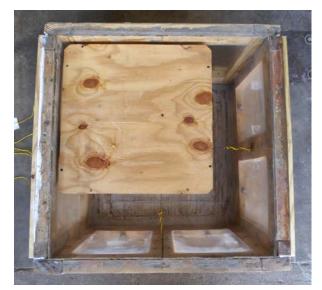
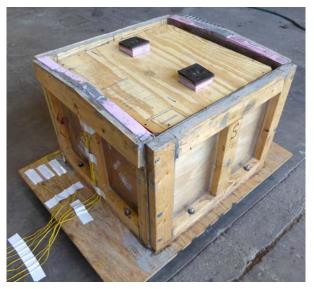
Figure 3.12 illustrates the assembly process and shows how the elements were pieced together. The

(a) Mockup specimen MU7

(b) Mockup specimen MU11

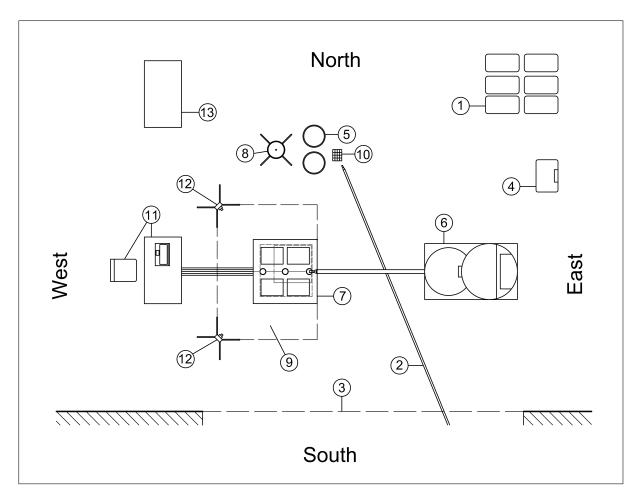
After the formwork for an individual mockup specimen was prepared and set up, the laboratory was readied for the grouting process. For consistency purposes, the laboratory was identically arranged and prepared for each mockup specimen. Figure 3.15 illustrates the floor plan for the experimental setup and shows all relevant materials and devices, that were needed throughout the batching, mixing, and filling process. The cardinal directions — in reference to the FDOT Structures Research Center — are shown along the four (4) sides of the figure. The dry grout powder, BASF MasterFlow 928, was stored at the Northeast corner (1). The temperature of the dry grout powder was very important to target the test temperatures of the fresh grout material. Relative to the mixing water, the dry grout powder has much more mass and a higher heat capacity. Depending on the target temperatures of the fresh grout, the grout powder (inside the sealed bags) was preconditioned to to reach uniform temperatures Depending on the time of the year and ambient temperatures in the laboratory, the grout powder was either preheated in an oven, or exposed to the surrounding ambient temperature for more than 24 hours. The required grout powder temperature was experimentally determined via small size batches, which were evaluated for temperature and efflux time via the flow cone. For example, for Task 2 throughout August and September, it was found that the grout powder had to be at 85 °F (29.5 °C) for the fresh grout to reach 85 °F to 90 °F (29.4 °C to 32.2 °C) as it was targeted by test matrix. Sometimes, up to 6 lbs. (2.72 kg) ice had to be substituted for parts of the mixing water to stay within the desired fresh grout temperature range. A hose provide a continuous water source for mixing and equipment cleaning (2). The water-hose was connected to a faucet outside of the laboratory (3),

Figure 3.15: Laboratory Setup

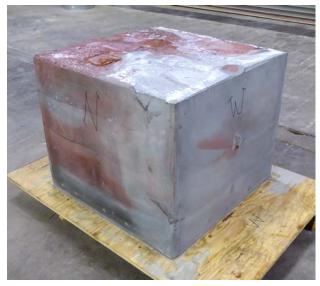
(b) MU8 — after demolding

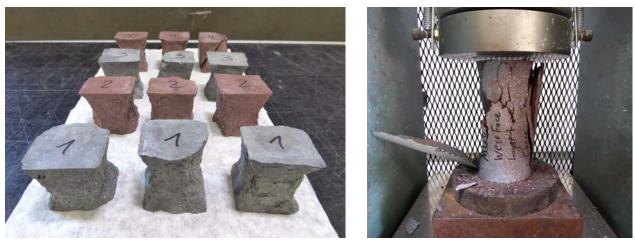
MU7 and MU8, because these mockup specimens provide a gap size that was large enough to accommodate the cylinder length. In total three (3) cubes per batch were extracted from two (2) different vertical side volumes for MU9 & MU10 and from one (1) vertical side volumen for MU7. Two (2) cores from each batch from two (2) different — perpendicular to each other — vertical side volumes were drilled out of MU7 and MU8. All extracted samples were tested 28 days after grouting was completed. Figure 3.19 illustrates two (2) photos of the compression tested cubes and cores — these particular companion samples were tested for MU8. On the left side, Figure 3.19(a) shows all MU8 cubes that were cast for 28 day compressive

(a) Tested cubes

strength testing, after they were taken to failure. Figure 3.19(b) shows an extracted core that failed after it

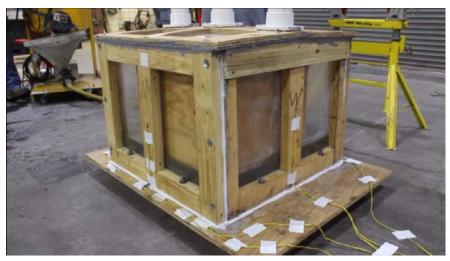
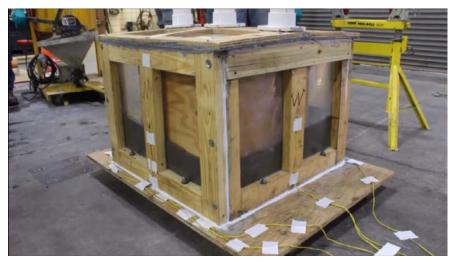
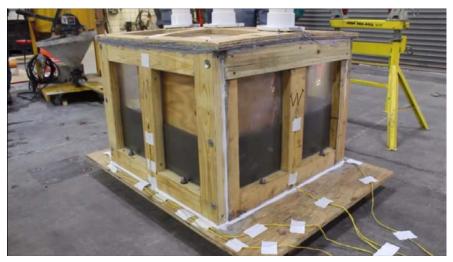
Figure 4.1 illustrates the filling sequence for the vertical side volumes of MU7. Three (3) pictures, that were taken from the same position, are chronologically ordered to illustrate the grout flow inside the formwork at different times. For this particular specimen, two (2) vertical gaps measured 0.5 in. (12.5 mm) at two (2) adjacent sides, the other two (2) adjacent vertical side gaps had a thickness of 7.5 in. (187.5 mm). The presented view shows the corner with the two (2) adjacent 0.5 in. (12.5 mm) thick vertical volumes, which was chosen because this was the minimum thickness throughout Task 2 (MU7 through MU11), and therefore,

(a) $2\min 37s$ after pumping was initiated (Batch 1)

(b) $3\min 40 \, s$ after pumping was initiated (Batch 2)

(c) $4\min 10s$ after pumping was initiated (Batch 2)

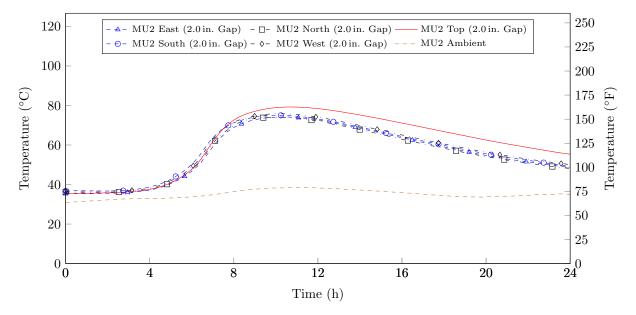
used to model the pile head for specimen MU2. MU1 is not shown here, because the data acquisition system malfunctioned throughout the temperature monitoring phase. However, the following Figure 4.4 graphs the temperature developments for specimen MU2, which measured the same gap size openings as MU1. Furthermore, the temperature trends shown in the figure, are representative for specimens MU2 through MU4.

Figure 4.4: Temperature development after mixing grout for MU2

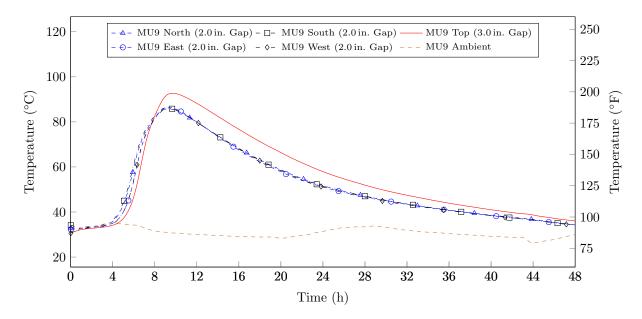
All specimens from Task 2 — MU7 through MU11 — were made from grout with an efflux time from about 48 s and a temperature range between 85 to 90 °F (29 to 32 °C), so that the fresh grout material had the highest temperature and the highest efflux time, which was evaluate in this research project. Figure 4.5 illustrates the temperature development that was recorded for MU9, which was produced with a minimum horizontal (top) gap size of 2.0 in. (50 mm). Due to the tapered surface at the roof of the bent cap the top gap increased to a maximum thickness of 3.0 in. (75 mm). The graph plots time, in hours, on the horizontal axis and the temperatures, in °F and °C, on each vertical axis. The data shows that all four (4) vertical volumes responded identically with the same temperature development due to the hydration heat.

Figure 4.5: Temperature development after mixing grout for MU9

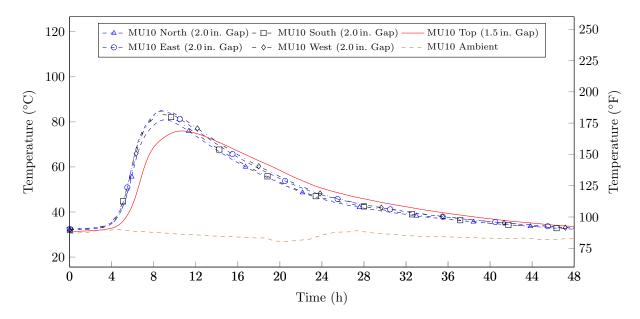
Figure 4.6 illustrates the temperature measurements for MU10 which was geometrically identical to MU9, except for the horizontal volume at the top of the specimen — it was less massive with a maximum thickness of 1.5 in. (37.5 mm). Similar to MU9 (Figure 4.5), all 2 in. (50 mm) vertical volumes responded identically to the hydration process, with a rapid temperature increase between hour four (4) and eight (8), and a cool down period thereafter — relatively fast until the 24^{th} hour, and then less rapidly to eventually reach equilibrium with the ambient temperature after approximately 48 hours. The maximum temperature of the vertical volumes was $185 \,^{\circ}\text{F}$ ($85 \,^{\circ}\text{C}$) after approximately eight (8) to nine (9) hours. However, compared to MU9 (Figure 4.5), it is clear that the top volume in Figure 4.6 (MU10) did not reach such high temperatures — but instead peaked at $185 \,^{\circ}\text{F}$ ($85 \,^{\circ}\text{C}$), which remained well below all other temperatures measured for that specimen.

Figure 4.6: Temperature development after mixing grout for MU10

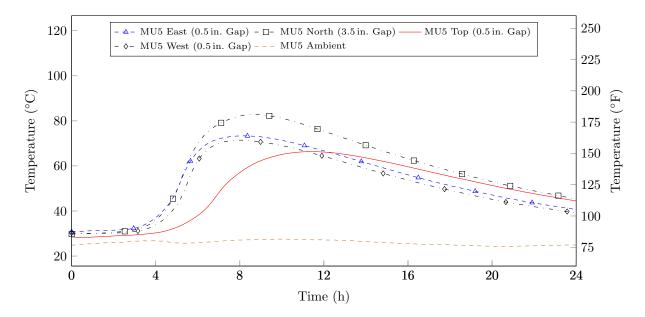
Figure 4.7: Temperature development after mixing grout for MU5

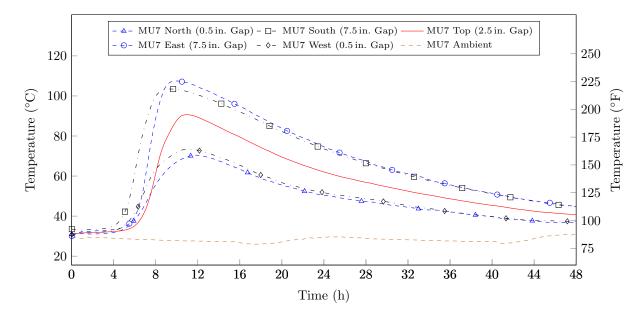
Figure 4.8 plots the temperature data of MU7 on the y-axis against the maturity along the x-axis. For this particular specimen, the top horizontal volume was built with a a minimum vertical gap size of 2.0 in. (50 mm) and a taper of 0.5 in. (12.5 mm) over a length of 14.0 in. (300 mm) — leading to a slope of 3.5%. Consequently, its thickest dimension at the center line (under the ventilation pipes) measured 2.5 in.

Figure 4.8: Temperature development after mixing grout for MU7

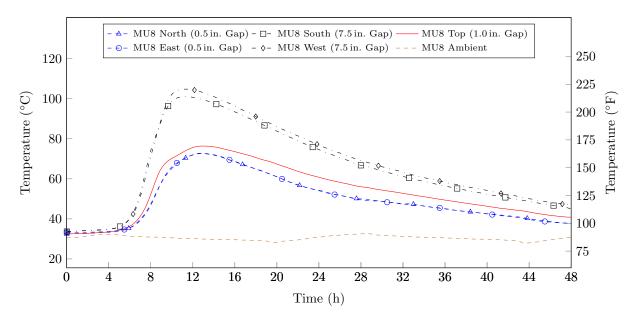
The temperature development plot for MU8 is provided in Figure 4.9. MU8 was built very similarly to MU7, but with a lower minimum gap size of the top volume of 0.5 in. (12.5 mm), such that the maximum thickness of the horizontal grout volume at the centerline under the ventilation pipes measured 1.0 in. (25 mm) instead of 2.5 in. (62.5 mm). The only significant difference between Figures 4.8 and 4.9 are the recorded temperatures for the horizontal top volume. The thinner top volume for MU7 peaked at 170 °F (75 °C), whereas the previously graphed thicker top volume for MU8 measured a maximum temperature of 195 °F (90 °C). Furthermore, the ambient temperatures varied slightly between 75 °F to 85 °F (25 °C to 30 °C) reflecting the differences between night and day temperatures.

Figure 4.9: Temperature development after mixing grout for MU8

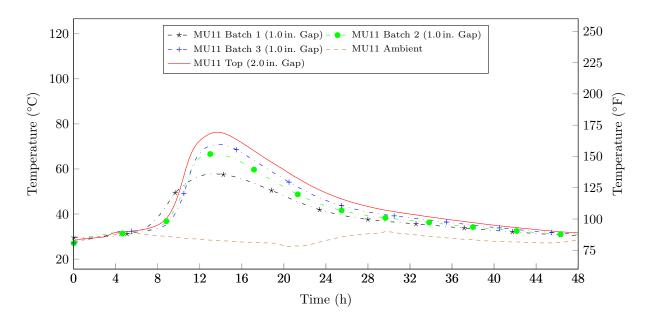
Besides the ambient temperature and the temperature within the top grout volume, Figure 4.10 plots the temperature development for the three (3) different batches that were necessary to fill MU11. Because all four (4) vertical volumes measured an identical gap size opening of 1.0 in. (25 mm), the presented data are the averaged results from two (2) thermocouples at the center of each batch at two adjacent sites (e.g.: North and East side). The top gap measured a maximum thickness of 2.0 in. (50 mm). As seen in Figure 4.10, the first batch reached the lowest maximum temperature of all three (3) batches with approximately 140 °F (60 °C). It was followed by Batch 2, and then by Batch 3 (top batch) with more than 160 °F (70 °C) The highest maximum temperature was measured for the 2.0 in. (50 mm) — most massive — horizontal grout volume. A similar dormant period of seven (7) hours was measured for all batches, but the temperatures rose rapidly thereafter. As Figure 4.10 shows, MU11 batches reached their peak temperature about 14 hours after the first batch was poured. After 48 hours, all grout volumes reached equilibrium with the ambient temperature, which did not change significantly throughout the monitoring period.

Figure 4.10: Temperature development after mixing grout for MU11

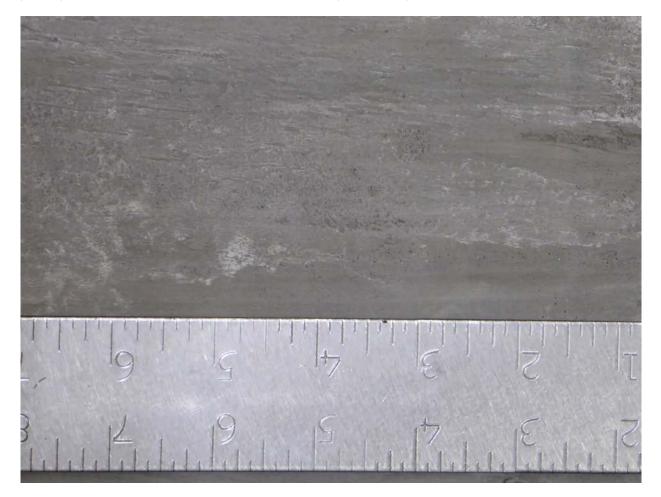
Figure 4.12 shows the inner vertical side surface of MU9, that was produced with a gap size of 2.0 in. (50 mm). The surface appeared very smooth and tight (dense grout), and the grout material was fine enough

Figure 4.12: Inner vertical side surface for MU9 — maximum grout volume thickness of 2.0 in. (50 mm) Gap to mirror the minute surface imperfections of the plywood texture. No significant air voids were visible.

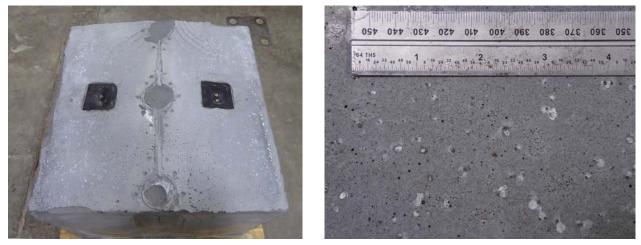
For comparison, Figure 4.17 illustrates the 1.0 in. (25 mm) surface of MU11. Like the previously shown Figure 4.16, Figure 4.17 offers a complete overview of the top surface (a), and a closeup view of the Northwest corner (b). Figure 4.17 demonstrates findings, that were representative for all mockup specimens with a slope of 7% (MU9 through MU11). More air voids as noticed on the sides could be seen, but in total, the surfaces was very tight and almost non-porous. As seen in the North West corner, numerous 1.0 in. (25 mm) dark

(a) Overview

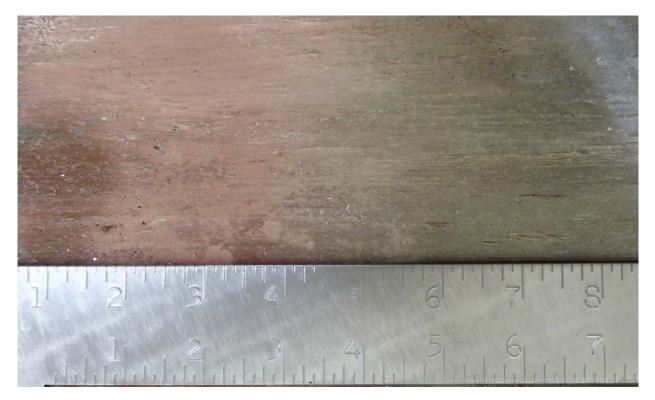
For quality control at the interface at the top of the pile head, the grout was dismantled and visually inspected. Figure 4.18 shows the bottom surface of the horizontal grout volume of MU11, which was produced with a minimum top gab size of 1.0 in. (25 mm) and a taper of 1.0 in. (25 mm) over 14 in. (350 mm) length. The surface appeared well consolidated with virtually no air voids. No significant differences between the

Figure 4.18: Inner top surface for MU11 — maximum grout volume thickness of 1.0 in. (50 mm)

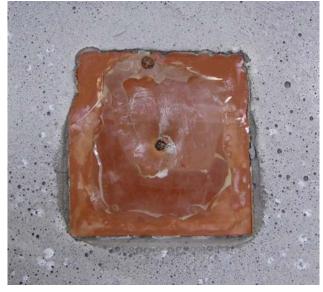
As explained previously, all Task 2 specimens were produced with two (2) shims with dimensions of 4.0 by 4.0 in. (100 by 100 mm) in each top volume. Figure 4.19 shows the grout surface conditions around the rubber shims 48 hours after grouting. Figure 4.19 (a) illustrates the shim detail for MU8 (0.5 in. (12.5 mm)) taper with a slope of 3.5 %, while Figure 4.19 (b) shows the area around the shim for MU9 (1.0 in. (50 mm)) taper with a slope of 7.0 %. The surface of MU8 (a) showed light air void accumulation around the entire shim and besides such small air bubbles, isolated air voids with a diameter of up to 2.0 in. (50 mm) occurred, as seen on the right side above the shim. In contrast, these larger air voids did not appear for MU9 in Figure 4.19 (b). The air void size was no larger than 1/8 in. (3.0 mm), and the voids were evenly distributed around the shim.

(a) Shim in specimen MU8 — 0.5 in. (12.5 mm) Taper

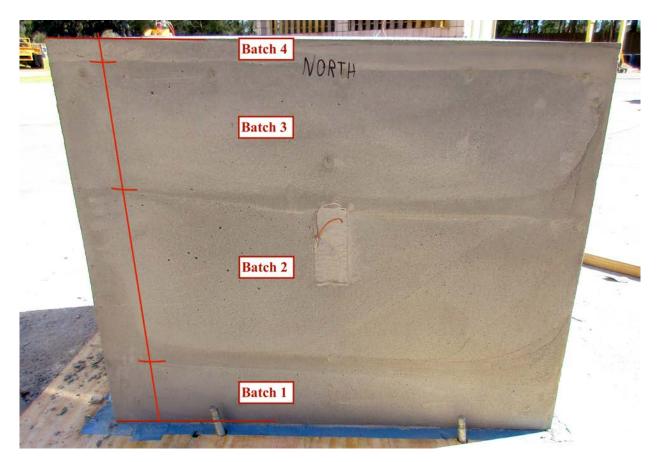
Figure 4.20: Outer side surface MU1 - 2.0 in. (50 mm) gap

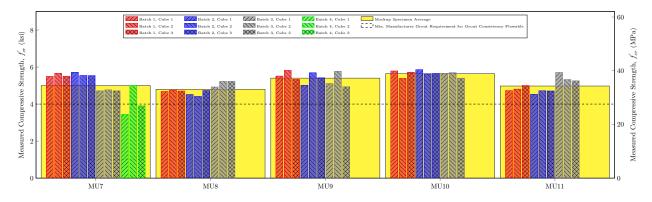
Figure 4.22 presents the compressive strength for all specimens and batches at one (1) day of curing. The Graph shows individual bars, that represent the (individual) cube strength. Moreover, batches are

Figure 4.22: Cast cube compressive strength after one (1) day — Task 2

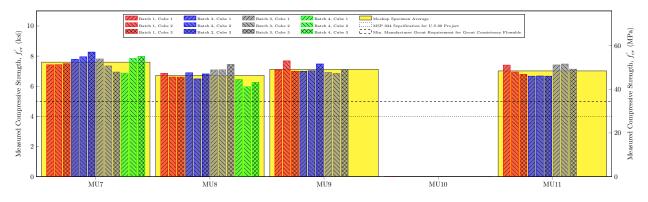
Figure 4.23: Cast cube compressive strength after three (3) days — Task 2

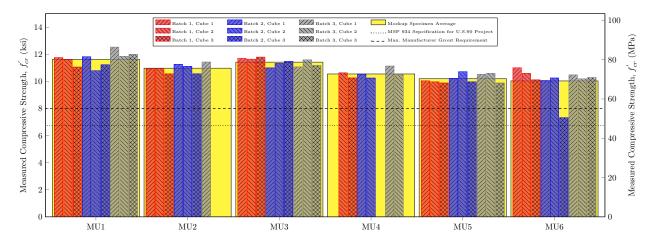
Figure 4.24: Cast cube compressive strength after 28 days — Task 1

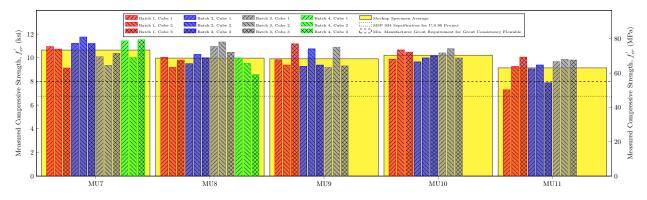
Figure 4.25: Cast cube compressive strength after 28 days — Task 2

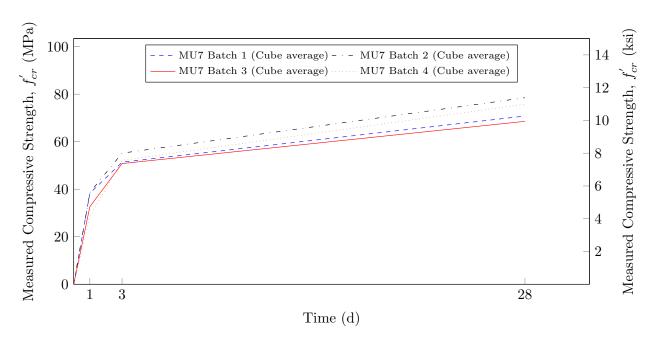
Figure 4.26: Compressive strength development of each batch for MU7 (based on average of cast cubes)

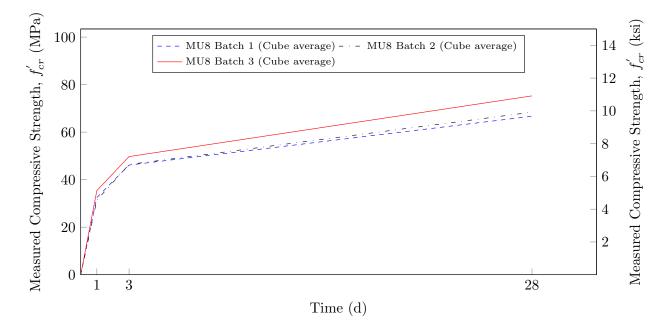
Figure 4.27: Cube Compressive Strength Development MU8

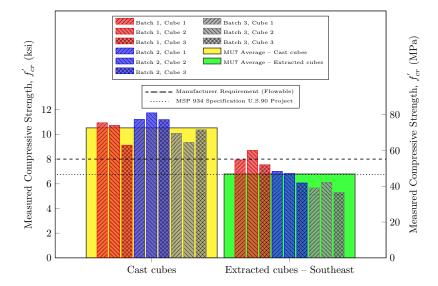
The bar graph in Figure 4.28 illustrates the strength measurements for MU7. The cubes extracted from

Figure 4.28: Compared Cube Compressive Strength for MU7 after 28 days

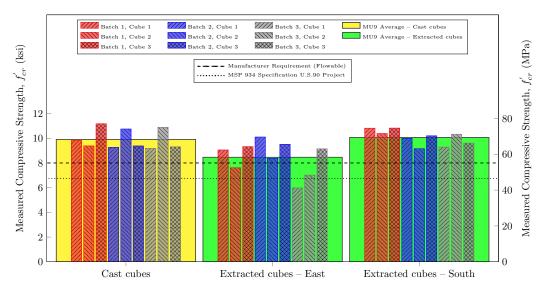
The 28-day compressive strengths for MU9 are illustrated in Figure 4.29. Because two (2) vertical volumes

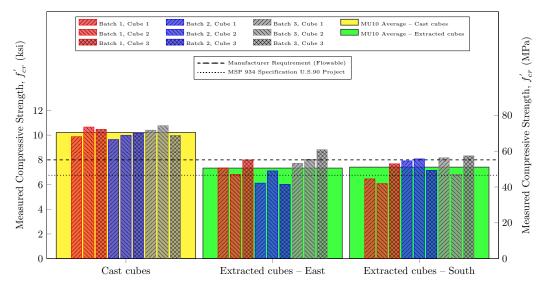
Figure 4.30: Compared Cube Compressive Strength for MU10 after 28 days

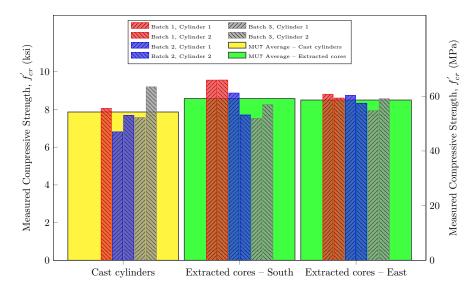
The cast and extracted cylindrical specimens for MU7 are visualized in Figure 4.31. The bar graphs show

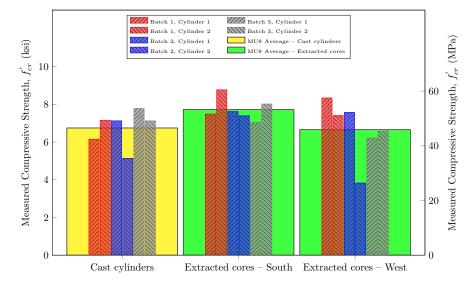
Figure 4.32: Compared Cylinder Compressive Strength for MU8
