# Replaceable Unbonded Tendons for Post-Tensioned Bridges

**Final Report**

**December 2017**

Florida Department of Transportation (FDOT)

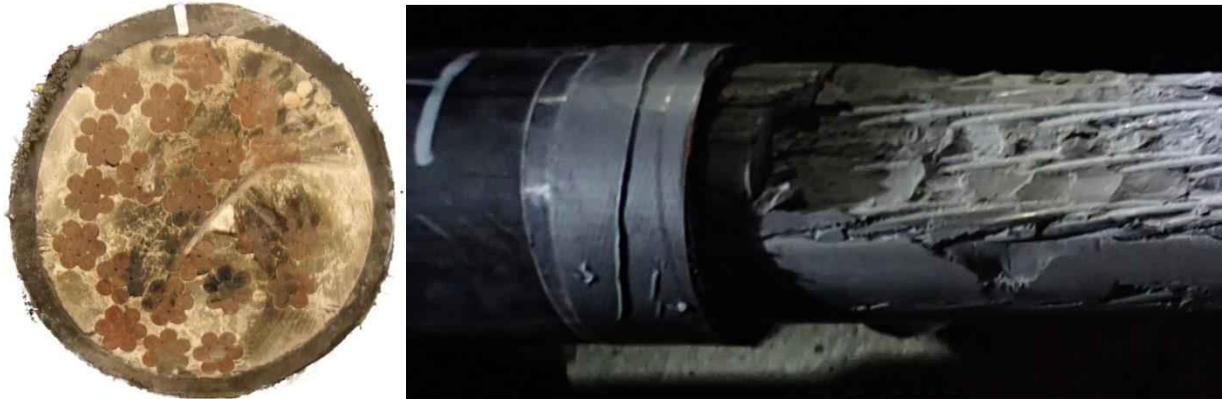
Figure 2-4 External tendons with cementitious grout

both bonded and unbonded tendons. In the U.S., external tendons are typically enclosed in a high-density polyethylene (HDPE) duct and injected with high-performance cementitious grout (Figure 2-4). At the anchors and deviation points, a steel pipe is used to protect the strand from the lateral pressure imparted at these locations that would otherwise damage the HDPE.

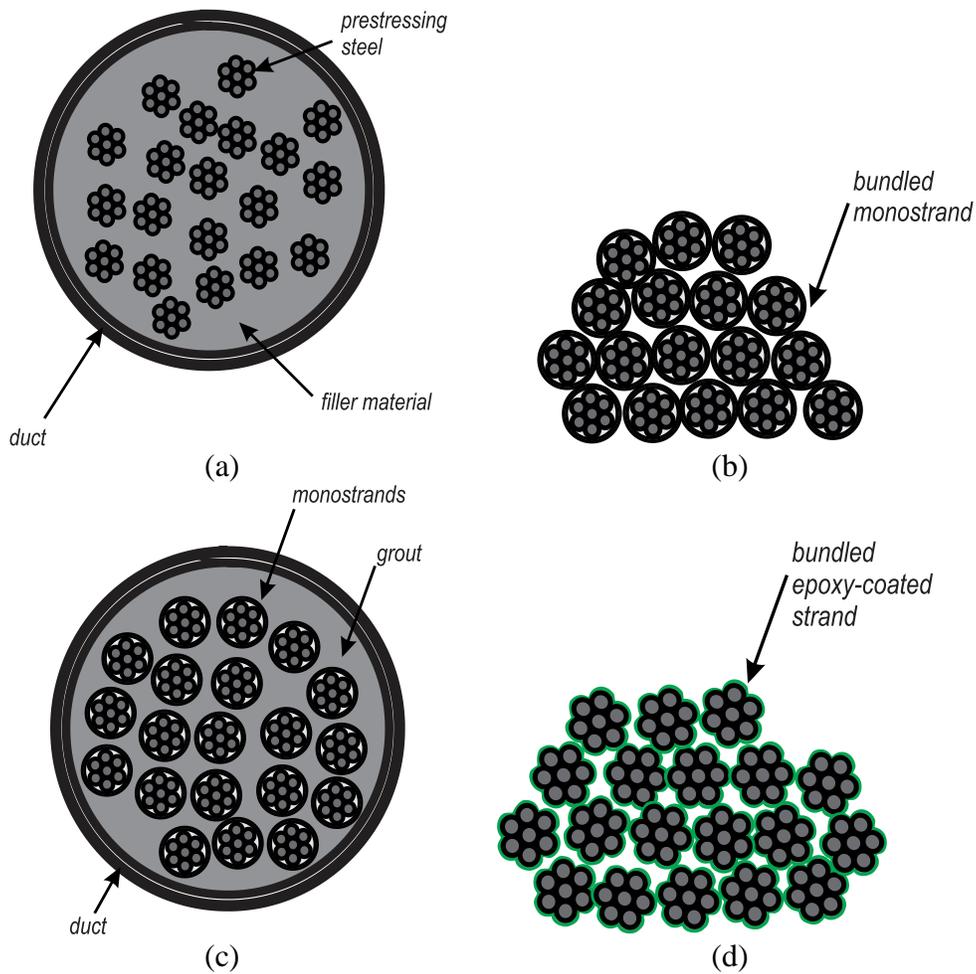
Figure 2-7 Unbonded multi-strand tendons: (a) bare and (b) bundled monostrand (c) monostrand in duct (d) bundled epoxy-coated strand

Monostrands can be bundled (Figure 2-7b) or bundled and placed in a duct (Figure 2-7c), depending on the application. If left bare, care must be taken at deviation points to avoid strand movement and sheathing damage (VSL International Ltd. 2008). One option, though more costly, is to provide individual deviation to each strand. Another option is to place the bundle in a duct and inject with cementitious grout (Figure 2-7c). The grout fixes the strand in place and provides uniform force transfer between the strand and deviator. Testing (VSL report 498 (2005)) of monostrand bundles has shown that the best approach is to apply a small prestressing force to the tendon prior to grouting. The full prestress force can then be applied after the grout has gained sufficient strength to resist the lateral force of the individual strands during prestressing. The same testing indicated that when the monostrand bundle was fully tensioned prior to grouting, the sheathing was damaged.

Another multi-strand system—even more uncommon—is bundled epoxy-coated strand (Figure 2-7d).

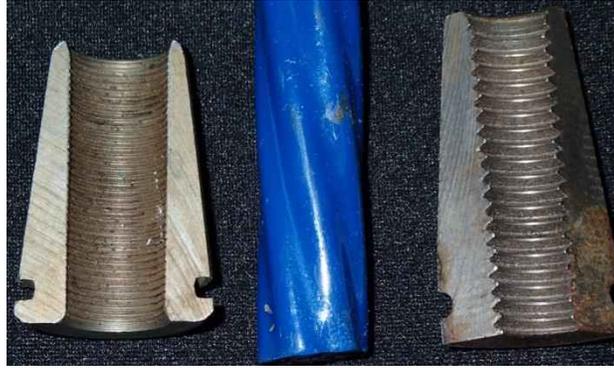
Figure 2-11- Wedges and epoxy strand

The third anchorage type is designed to anchor epoxy-coated strand. Wedges with deep serrations are needed to cut through the epoxy and grip the strand to transfer the prestressing force to the anchor plate (Figure 2-11). Special anchor plates with increased spacing between strands are required to accommodate these larger diameter wedge sets.

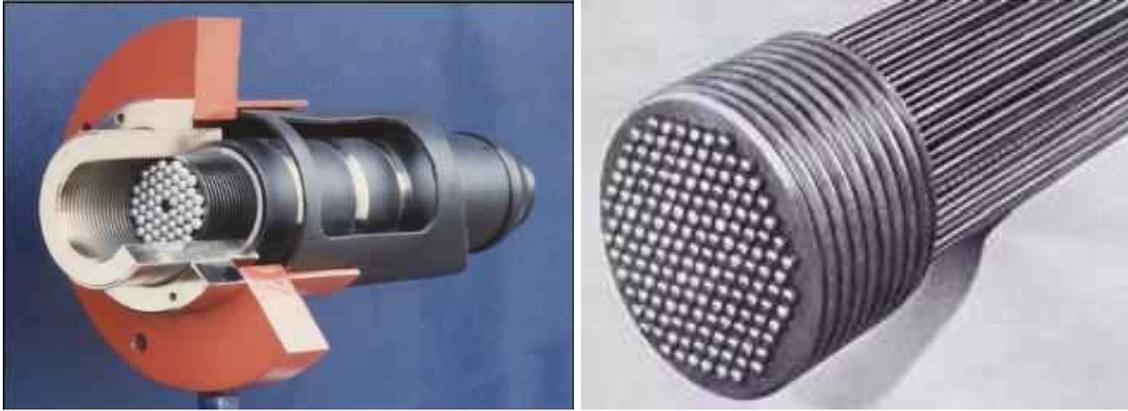
Figure 2-13 Button headed wire anchorage and tendon systems (a) DSI (Traute and Weiher 2011) (b) BBR (BBR 2013)

While this system is used in Europe, it is not typically used in U.S. bridge construction. One advantage of this system is that the entire tendon, including the corrosion protection system and anchorages, is factory-assembled and shipped to the site for installation. This advantage is offset somewhat by the need to provide duct and anchorage openings of sufficient size to allow the passage of the anchorage assembly during installation. The anchorage then requires special stressing equipment to stress the tendons. (Figure 2-13) shows the anchorage system used by DSI for their wire-bundled tendons.

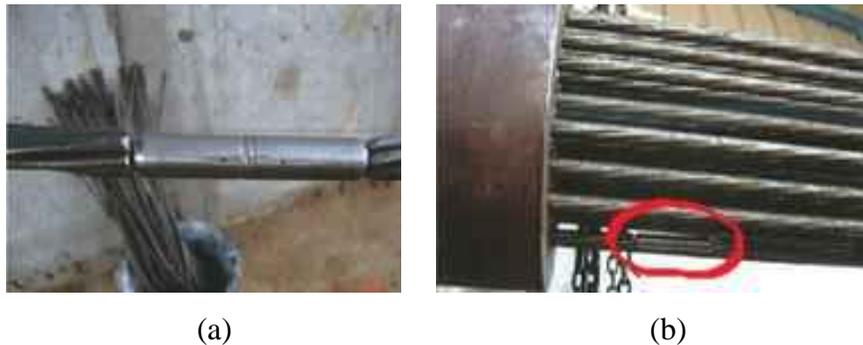
Figure 3-1 Strand replacement: (a) strands coupled (b) introducing the new strand (Thonier 2009)

Thonier describes strand replacement in a nuclear containment structure (Thonier 2009). The strand selected for replacement was de-tensioned and left in place. A new replacement strand was then fastened to the end of the strand being replaced. The opposite end of the existing strand was then pulled out of the tendon, in turn, pulling the new strand into the space evacuated by the existing strand (Figure 3-1). To complete the replacement process, the new strand was stressed using a single-strand jack.

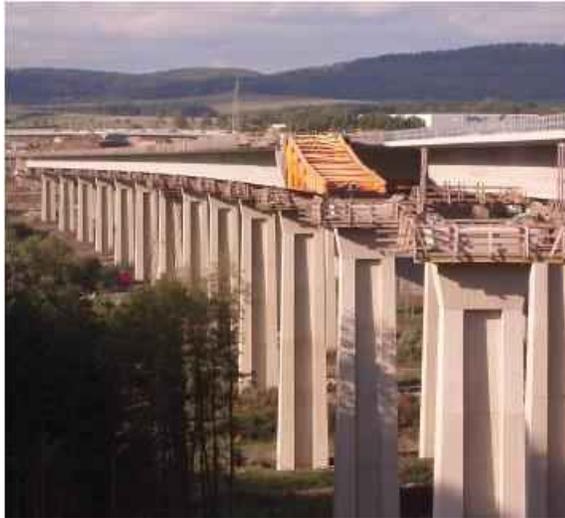
Figure 3-2 Itztal bridge (Zilch et al. 2007)

The Itzal Bridge is part of the Autobahn highway near Coburg, Germany. A 2800 ft (852-m) long bridge composed of two superstructures; it is prestressed with both external unbonded tendons and internal bonded tendons (Figure 3-2). The maximum span length is 190 ft (58 meters).

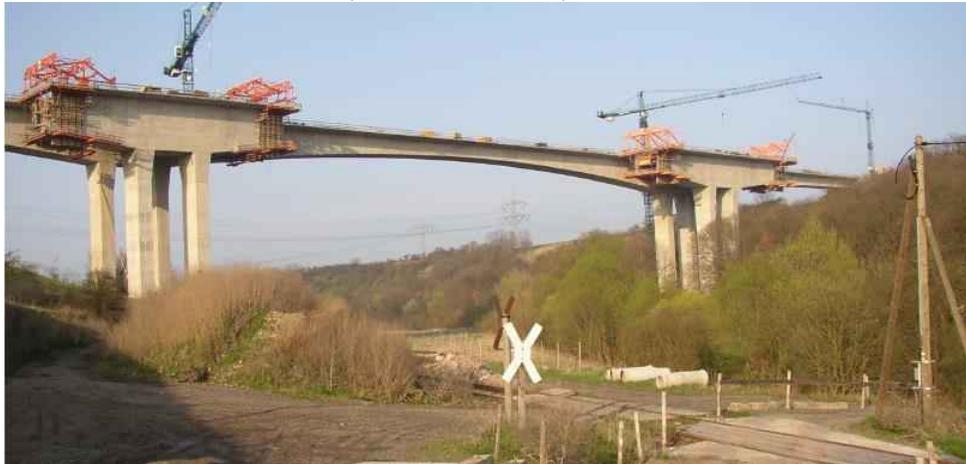
Figure 3-3 Weidatal bridge under construction (Zilch et al. 2007)

The Weidatal Bridge also composes a portion of the Autobahn and is located between the German cities of Kassel and Halle (Figure 3-3). Completed in 2007, it is 1430 ft (435-m) long and includes a 550 ft (169-m) main span. This bridge incorporates both external unbonded tendons and internal bonded tendons (Zilch et al. 2007).

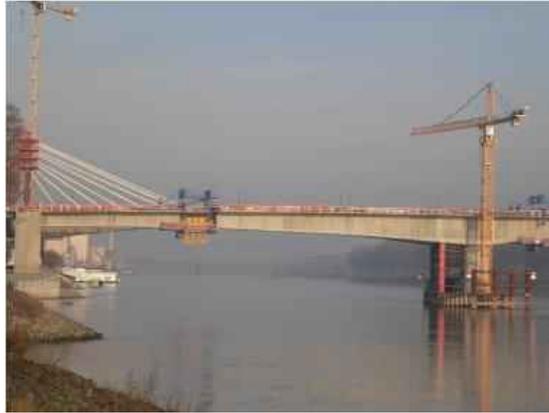
Figure 3-4 Rhine bridge (Zilch et al. 2007)

The Nibelungenbrücke was constructed in 2004 and crosses the Rhine River in Germany. It combines external unbonded tendons and internal bonded tendons (Figure 3-4). Twelve spans create a total length of 2440 ft (745 m), including a maximum span of 380 ft (115 m) (Zilch et al. 2007).

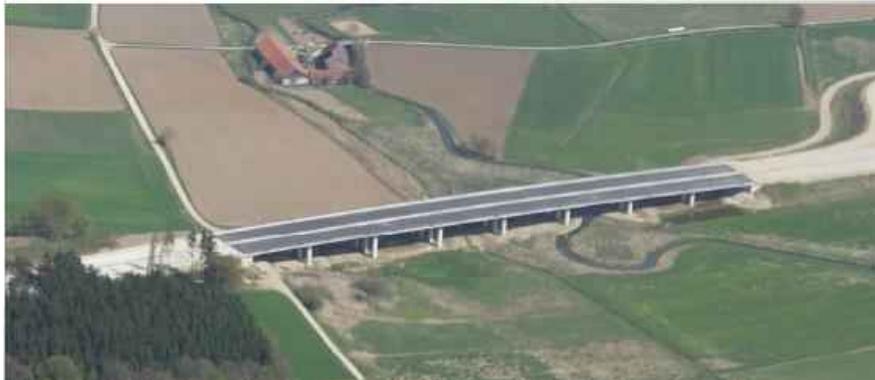
Figure 3-5 Ariel view of Kleine-Laber-Viaduct (Traute and Weiher 2011)

Spanning 900 ft (273 m), the Kleine-Laber-Viaduct in Germany is constructed with internal unbonded tendons. The bridge provides six traffic lanes over four concrete T-beams (Figure 3-5), and includes a 280 ft (84-m) tendon which extends over two spans. Replaceable tendons cannot be coupled so the span-by-span is made continuous by overlapping the tendons at the supports (Traute and Weiher 2011).

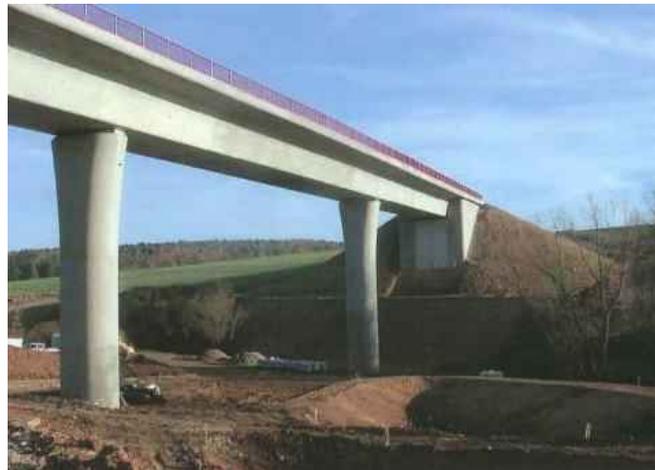
Figure 3-8 Rossriether Graben (Weiher and Zilch 2008)

Located in Mellrichstadt, Germany, the Rossriether Graben bridge is a 430 ft (130-m) three-span bridge. The Rossriether Graben was one of two pilot projects to test the practicality of using both external and internal unbonded tendons (Figure 3-8).

The internal tendons of the Rossriether Graben were arranged in the slabs with one concrete deviator per slab. During construction, a strand within an internal tendon was replaced to check the feasibility of removal. The strand was successfully replaced, but required a high force to remove it due to friction and clamping between wires (Weiher and Zilch 2008).

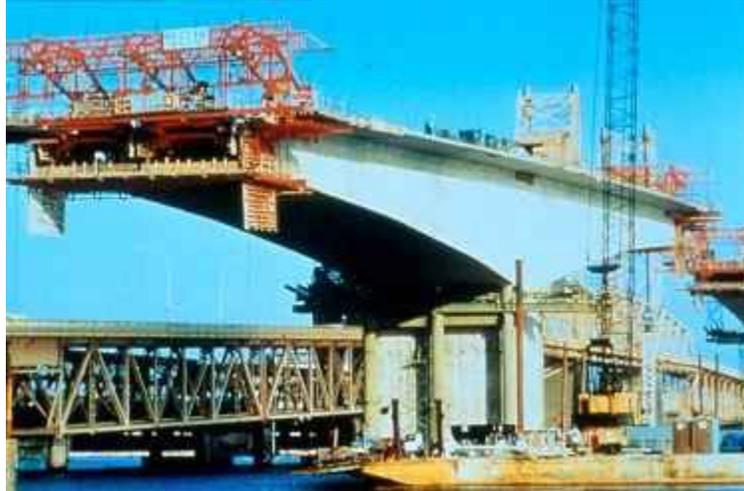
Figure 4-4 Form travelers (Corven J. and Moreton A 2004)

This type of construction includes the same post-tensioning philosophy as used in precast segmental balanced cantilever bridges. The primary difference is that cast-in-place construction does not require temporary longitudinal PT. Traveling formwork supports the concrete poured for the cast-in-place segments until the concrete has reached specified strength (Figure 4-4).

In some cases, to keep the segment casting cycle duration short, segments are stressed soon after casting (sometimes only two days after), prior to the development of the full specified 28-day concrete compressive strength. The longitudinal prestressing tendons within the newly-cast segment will be post-tensioned, rigidly connecting it with the existing cantilever arm. The form traveler is then advanced to the next casting position and whole casting cycle is repeated.

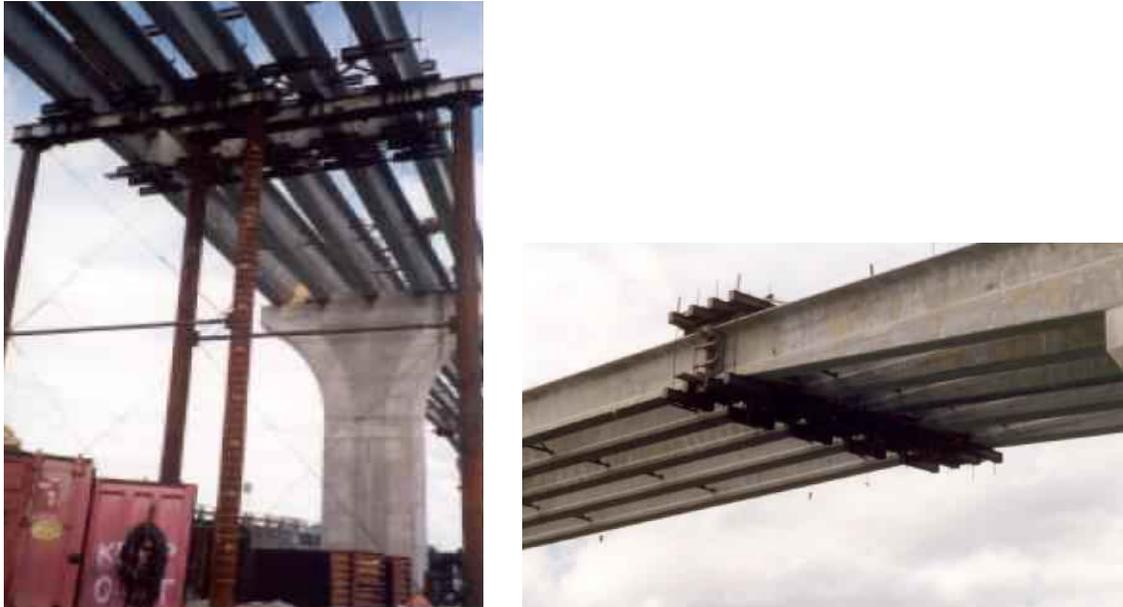
Figure 4-6 Splice construction for AASHTO Bulb-T and Splice girders (FDOT 2002-1)

In this construction method, girder segments are erected at the pier and supported by falsework. A drop-in girder is placed between two pier segments and supported by hangers; tendon ducts are spliced and the closure joint is cast (Figure 4-6). After the closure has reached specified strength, the tendons are stressed to provide continuity for the system. The bridge deck is then placed and tendons are stressed again to complete the composite construction.

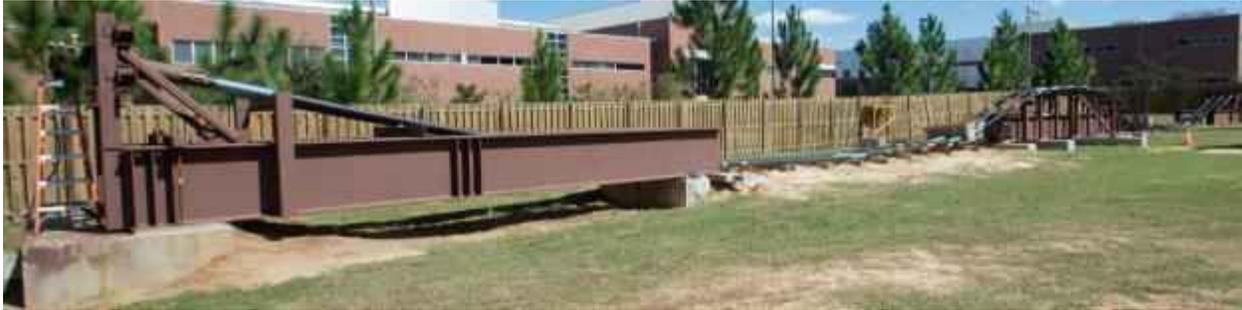
Figure 5-1 Tendon profile for the mockup testing on unbonded tendons

Five 200-ft long specimens were fabricated with a profile that simulated both internal and external tendons. In addition, the tendons were lightly stressed to ensure that the strand bundle was oriented in the duct in a similar manner to a fully stressed tendon in the field (Figure 5-1). HDPE duct of 4 in. diameter with nineteen 0.6-in. prestressing strands formed the tendon. Anchors from FDOT approved post-tensioning equipment suppliers were used at each end of the tendon. Three locations were selected along the length of each tendon at which transparent polycarbonate tubes were installed to allow the injection process to be visible. Figure 5-2 shows an example of one of the locations.

Figure 5-1 illustrates the profile of the mockup tendon, which was designed to simulate the geometry of a post-tensioned tendon in a bridge. The overall length of the tendon was 200 ft with the profile symmetrical about the mid-length of the tendon. Two profile forms were incorporated into the tendon. The external tendon profile included a draped tendon at ends (~30 ft) and straight tendon (~40 ft) in the middle. The parabolic profile (~60 ft) at mid-length mimicked the internal tendon profile in a girder bridge with drop-in spans. Deviators were placed at four locations to hold the tendon geometry. HDPE duct of 4 in. diameter with 19-0.6 in. prestressing strands formed the tendon. Anchors from FDOT approved post-tensioning equipment suppliers were used at each end of the tendon.

The tendon was designed to follow the profile shown in Figure 5-1 by inducing sufficient prestressing force on the anchors. The weight of each “gravity” deviator was 0.6 kips, while the collective weight of the tendon (including weight of strands, duct, and flexible filler) was approximately 19 plf. This approach was intended to draw the strand bundle toward the top of the duct in the external profile and the bottom of the duct in the internal profile.

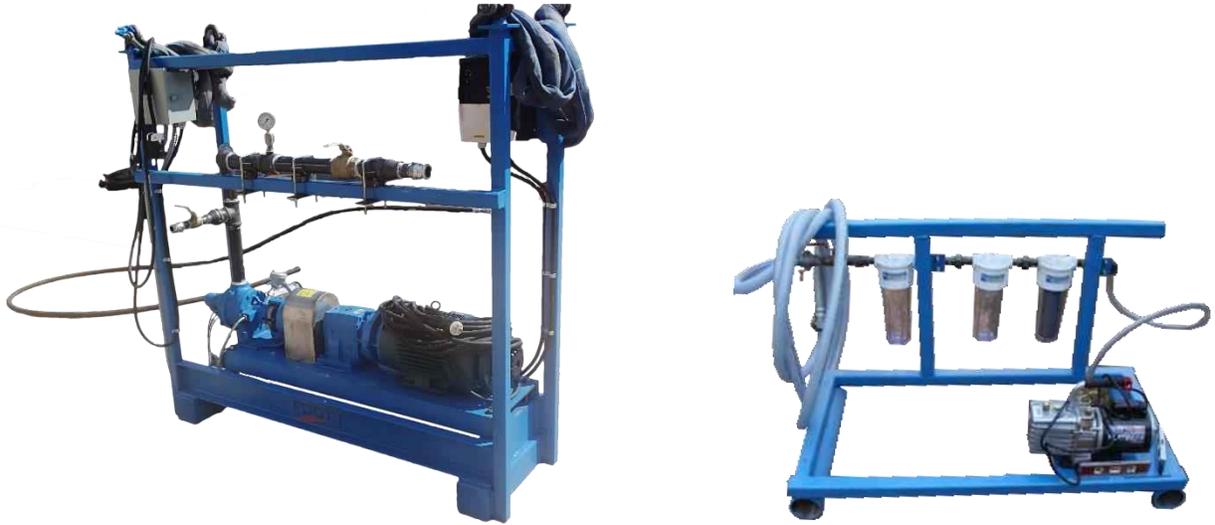
Figure 5-3 Viking pump used for filler injection (left) and vacuum pump and reservoirs (right)

Flexible fillers were delivered in 55 gallon barrels and were solid at room temperature. To liquefy the filler, the barrels were heated to about 220° F, which was achieved by using barrel heaters on the outer surface of the barrel (Figure 5-4). Insulation blankets were used to improve the efficiency of the barrel heaters.

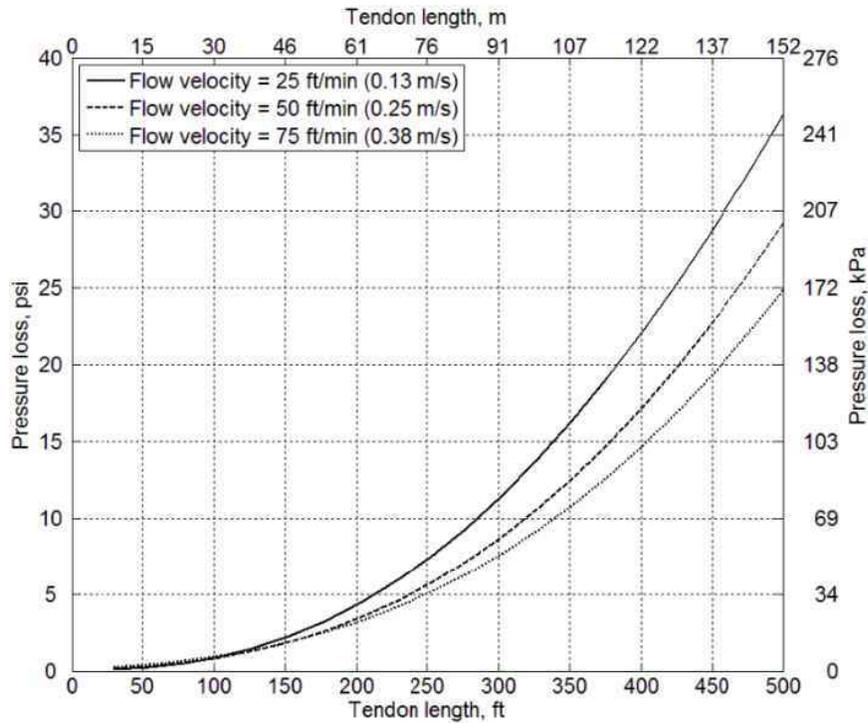
Figure 5-9 Pressure loss from thermal model

This simplified approach in estimating the minimum injection pressure assumes laminar flow in a straight horizontal tendon. In reality, the strand bundle is expected to cause some turbulence, and the tendons often have deviated segments rather than a straight profile. Therefore, this approach should be viewed as an attempt to obtain a basic understanding of evaluating the pumping pressure; more detailed analysis is required for a better estimation. Mockup trials to confirm the efficacy of the injection should also be conducted.

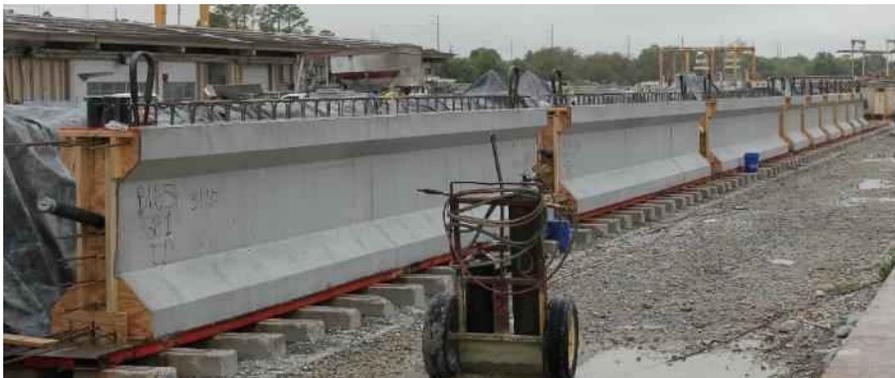
Figure 6-6 Segments in prestressing bed

Portions of the specimens were precast and pretensioned (Figure 6-6) and then shipped to FDOT Structures Laboratory to complete fabrication. Specimens with internal tendons (IGS, IWS and IWC) were precast in single lengths and shipped to the FDOT Structures Laboratory. The end blocks containing the post-tensioning anchorages were then cast. Specimens with external tendons (EWS and EWC) were constructed using three precast segments (Figure 6-7) with closure pours located at the deviators for the external tendons. The specimens were injected with post-tensioning grout or flexible filler (Figure 6-8) after the tendons were post-tensioned. The fatigue specimens were constructed in two segments with the mechanical hinge placed near midspan (Figure 6-9).

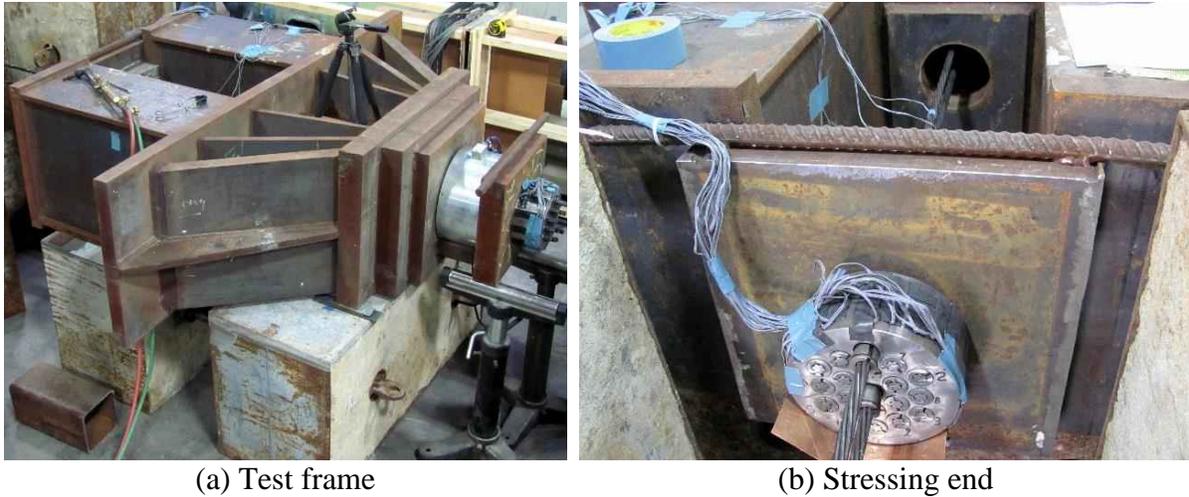
Figure 7-1 Experimental setup

Under the loading and boundary conditions, the resulting strain in an anchor head is expected to develop primarily in three directions: axial (because of tension in strands), circumferential, and radial (because of wedge seating in anchor head). The strain response in all these three directions was captured to assess the sensitivity of measured strains to wire breaks (Figure 7-2).

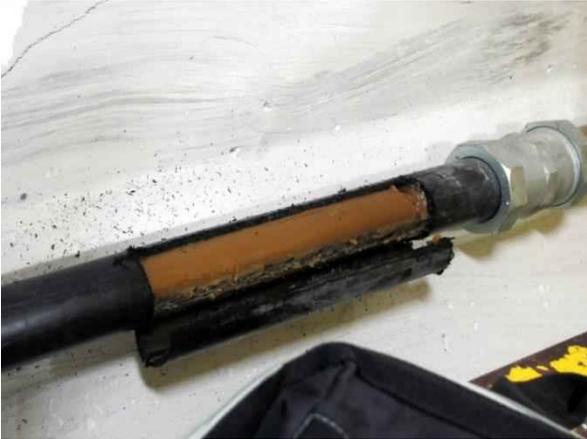
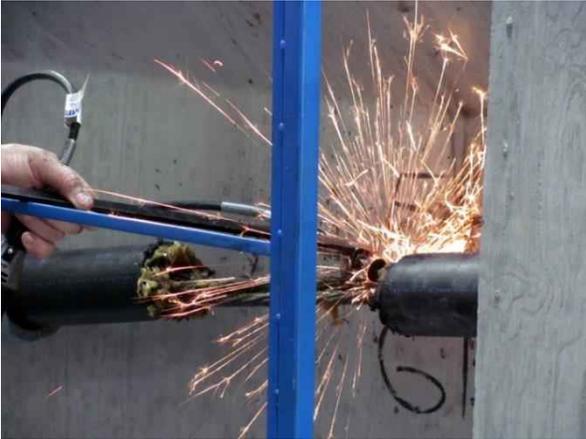
Figure 7-4 Cutting prestressing strands

(a) exposing the duct to access the strands

(b) wire cuts with Dremel tool

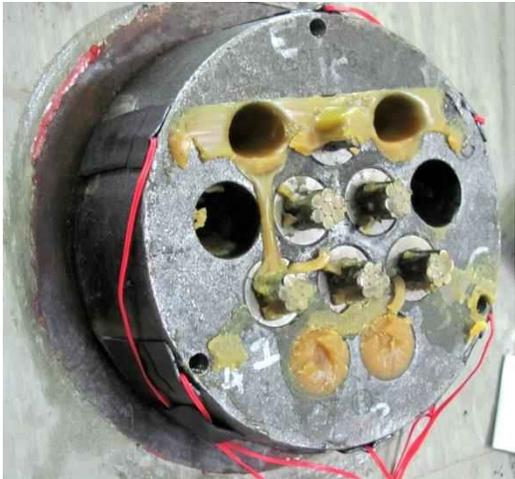
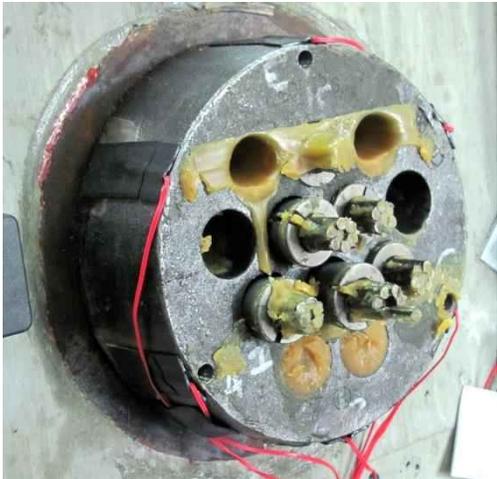
Figure 7-5 Wedge movement after strand cuts

(a) before strand cuts

(b) after strand cuts

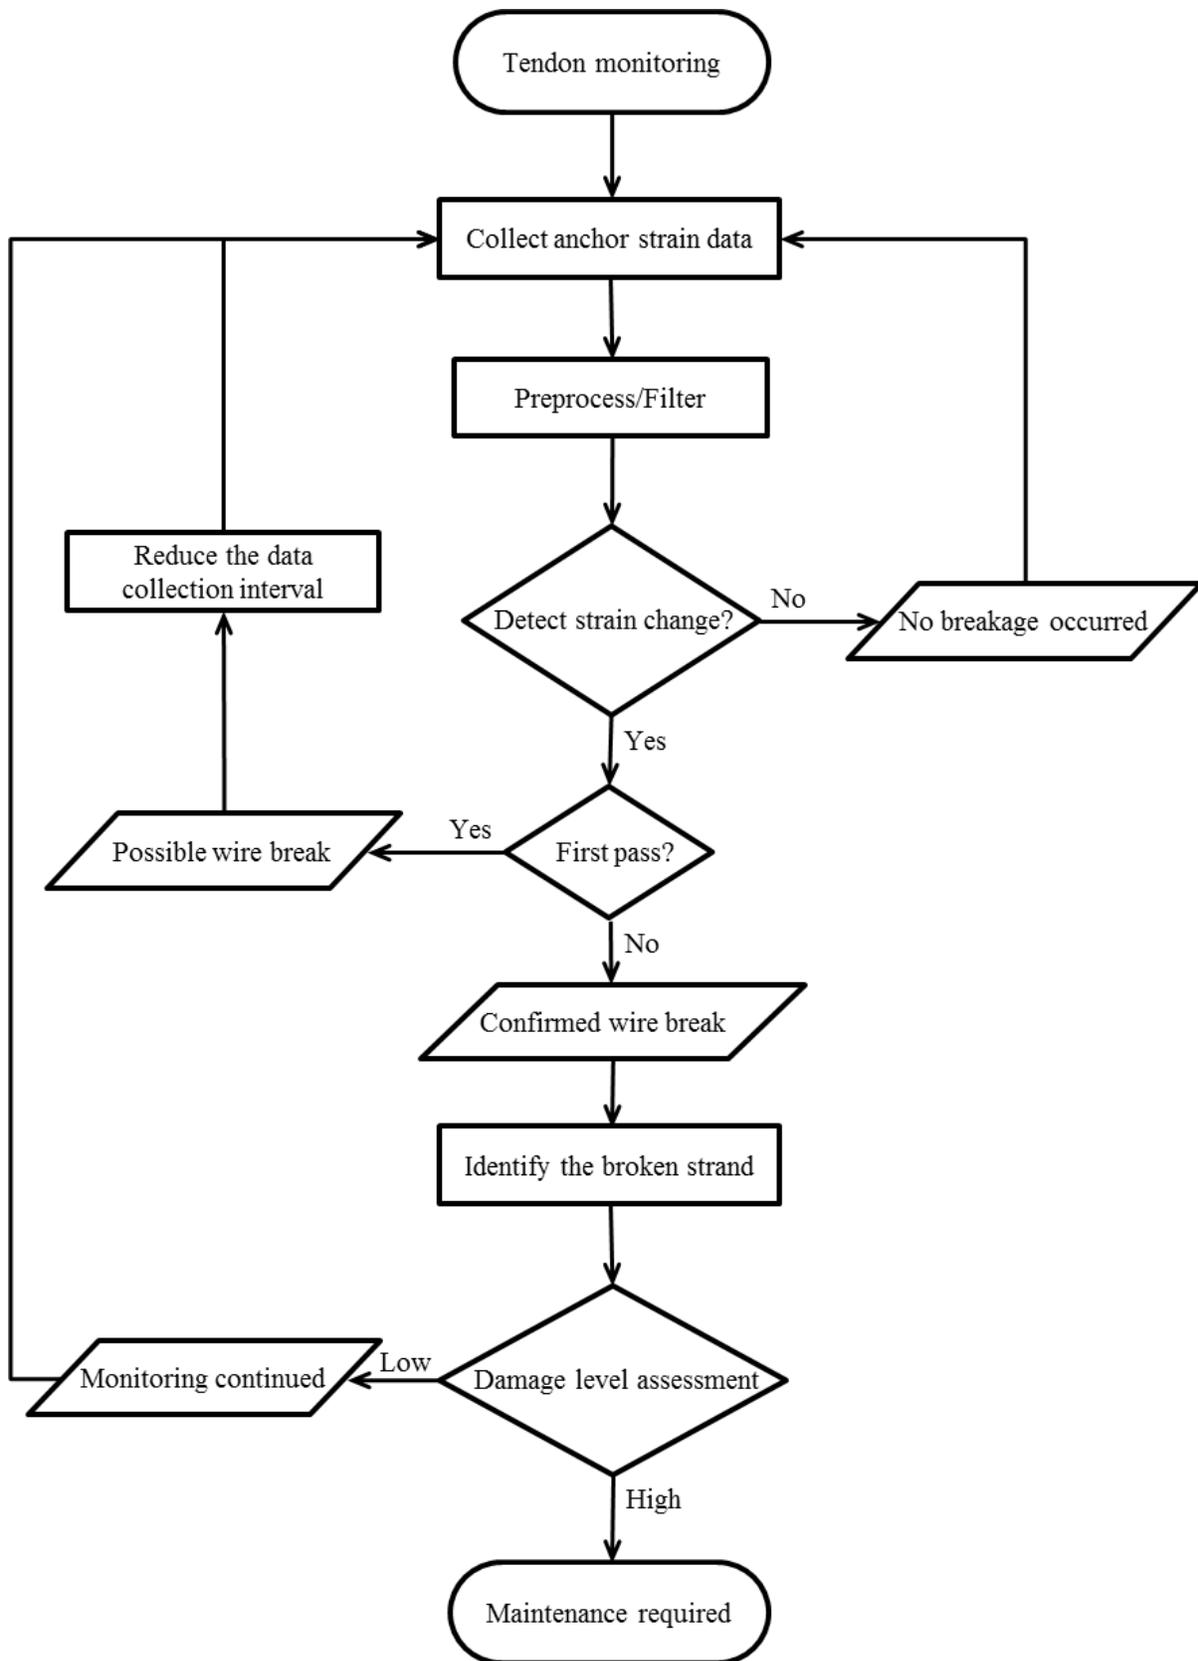
Figure 7-6 Wire breakage identification flowchart

Figure 7-6 shows a monitoring framework for the strain-based approach developed. The purpose of the framework is to provide alerts when strand breakage is detected and to identify the strand that has sustained the damage. The data collection and processing is expected to be fully automated, requiring very little user input. The framework assumes that at least one wedge plate for the strand(s) of interest is instrumented with a number of strain gages capturing axial strains on a predetermined schedule (e.g., daily or weekly), such as at night when traffic loads and temperature loads are expected to be at their lowest. The anchor strain data is collected for an amount of time adequate to capture mean strain levels each day. Then the captured data may be pre-processed to exclude the effects of live load, temperature differentials, and other non-breakage events. The preprocessed data is compared with the data collected during the previous monitoring event to determine if any significant strain change has occurred, indicating a wire break. After detecting a break event, the next step is to identify the broken strand. Finally, an assessment of the damage level, relative to previous monitoring events, is carried out. The

damage level assessment may then be used by the maintenance office to decide whether to continue monitoring the strains or to perform a maintenance operation.

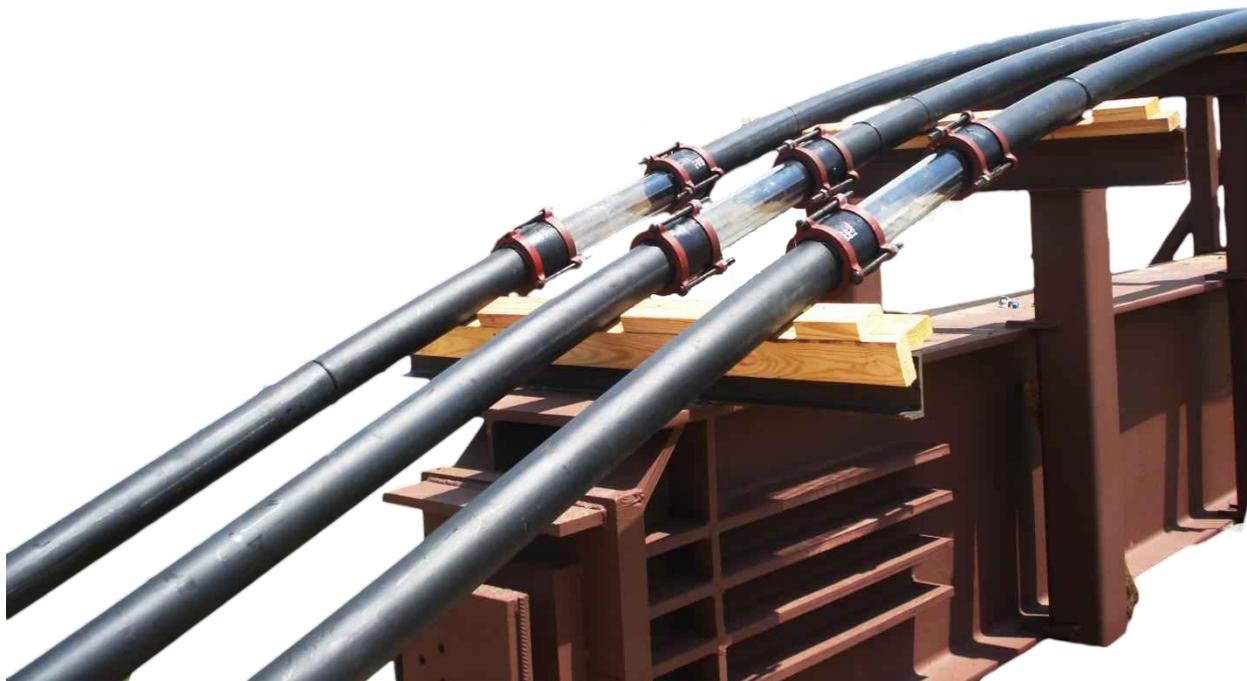
Figure 5-3 Window locations on tendon

Three locations along the tendon profile were selected at which the HDPE duct was replaced with transparent polycarbonate tubes to allow the injection process to be visible. These tubes were rated to withstand temperatures up to 280° F. The tube size was selected to match the outer diameter of the HDPE duct (4.5 in.). The wall thickness of the polycarbonate tube was 1/8 in., which made the inner diameter slightly larger than that of the HDPE. Figure 5-3 shows the location of transparent windows on each tendon.

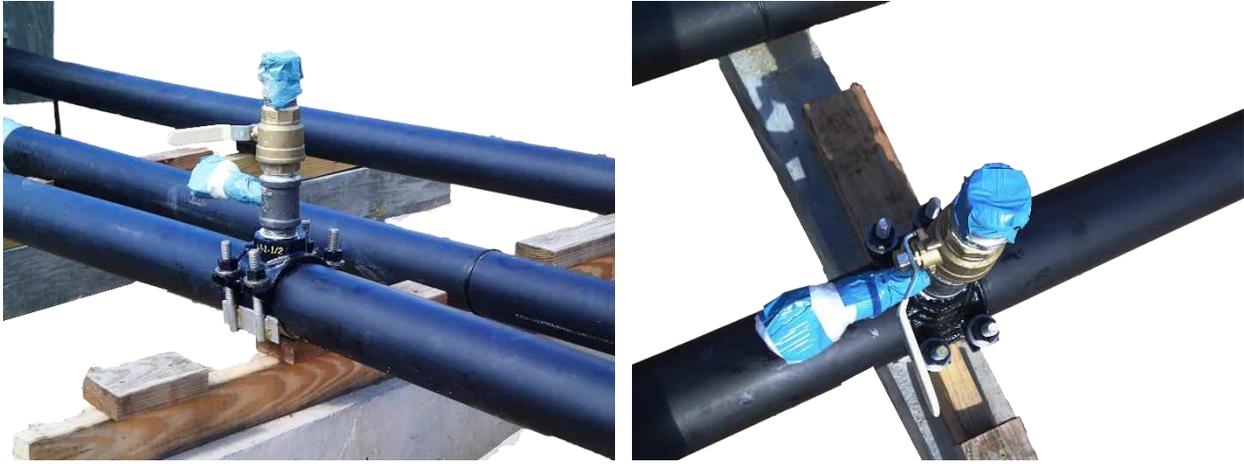
Figure 5-6 Injection into saddle

The anchorages used in this study were fitted with injection ports intended for use with cementitious grout (Figure 5-5). Filler was introduced into the tendon through either the anchorage injection port or a saddle connected directly to the duct (Figure 5-6). A pipe saddle with an opening diameter of 1½ in. was mounted on the duct; the duct was also lifted slightly in the vicinity of the injection point to ensure that the strands did not block the injection. The material was injected by connecting the discharge hose of the pump to the saddle fitting. After injection was completed, the valve was closed to prevent filler from escaping when the injection hose was removed.

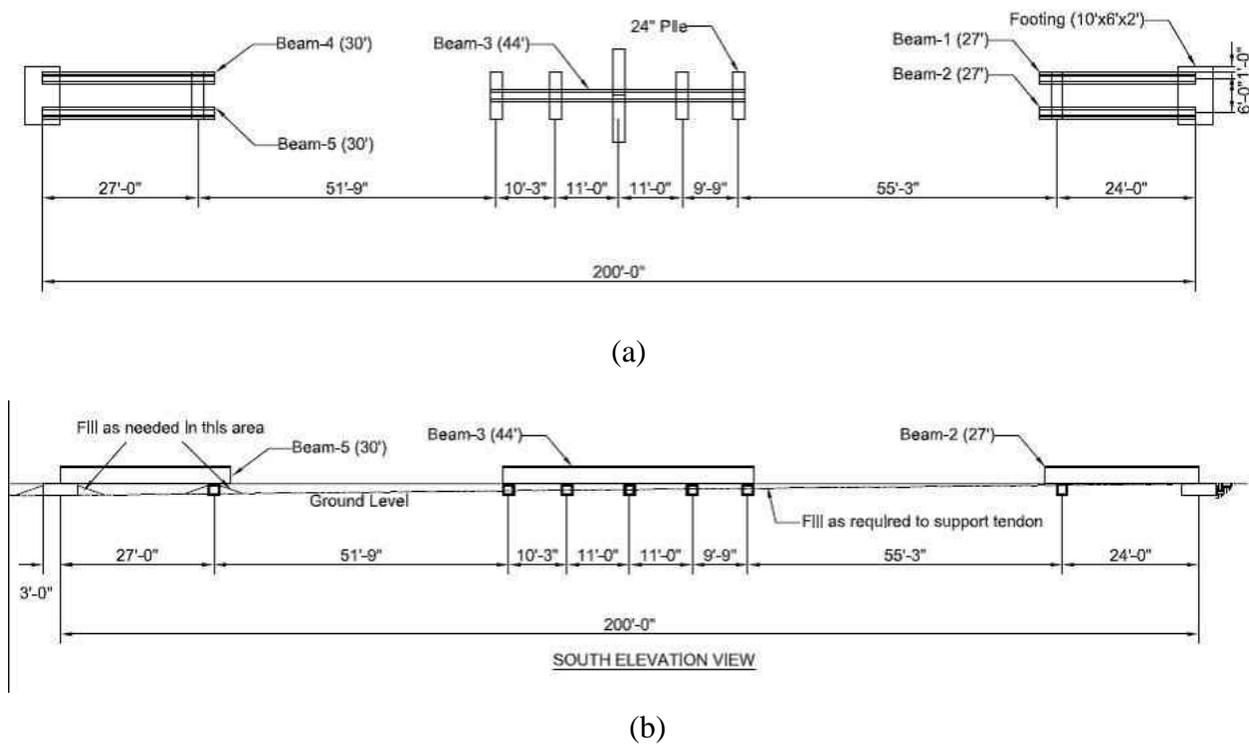
Figure 5-7 Plan and elevation of the foundation plan

To support the tendons, structural steel frames were placed at each end (anchorage) and at mid-length (Figure 5-7 and Figure 5-8). These frames were then supported by salvaged pile segments and footings. Cast-in-place footings (10 ft x 6 ft x 2 ft) were placed under the anchorages at each end frame. Square pile segments were placed prone at the other end of the end frames and evenly distributed under the middle frame. The foundation was constructed such that the three support frames were at the same elevation. This ensured a uniform and symmetric tendon profile.

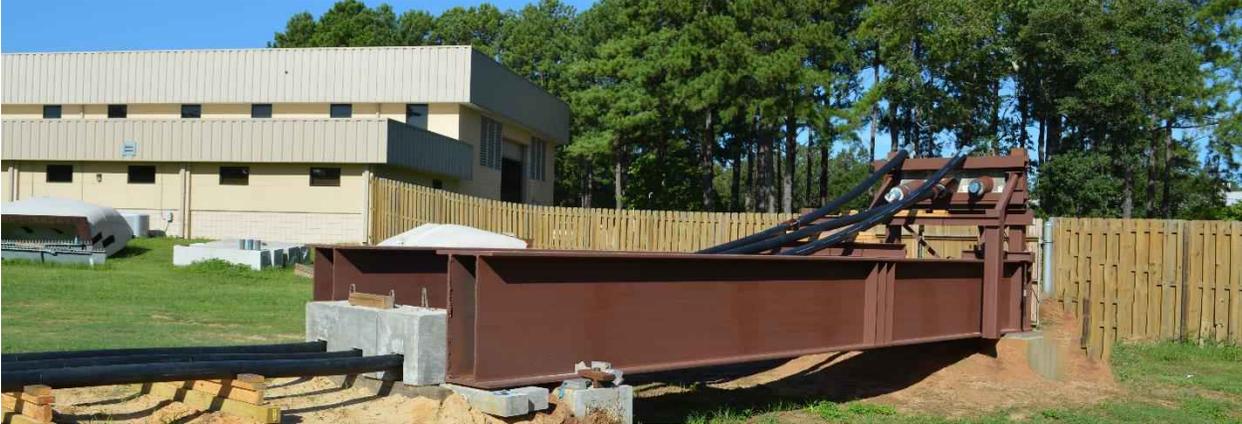
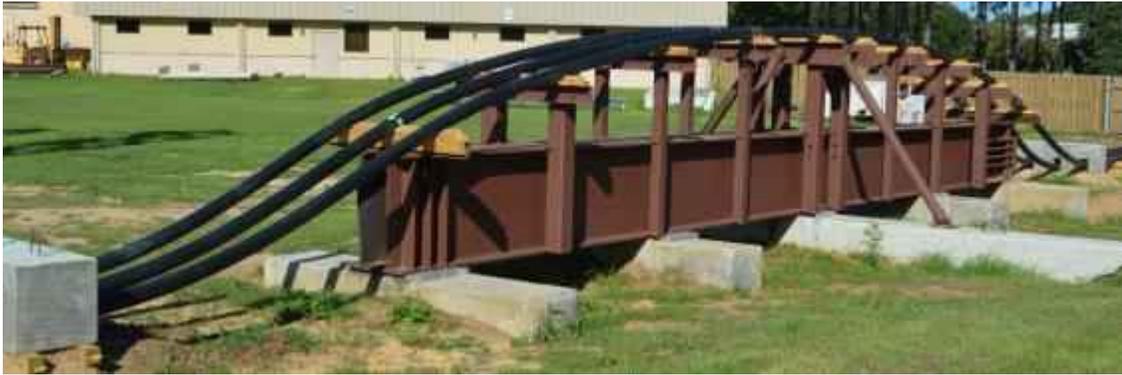
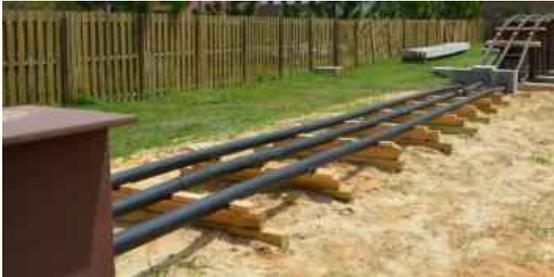
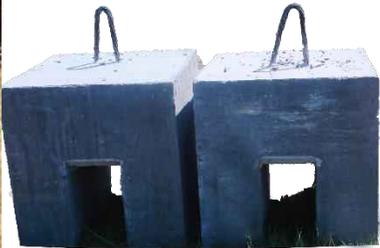
Figure 5-8 Mockup support system, including (a) anchorage frame, (b) middle frame, (c) supports between frames, and (d) gravity deviators

The support at the end frame was designed to carry the loads from the prestressing force applied at the anchors and dead loads from the strand and duct. Prestressing force was transferred to the steel beams through the cross beams and the vertical members on the frame. Epoxy anchors were used to connect the steel beams to the footings and transfer force from steel beams to the footing. A friction coefficient of 0.45 between steel and concrete was assumed. Details of the end frame are shown in Appendix A.

Gravity deviators were used to obtain the desired tendon profile. These were used in conjunction with the support frame to balance the nominal prestress force on the tendon. Four deviators were used on each tendon (Figure 5-8).

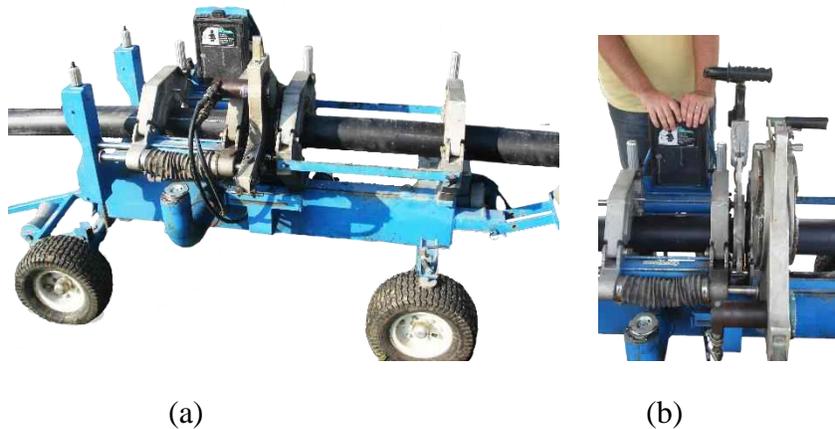
Figure 5-9 (a) McElroy HDPE fusion machine; (b) Duct fusion in progress

HDPE pipe was delivered in 20 ft and 40 ft lengths. A McElroy 14.0 HDPE duct fusion machine (Figure 5-9a) was used to fusion weld HDPE ducts. The following procedure was used to weld HDPE ducts.

- Heaters, which were kept in the heating machines, were periodically checked for the optimum temperature for butt weld fusion ( $425^\circ$  F).
- Heaters were placed in position between the pipe ends, the pipe or fitting ends were brought into full contact with the heater to ensure proper seating. The locking cam was raised into the engaged position during the heating cycle. Proper contact was maintained without force, while a bead of molten polyethylene developed between the heater and the pipe or fitting ends. Heating was continued until the minimum melt bead size ( $3/16$  in. for 4 in. duct) had developed.

- The ends of the ducts were pushed together to join the beads. The force was maintained for about 3 min. and then removed. The optimal interfacial pressure to join beads is 75 psi. The required torque reading corresponding to this pressure for 4 in. duct size was 25 ft-lb.
- The cam was unlocked and unscrewed to open the clamps. Pipe was pulled through machine, and prepared for fusing the next joint. The joint was inspected and checked for any high or low locations or misalignment. The process was repeated if the joint was not properly fused.

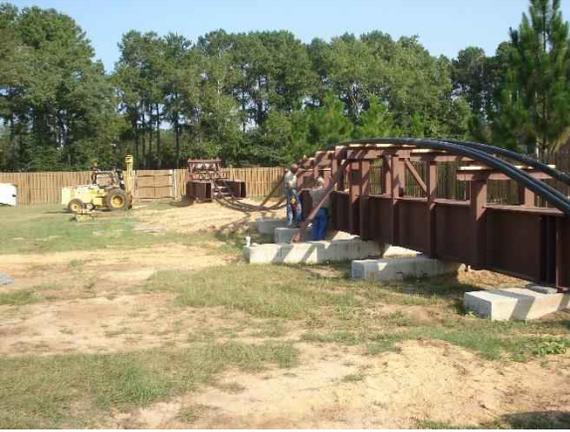
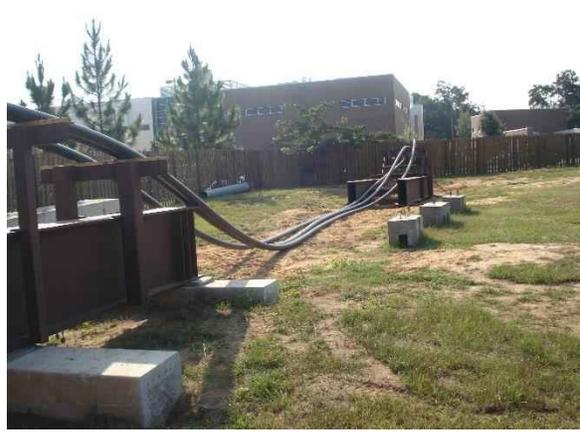
Figure 5-10 HDPE duct on the support frame after welding

The total length of the welded duct for a single mockup tendon was approximately 230 ft. Ducts were placed on the support frame using a fork lift (Figure 5-10).

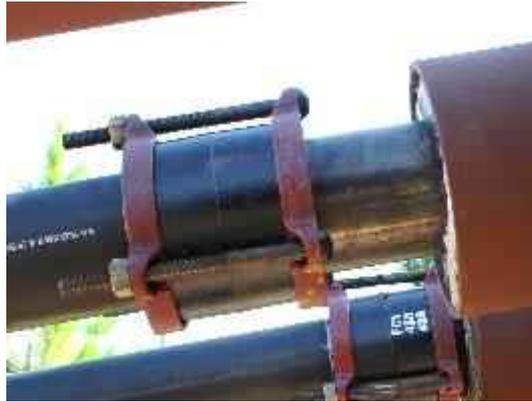
Figure 5-11 HDPE duct connected to the anchor block at the east end

The east end of the HDPE duct was connected to the anchorage pipe using the coupler (Figure 5-11).

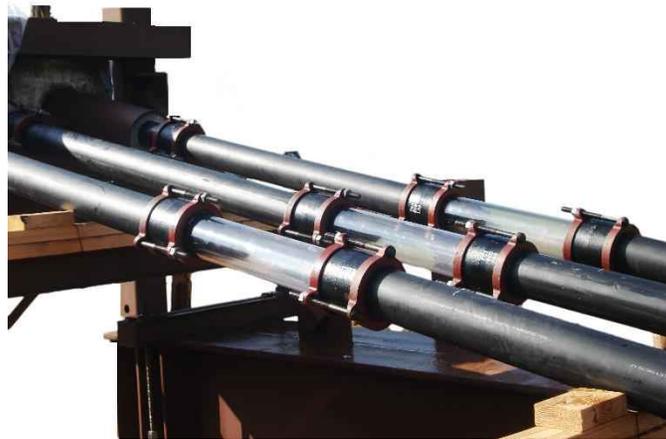
Figure 5-12 Clear windows in duct

Clear window locations were marked and HDPE duct was cut and removed at these locations (Figure 5-12). Clear windows were precut in 2-ft lengths and installed with couplers.

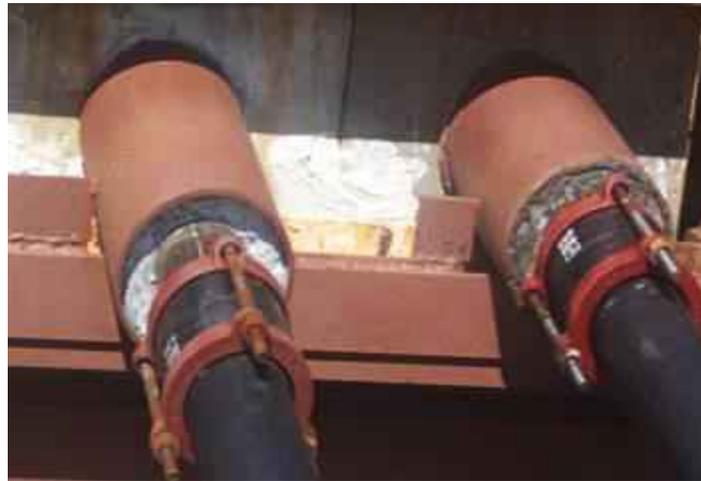
Figure 5-13 West end connected to the anchor block

Excess HDPE duct was cut at the west end and HDPE duct was connected to the anchor pipe using a coupler (Figure 5-13).

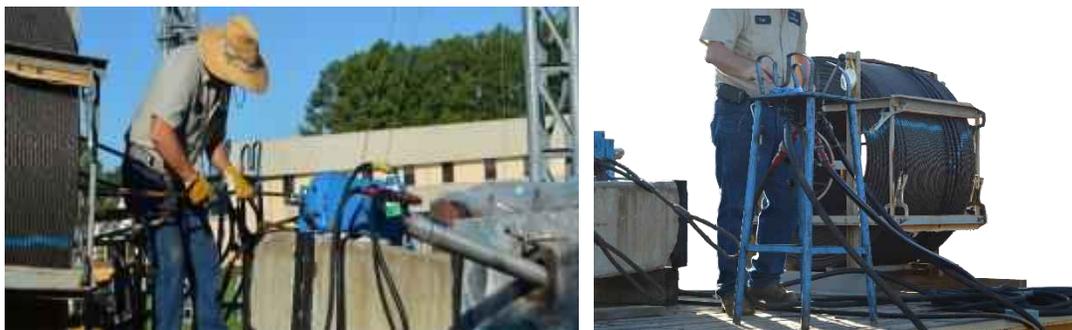
Figure 5-14 Strand installation using Model 00143604/2 strand pusher from PAUL Maschinenfabrik GmbH & Co

A hydraulic strand pushing machine was used to push individual strands into the duct (Figure 5-14). The machine had the capacity to push strand up to 500 ft. This machine consisted of three parts: strand pusher that pushed the strand into the duct, a hydraulic controller that controlled the speed of the machine, and a diesel-hydraulic power unit.

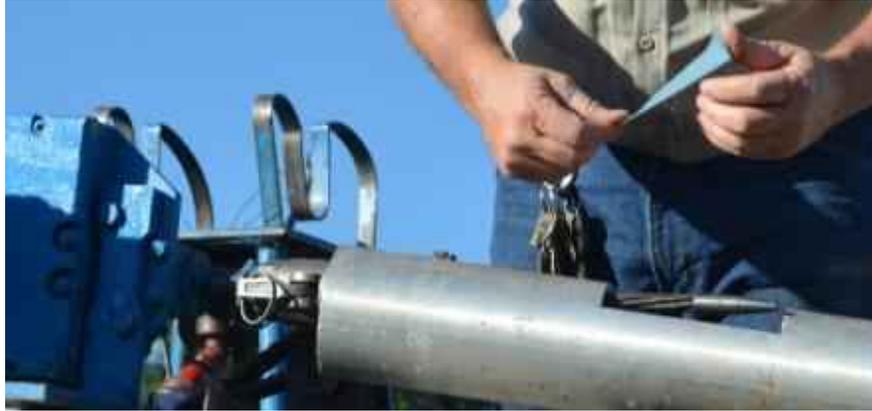
Figure 5-15 Bullet on the head of the strand during pushing

The strand coil was loaded onto the reel, which was placed behind the strand pusher. The strand pusher was connected to the diesel generator and controller. The diesel generator was started. A strand bullet was placed on the end of the strand and the strand number was marked on tape (Figure 5-15). Machine speed was adjusted and strand was pushed at about 20 ft/sec. The tail of the strand at east end was cut and a new bullet was placed on the end and the strand was pushed again. This process was repeated until all 19 strands were pushed into the duct.

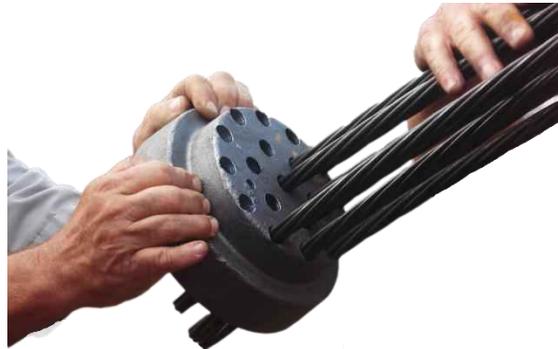
Figure 5-16 Wedge plate installation

The last three strands pushed were marked and then placed at the top of anchor wedge plate. The other strands were placed at random in the wedge plate (Figure 5-16). Wedges were placed on the strands. Strand tails of about 5 feet were left beyond wedge plate for stressing (Figure 5-17).
