# Replaceable Unbonded Tendons for Post-Tensioned Bridges

**Final Report**

**December 2017**

Florida Department of Transportation (FDOT)

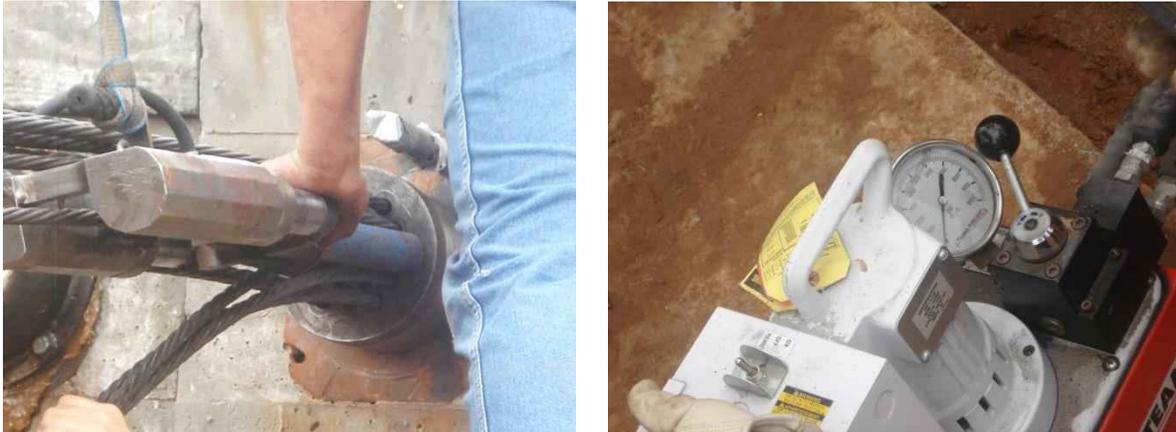
Figure 5-18 Monostrand hydraulic jack and pump used to stress strands

Strands were stressed individually with a monostrand jack (Figure 5-18). The first strand was pulled until the concrete deviator lifted slightly off of the ground (Figure 5-19). Subsequent strands were stressed until slight movement was noticed in the deviator. No strand was stressed more than 1 kip. This approach ensured that the tendon formed the correct tendon shape without developing undue prestressing force.

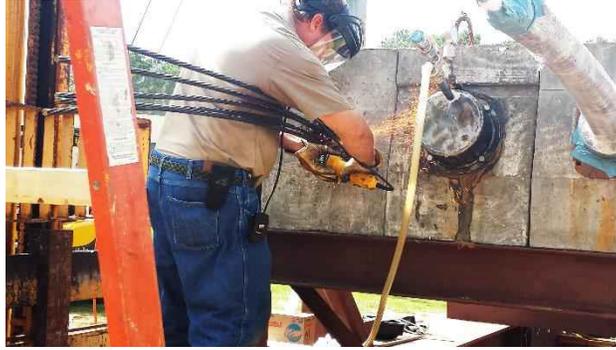
Figure 5-20 Strand tails cutting in operation

Strand tails were cut and caps were installed (Figure 5-20).

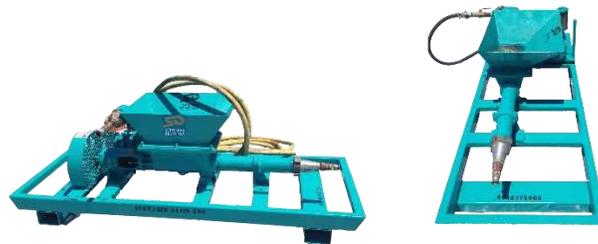
Figure 5-21 Grout pump (Schwager Davis Inc.)

A positive displacement grout pump was used in the small-scale tests and the first mockup injection (Visconorust). It was a 20 gallons per minute (gpm) air driven pump with a hopper intake and required 185 cfm at 100 psi air supply. The discharge line of the pump had a 1 in. diameter opening and thus 1 in. hose was used to supply filler from pump to injection port. Figure 5-21 shows the pump used in the mockup and small-scale tests.

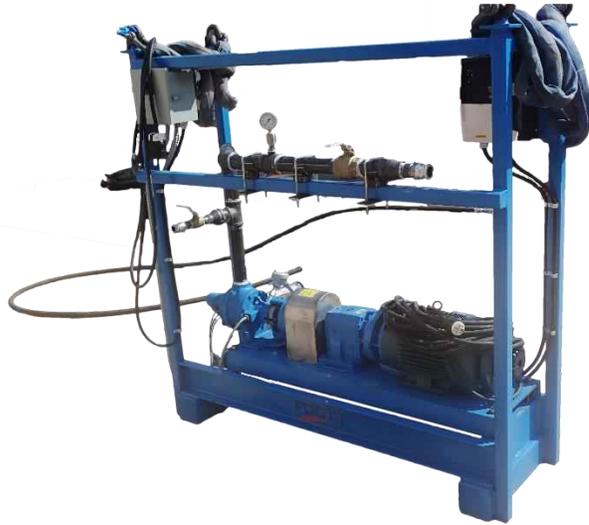
Figure 5-22 Viking pump used for filler injection

The pump used for the remainder of the mockup injections was a Viking centrifugal pump with a variable frequency electric drive (Baldor VFD controller) (Figure 5-22). The maximum running speed of the pump was 780 rpm. The pump housing was heated (up to 250° F). The pump had 2-in. diameter NPT suction and discharge cast iron ports. At maximum speed, the discharge rate was 100 gpm @ 75psi for a liquid with a viscosity of 20 cP.

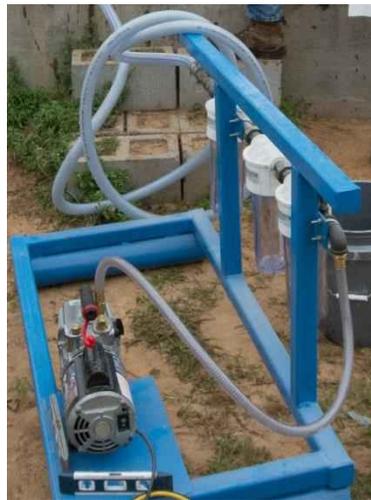
Figure 5-23 Vacuum pump and reservoirs

A vacuum pump was used in the vacuum assist filler injection for the Trenton 1 specimen (Figure 5-23). The vacuum pump was a high capacity HVAC vacuum pump with a capacity to pull a nearly complete vacuum. The pump was connected to two chambers. One of the chambers was fitted with a filter to protect the pump from debris.

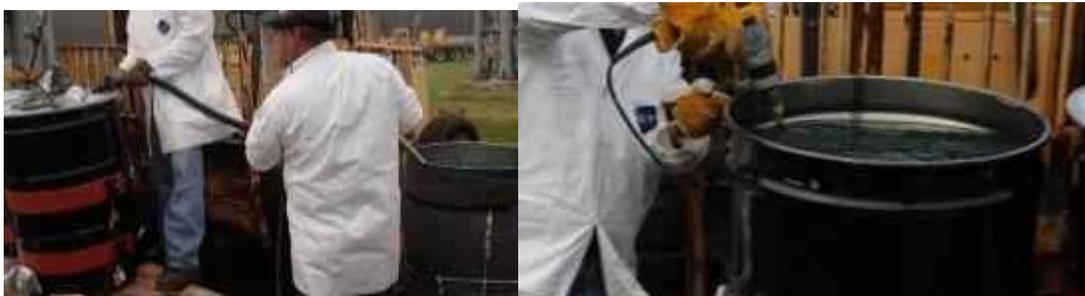
Figure 5-25 Filler heating logistics: (a) transfer of filler between barrels and (b) filler agitation.

Once the filler was heated sufficiently, it was transferred to the injection barrels using an air driven transfer pump (Figure 5-25 (a)). Barrel heaters and insulation blankets were also moved to the injection barrels to maintain temperature for injection. The filler was stirred regularly to ensure even distribution of heat in the barrel (Figure 5-25 (b)).

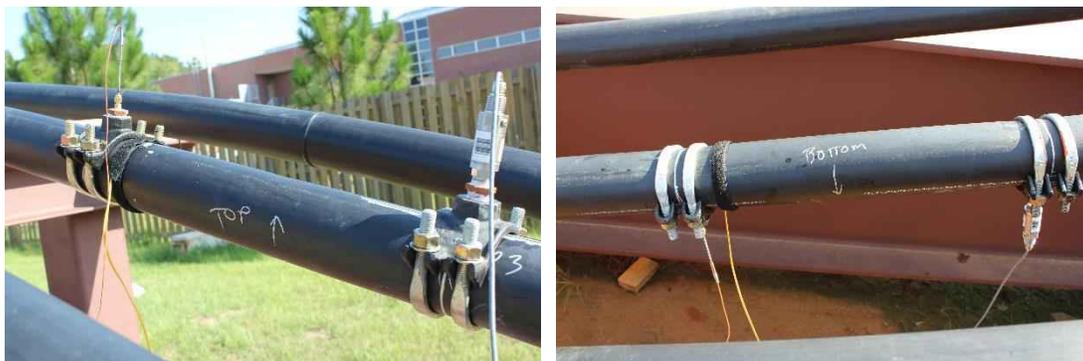
Figure 6-2 Instrumentation orientation on the tendon

Table 6-1 Distance from the face of the east anchor to the sensor. See Figure 6-1

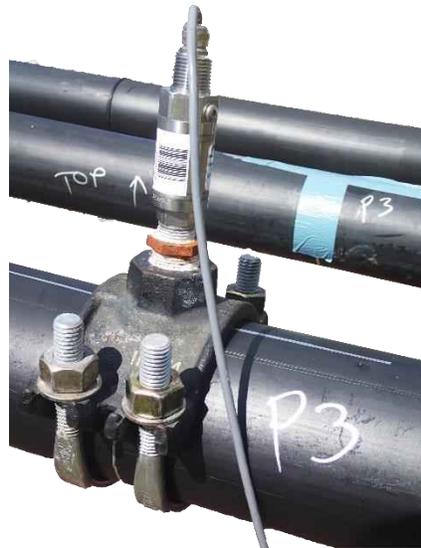
Figure 6-4 Typical transducer installed on the tendon

Pressure transducers were used to measure the pressure inside the duct during and after injection of flexible fillers. They were selected based on a maximum pressure of 75 psi and a maximum temperature of 220° F (105° C). Omega PX209-015G5V pressure transducers were used, which had operating temperature from -65°F (-54°C) to 250°F (121° C) and operating pressure up to 300 psi. The transducer's response time of 2 ms allowed quick measurement of the pressure. Transducers were installed on the duct using a pipe saddle (Figure 6-3) with ¾ in. NPT opening. A ¾ in. male to ¼ in. female adapter was used to connect transducer and saddle. Figure 6-4 shows a typical pressure transducer.

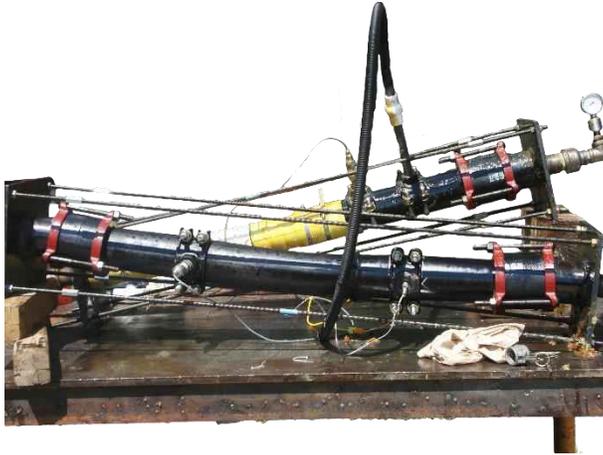
Figure 7-3 Deformation in the duct due to high pressure

In one of the tests conducted, the HDPE duct deformed due to heat accumulation during the prolonged circulation of filler (more than 8 minutes) and high injection pressure (above 100 psi) (Figure 7-3). No leaks occurred, however, in any part of the specimen (duct and coupling). Hence the injection pressure was limited to 75 psi for full-scale mockup tests.

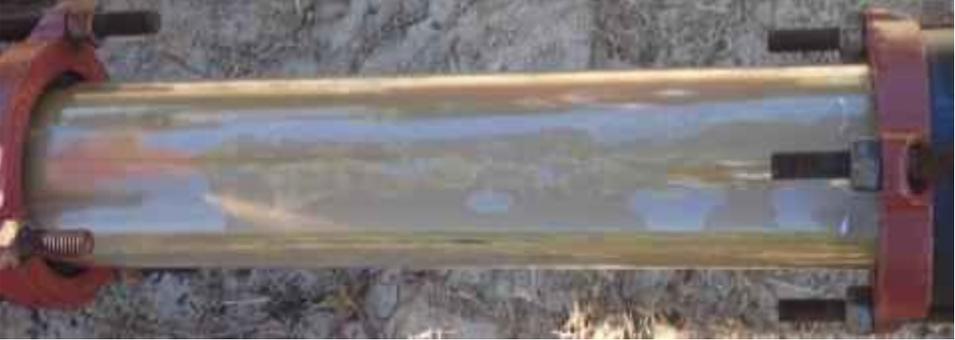
Duct windows			
C1	60	Top	Elongated cracks on the top of the filler. Strands completely coated with filler.

Duct windows			
C1	60	Top	Elongated cracks on the top of the filler. Strands completely coated with filler.

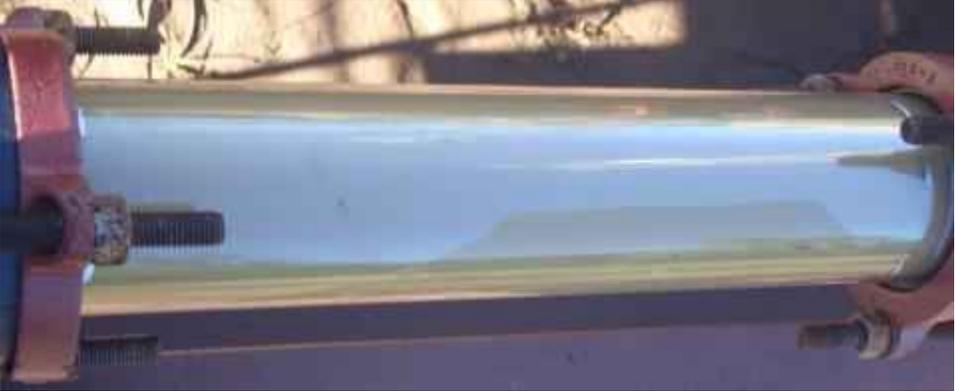
C3	190	Middle	Cracks in the filler at the top and north side of the window. Strands completely coated with filler.

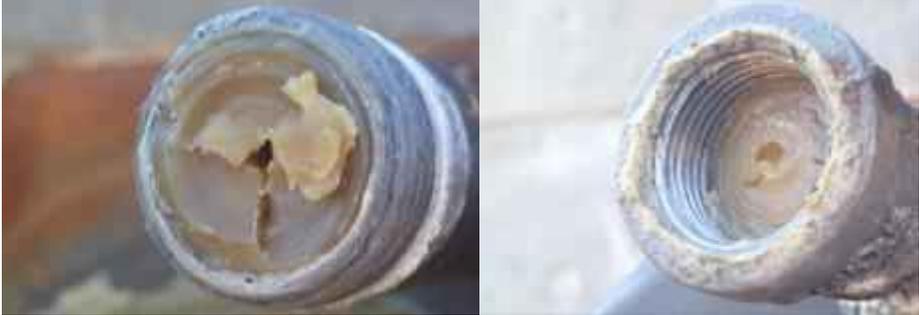
Vents and caps			
East anchor and cap vent	0	-	Anchor vent had a pin hole in the filler. Cap vent completely filled with filler.

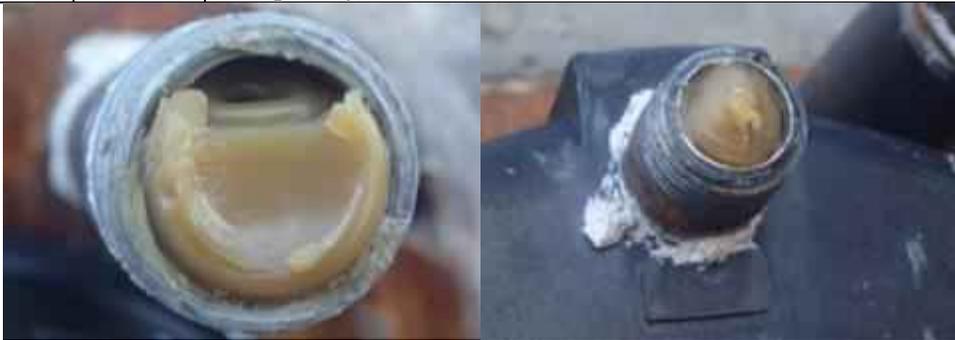
West anchor and cap vent	200	-	Anchor vent had a ¼ in. hole in the filler. Cap vent completely filled with filler.

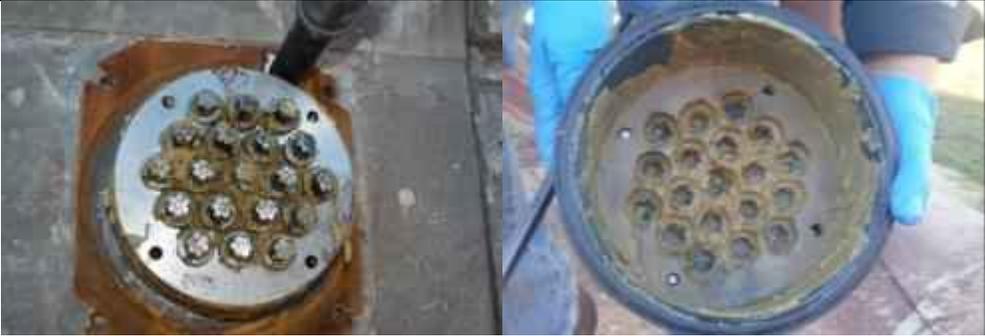
West end Cap	0	Middle	Cap completely filled with filler.

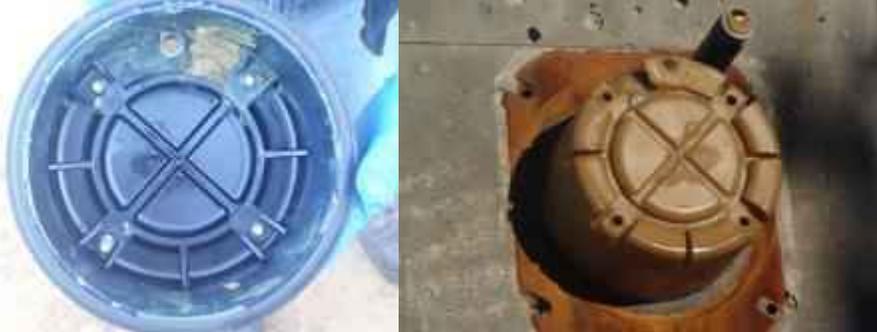
East end Cap	200	Middle	Cap completely filled with filler.

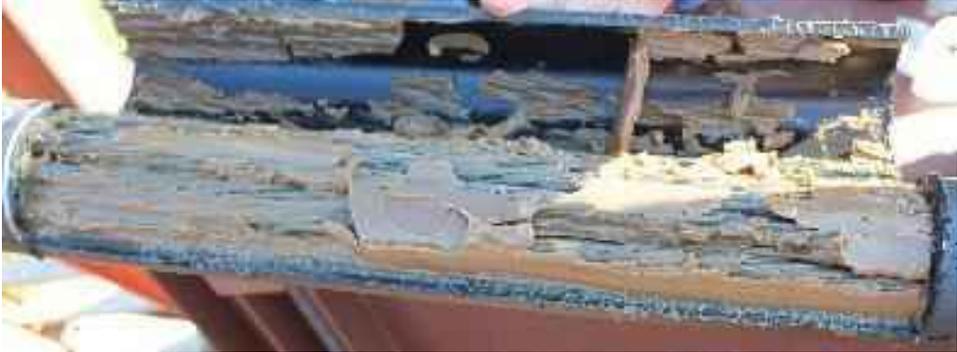
Inspection port	Location (ft)	Strand location	Comments
IP01	1	Top	No voids visible. Visible strands completely coated with filler.

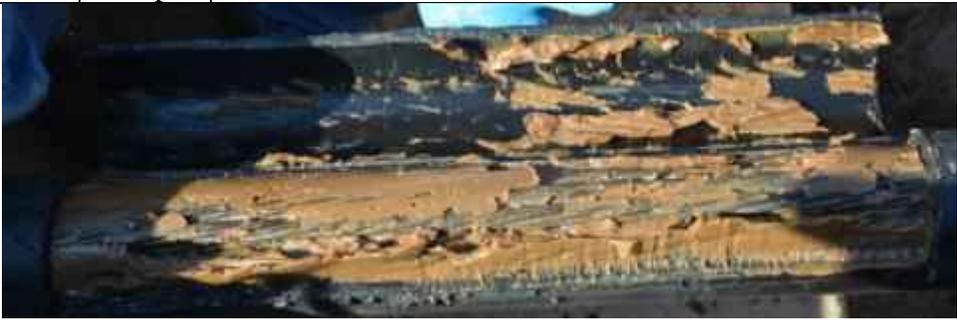
IP02	27	Top	No voids visible. Visible strands coated with filler.

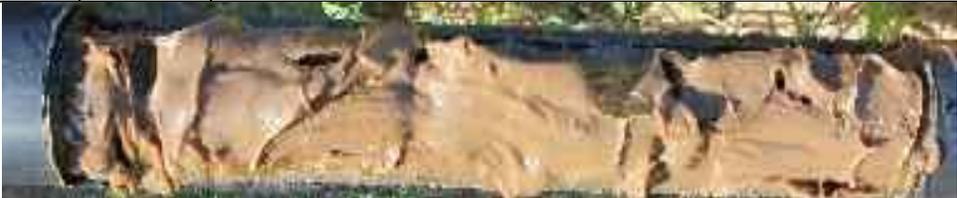
IP03	31	No inspection due to instrumentation.	
IP04	55	Bottom	No voids visible. Visible strands completely coated with filler.

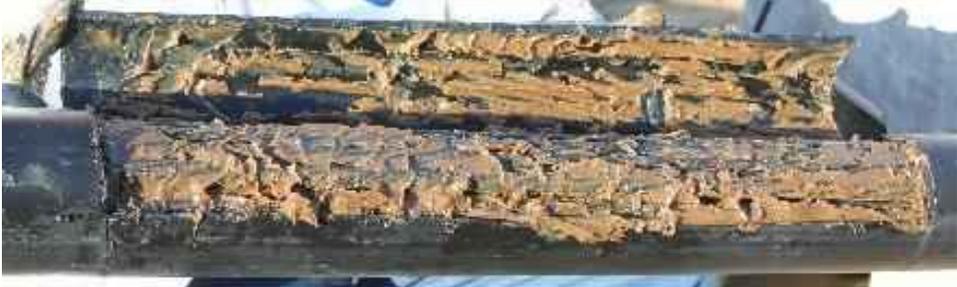
IP05	67	Top	No voids visible. Strands coated with filler.

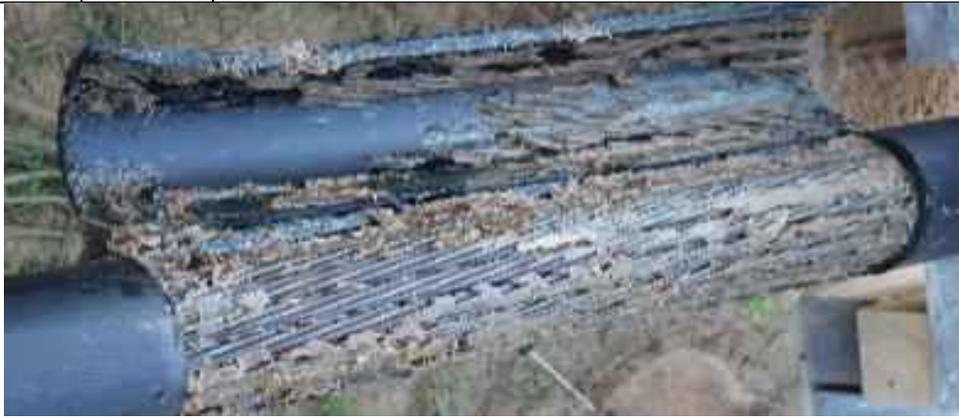
IP06	71	Top	Dry stand at some locations and some voids. Strands mostly coated with filler.

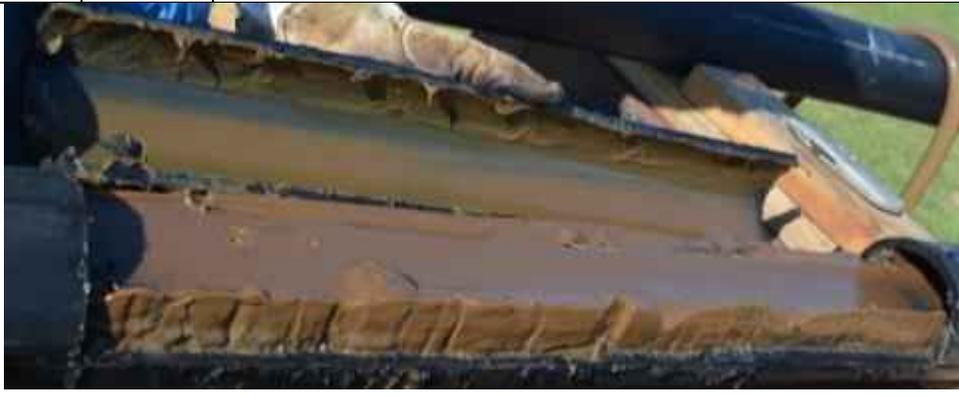
IP07	92	Bottom	Void at the top on east side ¼ in. deep. Strands completely coated with filler.

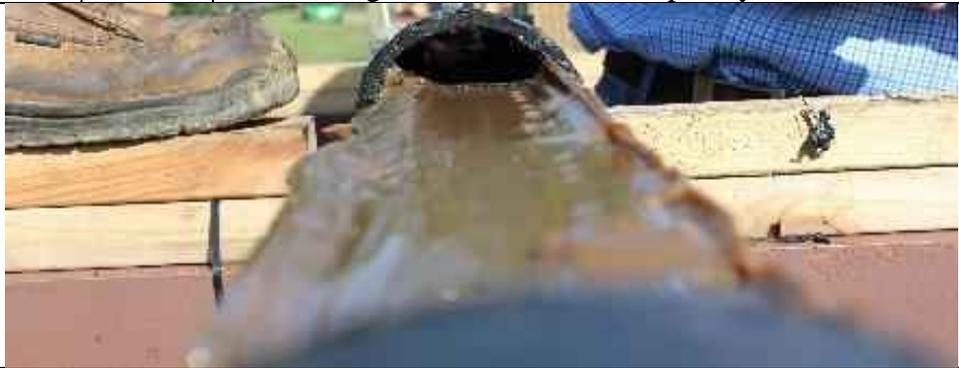
IP08	97	Bottom	Void at the top. 1 ¼ in. on west side, 7/8 in. on east side. Void through to IP-7. Strands completely coated with filler.

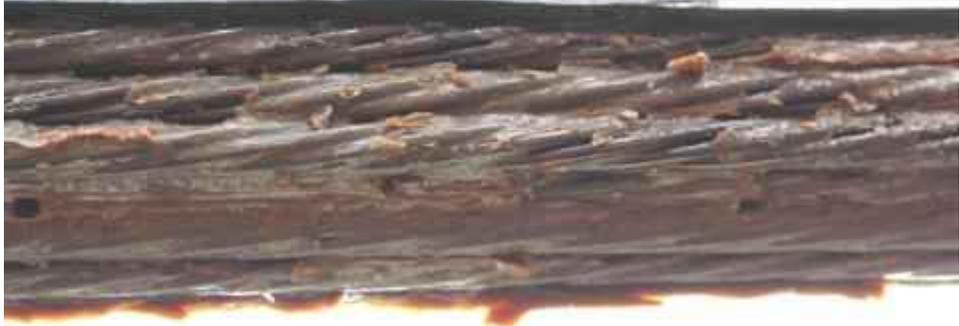
IP09	100	Bottom	No voids visible. Strands completely coated with filler.

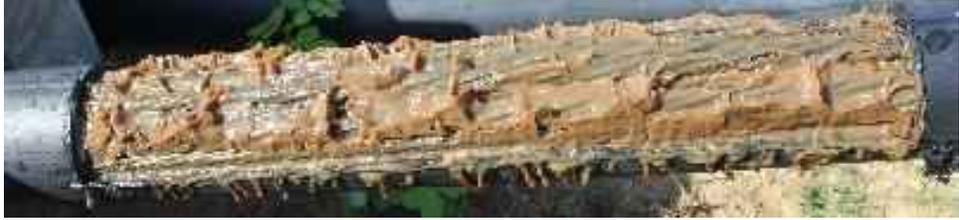
IP10	125	Top	No voids visible. Strands completely coated with filler.

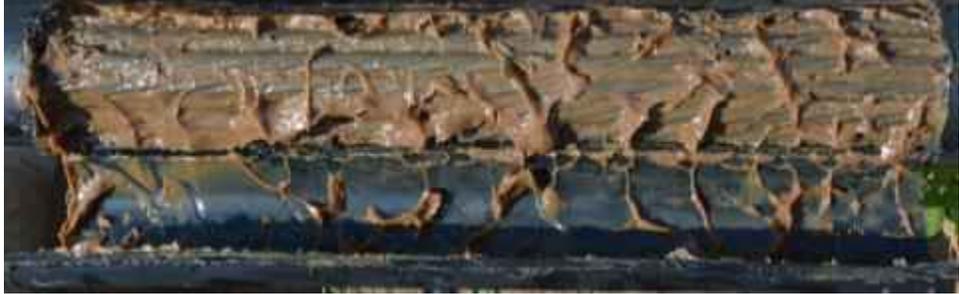
IP11	129	Top	No voids visible. Strands completely coated with filler.

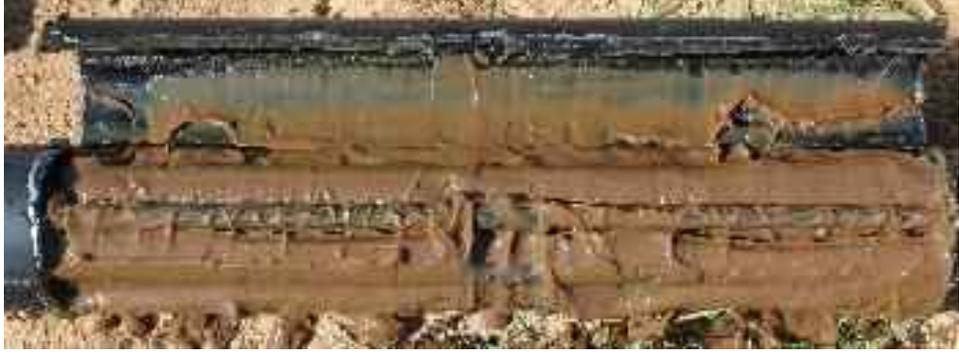
IP12	145	Middle	No voids visible. Strands completely coated with filler.

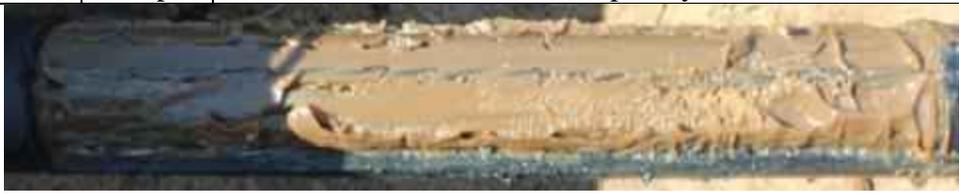
IP13	167	Top	No voids visible. Strands completely coated with filler.

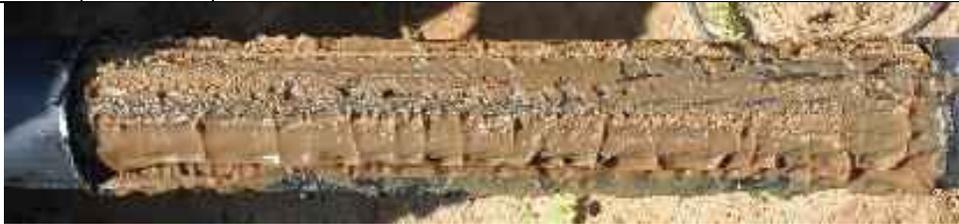
IP14	171	Top	Foam/bubble at the top of the filler. Strands coated with filler.

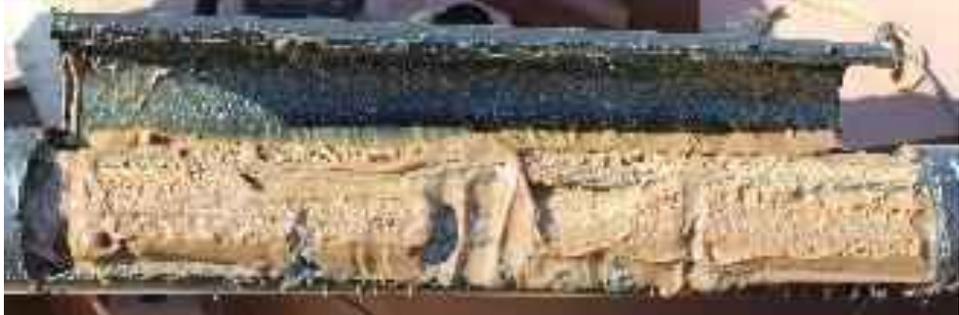
IP15	197	Top	Foam/bubble at the top of the filler. Strands coated with filler.

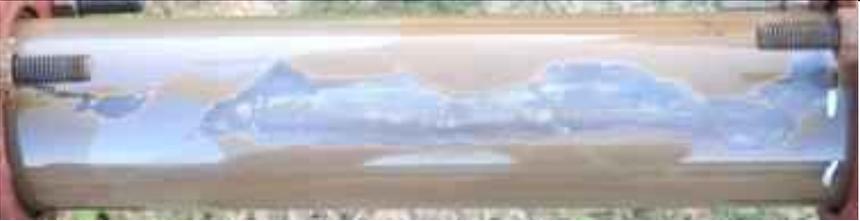
Duct windows			
C1	60	Top	Elongated void at the top of the filler. Strands completely coated with filler.

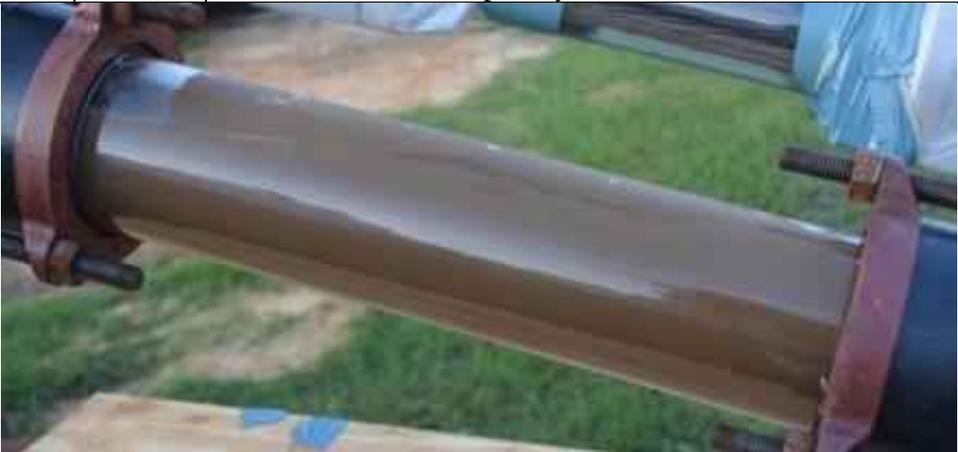
C2	81	Middle	Discontinuous bubble at the top of the filler. Strands completely coated with filler.

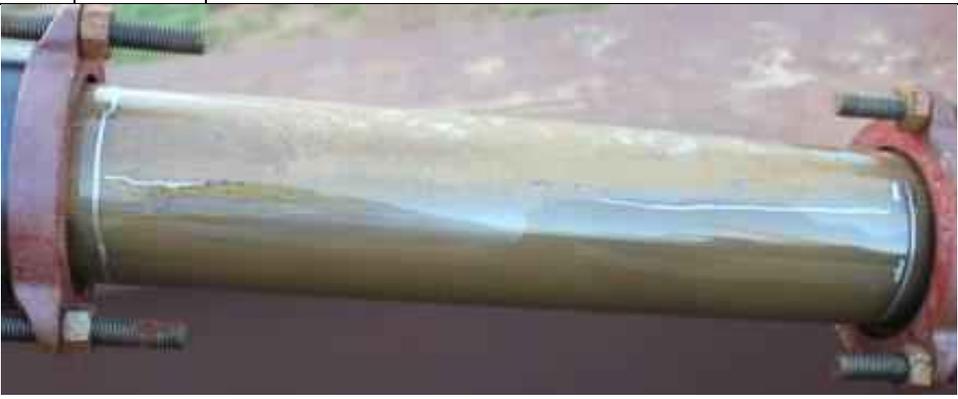
C3	190	Middle	Foam/bubble at the top of the filler. Strands coated with filler.

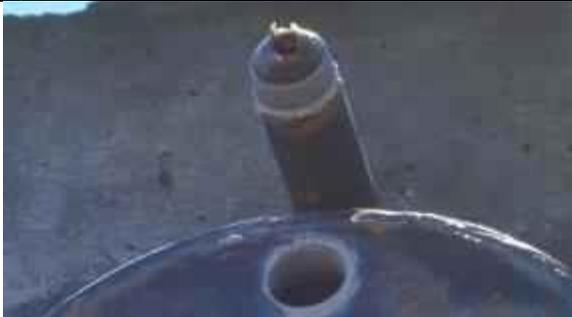
Vents and Caps			
West end vent	0	-	Anchor vent had a pin hole about 1 in. deep. Cap vent was completely filled with filler. Cap was not opened at west anchor.

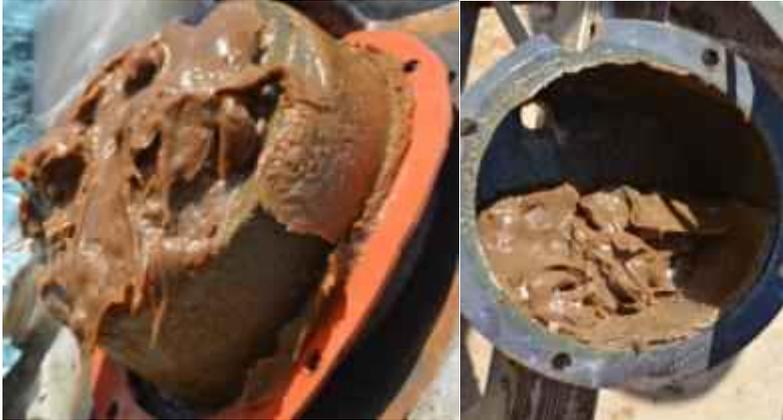
East end Cap	200	Middle	Cap was completely filled with filler.

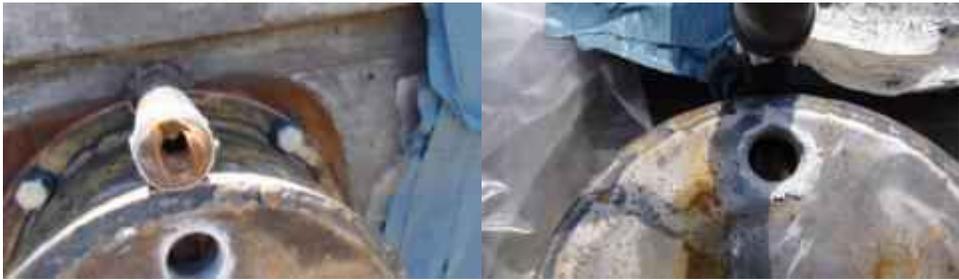
East end vents	200	Middle	Anchor vent had a pin hole about 1 in. deep. Cap vent was completely filled with filler. Cap was not opened at west anchor.

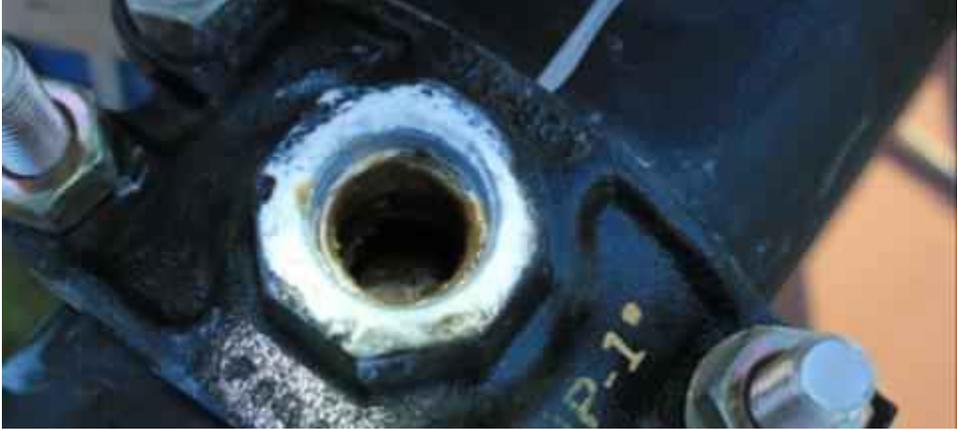
Middle vent	97	Bottom	Void at the top of the filler about 1 in. deep.

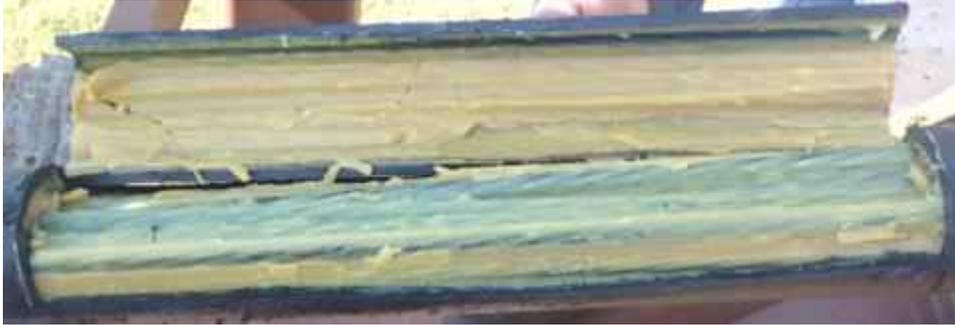
Inspection port	Distance from east end, ft	Strand location	Comments
IP01	1	Bottom	A small pin hole on the east side of the port. Strands completely coated with filler.

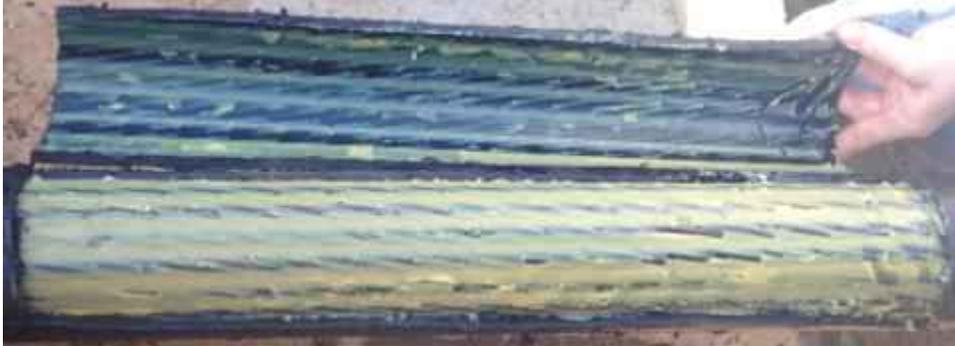
IP02	27	Top	No voids visible. Strands completely coated with filler.

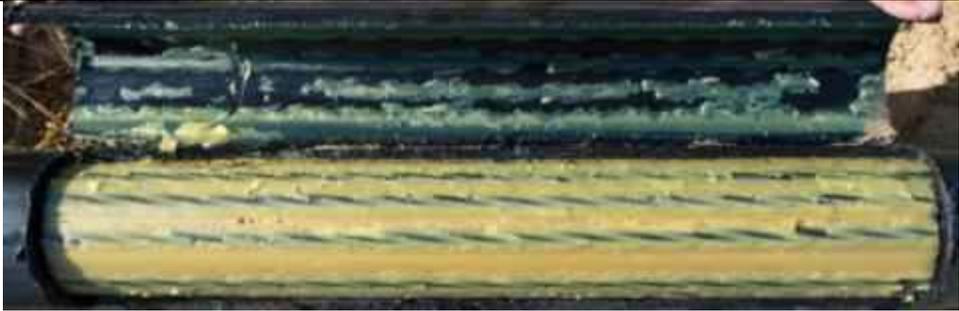
IP03	31	No inspection due to instrumentation	
IP04	55	Top	No voids visible, small air bubbles on the top of the filler. Strands completely coated with filler.

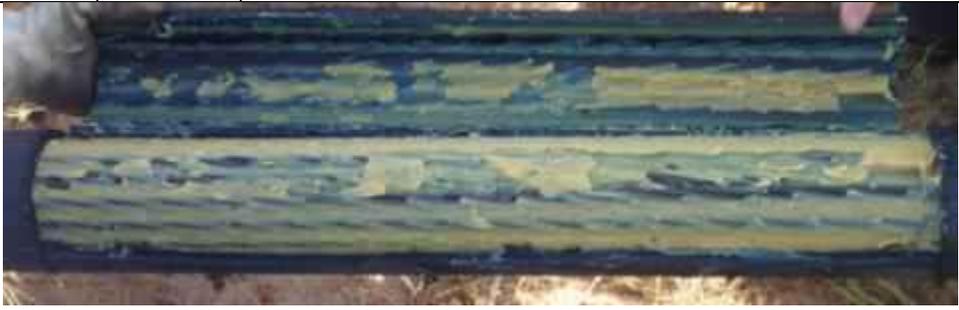
IP05	67	Top	No voids visible. Strands coated with filler.

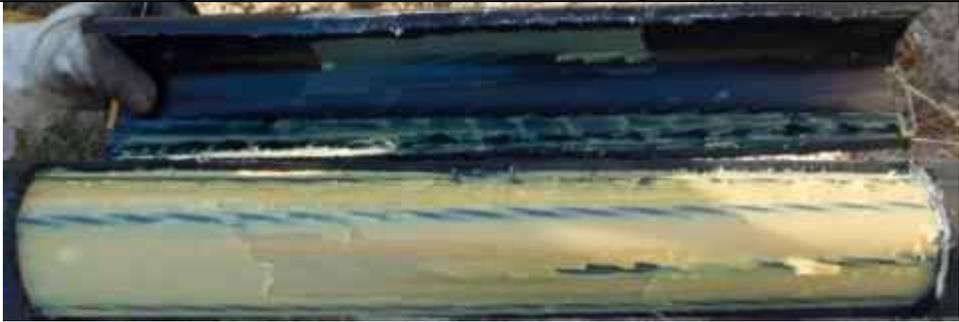
IP06	71	Top	No voids visible. Strands completely coated with filler.

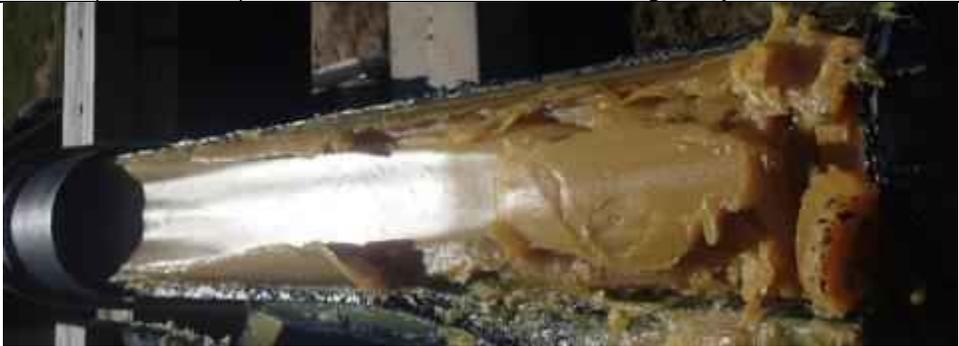
IP07	92	Bottom	Void at the top of filler 1 in. deep on east side and a small hole on west side. Strands completely coated with filler.

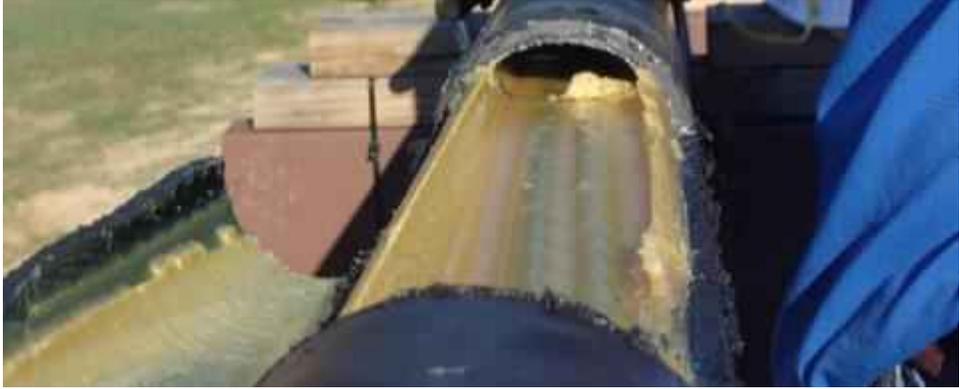
IP08	97	Bottom	Void on the top of filler about 1 ½ in. on east side and 1 in. on west side. Strands completely coated with filler.

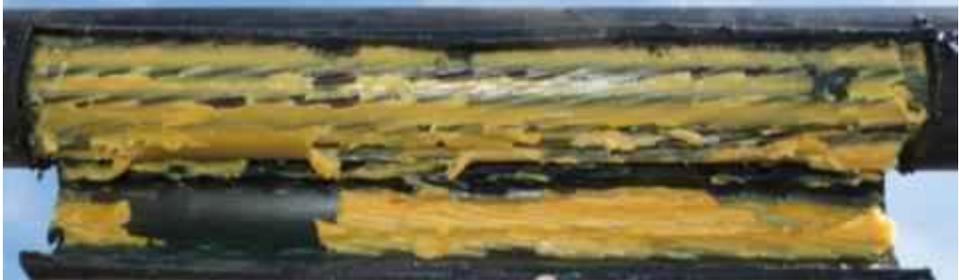
IP09	100	Bottom	No voids visible. Strands completely coated with filler.

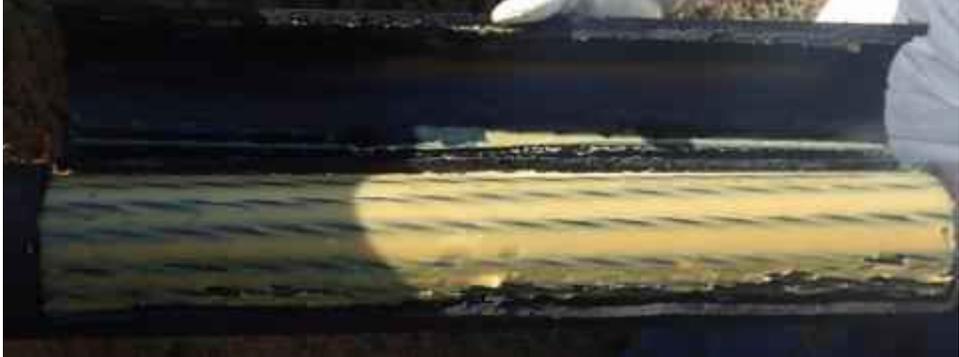
IP10	125	Top	No voids visible. Strands completely coated with filler.

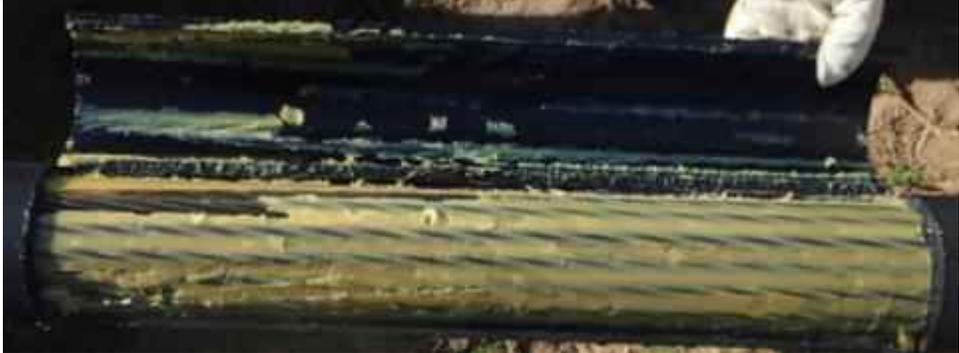
IP11	129	Top	Line void at the top near east end of the inspection port. Strands coated with filler.

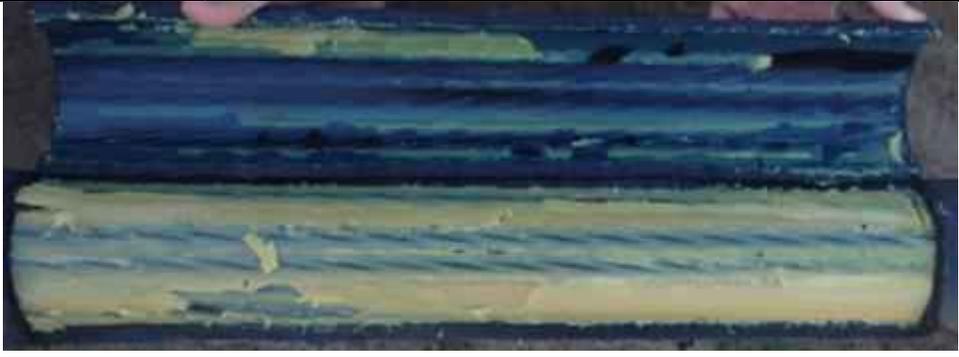
IP13	167	Top	No voids visible. Strands completely coated with filler.

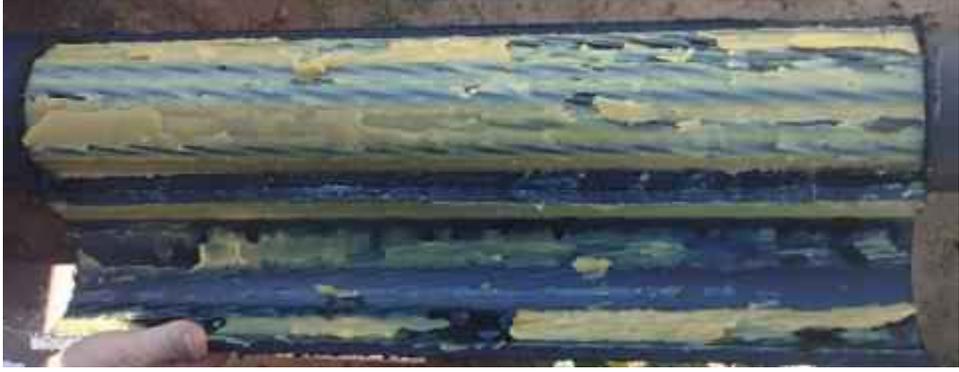
IP14	171	Top	No voids visible. Strands completely coated with filler.

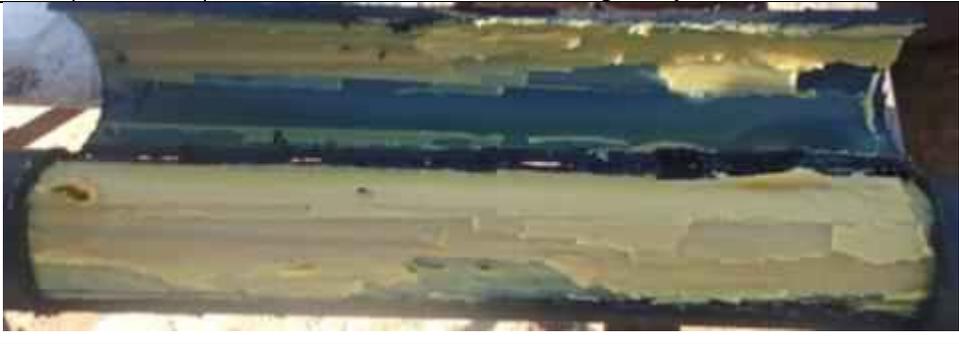
IP15	197	Middle	No voids visible. Strands completely coated with filler.

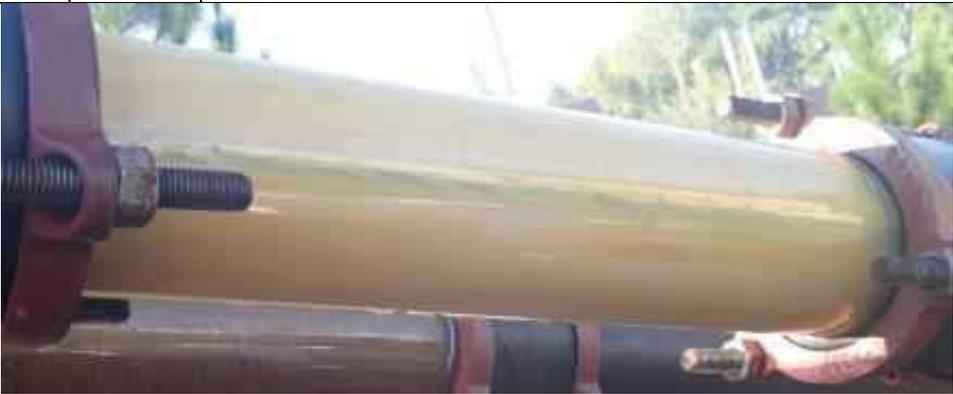
C2	81	Middle	Cracks on the south side of the window. Strands completely coated with filler.

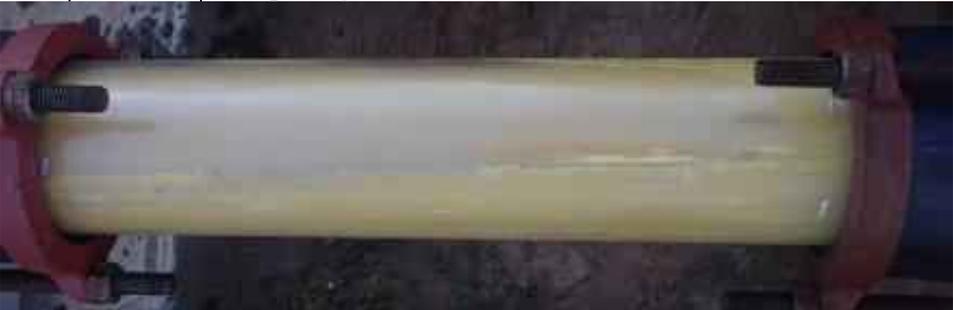
C3	190	Middle	Cracks in the filler at the top of the window. Strands completely coated with filler.

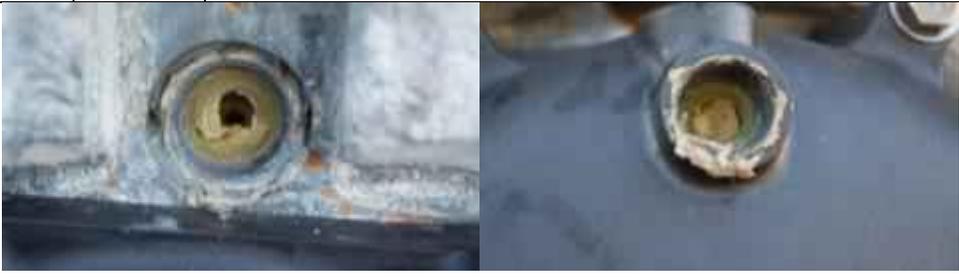
Vents and caps			
East anchor and cap vent	0	-	Anchor vent had a pin hole in the filler. Cap vent completely filled with filler.

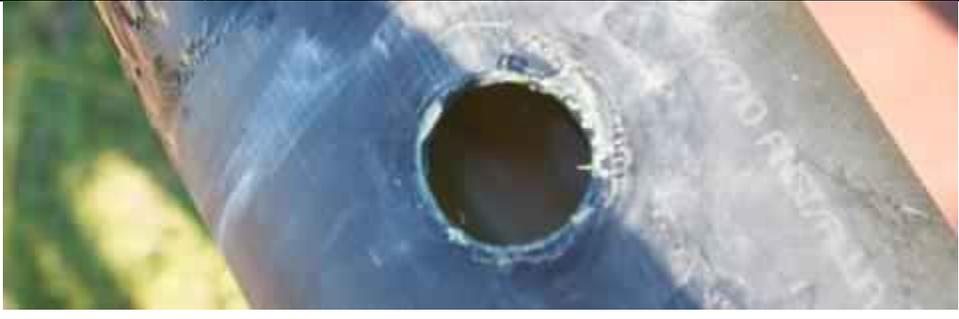
<p>Injection port</p>	<p>140</p>	<p>Bottom</p>	<p>Port completely filled with filler.</p>

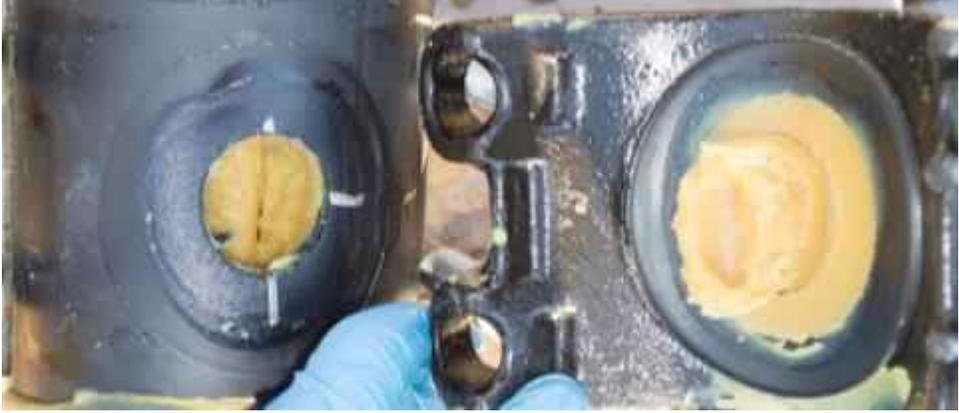
<p>West anchor and cap vent</p>	<p>200</p>	<p>-</p>	<p>Anchor vent had a pin hole in the filler. Cap vent completely filled with filler.</p>

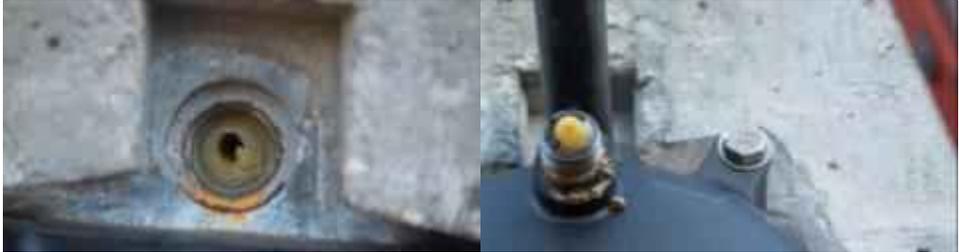
<p>East and West Caps</p>	<p>0, 200</p>	<p>Middle</p>	<p>Caps completely filled with filler.</p>

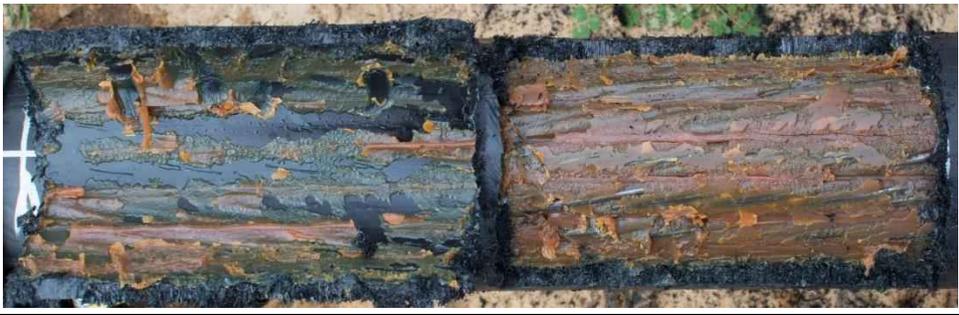
IP04	68	Top	No voids visible. Strands coated with filler.

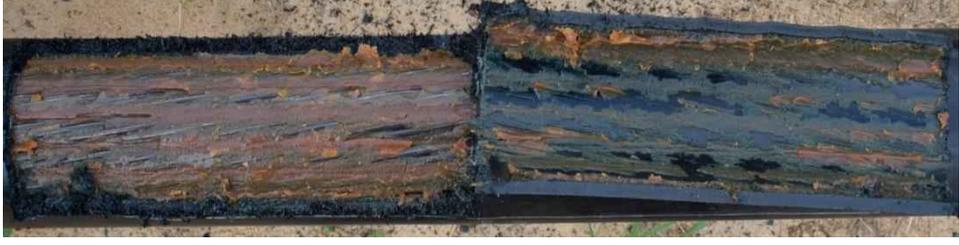
IP05	71	Top	No voids visible. Strands coated with filler.

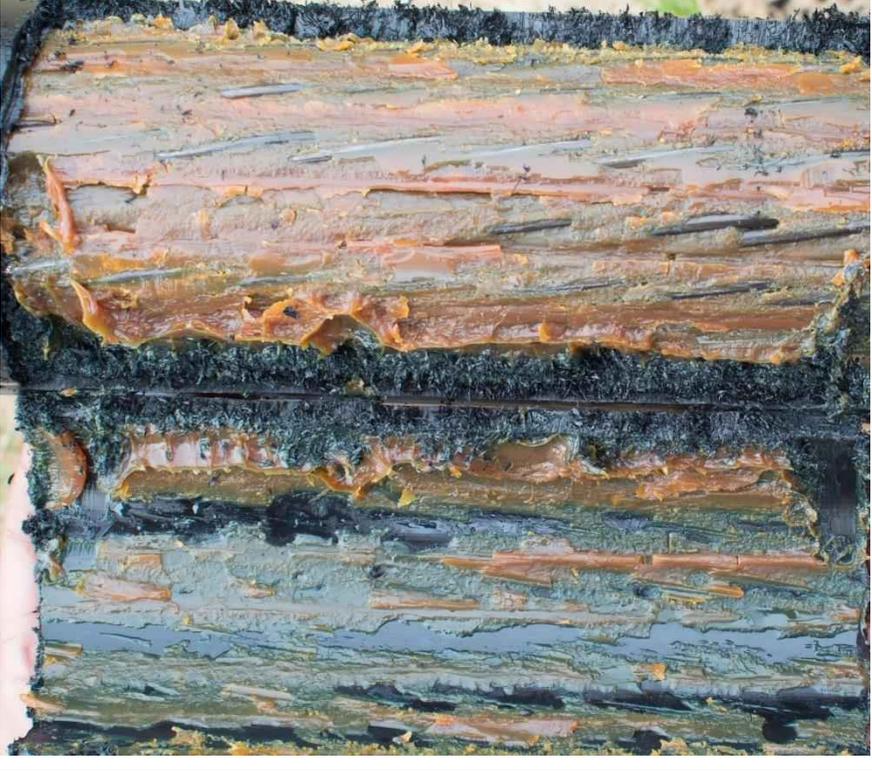
IP06	97	Bottom	Small air bubbles at top of filler. 1/8 in void at the top of the wax near east end of the port. Strands completely coated with filler.

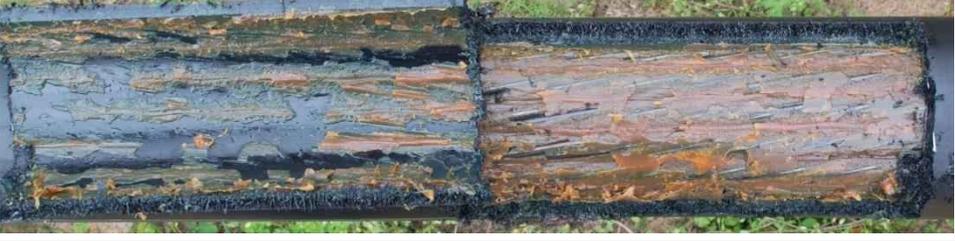
IP09	168	Top	No voids visible. Strands coated with filler.

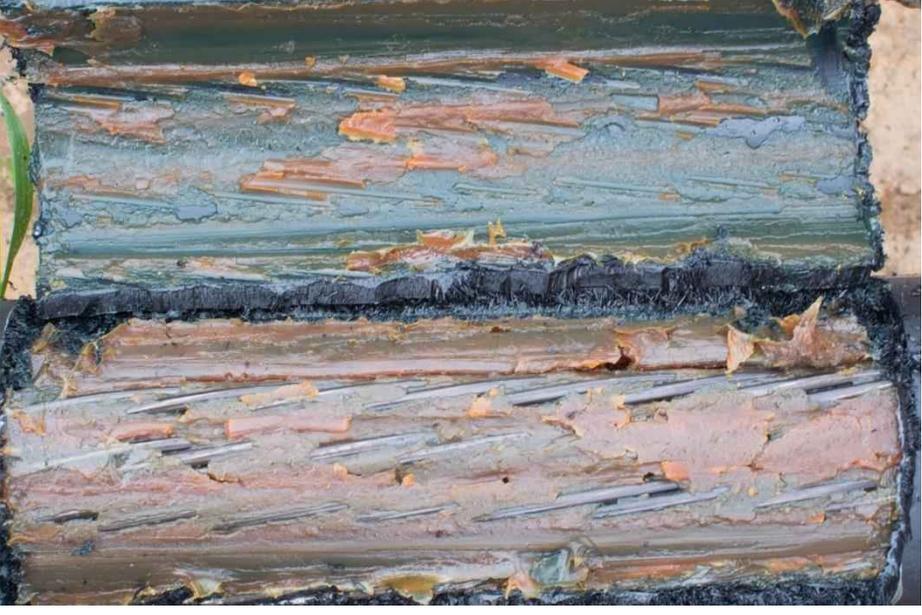
IP10	171	Top	No voids visible. Strands coated with filler.

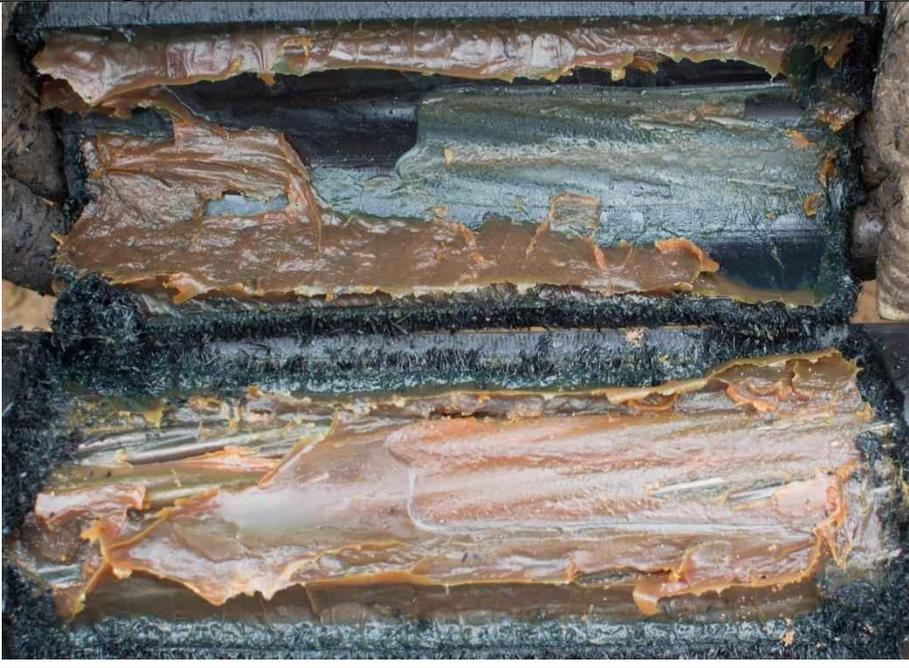
IP11	198	Middle	Small air hole on the top of the filler. Strands coated with filler.

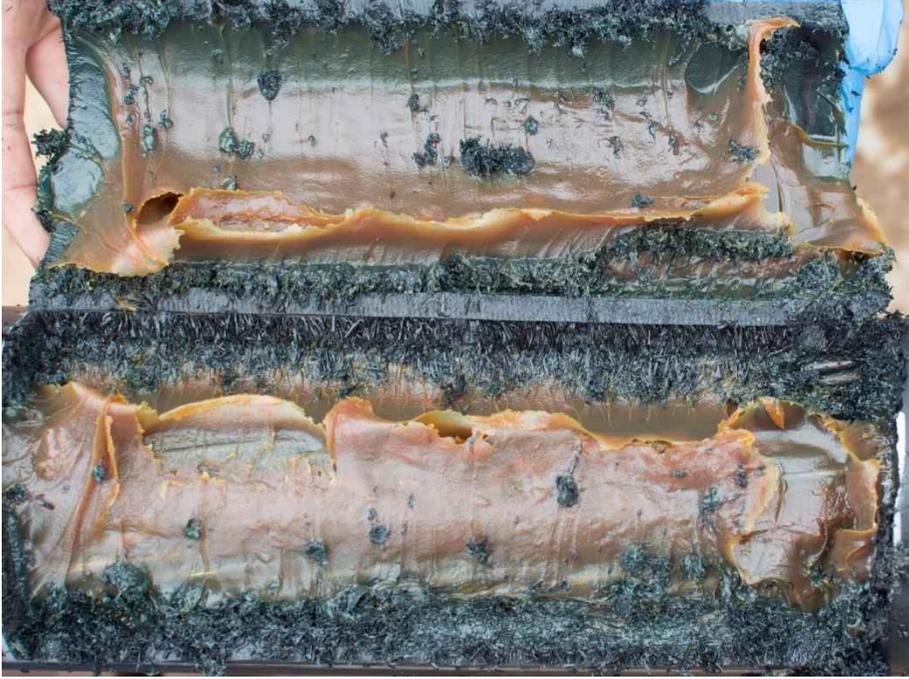
Duct windows			
C1	8	Middle	Elongated crack on the top of the filler. Strands completely coated with filler.

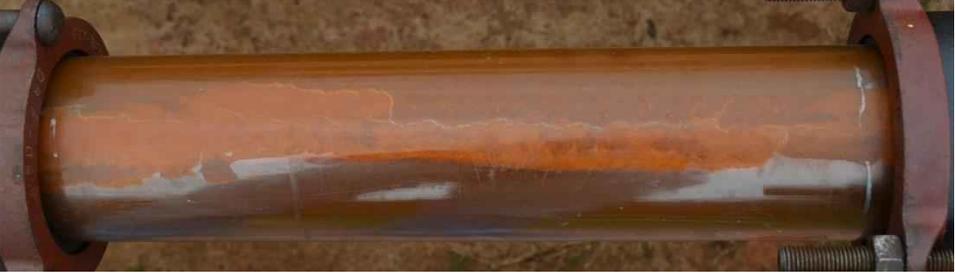
C2	81	Middle	Cracks in the wax at the top. Air pockets on north west end of the window. Strands completely coated with filler.
