# Replaceable Unbonded Tendons for Post-Tensioned Bridges

**Final Report**

**December 2017**

Florida Department of Transportation (FDOT)

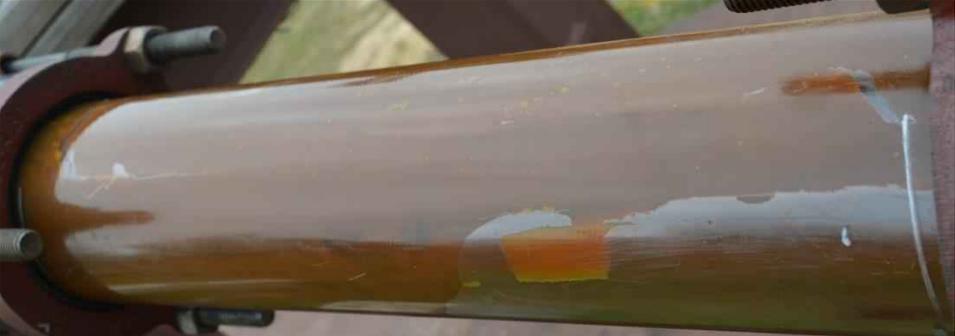
C3	99	Bottom	Elongated cracks in the filler at the top of the window. Air pockets on the north side of the window. Strands completely coated with filler.

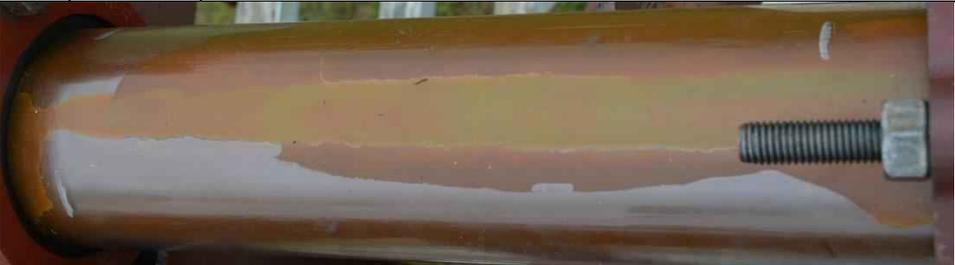
C4	190	Middle	Elongated cracks in the filler at the top of the window. Strands completely coated with filler.

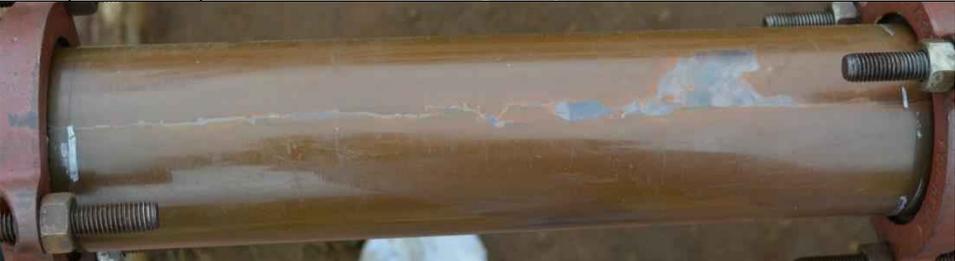
Vents and caps			
East and west anchor vents	0	-	Anchor vent had a pin hole in the filler. Cap vent completely filled with filler.

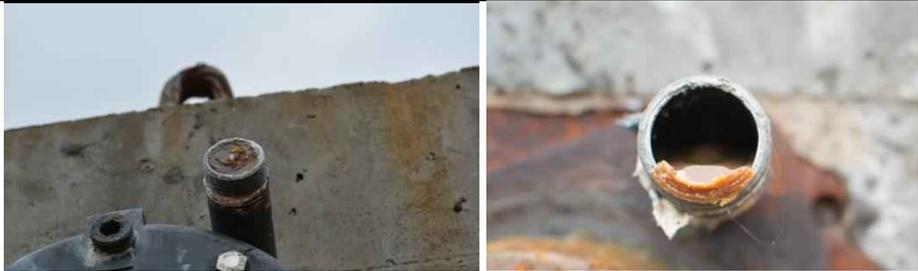
East anchor cap	0	-Middle	Anchor vent had a pin hole in the filler. Cap vent completely filled with filler.

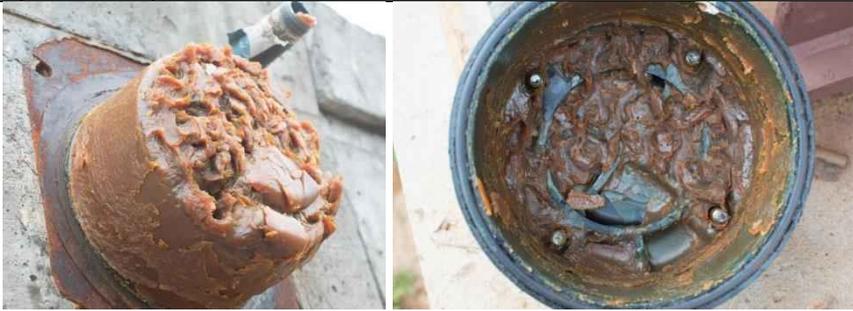
West anchor caps	200	Middle	Caps completely filled with filler.

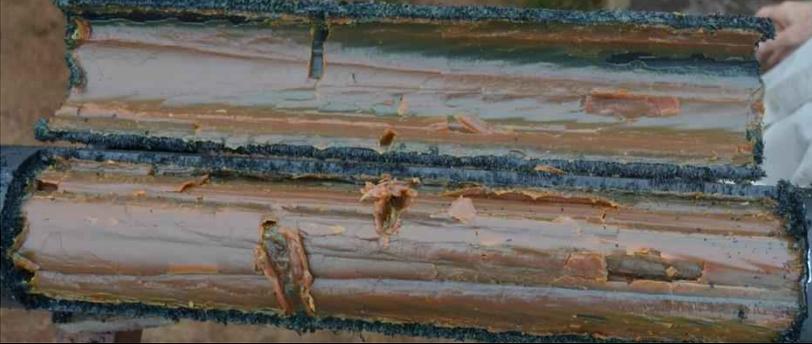
IP02	28	Top	<p>No voids visible. Strands completely coated with filler.</p>

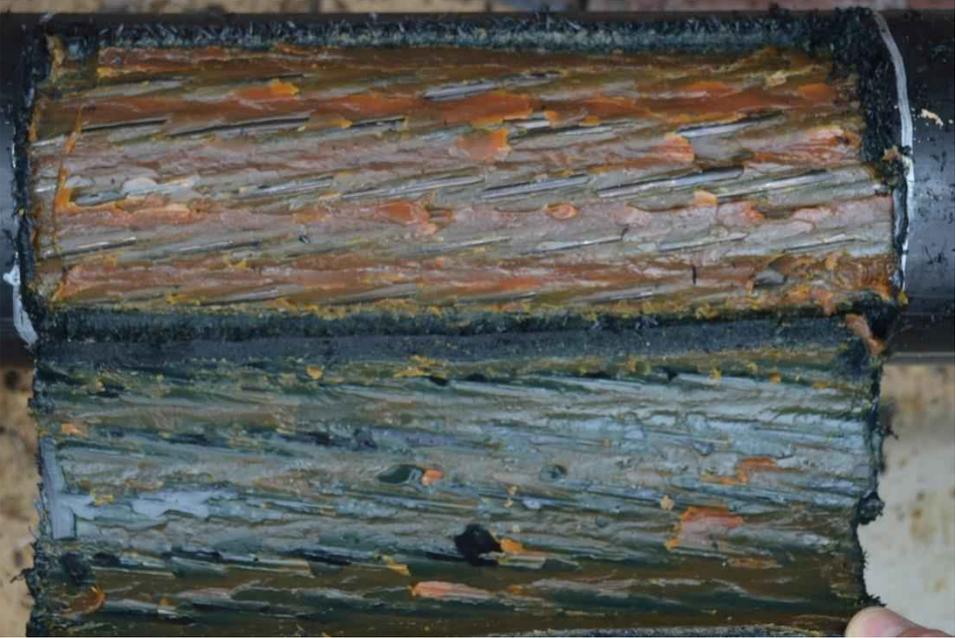
IP03	31	Top	No voids visible. Strands coated with filler.
IP04	68	Top	No voids visible. Strands coated with filler.

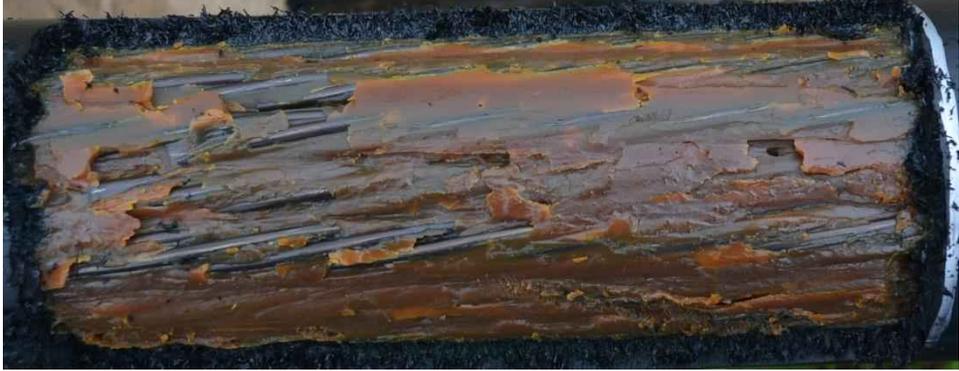
IP09	168	Top	No voids visible. Strands coated with filler.

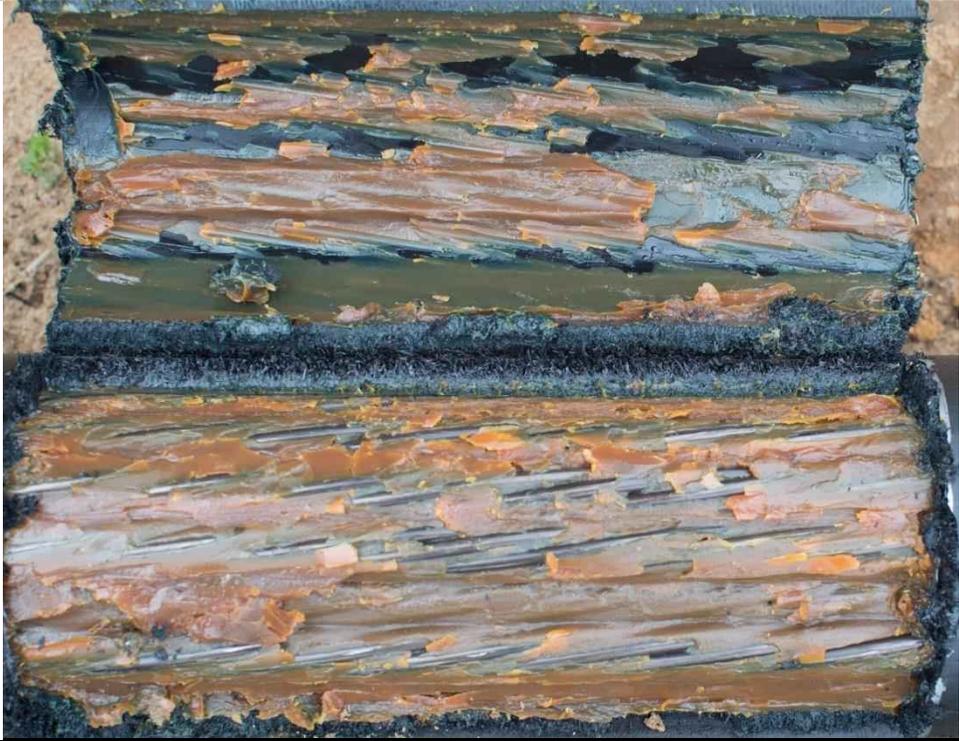
IP10	171	Top	No voids visible. Strands coated with filler.

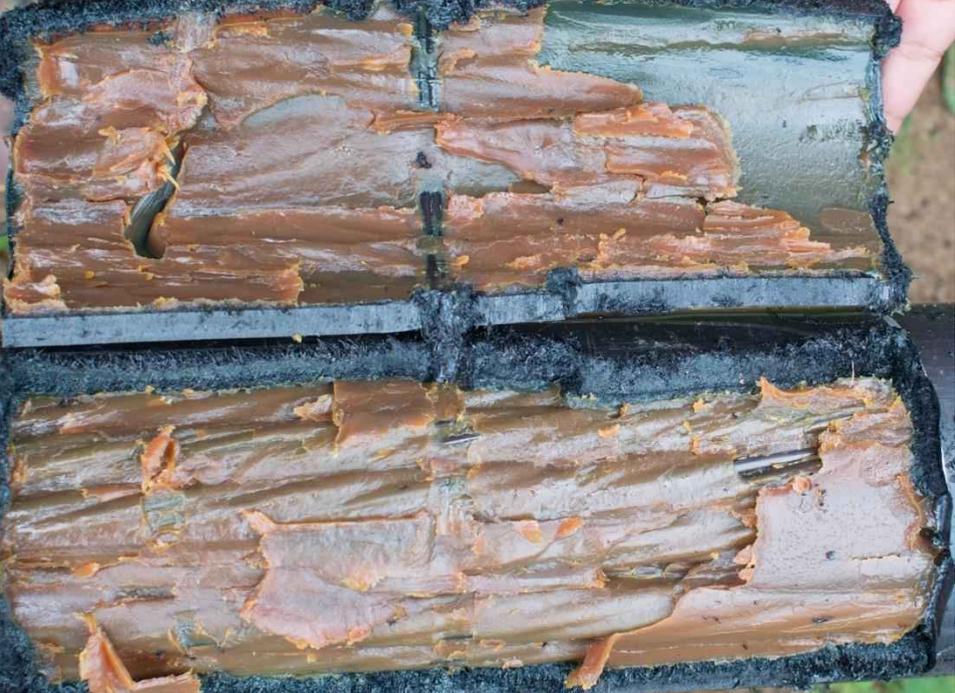
IP11	198	Middle	Small holes in the filler. Strands coated with filler.

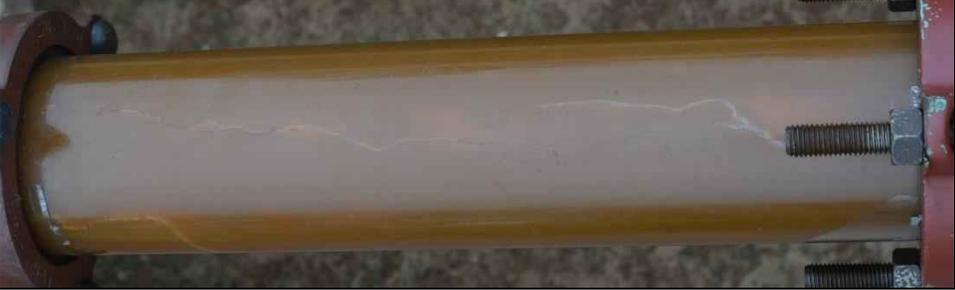
C2	81	Middle	Elongated crack at the top of the window. Strands coated with filler.

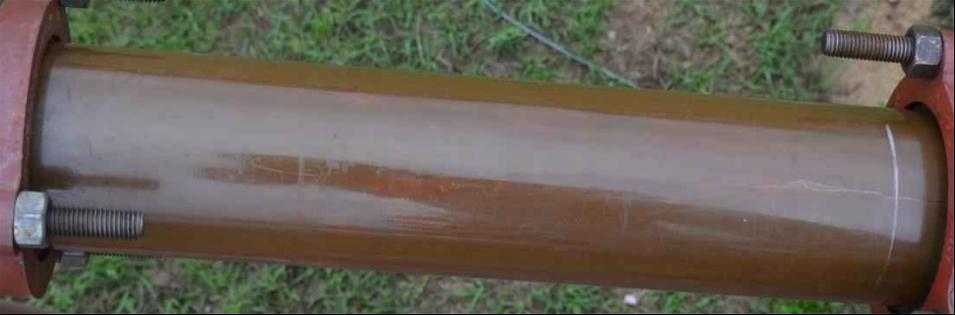
C3	99	Bottom	Air void on the top of the window. Strands coated with filler.

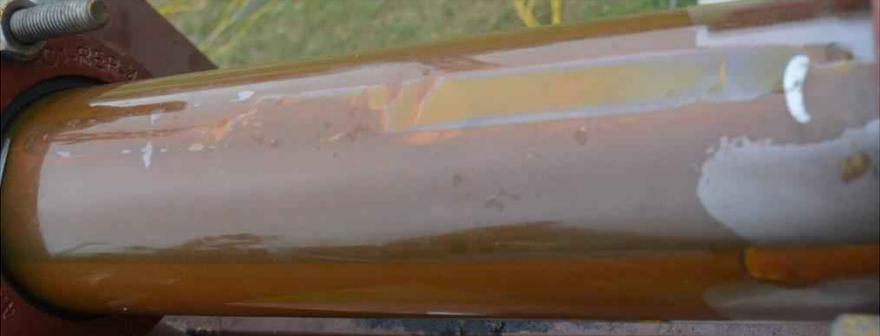
C4	190	Middle	Air void around top east side of the window. Strands completely coated.

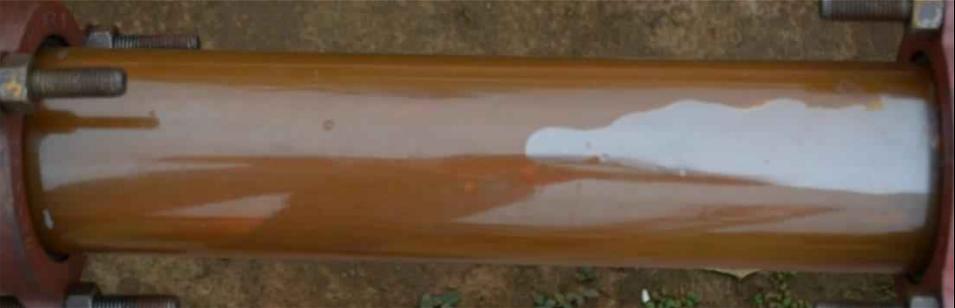
Vents and caps			
East and west vents	0, 200	Middle	Vent ports with air voids at east and west anchors.

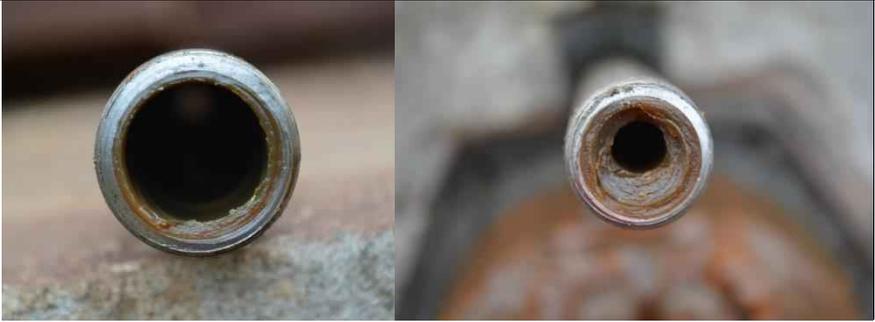
West cap	0	Middle	Small void in the middle of the anchor. Strands completely coated with filler.

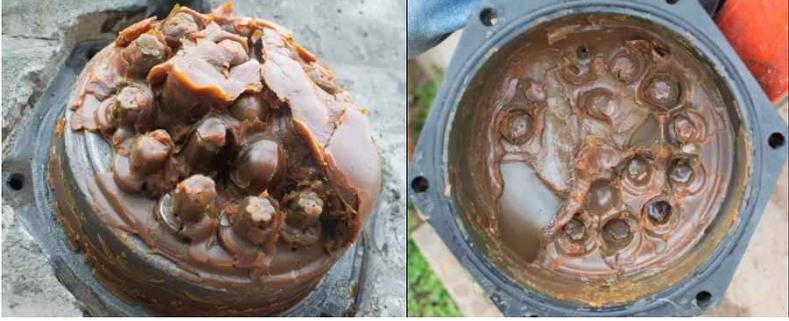
East cap	200	Middle	Strands coated with filler. Cap completely filled.

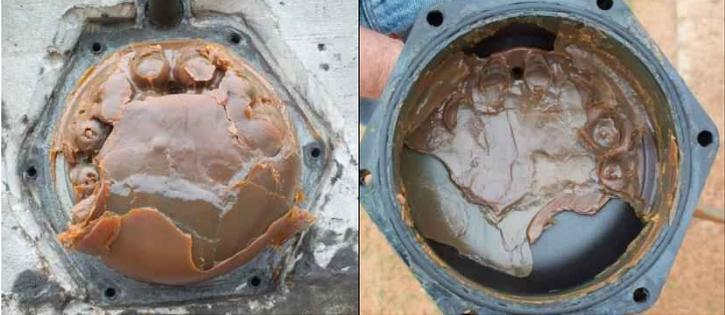
Injection port	60	Bottom	Port full of filler.

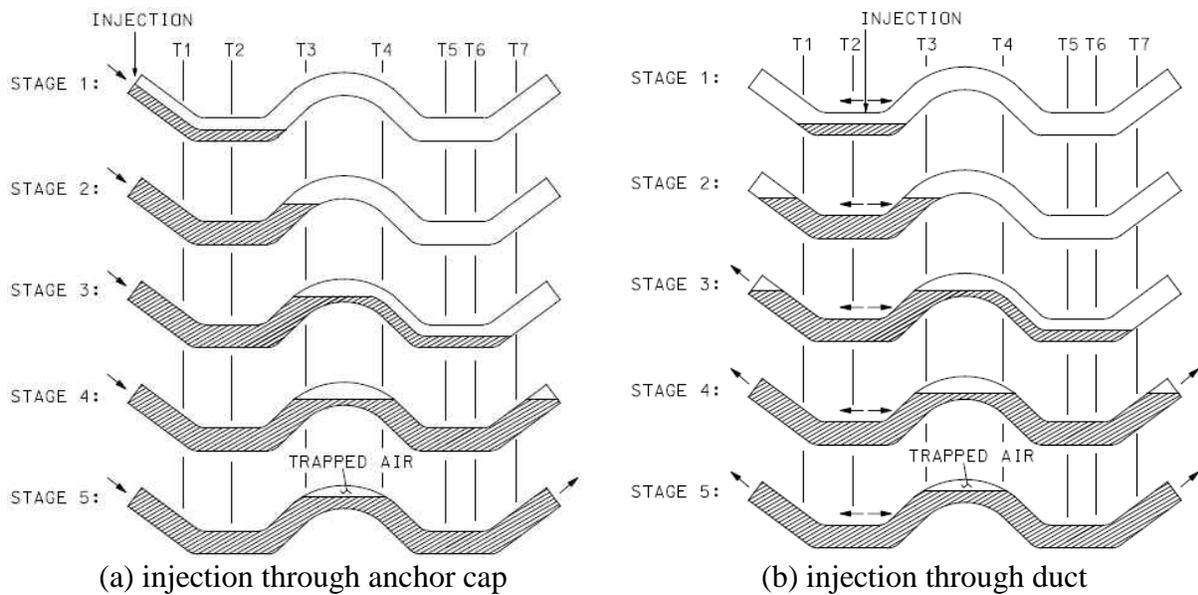
Figure 10-2 Duct filling sequence during mockup injection

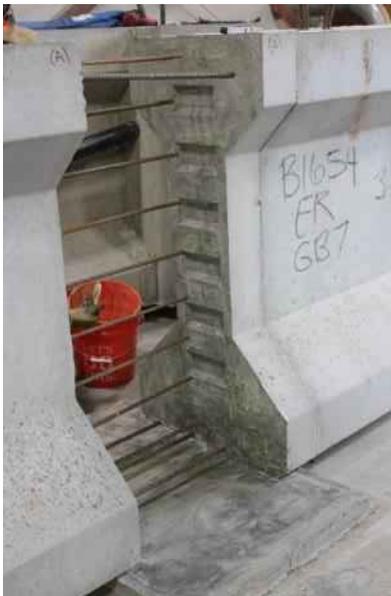
Figure 4-7 Shear keys and protruding reinforcement

Shear keys were detailed at the joint locations to provide mechanical interlock to increase the shear capacity of the interface between the precast concrete and the deviator block (Figure 4-7). Design recommendations are provided by AASHTO-LRFD regarding the geometry of shear keys; these recommendations are dependent on the size of the aggregate and the width of the web and were considered for the determination of the shear key dimensions. The bonded prestressing strand was detailed to protrude from the outside segments to extend into the deviator block (Figure 4-7).

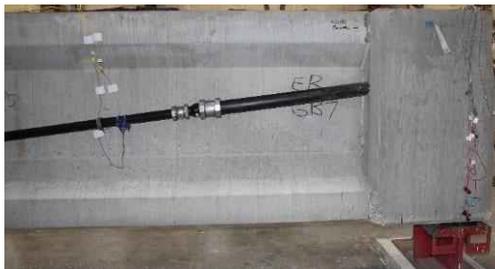
The 3-in. DR17 IPS HDPE duct was necked down to 2-in. DR 17 IPS HDPE after exiting the end block. The transition piece and mechanical splice connections are shown in Figure 4-11. The smaller duct diameter was used for the critical section of the tendon length (between deviators and at mid-span) to simulate the strand congestion that would result from the specified ratio of duct area to strand area of 2.5.

Figure 4-11 Duct exiting end block of external specimen

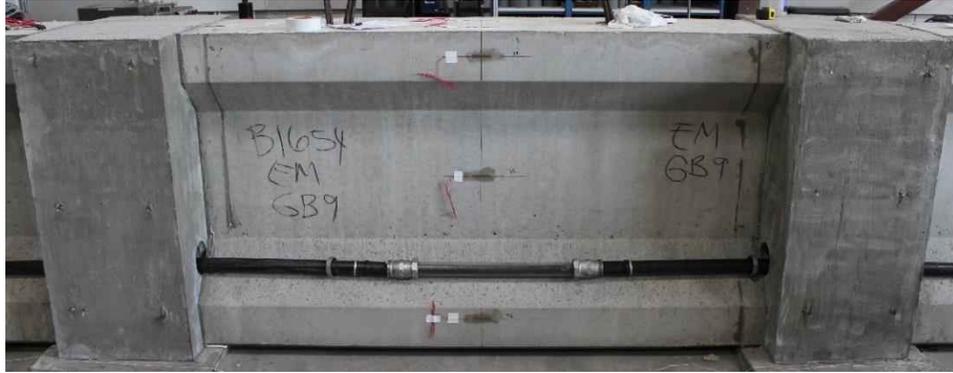
A 30-in. length of clear 2-in. polycarbonate tube was spliced in-line with the 2-in. HDPE near midspan of both tendons to provide a clear observation window. Connection to the 3-in. HDPE was made through a commercially-available iron duct coupler. The clear window can be seen in Figure 4-12.

Figure 4-12 PT tendon (unstressed) (a) between deviator blocks and (b) clear polycarbonate window

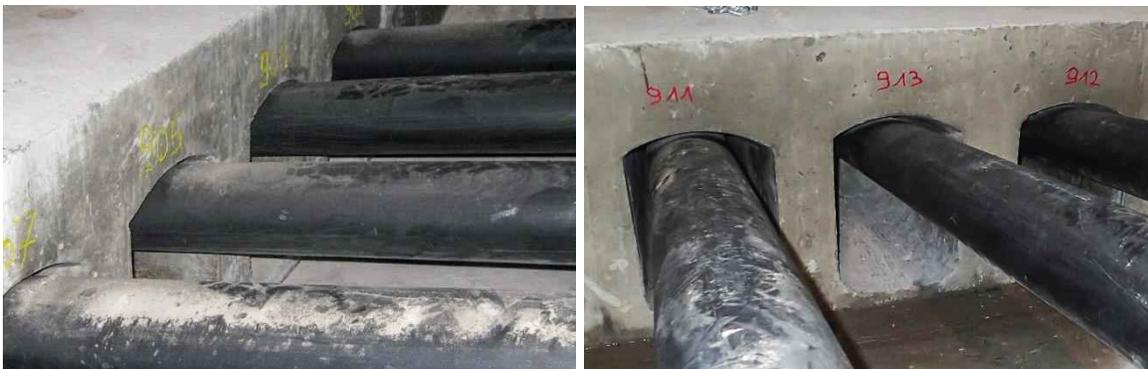
The flare at the exit of the opening formed by the diablo inserts is an important design parameter. It is desirable for the curvature of the opening to continue beyond that of the tendon to ensure that a sharp angle change in the tendon does not occur at the exit. If it does, then the concentrated force at the corner of the concrete could cause spalling. Furthermore, the concentrated force at this location will cause high localized compressive stresses on the HDPE duct as it is pinched between the strand bundle and the corner of the concrete deviator. Another potential issue is the possibility of fretting fatigue caused by the high contact stresses between the prestressing strands at this point. Consequently, an appropriate duct lift off distance (Figure 4-16) is desirable to prevent stress concentrations at the deviator corner.

Figure 4-16 Tendons with point of contact located inside deviator. Note small gap between duct and concrete at tendon exit from deviator.

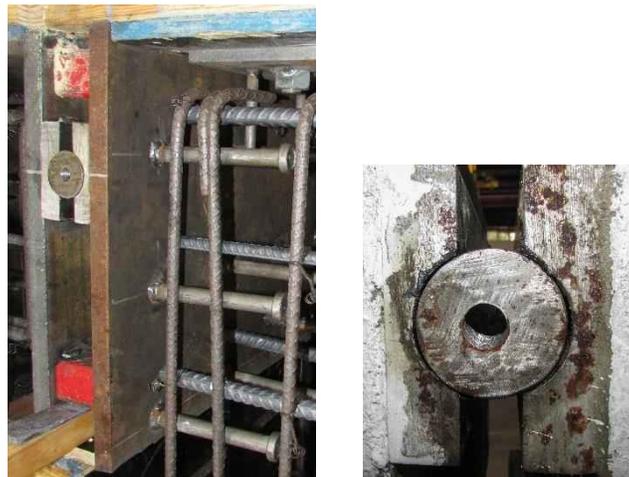
The mechanical hinge was formed in the beam adjacent to the deviator to ensure a smooth, relatively friction-free, action during load cycling. The top of the hinge was constructed from structural steel plates and a steel rod (Figure 4-18). Plates were fitted with welded headed studs and embedded in each of the segments. Two thicker steel plates were machined to fit the steel rod and were welded to the face of the embedded plates. These plates were intended to allow smooth rotation of the hinge and to evenly distribute the bearing stresses from the large compressive force routed through the steel rod.

Figure 4-18 Mechanical hinge details

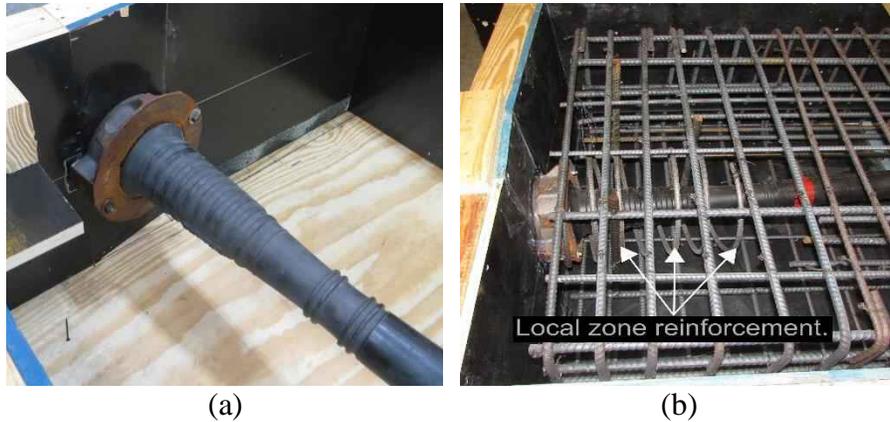
Local zone reinforcement used to provide confinement for the SDI 12.6-PC anchorage system was specified by the anchorage manufacturer Schwager Davis (Figure 4-19). The local zone reinforcement specified by the manufacturer was #4 mild reinforcement steel spirals @ 13-in outside diameter with 6 turns @ 3 in. spiral pitch.

Figure 4-19 Anchorage system (a) without local zone reinforcement (b) with local zone reinforcement

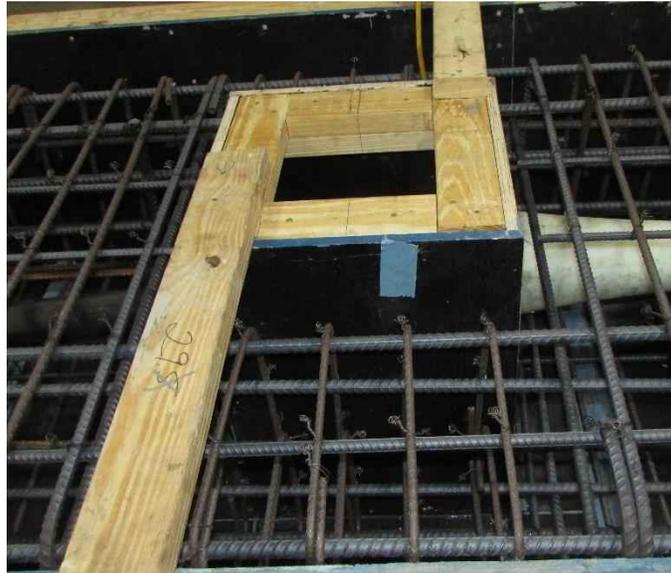
The concrete section discontinuity created by the hollow rectangular section (Figure 4-21) was also reinforced heavier than other regions to prevent cracking.

Figure 4-21 General zone reinforcement at hollow section

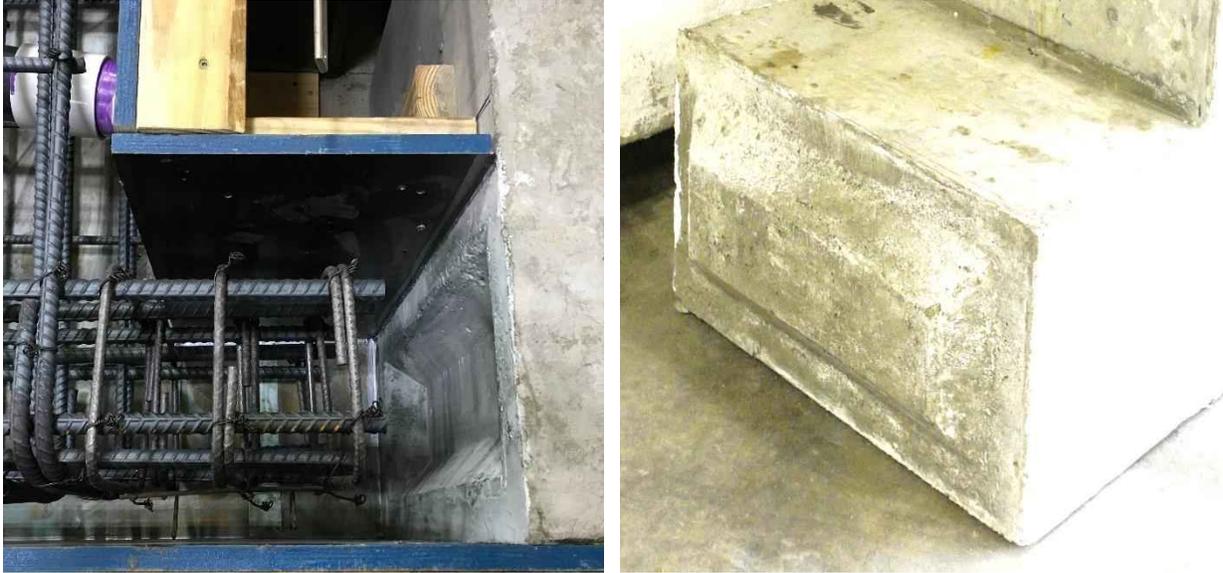
Figure 4-22 Specimen F1 reinforced concrete shear key

During initial static loading of F1, concrete surrounding the shear key cracked as the specimen was unloaded (Figure 4-23). The intent of the shear key was to maintain alignment of the segments. What occurred, though, is that when the specimen was first loaded, the mechanical hinge seated, which caused a slight misalignment in the shear key joint. The specimen was then unloaded, and as the shear key re-seated during unloading, the misalignment caused cracking in the area around the key. Because the joint was open for the entirety of the static and fatigue cycling, the cracking had no effect on the test. To avoid this problem in F2, however, the joint was redesigned.

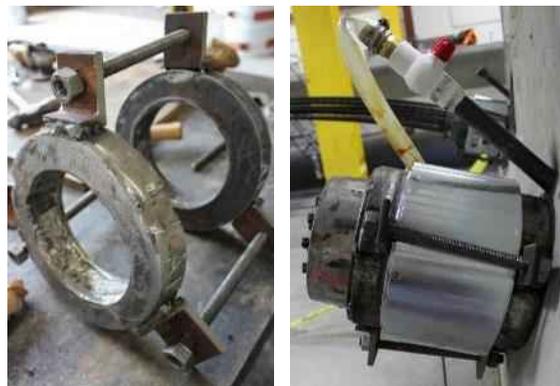
Tendon force was measured directly with hollow-core 850-kip Geokon load cells (Figure 5-1). The geometry of the load cell was specifically manufactured to ensure that a tendon of (12) 0.6-in. dia. 7-wire prestressing strands could pass through without obstruction, and to ensure that the face of the load cell would bear against only the face of the anchorage (in other words, such that the load cell would not bear on the concrete). Steel washers were machined at the laboratory and used to guide the alignment of the load cell and the wedge plate to ensure concentric application of the tendon force to the load cell (Figure 5-1). For specimen EWC, tendon force was also indirectly determined through strain measured by 5 mm foil type strain gages applied to individual wires of the prestressing strand after post-tensioning.

Figure 5-1 Hollow-core load cell

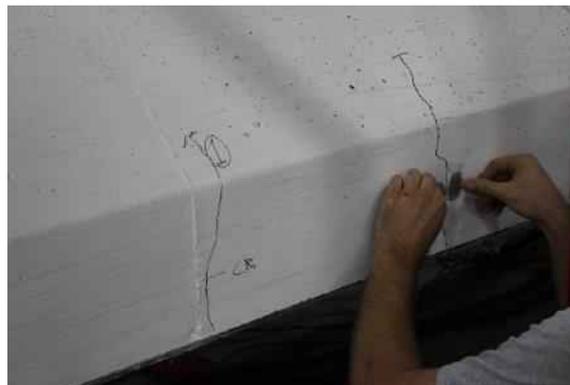
Figure 5-5 Crack opening gage installation

Concrete strain was measured with 60-mm foil-type strain gages. Post-tensioning tendon strain was measured during load application in one specimen – EWC – using 5-mm foil type strain gages. Strain gages used for crack opening determination were 5-mm foil-type; installation is shown in Figure 5-5. These gages were installed during testing to determine the load at which flexural cracks open upon reloading. These data were used to indirectly estimate the effective prestress force. Anchor strain was measured with 5-mm foil-type strain gages (Figure 5-6); description and discussion of the anchorage instrumentation is covered in Part III.

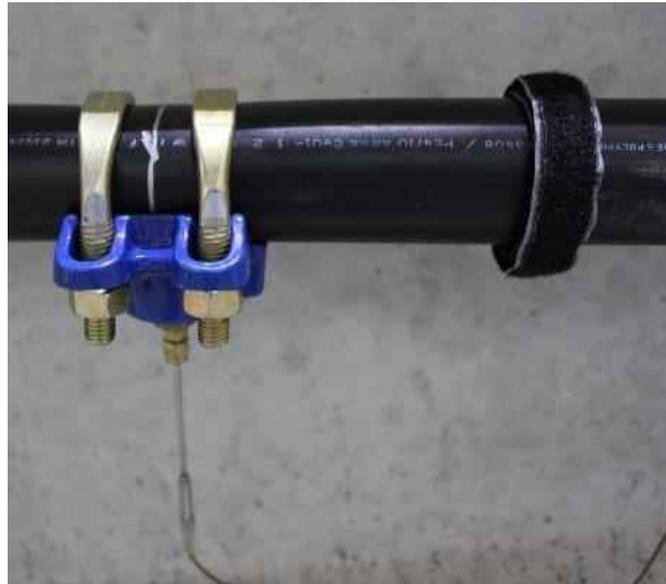
- SMPW-M was chosen to measure the filler temperature. A compression fitting was needed to obtain a pressure-tight seal around the probe (Figure 5-10).
- 2) External tendon duct surface temperatures were monitored with Fluke 80-pk-11 flexible cuff type K surface strap instruments (Figure 5-10).
  - 3) Exposed wire type-K thermocouples were used to monitor internal concrete temperatures. Installation of the internal thermocouples is shown in Figure 5-11; a steel cage was used to set the locations of the internal thermocouples.

Figure 5-10 Probe (left) and surface strap (right) thermocouples

- 1) Probe-type thermocouples were used to monitor filler temperature inside of the tendon duct. Type K thermocouples were selected based on the anticipated injection temperature of 220° F (105° C). Omega thermocouple part no. TJ36-CASS-116G-6-

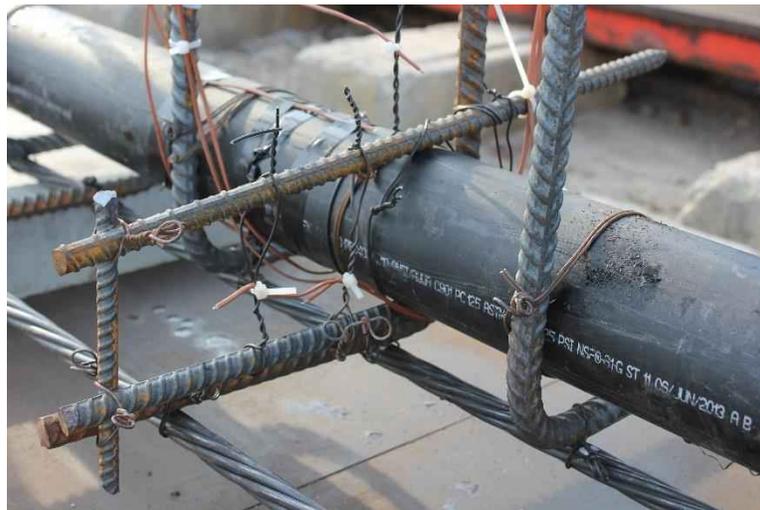
Figure 5-11 Installation of internal thermocouples

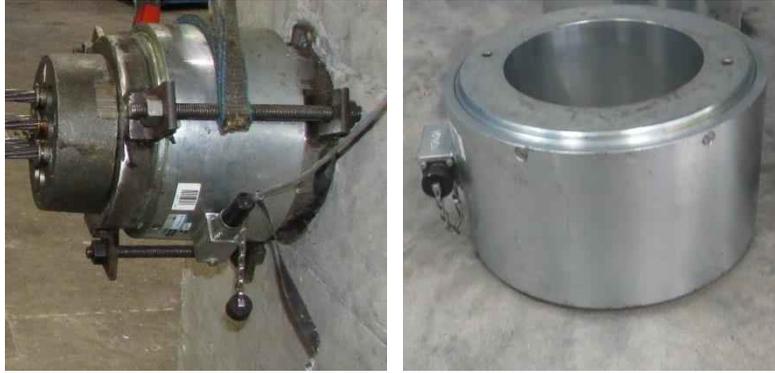
Tendon force was measured directly with a hollow-core 850-kip Geokon 3000X-850-150MM load cell shown in Figure 5-17. The geometry of the load cell was the same as described in Section 5.1.1. The load cell was installed to ensure that six 0.6-in. dia. 7-wire prestressing strands passed through without obstruction and ensure that the tendon force was applied concentrically to the load cell.

Figure 5-17 Geokon hollow-core load cell

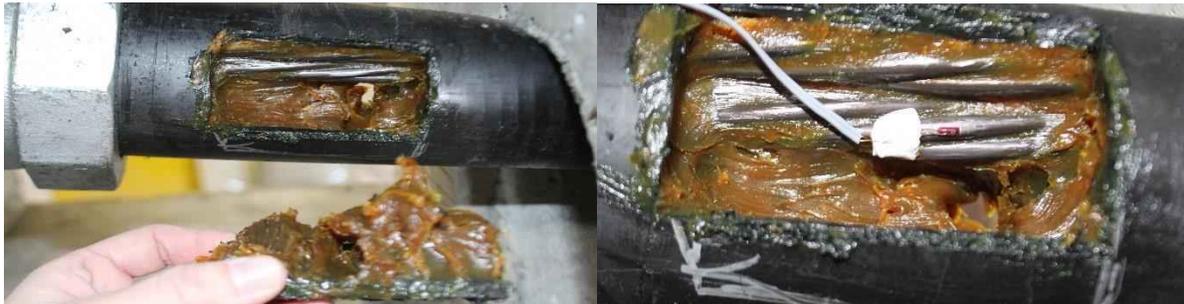
Prestressing strand strain was measured using TML FLA-05-11-1L 0.5-mm foil type strain gages during cyclic loading. After injection of the filler, the prestressing strands were accessed through a port cut into the HDPE sheathing (Figure 5-18) on each side of the deviator (Figure 5-16). Strain gages were placed on a single wire that was the most accessible in the areas where the HDPE was cut. Strain gages were placed on each side of the tendon (Figure 5-19) to provide redundant readings on both ends of the deviator. The strand numbers shown in the figure correspond with the strand arrangement in the wedge plate detailed in Section 6.1.2.

Figure 5-18 Removal of HDPE section to attach strain gage

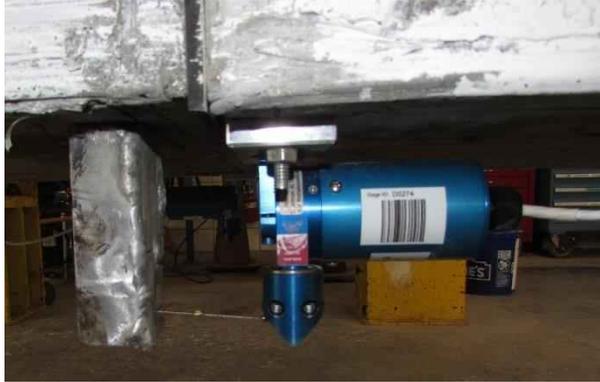
Gap opening was measured using two Firstmark Controls 60-01-74C1-1 string potentiometer displacement gages (Figure 5-20). This measurement was used to evaluate the progression of the fatigue test and possible damage that might occur during the test. To maximize the displacement measurement, the gages were installed on the bottom face of the specimen mounted as close to the side face as practical. The potentiometer was bolted to the concrete face on one side (live-end segment) of the specimen. The reference attachment point was a steel angle mounted on the opposite side of the gap. This configuration caused a slight amplification of the readings due to the extension of the reference point by approximately 3.25 in. below the bottom of the beam. This amplification was corrected using the geometry of the mechanical hinge.

Figure 5-20 Gap displacement gages attached to specimen

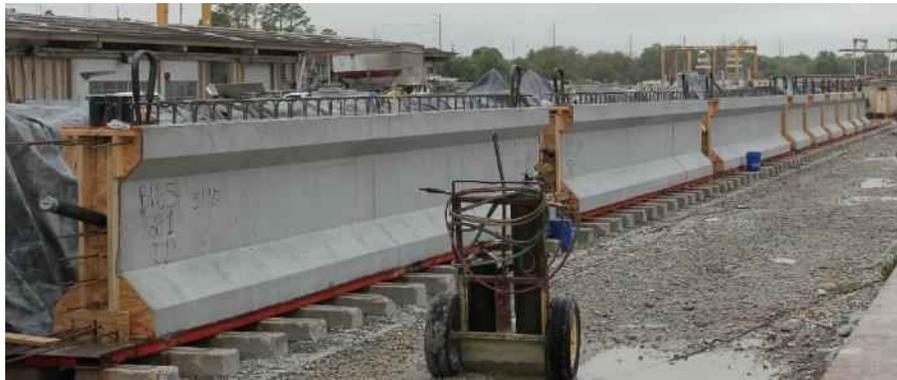
To reduce the likelihood of strand recoil during detensioning, segments to be cast first were arranged in the bed such that segments were located close to one another, but away from the abutments (Figure 6-1).

Figure 6-1 Segments in prestressing bed

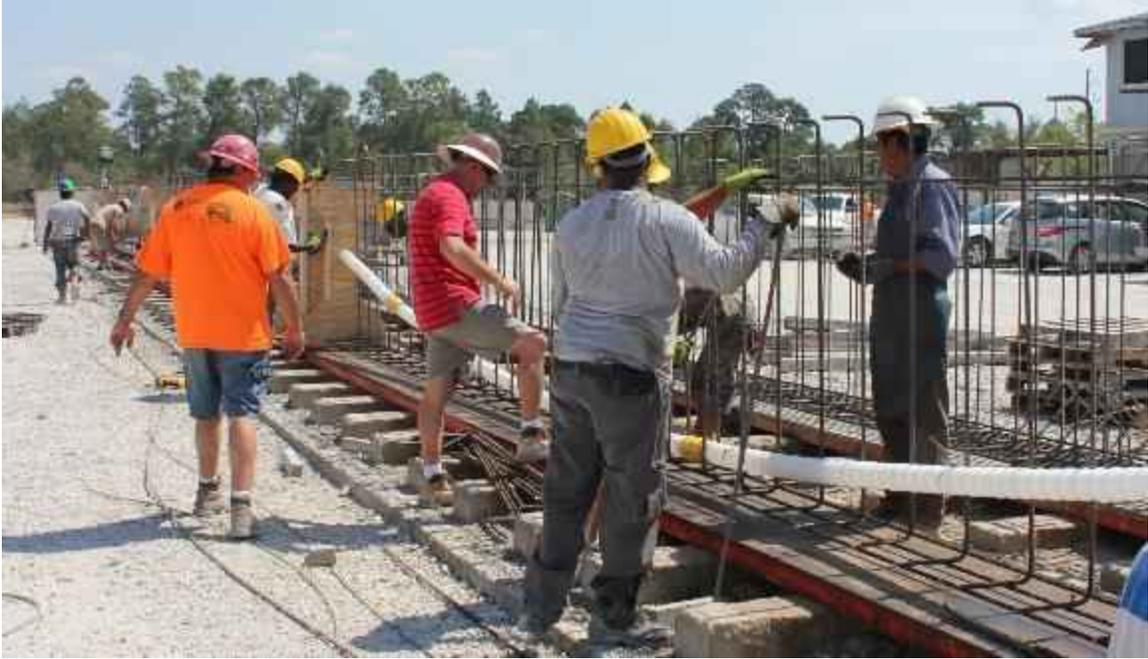
The prestressing strands were stressed to  $0.75f_{pu}$ . Mild steel reinforcement (stirrups) were tied in and ducts for the internal tendon specimens (IGS, IWS, and IWC) were tied in between the stirrups (Figure 6-3). The ends of the ducts were covered with tape to prevent water/concrete from entering during casting. Thermocouple instrumentation for measurement of internal concrete temperature was installed prior to pulling up both side forms. Wire leads from the instrumentation were protected with plastic wrap. A self-consolidating mix with specified 28-day strength of 8.5 ksi was placed, taking care to not damage exposed instrumentation, to complete the AASHTO shape for all test specimens.

Figure 6-3 Duct installation

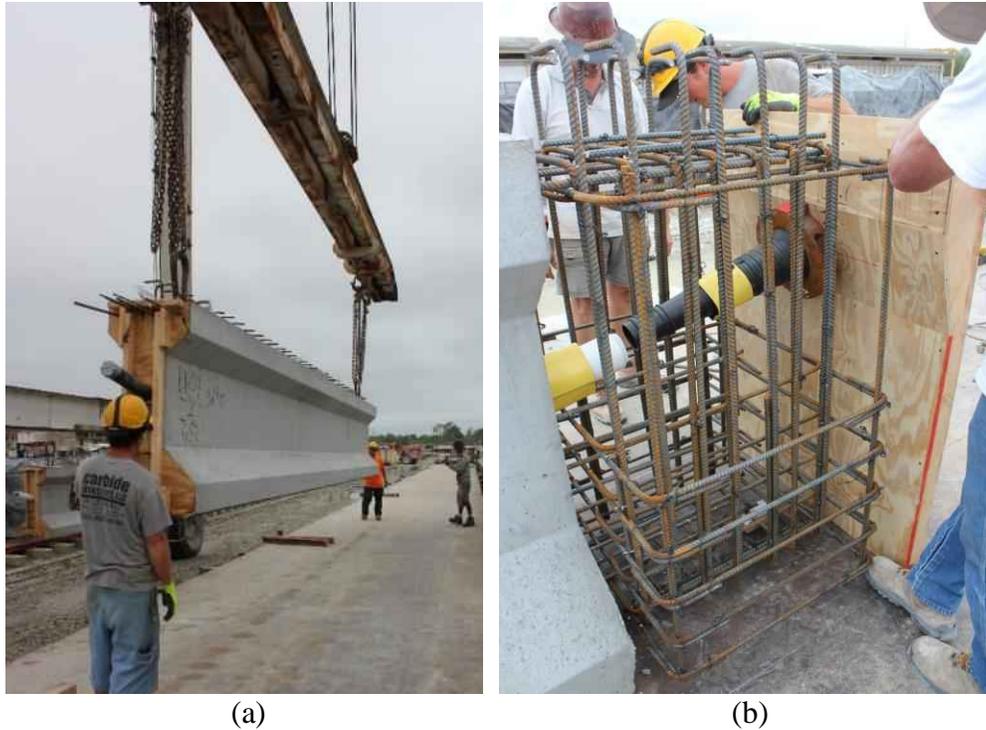
End-blocks (housing the post-tensioning anchorage hardware and additional reinforcement) were constructed on a separate steel bed at the prestressing yard (Figure 6-4), reusing the plywood formwork for consistency. Alignment of the anchorages was controlled by bolting the anchorheads to the wooden forms.

Figure 6-4 Specimen construction: (a) main span, (b) endblocks

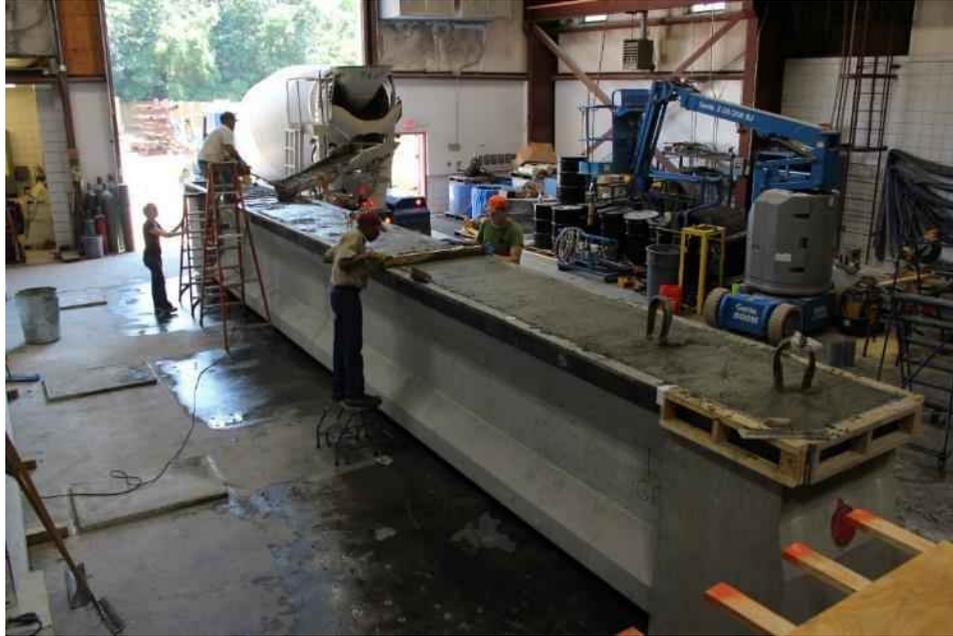
Internal specimens were topped with an 8-in by 34-in. deck, which was cast in the lab prior to post-tensioning (Figure 6-5). Longitudinal and transverse deck reinforcement was detailed in consideration of FDOT temperature and shrinkage requirements. The deck concrete was a self-consolidating concrete (SCC) mix with a specified compressive strength of 8.5 ksi; vibrators were used, however, because of the steel reinforcement congestion. Concrete cylinders (6 in. × 12 in.) were cast to test for compressive strength and modulus of elasticity.

Figure 6-5 Deck casting on internal specimens

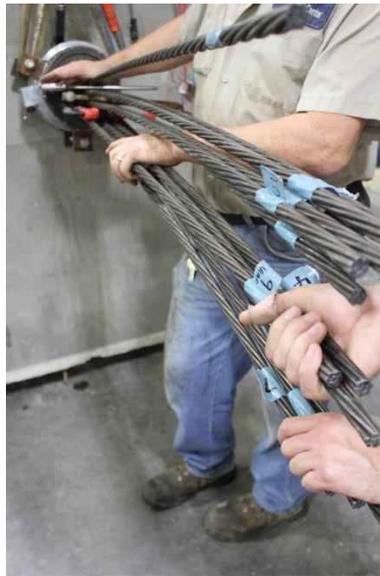
After the deck achieved the minimum specified compressive strength (8.5 ksi), the prestressing strands were hand-pushed into the specimen from the dead end, paying attention to install each strand in matching locations in the wedge plate; no effort was made to prevent strands from twisting around each other inside the specimen (Figure 6-6).

Figure 6-6 Strand pushing

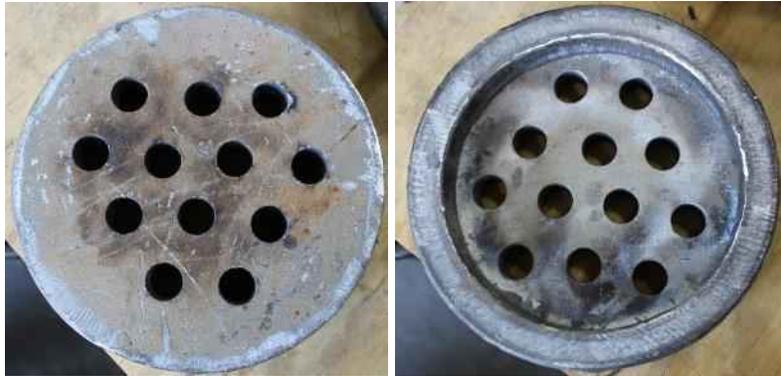
The tendon was stressed with a monostrand jack incrementally to a target prestress of  $0.8f_{pu}$ , or 46.9 kip/strand. A stressing plate was utilized to protect adjacent wedges (from the nose of the monostrand jack) during stressing of individual strands (Figure 6-7). During the

Figure 6-7 Stressing plate

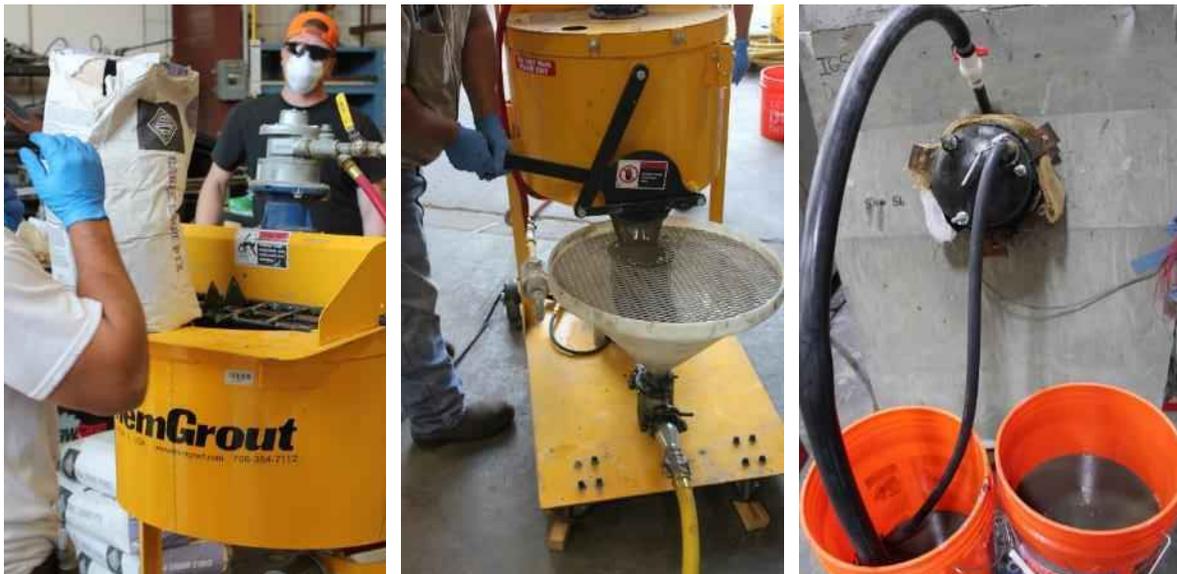
Specimen IGS was injected end-to-end with a commercially-available cementitious grout, Euclid Cable Grout PTX with a standard hopper-fed grout pump (Figure 6-10). The plastic grout tube typically supplied was not used. The inlet was a 3/4-in. dia. steel pipe in the top of the anchor; epoxy was used to secure the pipe. Vents were located at each nylon anchor cap and at the top of the anchor at the far end (3/4-in. dia. steel pipe).

Figure 6-10 Grouting operation: (a) feeding hopper, (b) uniform consistency, (c) at outlet

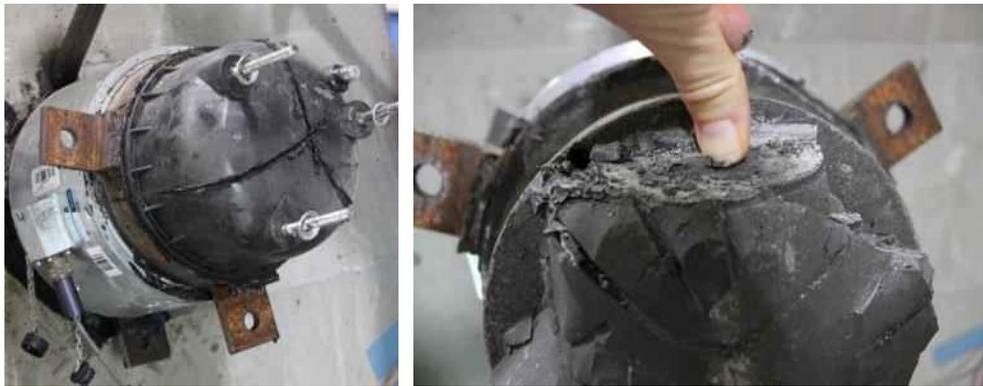
Visual observations were noted during the cap removal (Figure 6-11 and Figure 6-12). At the outlet cap (dead end), grout started to fall away, but appeared to fill most of the cap. A small void was observed at the very top, with a thin layer of soft grout (1/8-in. thick) at this void. The void was approximately 1-in. deep from the top of the cap. At the inlet cap, most of the grout was damaged during the cap removal. From earlier sounding of the nylon cap, however, it is assumed the inlet cap was completely full.

Figure 6-11 IGS Outlet (dead end) prior to and after cap removal

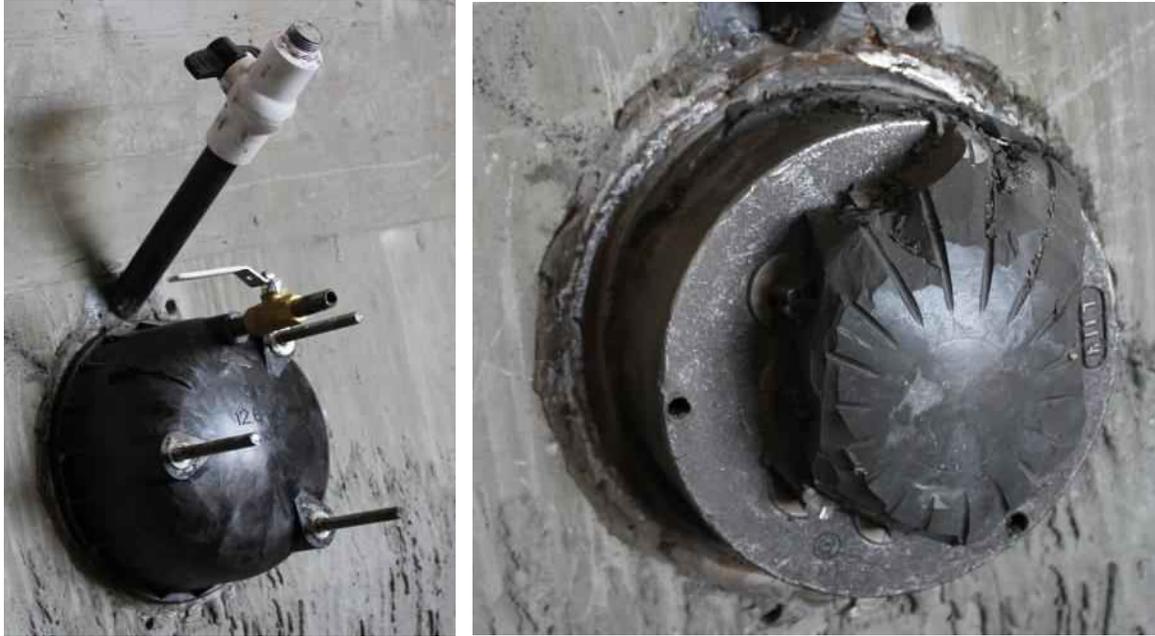
Figure 6-12 IGS inlet (live end) prior to and after cap removal (damaged)

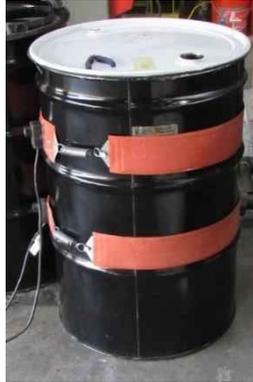
tendon. Strap barrel heaters were used to preheat the filler material (Figure 6-14Figure 6-40). The filler material was periodically stirred with a paddle mixer to ensure uniform temperature of the filler, and to prevent local overheating. Prior to connecting the injection hoses to the beam, filler material was pumped continuously into a spare bucket to evacuate air from the hoses and ensure good filler flow. Following heating of filler material and preparation of the pump, the pump line was opened to allow filler to flow into the tendon. Once the filler was observed to discharge from the vacuum line, that valve was closed. Pumping continued until the tendon was pressurized and the inlet valve was then closed. Pressure was monitored to ensure no pressure loss.

Figure 6-14 Heating flexible filler for injection

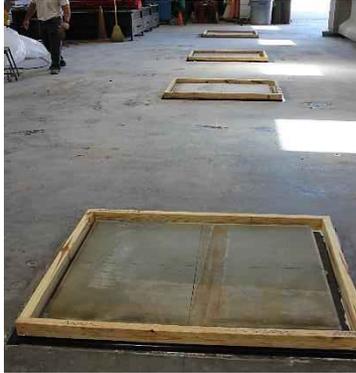
In preparation for casting the deviation blocks, a set of four level pads were placed in the lab; each pad was constructed with non-shrink cementitious grout (Lambert Corporation's Vibropruf #11) and 1-in thick steel plates (Figure 6-19). Precast segments were aligned and leveled on the grout pads, the reinforcement cage and diabolo void-former were installed, and the formwork constructed of plywood. Both deviators were cast from the same batch using a ready-mix self-consolidating concrete with 8.5 ksi specified compressive strength (Figure 6-20). Hand-held vibrators were used to consolidate the concrete. The top of the deviator block was trowel-finished and leveled to match the rest of the beam.

Figure 6-19 Grout pads for deviator blocks

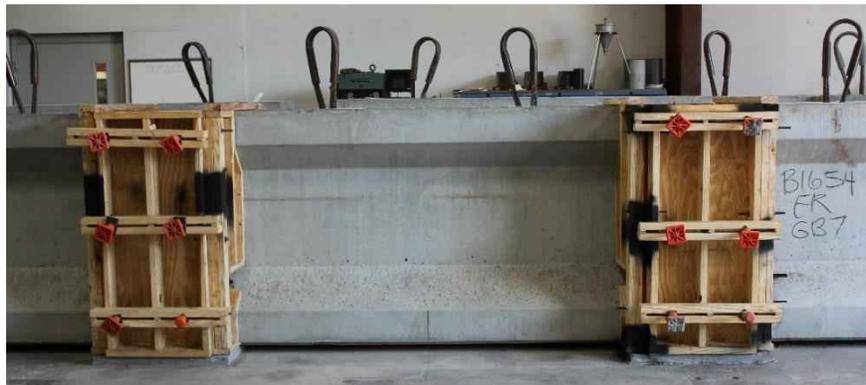
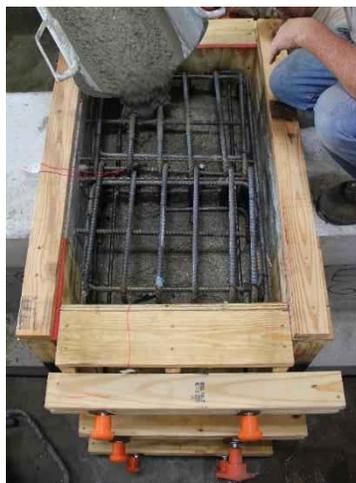
Figure 6-20 Deviator block (a) formwork and (b) concrete placement

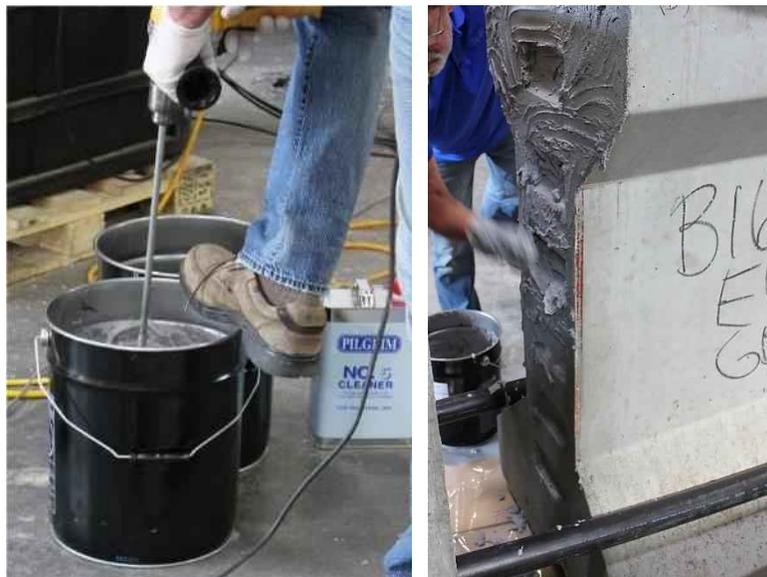
The epoxy was prepared according to the manufacturer's instructions. The two-part epoxy was mixed in a bucket with a drill mixer until achieving a uniform color and consistency (approximately 3 minutes). The epoxy was then applied by hand to both faces of the joint.

Figure 6-21 Epoxy application

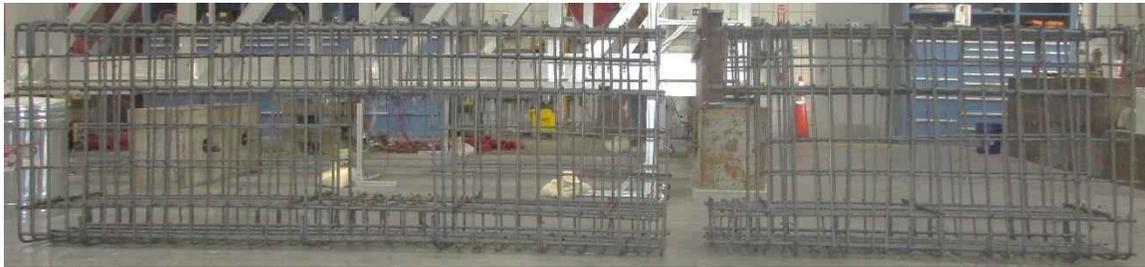
Formwork and reinforcement cage, including portions of the mechanical hinge, were fabricated separately for each of the two segments (Figure 6-24). The reinforcing bar arrangement was the same for both specimens. Cages were assembled upright using 2×4 bracing and plywood sheets for stability (Figure 6-25). The plywood sheets were used to support the longitudinal steel in the arrangement indicated on the construction drawings.

Figure 6-24 Reinforcement cage (a) schematic and (b) assembled
