# Replaceable Unbonded Tendons for Post-Tensioned Bridges

**Final Report**

**December 2017**

Florida Department of Transportation (FDOT)

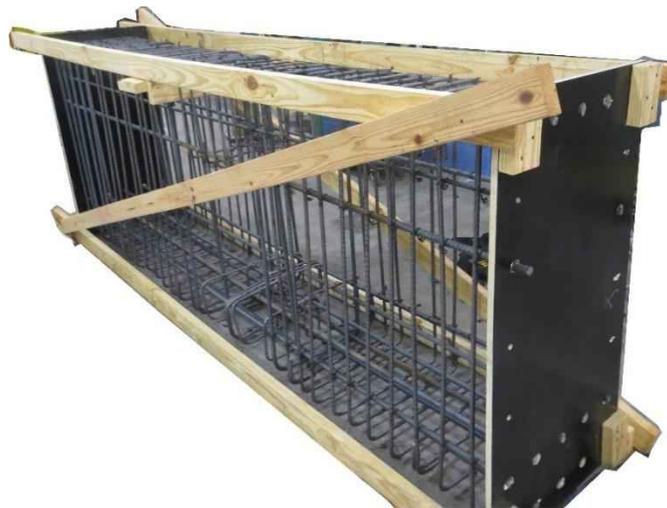
Formwork and reinforcement cage, including portions of the mechanical hinge, were fabricated separately for each of the two segments (Figure 6-24). The reinforcing bar arrangement was the same for both specimens. Cages were assembled upright using 2×4 bracing and plywood sheets for stability (Figure 6-25). The plywood sheets were used to support the longitudinal steel in the arrangement indicated on the construction drawings.

Figure 6-25 Reinforcing bar cage

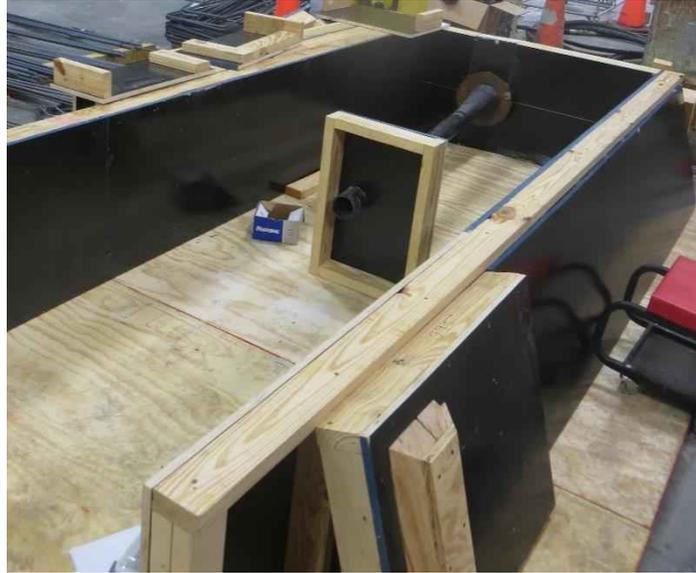
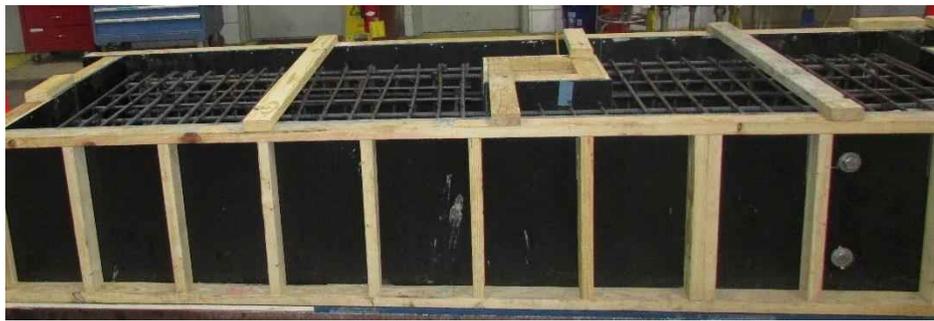
Formwork (Figure 6-26) was assembled separately from the reinforcement cage, consisting of 2×4 and plywood sections placed with the side face of the specimen on the floor. The reinforcement cage was placed inside of the formwork after assembly.

Figure 6-26 Fatigue specimen formwork (a) during assembly (b) after insertion of reinforcing bar cage

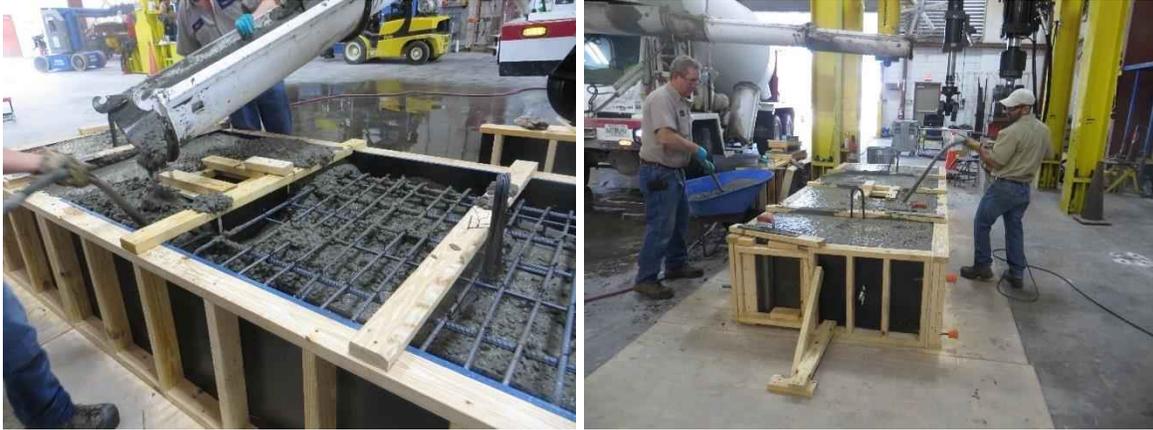
Each specimen was cast in separate segments. For F1, concrete was placed in the first segment and allowed to harden (Figure 6-27). The formwork for the second segment was then erected so that the concrete for the second placement was cast against that of the first segment. This was done to ensure a proper fit and alignment of the shear key. F2 (Figure 6-28) was also fabricated in two segments, but the concrete was placed for both segments at one time. Each segment was positioned flat on the floor to ensure proper alignment. Concrete in both specimens was consolidated with an internal vibrator. Slump tests were conducted before each concrete placement and concrete cylinders (4×8) were collected for 7-day, 14-day, 28-day and test-day compressive strength tests. Formwork was removed after 7 days of curing. Segments were then placed on steel supports in preparation for post tensioning (Figure 6-29).

Figure 6-27 Concrete placement of specimen F1

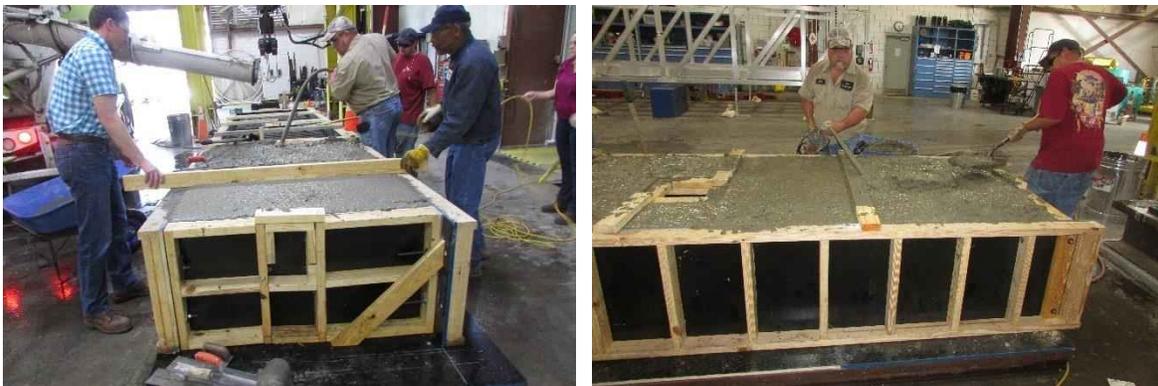
Figure 6-28 Concrete placement of specimen F2

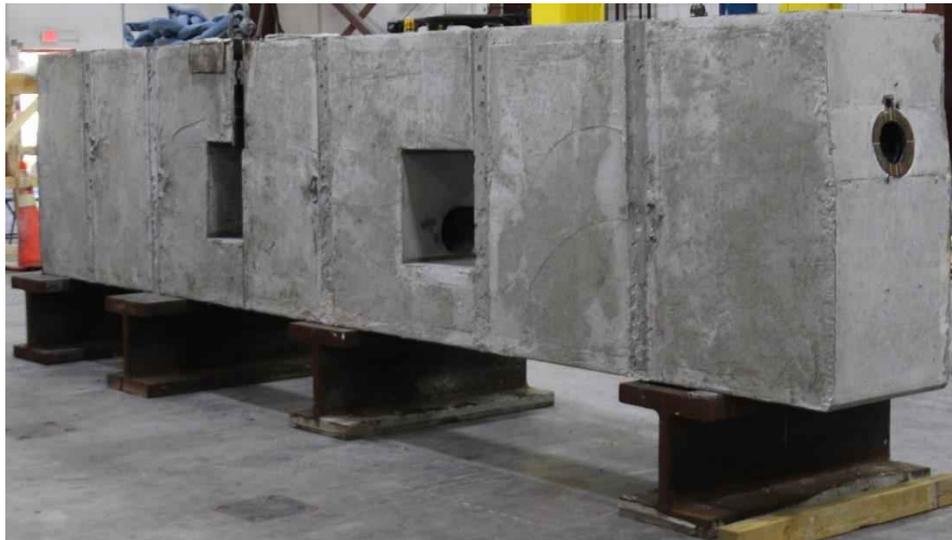
Figure 6-29 Completed fatigue specimen without post-tensioning

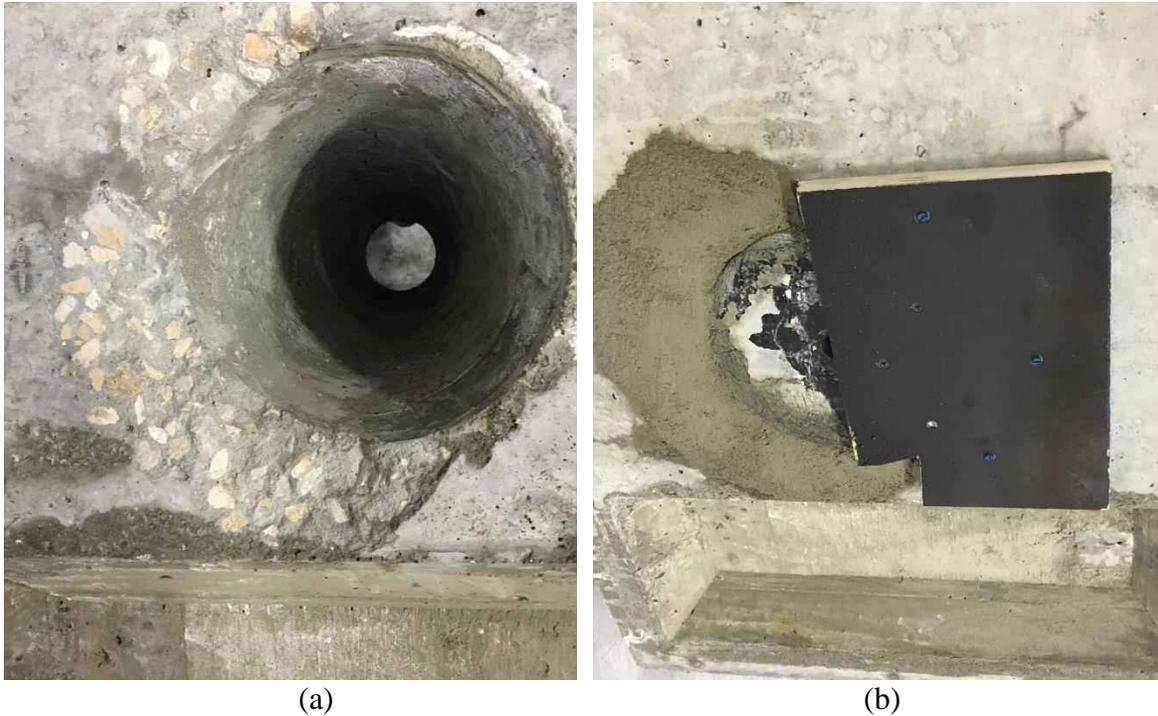
Figure 6-30 Specimen F1 after formwork removal (a) concrete spalling and (b) concrete repair

During formwork removal of specimen F1, concrete spalled locally around the south (dead) end of the diabolo deviator. The damaged concrete was immediately repaired with mortar (Figure 6-30) to ensure sharp edges that could potentially damage the duct were removed.

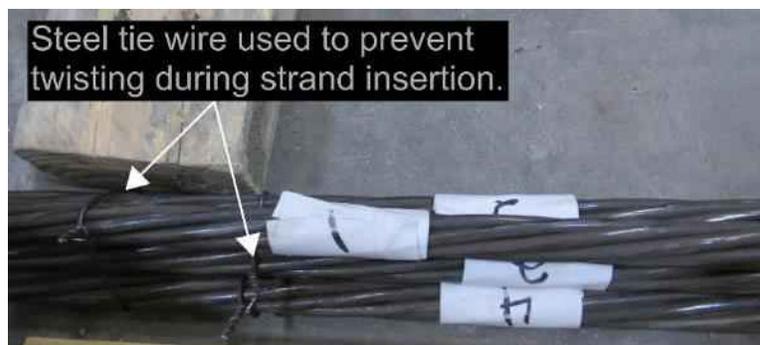
Once the specimen attained the specified 28-day compressive strength (6.5 ksi) the post-tensioning tendon was installed and stressed. The installation process was controlled to ensure that the strands were installed parallel and that they occupied the same respective position in the wedge plates at each anchorage. Prior to insertion, each strand was labeled using duct tape at both ends to match their corresponding wedge plate position (Figure 6-31). The strands were also tied at both ends with steel tie wire to prevent twisting during installation. The strand bundle was pushed in by hand (Figure 6-32) and arranged to match their intended position in the wedge plate. Steel tie wires were removed from the strands after tendon was inserted. Post-tensioning of both specimens was done by individually stressing each strand with a monostrand jack (Figure 6-33).

Figure 6-31 Strand labeling and steel ties

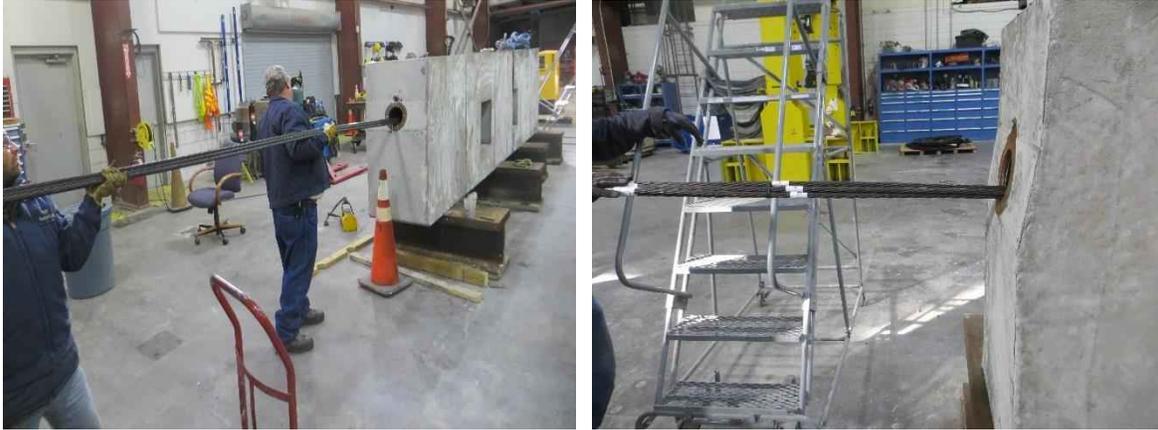
Figure 6-32 Strand installation

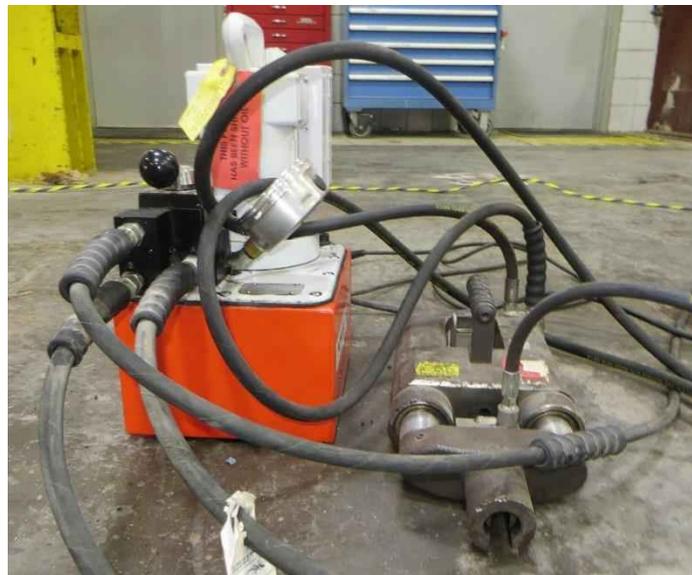
Figure 6-33 Monostrand jack

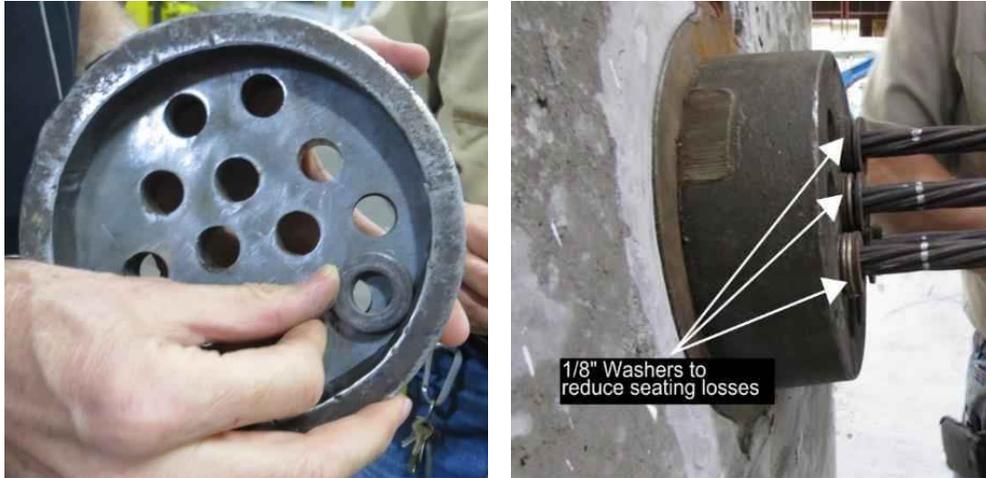
Figure 6-35 Washers to reduce seating losses

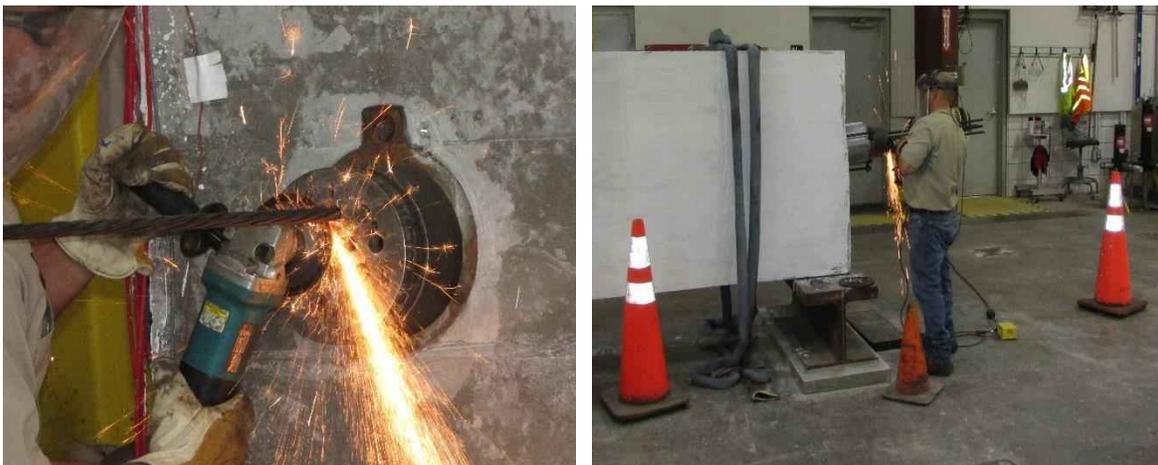
At the end of the post-tensioning procedure the strands protruding at the live end and dead end were cut with a circular saw to 1.5 in. from the anchor head (Figure 6-38).

Figure 6-38 Strand cutting after post-tensioning

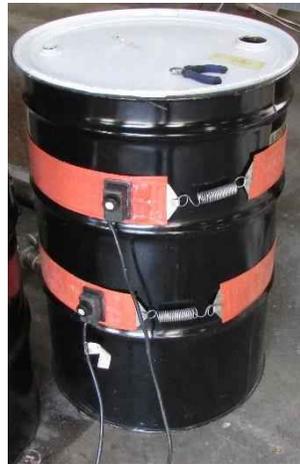
In preparation for injection, the filler was heated using strap barrel heaters (Figure 6-40) until the temperature was 220 degrees F. The filler material was periodically stirred to ensure uniform heating and prevent overheating.

Figure 6-40 Heating barrel containing flexible filler for injection

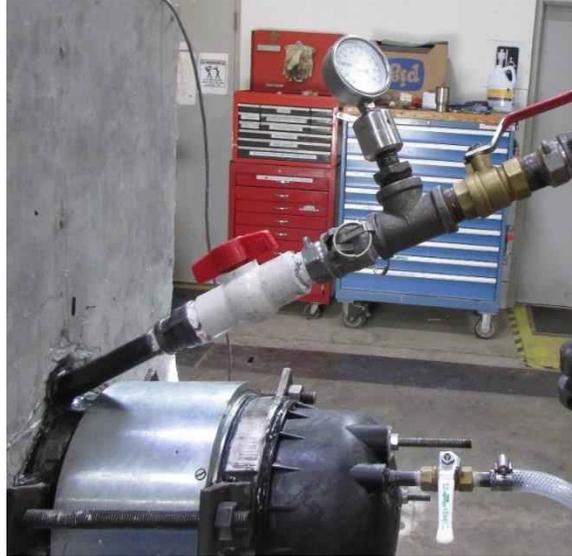
After the filler material had been sufficiently heated, pressure and vacuum tests were conducted on each specimen. The tendon was pressurized to 50 psi and the test was considered successful if the pressure drop after one minute was less than 25 psi (Figure 6-41).

Figure 6-41 Pressure test for specimen

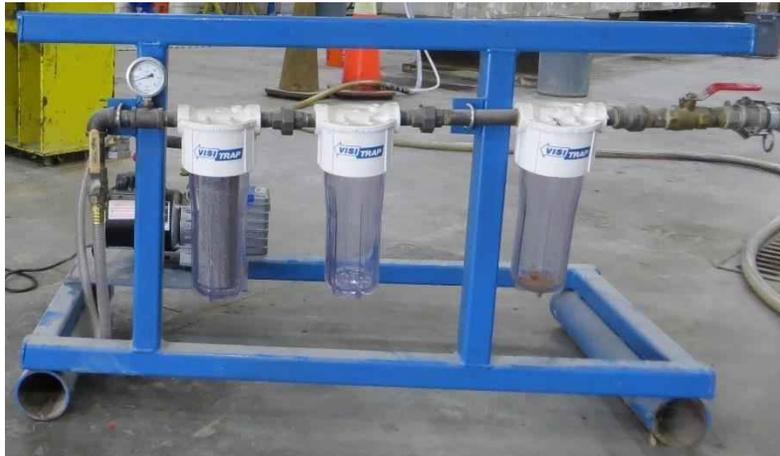
The vacuum test was performed by creating a vacuum in the tendon of target gage pressure of -28 in. Hg. and was considered successful if the no more than 10% vacuum loss occurred after 1 minute (Figure 6-42). Leaks found during the test were repaired using generic methods (Figure 6-43).

Figure 6-42 Vacuum for filler injection

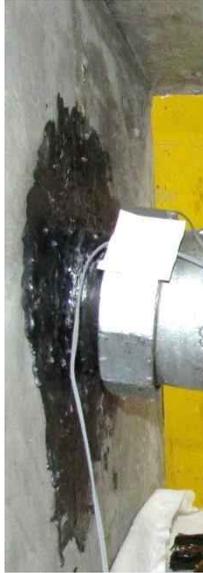
Figure 6-43 Sealant placed on concrete around HDPE pipe

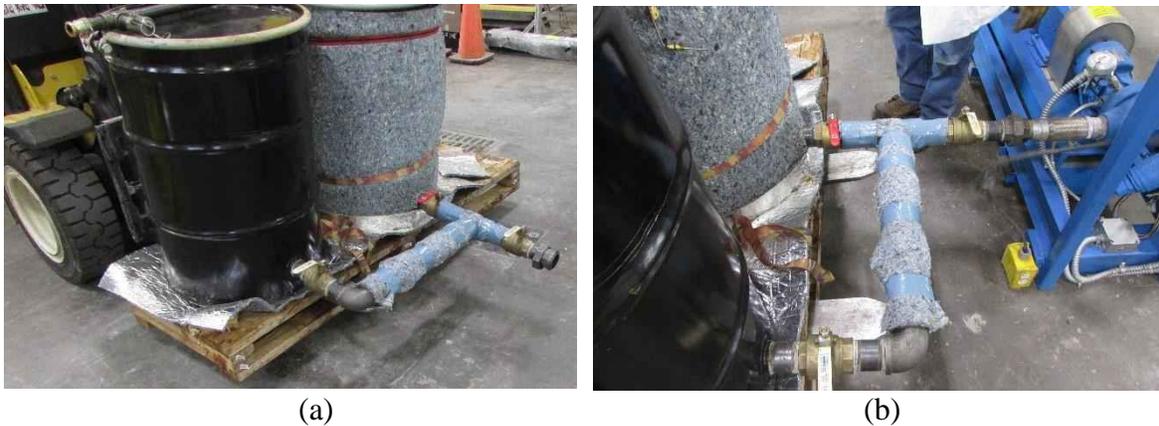
Once all the tests associated with the pre-injection process were passed, the injection process began. The barrel containing the heated filler was placed adjacent to the centrifugal pump (Figure 6-44). The barrels were aligned and then connected to the centrifugal pump. A return line was also placed in an empty barrel to discharge filler if necessary.

Figure 6-44 Positioning of filler barrels (a) transporting filler barrel and (b) centrifugal pump connection

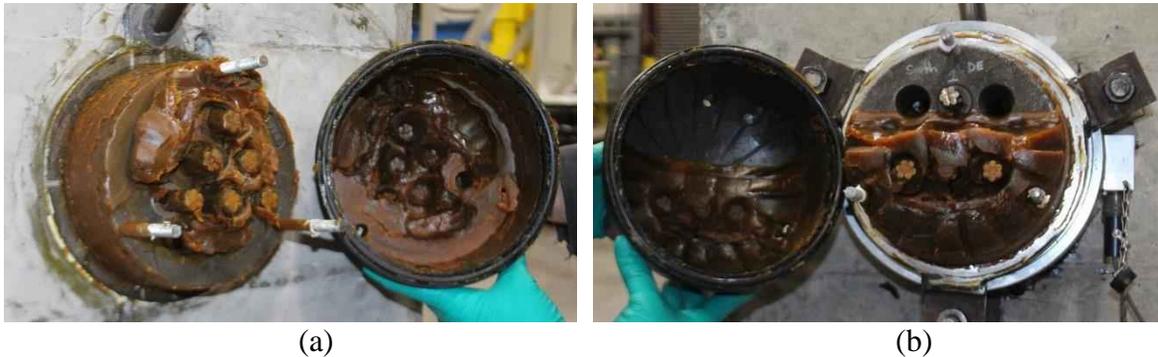
The filler was allowed to cool for 24 hours and then visual observations were noted after cap removal for each specimen. In F1, cap at the live end was full, but approximately half of the dead end cap was full (Figure 6-45).

Figure 6-45 F1 anchor after injection at (a) live end and (b) dead end

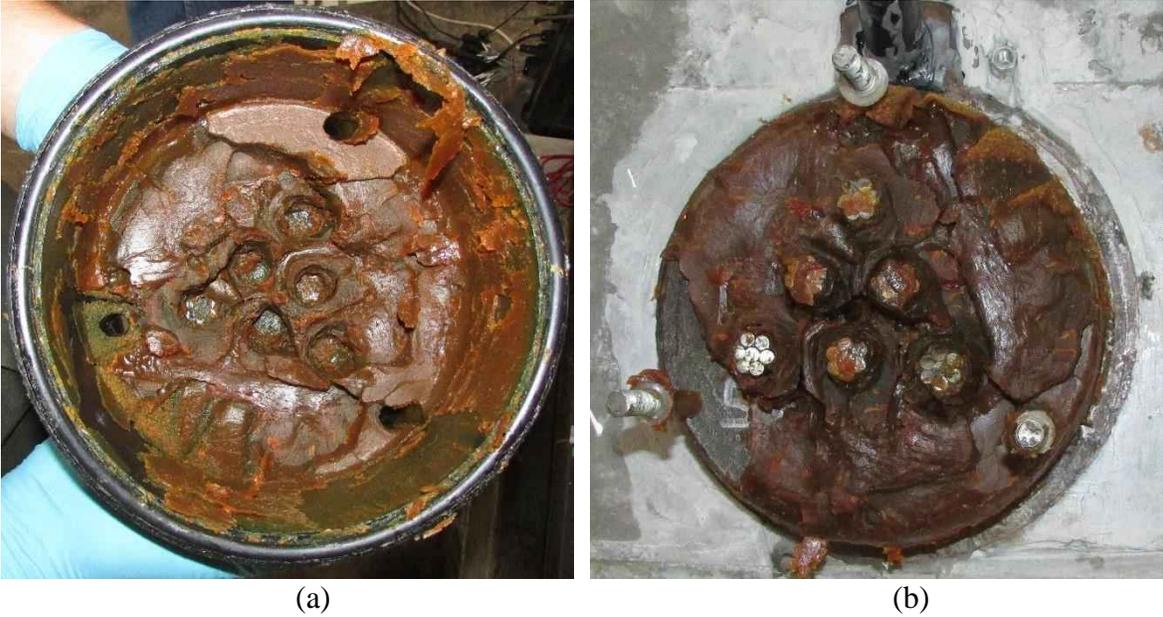
Figure 6-47 F2 live end anchor after injection

siphoning after injection. It is recommended to elevate the hose above the connection at all times during injection to better fill the cap.

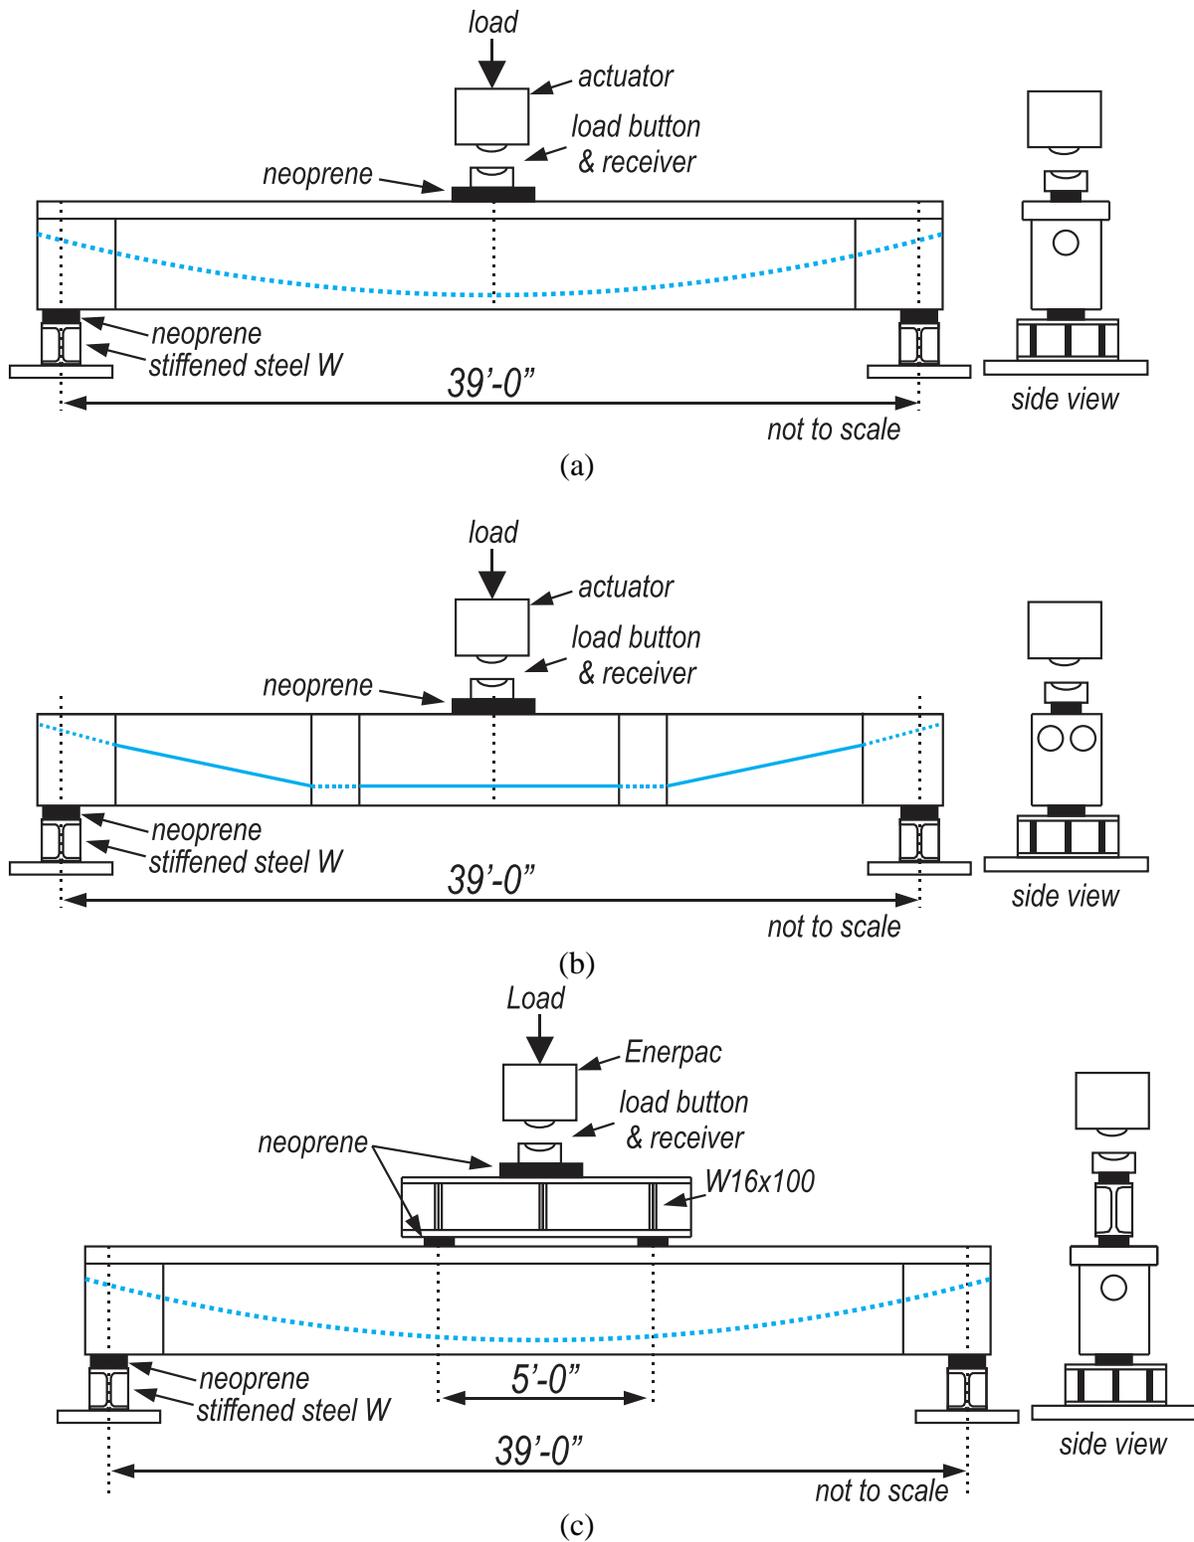
Figure 7-1 Flexural test set-up: (a) IGS, IWS; (b) EWS; and (c) IWC

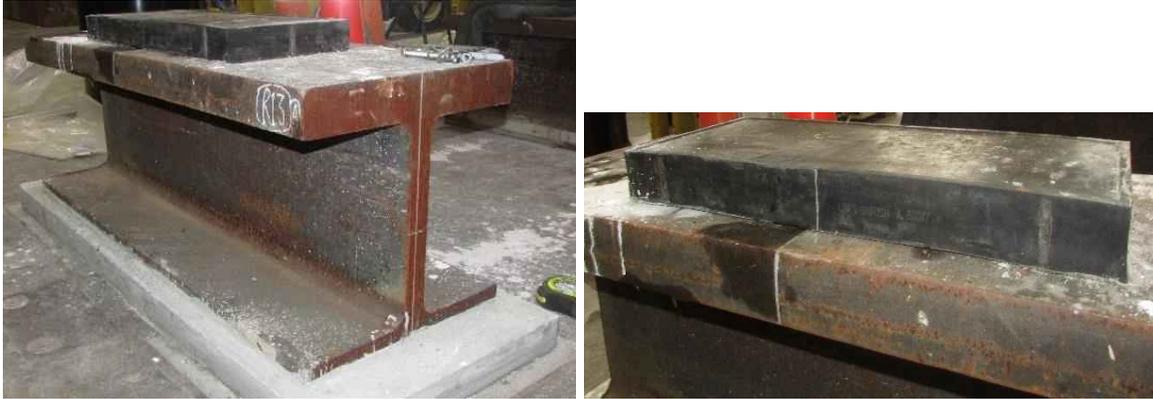
A W-shape steel section (Figure 7-4) was grouted to the floor to ensure that the specimen would not move laterally or twist during the test. A 1 in. thick grout pad was placed to ensure each specimen was level. Two 10 in.  $\times$  24 in.  $\times$  2in. neoprene bearing pads were used to support the specimen on top of two W sections; pads were arranged so that the bearing length was 10 in. The bearing pad allowed for small rotations and small horizontal movements without generating significant reactions.

Figure 7-4 Specimen support (a) steel W section on top of 1-in. grout pad (b) neoprene pad

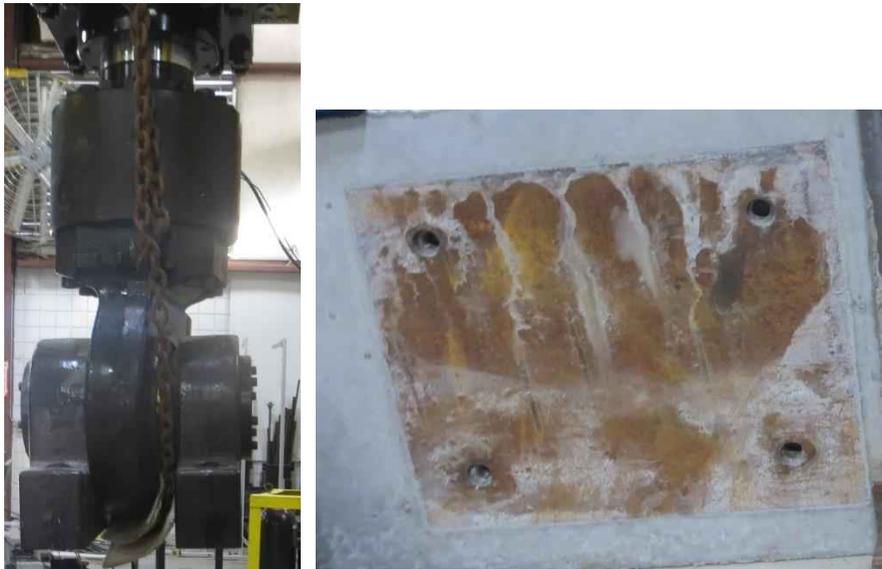
A Shore Western 926E-104/154-10(0)-5-2348 fatigue rated actuator (Figure 7-5) with a static capacity of 460 kip was attached to the specimen using 1 in. dia. steel bolts threaded into a steel plate embedded in each specimen.

Figure 7-5 (a) Shore Western actuator (b) steel bearing pad for actuator

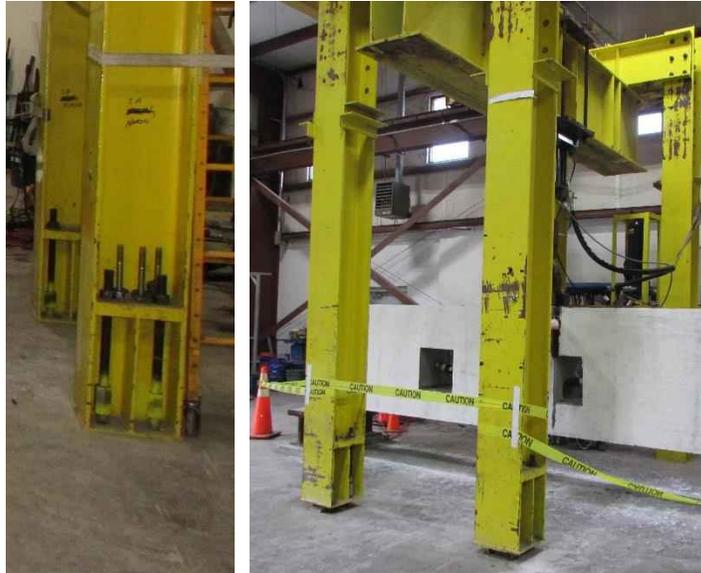
The testing frame (Figure 7-6) was bolted to a reinforced concrete strong floor at the FDOT Structures Research Center. Columns of the testing frame were made up of four W14x90, double W21x73 spreader beams and a double W36x150 jacking beam.

Figure 7-6 Testing frame

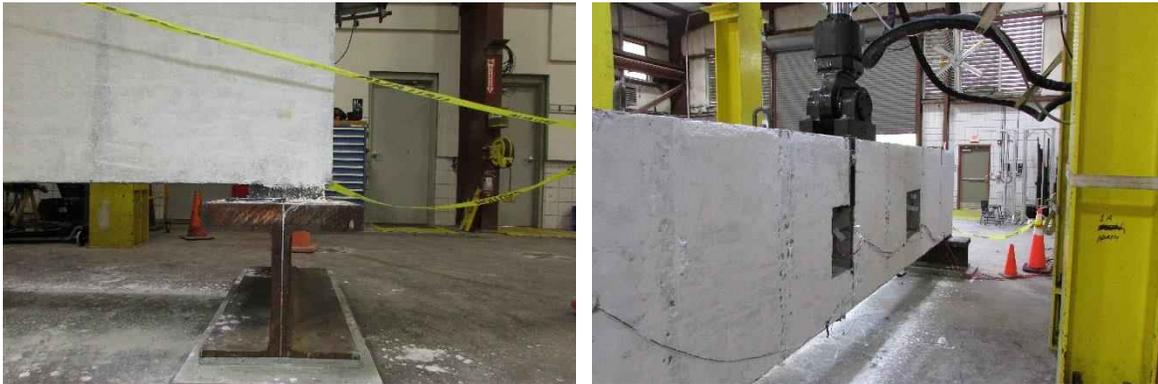
The specimen was moved into the testing frame in preparation for loading as shown in Figure 7-7. Once in place, the actuator was bolted loosely (Figure 7-8) to the specimen in preparation for static and cyclic loadings.

Figure 7-7 Fatigue test set-up

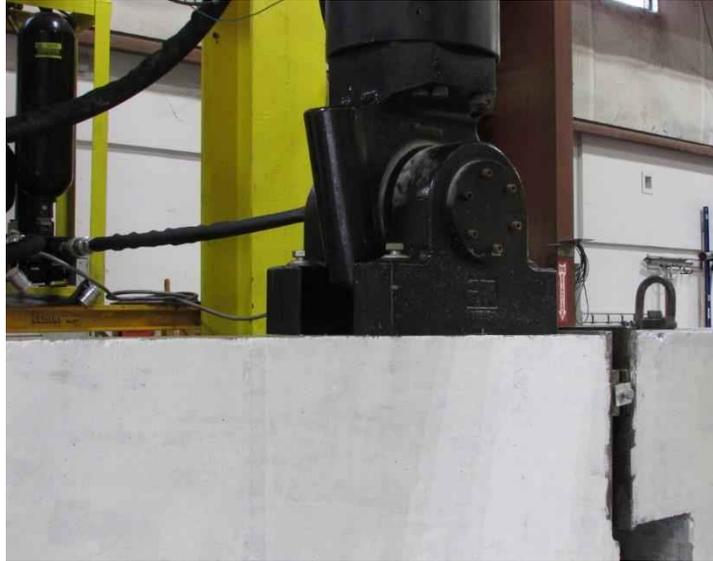
Figure 7-8 Actuator connected to fatigue specimen

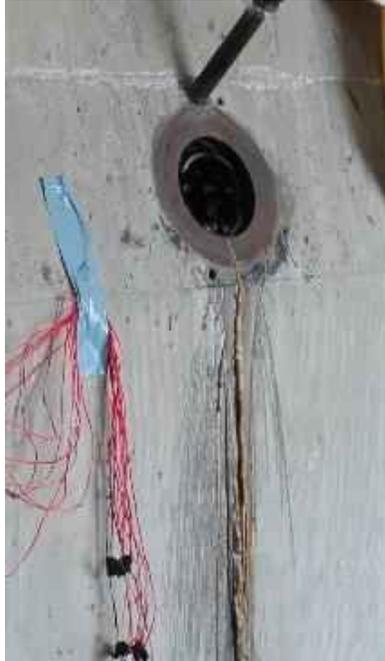
Figure 8-2 End of beam where wedges were torched

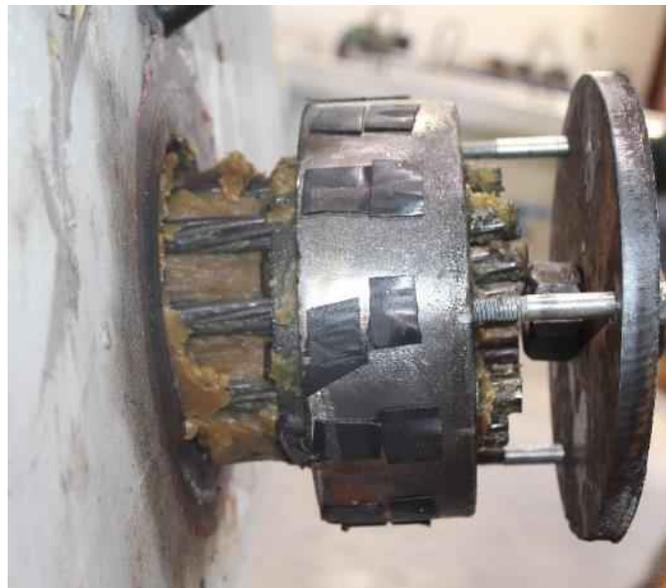
To allow easier access to the anchorages, the beam was placed on the lab floor for the duration of the tendon replacement. After detensioning, the tendon was pulled from the non-torched anchorage in two stages: 1) with a hollow-core actuator and hand-pump and 2) with a chain attached to a forklift. During the initial pull, a tension ring was installed in-line with the tendon and care was taken to pull concentric to the tendon (Figure 8-3). The force required to break the tendon free (overcome friction) was monitored while pressure was applied with a hand-pump to the actuator (Figure 8-4); the maximum recorded load to overcome friction was 730 lbs.

Figure 8-3 First tendon pull

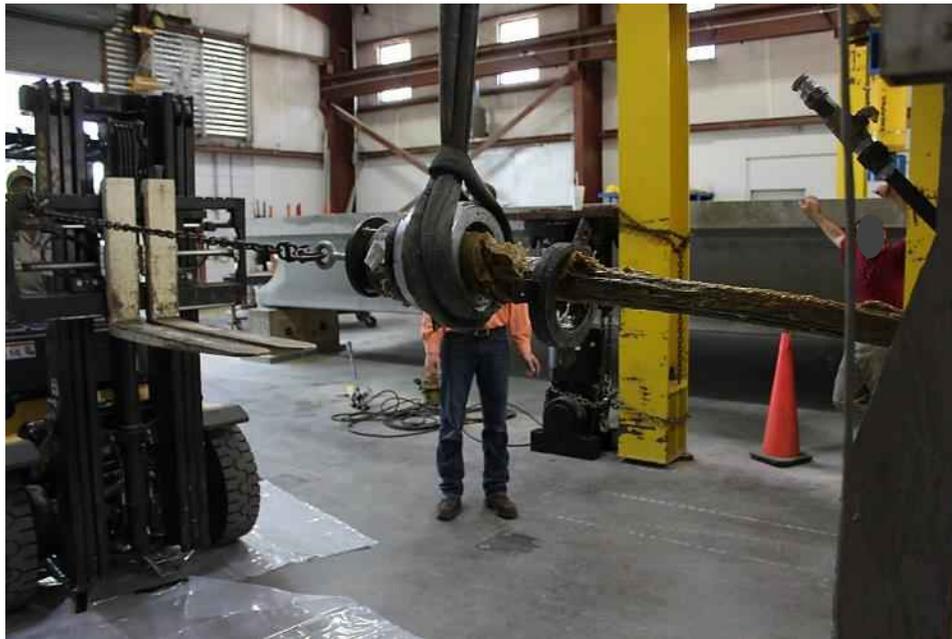
To fully remove the tendon, an eye-hook and chain were attached to the wedge plate. The tendon was pulled via the chain with a forklift (Figure 8-5), removing the wedge plate, wedges, load cell and strand as a connected unit.

Figure 8-5 Tendon removal

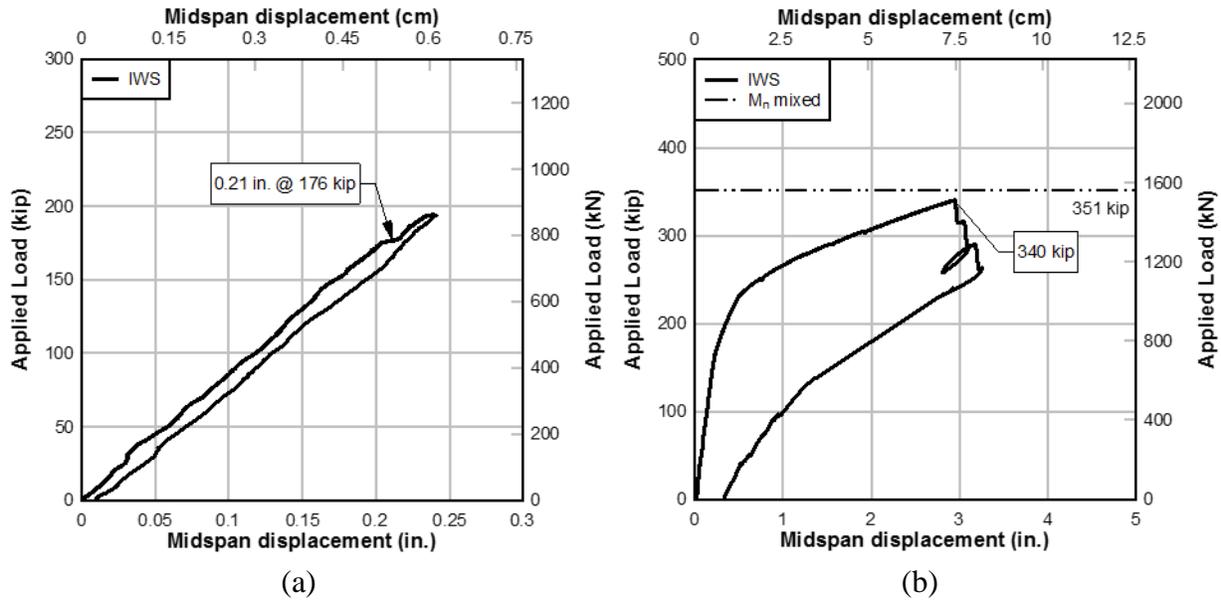
Figure 10-5 IWS (a) elastic behavior and (b) ultimate strength behavior

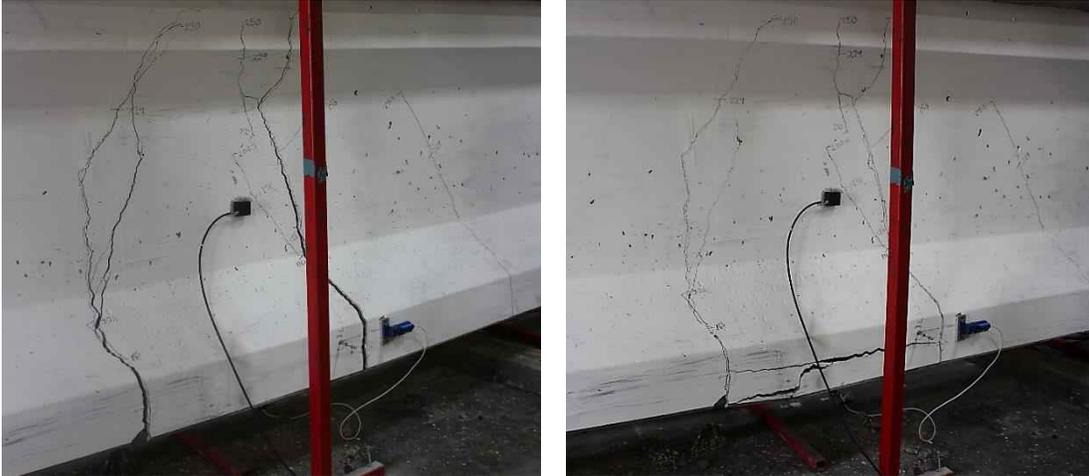
Figure 10-7 Cracking (a) after strand rupture, load held at 240 kip and (b) after load removed

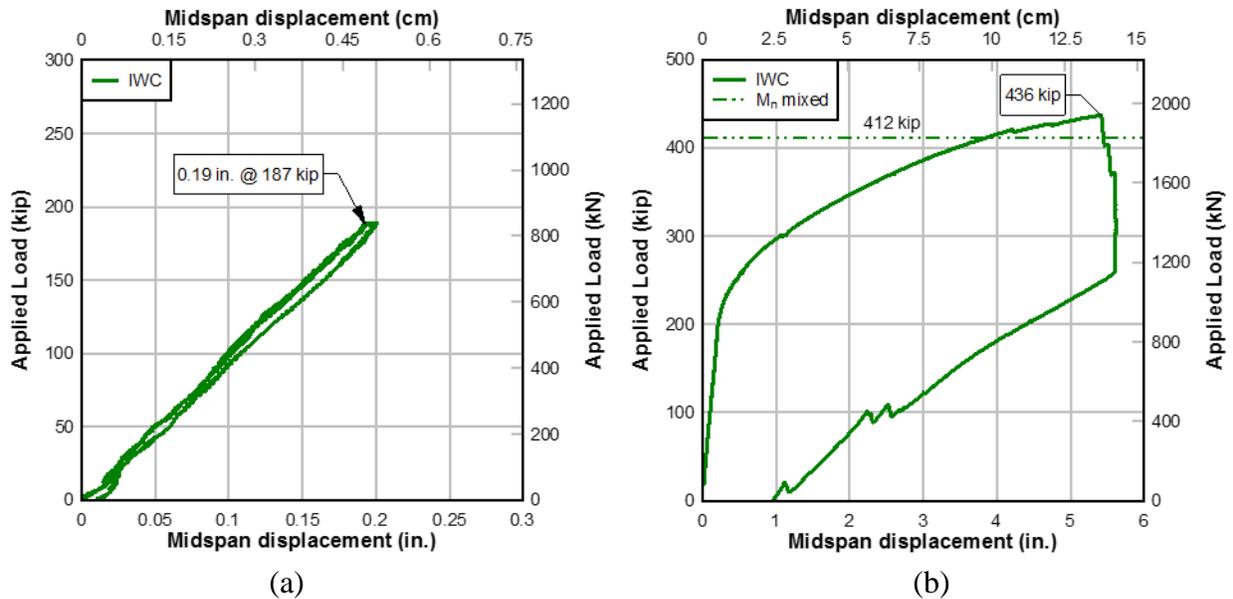
Figure 10-12 IWC (a) elastic behavior and (b) ultimate strength behavior

A four-point bending flexure test was performed on specimen IWC. The load-deflection plots shown in Figure 10-12 show the (a) elastic and (b) ultimate behavior. The applied load indicated by the reference line labeled  $M_n$  was calculated using AASHTO-LRFD Equation 5.7.3.1.3b, which provides a simplified approach for an approximation of the ultimate tendon stress for members with mixed tendons; *specified material strengths and 20% PS losses* are assumed for this calculation.

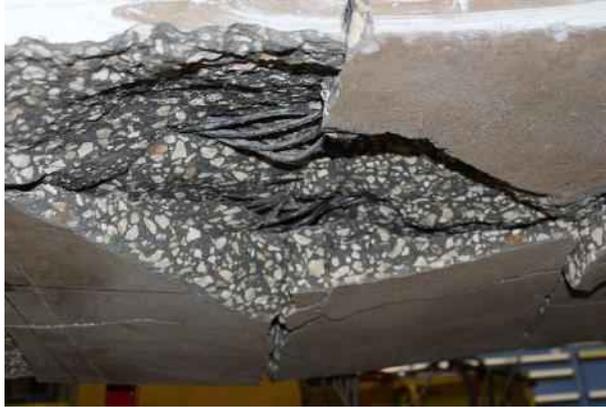
At approximately 436 kip, maximum load was reached at 5.5-in. of vertical displacement when a series of three loud pops occurred in succession indicating rupture of the bonded strand, accompanied by load drops of approximately 32.5 kip per event. Following the third strand rupture, the applied load was approximately 339 kip. Shortly after attempting to resume to load application, deck rupture occurred near a load point (Figure 10-13). Post-mortem inspection revealed that all three bonded strands located in the bottom flange had ruptured (Figure 10-14).

Figure 10-14 IWC: ruptured bonded strands

In the ultimate load tests of mixed tendon specimens IWS and IWC, however, the opening of a primary crack under the load points – and exposure of the unbonded tendon - prevented additional flexural cracking, concentrating the strain of the bonded reinforcement to the primary crack location, which led to strand rupture prior to the compressive failure of the deck. Both specimens IWS and IWC experienced steel rupture of the bottom prestressing strand at the primary crack location (the crack observed to open widest) at ultimate strength (Figure 10-10; Figure 10-14).

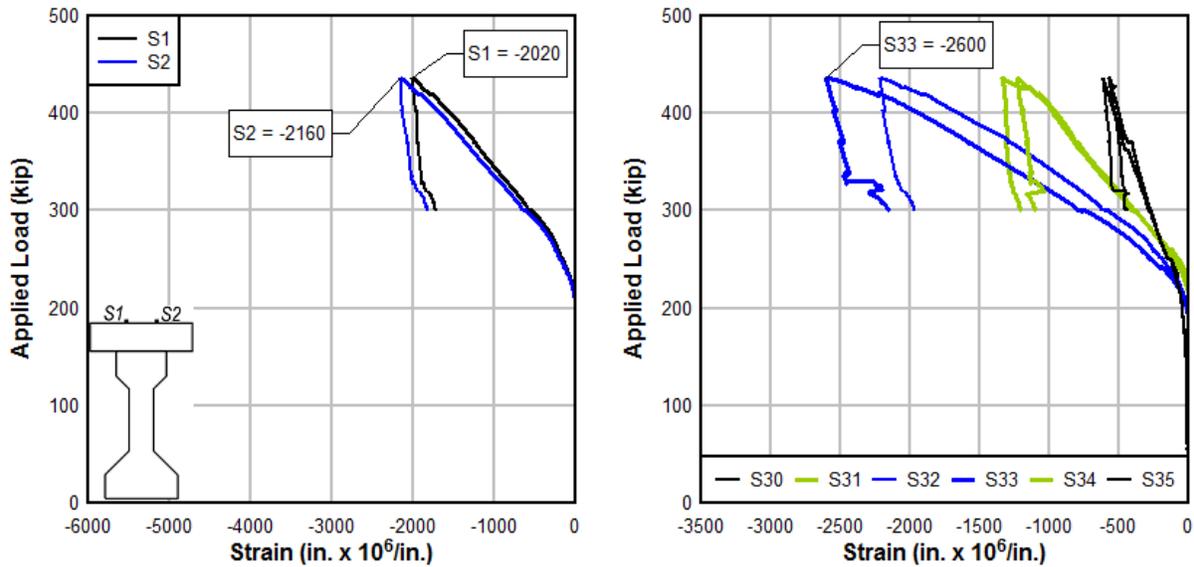
Figure 10-15 IWC: deck strain (a) at midspan and (b) along top of deck

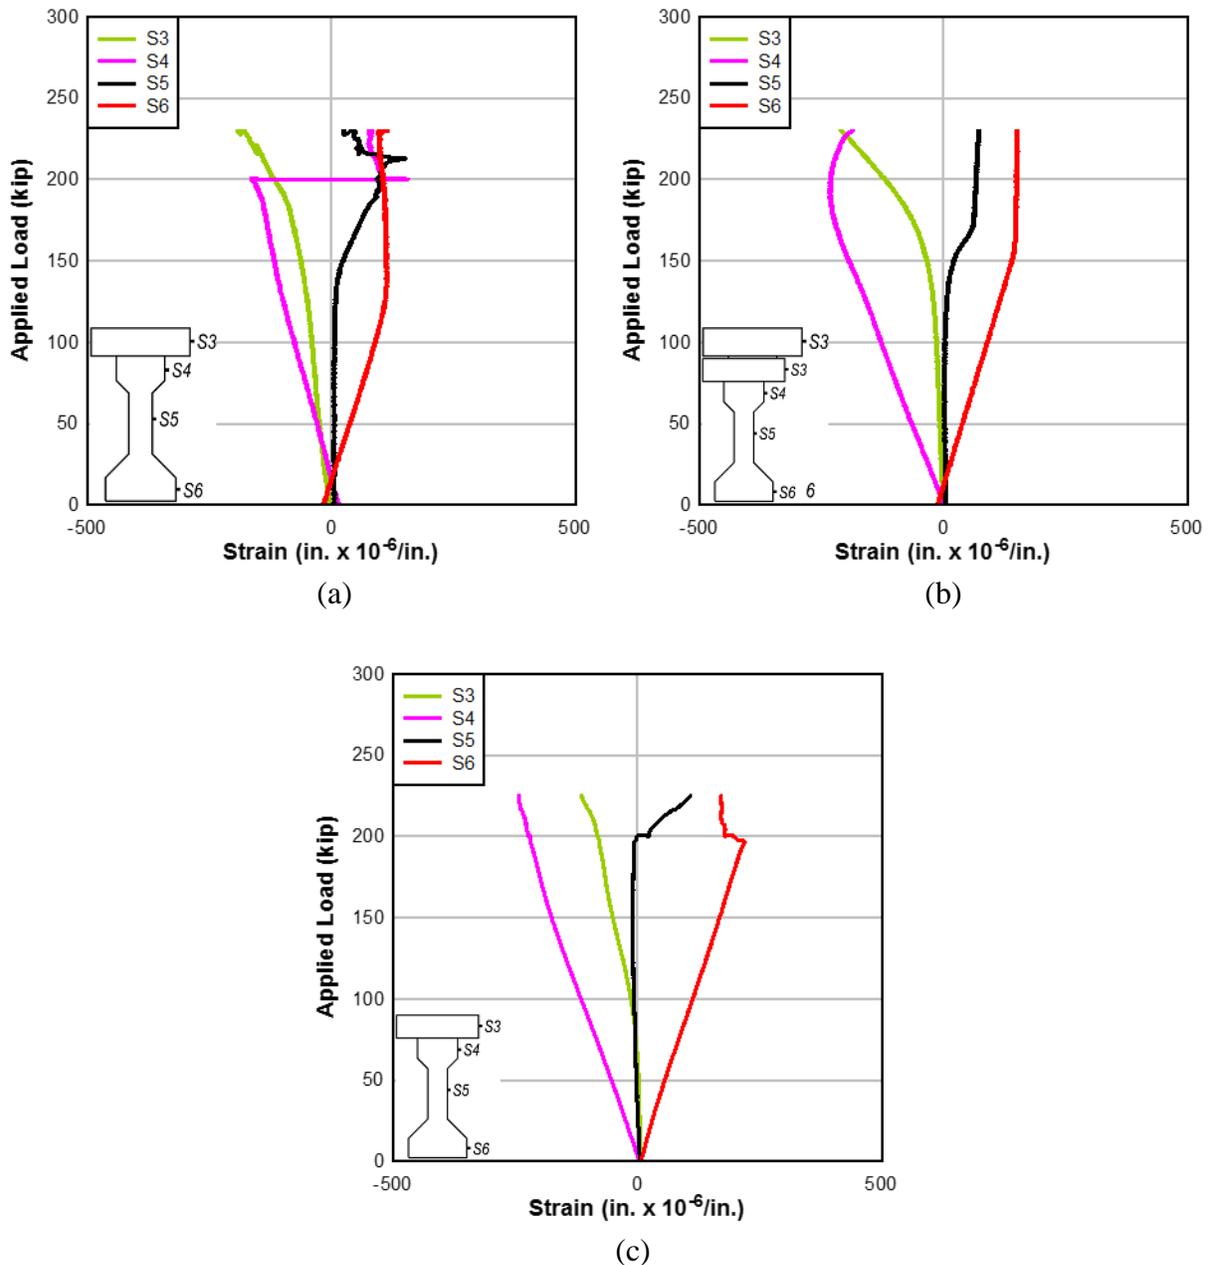
Figure 10-18 Strain along profile at load point (a) IGS, (b) IWS, (c) IWC

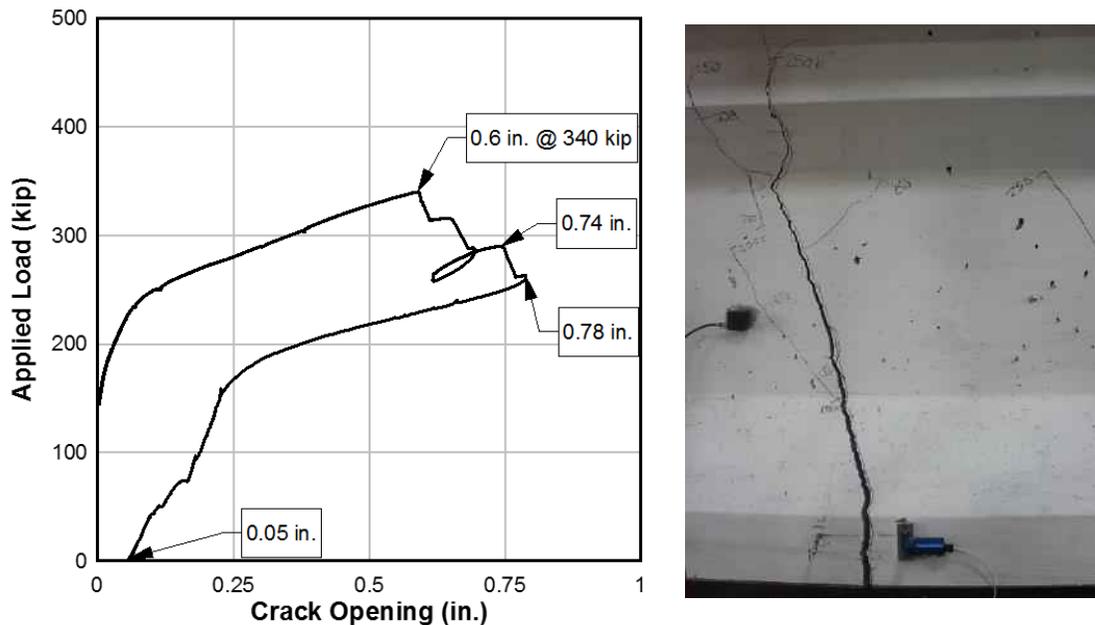
Figure 10-22 IWS: string-pot measuring a primary crack

To quantify the crack opening in IWS, a string-pot was added after identifying an assumed primary crack (Figure 10-22). Figure 10-20 shows the applied load versus the instrumented crack; a second crack was visually observed to open a similar width during the test. At maximum load, the instrumented crack had opened 0.6 in.; rupture of the bonded strand at the bottom of the beam caused the crack to open to 0.8 in. Assuming that the other primary crack opened an equivalent amount, the total crack widths at ultimate can be estimated as 1.2 in. – or a stress increase (due to applied load) of approximately 70 ksi – the same tendon stress increase as measured by the hollow-core load cell (72 ksi; Figure 10-21). While this provides a validation method for determining the load cell’s accuracy at measuring a change in tendon force, it does not eliminate the possibility of initial offset or drift.

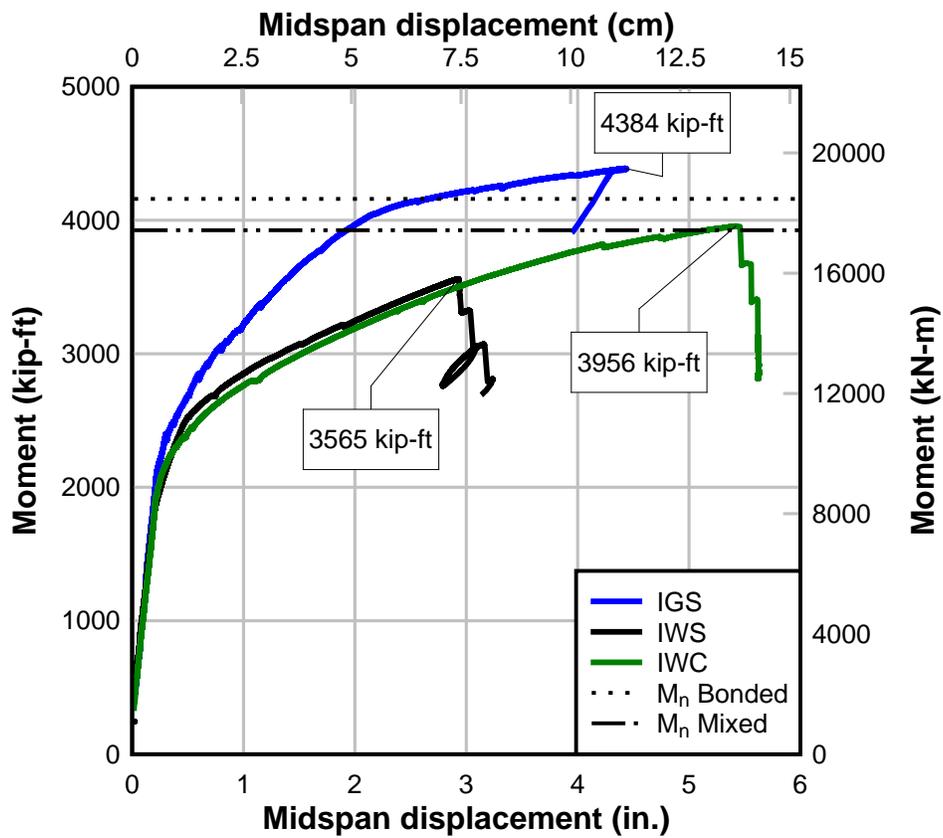
Figure 10-23 Flexural strength: internal tendon specimens
